6 BEFORE THE CALIFORNIA
7 STATE WATER RESOURCES CONTROL BOARD

8 JON AND DEANN GREEN)
9)
10) Petitioner,) PETITION FOR REVIEW
11) and)
12) [Cal. Water Code §13320]
13) CALIFORNIA REGIONAL WATER)
14) QUALITY CONTROL BOARD - NORTH)
15) COAST REGION)
16) Respondent.)

Subject: Notice of Violation for Failure to Comply with Active Regional Board Orders and for New Basin Plan violations, and Order Requiring Technical Reports Investigating New Sources of Waste Discharge pursuant to California Water Code (Water Code) Section 13267(b)

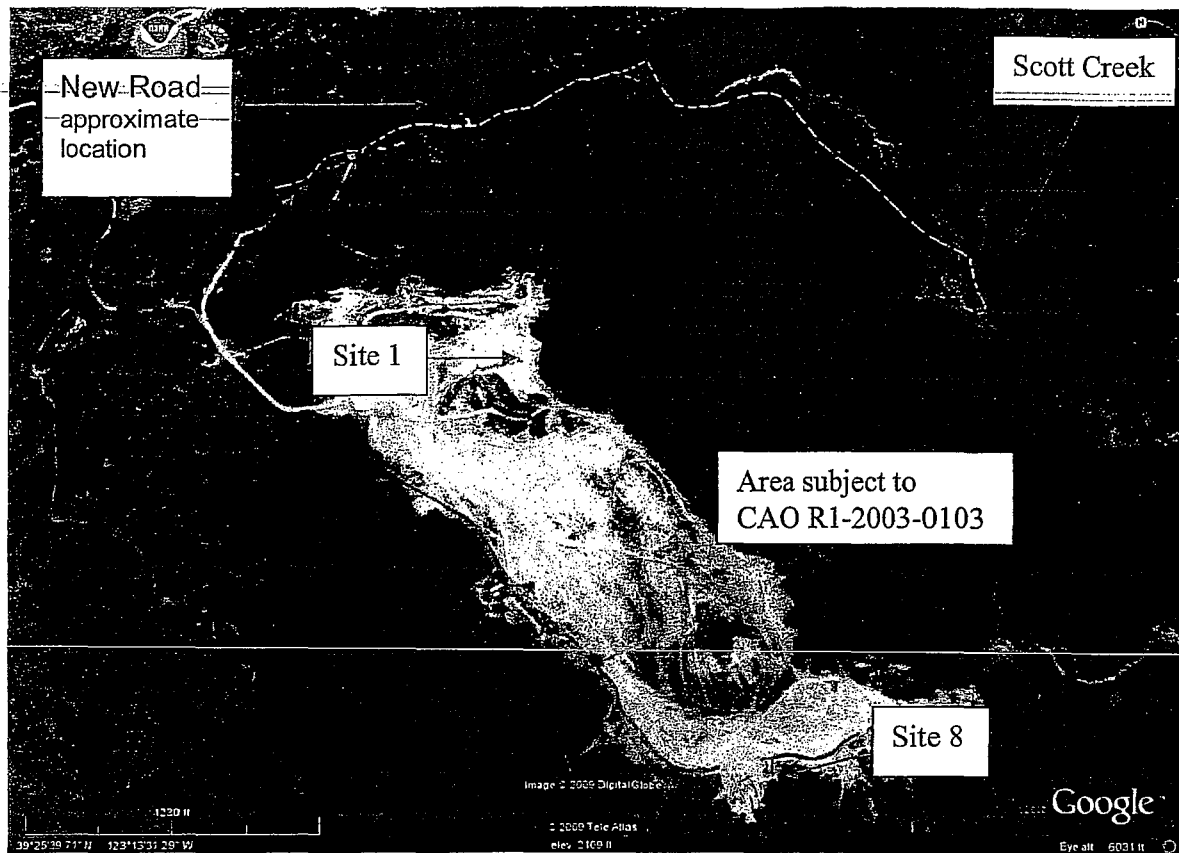
Photo of the portion of Green property subject to the Regional Board CAO. Sites 1 and 8 are identified. The new road is approximately located from Google Earth

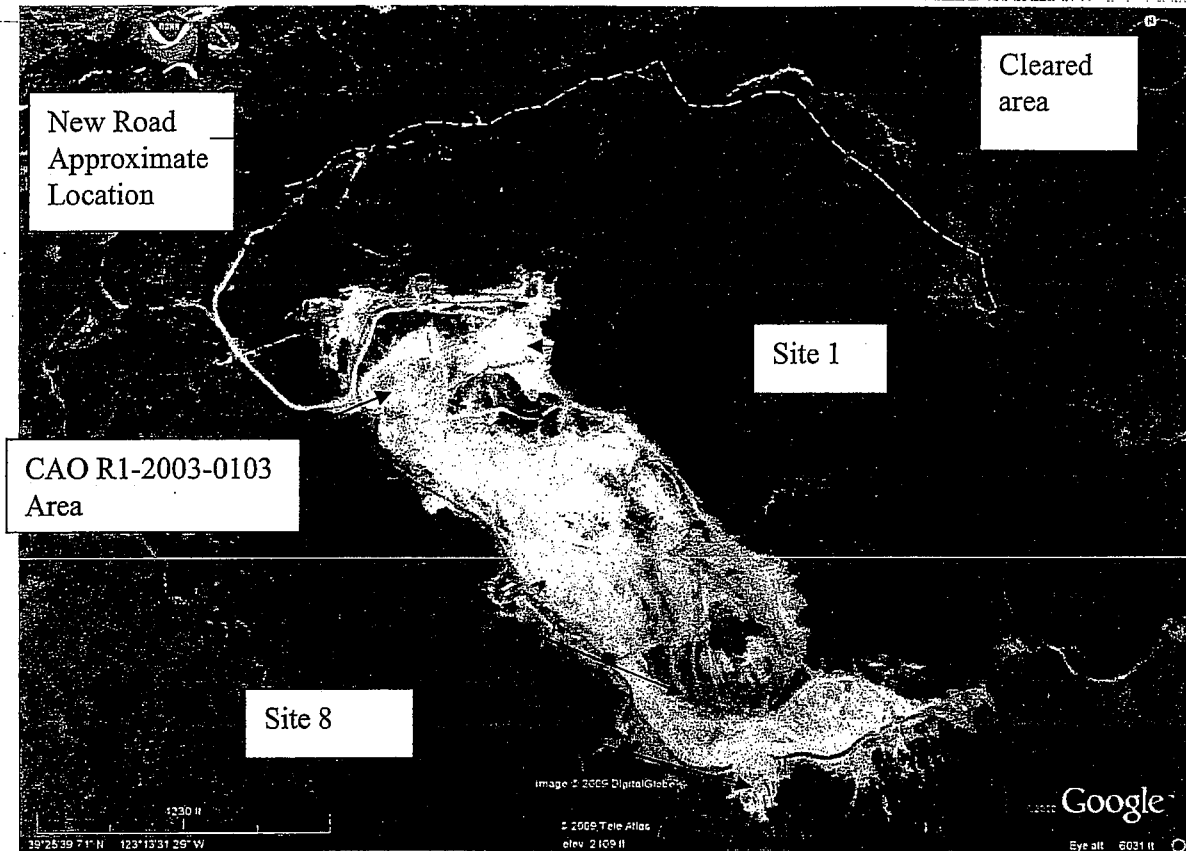
Green Property an overview from Google Earth. The sites reviewed are identified with arrows for further discussion in the body of this report.
