Los Angeles Regional Water Quality Control Board

NOTICE OF VIOLATION: FEDERAL WATER POLLUTION CONTROL ACT SECTIONS 301 AND 401, AND PORTER COLOGNE WATER QUALITY CONTROL ACT SECTIONS 13260, 13376, and 13385(a)(1) and (5) FOR PROPERTIES LOCATED IN SANTA SUSANA MOUNTAINS, PARCELS 2821009030, 2821009031, and 2821009023; LOS ANGELES COUNTY

October 17, 2016 Inspection Report

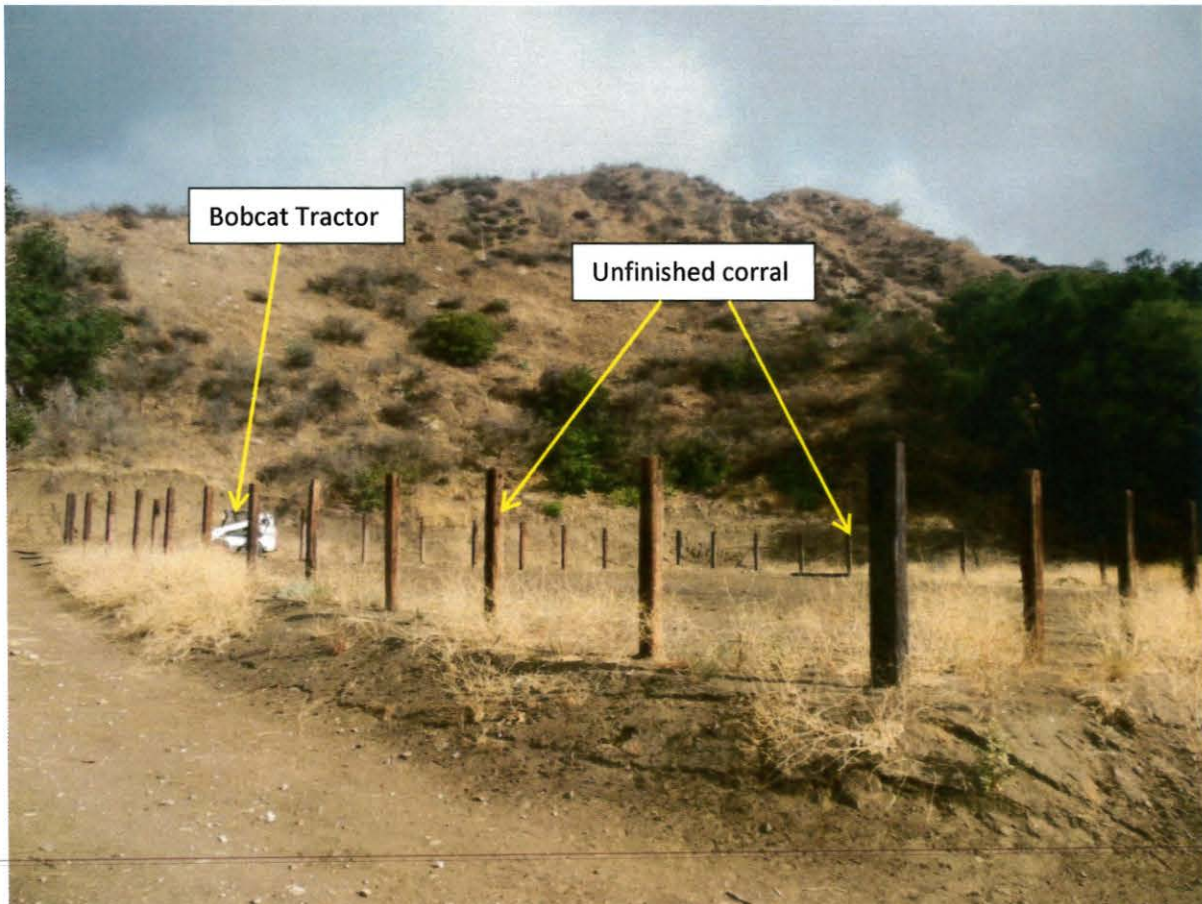
- **Partially completed corral** – A partially completed corral under construction was present in the parcel (Photo 15). A bobcat tractor was present near the partially completed corral (Photo 15).
- **Terrain** – The parcel is heavily covered with weeds, bushes, and trees. Several hillsides with valleys were discernable (Photo 16). Devil's Creek runs through the Parcel; there was no visible flow in the creek.

Photo 15. This photo shows a Bobcat tractor and an unfinished corral found in Parcel 2821-009-029.

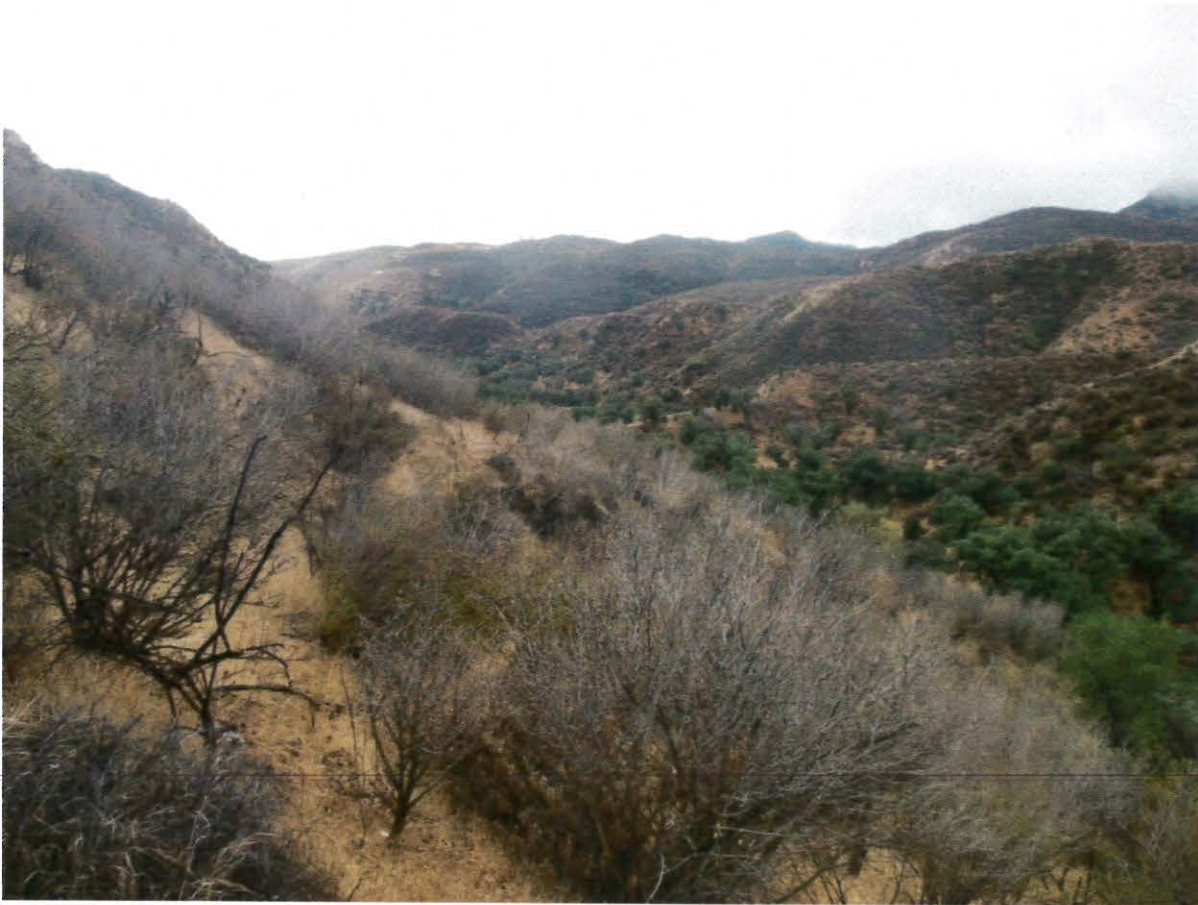
Photo 16. Showing undisturbed land found in parcel 2821-009-029.

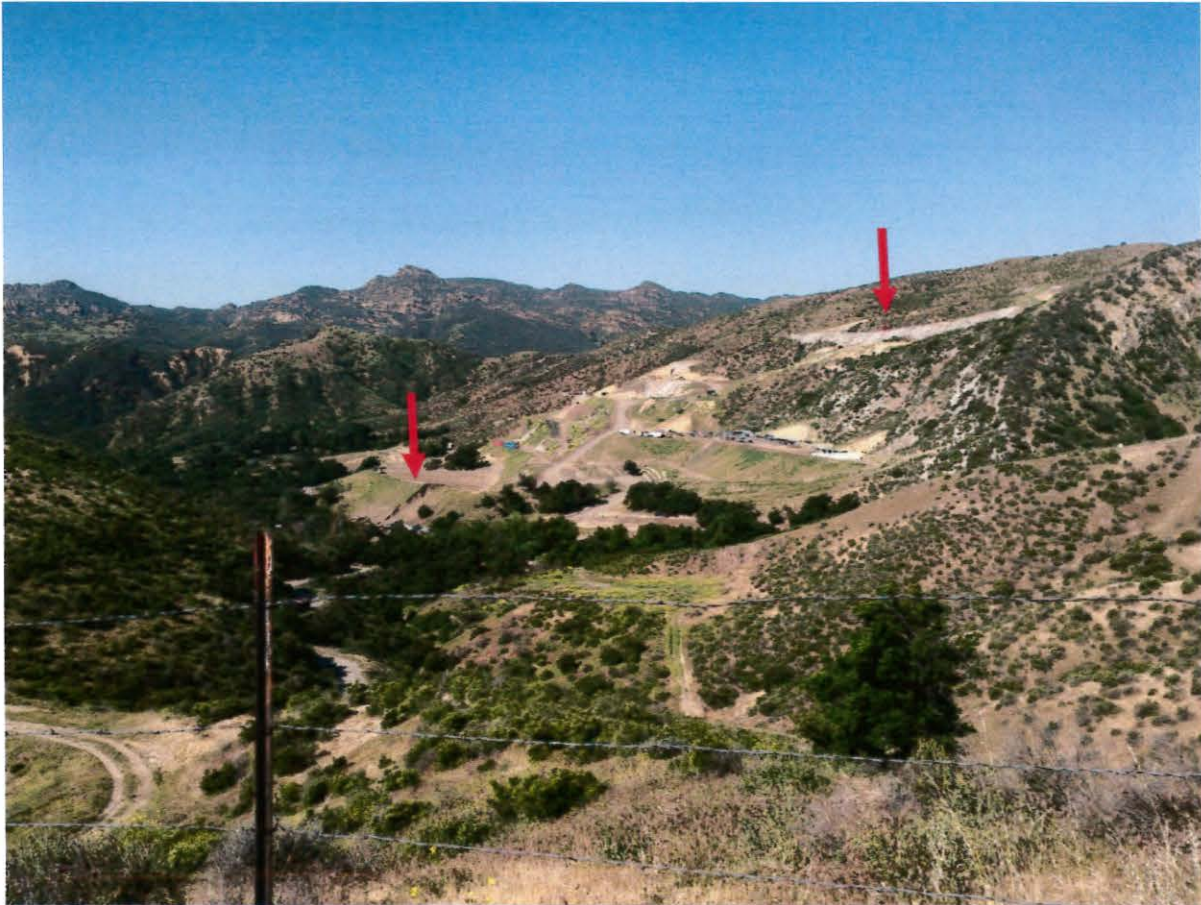
Photo 1. View looking southwest from Photo location 1. Showing parcels 2821-009-030 and 2821-009-031, which are owned Mr. Wayne Fishback and Cepheid V, LLC respectively. The barbed wire fence is the border between Parcels 2821-008-902 owned by MRCA and 2821-009-034 owned by the Alajajian Family Trust. The photo was taken at Longitude -118 36 21.75 and Latitude 34 18 22.79 on April 12, 2017. The arrows indicate the location of close-up views in the following photos.

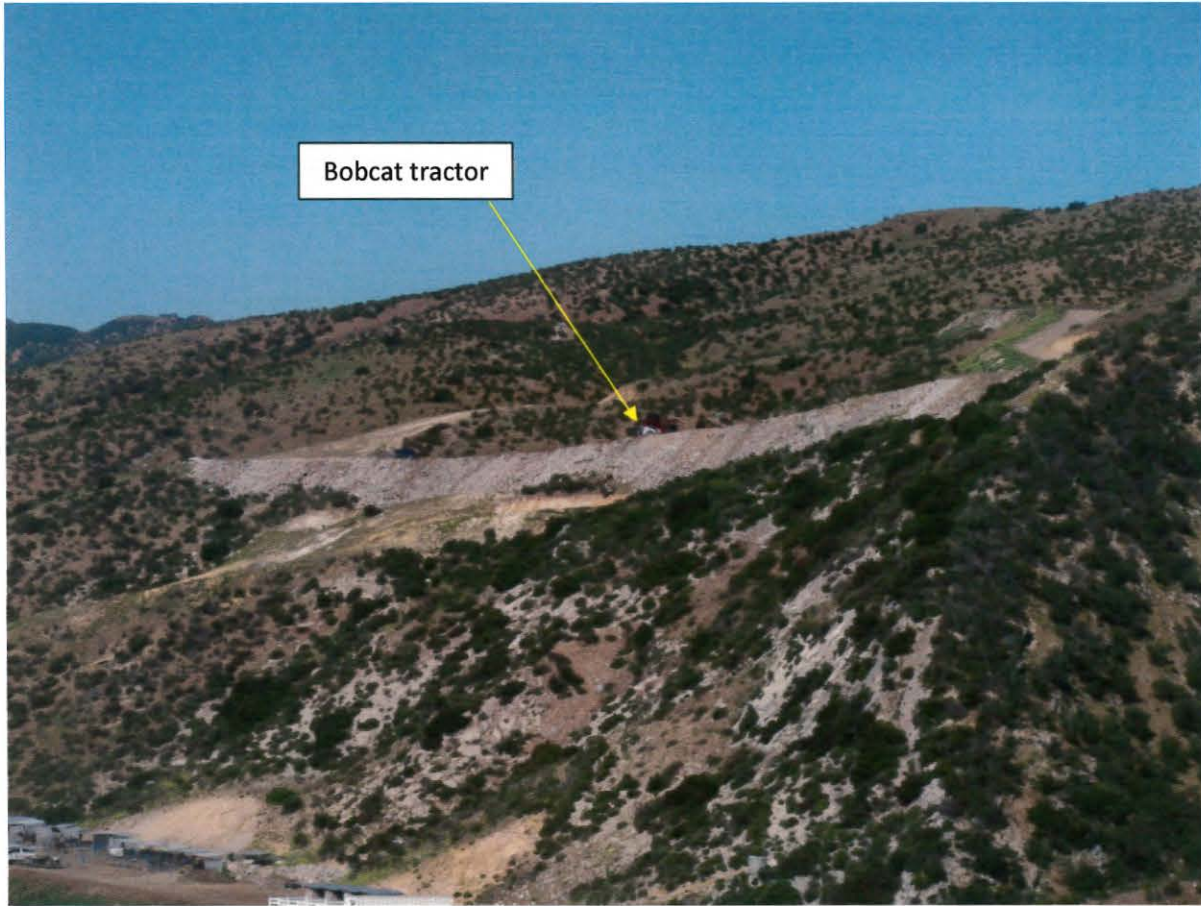
We observed large trucks traveling uphill on the property to the northwest and a bobcat tractor working on a hillside on the property (Photo 2). We also observed the canyon that was carved into a graded slope during the February 2017 rain events that was referenced in the Ex Parte Application for Clarification (Photo 3). Sandbags that had fallen down the fill slope were visible (Photo 4). Photos of the slope during the October 17, 2016 inspection have been attached that illustrate the change in condition of the slope from October 17, 2016 to April 12, 2017 (Photos 5 and 6). Sandbags from the sandbag wall that had fallen down the fill slope were present during the October 17, 2016 inspection.

Photo 2. View looking Southwest from Photo Location 1. Showing the location of bobcat tractor doing work on a roadway previously constructed by Mr. Fishback in parcels 2821-009-030 and 2821-009-031, which are owned by Mr. Wayne Fishback and Cepheid V, LLC respectively. Haul trucks observed on Browns Canyon Road driving to the Site were seen driving to this location and discharging materials onto the roadway. The photo was taken at Longitude -118 36 21.75 and Latitude 34 18 22.79 on April 12, 2017.

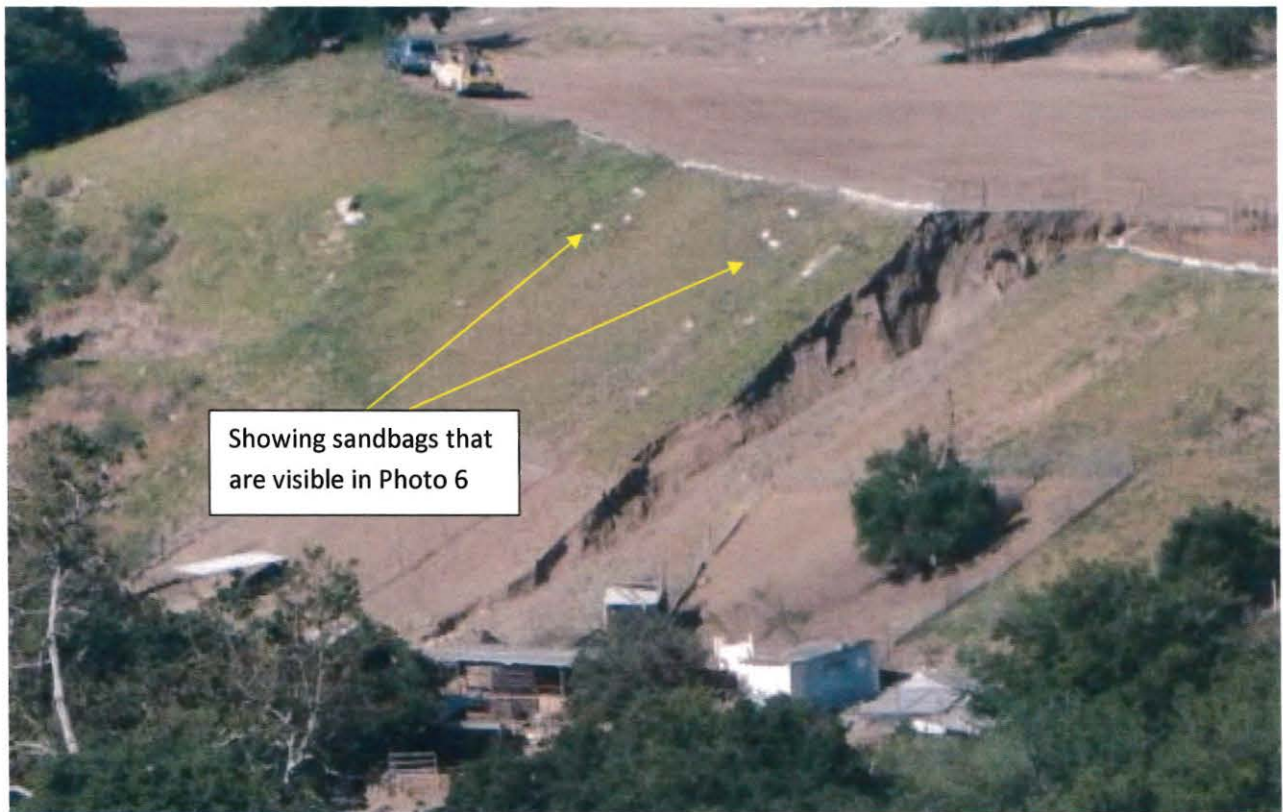
Showing sandbags that
are visible in Photo 6

Photo 4. View looking southwest from Photo Location 1. Close up of Photo 3. Showing the sandbags from the sandbag wall that have fallen down the fill slope. These sandbags are visible in Photo 6 and were present during the October 17, 2016 Inspection.

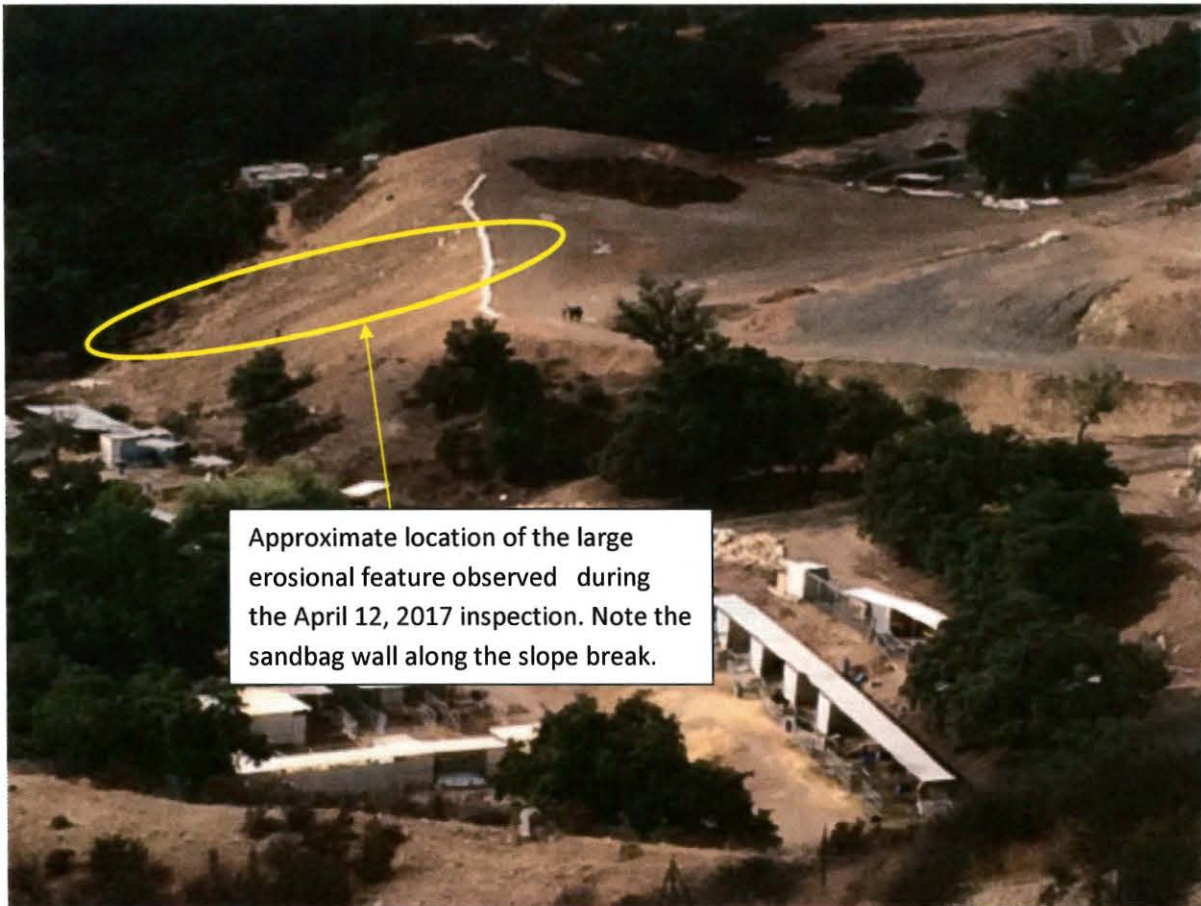
Photo 5. Showing the same area shown in Photo 3 during the October 17, 2016 inspection. Photo was taken at a different angle than Photo 3.

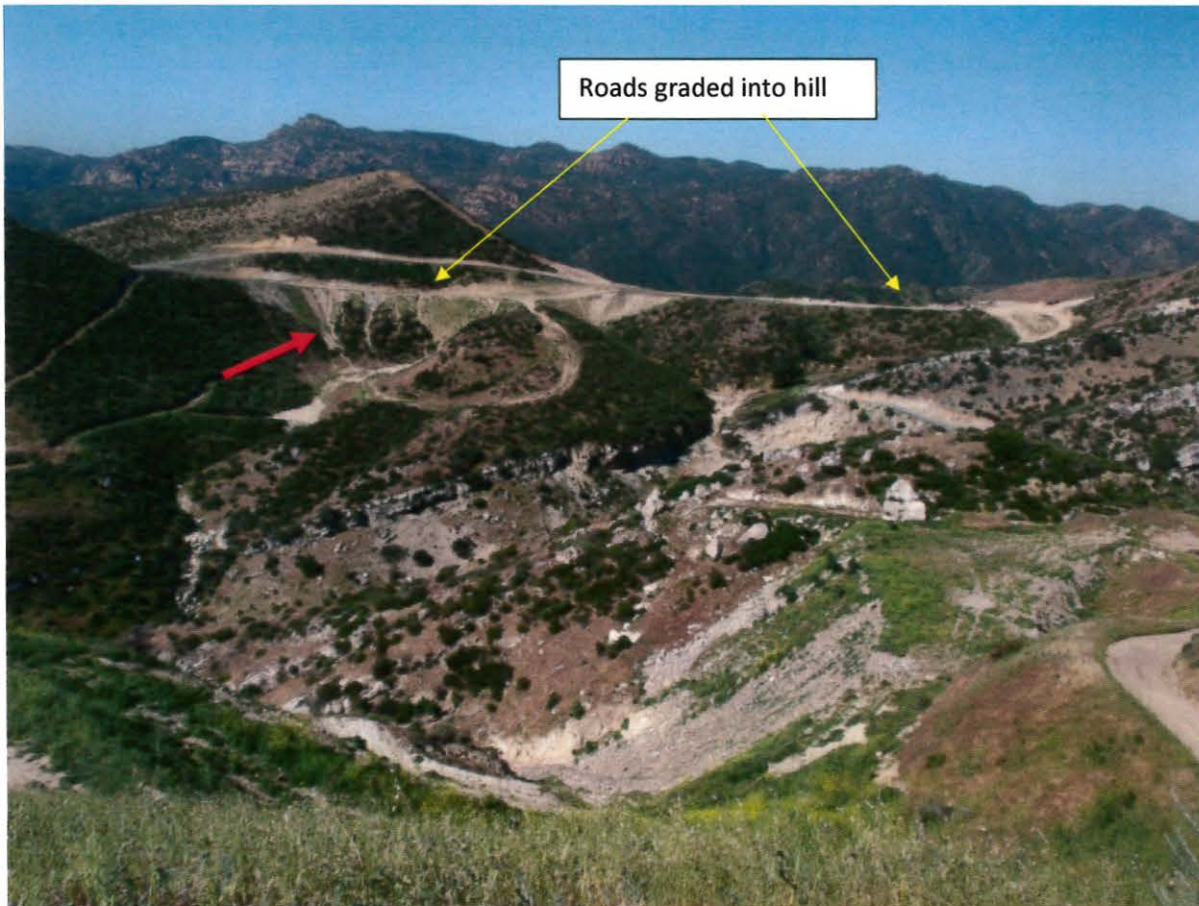
We proceeded to parcel 2821-002-905 which is owned by MRCA. From this parcel we were able to view Mr. Wayne Fishback's parcel 2821-002-023 to the south and southwest (Photos 7 and 8). From this point graded roads were visible running along a hilltop in parcel 2821-002-023 (Photos 7 and 8). These roads were noted in the October 17, 2016 inspection report. Deposited material that appeared to be crushed cement and sediment also was visible from this location on parcel 2821-002-023 near the access road (Photo 8). The location where we took Photos 7 and 8 is shown in Map 1 labeled Photo Location 2. Regional Board staff did not take pictures of the area shown in Photo 7 during the October 17, 2016 inspection.

Photo 7. View looking south from Photo Location 2. Showing parcel 2821-002-023 owned by Mr. Wayne Fishback and roads graded onto hilltop in the parcel. The red arrow indicates where large erosional scours were visible in below graded roadways. The significant erosion indicates poor design or the lack of drainage controls to effectively convey stormwater from the roadways. This photo was taken from parcel 2821-002-905 owned by MRCA at Longitude -118 36 41.788 and Latitude 34 18 39.224 on April 12, 2017.
