# MCR Monitoring: Watercourse Crossings

# Hillslope Monitoring Program 1996-2001

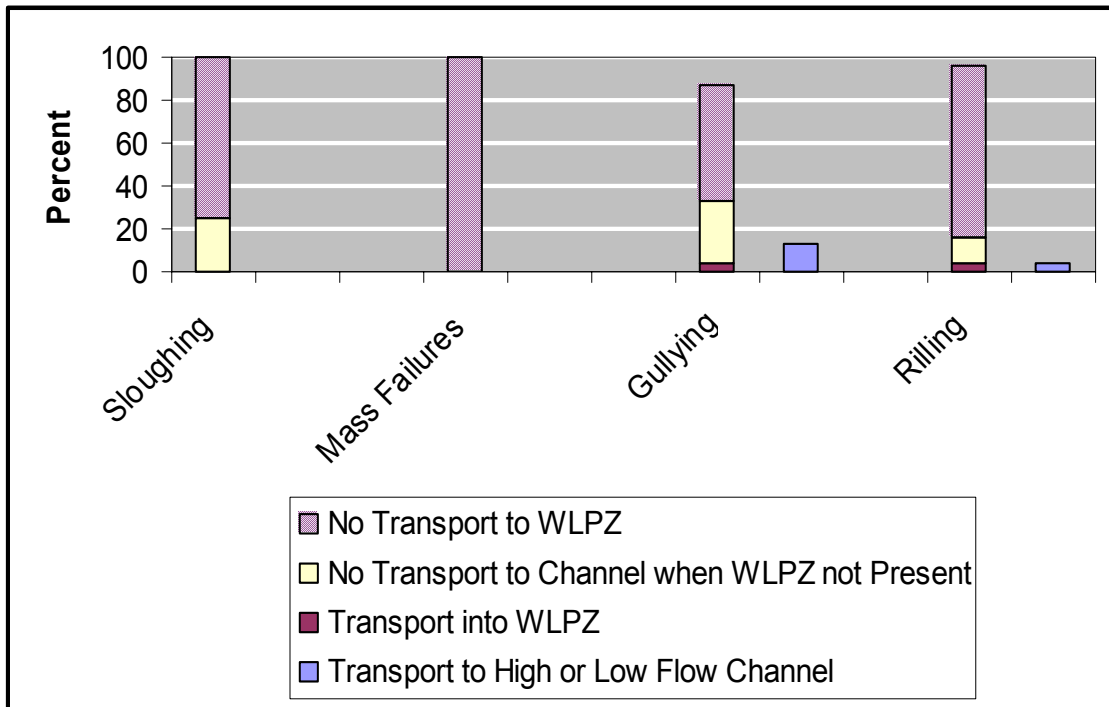
The percentage of inventoried skid trail erosion features related to current operations that had dry season evidence of sediment reaching the high or low flow channel of a watercourse is shown in Figure 10. The percentages of sediment delivering features for sloughing, mass failures, gullying, and rilling features are 0, 0, 13.0, and 3.8 percent, respectively. Sediment delivery data was not reported for 8.3 percent of the rilling features, 2.1 percent of the gullies, 14.3 percent of the mass failures, and 0 percent of the sloughing events. No sediment was transported to the channel from any of the sloughing features or mass failures, 87 percent of the gullies, and 96.2 percent of the rills. For gullies that delivered sediment, 83.3 percent delivered sediment to Class III watercourses. All of the sediment delivered to channels from skid trail rills went to Class III watercourses. The proportions of erosion features delivering sediment from skid trails are considerably lower than that reported from similar types of erosion features found on the road transects (Figure 9).

Figure 10. Percent of erosion features with dry season evidence of delivered sediment to the high or low flow channel of a watercourse from skid trail transect erosion features related to the current THP or NTMP NTO.

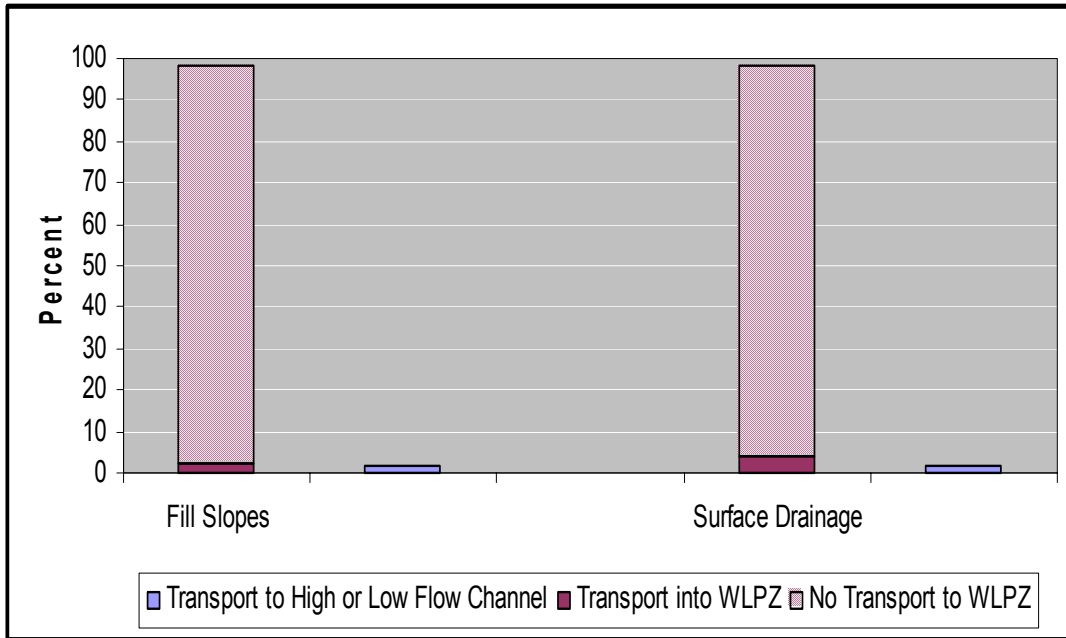
The landing evaluation also included a determination of the final location of sediment deposition originating from landing surfaces and fill slopes (Figure 13). Erosion features from two percent of the fill slopes produced sediment that entered channels, and another four percent of the time it reached the WLPZ. Similarly, erosion features from

Figure 13. Percent of landing features related to the current THP or NTMP project that had dry season evidence of sediment delivered to either the WLPZ or the high/low flow channel of a watercourse.

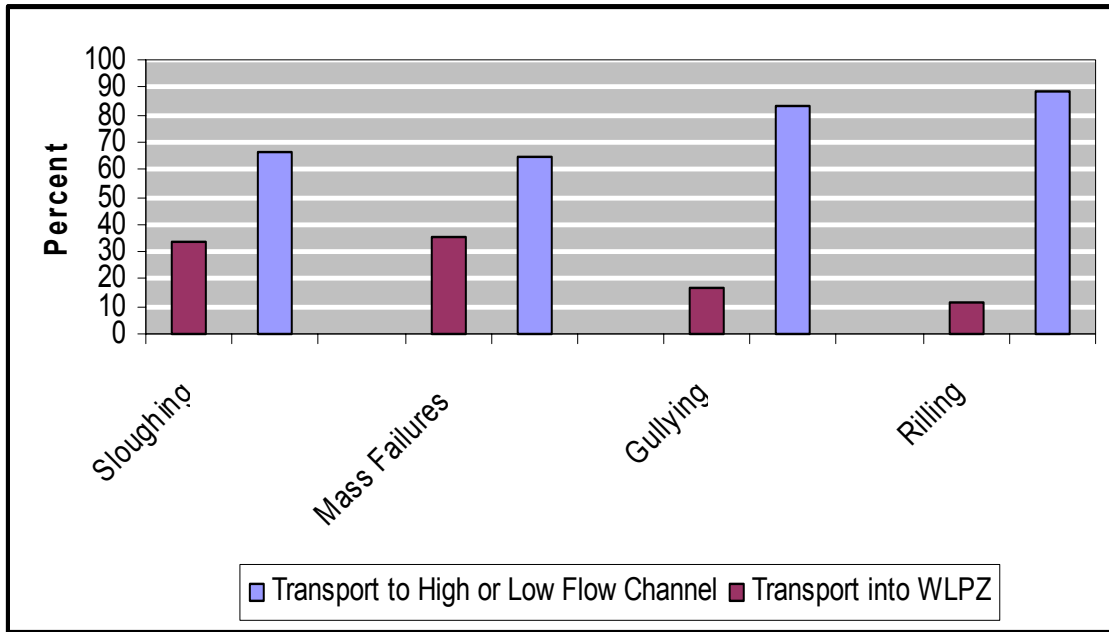
The percentage of inventoried watercourse protection zone erosion features related to current operations that had dry season evidence of sediment reaching the high or low flow channel of a watercourse is shown in Figure 20. The percentages of sediment delivering features for sloughing, mass failures, gullying, and rilling features are 66.7, 64.3, 83.3, and 88.9 percent, respectively. No sediment was transported to the channel for 33.3 percent of the sloughing features, 35.7 percent of the mass failures, 16.7 percent of the gullies, and 11.1 percent of the rills. Of the rills that delivered sediment to watercourses, 12.5 percent delivered to Class III watercourses. For gullies that delivered sediment, 20 percent input sediment to Class III watercourses. Sediment delivery data was not reported for 0 percent of the rilling features, 0 percent of the gullies, 22.2 percent of the mass failures, and 25 percent of the sloughing events. The proportions of erosion features delivering sediment in watercourse protection zones are considerably higher than that reported from similar types of erosion features found on the road and skid trail transects (Figures 9 and 10), due to the close proximity of these features to the channel.

Figure 20. Percent of erosion features with dry season evidence of delivered sediment to the high or low flow channel of a watercourse from watercourse protection zone transect features associated with the current THP or NTMP project.

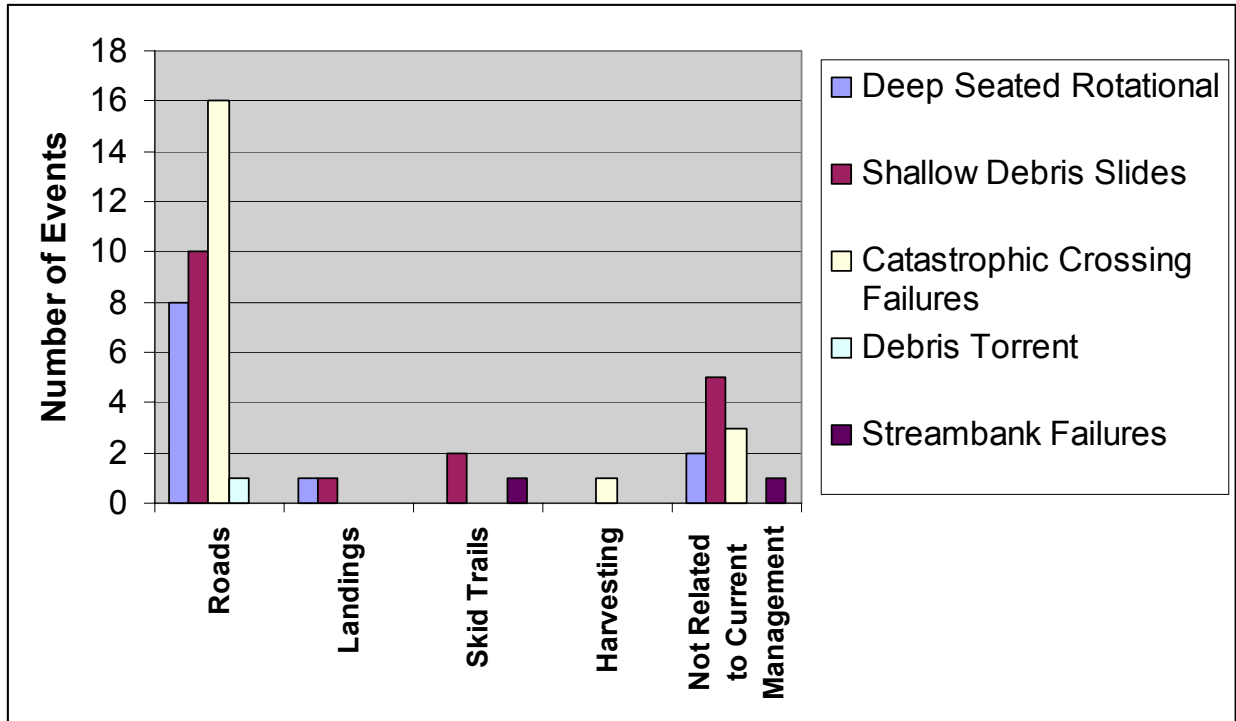
Figure 21. Primary causes of large erosion events and type of feature (note that multiple causes were assigned in some instances).

features, 39 were classified as being related to current timber management activities (Figure 21).

Most of the inventoried large erosion events related to management activities in the current plan were associated with roads (35), with smaller numbers of events associated with skid trails (3), landings (2), and harvesting (1). Cause codes and associated features are displayed in Figure 21, while specific cause codes are shown in Table 38 (multiple cause codes were assigned in some instances, so the total is greater than the 39 events). The most frequent causes of management related large erosion events were: cutbanks with slope support removed; subsurface water concentration;

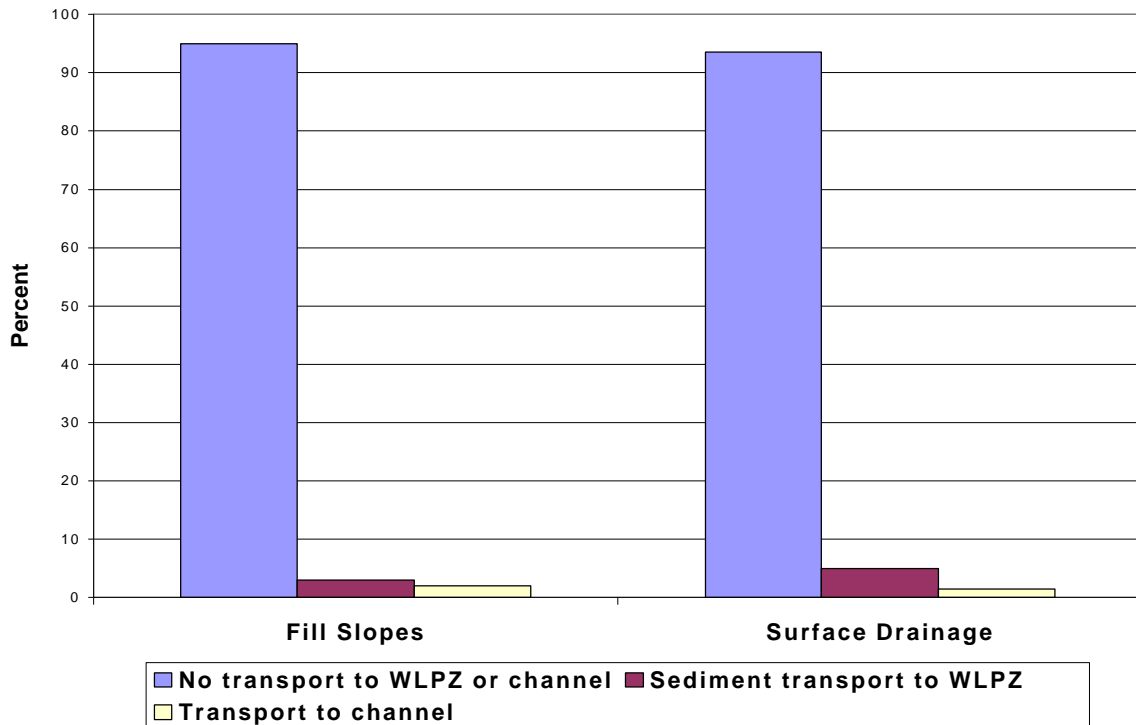
The location of sediment deposition originating from landing surfaces and fill slopes was also evaluated (Figure 5). For fill slopes, 2% of the time material entered channels, with another 3% reaching the WLPZ. Similarly for surface drainage, 1.5% reached channels, with another 5% reaching the WLPZ.

Figure 6. Sediment deposition sites associated with landing fill slopes and surface drainage.

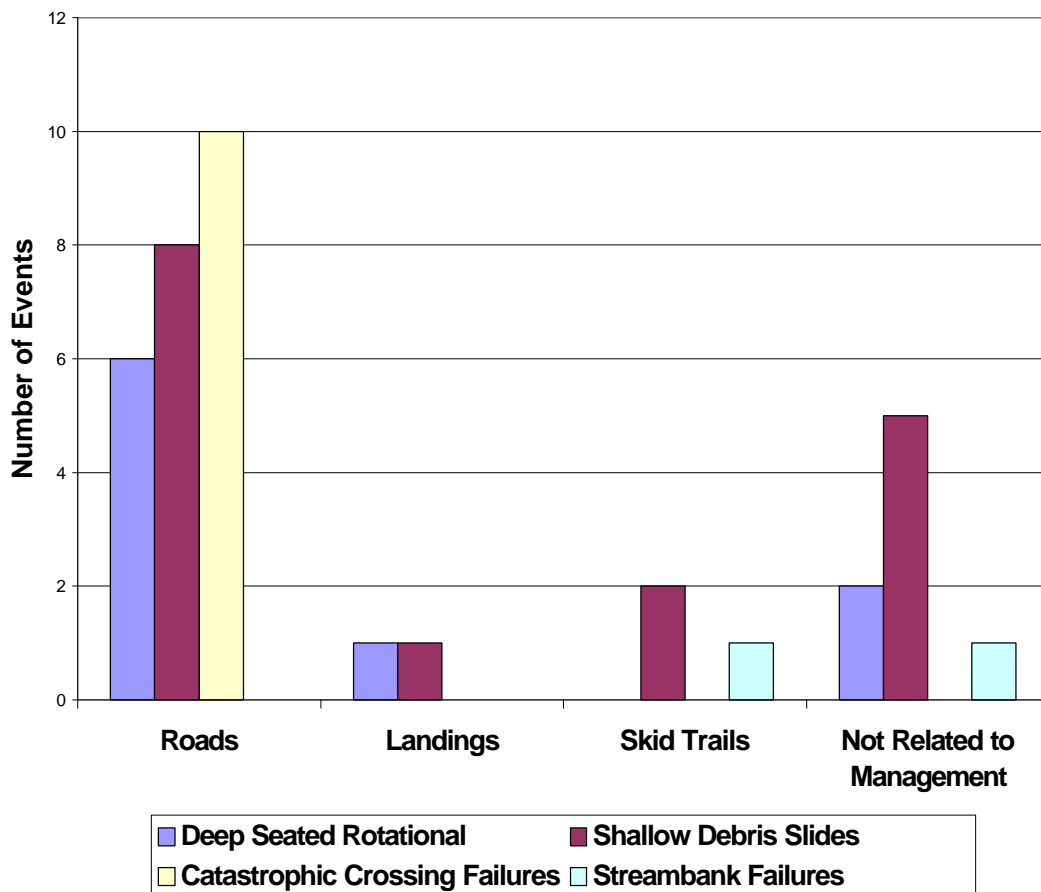
Mean erosion volumes for the various types of features related to current management activities are as follows: deep seated rotational (3,600 yd<sup>3</sup>), shallow debris slide (3,700 yd<sup>3</sup>), catastrophic crossing failure (200 yd<sup>3</sup>), and streambank failure (600 yd<sup>3</sup>). Most of the large erosion events were related to roads (24), with smaller numbers associated with landings (2) and skid trails (3). Eight of the features were judged to be unrelated to current management activities.<sup>16</sup> General cause code and associated feature type are displayed in Figure 6. Specific causes associated with the large erosion events are displayed in Table 26. The most frequent causes associated with large erosion events were: cutbanks with slope support removed; culverts with the inlet plugged; fill slopes with overloaded, deep sidecast; fill slopes with poorly compacted material; and surface water concentration.

Figure 7. Causes of large erosion events and type of feature.

Type	Cause of Feature	Count
<b>Roads</b>	Waterbars-discharge onto erodible material	1
	Waterbars-improperly constructed or located	2
	Fill slopes-too steep	2
	Fill slopes-overloaded, deep sidecast	4
	Fill slopes-poorly compacted	4
	Fill slopes-excessive organic material	1
	Surface water concentration	4
	Culverts too small	2
	Culverts-discharge onto erodible material	1
	Culverts-inlet plugged	4
	Inside ditch-ditch blocked and/or diverted	1
	Inside ditch-other drainage onto road no handled	2
	Cutbanks- too steep	1
	Cutbanks-slope support removed	7
	Subsurface flow alteration	1
	<b>Skid Trails</b>	Waterbars-not properly draining area
Cutbanks-too steep		1
Cutbanks-slope support removed		2
Surface water concentration-rilling and gullyng		1
Surface water concentration-discharge on erodible material		1
<b>Landings</b>	Cutbanks-too steep	1
	Cutbanks-slope support removed	1
	Fill slopes-excessive organic material	1
