Re: 2015-2016 Annual Monitoring and Reporting for Pepperwood Preserve Sediment Reduction Project SRNO-2H

Pepperwood Preserve Sediment Reduction Implementation Project
Appendix B- Photo Plates 2015-2016 Annual Monitoring Report

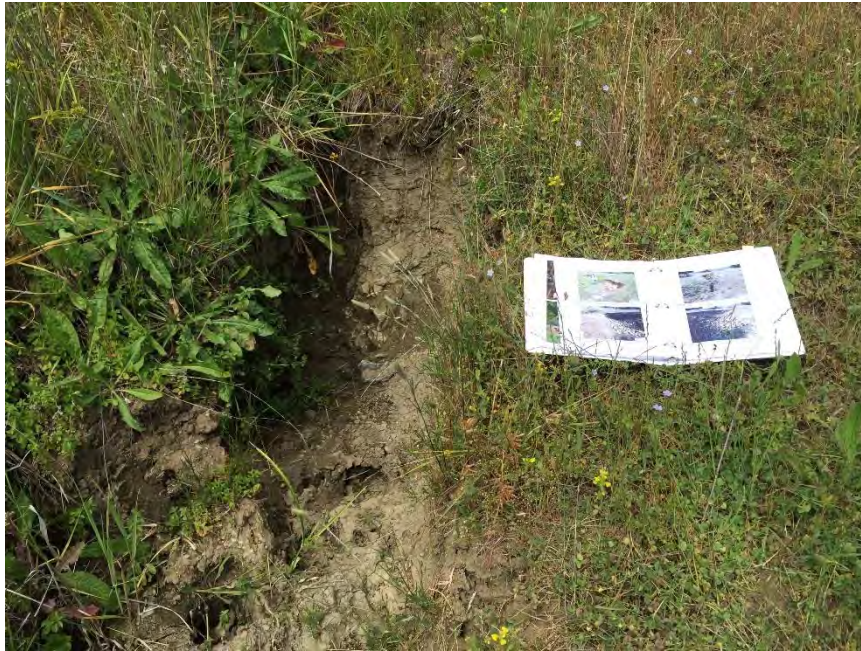
View of headcut above PWA Site #6.2, below PWA Site #8.1 (May 2015)

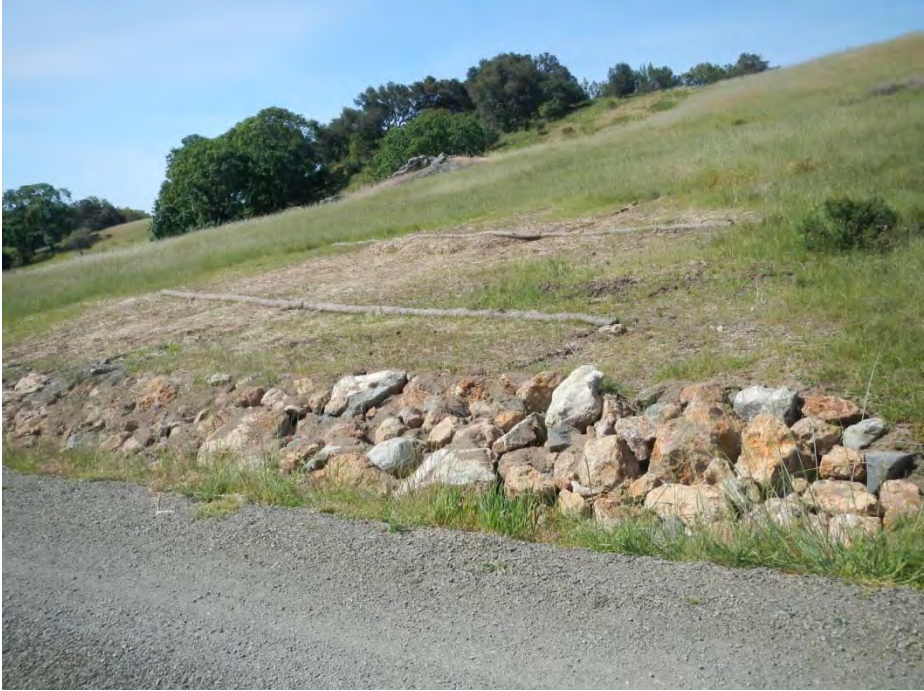
PWA Site 7.2 (May 2015)

- Site 7.2:
 - 7.2a: A 1-foot wide x 1-foot deep headcut has developed where the inboard ditch meets the rock slope protection. Recommendation to rock this headcut to prevent further migration of the headcut up the inboard ditch (See Photo Plate page 10).

- 7.2b: A 2-foot wide by 10 inch deep headcut has developed at the top right corner of the rockslope protection. Recommendation to monitor this area for any further movement (See Photo Plate page 10).

- 7.2c: Two sets of two 1-foot wide by 1.5-foot deep holes have formed near the top left end of the rock slope. A small 5-inch wide by 4-inch deep rill has formed near the left side of the landslide and is draining to one of the four holes at the top of the rockslope protection. A section of this rill has been rocked near one of the old straw wattles by Pepperwood staff (See Photo Plates page 11), but the rilling continues upslope of the rock. This area is sparsely vegetated.

Recommendation to exclude cattle activity from this site to help establish vegetation.

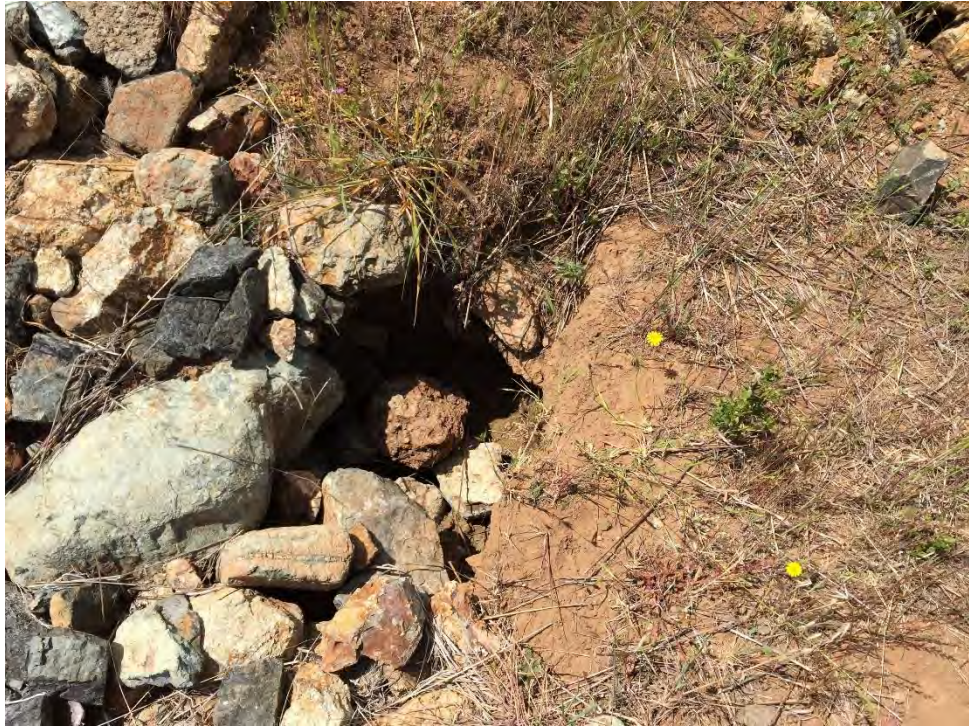
PWA Site #8.1 Grade Control Structure Headcut (May 2015)

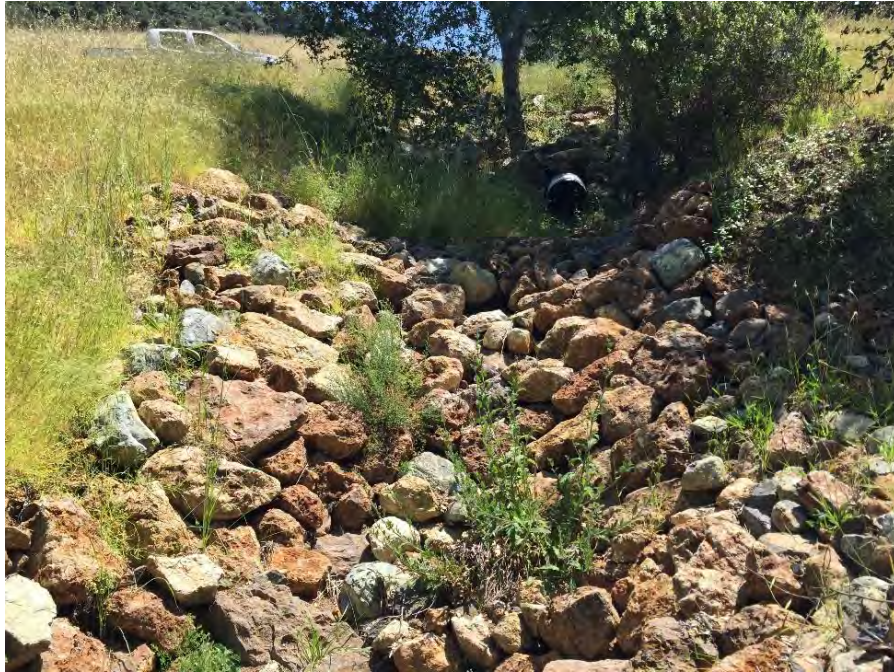
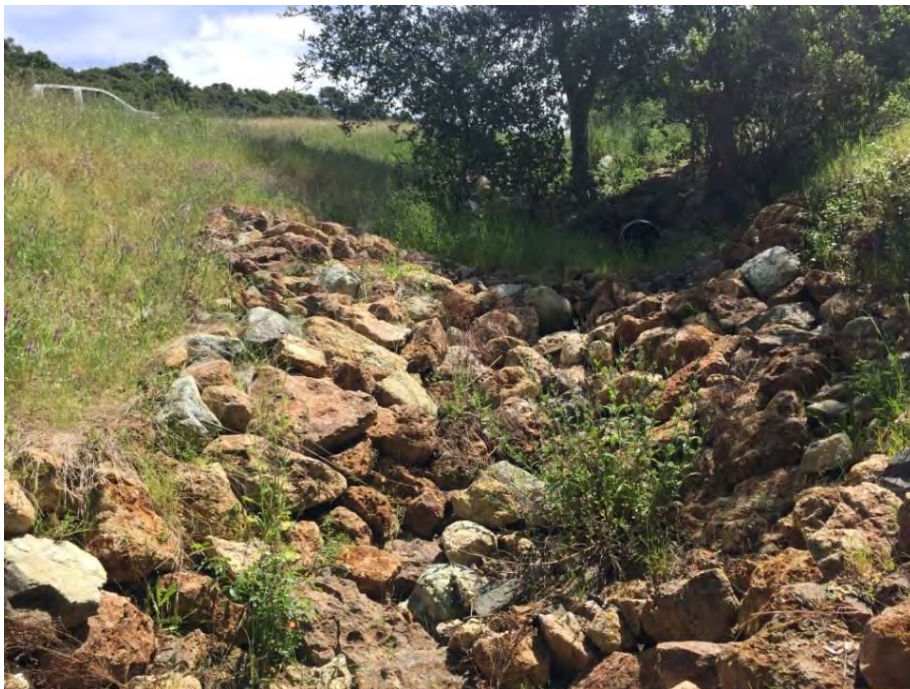
PWA Site # 11 (May 2015)

42+95	11	CD 4/ GCS 2	Site 11: Stream crossing with 24” culvert and active 8’ tall headcut below culvert. 1. Replaced with a 24” x 60’ long culvert. 2. Installed a critical dip on right hingeline. 3. Defined inboard ditch on left for 20’ and directed flow into new inlet. 4. Installed a total of 30 yd ³ of 0.5’-2’ riprap to inboard and outboard fillslopes. 5. Installed a grade control structure to headcut in channel below outlet 30 yd ³ of 0.5’-2’ riprap.	Culvert in good condition. Rock armor intact and stable, no erosion observed, critical dip in good condition and well vegetated.	<input checked="" type="checkbox"/> Y <input type="checkbox"/> N	<input checked="" type="checkbox"/>
