Re: Report on the Evaluation of the Integrity of the Subsurface Pipelines and Paved Surfaces
at LF-1, Recology Yuba Sutter, Yuba County, California

Project No. 053-7442-123

**RE: REPORT ON THE EVALUATION OF THE INTEGRITY OF THE SUBSURFACE PIPELINES
AND PAVED SURFACES AT LF-1, RECOLOGY YUBA SUTTER LANDFILL**

Appendix A
Example Pipeline Damage Photos

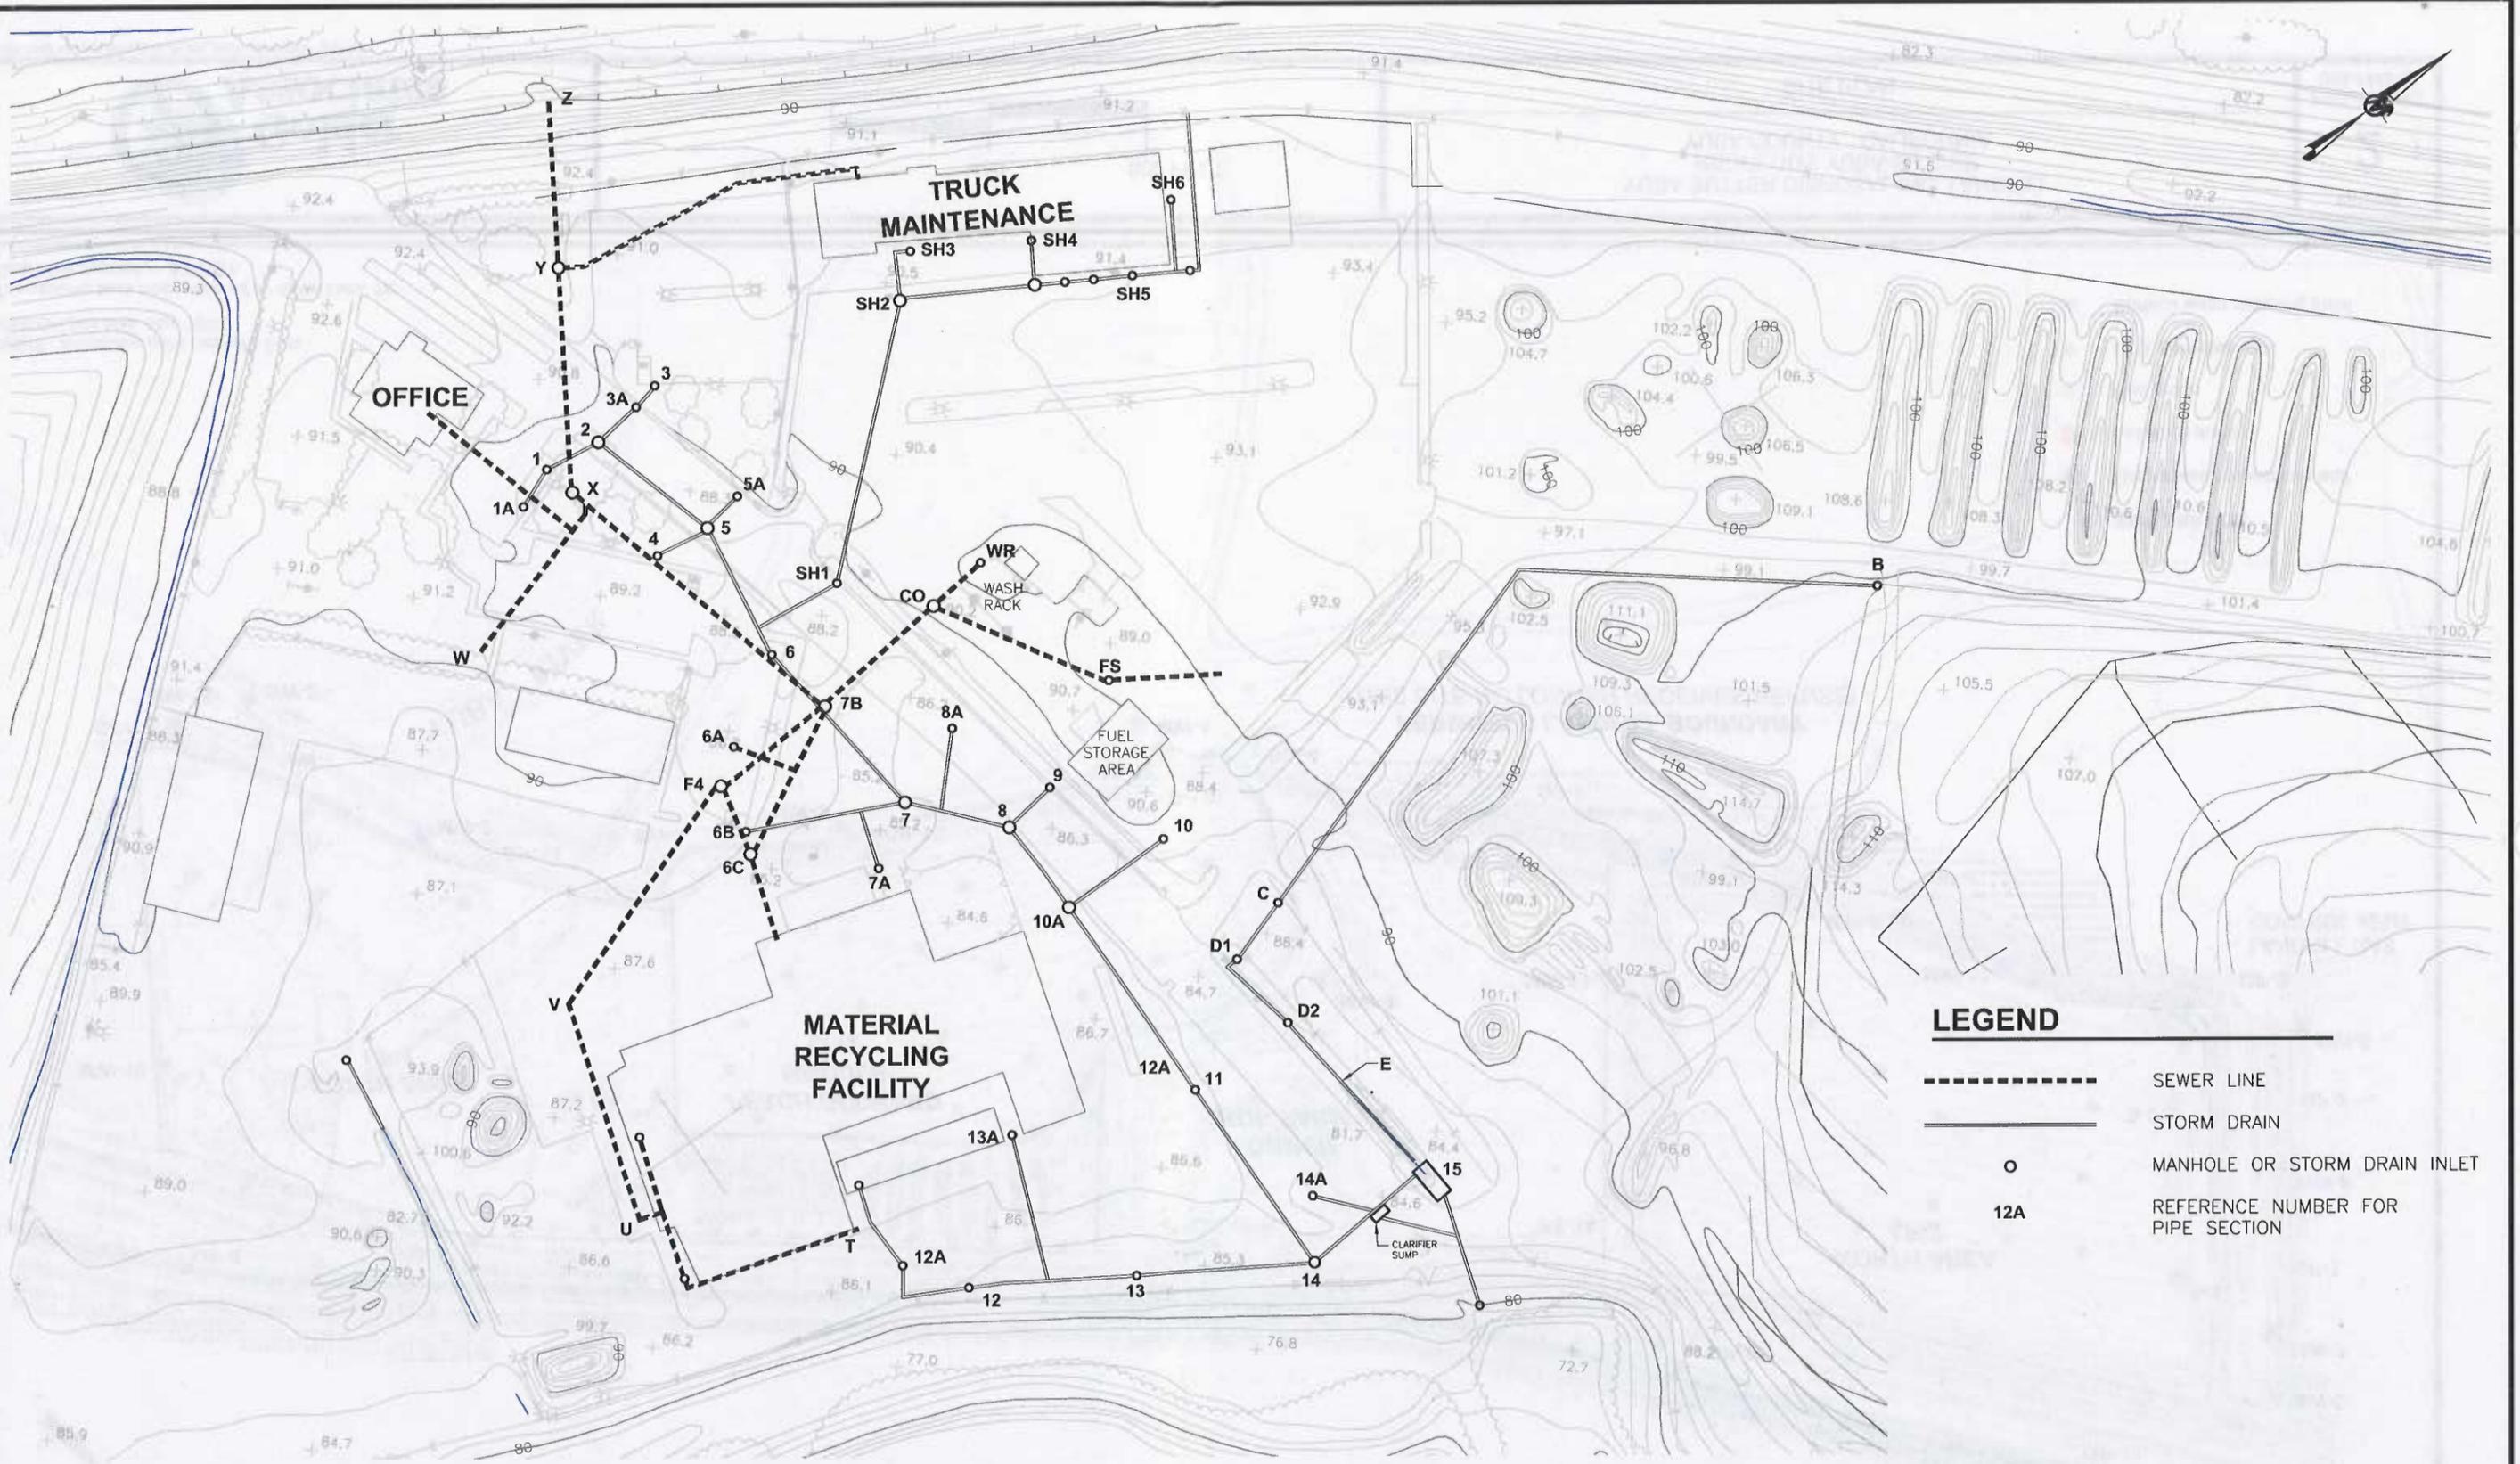
FIGURE 4
LF-1 DRAINAGE REVIEW
RECOLOGY YUBA-SUTTER FACILITY

Golder evaluated the landfill surface on October 31, 2012. The landfill surface evaluation identified areas where ponding of surface water runoff can occur. These areas are shown on Figure 4 and include:

- Locally depressed areas on unpaved surfaces (compacted gravel, landscaped areas, and bare soil)
- Locally depressed areas on paved surfaces with cracked or broken pavement
- Drain inlets that are clogged or located above surrounding grade

In addition, some potential drainage improvements were identified and are shown on Figure 4. The potential drainage improvements include:

- Cutting a notch in the speed bump by the site entrance to promote drainage.
- Extending the compacted gravel area to the southern fence line to promote sheet flow runoff and reduce potential for ponding.
- Repair or replace the small equipment shed at the truck wash area, where water can accumulate on the subsided floor.

Accumulation of water on top of the landfill surface can increase the rate of water infiltration into the landfill. The surfaces where ponding can occur can be repaired by filling to grade to remove depressions in unpaved areas, filling and then repairing damaged pavement, clearing clogged drain inlets, and reconstructing drain inlets to match the local grade to allow water flow to enter the inlets. Several potential areas of ponding are located in the southern portion of the compost area. This area should be re-graded to promote drainage and remove low spots where surface water runoff can accumulate.
