**Re: Amendment to Report of Waste Discharge (ROWD); Feather River Organics Compost Facility; Waste Discharge Requirements Order R5-2003-0093 (WDR Order); Recology Yuba-Sutter; Yuba County, CA**

PROJECT: RECOLOGY YUBA-SUTTER FACILITY  
MARYSVILLE, CALIFORNIA

TITLE: COMPOST OPERATIONS AREA AND TEST PIT LOCATIONS

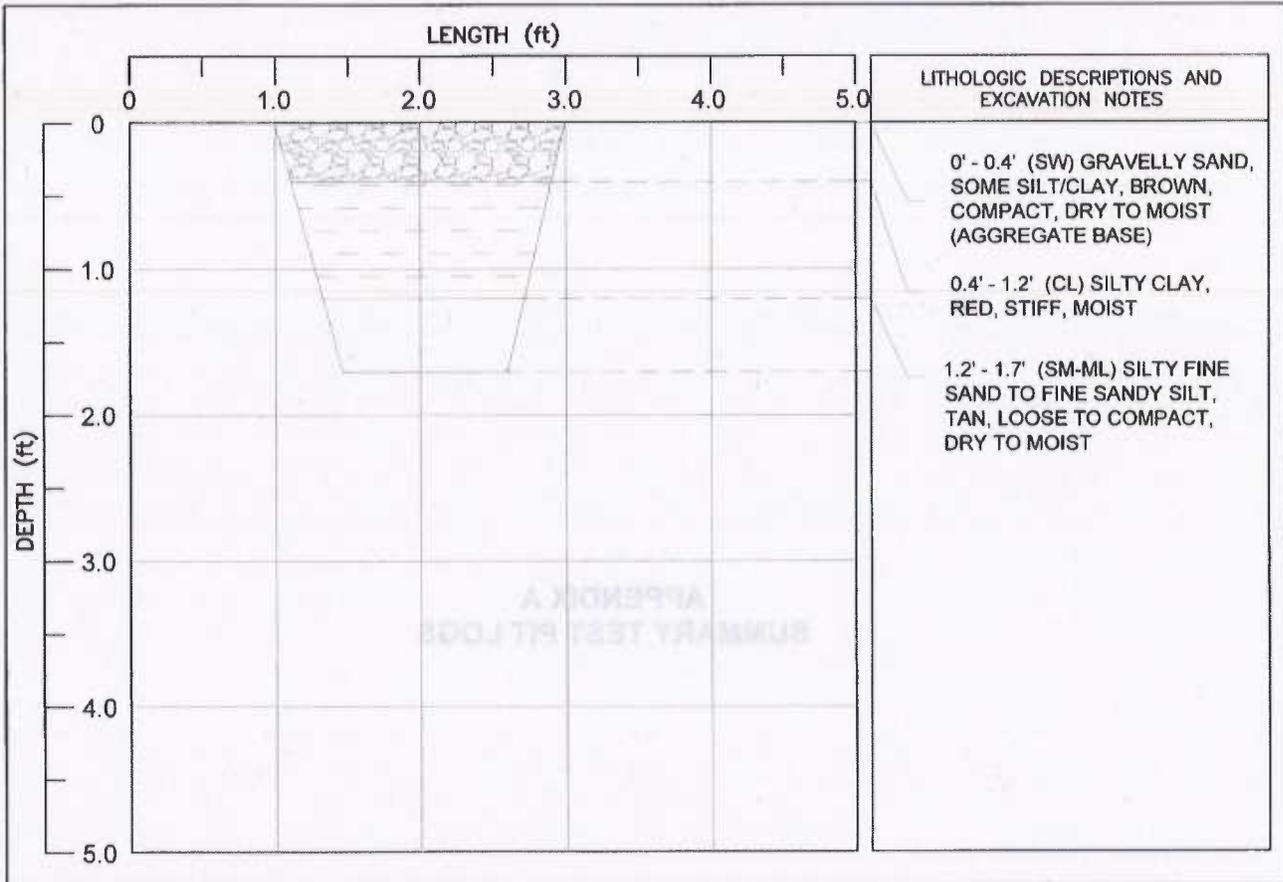
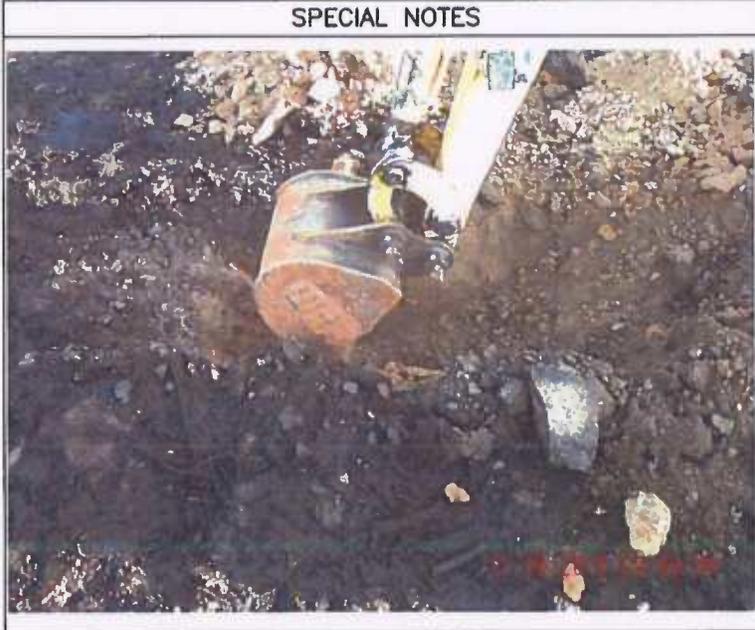
No. TP-1

TEMP 40 °F WEATHER SUNNY, CLEAR ENGINEER J. KELSEY OPERATOR -  
 EQUIPMENT YANMAR MINI-EX CONTRACTOR YSDI DATE 12-19-12  
 COORDINATES N - E - ELEV. AT GRADE DATUM - JOB 123-97604  
 LOCATION YSDI TIME -

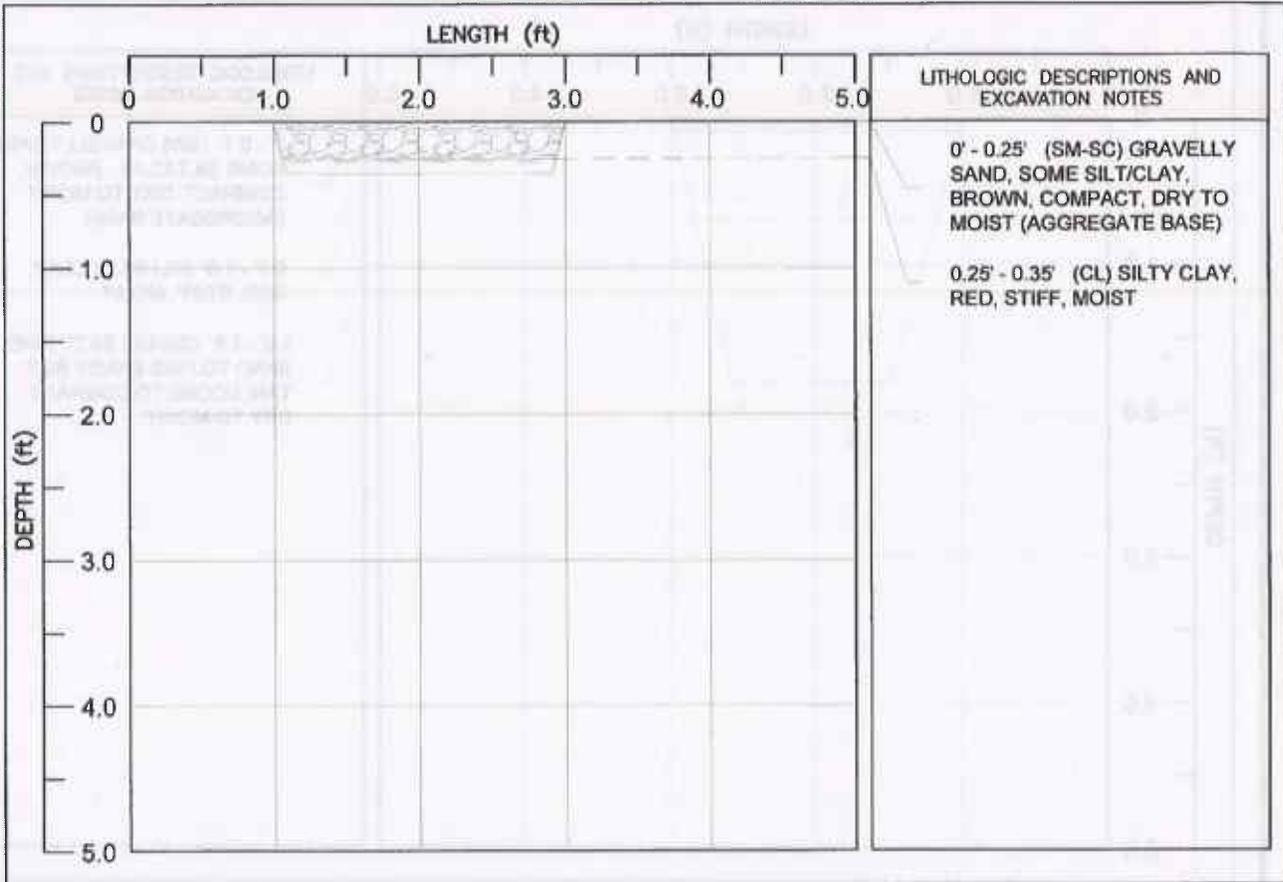
No. TP-3

TEMP 40 °F WEATHER SUNNY, CLEAR ENGINEER J. KELSEY OPERATOR -  
 EQUIPMENT YANMAR MINI-EX CONTRACTOR YSDI DATE 12-19-12  
 COORDINATES N - E - ELEV. AT GRADE DATUM - JOB 123-97604  
 LOCATION YSDI TIME -

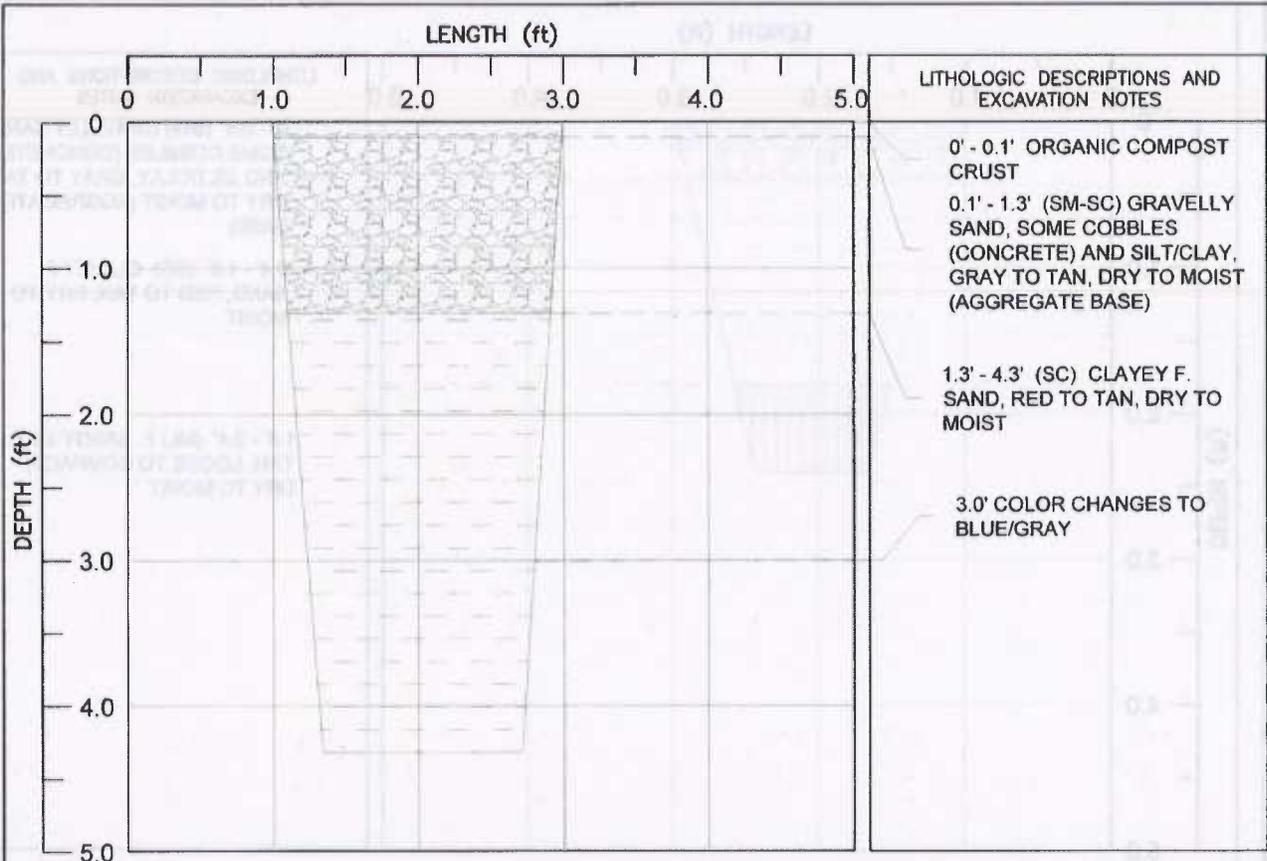
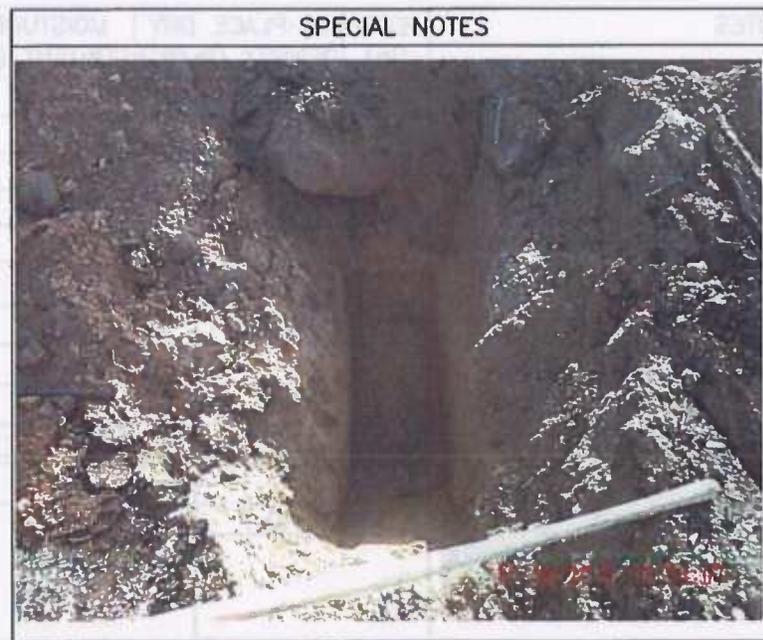
No. TP-5

TEMP 40 °F WEATHER SUNNY, CLEAR ENGINEER J. KELSEY OPERATOR -  
 EQUIPMENT YANMAR MINI-EX CONTRACTOR YSDI DATE 12-19-12  
 COORDINATES N - E - ELEV. AT GRADE DATUM - JOB 123-97604  
 LOCATION YSDI TIME -
