Appendix F: System-wide Evaluation to Identify Restoration Opportunities Technical Memorandum

**System-wide Evaluation to Identify Restoration
Opportunities**

**San Bernardino County
Flood Control District**

January 2011

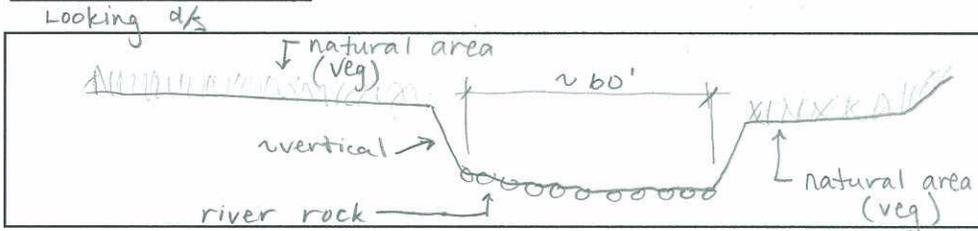
Facility:	Cucamonga Channel
X-Sec #:	Z1-RS2
Comment:	d/s of Chino Corona Rd
Pictures:	6313 - 6315

1. Bank Protection Condition (good or poor)	poor
2. Bank Erosion (yes or no)	y
3. Toe Erosion (yes or no)	y
4. Invert Degradation (yes or no)	y
5. Sediment Source (yes or no)	y

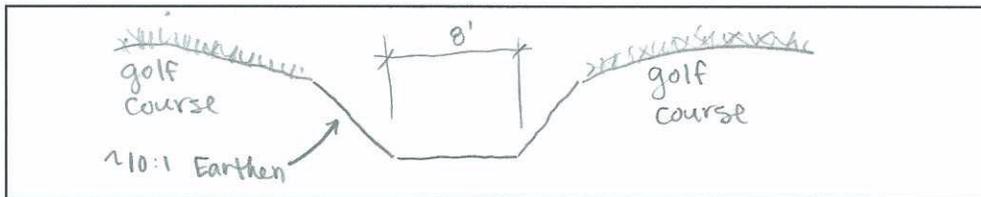
Facility:	Golf Course - Cypress Channel
X-Sec #:	in Chino
Comment:	Pine Ave Bridge
Pictures:	5043 - 5053

1. Bank Protection Condition (good or poor)	poor
2. Bank Erosion (yes or no)	y
3. Toe Erosion (yes or no)	y
4. Invert Degradation (yes or no)	y
5. Sediment Source (yes or no)	y

→ need to verify if Municipal Course (verified)
 → lots of degradation
 → plenty of space for restoration
 → Corp owns land
 → improvements needed on up- & downstream sides of Pine Ave.

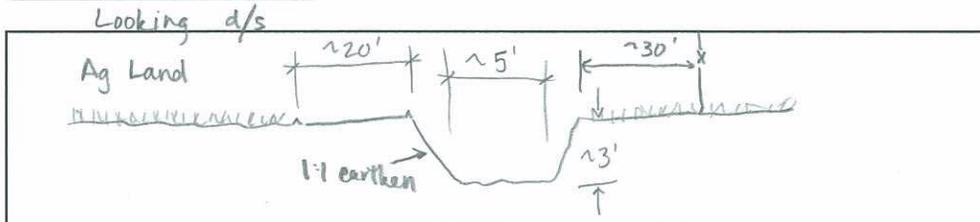
Facility:	Magnolia Channel
X-Sec #:	Z1-CP1
Comment:	at Kimball
Pictures:	5039 - 5043

1. Bank Protection Condition (good or poor)	poor
2. Bank Erosion (yes or no)	y
3. Toe Erosion (yes or no)	y
4. Invert Degradation (yes or no)	n
5. Sediment Source (yes or no)	y

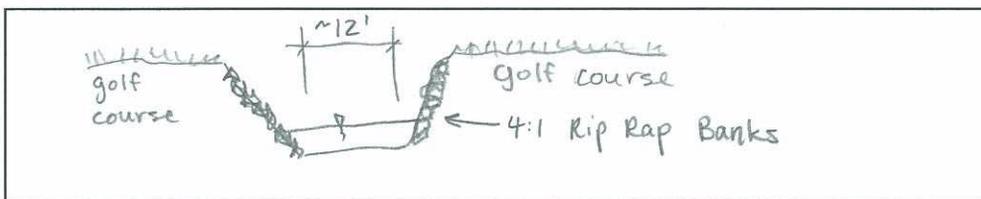
Facility:	Golf Course #2 - San Antonio Channel
X-Sec #:	
Comment:	Pine Ave Arizona Crossing
Pictures:	5053 - 5051

1. Bank Protection Condition (good or poor)	good
2. Bank Erosion (yes or no)	n
3. Toe Erosion (yes or no)	y
4. Invert Degradation (yes or no)	n/a
5. Sediment Source (yes or no)	y

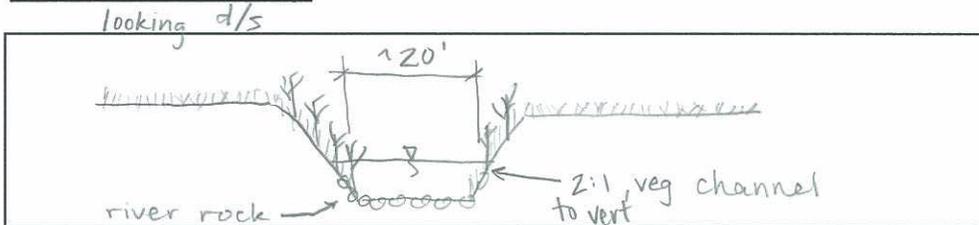
Facility:	San Antonio Channel
X-Sec #:	Z1 - RS1
Comment:	adjacent to El Prado Rd, 1/3 of WWP
Pictures:	6306 - 6309

1. Bank Protection Condition (good or poor)	poor
2. Bank Erosion (yes or no)	n
3. Toe Erosion (yes or no)	y
4. Invert Degradation (yes or no)	y
5. Sediment Source (yes or no)	n

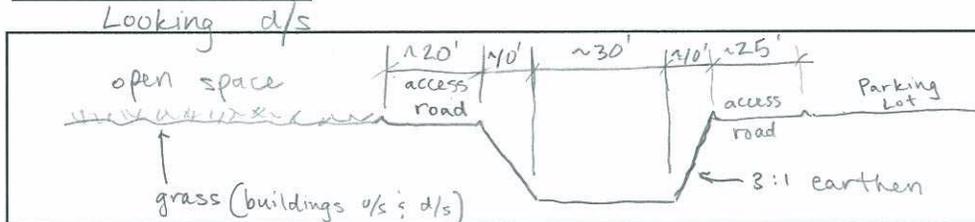
Facility:	Reche Canyon Channel
X-Sec #:	22-R57
Comment:	w/s of Mt Vernon Ave
Pictures:	5031 - 5038

1. Bank Protection Condition (good or poor)	poor
2. Bank Erosion (yes or no)	y
3. Toe Erosion (yes or no)	y
4. Invert Degradation (yes or no)	n
5. Sediment Source (yes or no)	y

→ channel looks recently repaired. Has "unfinished" look.

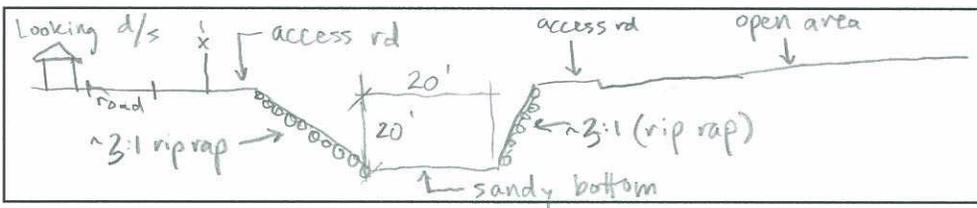
Facility:	Cable Creek
X-Sec #:	Z2-R53
Comment:	d/s of Little League Dr
Pictures:	(100-4847 to 100-4849 d/s section) (100-4850 to 4874 @ site)

1. Bank Protection Condition (good or poor)	good
2. Bank Erosion (yes or no)	no
3. Toe Erosion (yes or no)	y (minor)
4. Invert Degradation (yes or no)	n
5. Sediment Source (yes or no)	y

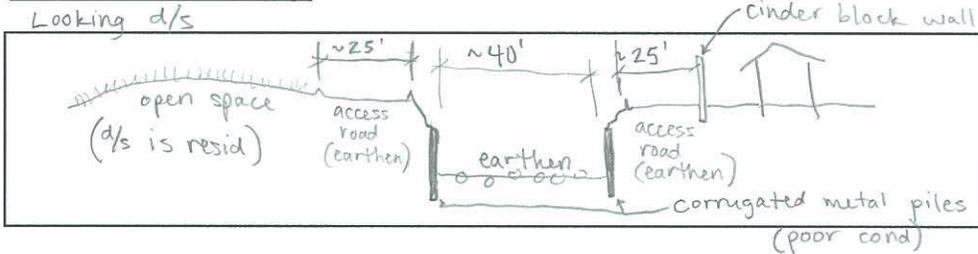
Facility:	Devil Creek Channel
X-Sec #:	
Comment:	University Pkwy Bridge
Pictures:	5060 - 5063

1. Bank Protection Condition (good or poor)	poor
2. Bank Erosion (yes or no)	n
3. Toe Erosion (yes or no)	y
4. Invert Degradation (yes or no)	y
5. Sediment Source (yes or no)	y

→ piles are protecting bank but are in poor condition
 → to widen an access road would be removed
 → invert shows scour
 → downstream there are dorms to the left. There is a cinder block wall at the edge of the access road.

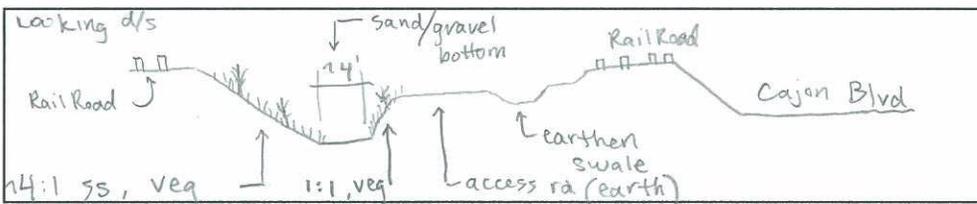
Facility:	Ono Storm Drain
X-Sec #:	22-R52
Comment:	Adjacent to Cajon Blvd & Railroad
Pictures:	4875 to 4885

1. Bank Protection Condition (good or poor)	decent (grass)
2. Bank Erosion (yes or no)	minor
3. Toe Erosion (yes or no)	y
4. Invert Degradation (yes or no)	y
5. Sediment Source (yes or no)	minor

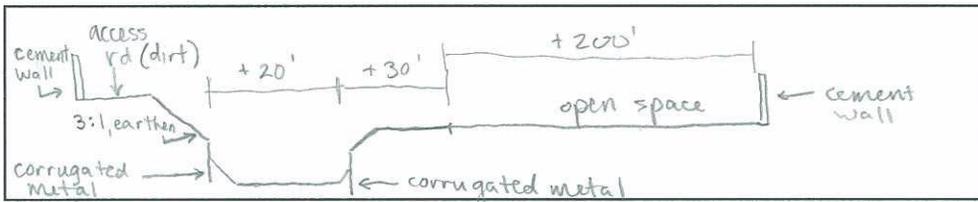
Facility:	Sand Creek
X-Sec #:	Z2-RS4
Comment:	@ end of Citrus
Pictures:	4886 - 4911

1. Bank Protection Condition (good or poor)	poor
2. Bank Erosion (yes or no)	✓
3. Toe Erosion (yes or no)	✓
4. Invert Degradation (yes or no)	no
5. Sediment Source (yes or no)	yes

→ drop structures every ~100' - 200'
 → Invert looks stabilized
 → corrugated metal piles are failing
 → side slopes showing scour up to ~4'
 → major drops d/s w/ energy dissipators
 → basin d/s

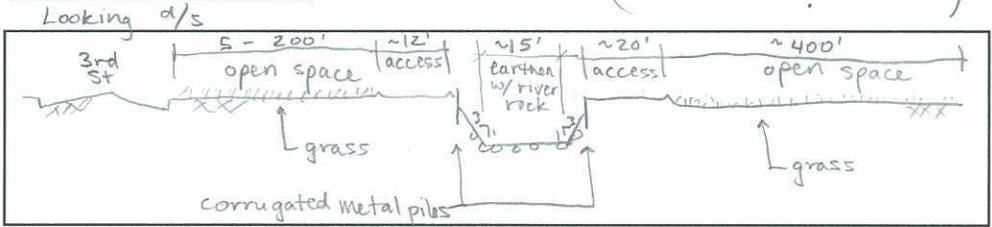
Facility:	City Creek
X-Sec #:	Z2-R56
Comment:	d/s 3rd St
Pictures:	4942 - 4962 (4963 - 4968 across from SBCFCD) (is there enough room here?)

1. Bank Protection Condition (good or poor)	poor
2. Bank Erosion (yes or no)	y (minor)
3. Toe Erosion (yes or no)	y
4. Invert Degradation (yes or no)	n
5. Sediment Source (yes or no)	y

→ invert looks fairly stabilized
 → corrugated metal piles have chain link fence above (21') to hold back access road (see to right)
 ... • starting to fail in some locations
 → 1/2 channel is 5-10' wider w/ concrete left bank

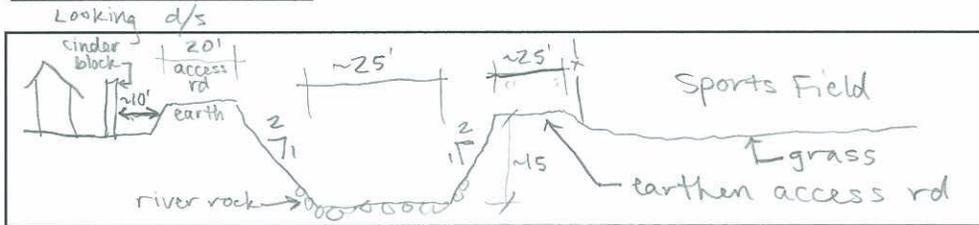
Facility:	Upper Warm Creek
X-Sec #:	22 - R55
Comment:	North of Baseline, South of Sports Field
Pictures:	4915 - 4934

1. Bank Protection Condition (good or poor)	poor
2. Bank Erosion (yes or no)	y
3. Toe Erosion (yes or no)	n
4. Invert Degradation (yes or no)	n
5. Sediment Source (yes or no)	y

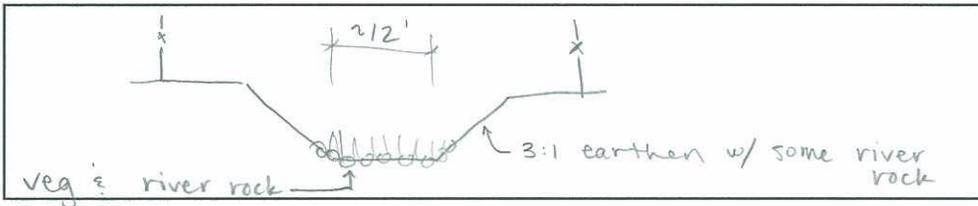
Facility:	Zanja Creek
X-Sec #:	Z3-RS2
Comment:	v/s Lincoln St
Pictures:

1. Bank Protection Condition (good or poor)	n/a
2. Bank Erosion (yes or no)	n
3. Toe Erosion (yes or no)	n
4. Invert Degradation (yes or no)	y < 1'
5. Sediment Source (yes or no)	y

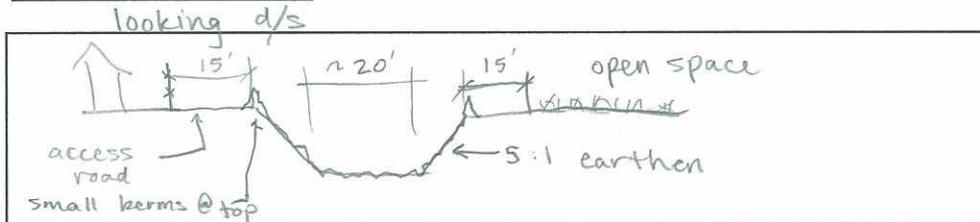
Facility:	Wildwood Creek
X-Sec #:	23-R54
Comment:	@ 6th Place
Pictures:	5013 -

1. Bank Protection Condition (good or poor)	poor
2. Bank Erosion (yes or no)	y
3. Toe Erosion (yes or no)	y
4. Invert Degradation (yes or no)	minor
5. Sediment Source (yes or no)	y

→ open spaces upstream & downstream for widening
 → u/s of 6th place channel has grouted rip rap banks of very good quality
 → d/s channel is of poor quality but banks look stable. Doesn't look "finished", aka "rough engineered"
 → seems to have been recently repaired by a tractor but not finished

→ found out the channel is maintained regularly.

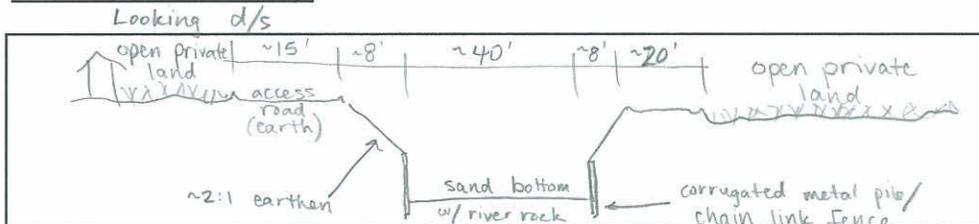
Facility:	Wilson Creek
X-Sec #:	Z3 - R53
Comment:	Ave D
Pictures:	4990 - 5012

1. Bank Protection Condition (good or poor)	poor (eroding)
2. Bank Erosion (yes or no)	n
3. Toe Erosion (yes or no)	n
4. Invert Degradation (yes or no)	n
5. Sediment Source (yes or no)	y

→ drop structures every ~50'
 → channel is stabilized
 → corrugated metal piles in some locations & others only has fence. Both are deteriorating
 → banks above piles/fence are intact and show very little signs of scour
 → some river rock on invert

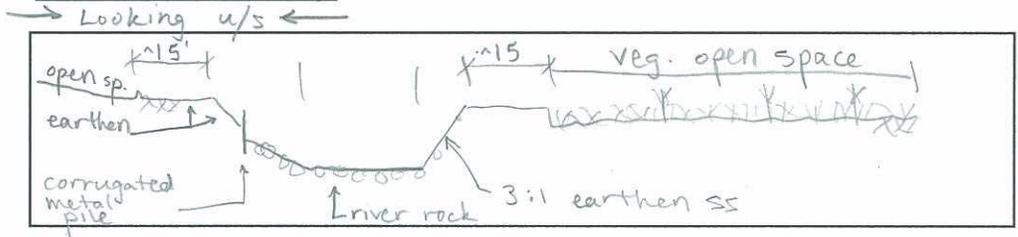
Facility:	Wilson Creek
X-Sec #:	Z3-R55
Comment:	Between Oak Glen Rd & Bryan St
Pictures:	4969 - 4989

1. Bank Protection Condition (good or poor) good
2. Bank Erosion (yes or no) y
3. Toe Erosion (yes or no) n
4. Invert Degradation (yes or no) y
5. Sediment Source (yes or no) y
