Los Padres National Forest Road Repair Project

Figure 1:
Project Location Map

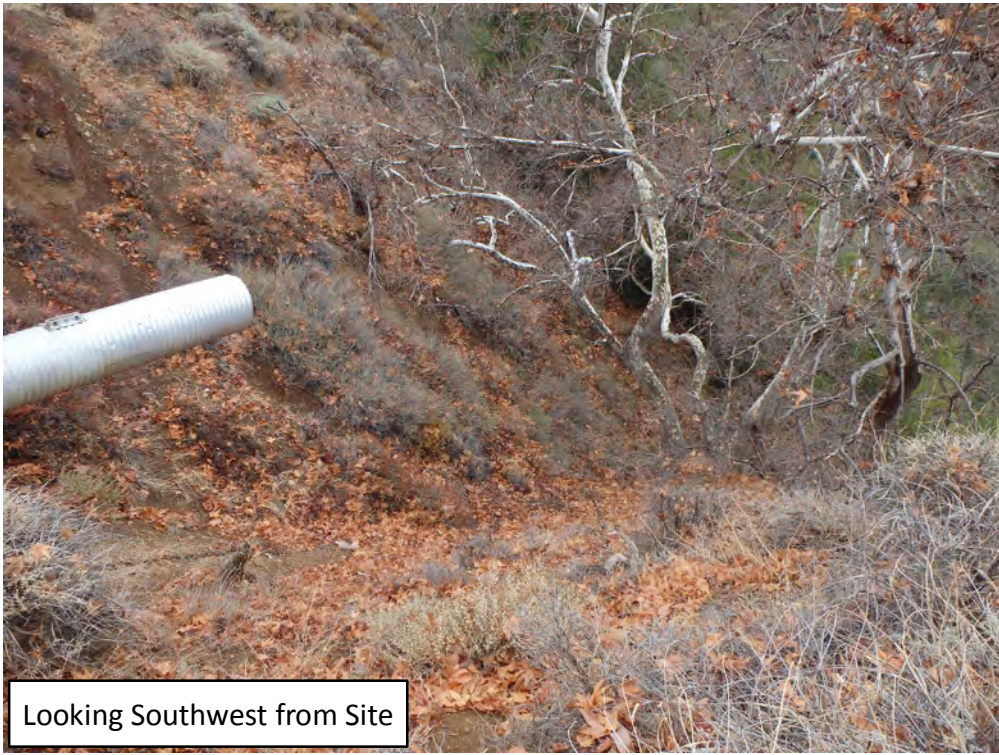
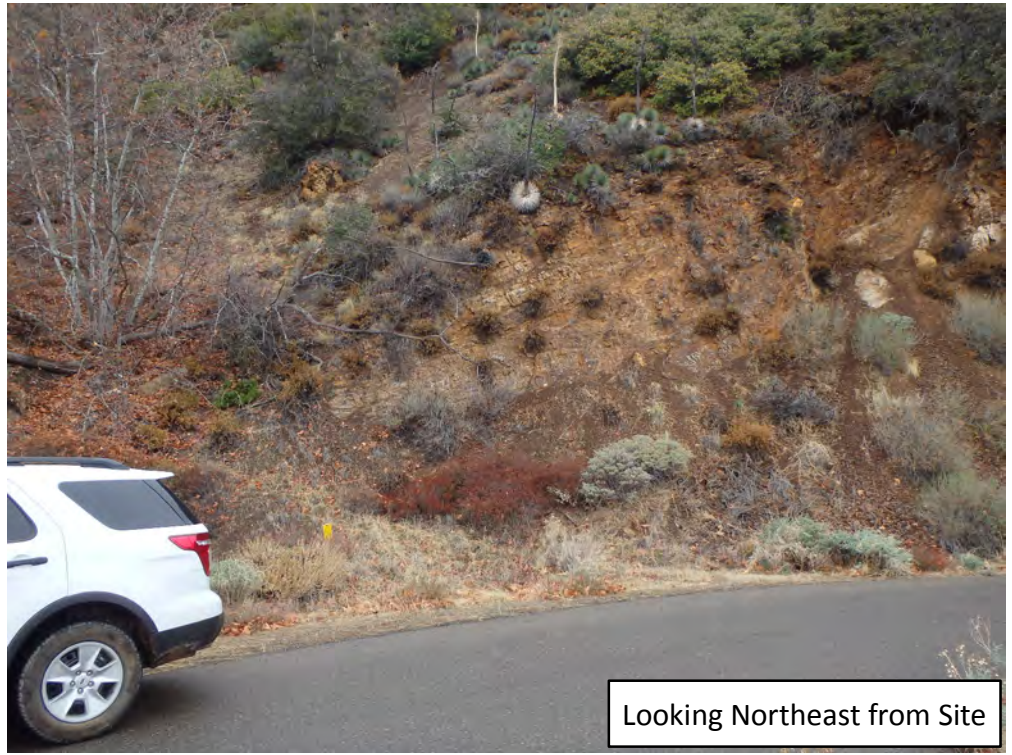
Looking Southwest from Site

Looking Northeast from Site

Site 7N07-7.4 is located on a drainage that was dry at the time of the October 2011 site visit. However, large sycamores in the drainage indicate the presence of subsurface moisture. No other wetland plants were present. The stream lacked pools and an Ordinary High Water Mark. The drainage is an unnamed tributary to Lion Canyon, which flows into Cachuma Creek. The surrounding hillsides were steep and vegetated by chaparral.

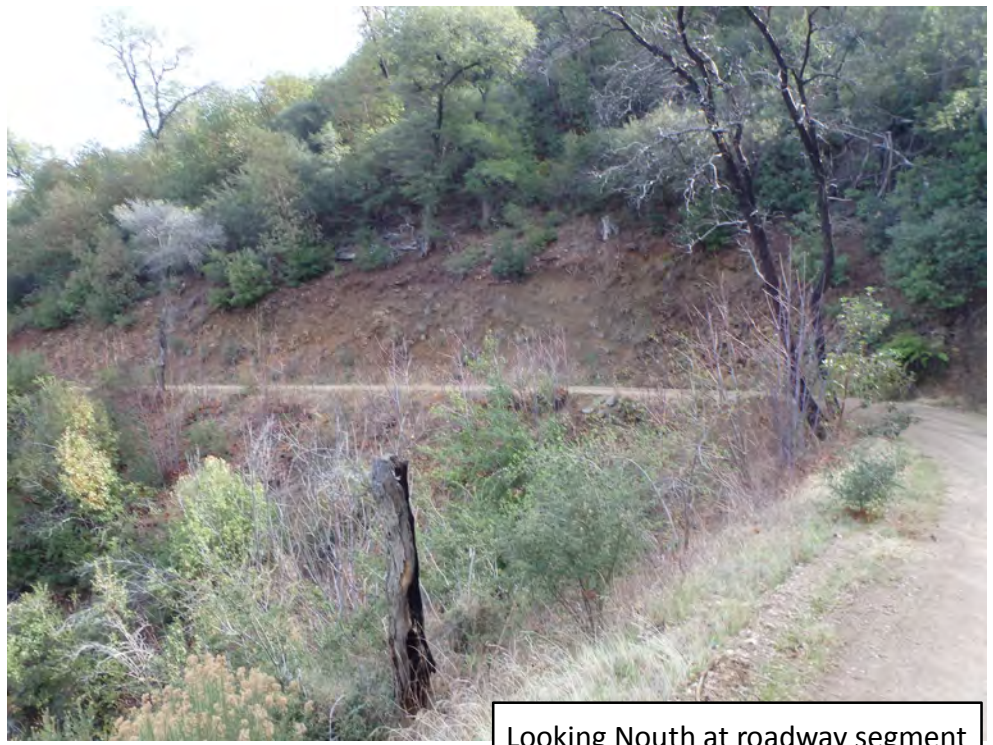
Looking South at roadway segment

Site 20S05.3 – 1.7 has a seep on the hillside that drips into a small pool on the side of the road that is a few inches deep. Wetland plants are located around the seep. The other sites are entirely in upland habitats.

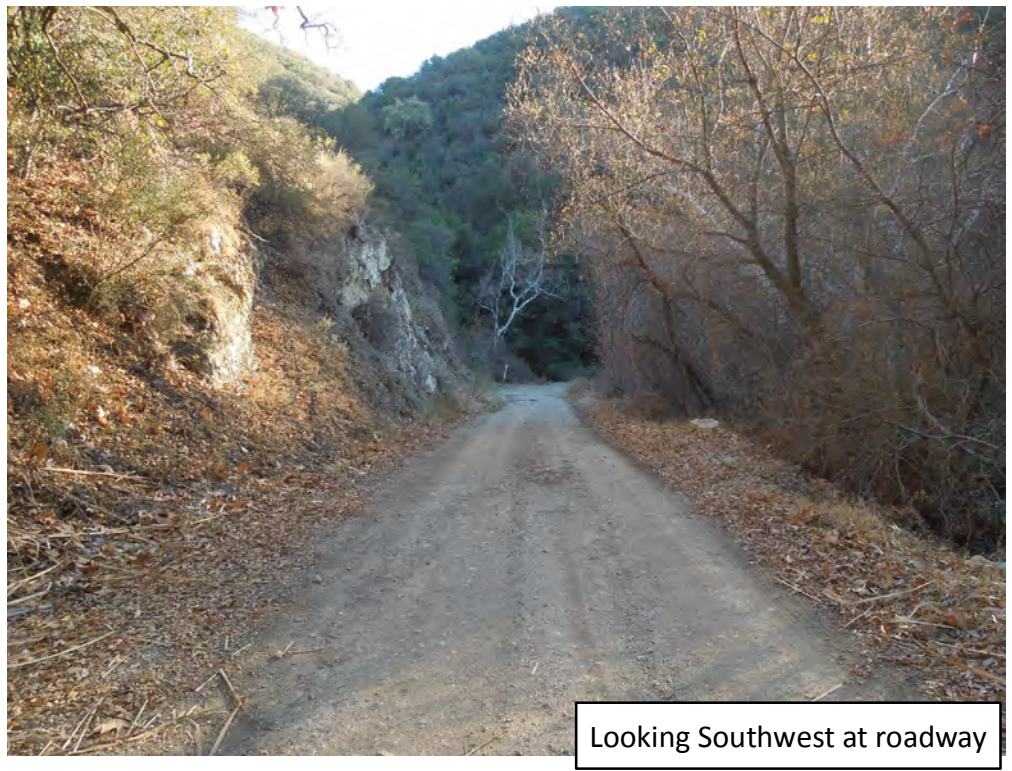
Looking Southwest at roadway

Site 11N04.4-3.1 includes a work area of approximately 772 linear feet, and encompasses one culvert on Colson Canyon, a culvert on a tributary, and a retaining wall on a tributary at the confluence of Colson Canyon. The work area is within riparian habitat with the exception of the inlet side of the uppermost culvert, which is in a disturbed grassland that is used for recreational target shooting. There is a seep that surfaces along the edge of the road and runs down the road, entering the canyon at the location of the proposed retaining wall. The stream is perennial within the work area during most years, but dries up in the summer both up- and downstream from this area. The project site was visited on 18 October 2011, which was during an extended dry period, and water was present in the mainstem. Pools on either end of the lowermost culvert had water depth in excess of 1 foot, and there was dense cover by cattails, overhanging willows and other herbaceous vegetation. The two tributaries within the work area are ephemeral.

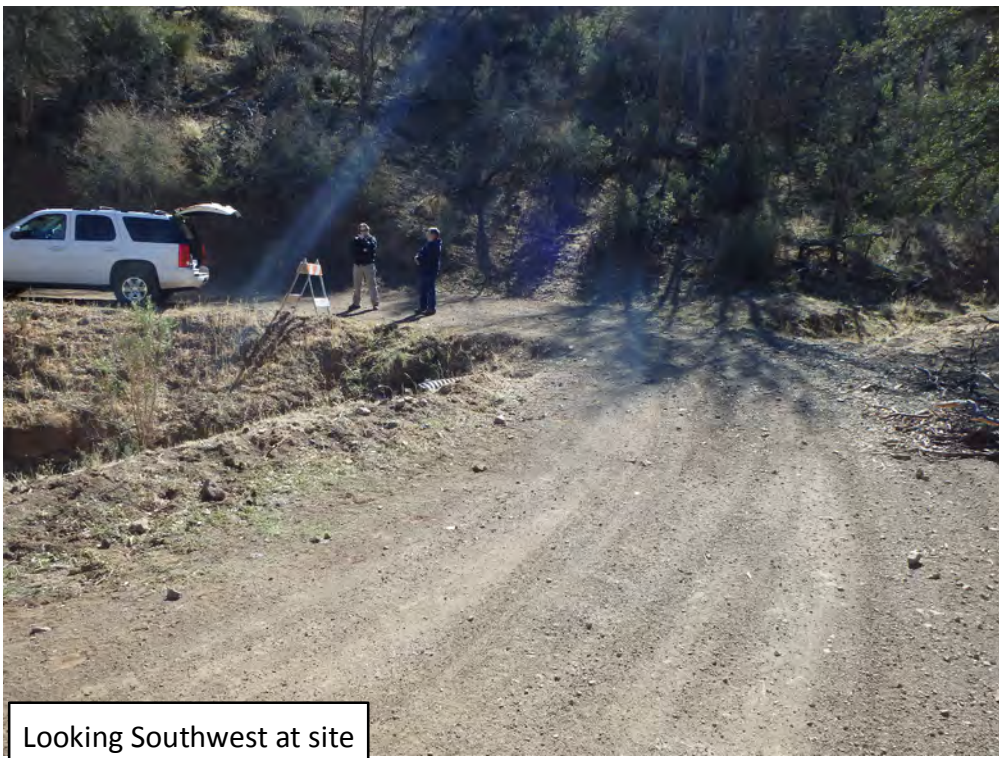
Looking Southwest at site

Notes:
 Site 11N03 – 3.7 is at a crossing of an intermittent stream that has been channeled into a culvert. It is an unnamed tributary of Kerry Canyon. During the November 2011 site reconnaissance survey, water was standing in shallow pools. Mulefat, willow, and dried algae were present in the drainage bottom, and the surrounding habitat was mixed oak woodland. Cattle grazing has resulted in eroded stream banks.

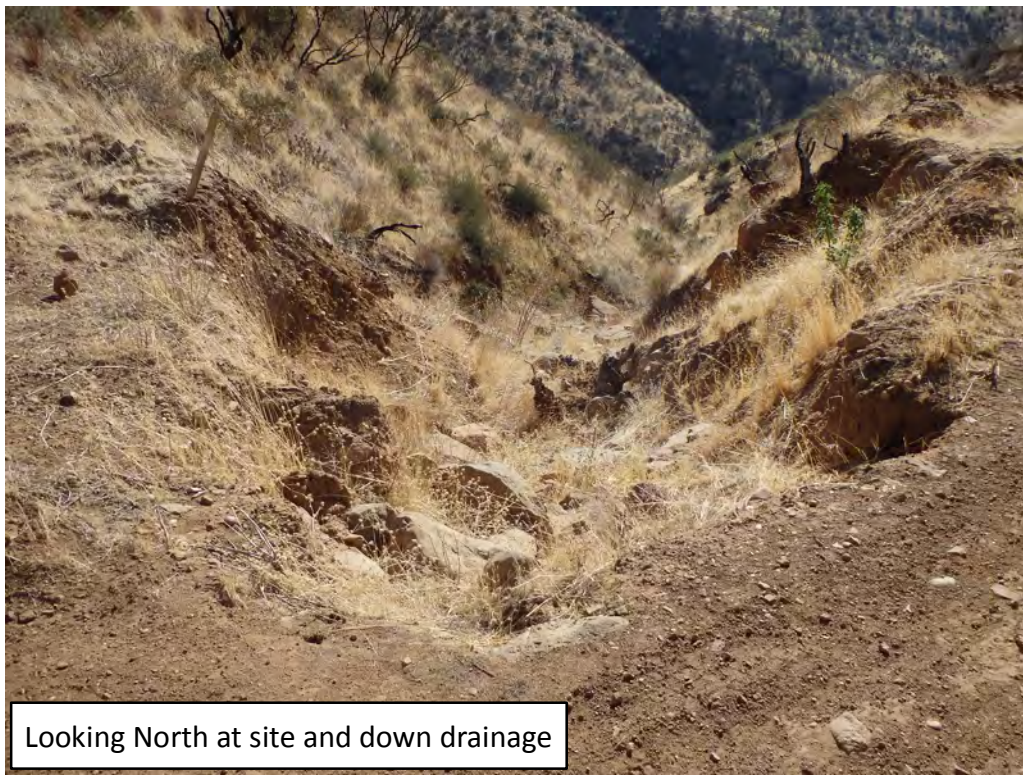
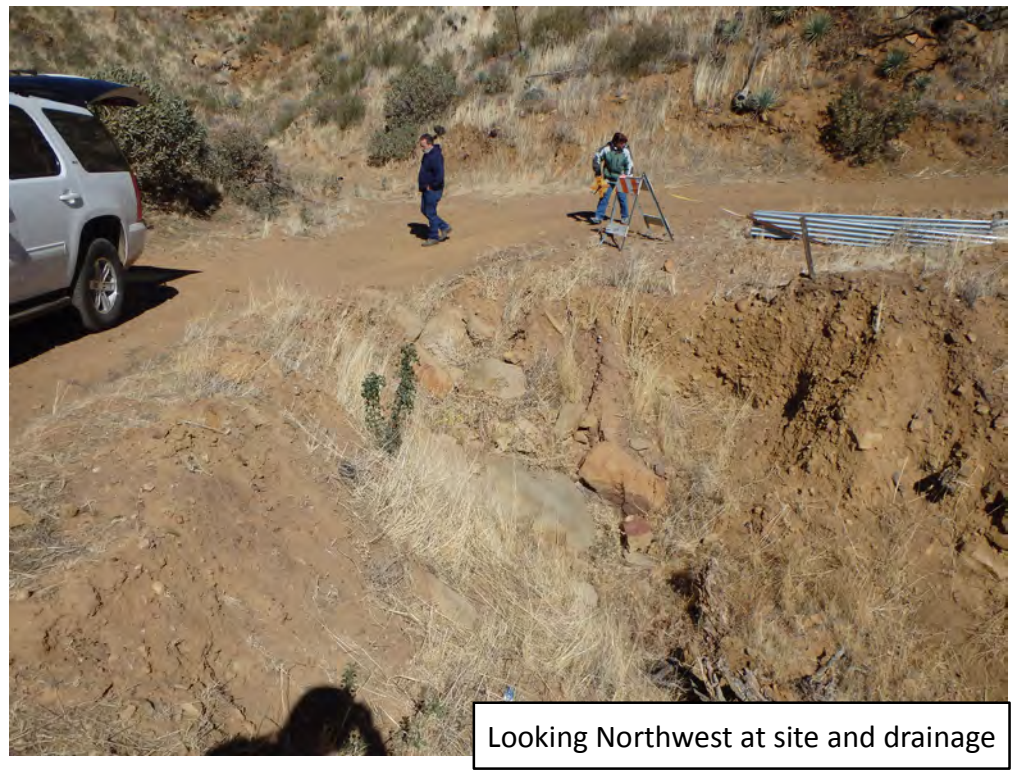
Looking North at site and down drainage

Looking Northwest at site and drainage

Sites 11N03 -1.6 is located on a small ephemeral drainage. The stream crosses the road without being channeled into a culvert. Site 11N03- 1.6 had sedge, willows, cattails and mulefat upstream of the road crossing and upland habitat (non-native grassland and chaparral) on the downstream side.

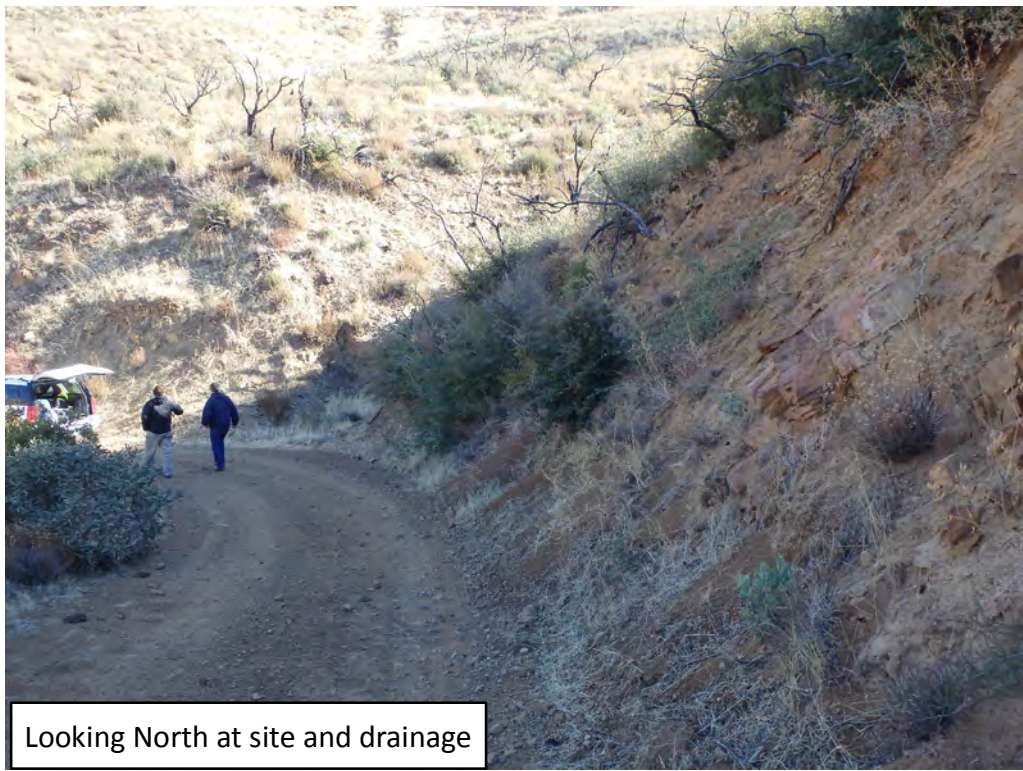
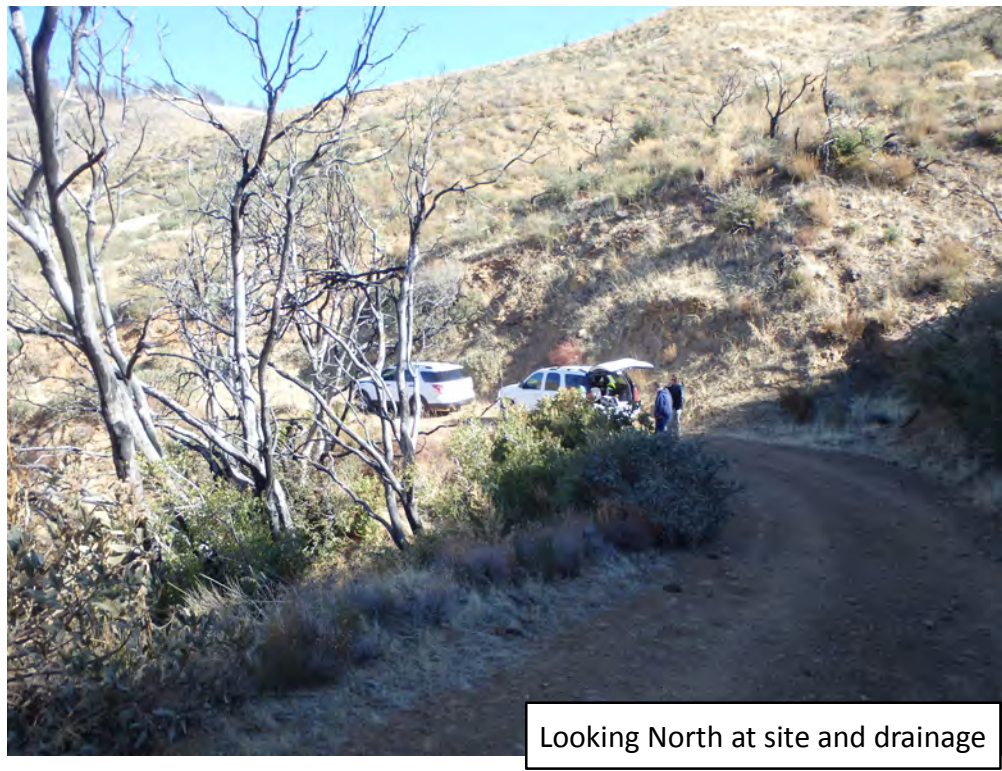
Sites 11N03 -1.2 is located on a small ephemeral drainage. The stream crosses the road without being channeled into a culvert. Wetland or riparian vegetation was not present in the drainage during the last site visit, and consisted of upland habitat types such as scrub oak chaparral and coast live oak.

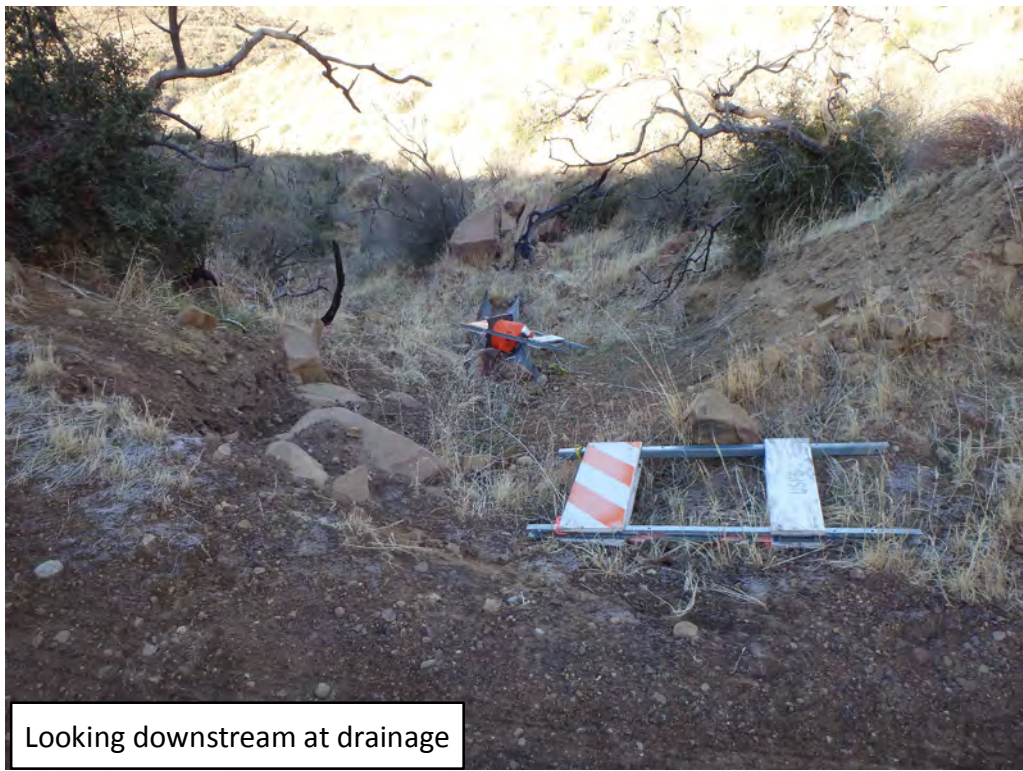
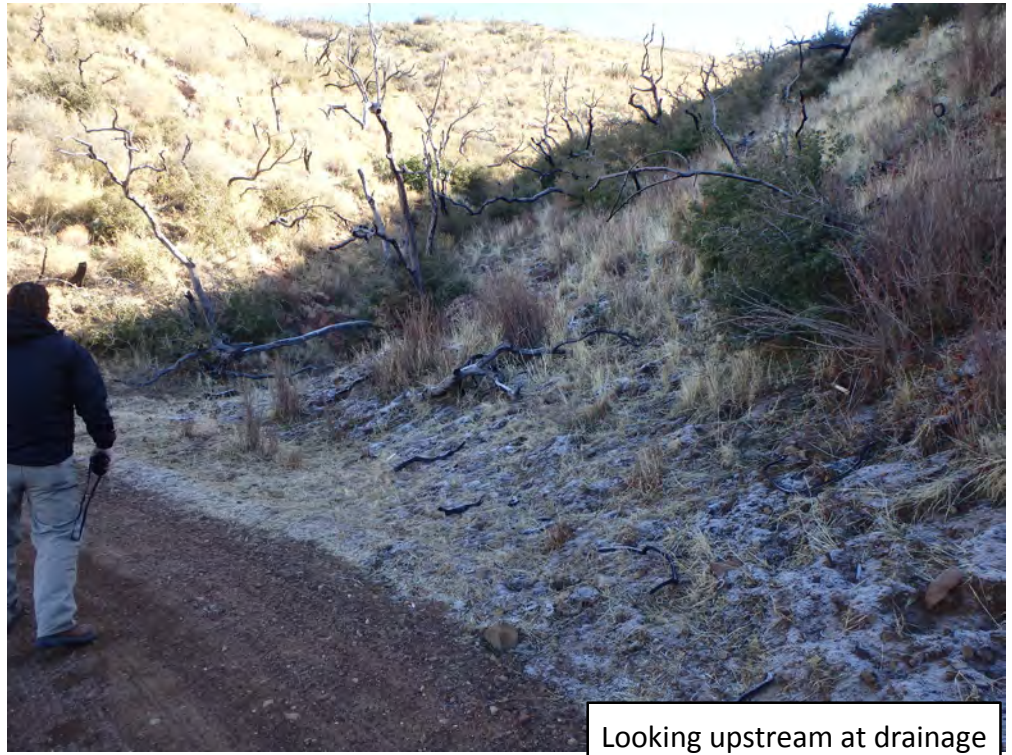
Looking downstream at drainage

Looking upstream at drainage

Sites 11N03 -0.2 is located on a small ephemeral drainage. The stream crosses the road without being channeled into a culvert. Wetland or riparian vegetation was not present in the drainage during the last site visit, and consisted of upland habitat types such as scrub oak chaparral and coast live oak.

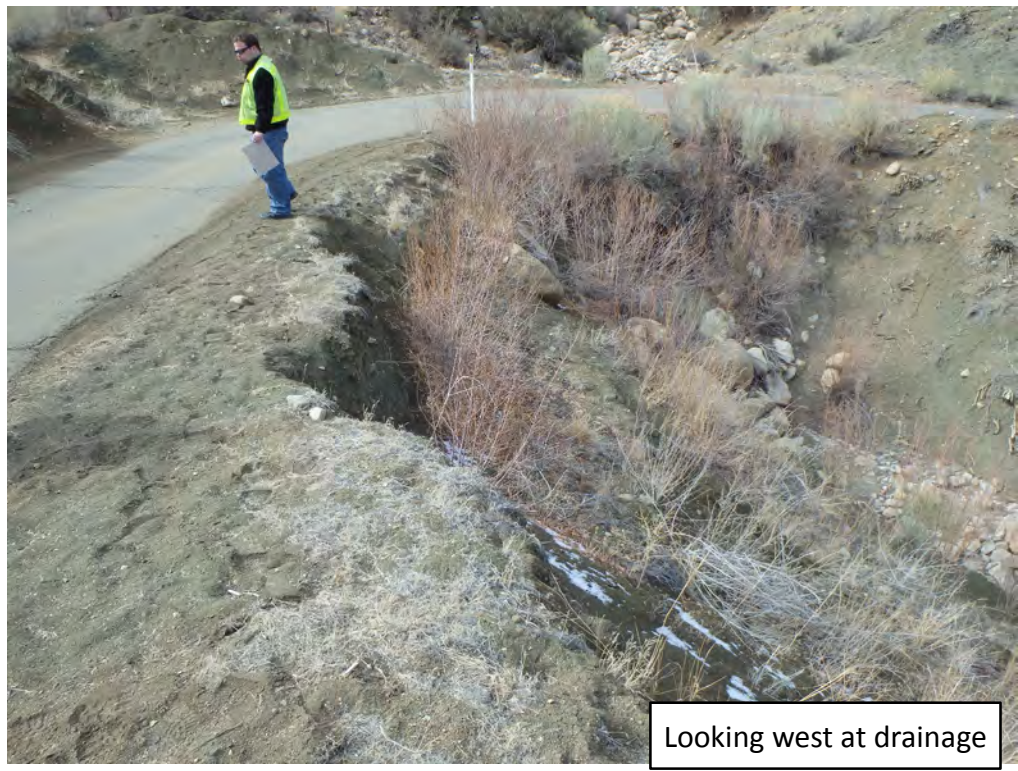
Looking west at drainage

At Site 7N03 – 1.1, an unnamed tributary to Lockwood Creek passes through Site 7N03 – 1.1, and is just downslope from Site 7N03 – 1.0. The soils are Lockwood Valley Clay, which is greenish in color and sparsely vegetated. The area burned in the 2006 Day Fire, killing many of the tall pine trees. The slide is vegetated by rabbitbrush and grasses. Pinyon pine and scrub oak were located nearby, and there were scattered small willows beside the stream channel. No water was present in the channel at the time of December 2011 and January 2013 site visits. The substrate in the streambed was rock and cobble, and the slope was relatively high and lacked pools.

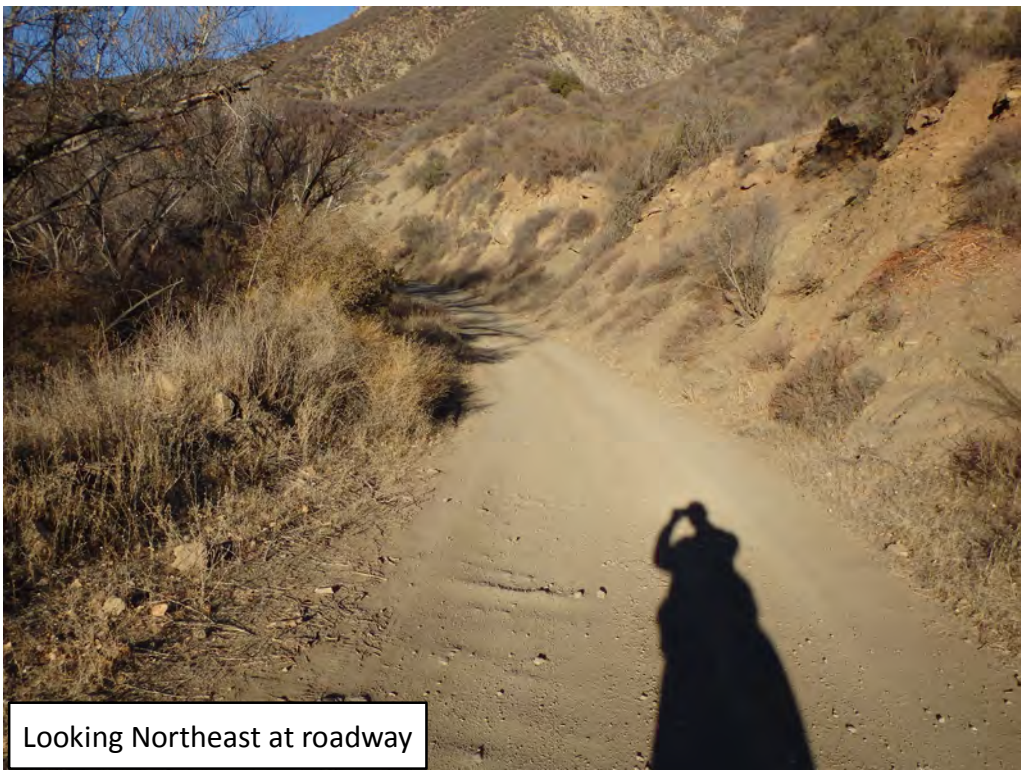
Looking Northeast at roadway

Site 5N16 – 1.2 consists of a culvert on an ephemeral tributary in which the outfall end of the culverts lies within the Agua Caliente Creek stream channel at the confluence of these two streams. Willows were present at the washed out end of the culvert, and thus the work would be conducted within the riparian habitat.

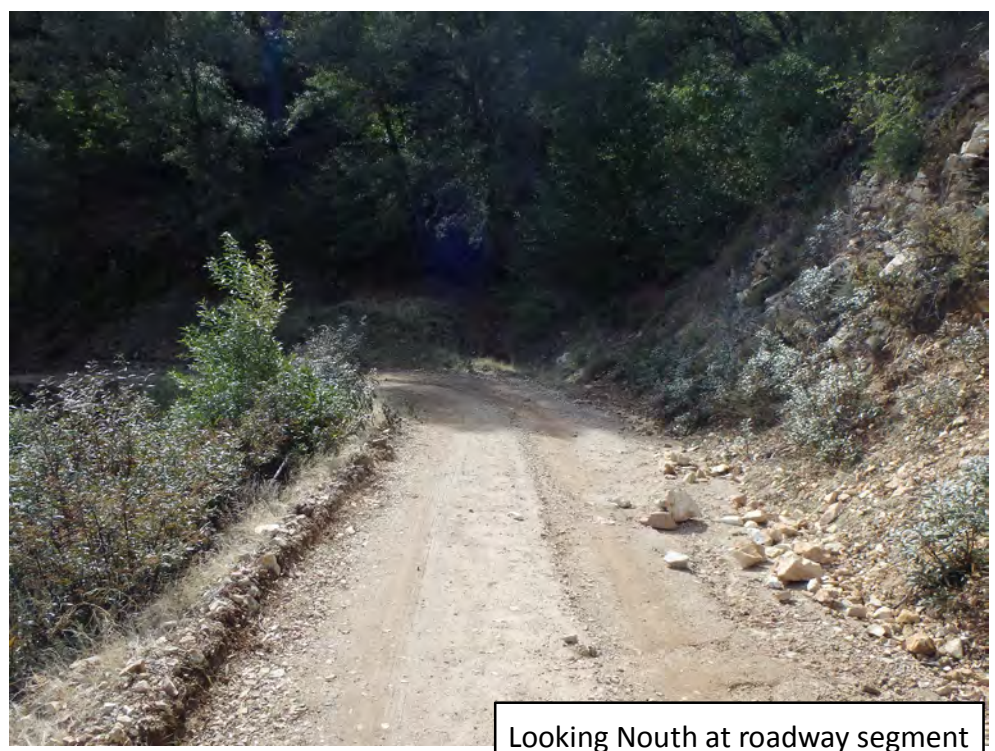
Looking South at roadway segment
