California Regional Water Quality Control Board Central Coast Region

CALIFORNIA WATER CODE SECTION 13267 REQUEST FOR REPORT, HWY 58 AREA PROPERTY, SAN LUIS OBISPO COUNTY

NOTICE OF VIOLATION; STORM WATER PERMITTING REQUIREMENTS; KELEGIAN RANCH PROPERTY; SANTA MARGARITA; SAN LUIS OBISPO COUNTY

SUBJECT: Assessment of Sediment Conditions and Possible Impacts to Beneficial Uses from Sediment on the Kelegian and Pierson Properties

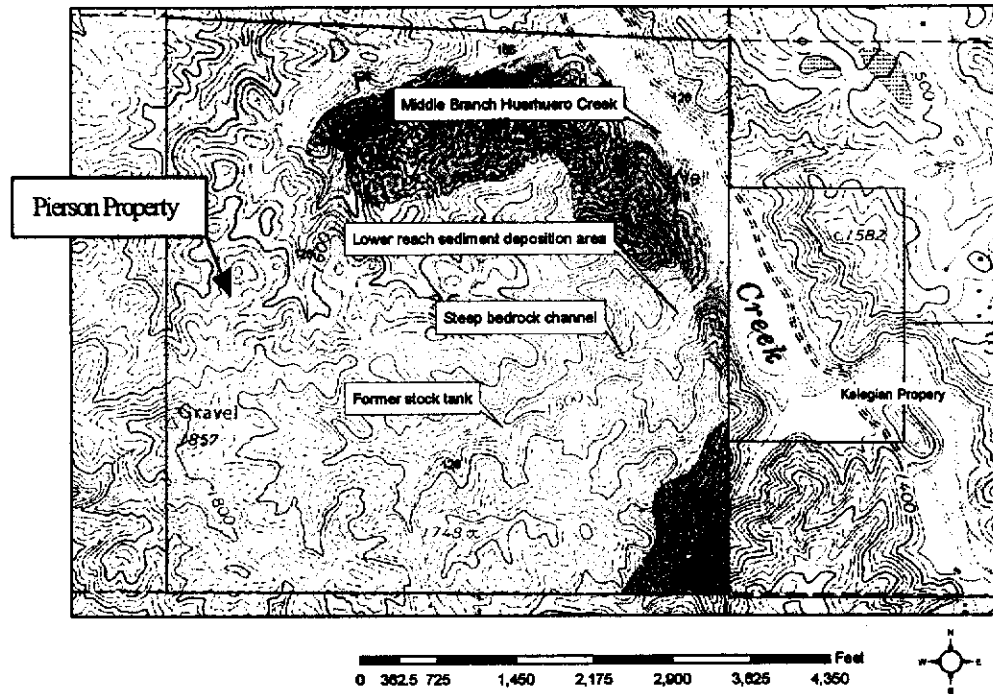
Figure 1 Pierson property showing soil units with 7.5-minute quad background (Soil Map Units on the map correspond to Soil Map Units in Table 1)

I evaluated portions of an unnamed tributary to the Middle Branch of Huerhuero Creek (see Figure 1). Sediment deposits were noted in the lower reach, two small side channels and in an area of a former stock tank. The soils in the grubbed area are primarily Cieneba coarse

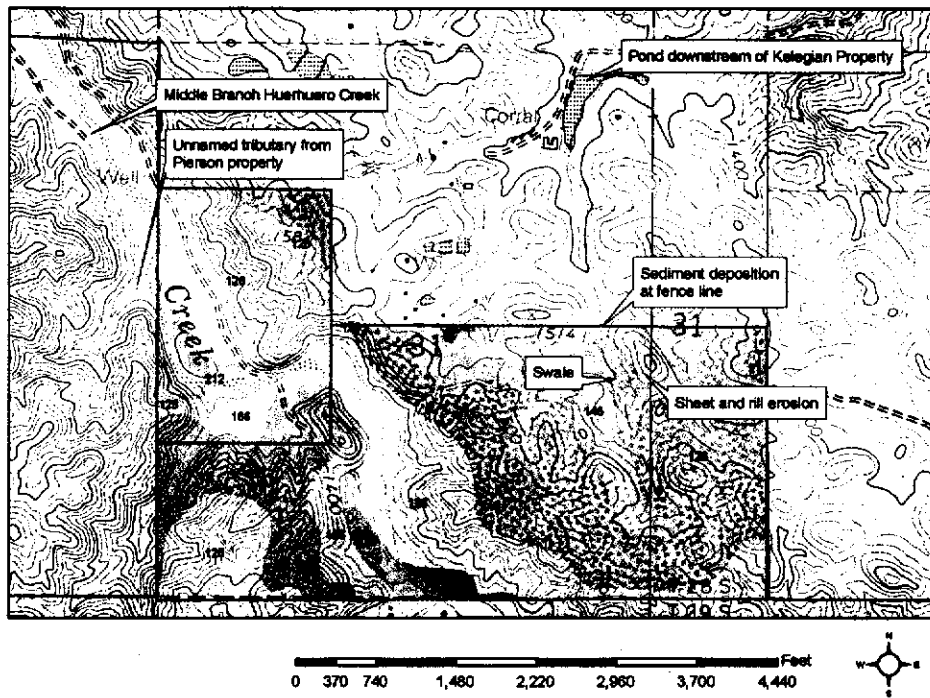
Figure 10 Kelegian property showing soil units with 7.5-minute quad background (Soil Map Units on the map correspond to Soil Map Units in Table 2)
