NOTICE OF VIOLATION - DELAVEAGA GOLF COURSE, SANTA CRUZ, SANTA CRUZ COUNTY; WDID#344C330064

Inspection Photos, De LaVeaga Golf Course, Santa Cruz
January 12, 2005

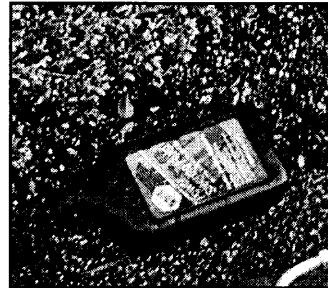
Below and Below Right: Unprotected storm drain inlets.

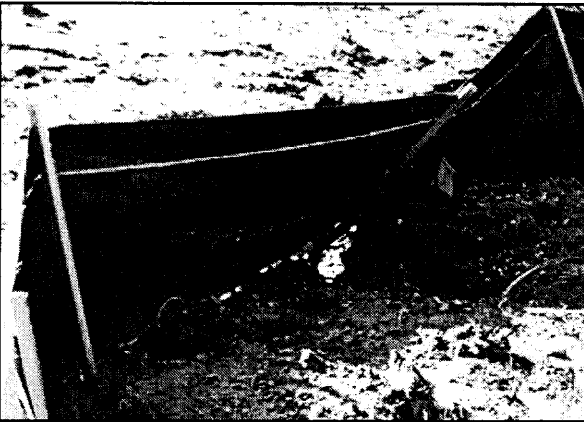
This Page: Onsite silt fences improperly installed. Silt fences are not trenched in at the bottom to prevent runoff from flowing under fences.
