CALIFORNIA REGIONAL WATER QUALITY CONTROL BOARD
CENTRAL VALLEY REGION

CLEANUP AND ABATEMENT ORDER R5-2019-0703
FOR
MARIA VALENCIA
ASSESSOR PARCEL 012-010-70
LAKE COUNTY

Attachment A – 8 August 2018 Notice of Violation and 22 May 2018 Inspection Report
Attachment B – 16 November 2018 Notice of Violation and 18 September 2018 Inspection Report

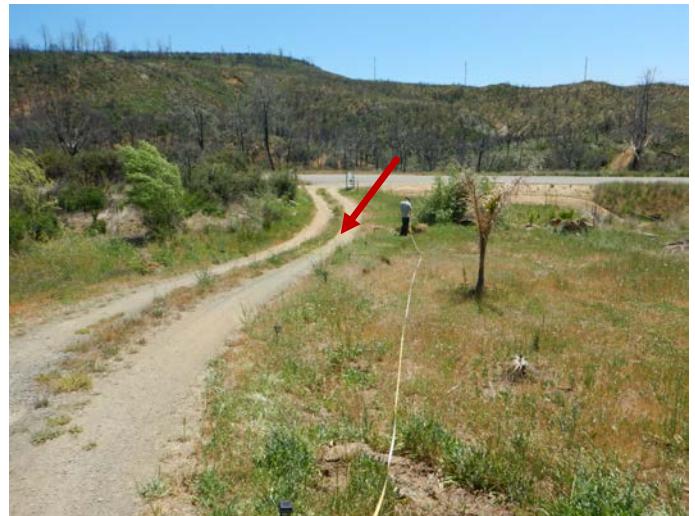
Photo 2. View looking at the location of the Watercourse Crossing. Red arrow points at approximate location of the Watercourse Crossing.

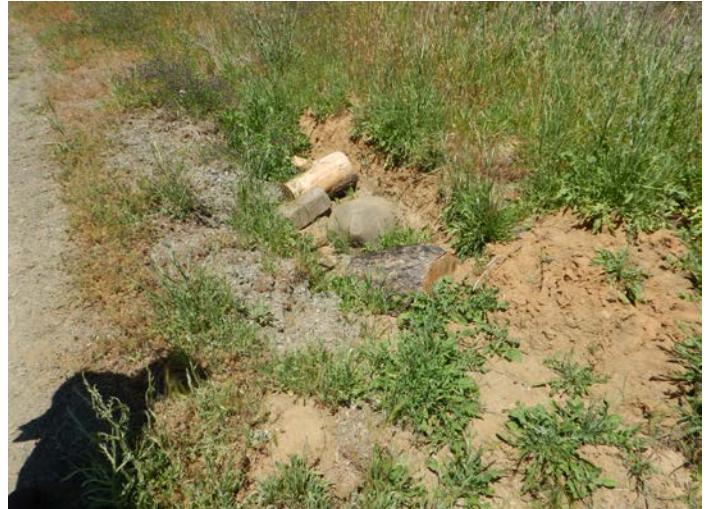
Photo 4. View looking northwest towards a drainage ditch that has been impacted with fine sediment from the plugged CMP.

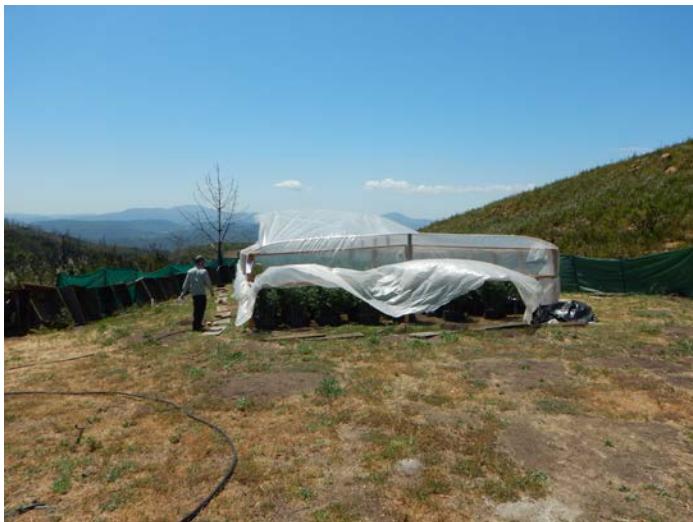
Photo 16. View of the well. The well head is uncapped, with rubber tubing and an extension cord extending down the hole.

utilizing a GPS, at approximately 0.5 acres. Cultivation Area One was located within this larger 0.5 acres graded pad. The larger graded pad fill slopes were well vegetated and were armored with rock slope protection (RSP), (Appendix B, Photo 15). The placement of the graded pad filled in an unnamed Class III watercourse. The Class III watercourse was redirected into a drainage ditch along the graded pad and continued down the access road. Located on the western edge of the graded pad was an uncapped well that had rubber tubing extending down the well with an electrical extension cord for power supply from a nearby generator (Appendix B, Photo 16).

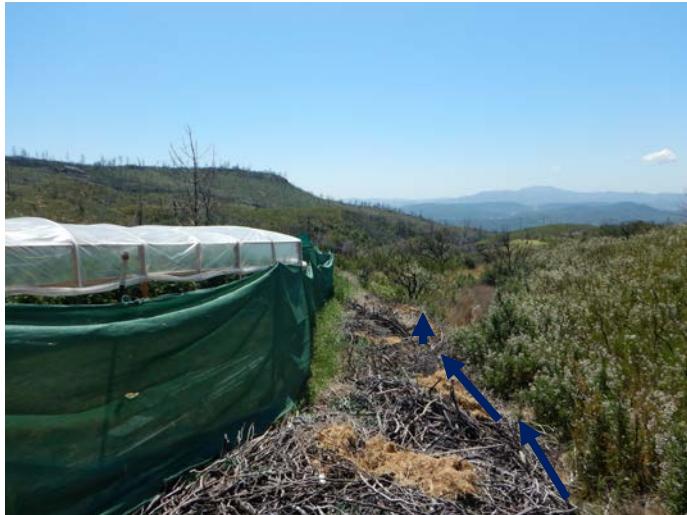
Photo 18. View of vegetation slash on the fill slope of the graded pad. Blue arrowed line shows general location of the Class III watercourse and flow direction.

Located west of Cultivation Area One staff documented Cultivation Area Two (Appendix A, Figure 2). Cultivation Area Two consisted of one wooden hoop house structure that was built on a graded pad (Appendix B, Photo 17). Cultivation was done in above ground plastic grow pots, placed directly on the native ground surface, containing imported potting soil. Vegetation was established on a majority of the pad with piles of imported potting soil from past cultivation. Staff calculated the area of the graded pad used for Cultivation Area Two, utilizing a Garmin GPS, at approximately 0.13 acres. The toe of the fill slope of the graded pad was measured at approximately 5 feet from an unnamed Class III watercourse, a tributary to Soda Creek. Vegetative slash was piled on the fill slope of the graded pad and within the Class III watercourse channel (Appendix B, Photos 18-19).

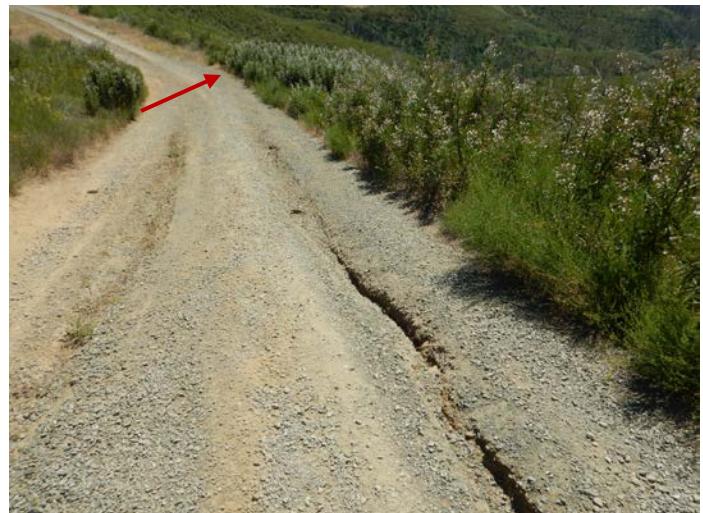
Photo 26. View looking down grade of the Ridge Access Road. It is evident in the photo that scouring from concentrated flow on the road surface has begun to cause rill erosion. Red arrow shows surface flow outlet onto a well-vegetated slope.

to 25%, which exacerbated rill erosion of the road surface. Rill erosion which extended 265 feet and discharged onto a well vegetated hill slope (Appendix B, Photo 25 & 26).

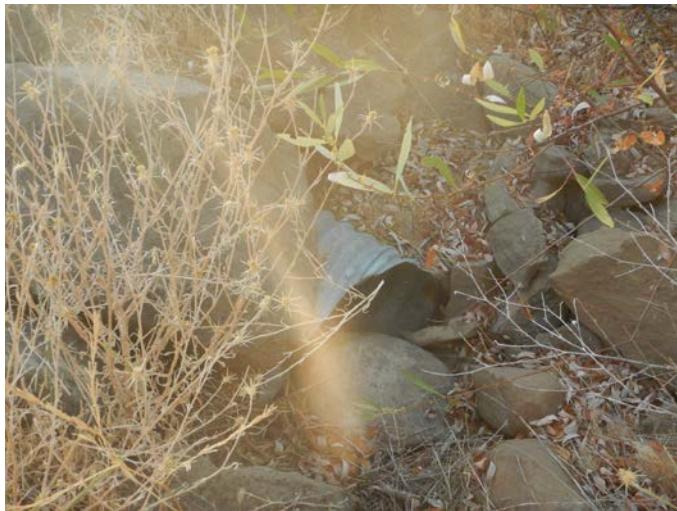
Photo 1. View looking at the plugged inlet of the corrugated metal pipe at the Watercourse Crossing.

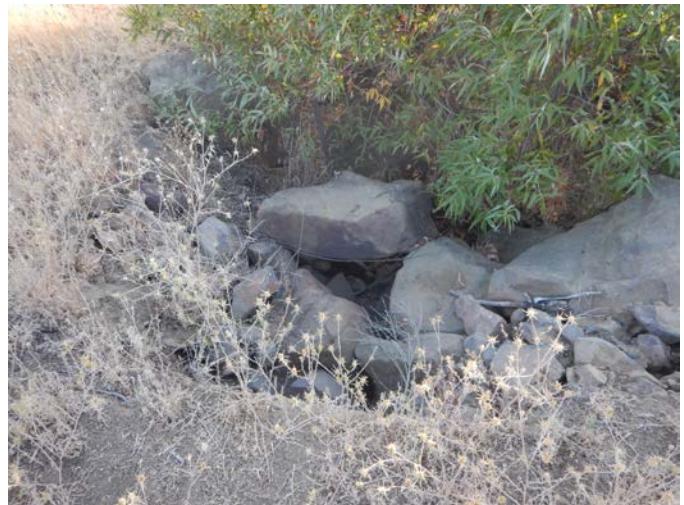
Photo 2. View looking at the eroded vertical fill slope above the outlet of the Watercourse Crossing.

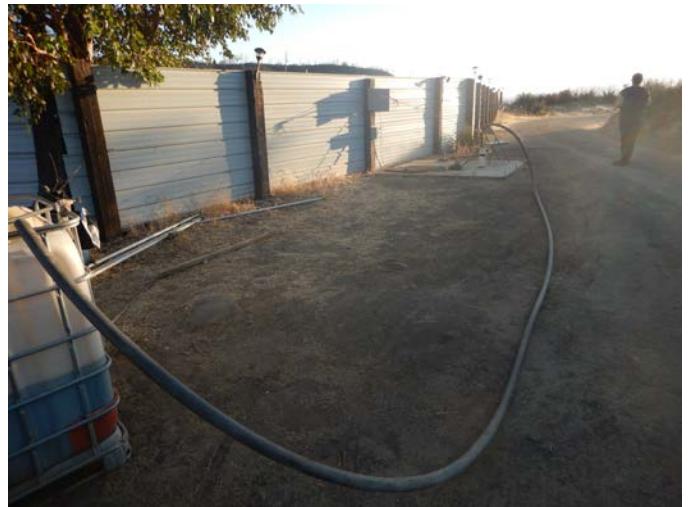
Photo 6. View looking at the uncapped well with a rubber line feeding an Intermediate Bulk Container (IBC), filled with an unknown liquid substance.

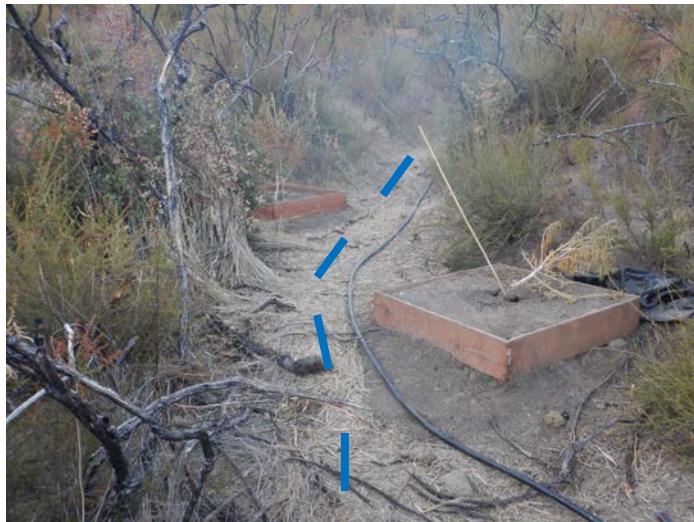
Photo 12. View of active cannabis cultivation in Cultivation Area Three. The dashed blue line shows the approximate location of the defined Class III watercourse channel.

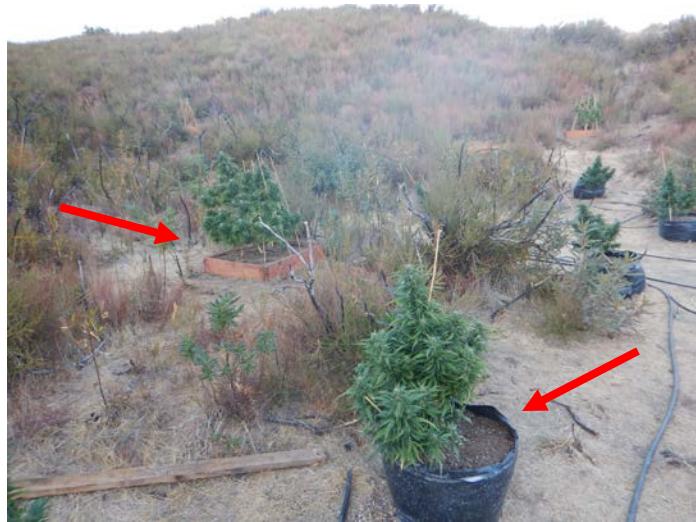
Photo 13. View of the upstream expanded area and the location of the excavation and constructed lumber grow boxes in proximity of the Class III watercourse in Cultivation Area Three. Dashed blue lines show the approximate location of the channel.

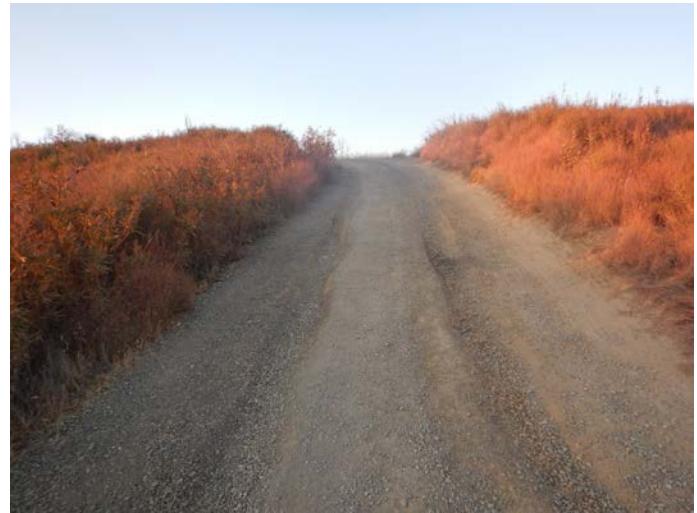
Photo 20. View looking up grade of the Ridge Access Road with rill erosion still present with no installed drainage features to mitigate the surface flow on the road.

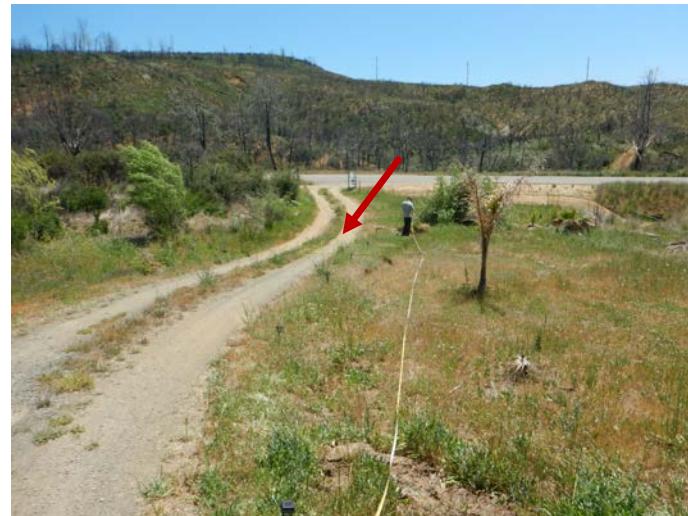
Photo 2. View looking at the location of the Watercourse Crossing. Red arrow points at approximate location of the Watercourse Crossing.

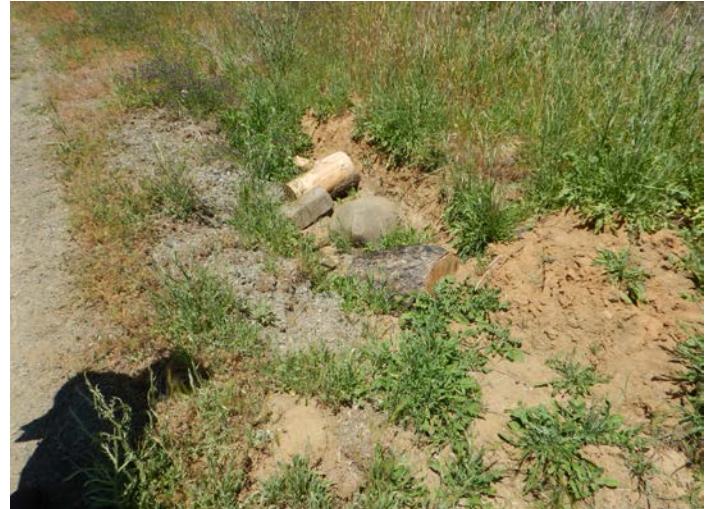
Photo 4. View looking northwest towards a drainage ditch that has been impacted with fine sediment from the plugged CMP.

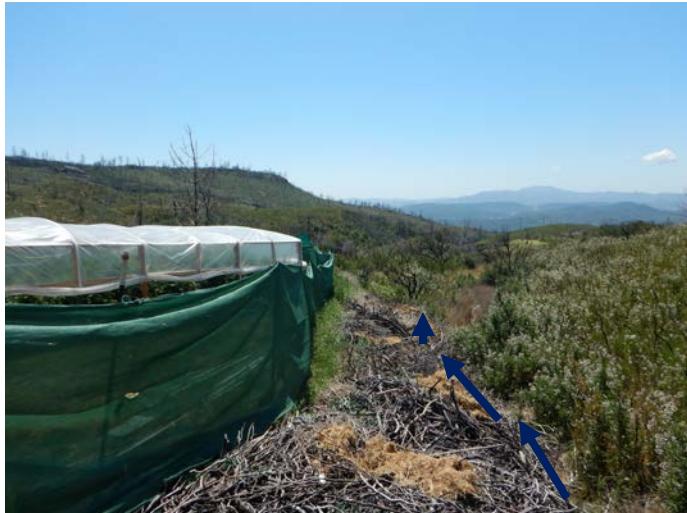
Photo 18. View of vegetation slash on the fill slope of the graded pad. Blue arrowed line shows general location of the Class III watercourse and flow direction.
