**Leviathan Mine
December 2012
TAC Meeting
Lahontan Water Board**

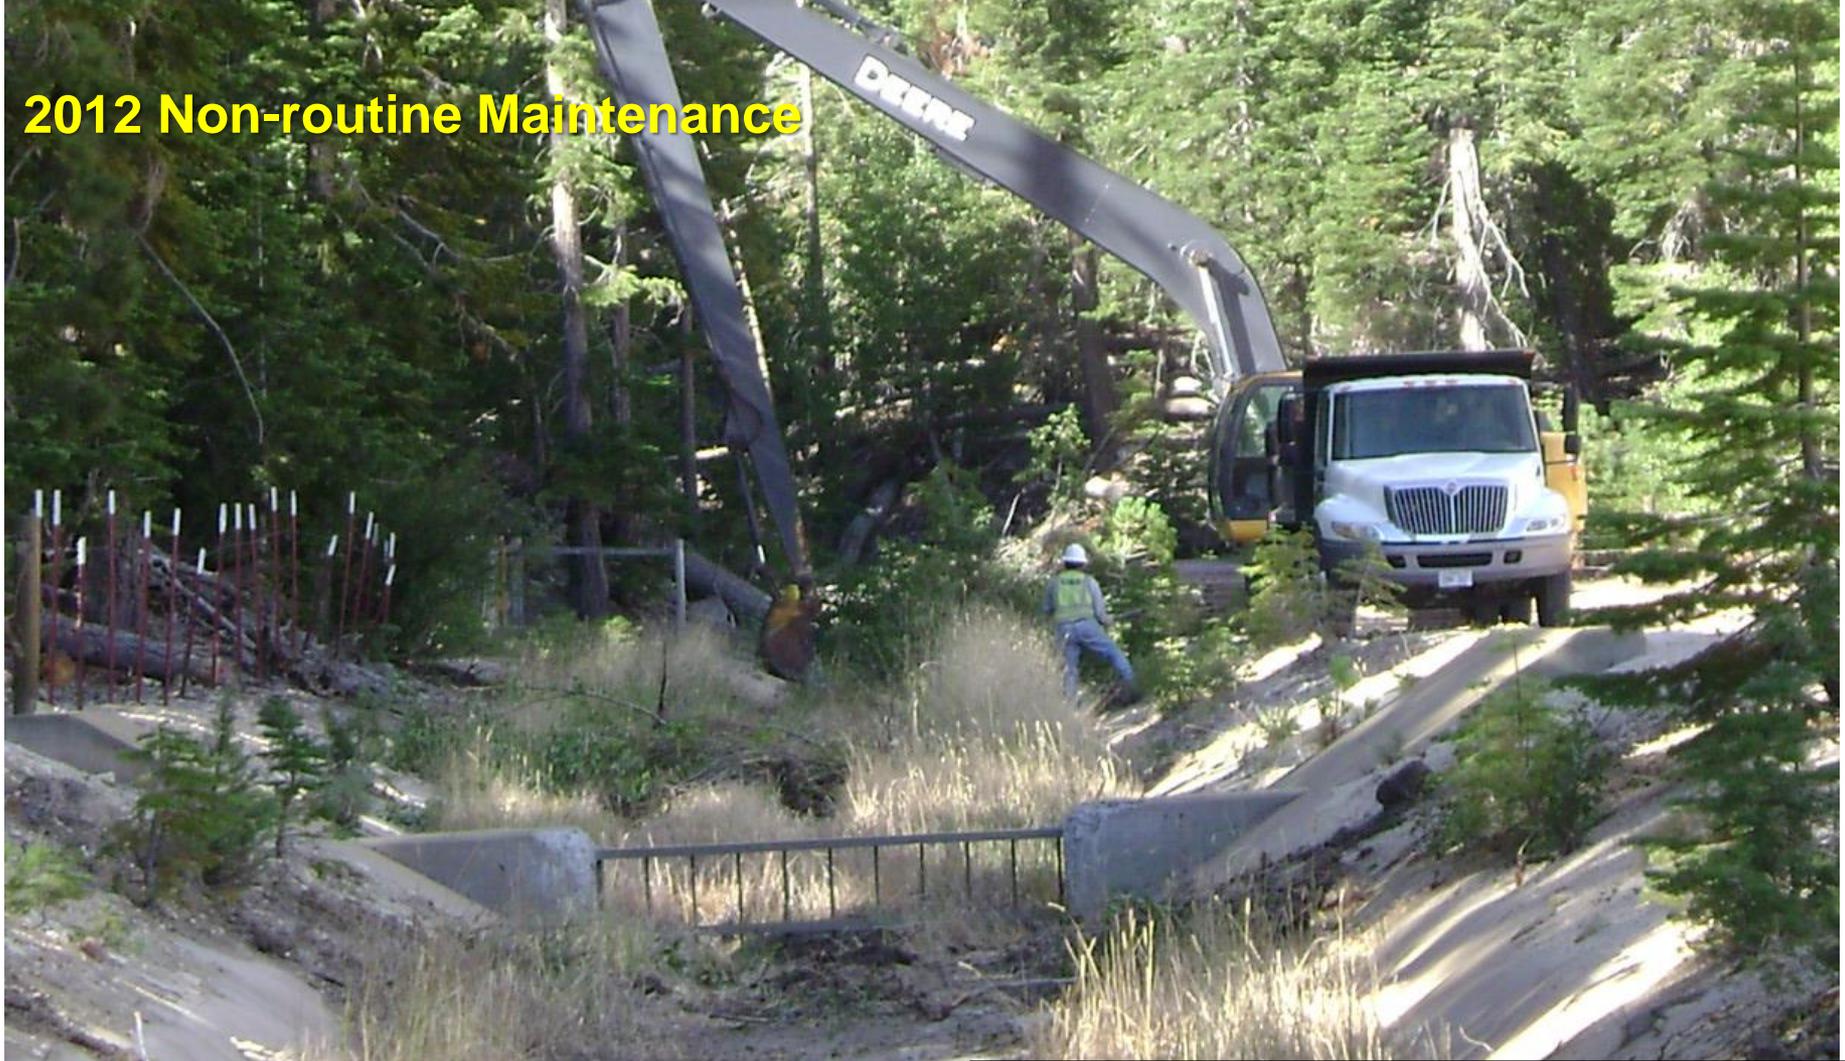
2012 Non-routine Maintenance

- Upper Tributary Channel clean-out
- Pond 1 Sludge Removal
- Pond 3 inlet/outlet maintenance
- Pond Liner Leak Detection Survey
- Pond Liner Repairs
