EXHIBIT B

DRY CLEANERS— A MAJOR SOURCE OF PCE IN GROUND WATER

27 March 1992

**REGIONAL WATER QUALITY CONTROL BOARD
CENTRAL VALLEY REGION**

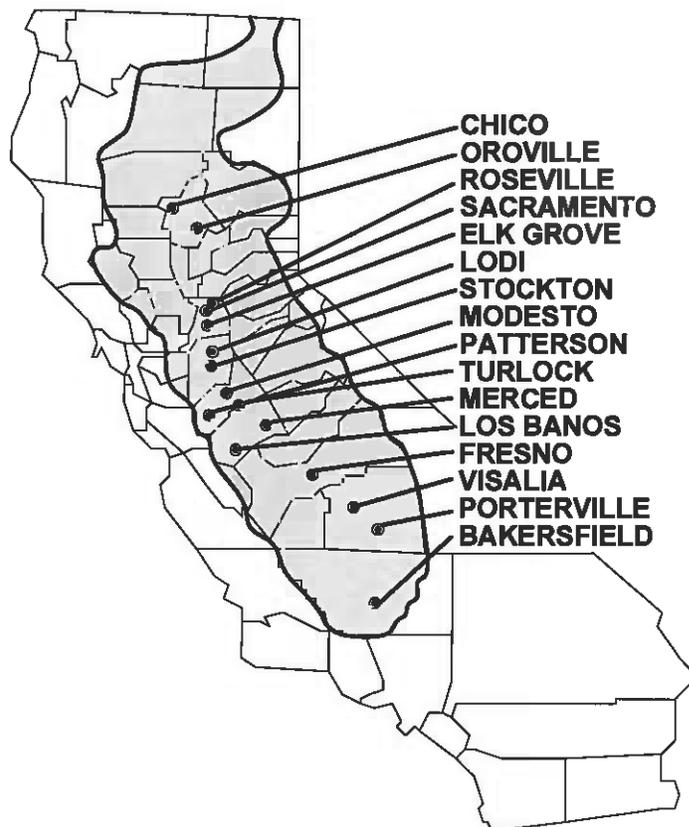
**CENTRAL VALLEY
CITIES WHERE MUNICIPAL WELLS ARE AFFECTED BY
TETRACHLOROETHYLENE (PCE)**

Tetrachloroethylene (PCE), a known carcinogen, has degraded at least 215 wells in the Central Valley of California. Figure 1 illustrates the extent of the problem. The majority of these wells are large system municipal wells of 200 connections of more. The Chico, Sacramento, Modesto, Fresno, Turlock, Lodi and Merced areas all have wells with levels of PCE above 0.8 ppb which is the estimated one in a million incremental cancer risk (8). The Maximum Contaminant Level (MCL) set by the Department of Health Services for drinking water is five ppb. Forty-seven of the 215 wells have PCE levels above the MCL.

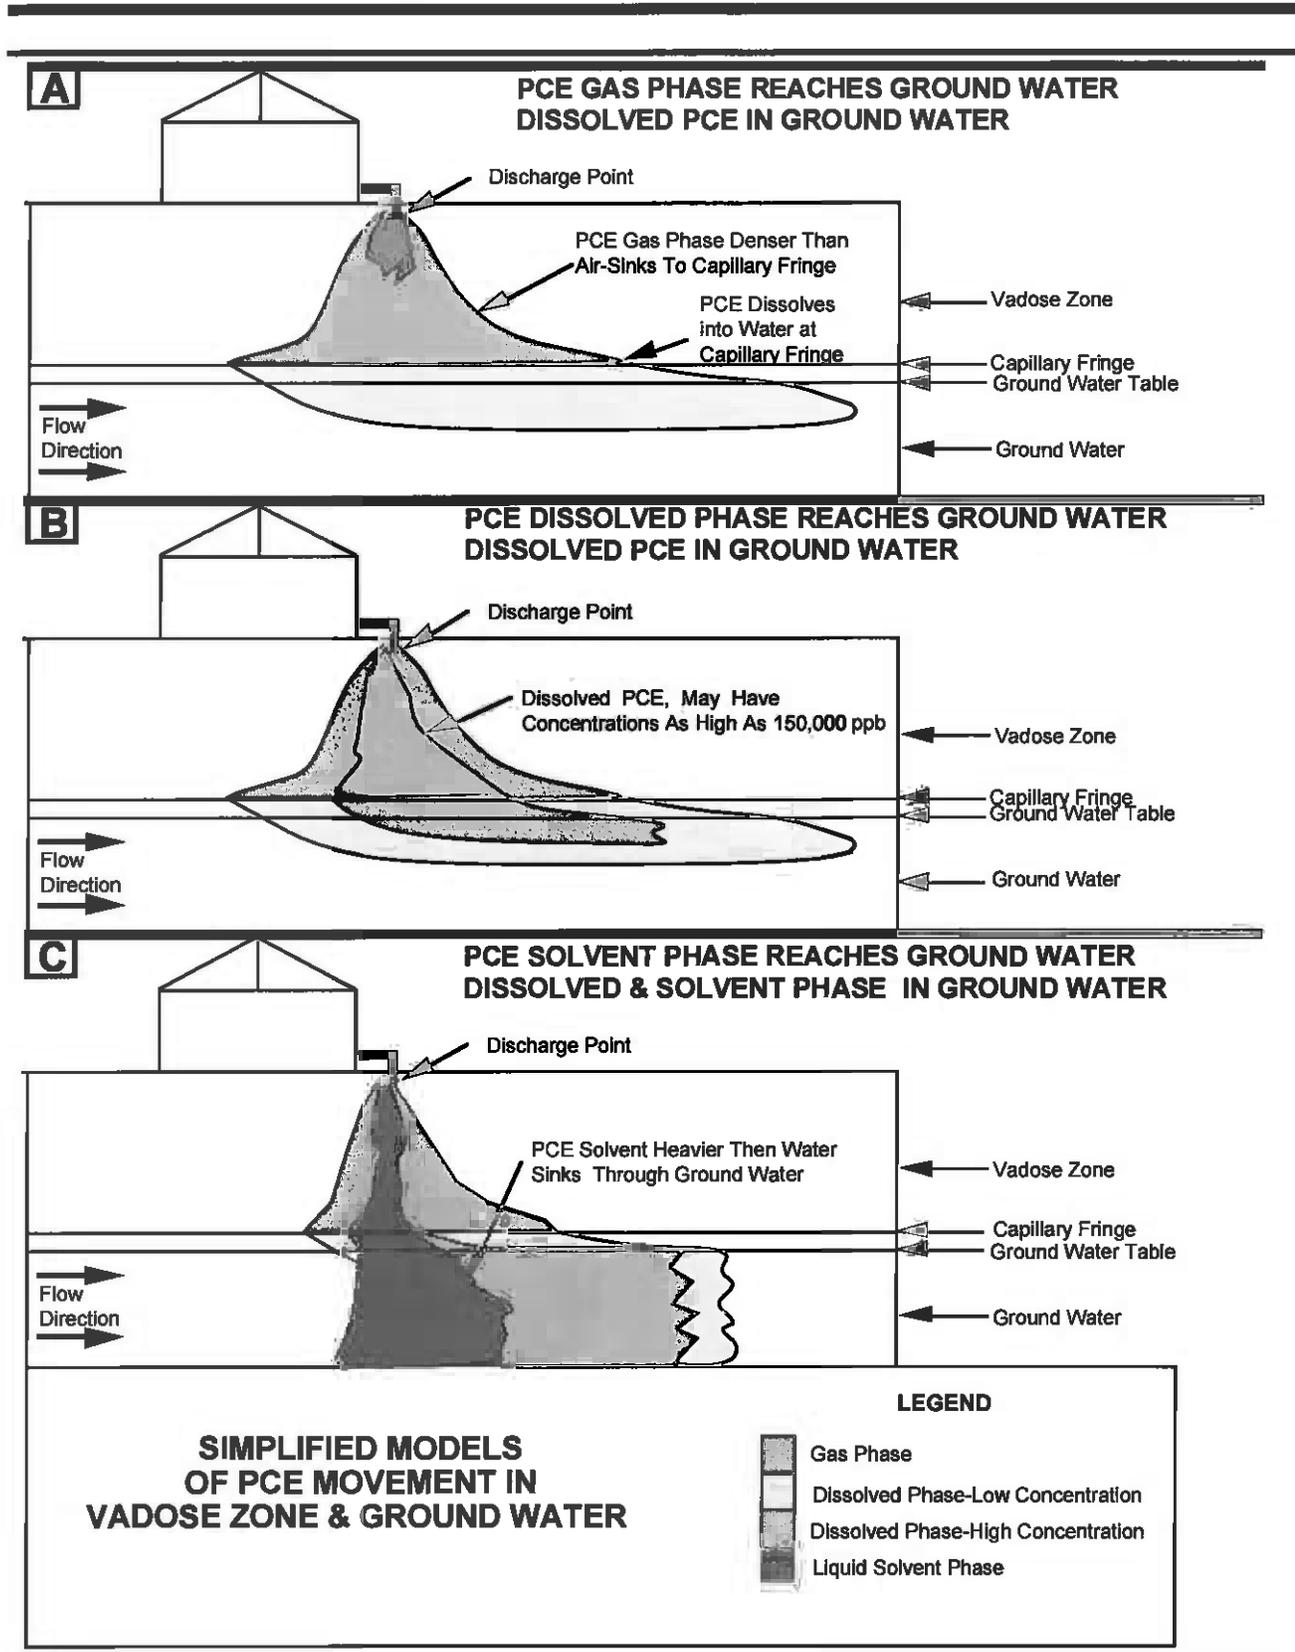
PCE is generally found in three phases in the subsurface: liquid, vapor, and dissolved in water. More than one phase usually exists in the subsurface after discharge. Figure 2 shows three possible scenarios at a discharge point.

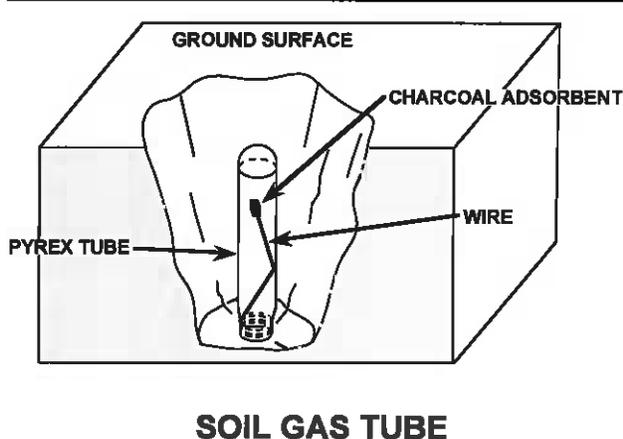
Figure 3

In step 5, the soil gas survey is used to identify areas of VOCs in the soil and ground water. A survey involves placing glass tubes, each containing a carbon coated wire, open end down, 10-12 inches below the soil surface (Figure 3). After placement, the tubes are covered with soil. The evaporating VOC gasses disperse through the soils and reach the survey

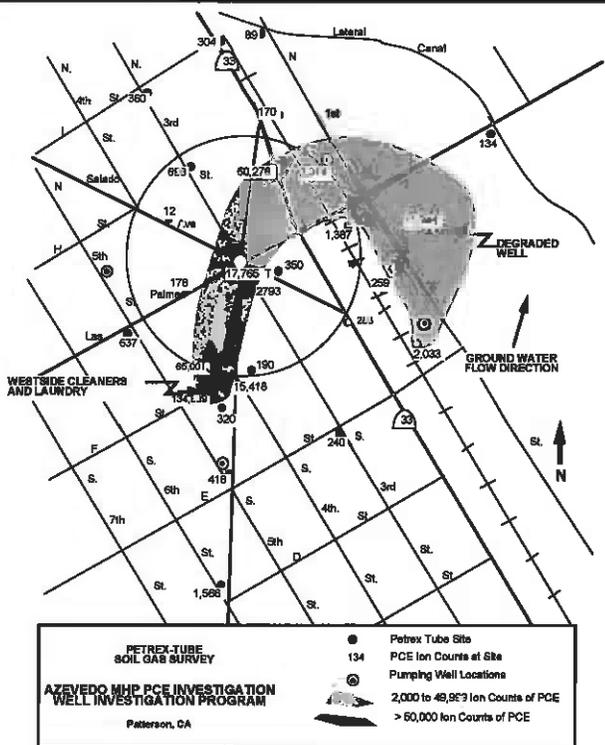
equipment. Approximately six week later, the tubes are removed and sent to the laboratory for VOC analysis. The results are in numbers of a specific VOC molecule retained by the carbon coated wire. The numbers are not concentrations, but are relative to each other. Locations with high counts have more of that VOC in the soil vapor than areas with low counts. Figure 4 is an example of the results of one of these surveys.

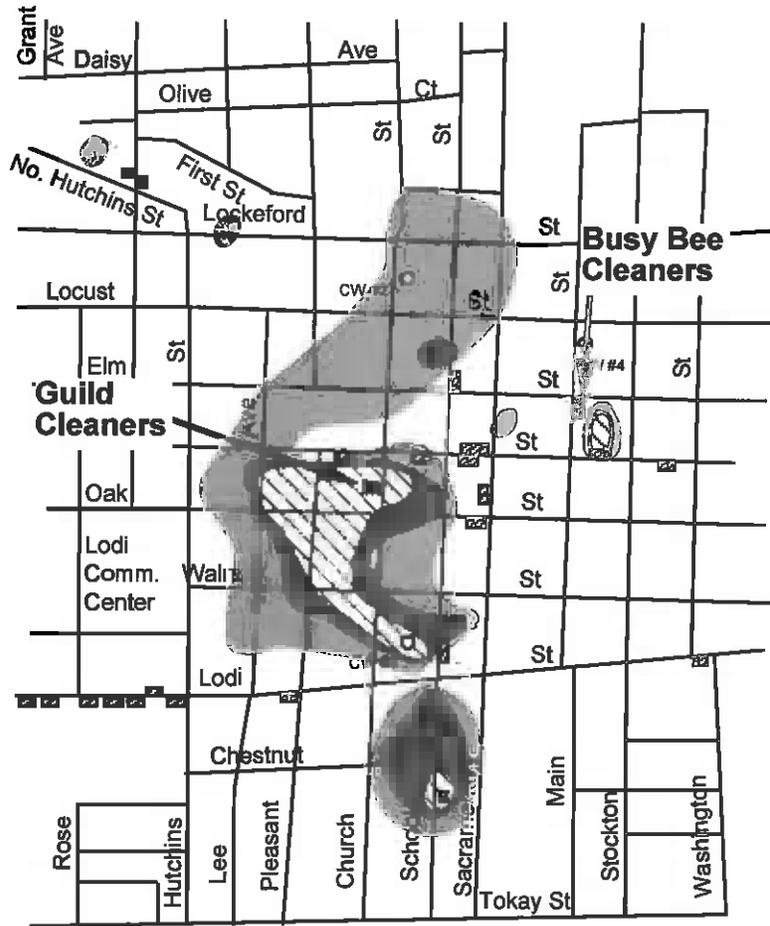
Figure 6

The staff soil gas surveys, which include all solvent users, show dry cleaners as the source areas. Figures 6 and 7 are two examples. None of the soil gas surveys have shown PCE vapor plumes near other solvent users.

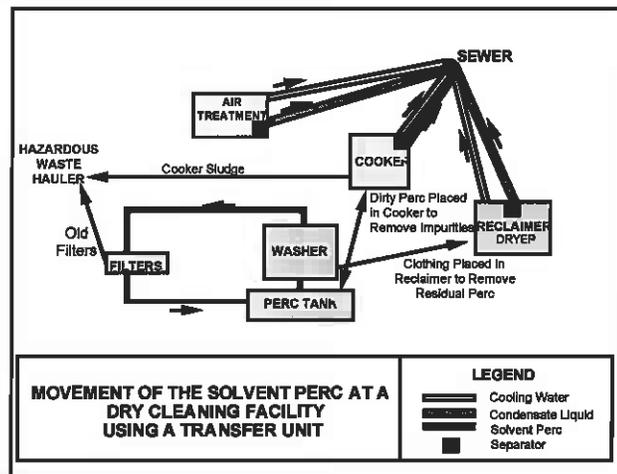
Figure 8

Dry cleaning transfer systems include a dry cleaning wash unit, PCE storage tank (generally part of the wash unit), reclaimer (dryer), cooker and vapor condenser (Figure 8). Pure PCE solvent is added directly from the PCE tank to the wash unit. A small amount of water and soap is usually added to remove stains that PCE will not. Most facilities send the spent solvent (after washing cycle) through solid filter canisters to remove solids and then return it to the PCE tank in a closed system. The solvent in the PCE tank also is periodically purified by physical transfer to the cooker, which separates solvent from solids through distillation and forms a sludge at the bottom.

In general, information provided by dry cleaner operators, inspections done by staff, and manufacturers' service manuals show that dry cleaning equipment is designed to discharge wastewater to the sewer. Figures 8 and 9 are schematics showing the two main types of wastewater discharges from dry cleaning equipment: liquid from the PCE-water separator and cooling water. Figure 10 is a schematic from one manufacturer's service manual that shows that wastewater should be discharged to the drain (11). This is typical of service manuals.

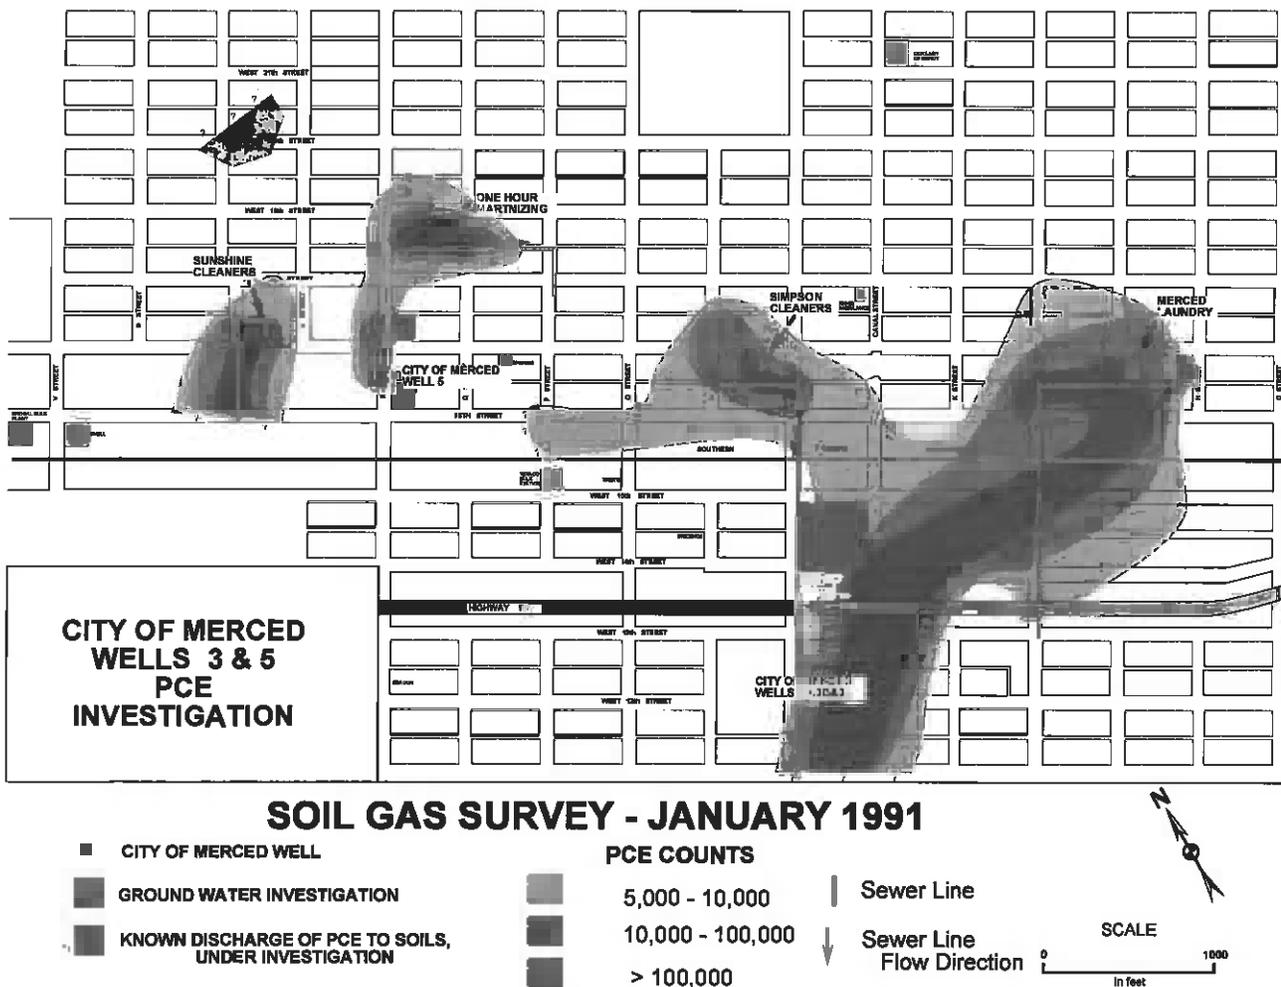
FIGURE 13

Figures 13 through 16 are maps showing results of soil gas surveys from Turlock, Modesto, Lodi and Merced which illustrate that PCE vapors are higher along the sewer lines. The highest counts are usually near the cleaners, but the counts continue high from the sites down the sewer line.
