Definite Plan for the Lower Klamath Project

Appendix A – Risk Management Plan

June 2018

Klamath River Renewal Corporation

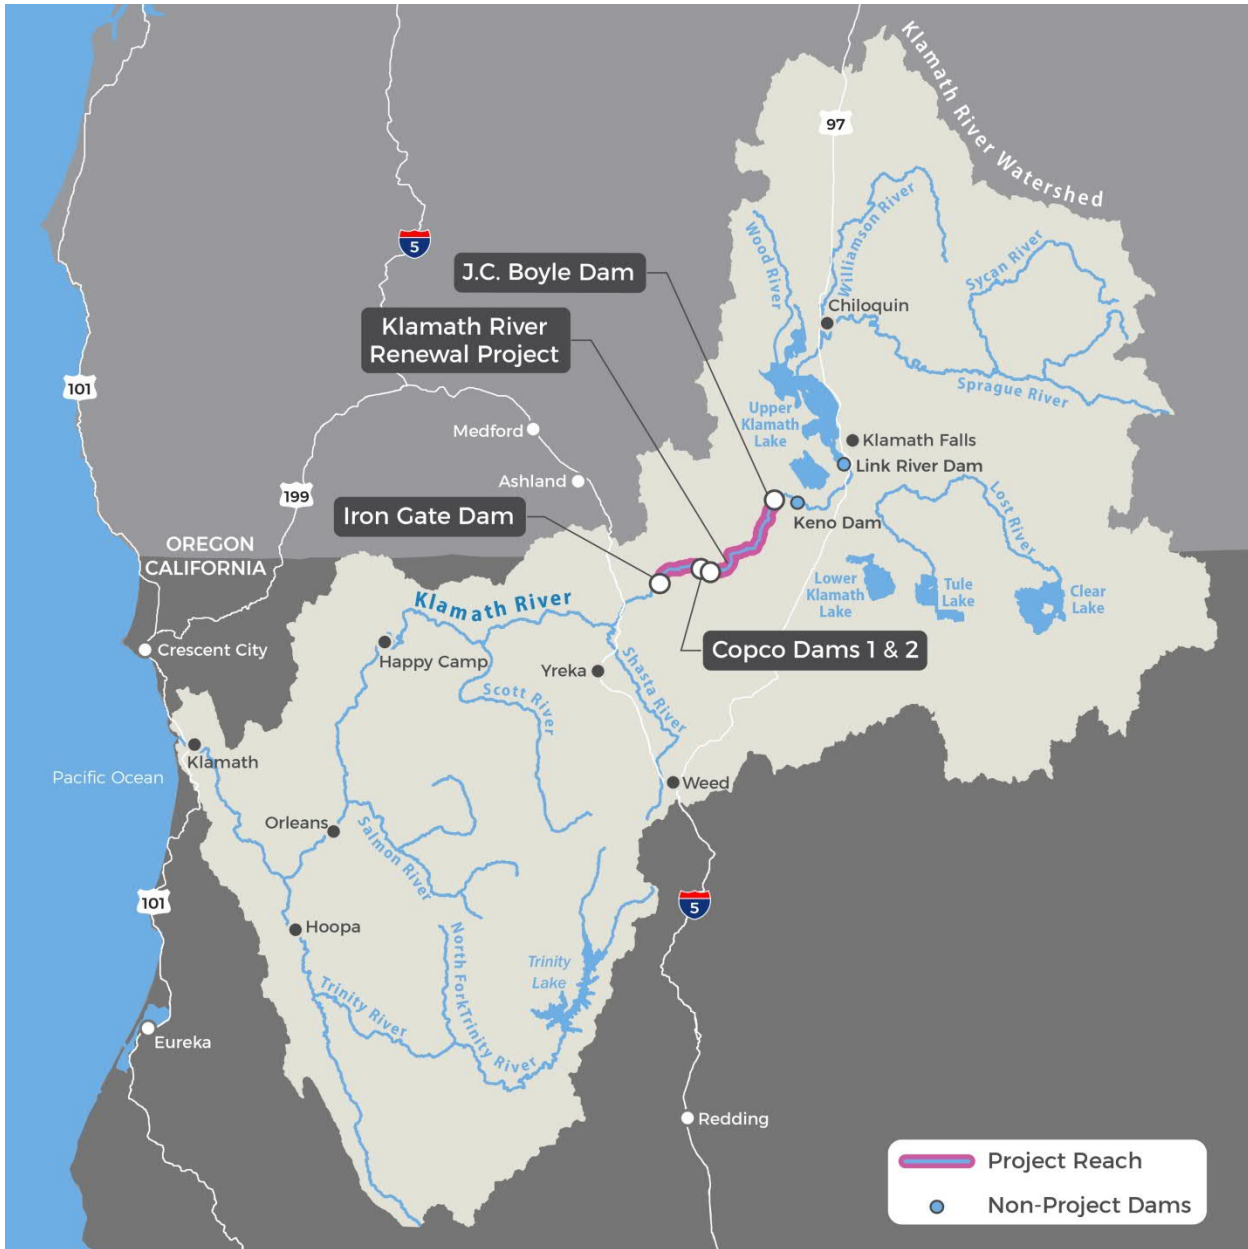
Figure 1.2-1 Klamath River Watershed and Facilities Locations

The proposed Project is described in Sections 4 through 7 of the Definite Plan, and generally includes the decommissioning and full removal of four dam developments (Iron Gate, Copco No. 1 and No. 2, and J.C. Boyle) on the Klamath River approximately 200 miles from the Pacific Ocean in the states of Oregon and California by the KRRC. Figure 1.2-1 provides an overview of the Klamath River watershed and the locations of the four dams. The Project objectives are to restore free-flowing river conditions and volitional fish passage by the complete removal of dams, power generation facilities, water intake structures, canals, pipelines, and ancillary buildings. The Definite Plan also describes a partial removal alternative which is presented for purposes of environmental review. Under the partial removal alternative, the objectives of a free-flowing river conditions and volitional fish passage would be achieved, but portions of each dam would remain in place, along with ancillary buildings and structures such as powerhouses, foundations, tunnels, and pipes.

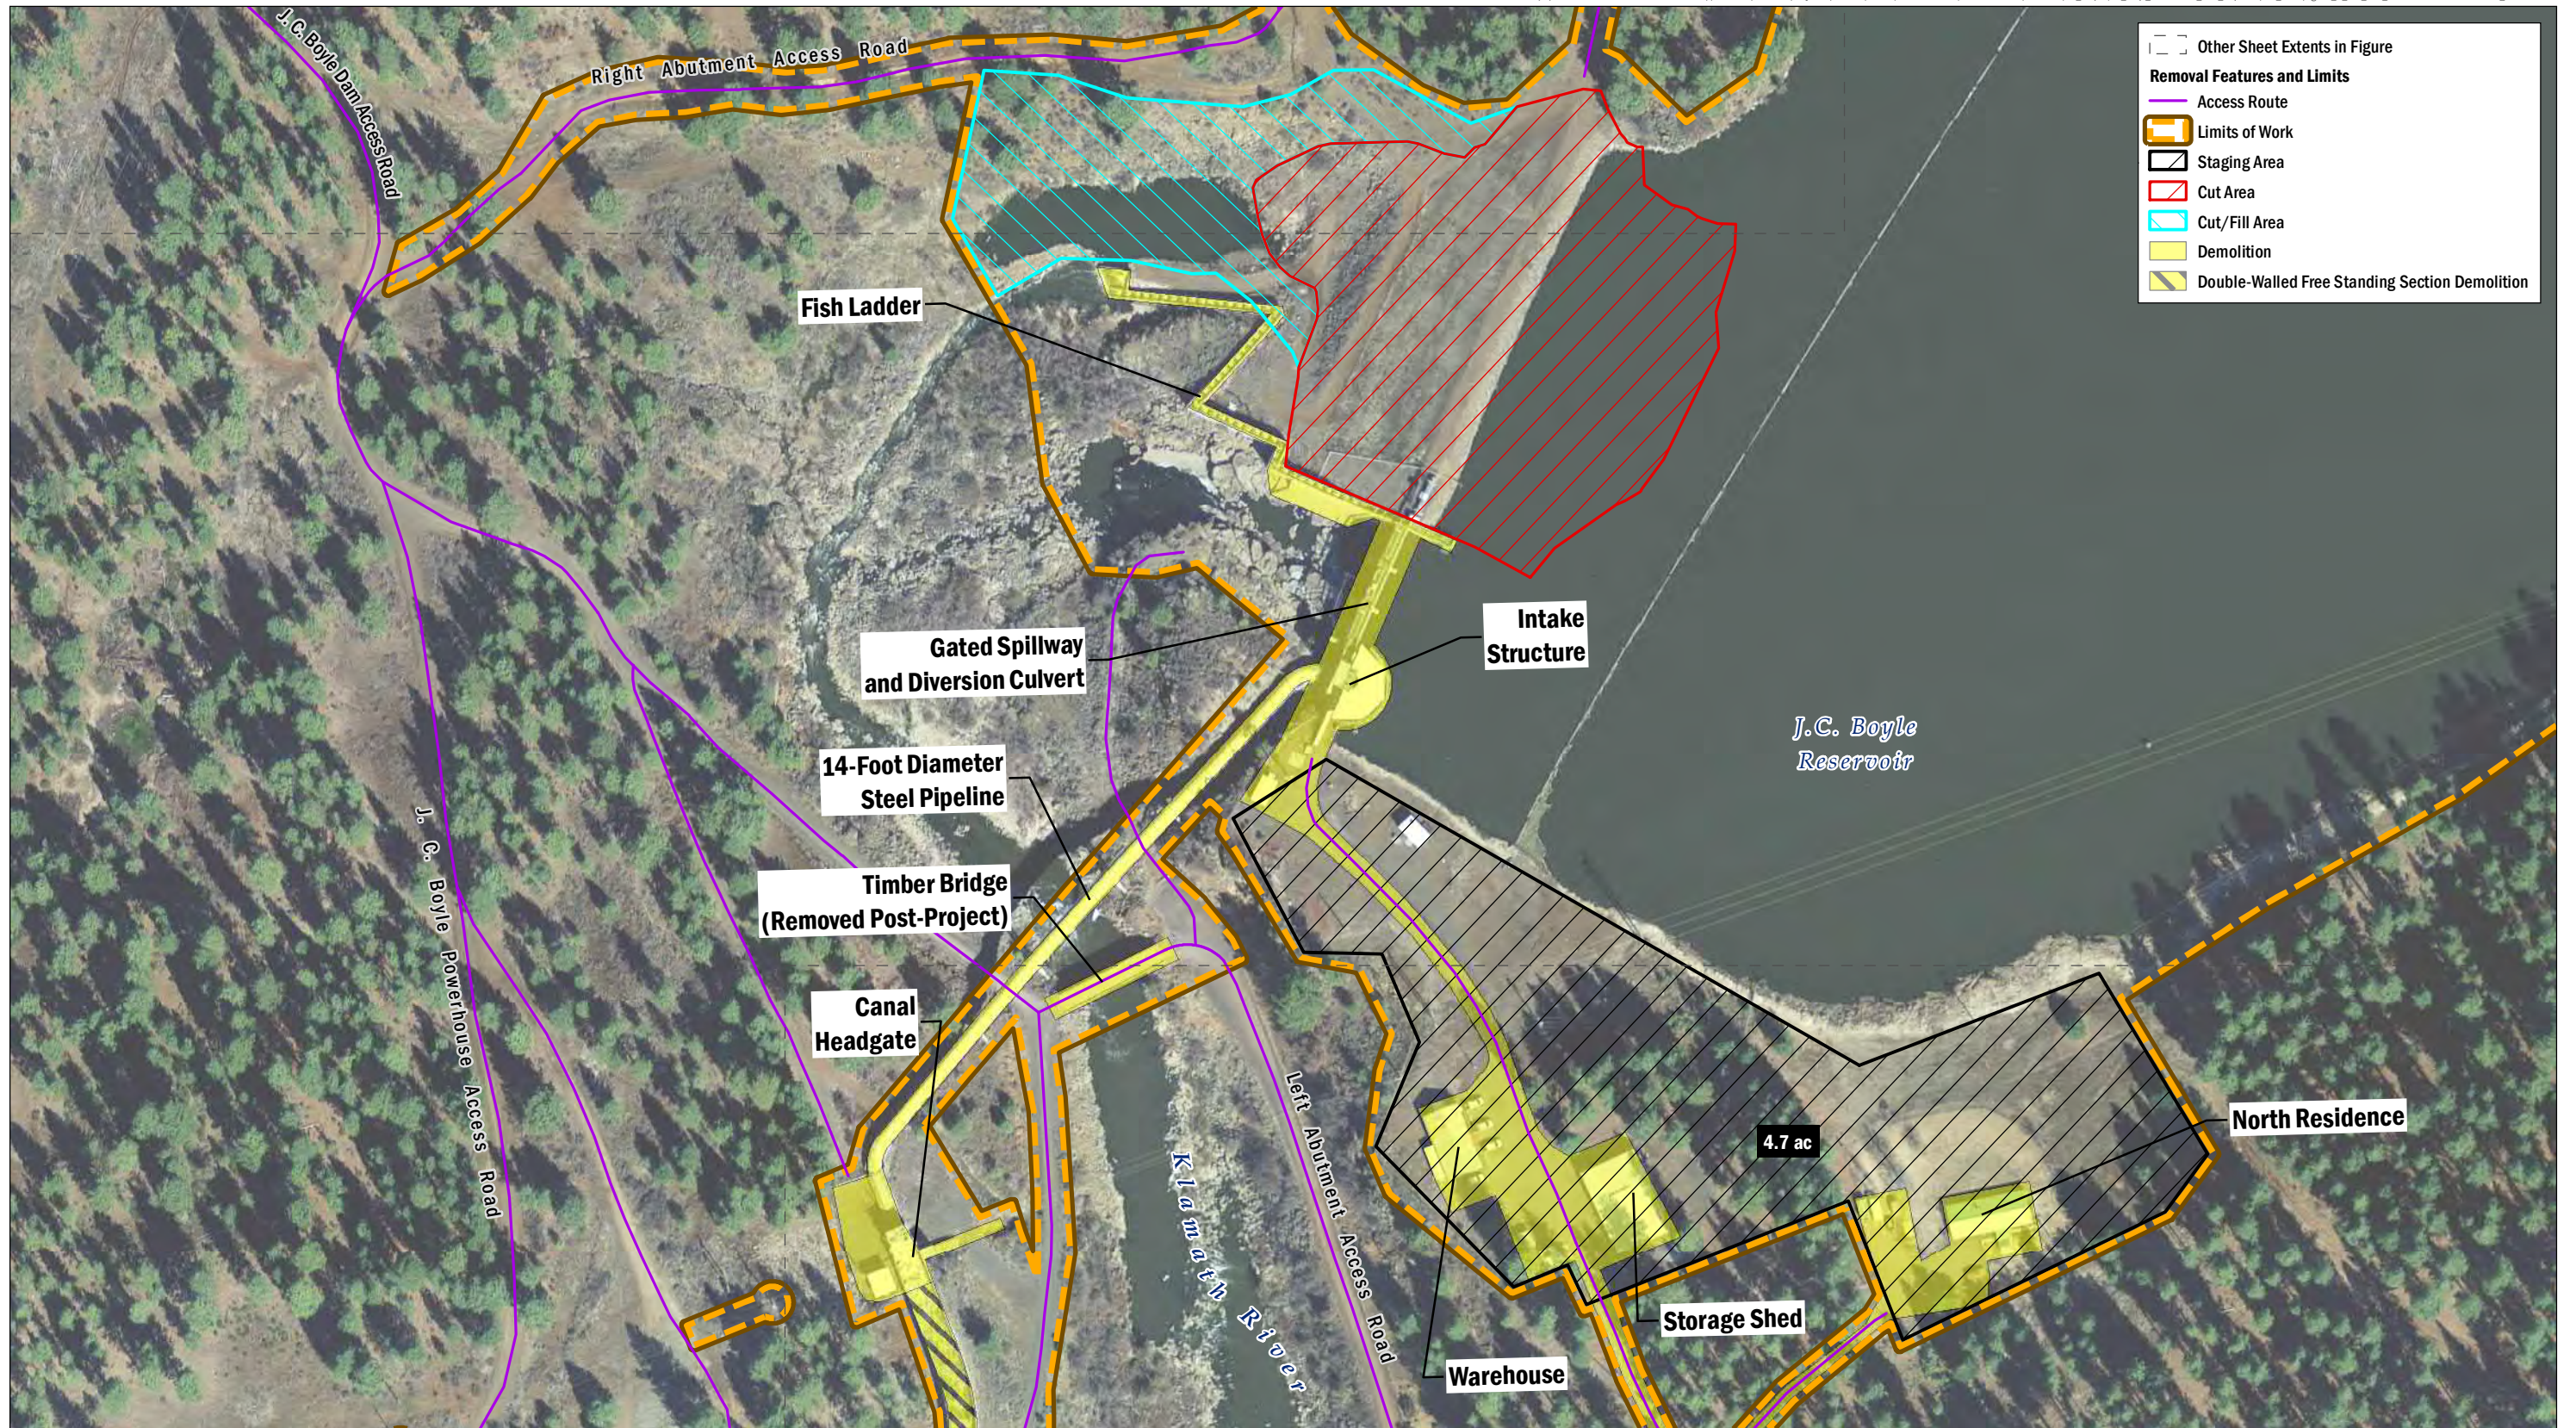
FIGURE 5.2-1
J.C. Boyle Dam Removal Features and Limits
Overview Sheet

Note: Limits of work features that exist as small islands and/or narrow linear corridors are associated with project transmission line removal

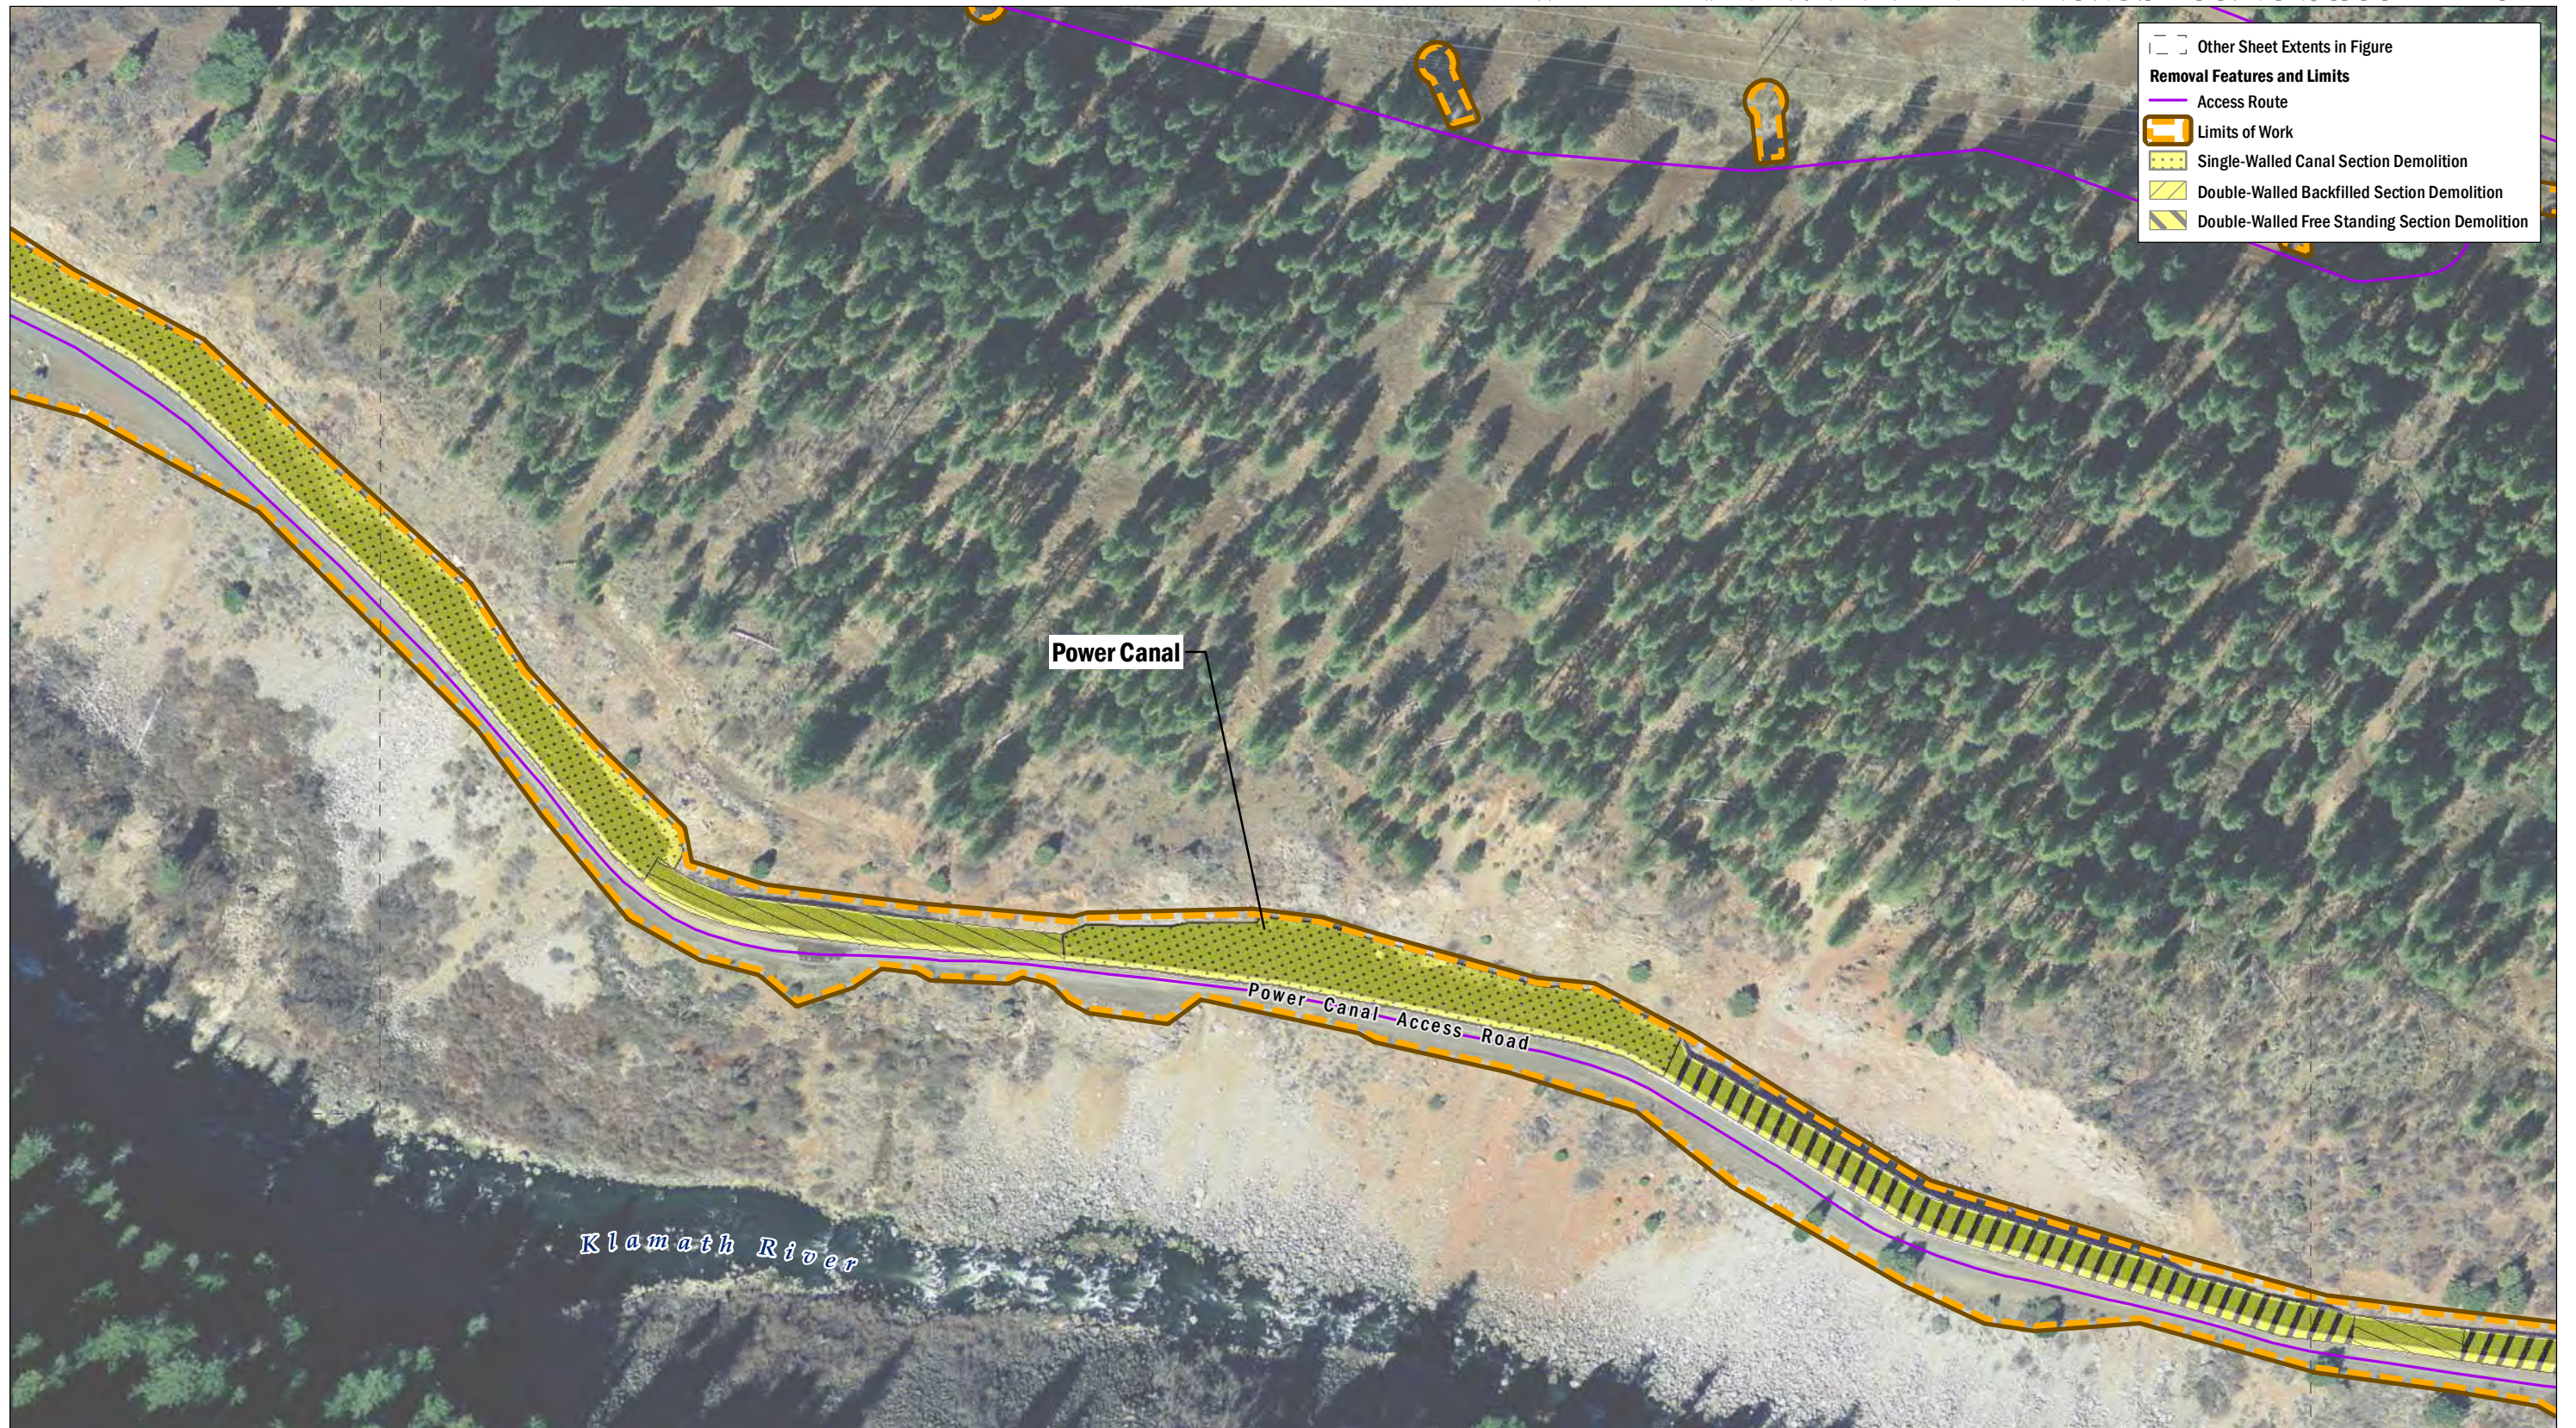
FIGURE 5.2-1
 J.C. Boyle Dam Removal Features and Limits
 Sheet 5 of 9

Note: Limits of work features that exist as small islands and/or narrow linear corridors are associated with project transmission line removal

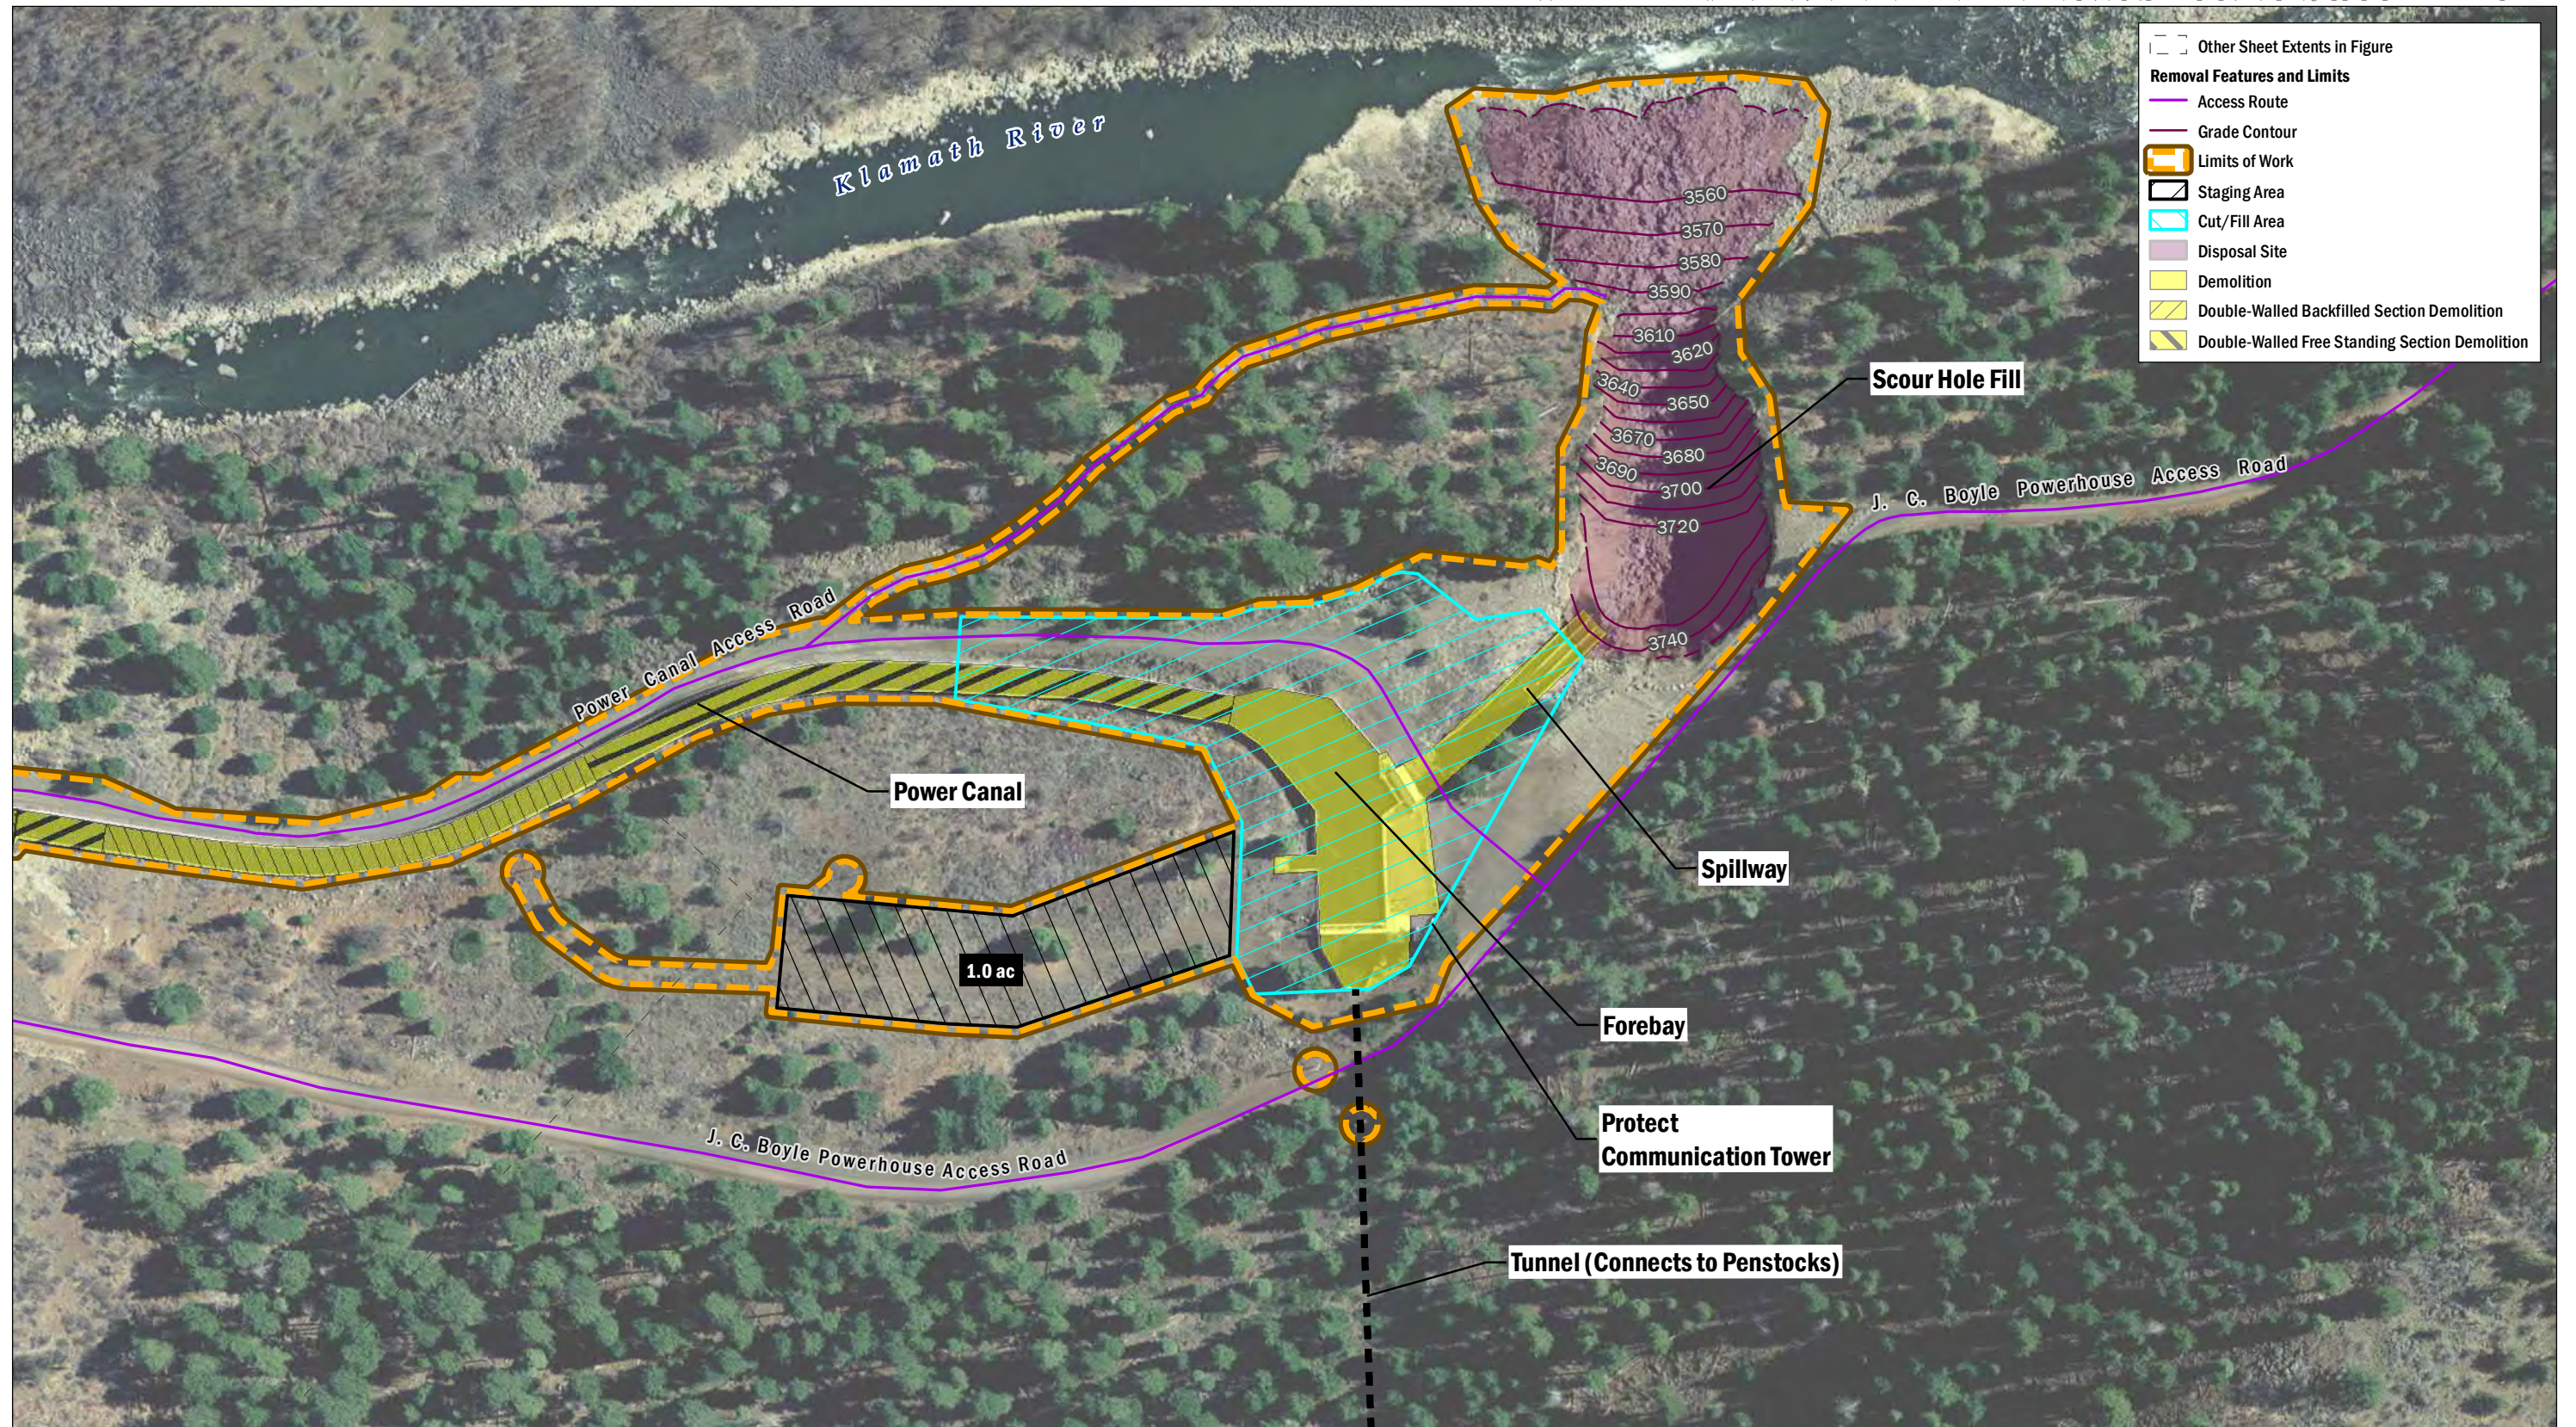
FIGURE 5.2-1
 J.C. Boyle Dam Removal Features and Limits
 Sheet 7 of 9

Note: Limits of work features that exist as small islands and/or narrow linear corridors are associated with project transmission line removal

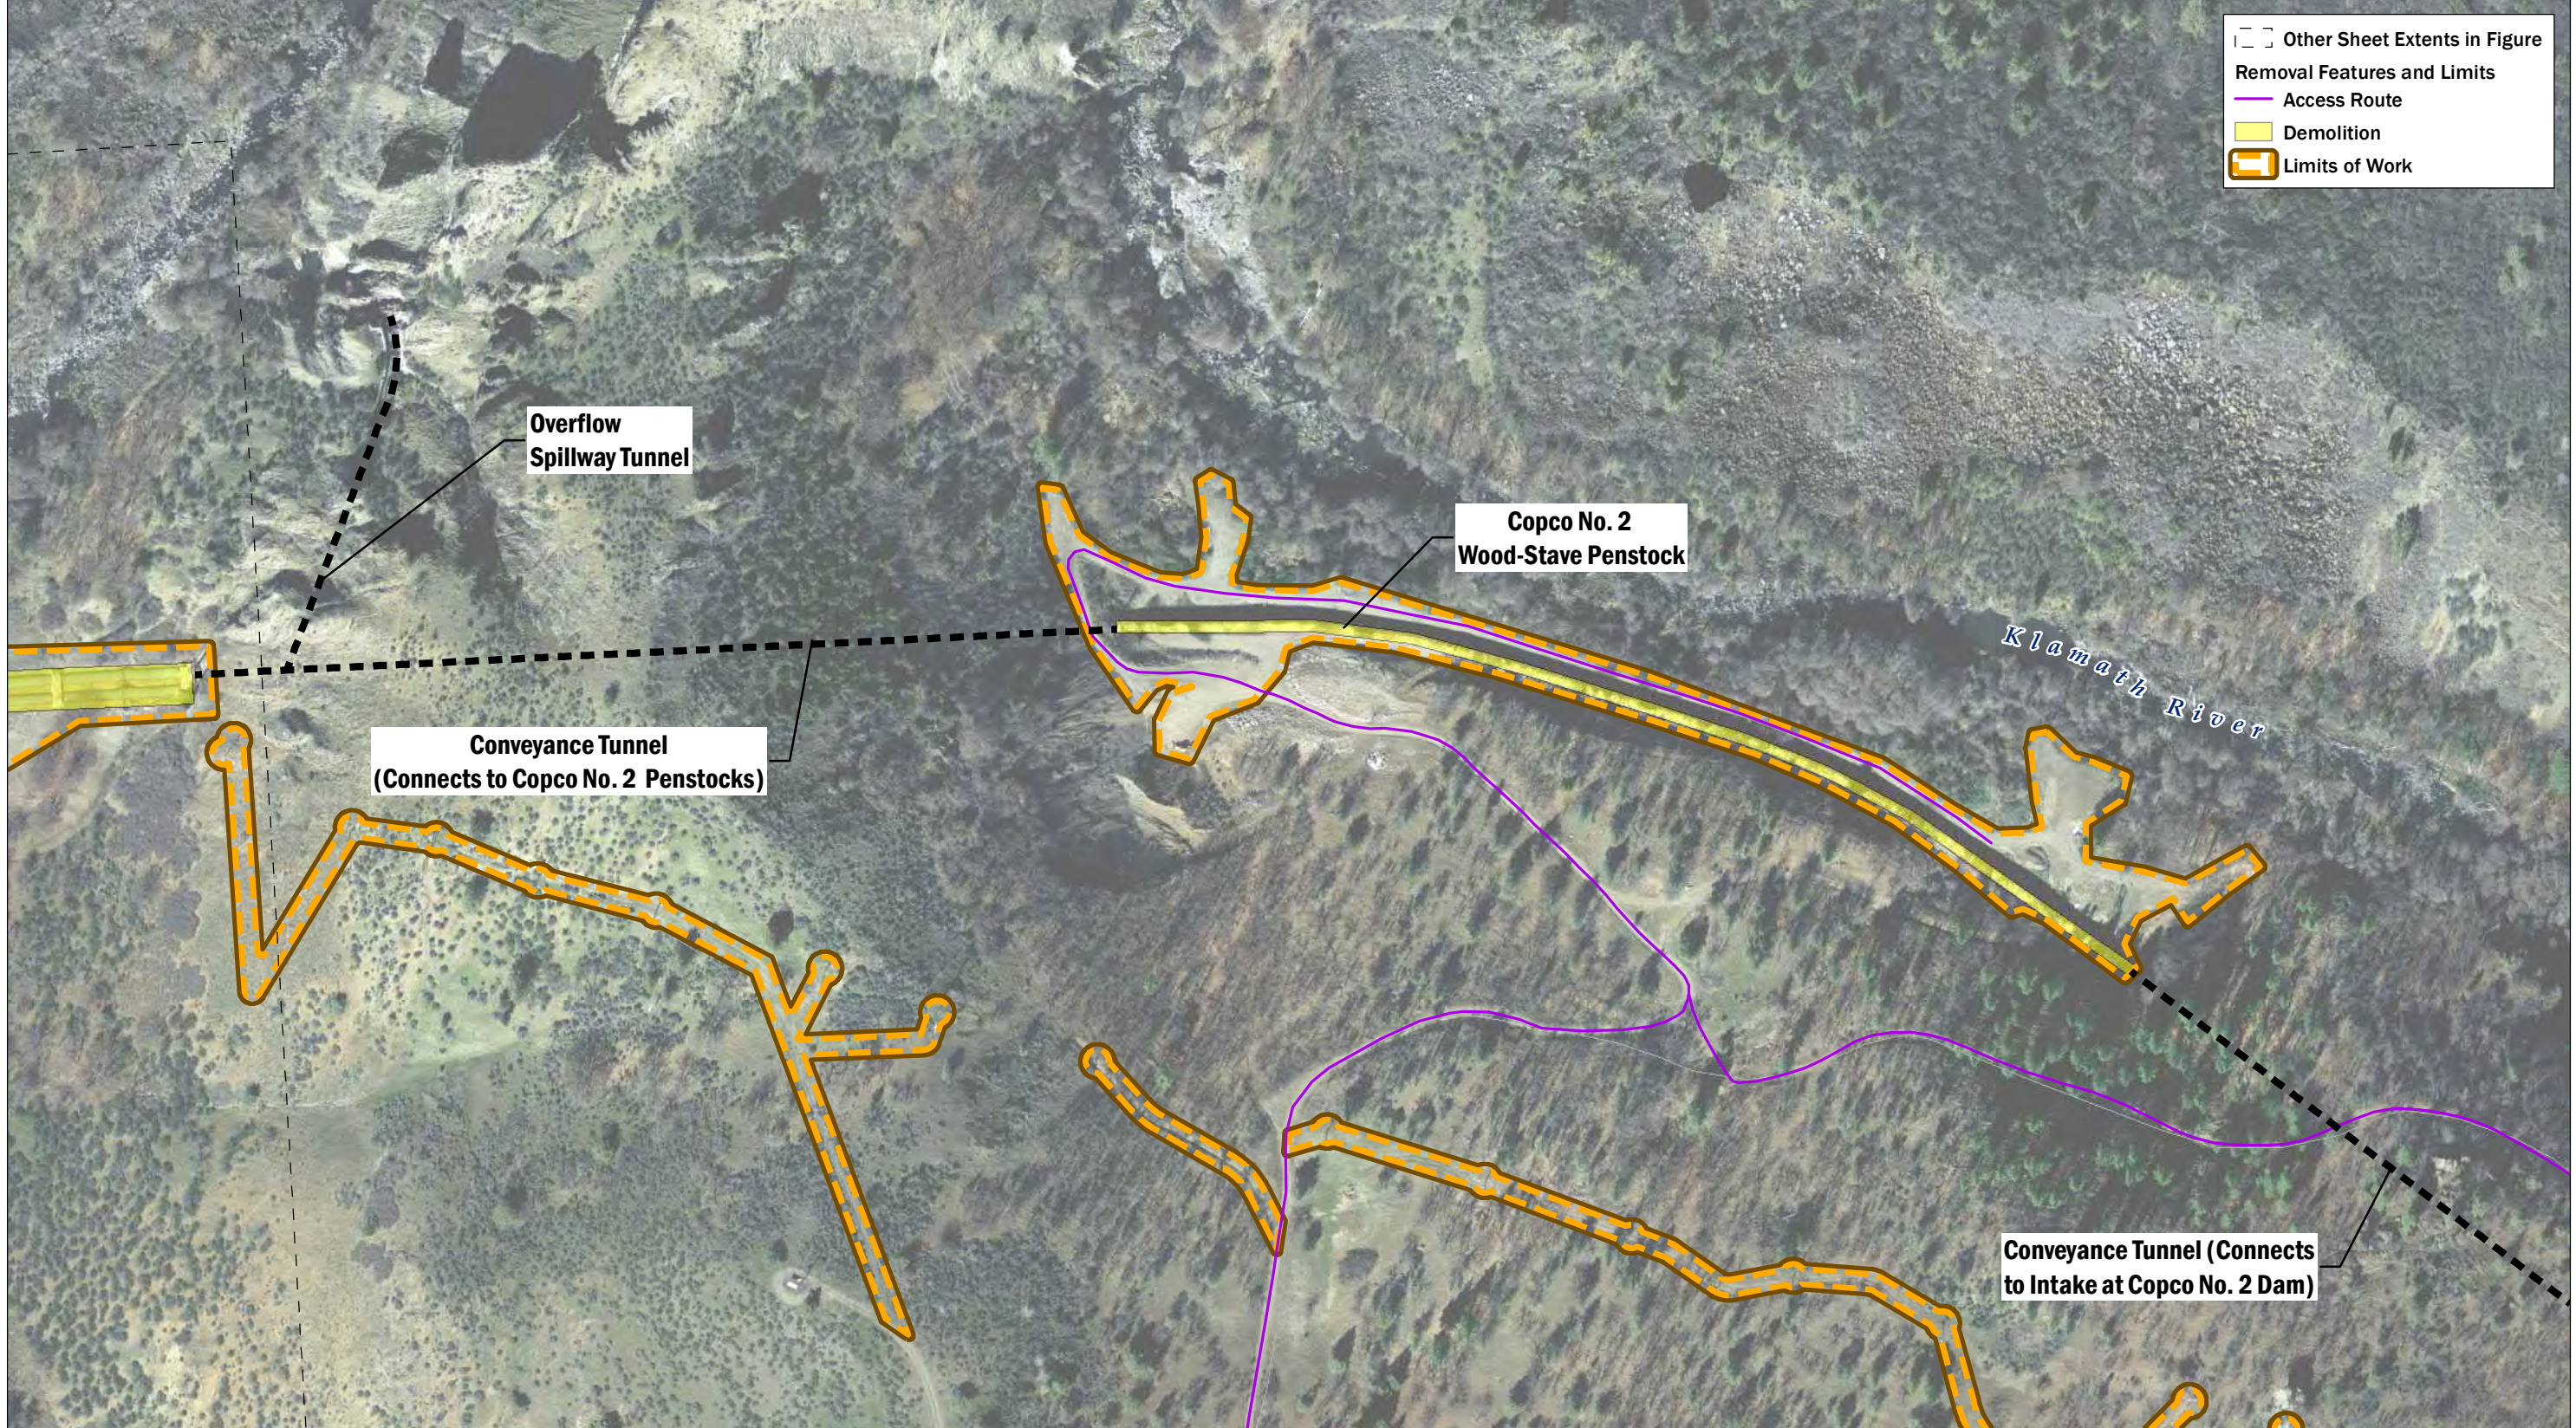
FIGURE 5.3-1
 Copco No. 1 and Copco No. 2 Dams Removal Features and Limits
 Sheet 1 of 4

Note: Limits of work features that exist as small islands and/or narrow linear corridors are associated with project transmission line removal

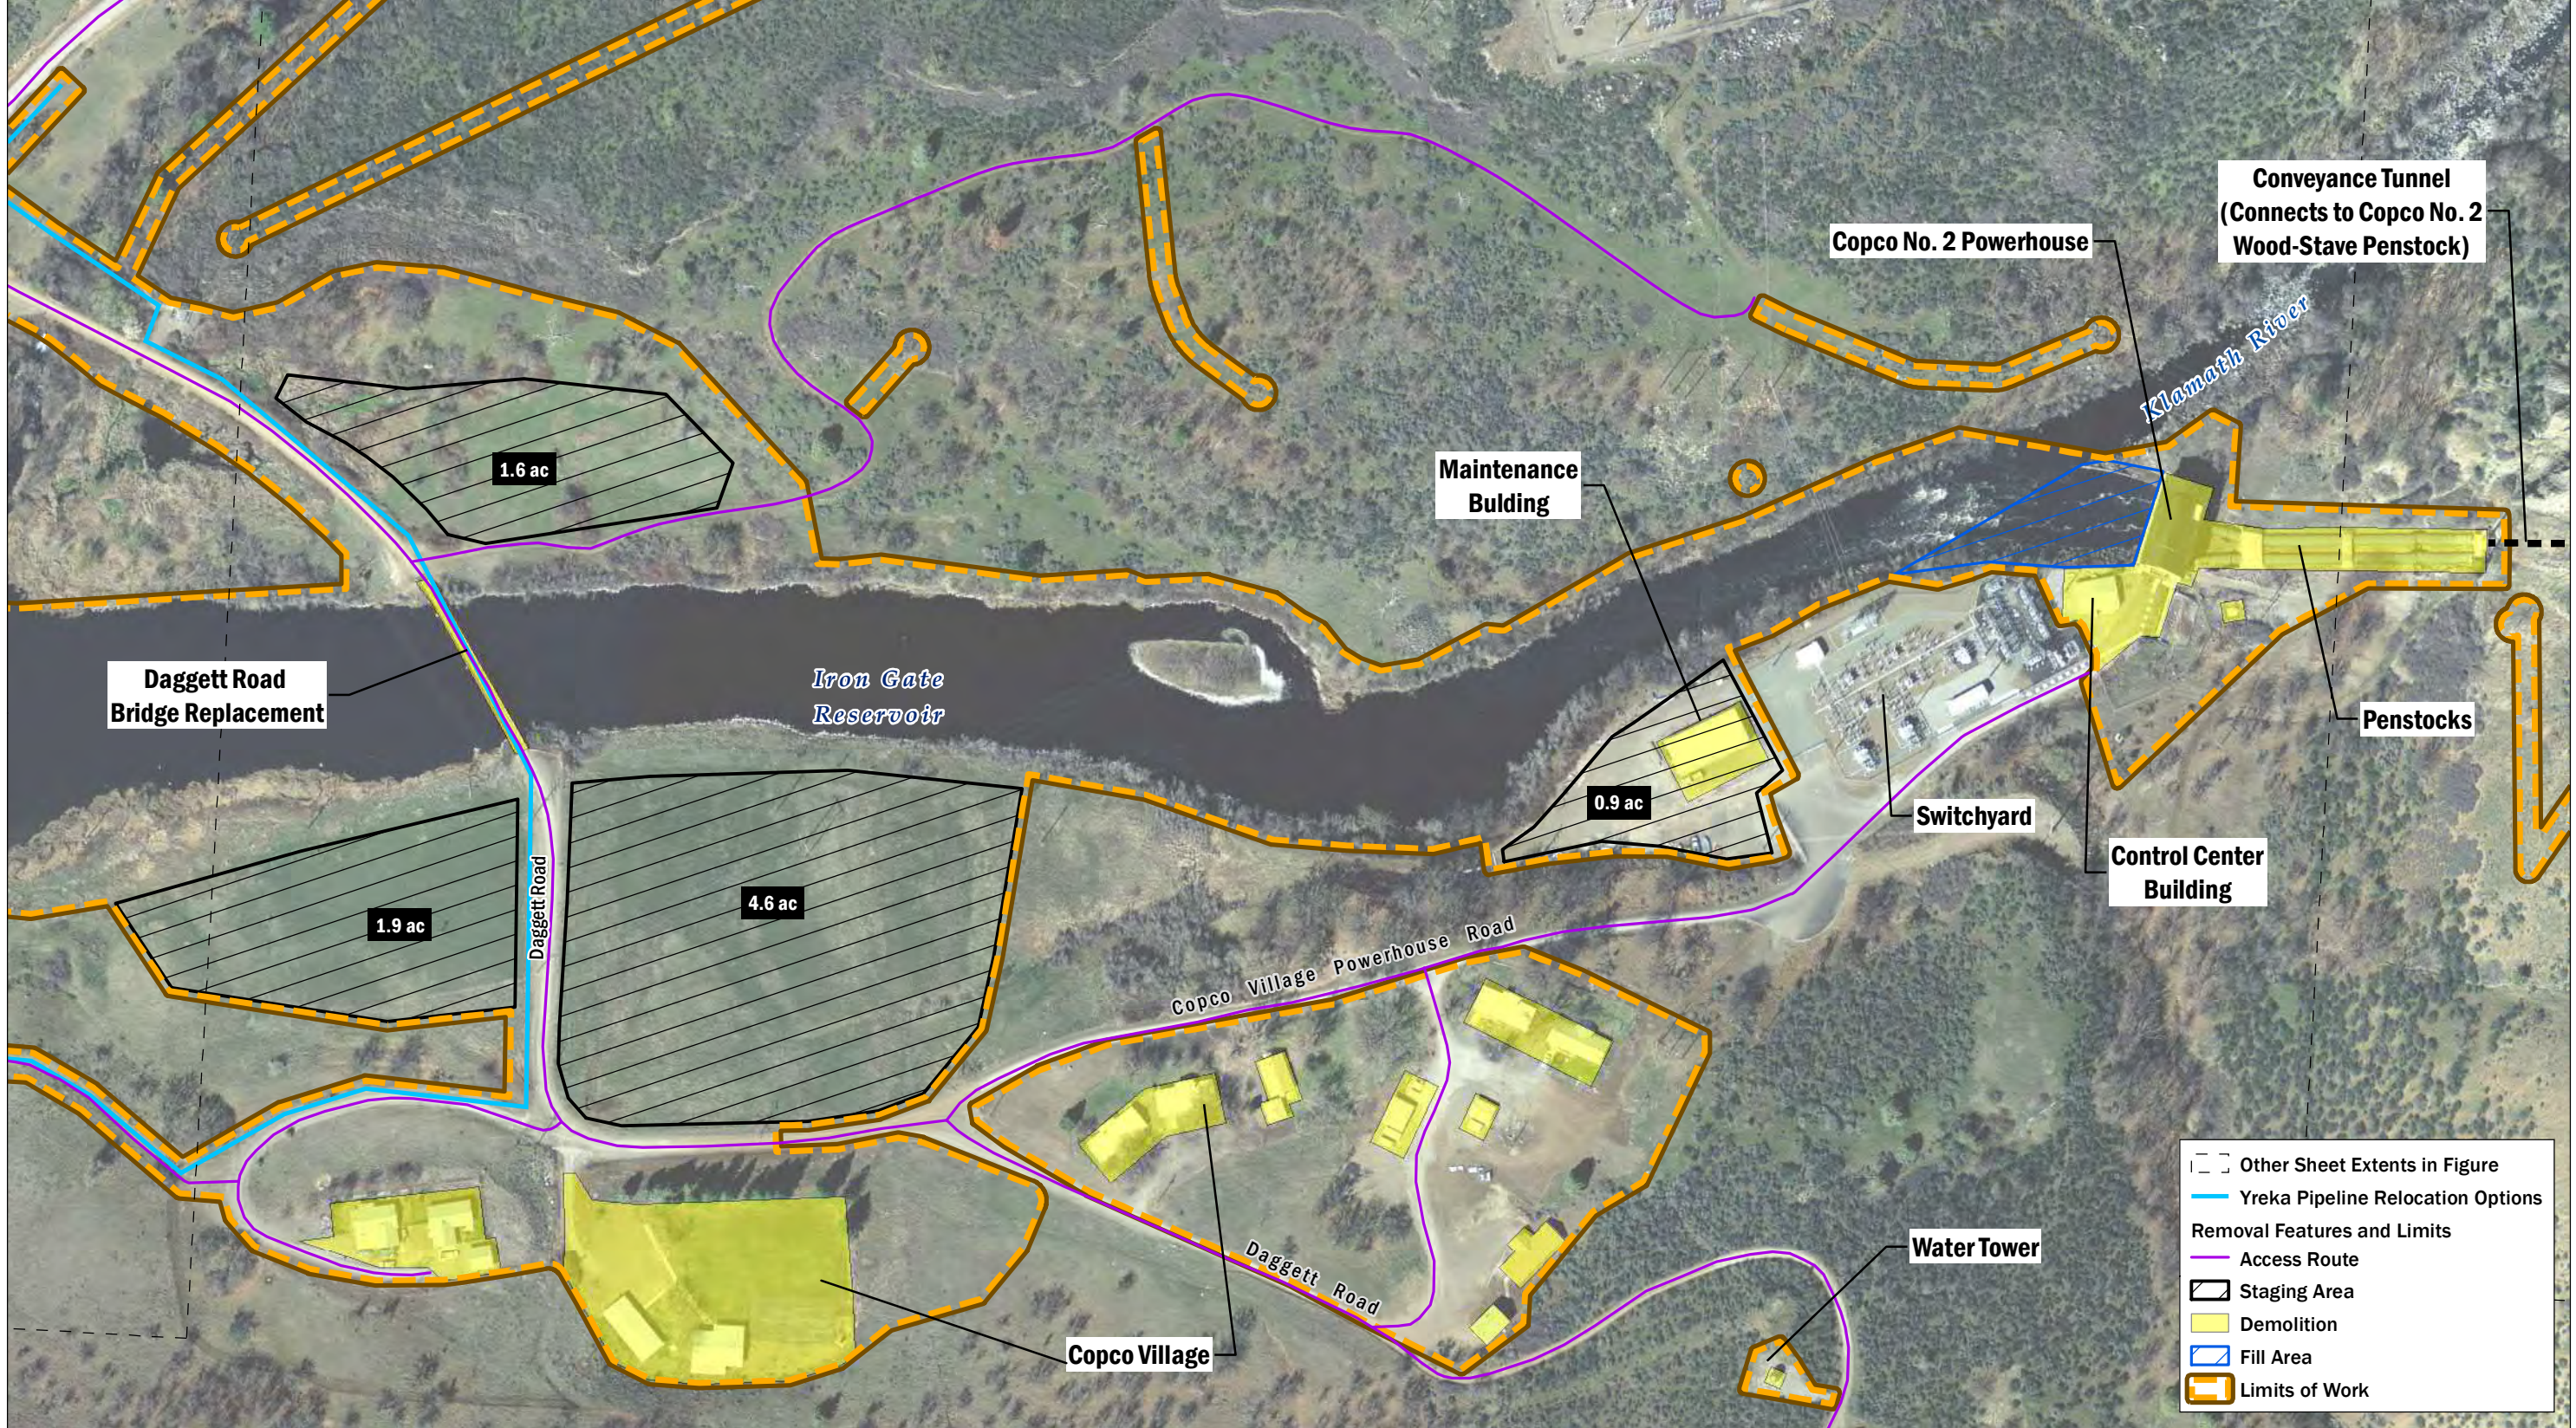
FIGURE 5.3-1
 Copco No. 1 and Copco No. 2 Dams Removal Features and Limits
 Sheet 2 of 4

Note: Limits of work features that exist as small islands and/or narrow linear corridors are associated with project transmission line removal
