Definite Plan for the Lower Klamath Project

Appendix A – Risk Management Plan

June 2018

Klamath River Renewal Corporation

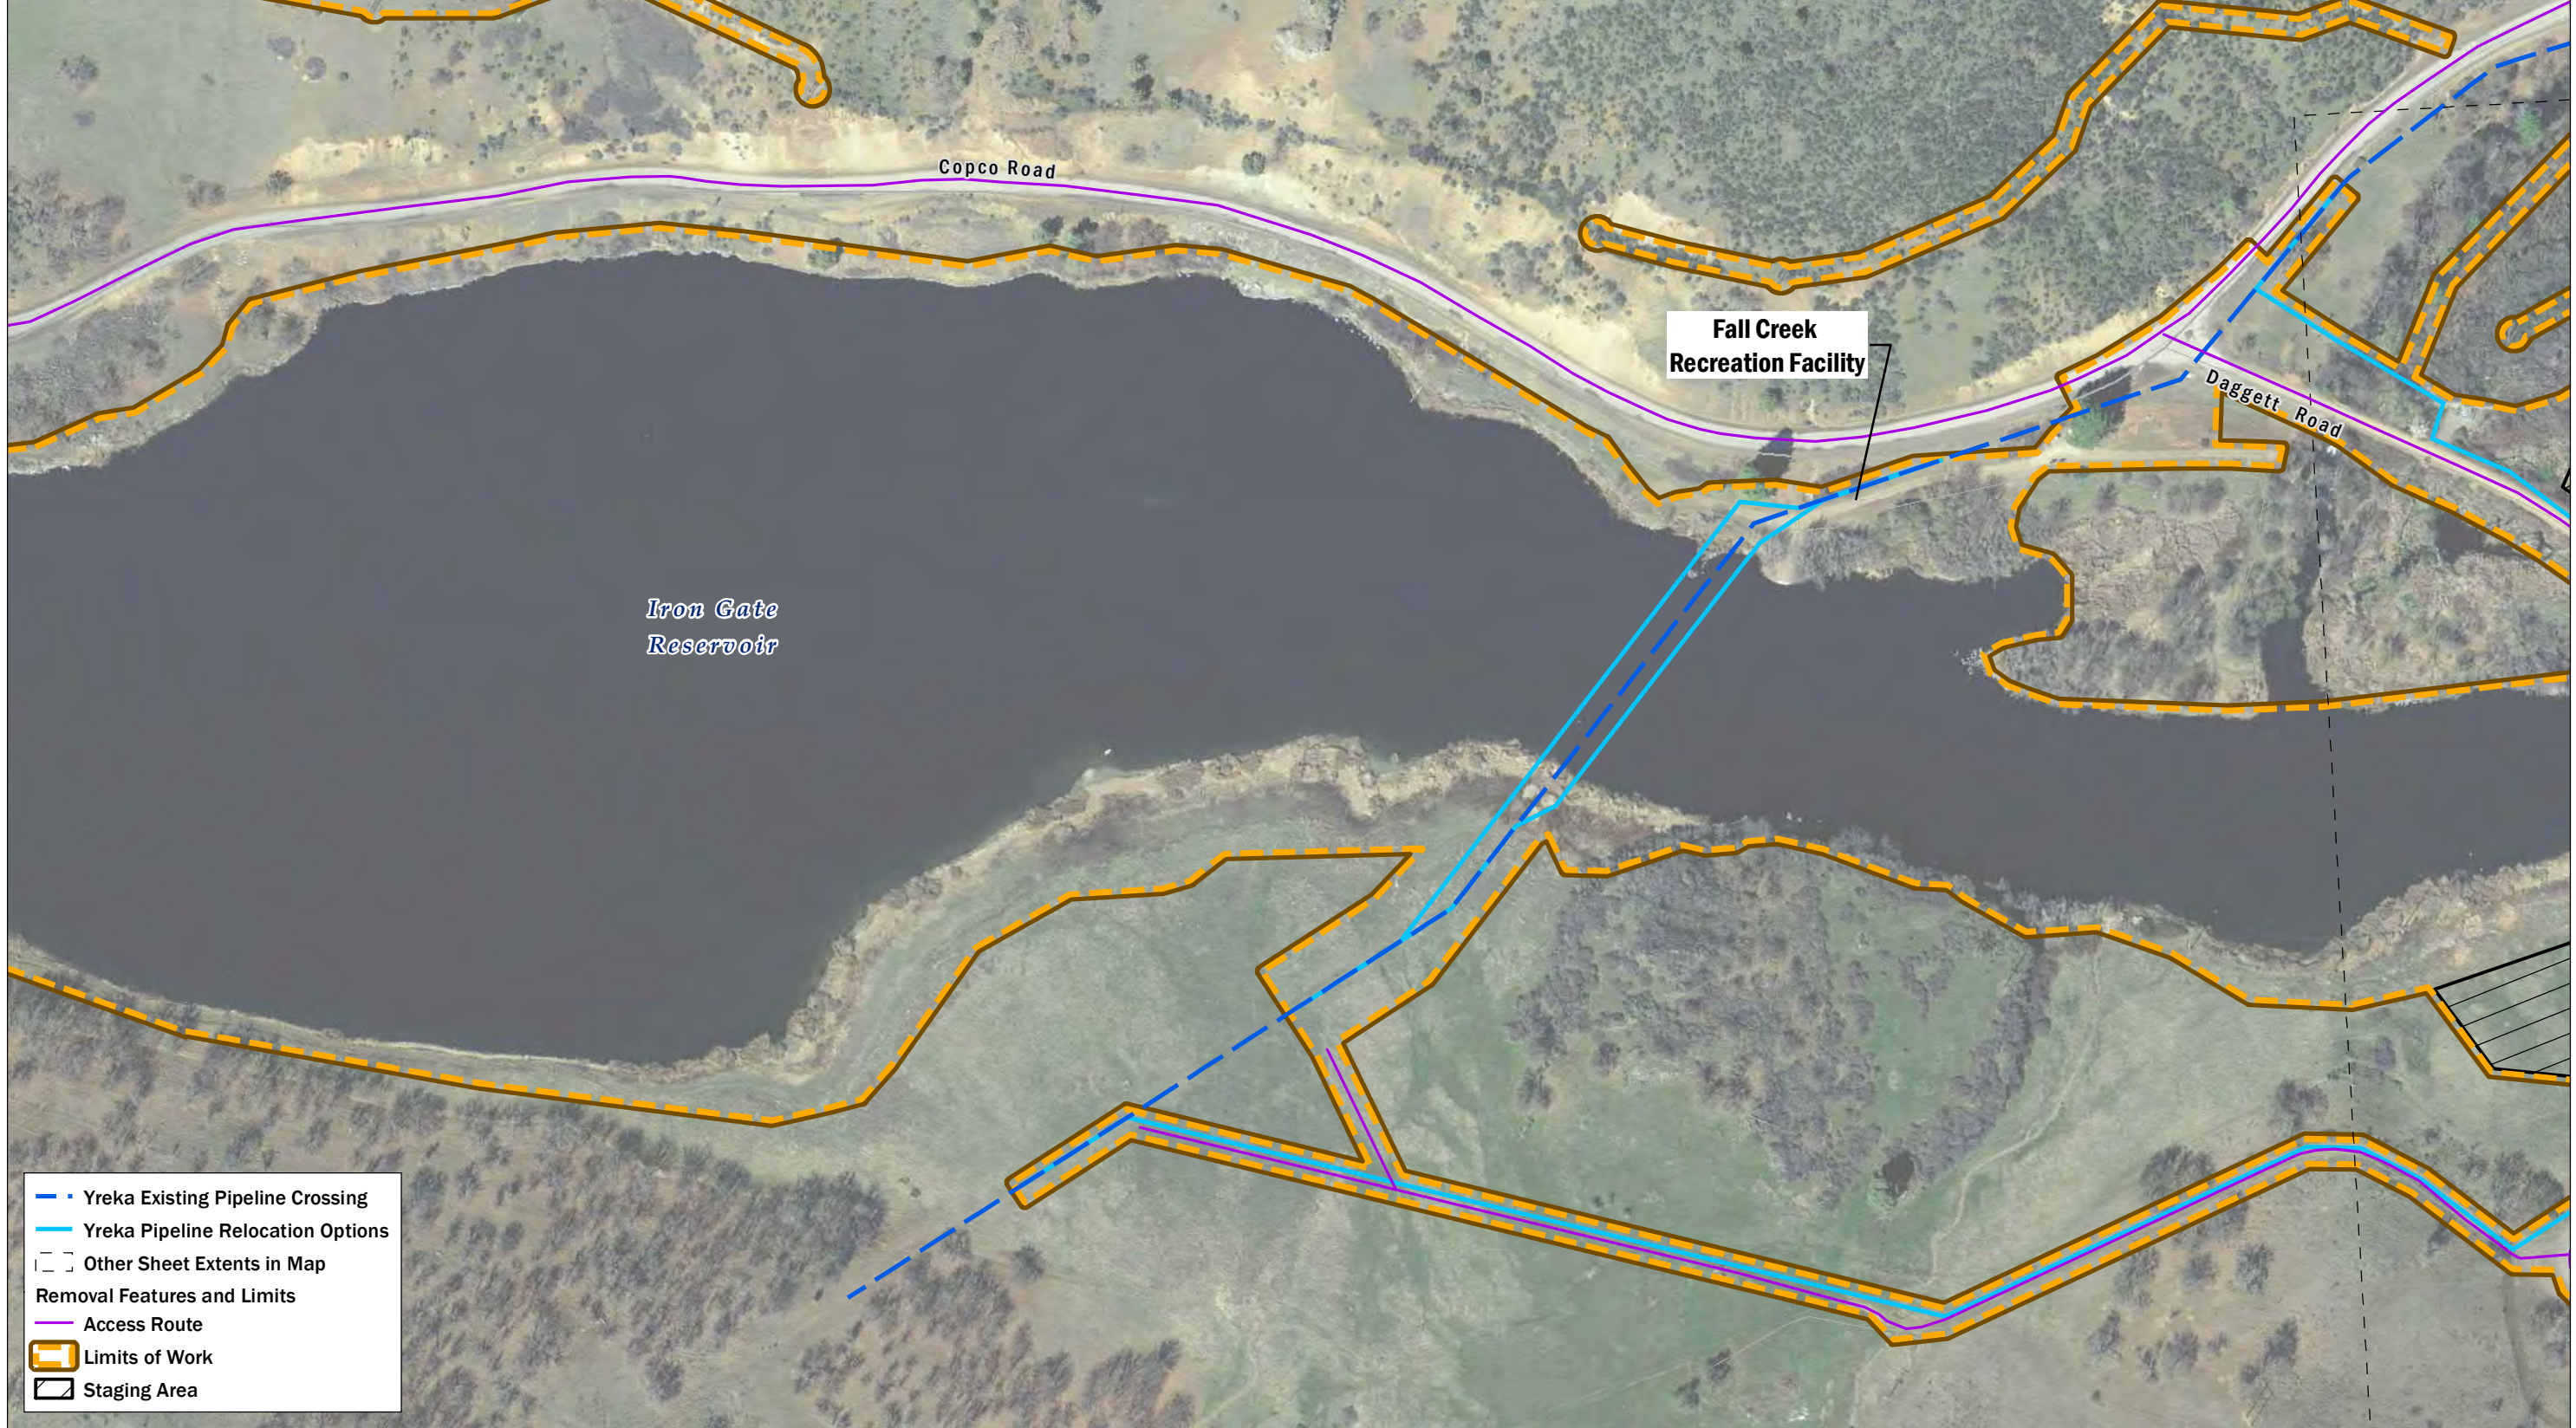
FIGURE 5.3-1
 Copco No. 1 and Copco No. 2 Dams Removal Features and Limits
 Sheet 3 of 4

Note: Limits of work features that exist as small islands and/or narrow linear corridors are associated with project transmission line removal

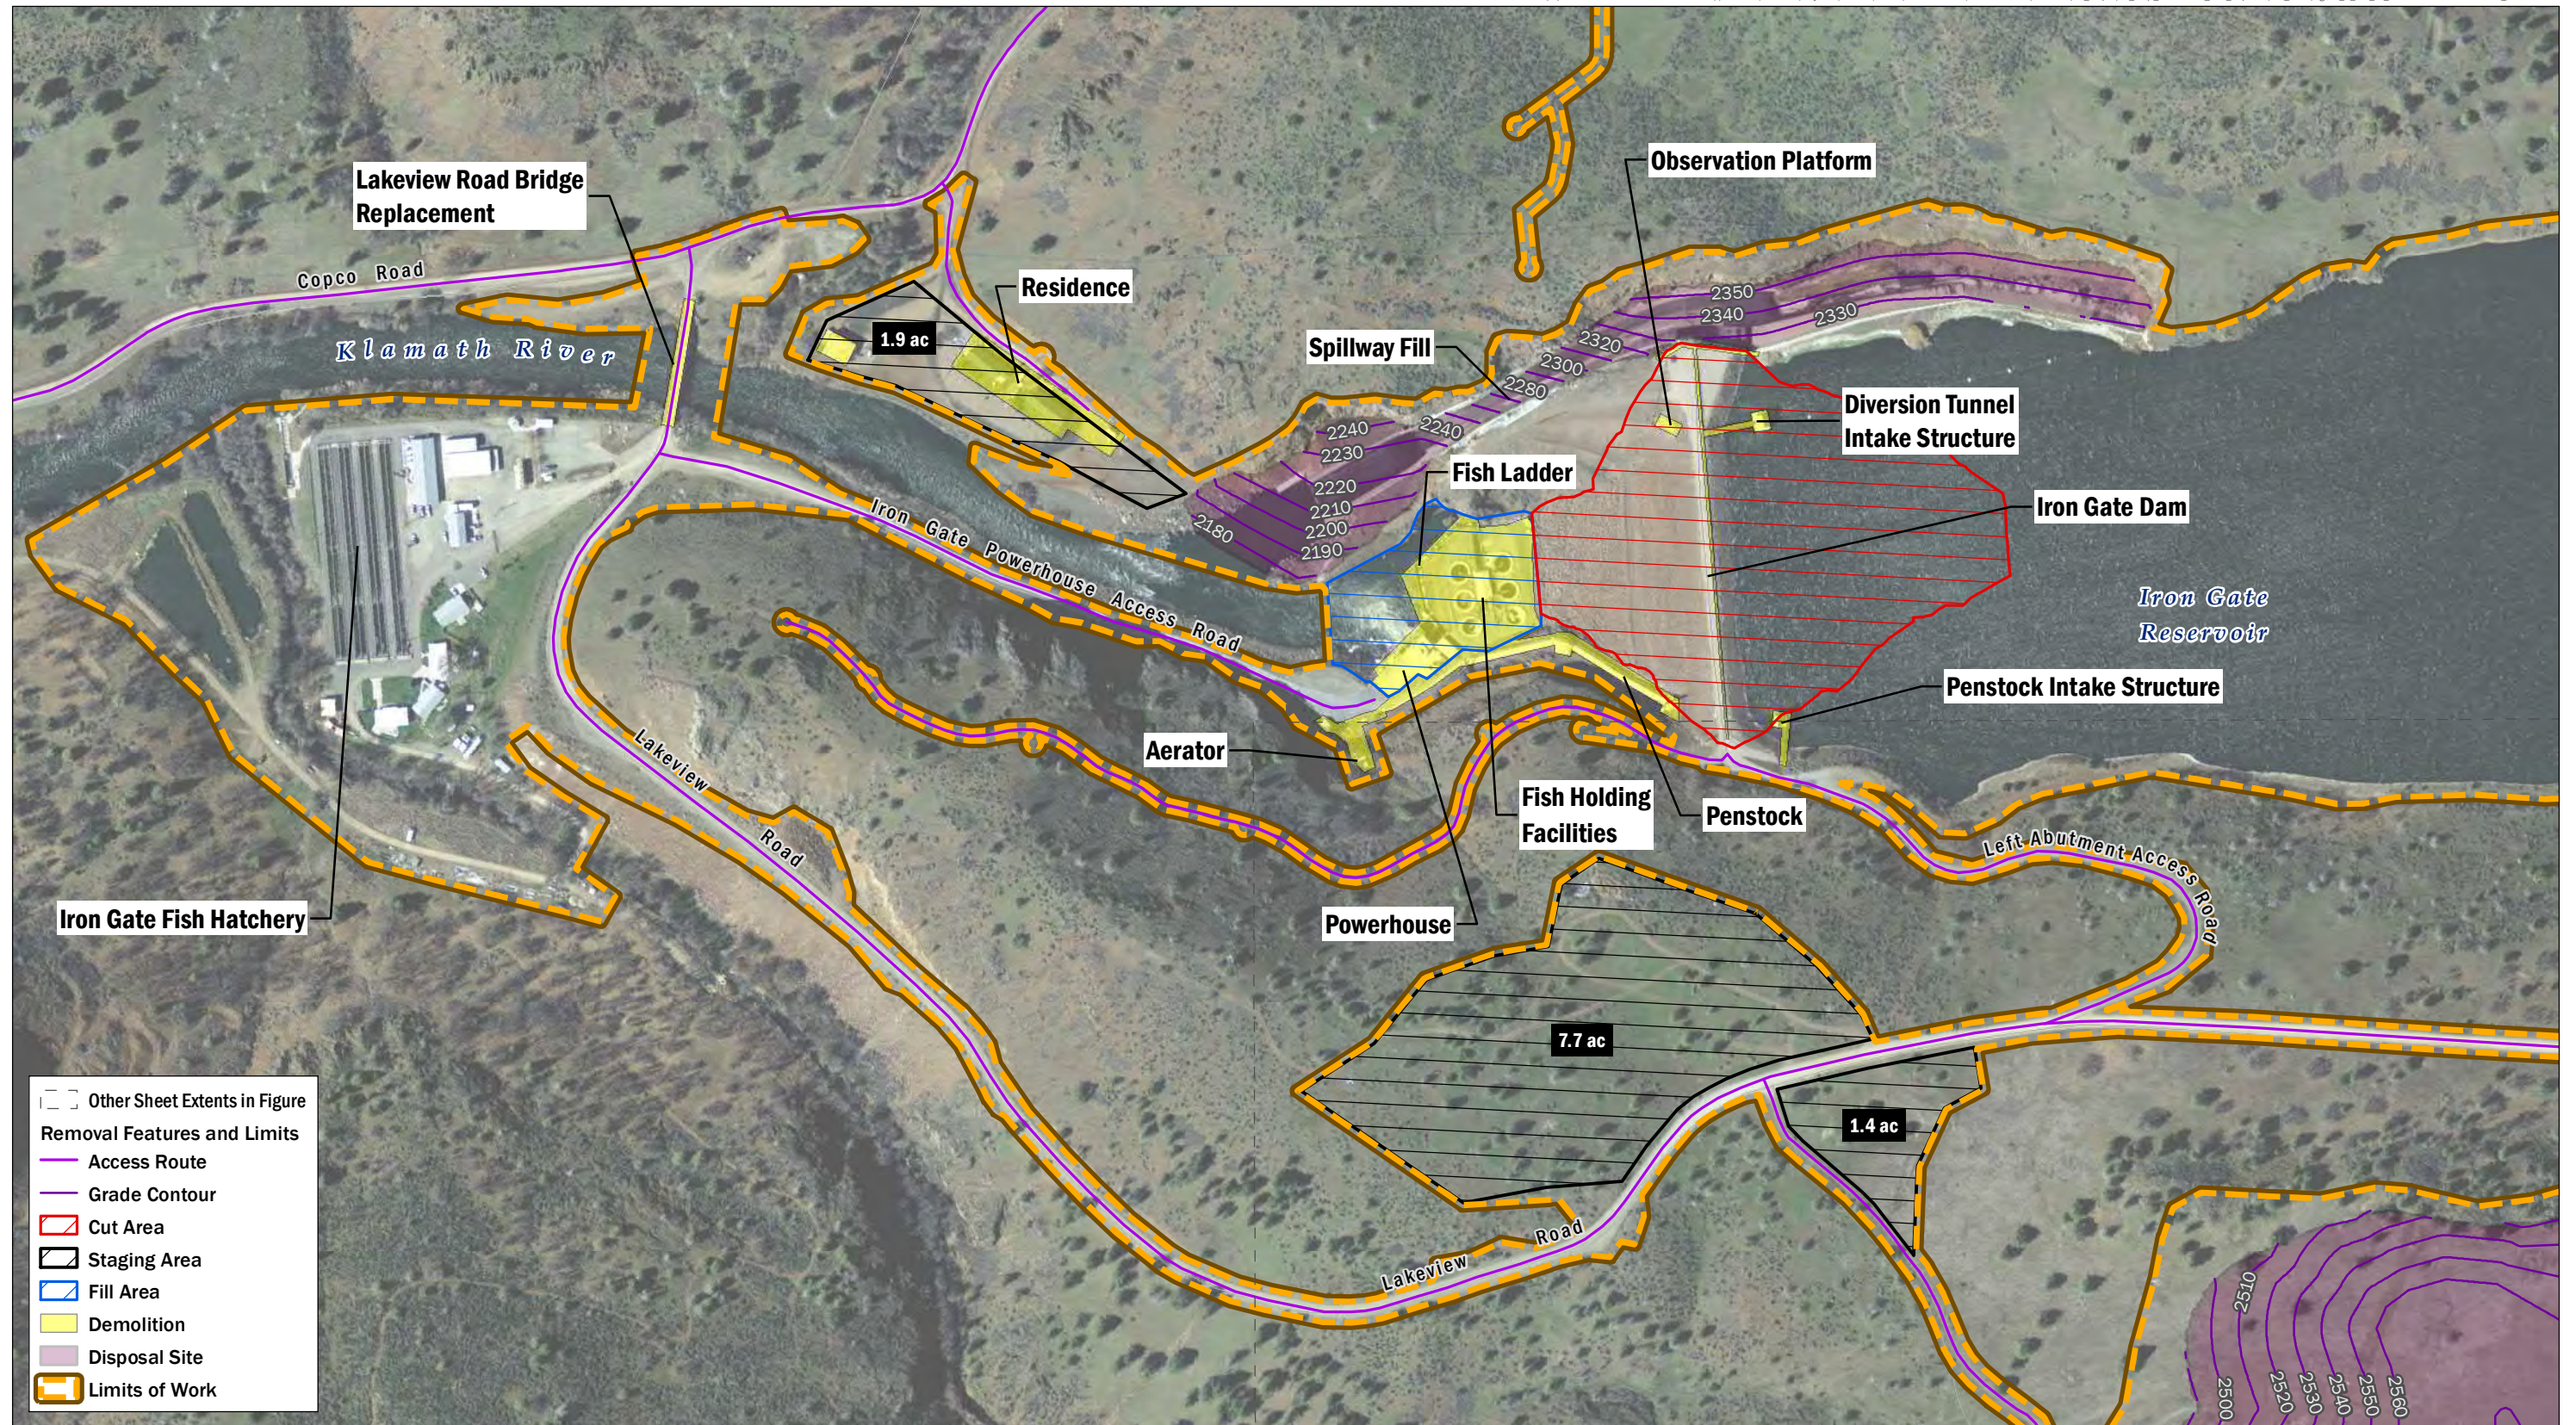
FIGURE 5.5-1
 Iron Gate Dam Removal Features and Limits
 Sheet 1 of 2

Note: Limits of work features that exist as small islands and/or narrow linear corridors are associated with project transmission line removal

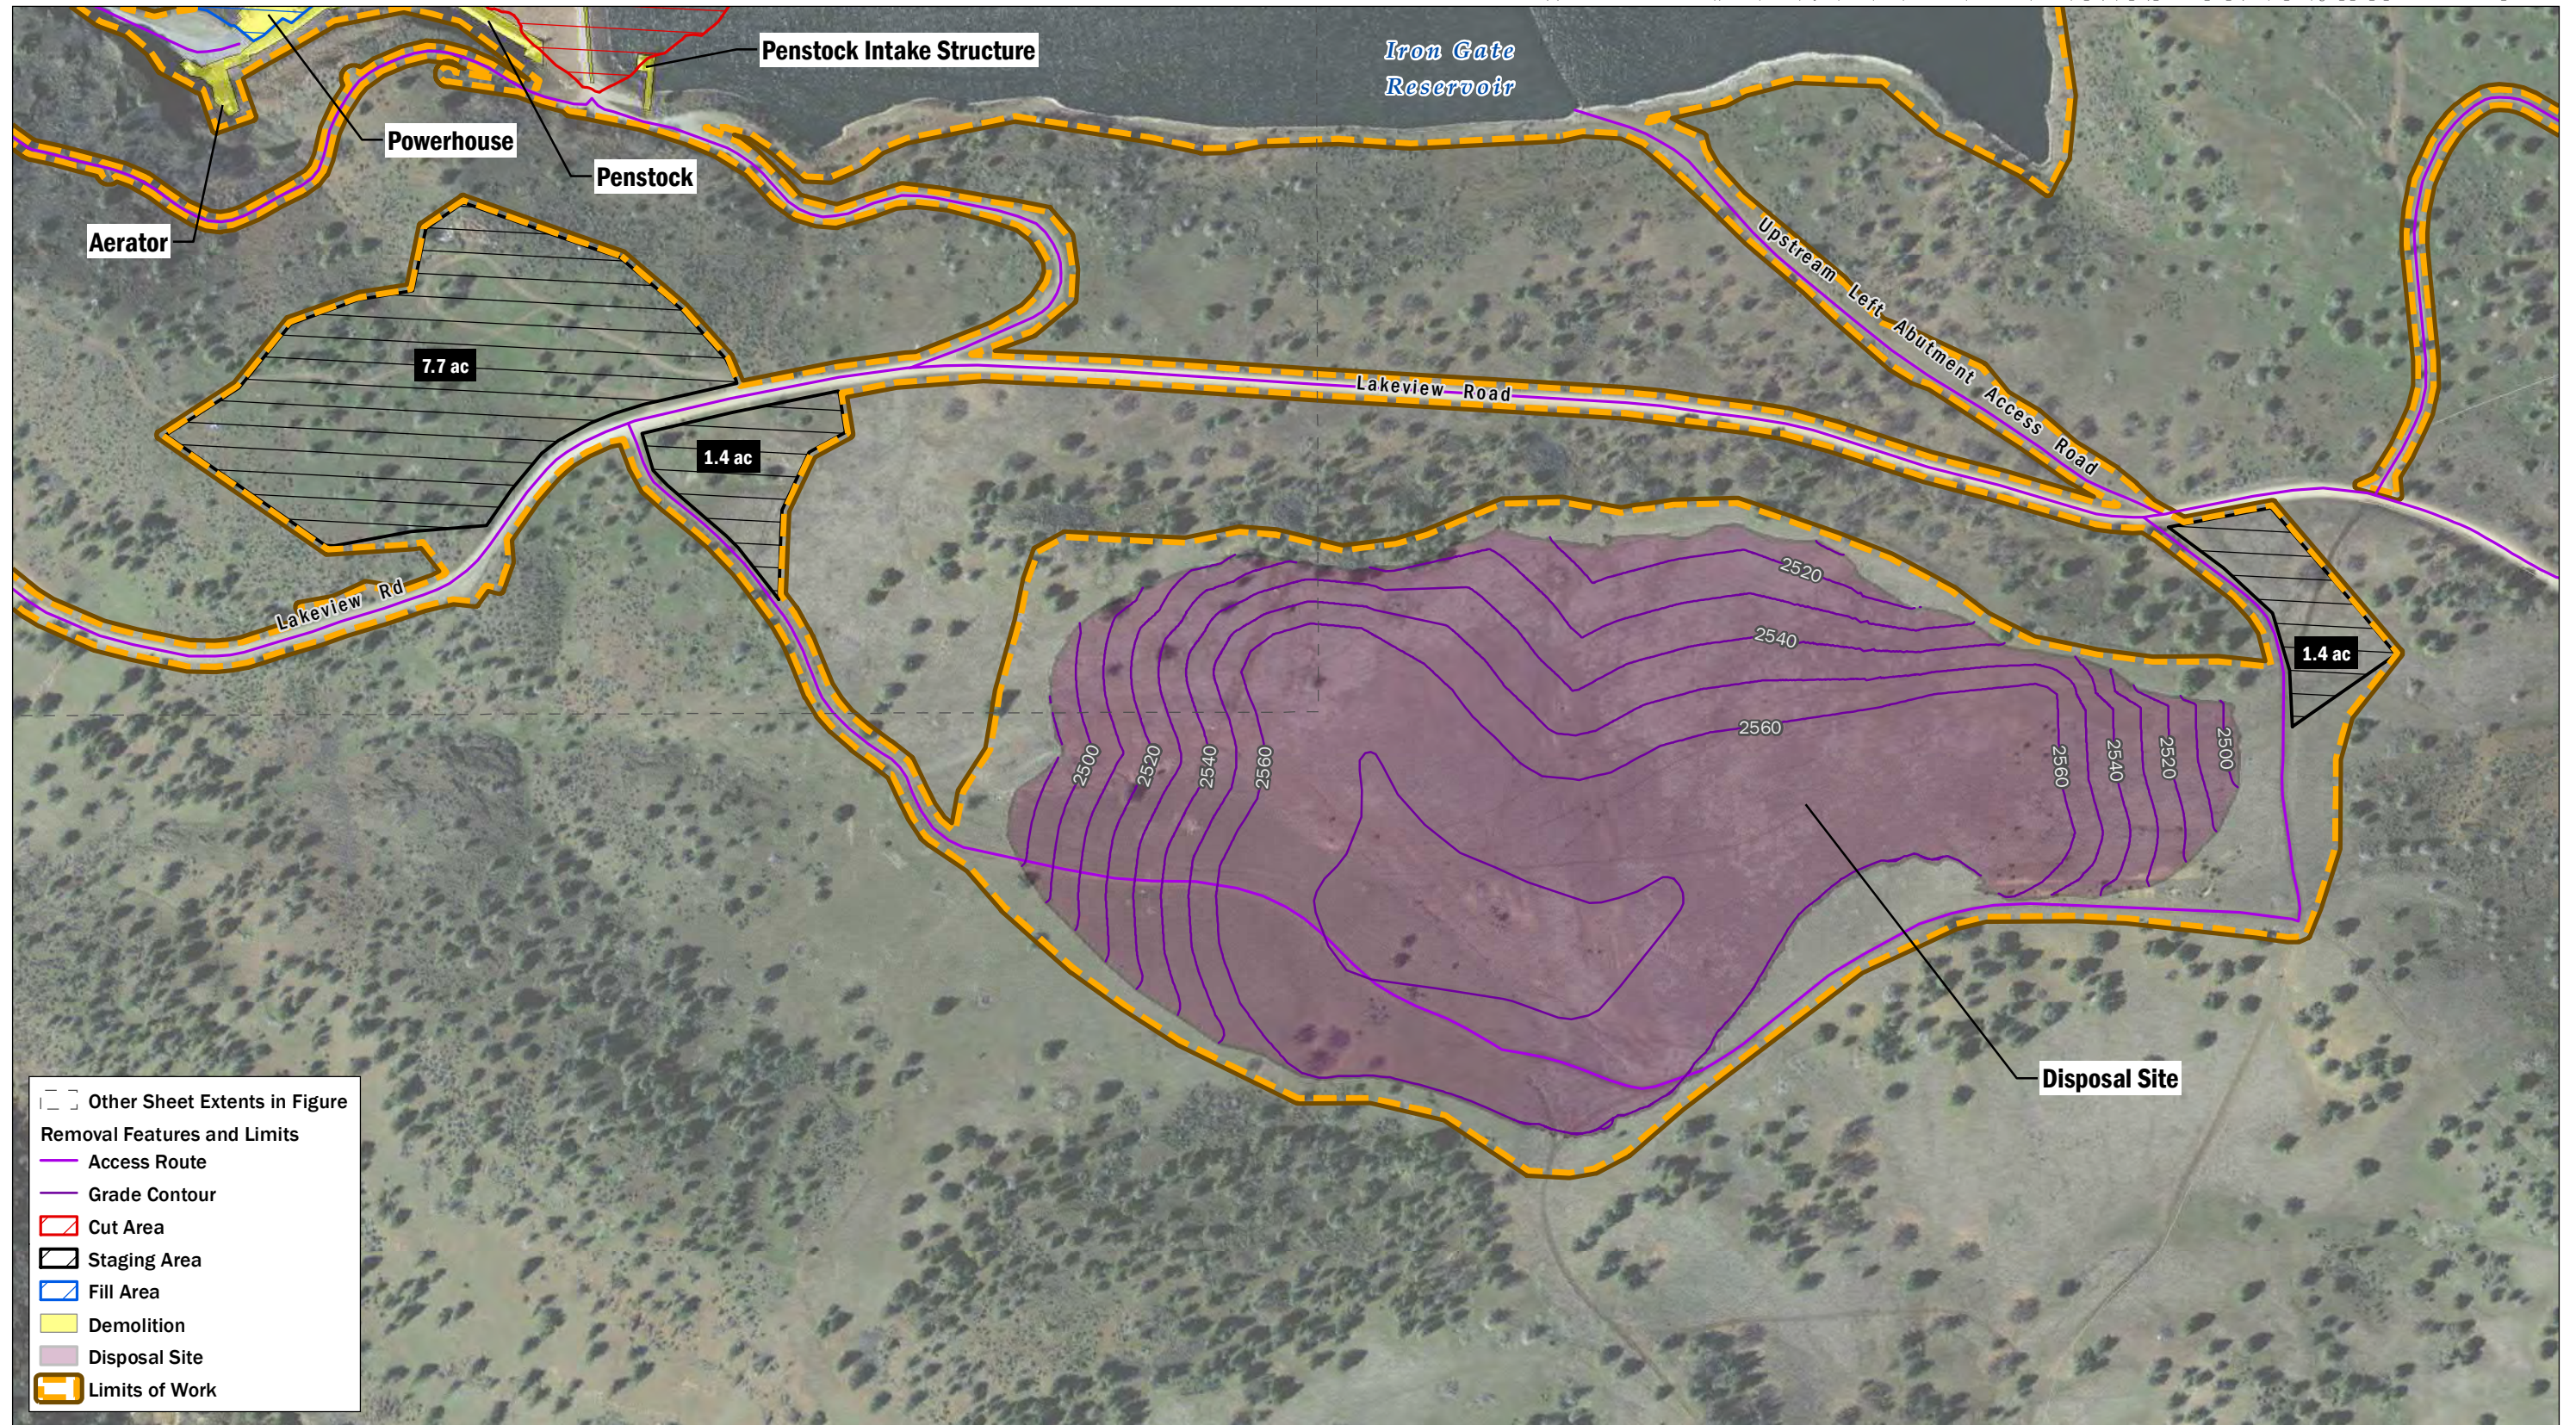
FIGURE 5.5-1
 Iron Gate Dam Removal Features and Limits
 Sheet 2 of 2

Note: Limits of work features that exist as small islands and/or narrow linear corridors are associated with project transmission line removal

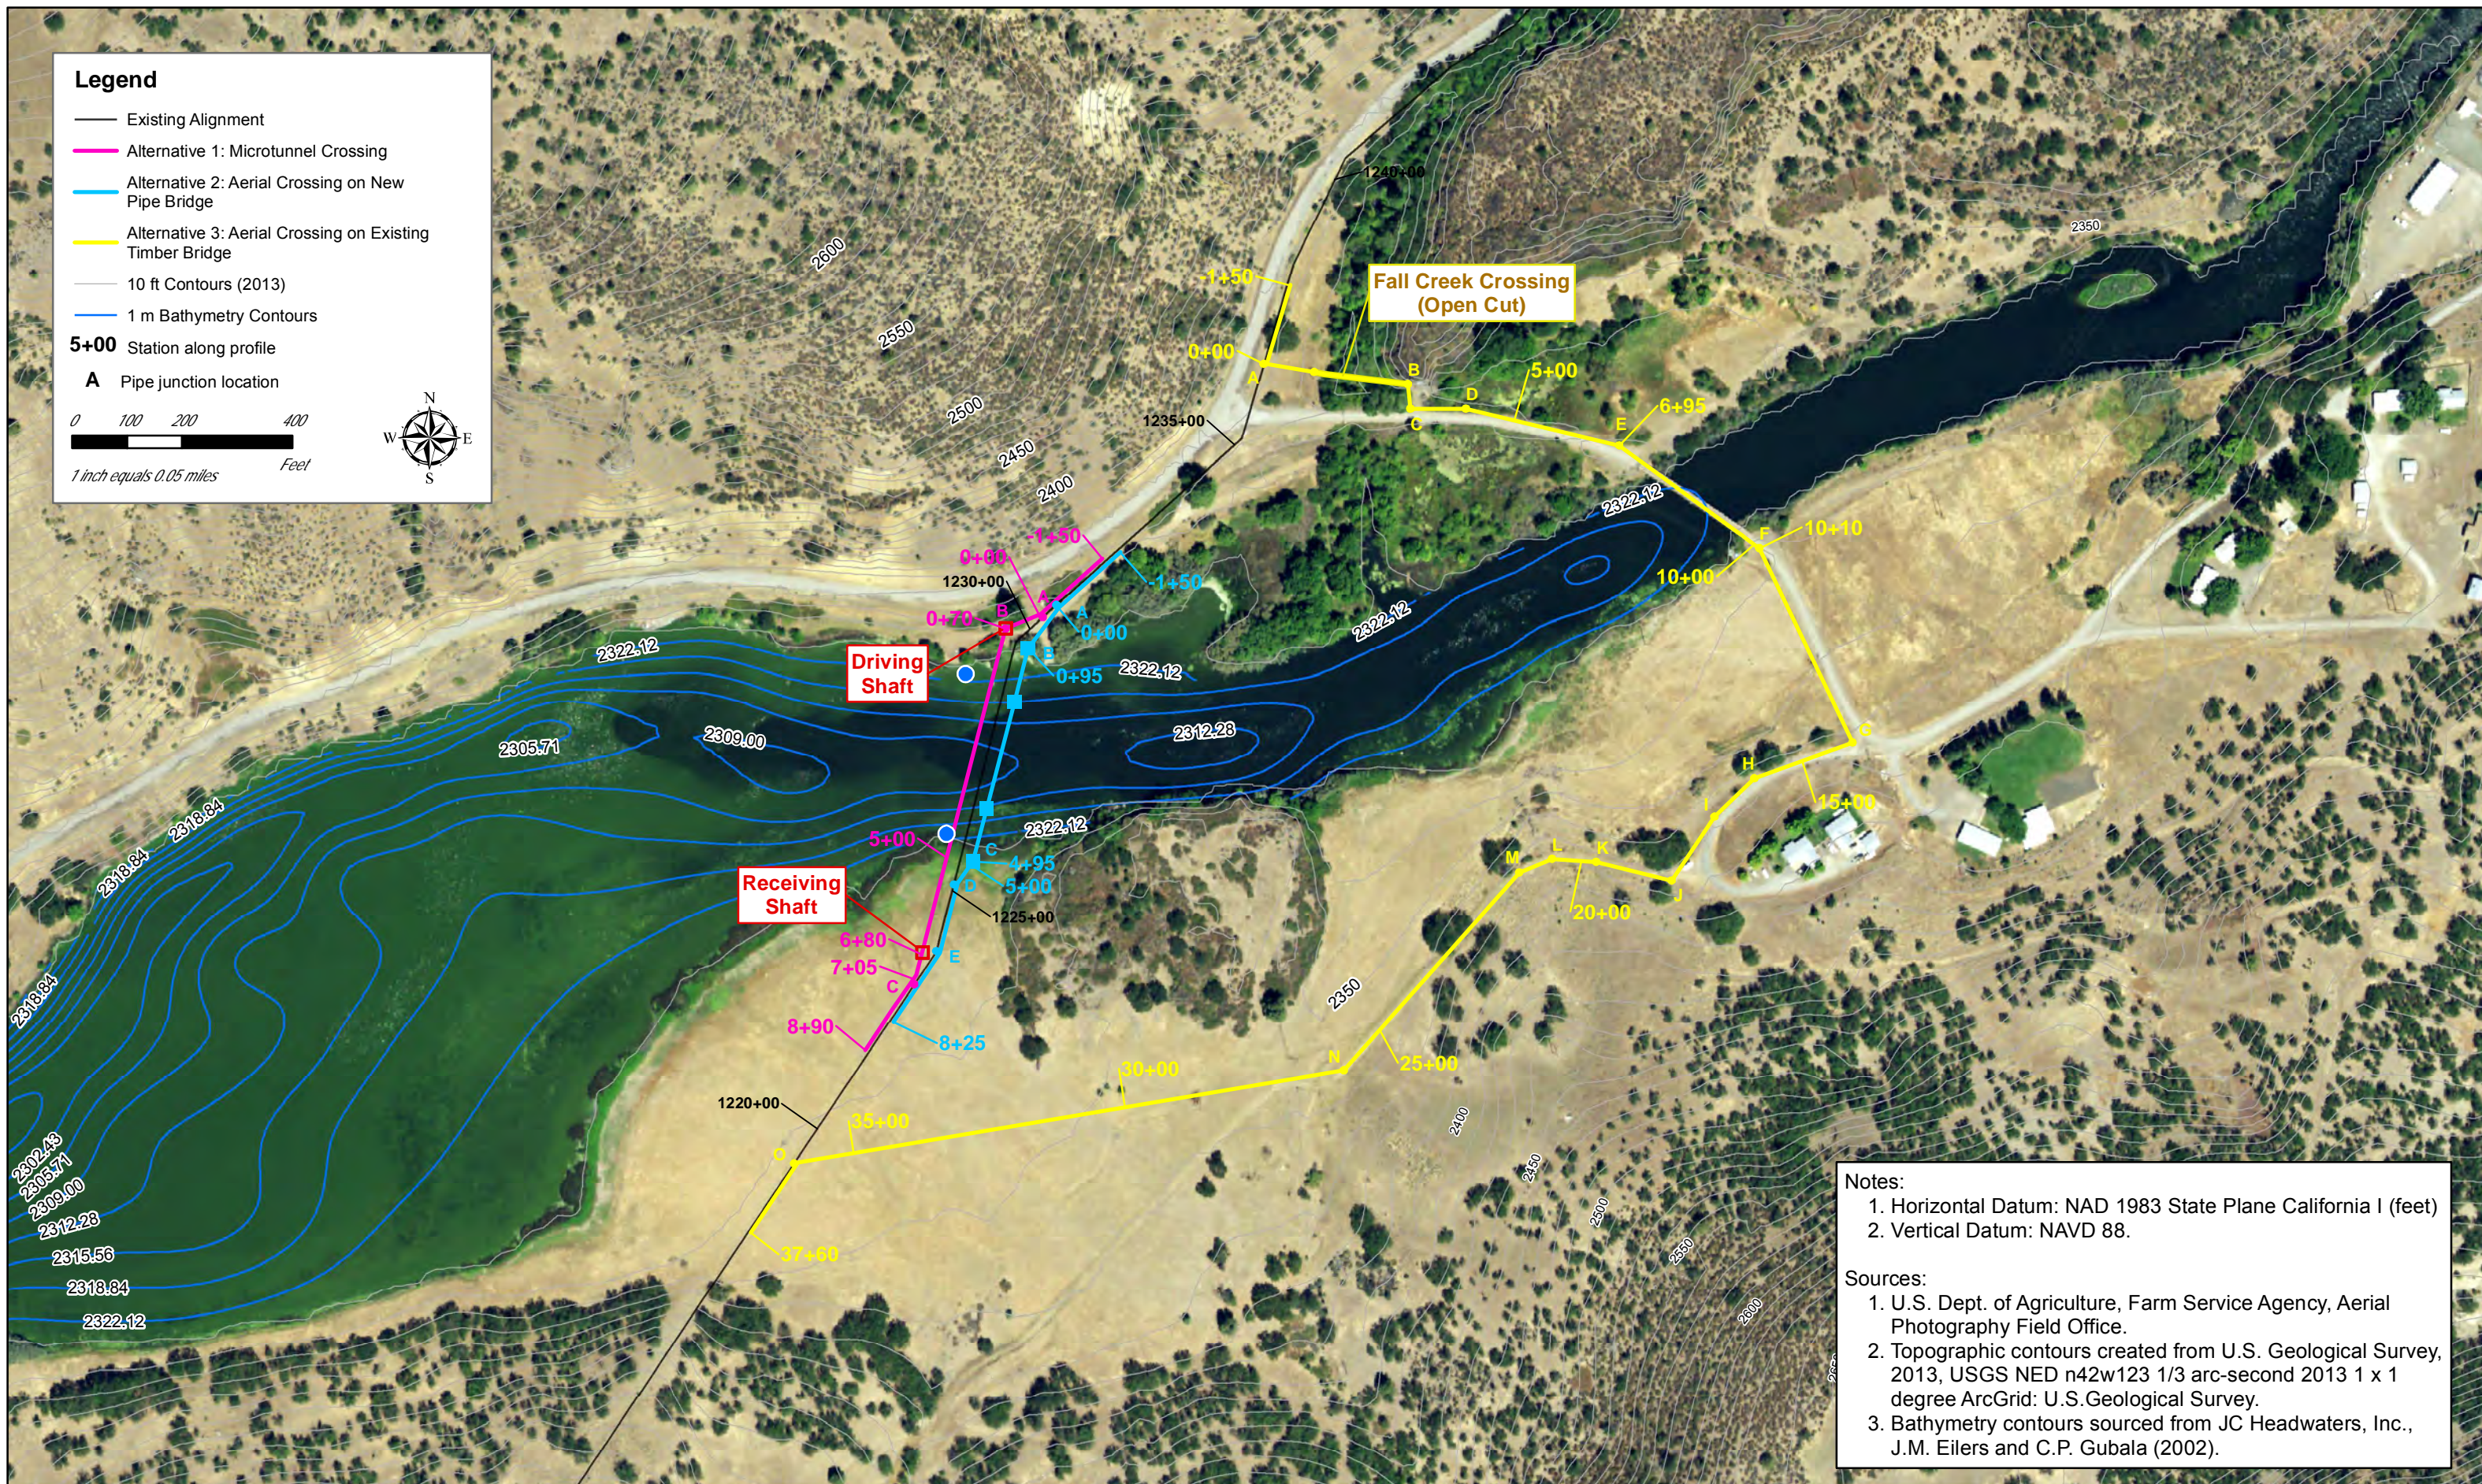
FIGURE 7.5-2: ALIGNMENTS FOR KLAMATH RIVER CROSSING CONCEPTUAL ALTERNATIVES
 Klamath Dams Removal Project – Yreka Waterline Replacement
 September 14, 2017

- Existing Alignment
- Alternative 1: Microtunnel Crossing
- Alternative 2: Aerial Crossing on New Pipe Bridge
- Alternative 3: Aerial Crossing on Existing Timber Bridge
- 10 ft Contours (2013)
- 1 m Bathymetry Contours
- 5+00** Station along profile
- A** Pipe junction location

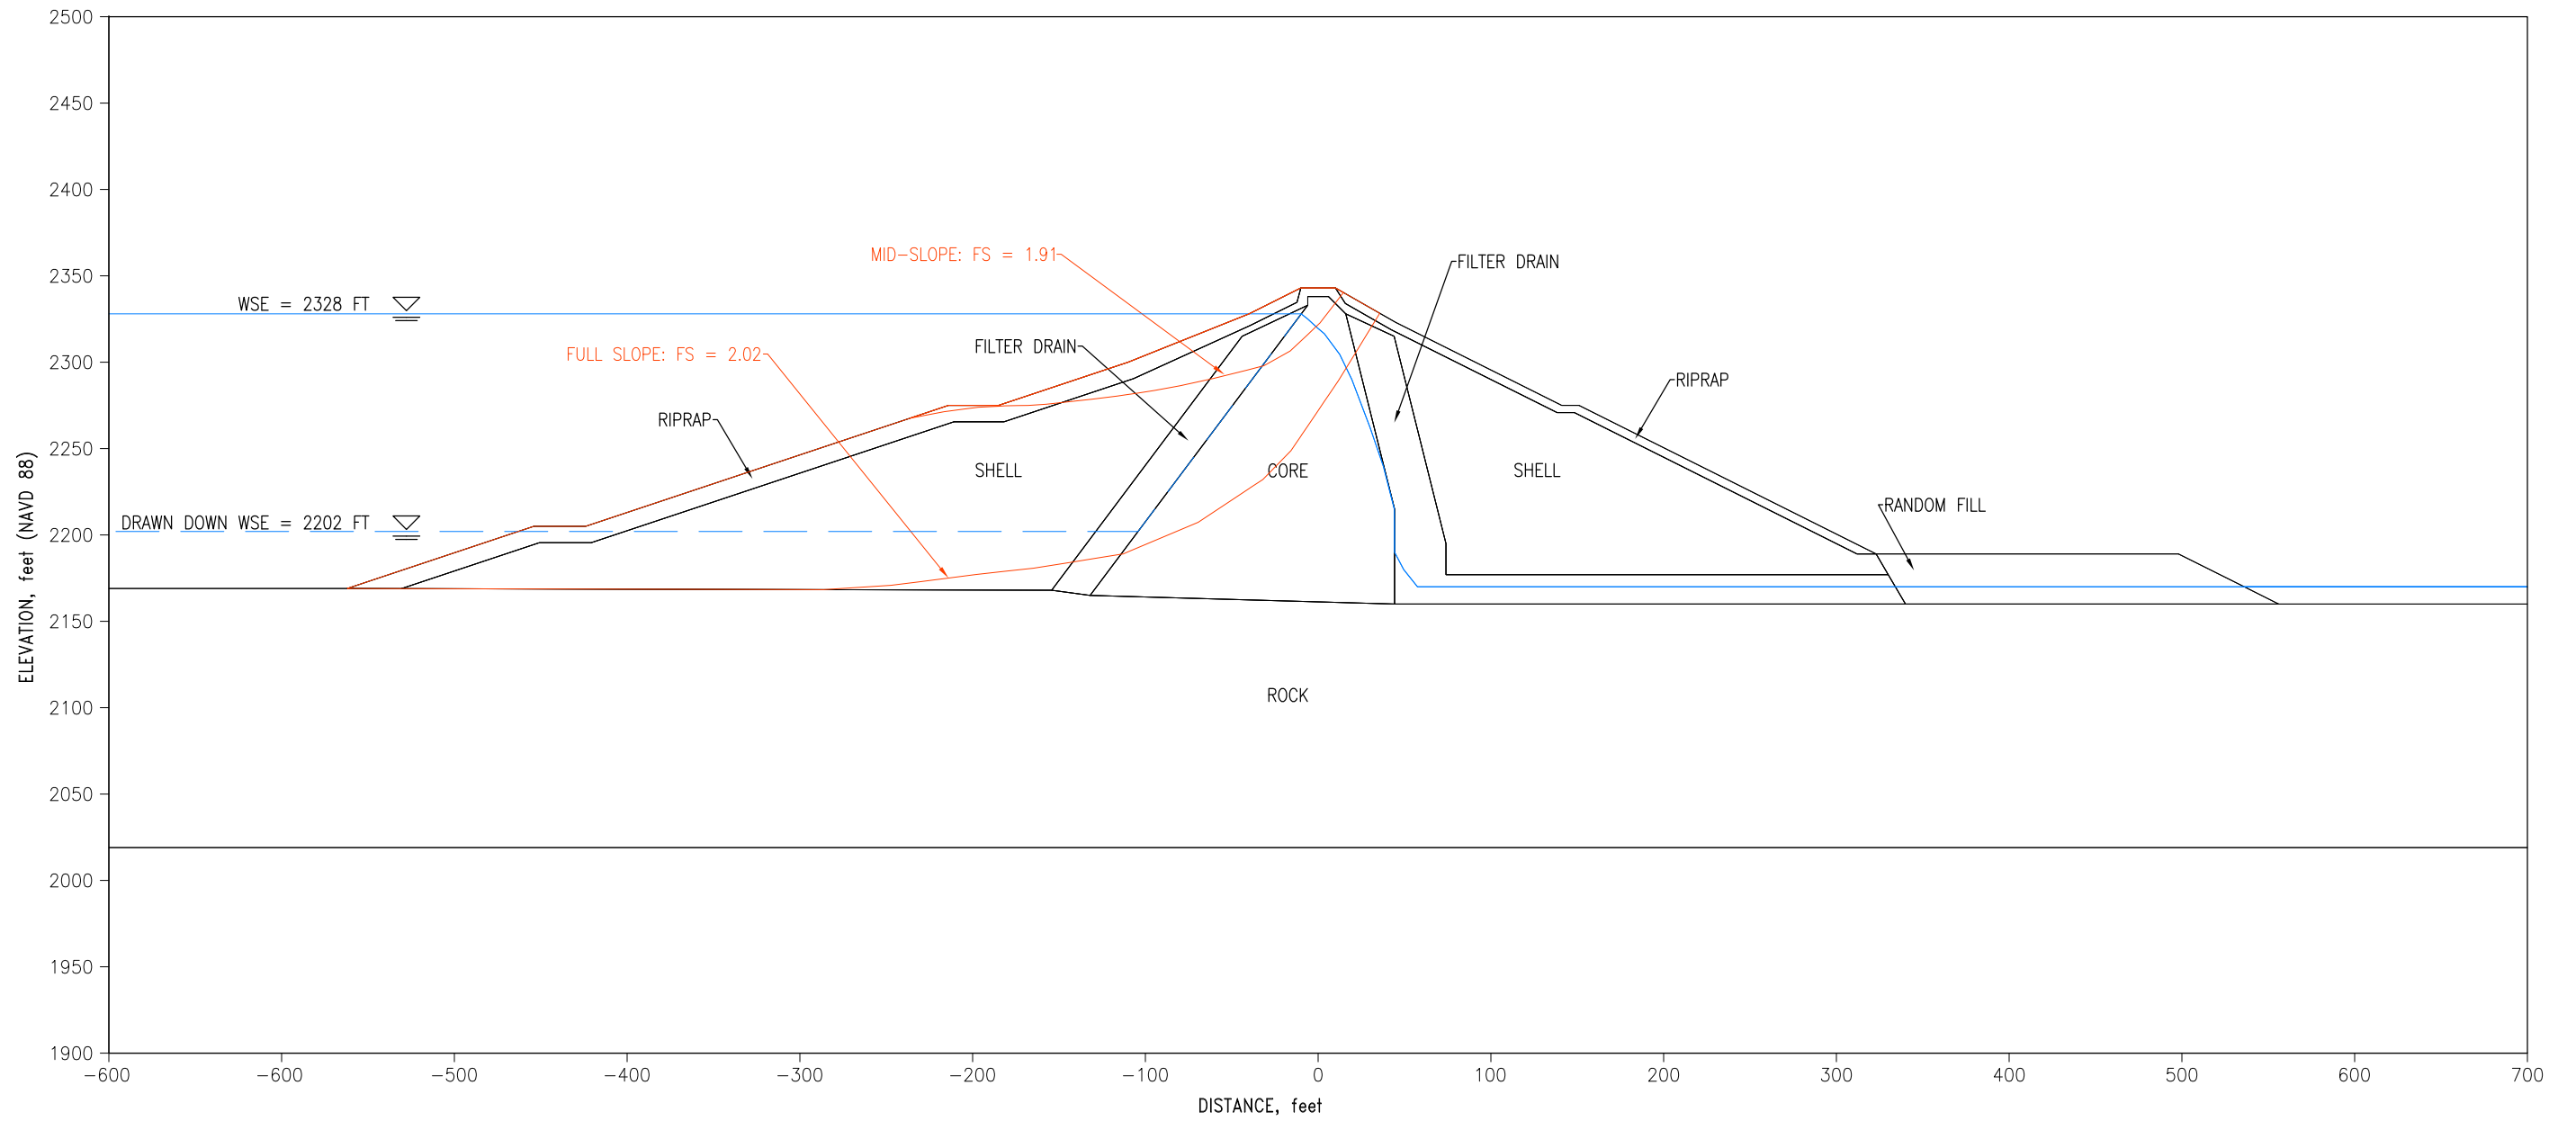
RAPID DRAWDOWN STABILITY ANALYSIS
 IRON GATE DAM
 INSTANTANEOUS DRAWDOWN SCENARIO
 FULL PORE PRESSURE DISSIPATION

For Iron Gate Dam, the reservoir was drawn down from El. 2328 feet to El. 2202 feet. For J.C. Boyle Dam, the reservoir was drawn down from El. 3793 feet to El. 3762 feet. The results of the rapid drawdown slope stability analyses for Iron Gate Dam are summarized in Table 3. Table 3 also includes the results of the sensitivity analyses, which consider the potential lower bound strength for the shell materials. The results of rapid drawdown slope stability analyses for J.C. Boyle Dam are summarized in Table 4. Table 4 also includes the results of the sensitivity analyses, which consider the lower bounds for both the core strength and the shell permeability. The analysis results for the best estimate parameters are also shown on Figures 3 through 7 for Iron Gate Dam, and on Figures 8 through 12 for J.C. Boyle Dam. It should be noted that the plotted phreatic surfaces shown on the figures for the transient rapid drawdown analyses correspond to the phreatic surfaces at the specific time when the calculated factors of safety are minimum.

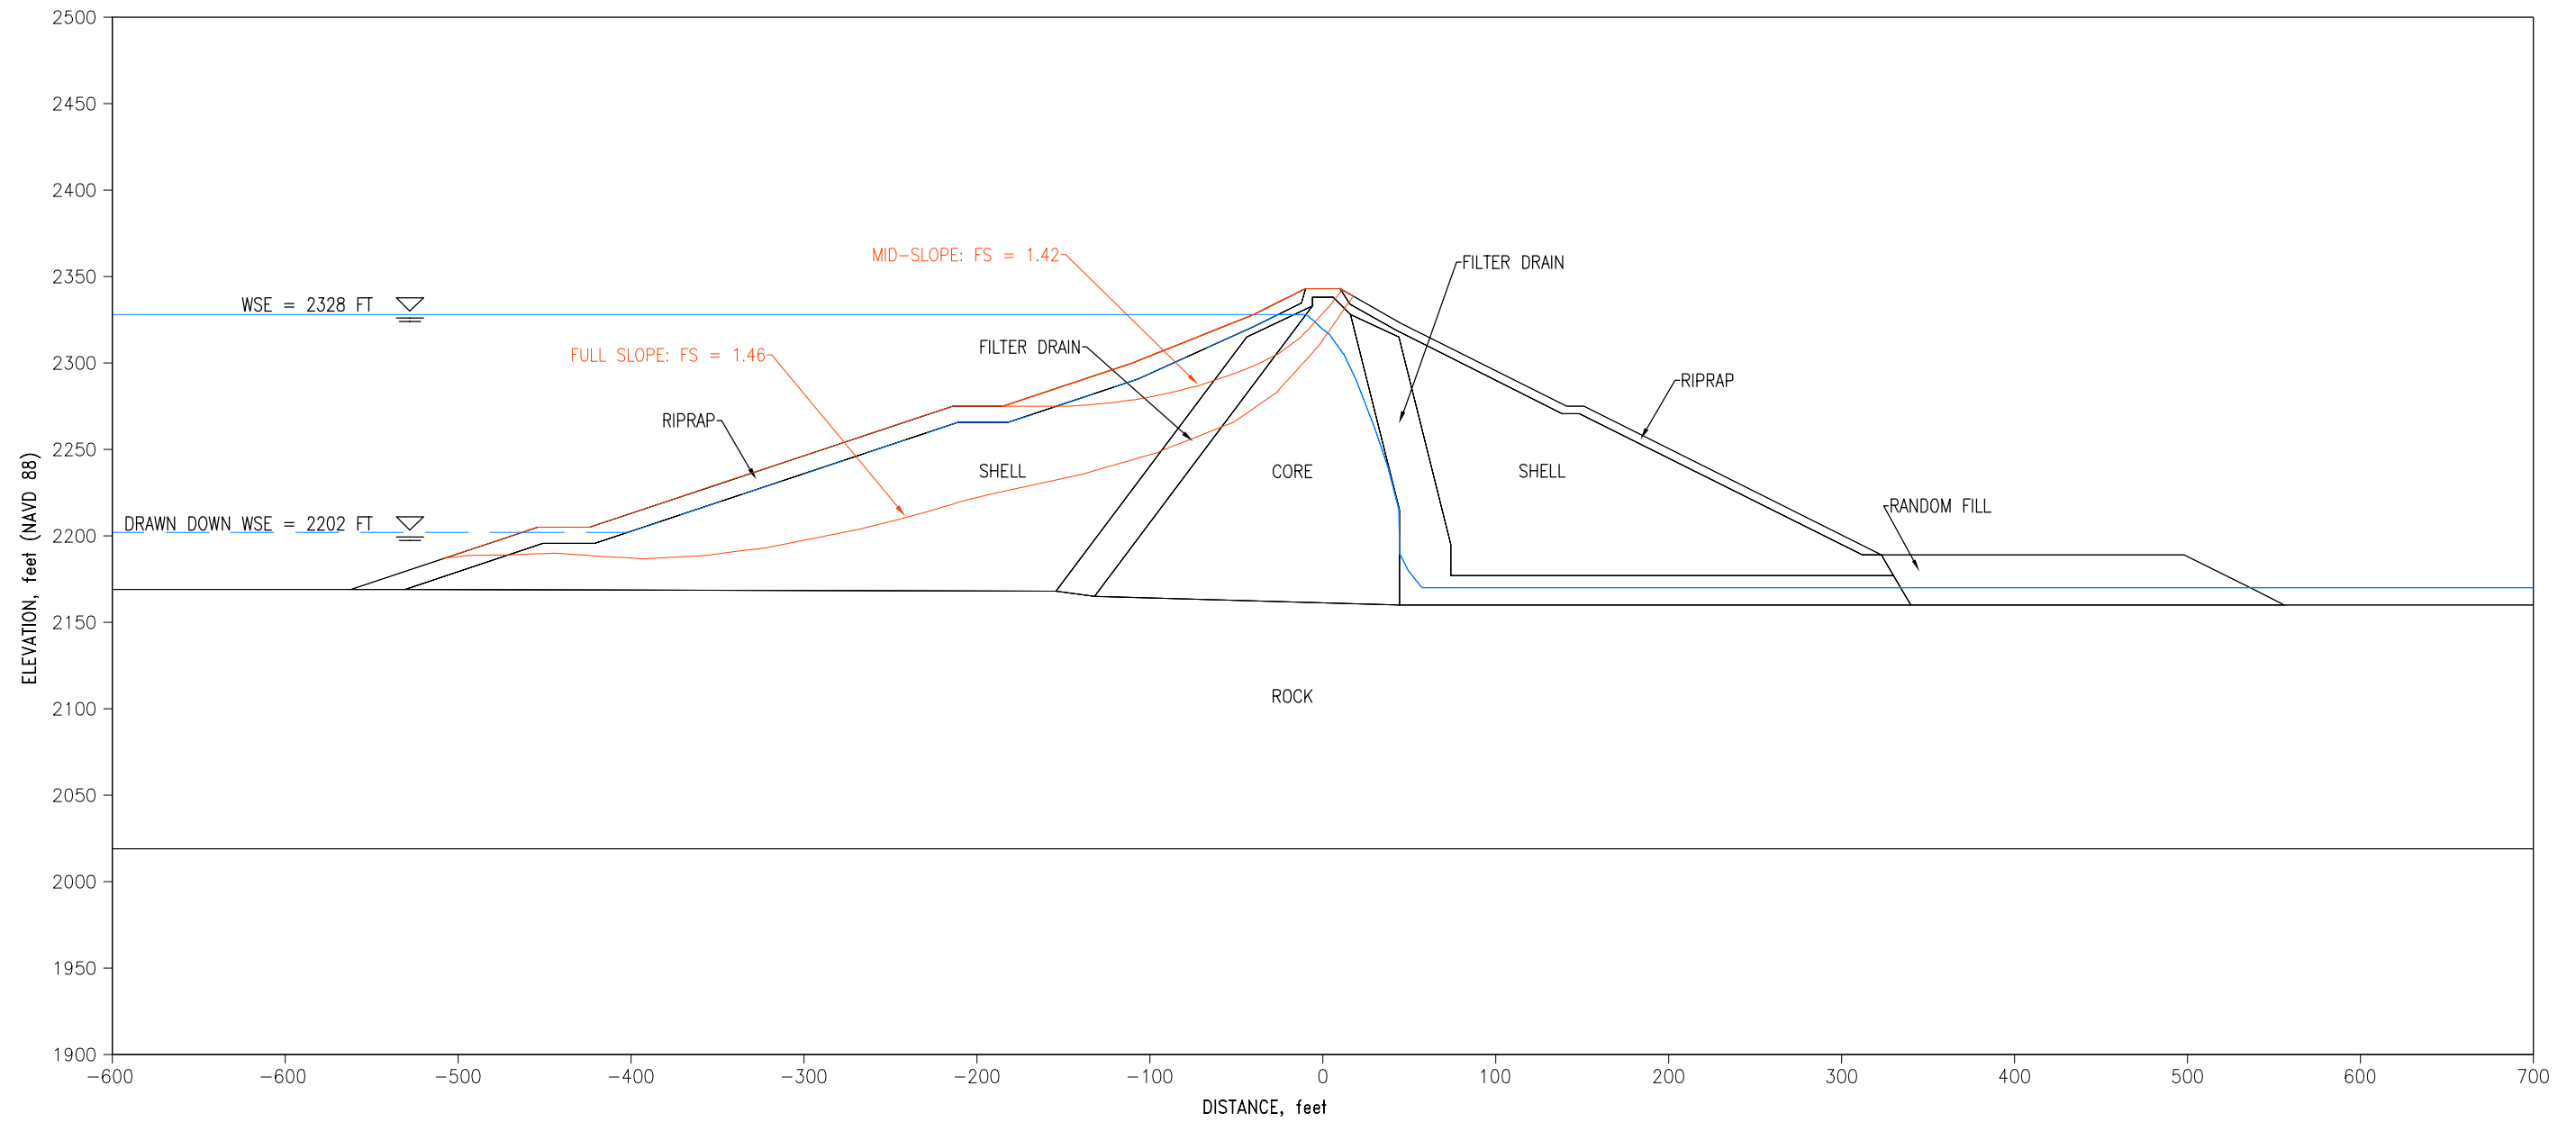
RAPID DRAWDOWN STABILITY ANALYSIS
 IRON GATE DAM
 INSTANTANEOUS DRAWDOWN SCENARIO
 NO PORE PRESSURE DISSIPATION
