Definite Plan for the Lower Klamath Project

Appendix A – Risk Management Plan

June 2018

Klamath River Renewal Corporation

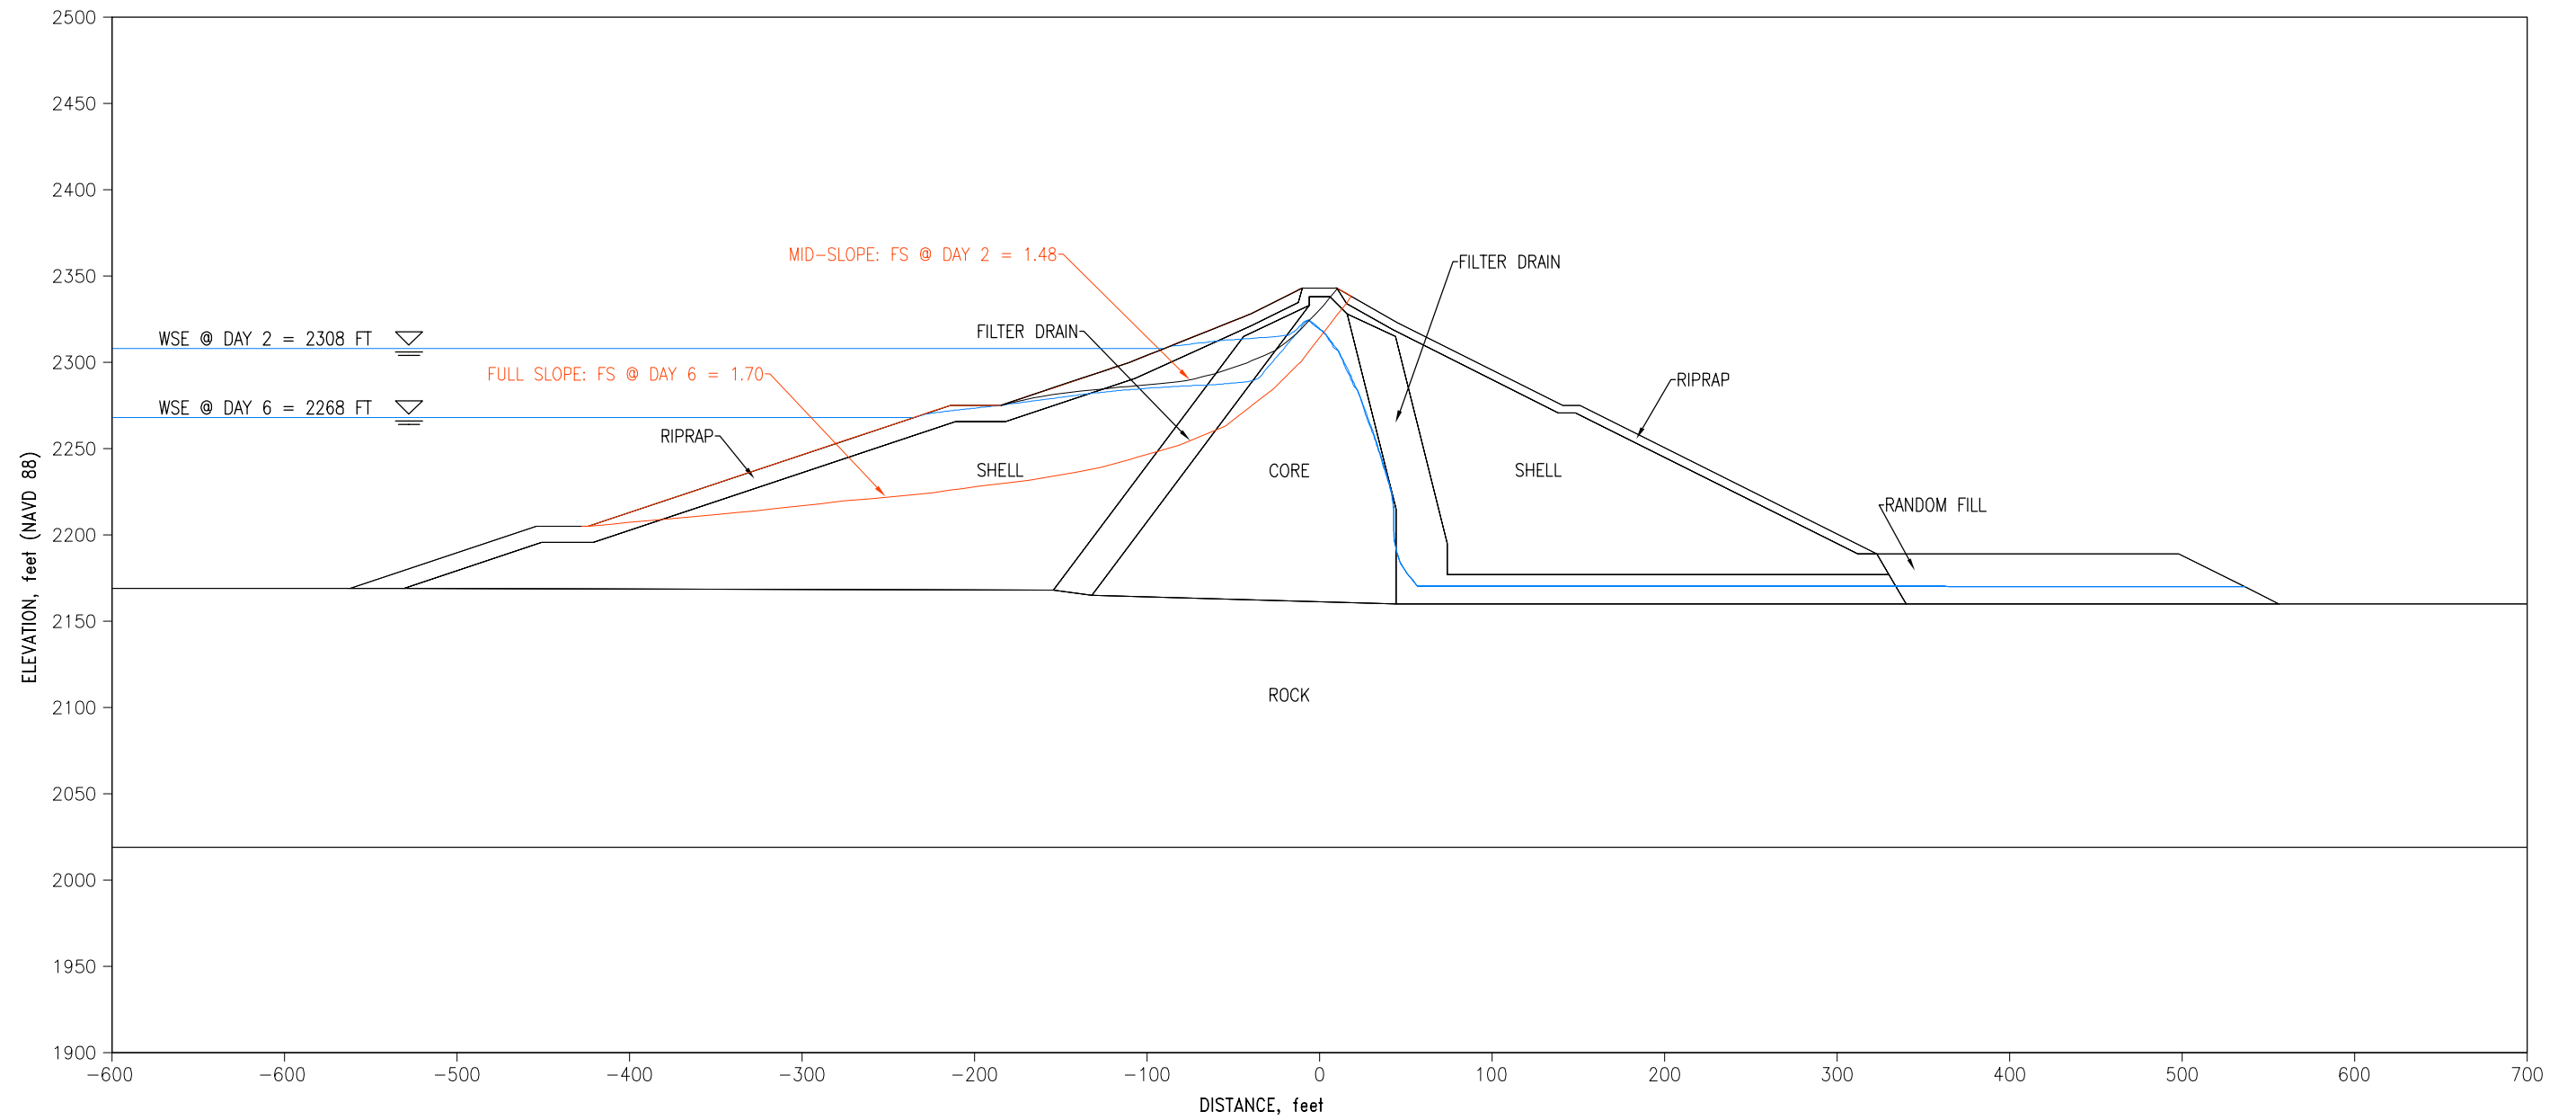
RAPID DRAWDOWN STABILITY ANALYSIS
 IRON GATE DAM
 SLOW DRAWDOWN SCENARIO
 10 FT/DAY DRAWDOWN RATE

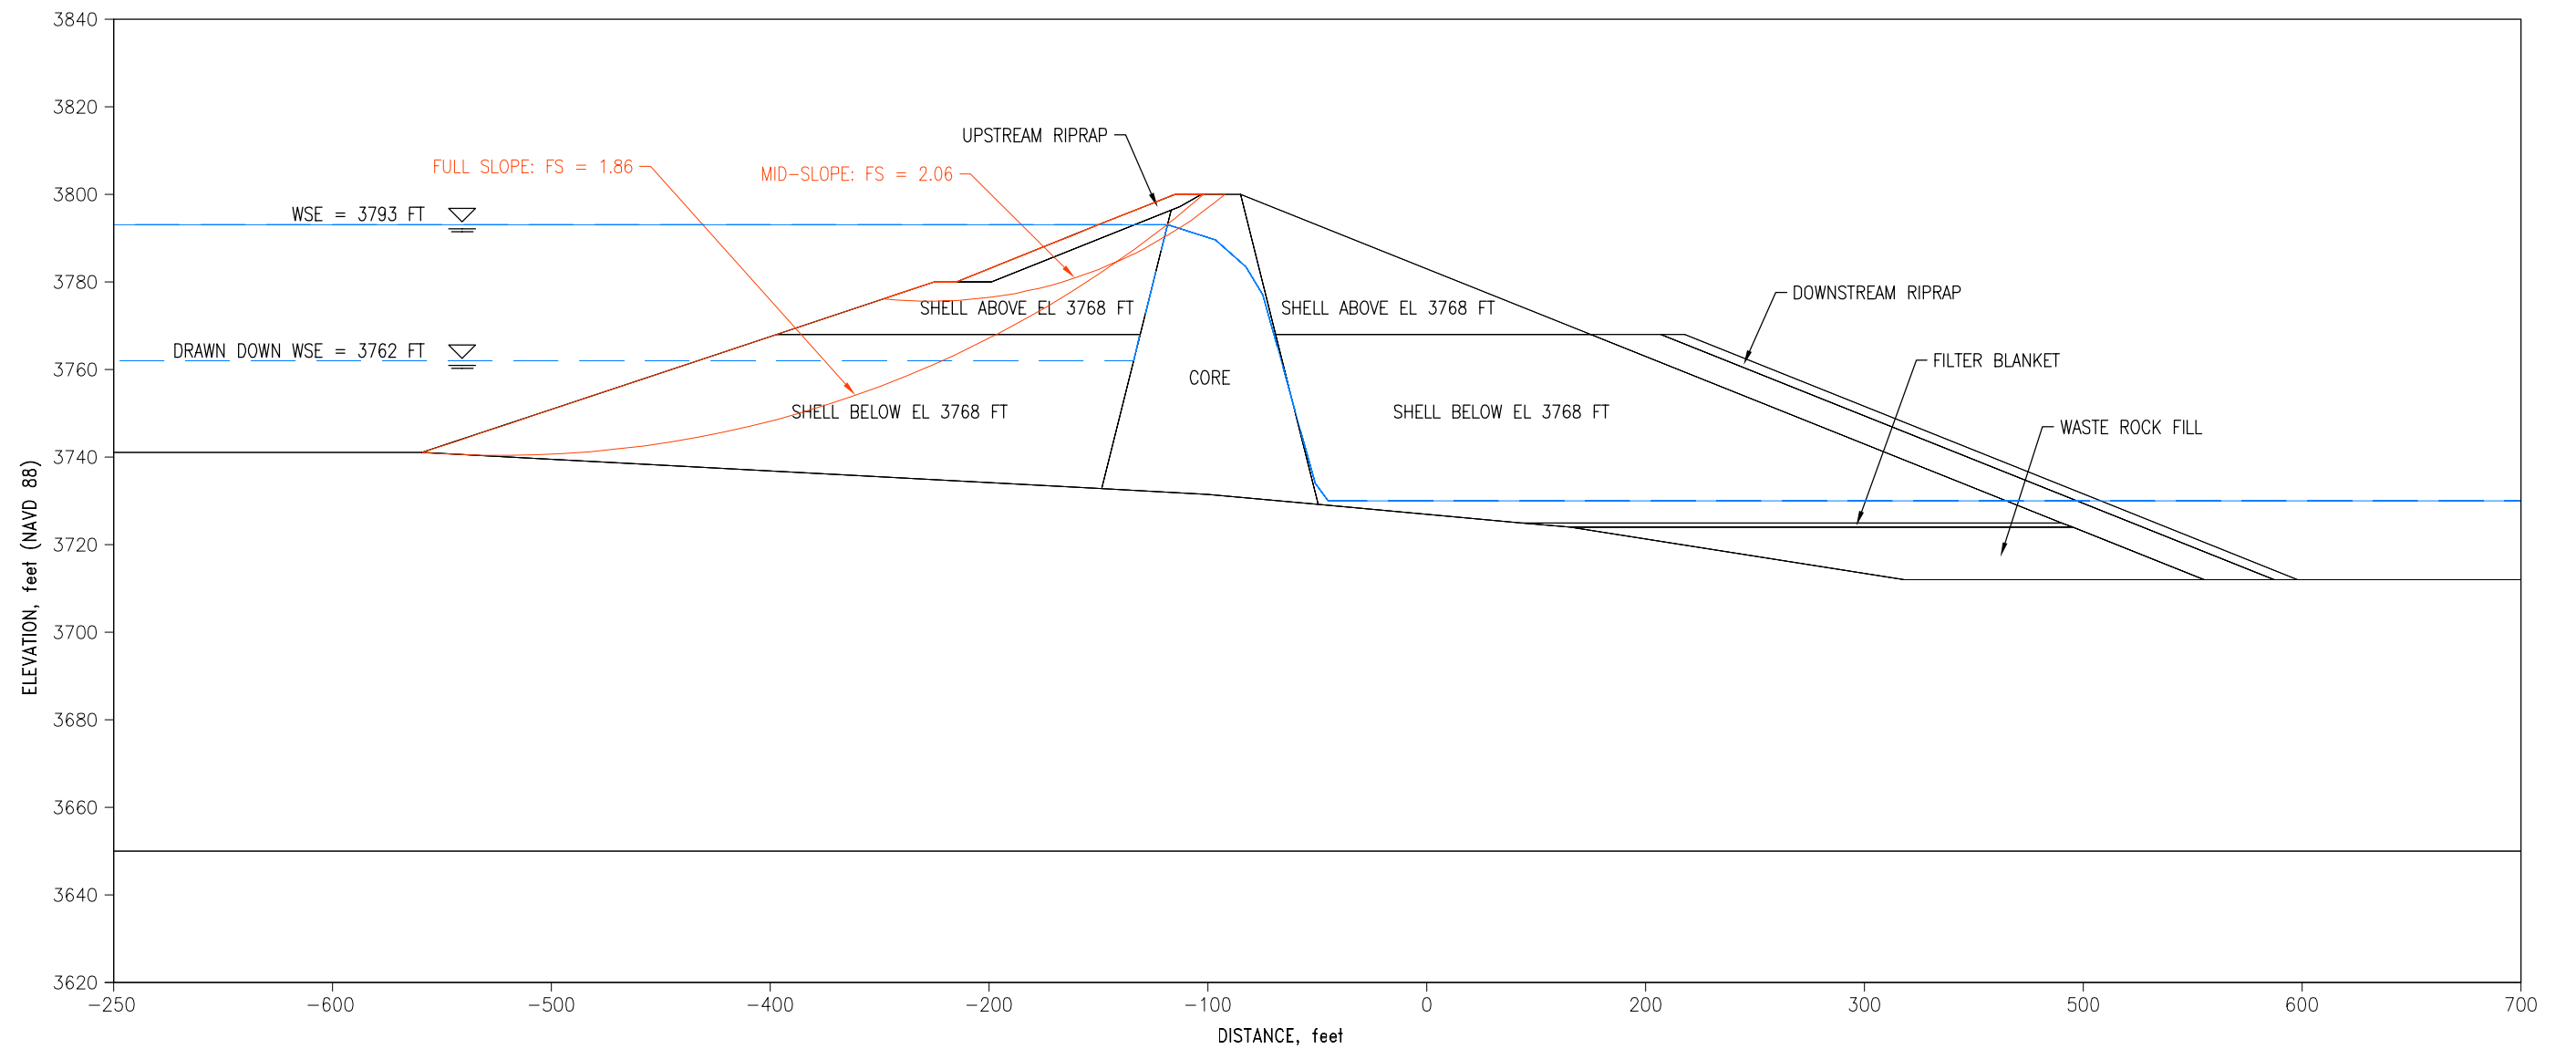
RAPID DRAWDOWN STABILITY ANALYSIS
 JC BOYLE DAM
 INSTANTANEOUS DRAWDOWN SCENARIO
 FULL PORE PRESSURE DISSIPATION

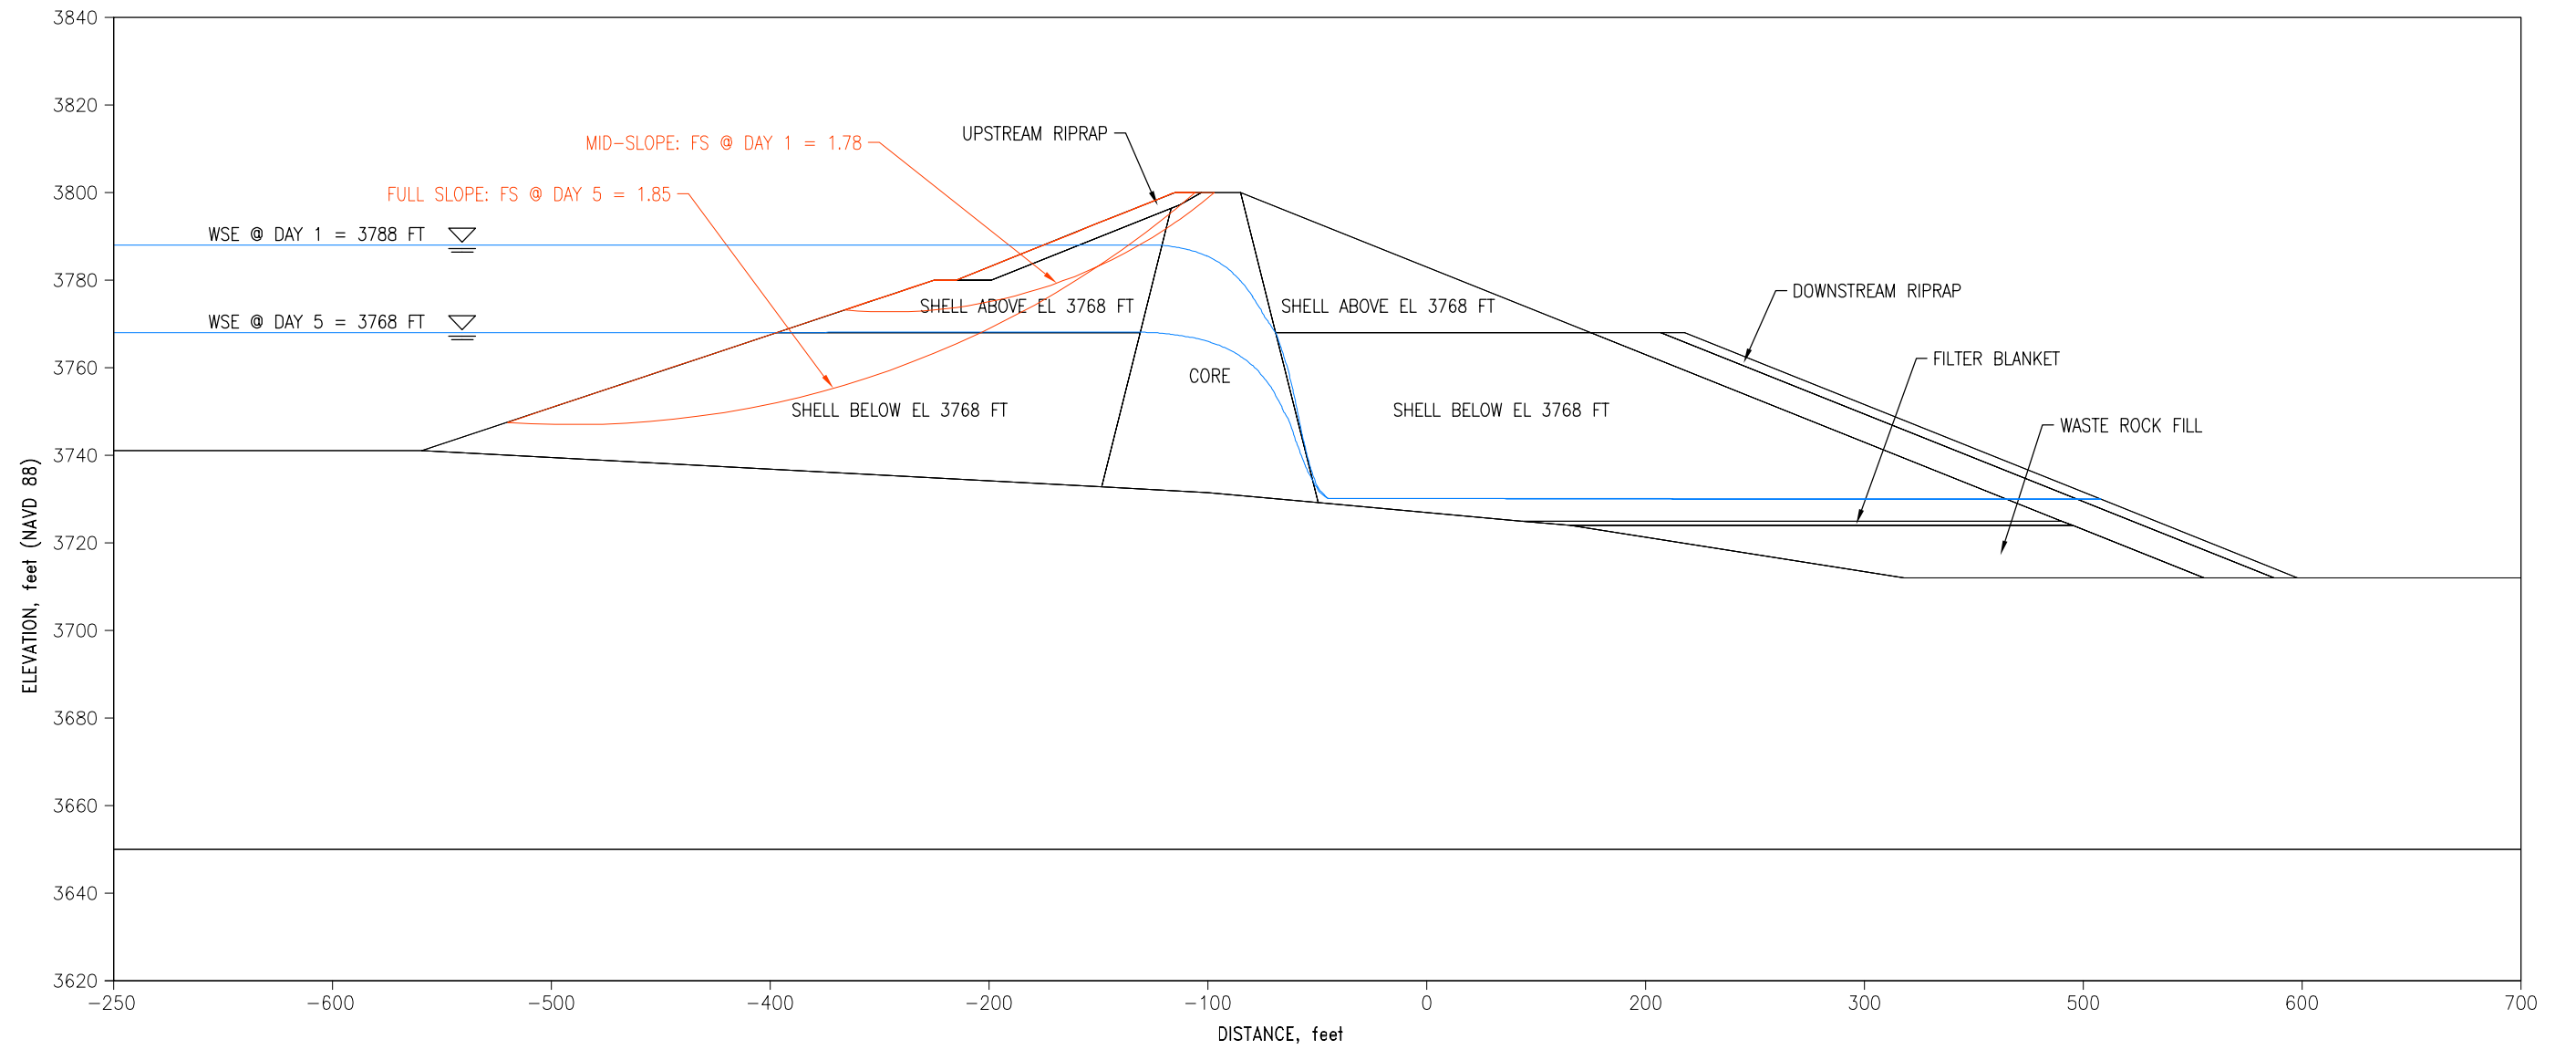
FIGURE
11

RAPID DRAWDOWN STABILITY ANALYSIS
 JC BOYLE DAM
 SLOW DRAWDOWN SCENARIO
 5 FT/DAY DRAWDOWN RATE

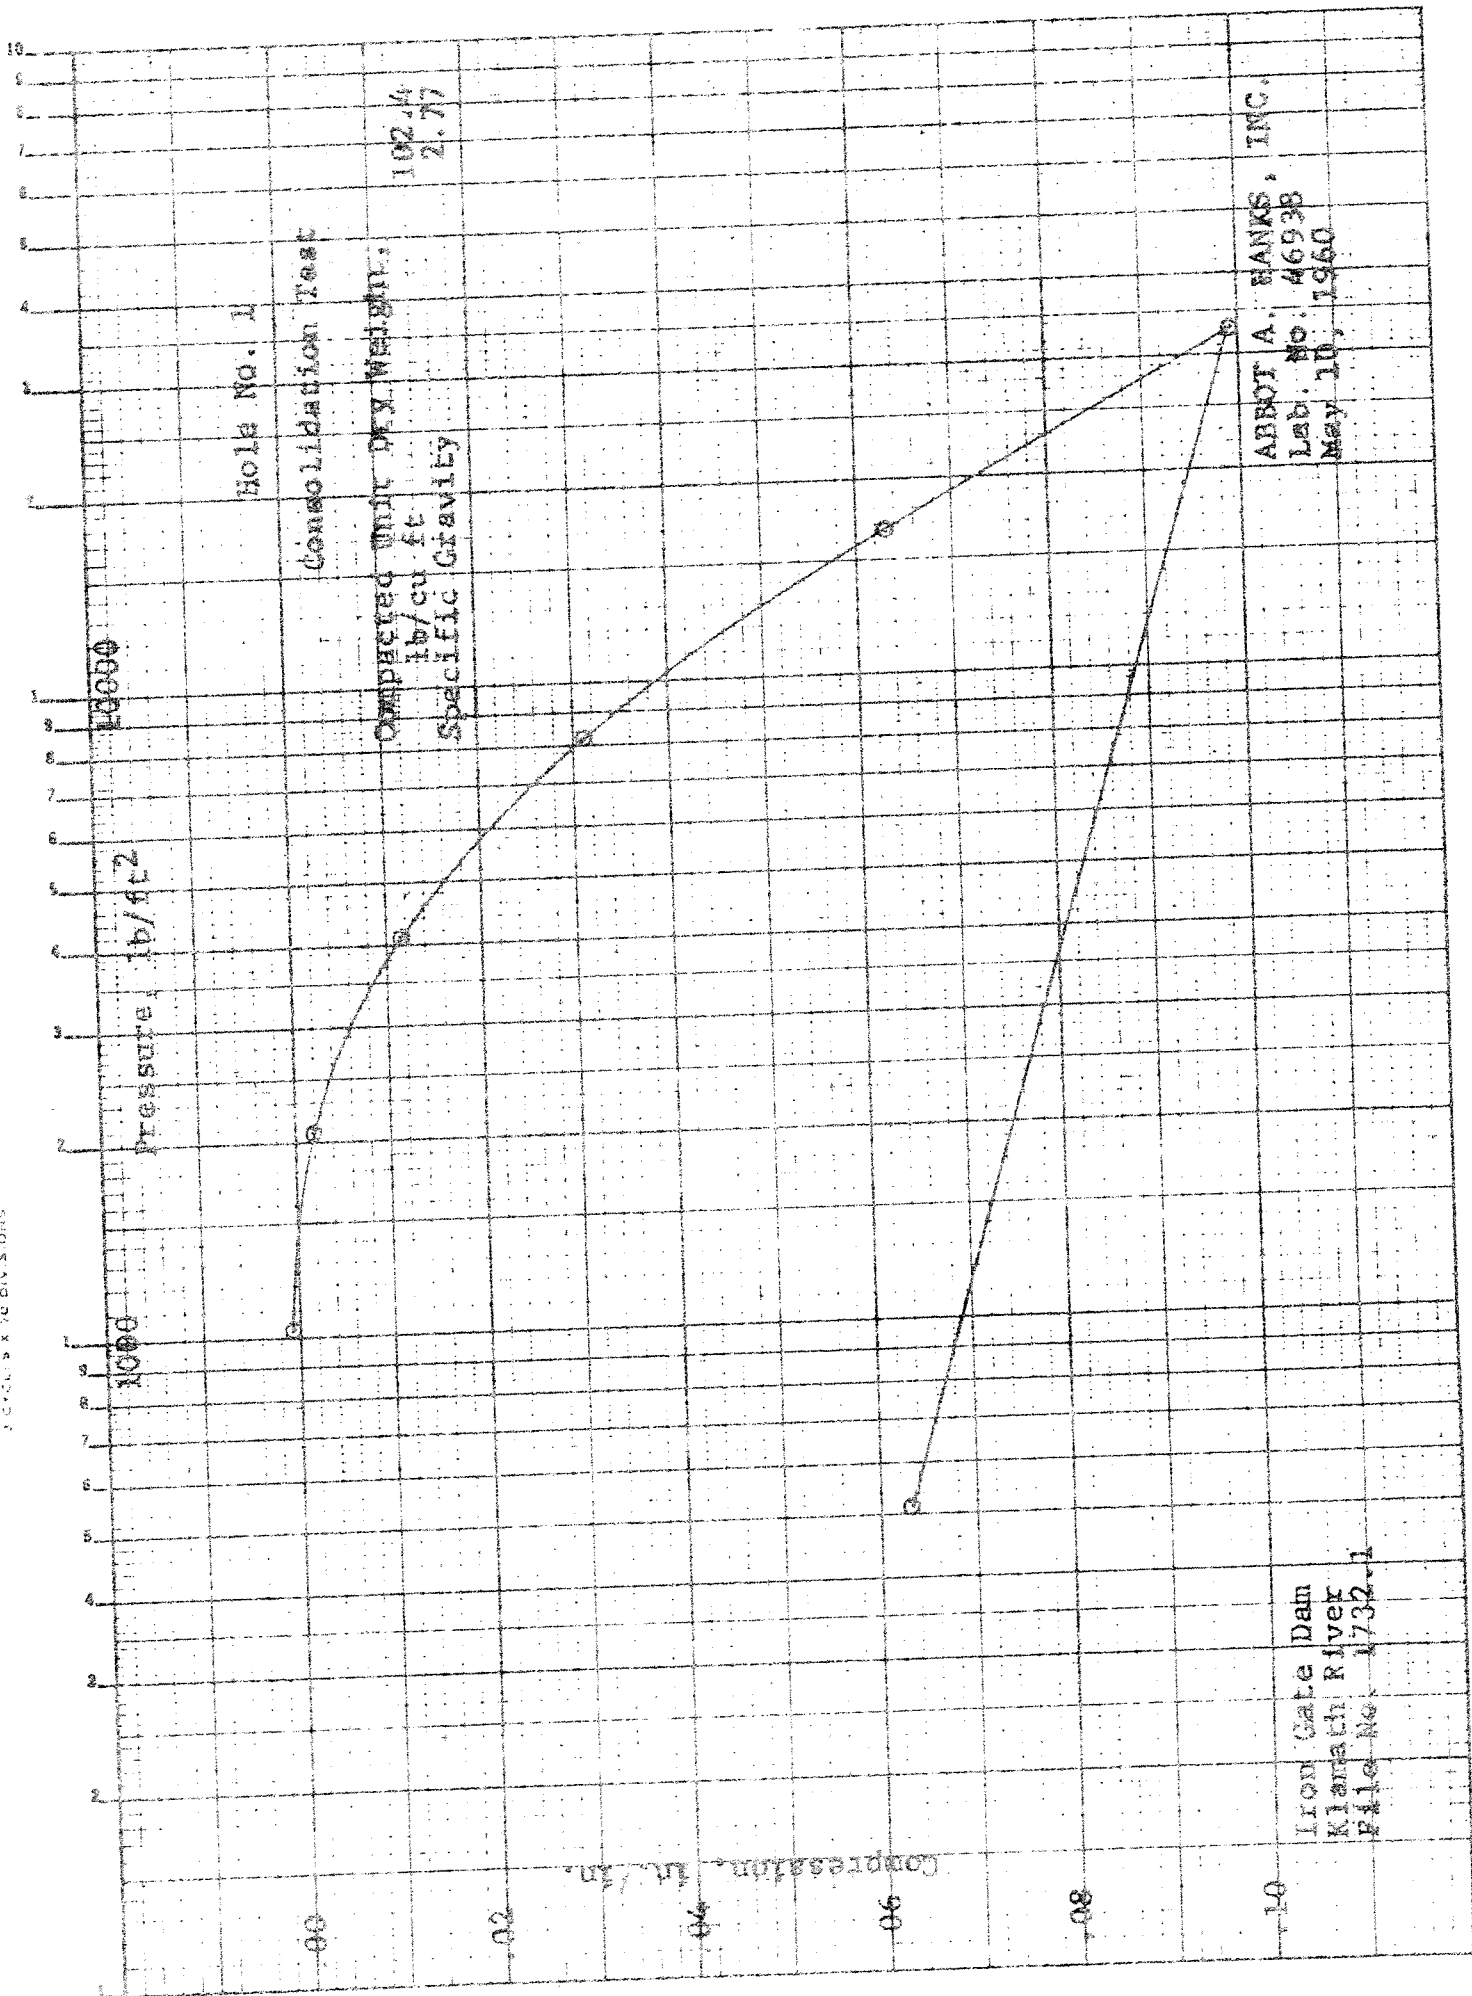
Hole No. 1

Consolidation Test

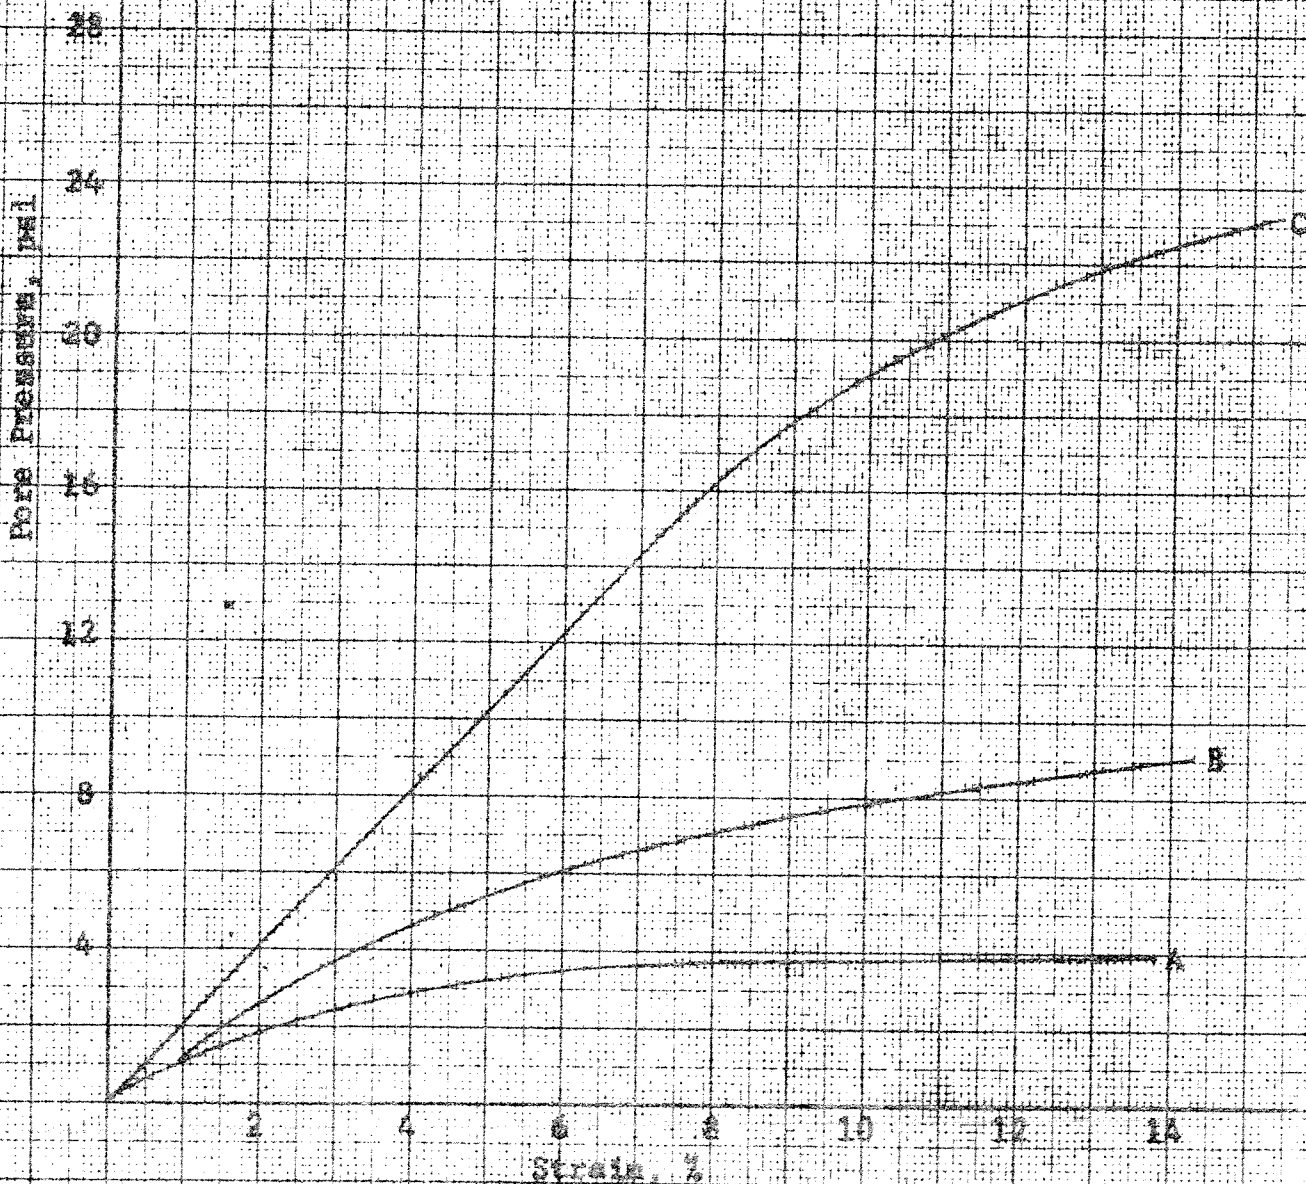
Dilatant Shear Test

Pore Pressure-Strain Relationships

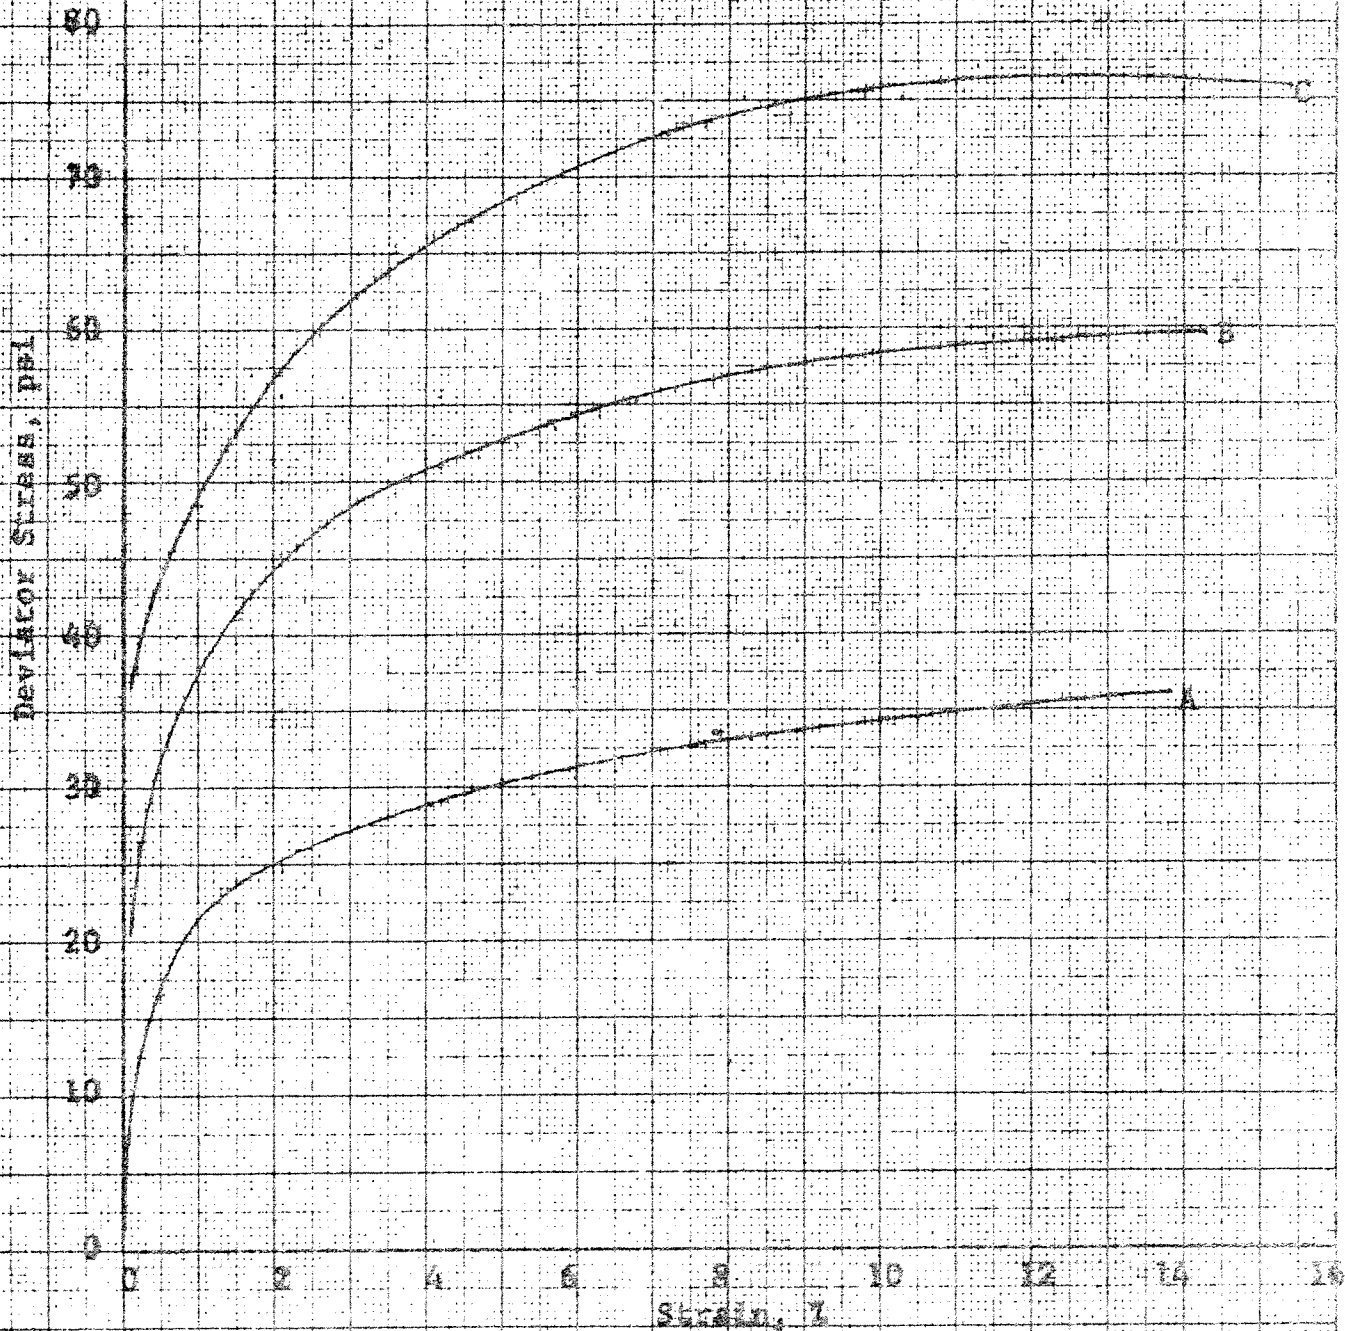
Hole No. 1
Triaxial Shear Test
Stress-Strain Relationships

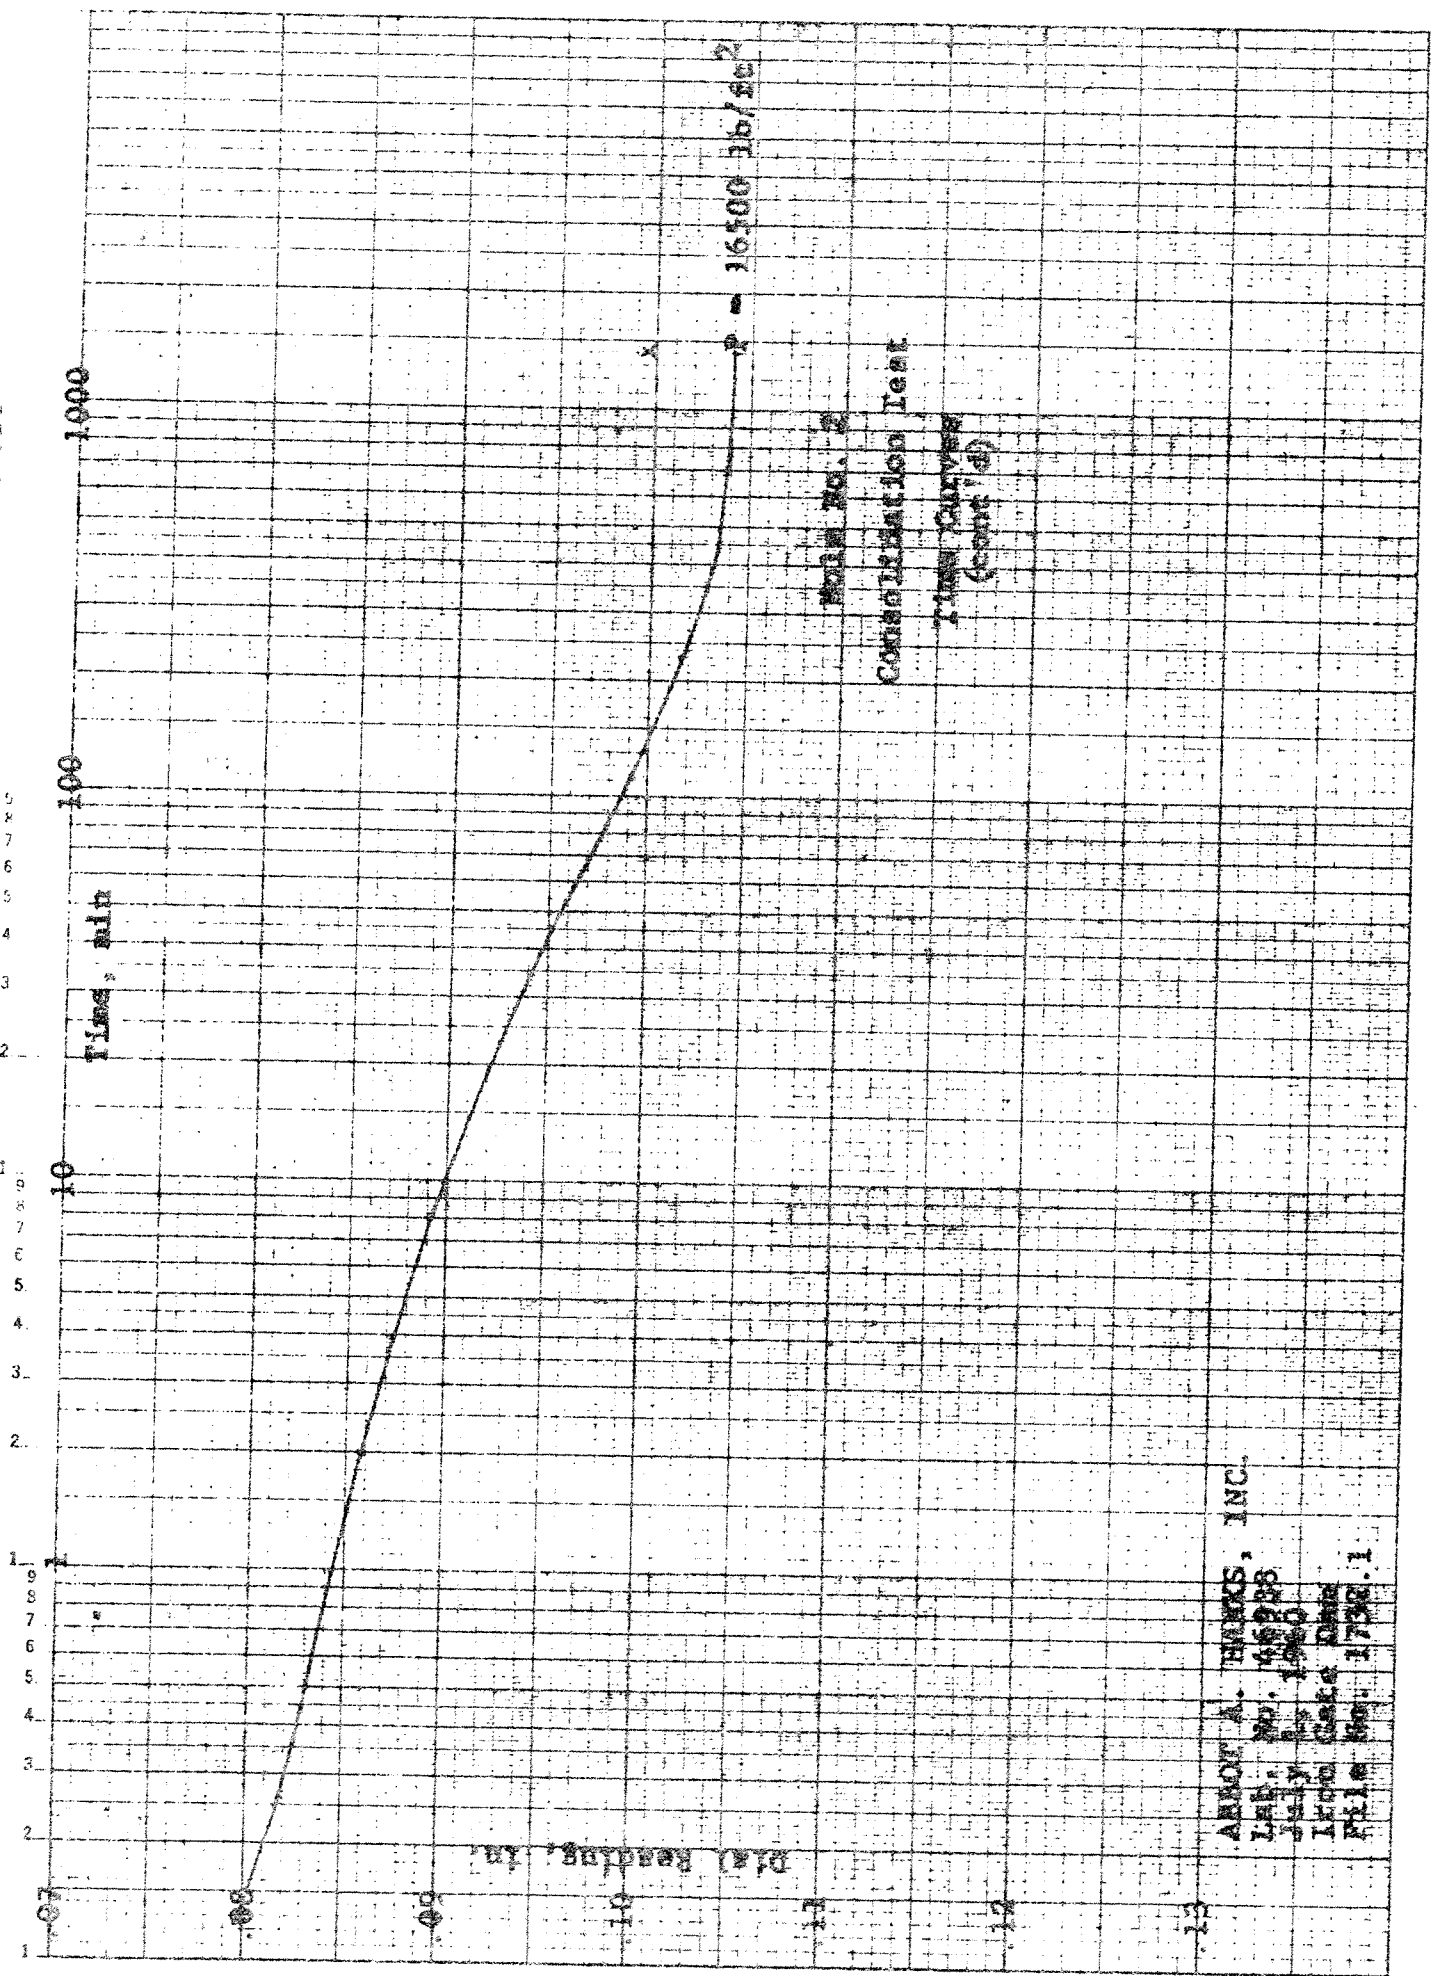
16100 16750
Main No. 2
Consolidation Test
Time Curves
(Cont'd)

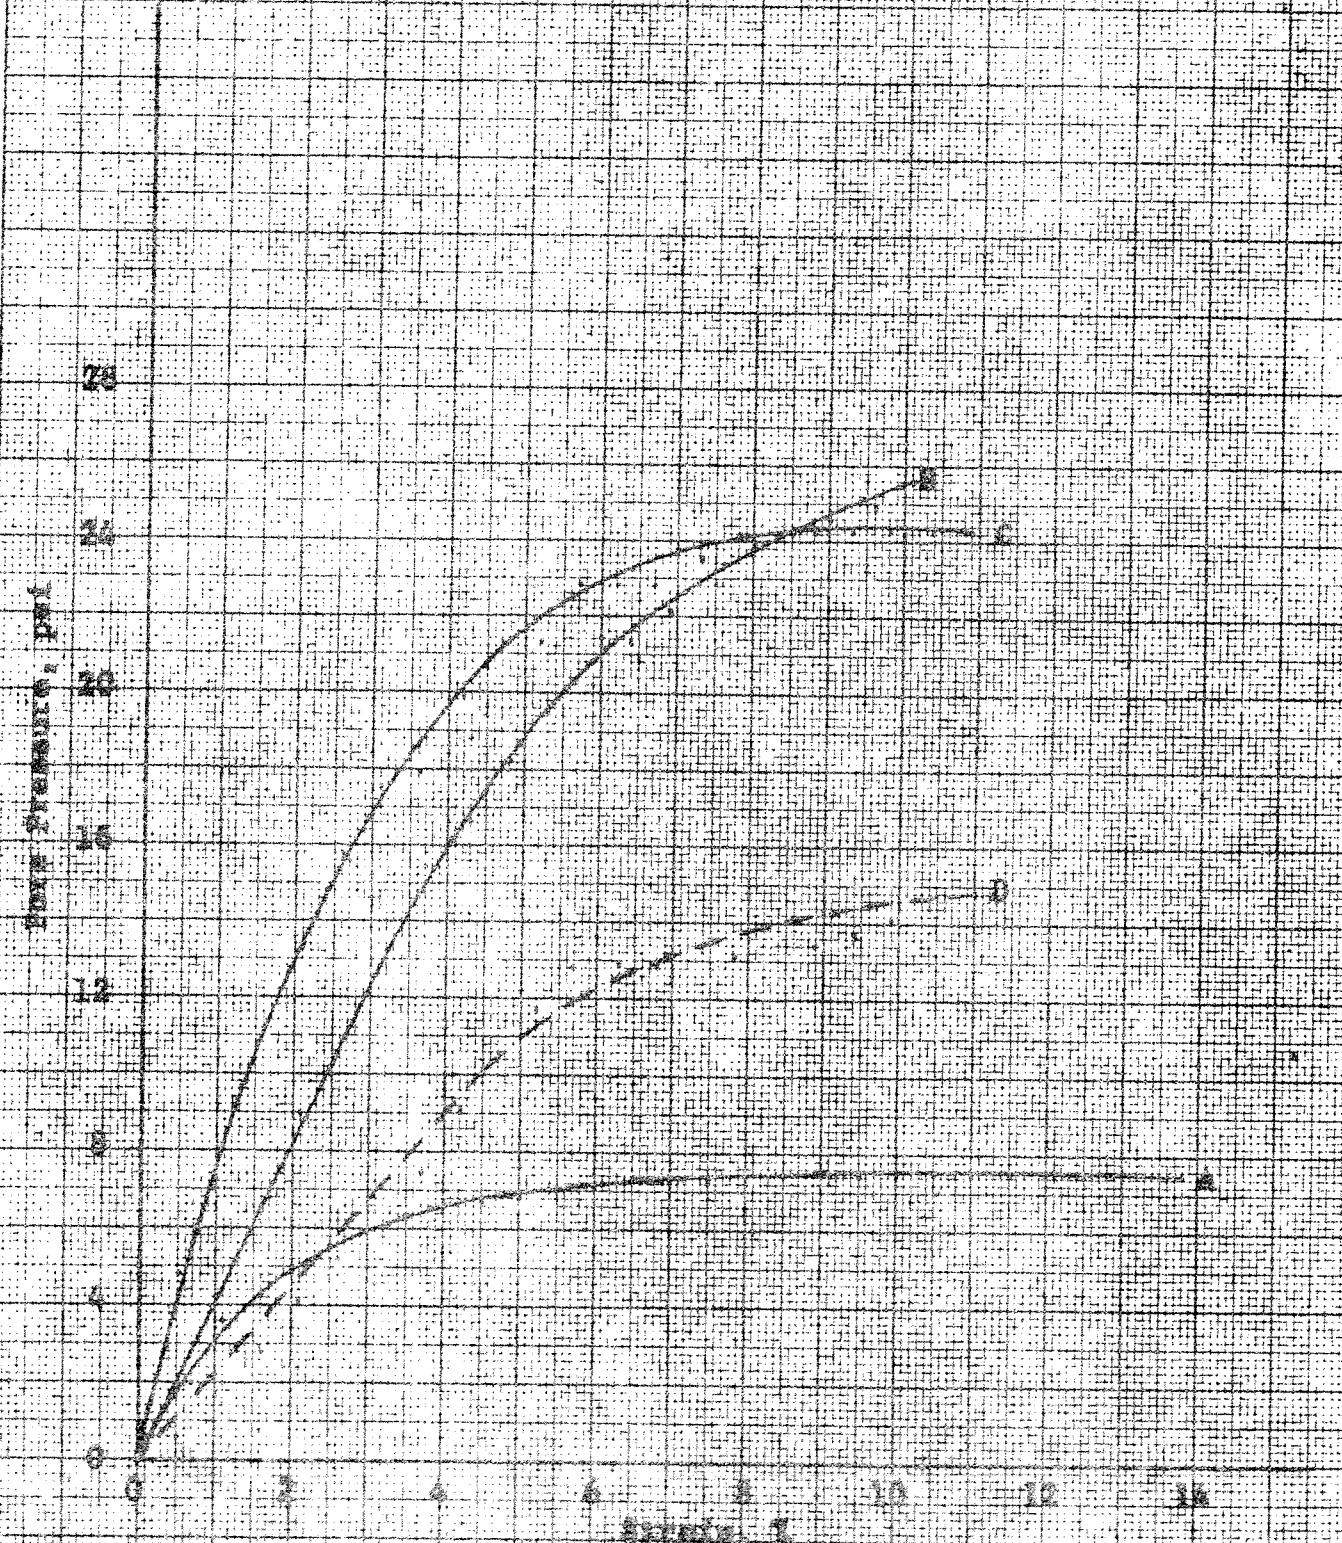
Hole No. 2
Triaxial Shear Test
Pore Pressure-Strain Relationships

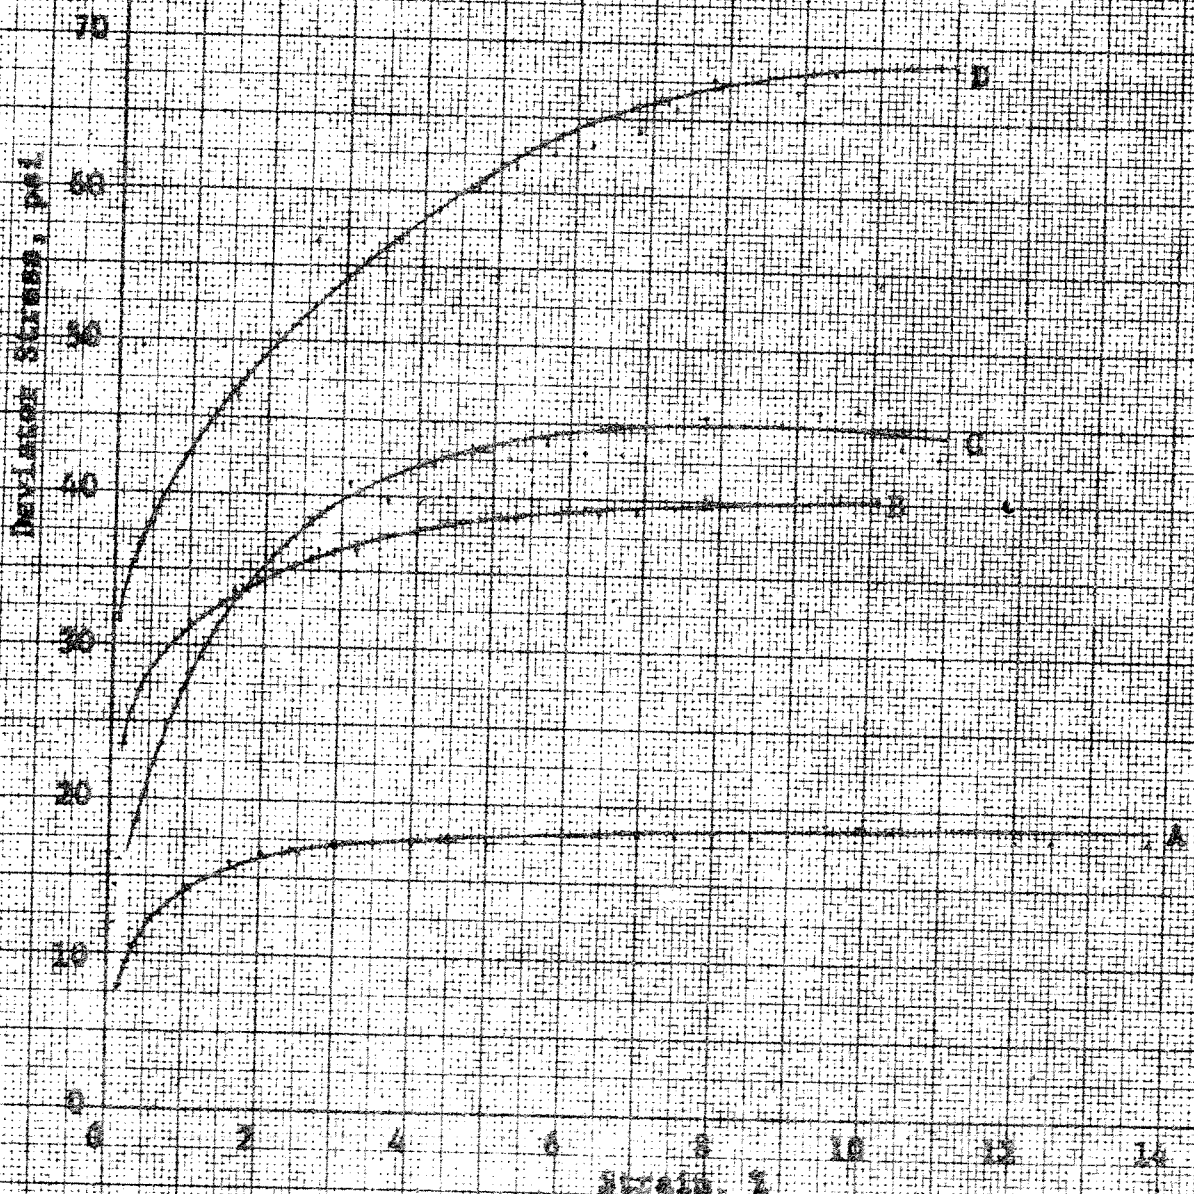
PILE No. 2
Triaxial Shear Test
Stress-Strain Relationships
