Definite Plan for the Lower Klamath Project

Appendix A – Risk Management Plan

June 2018

Klamath River Renewal Corporation

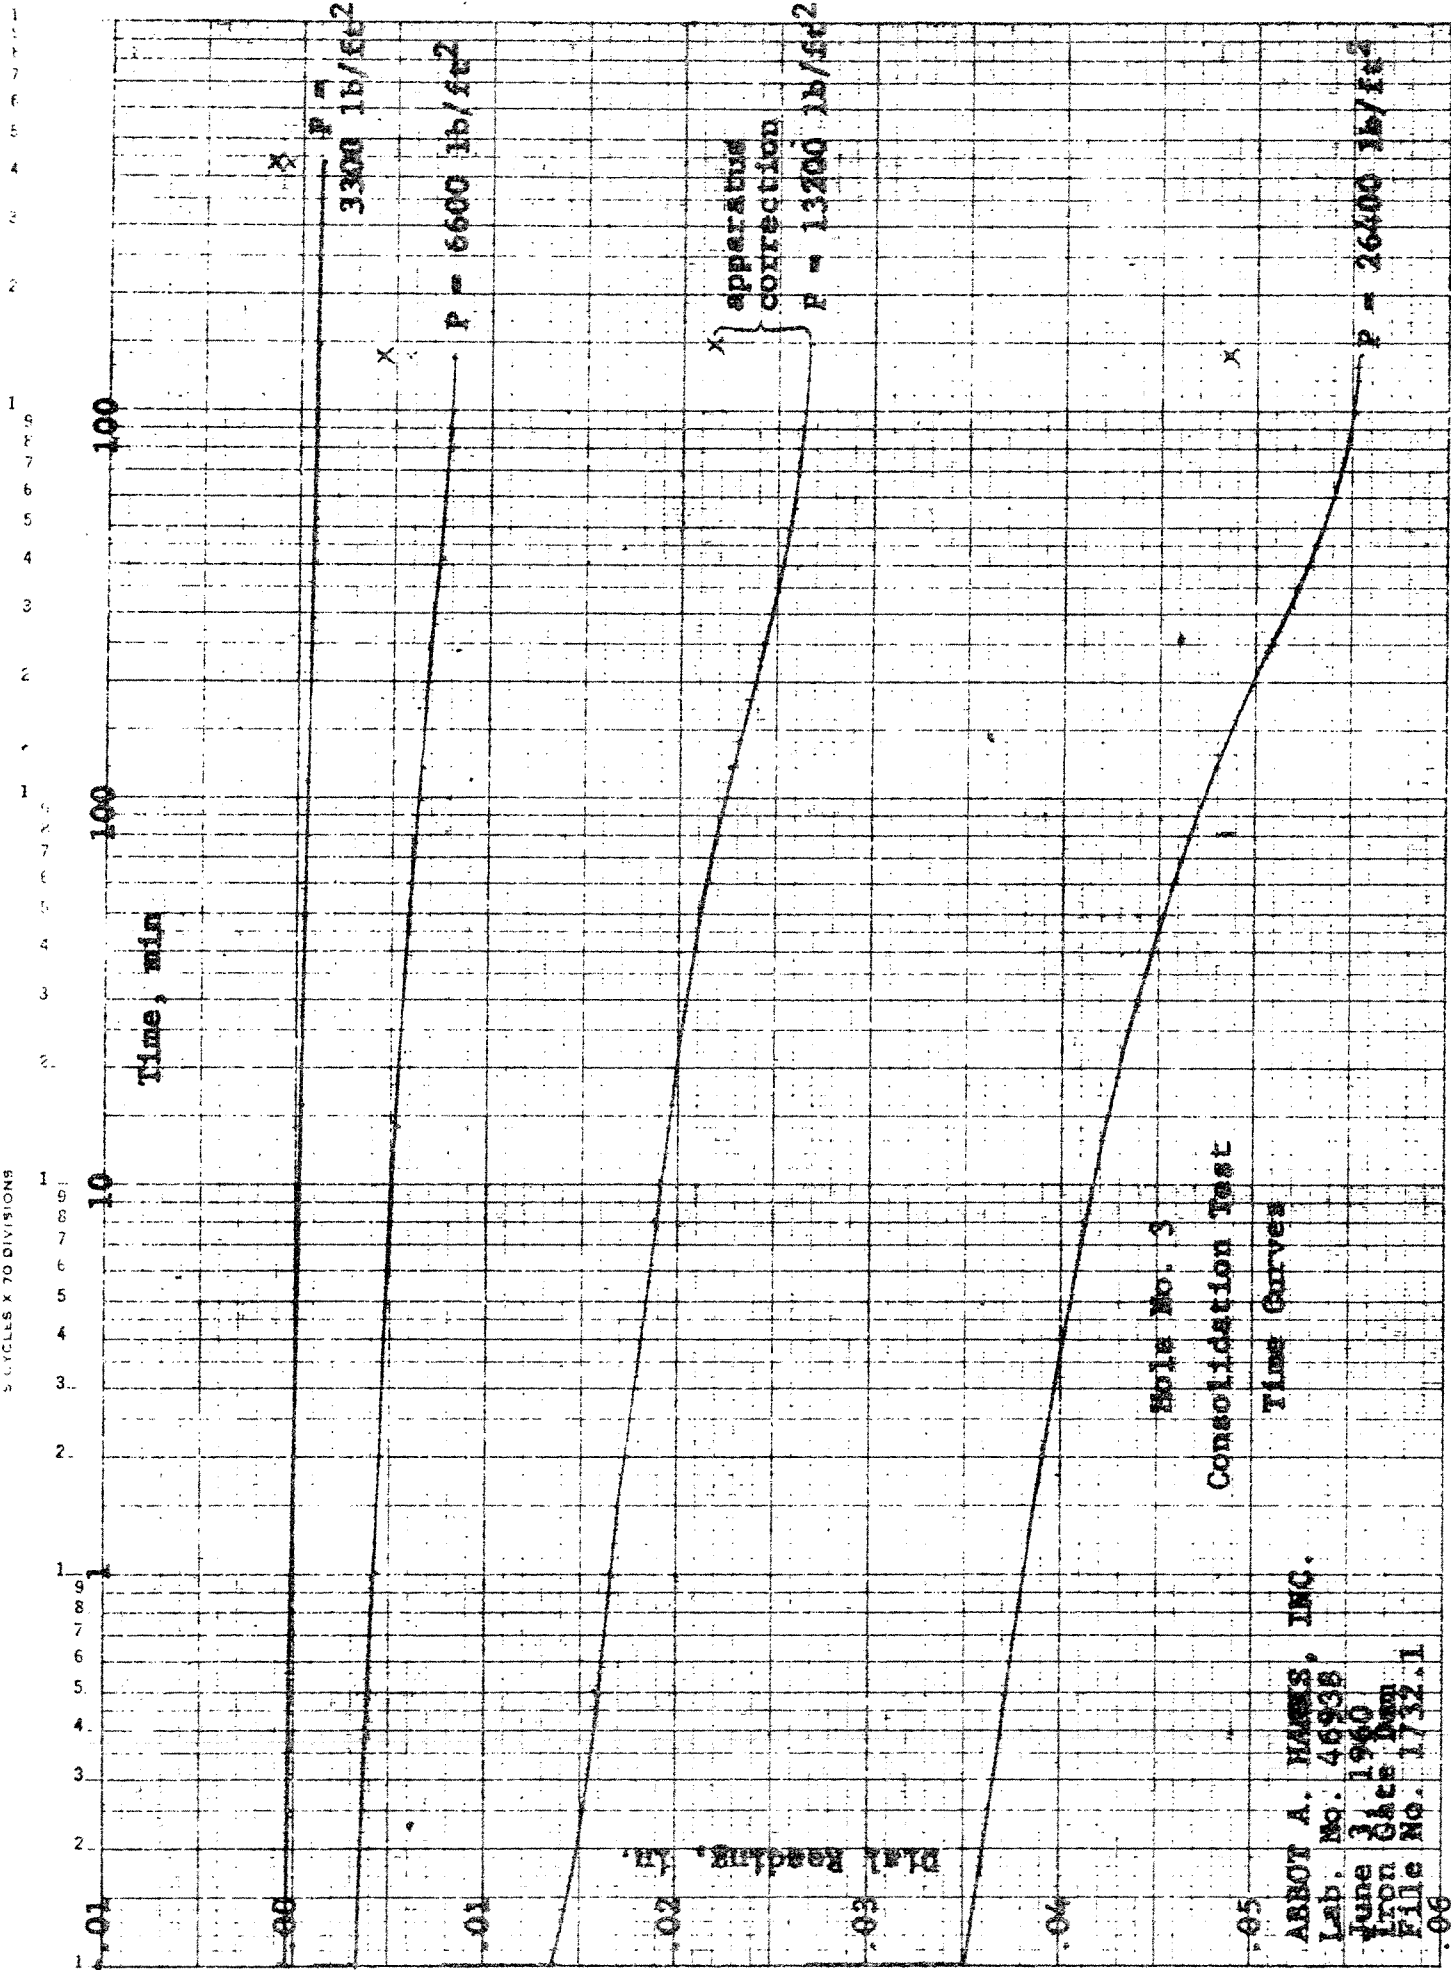
Hole No. 3

Consolidation Test

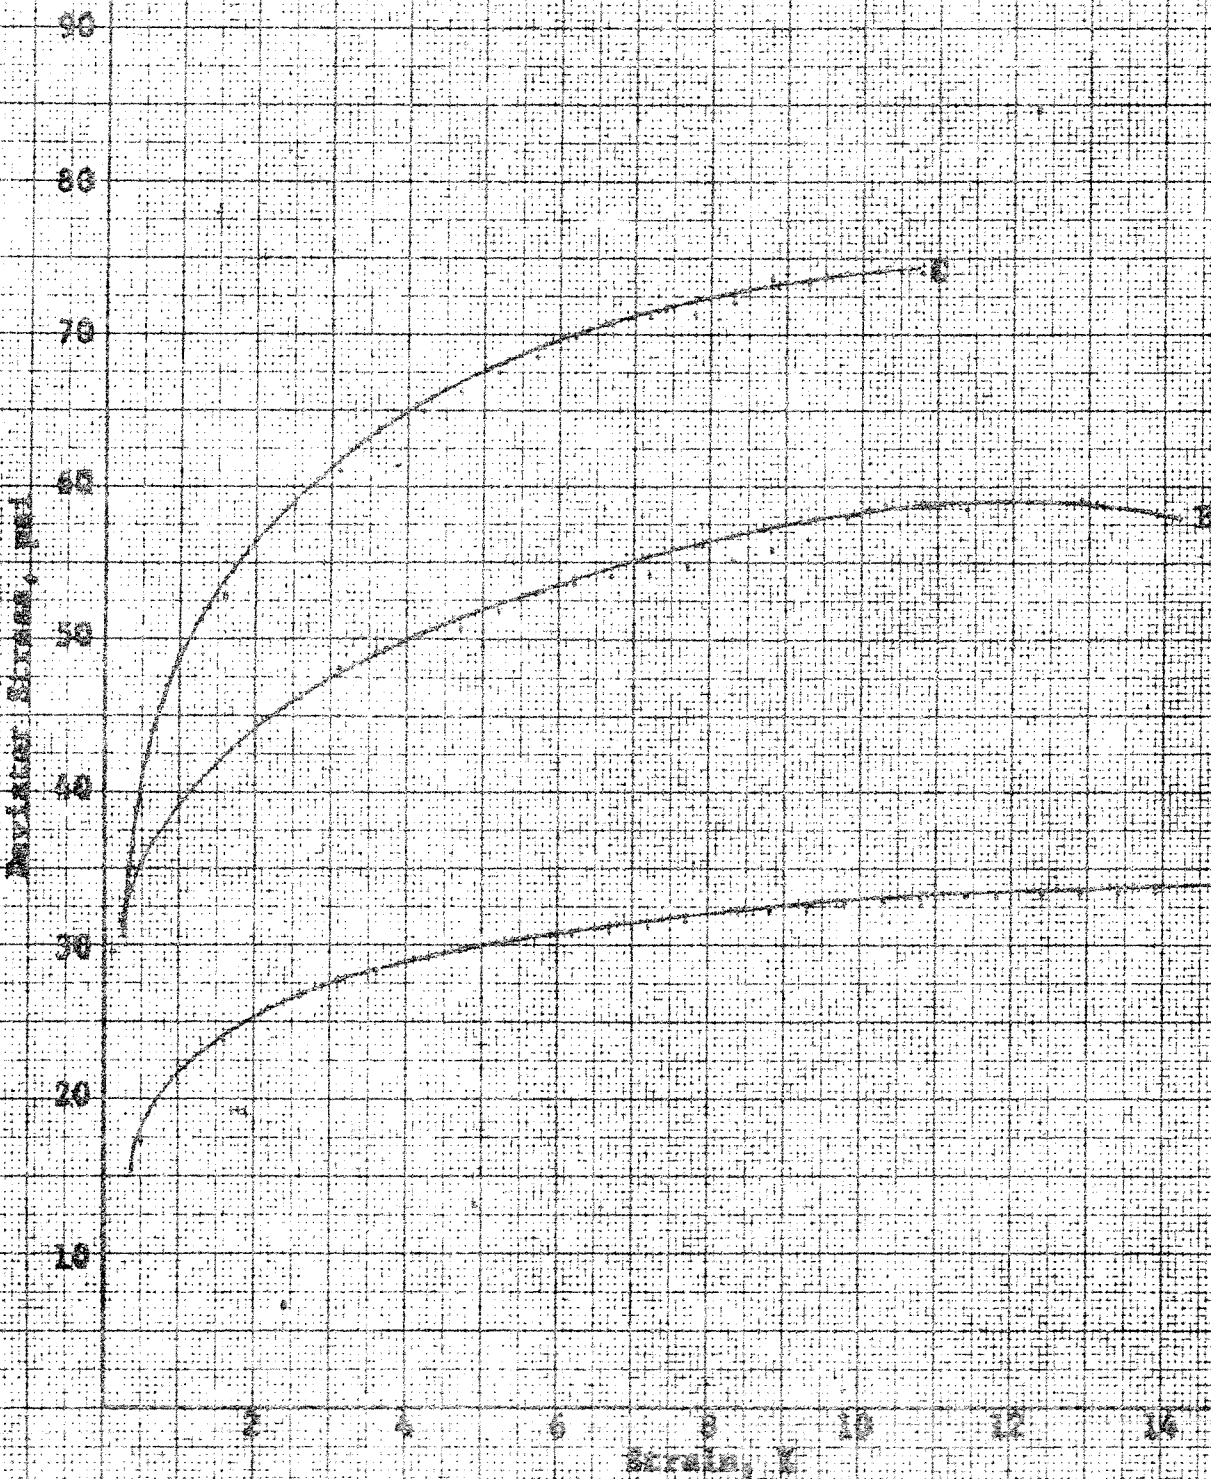
Bole No. 3
Triaxial Shear Test
Stress-Strain Relationships

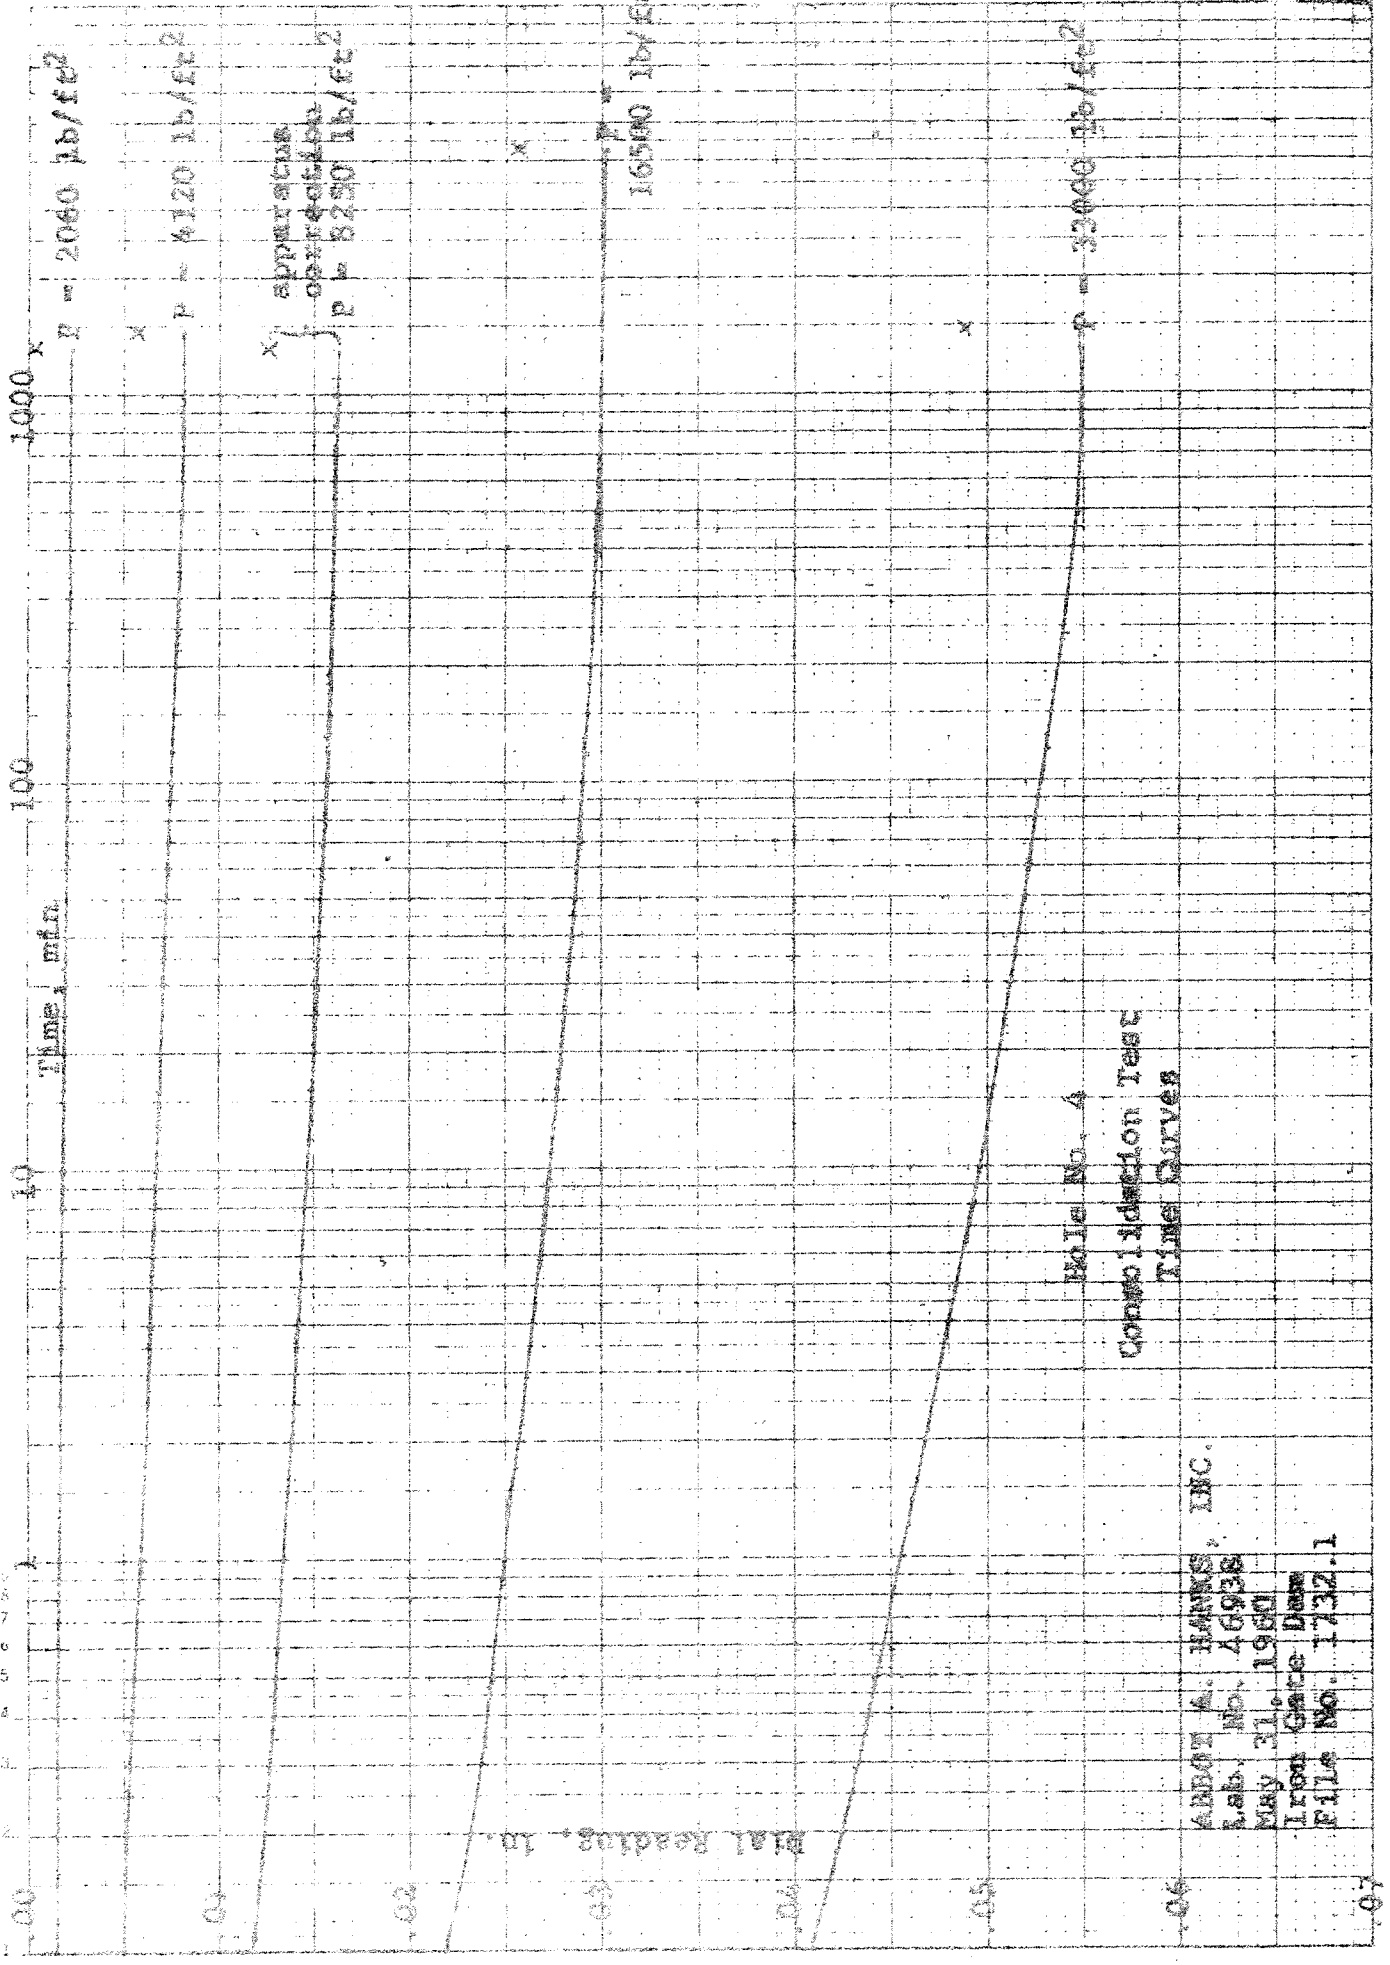
Hole No. 4

Consolidation Test
Time Curves

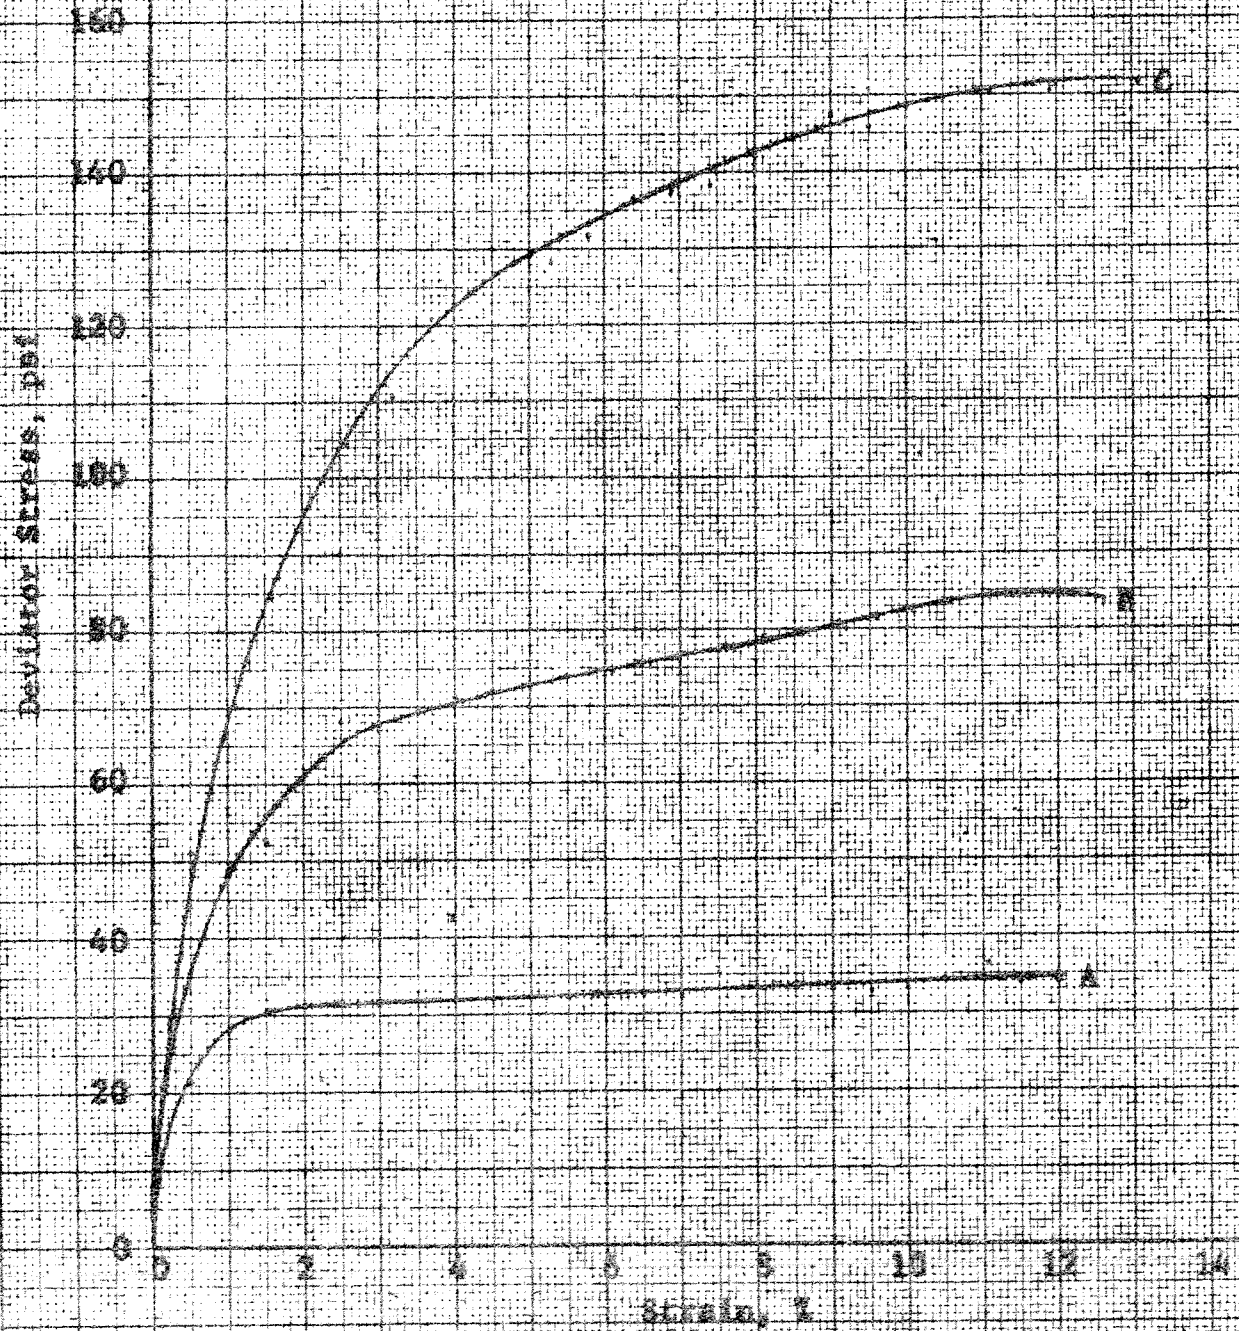
Bole No. 3
Triaxial Shear Test
Stress-Strain Relationships

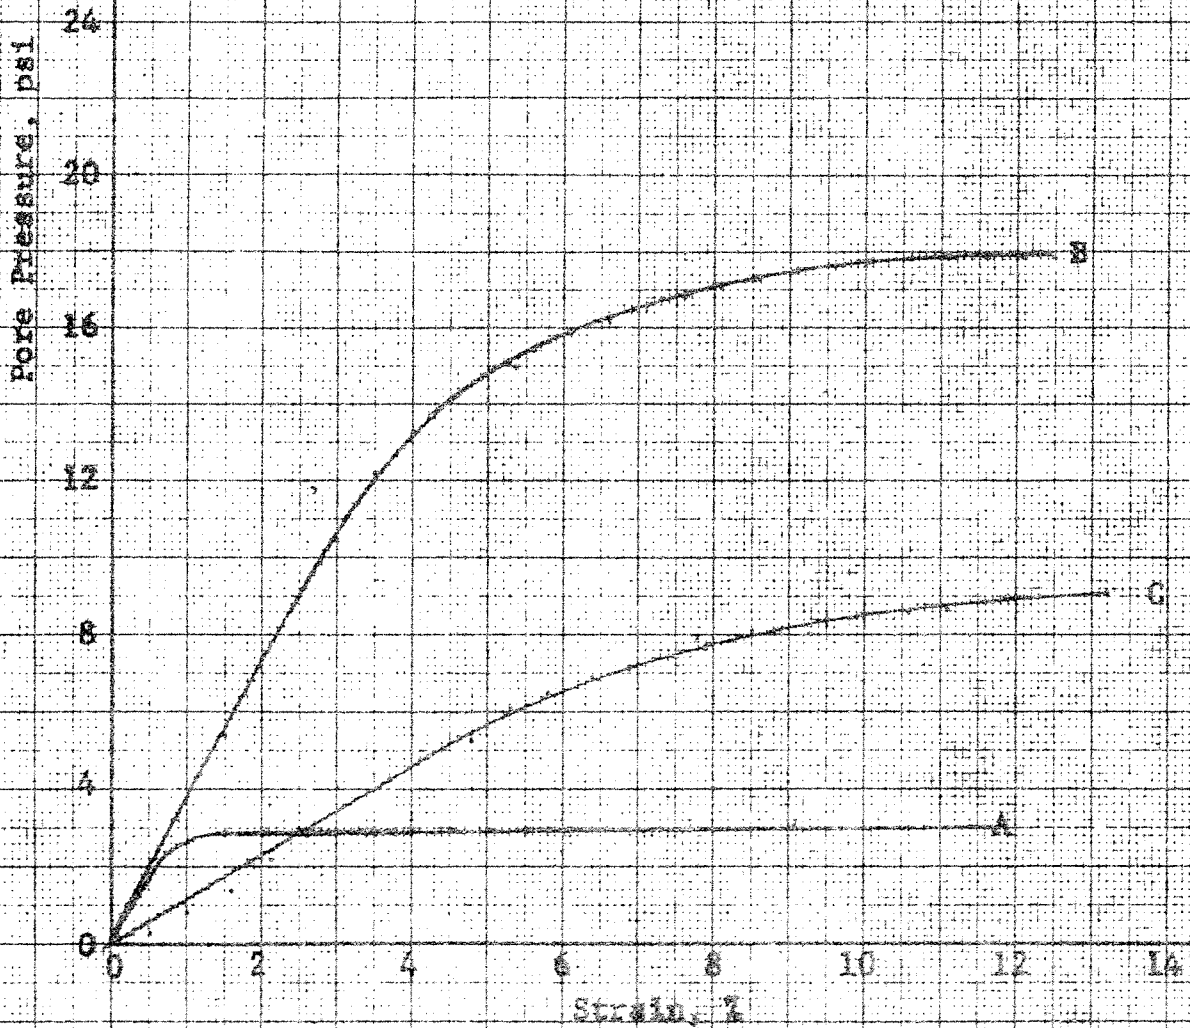
Triaxial Shear Test

Pore Pressure-Strain Relationships

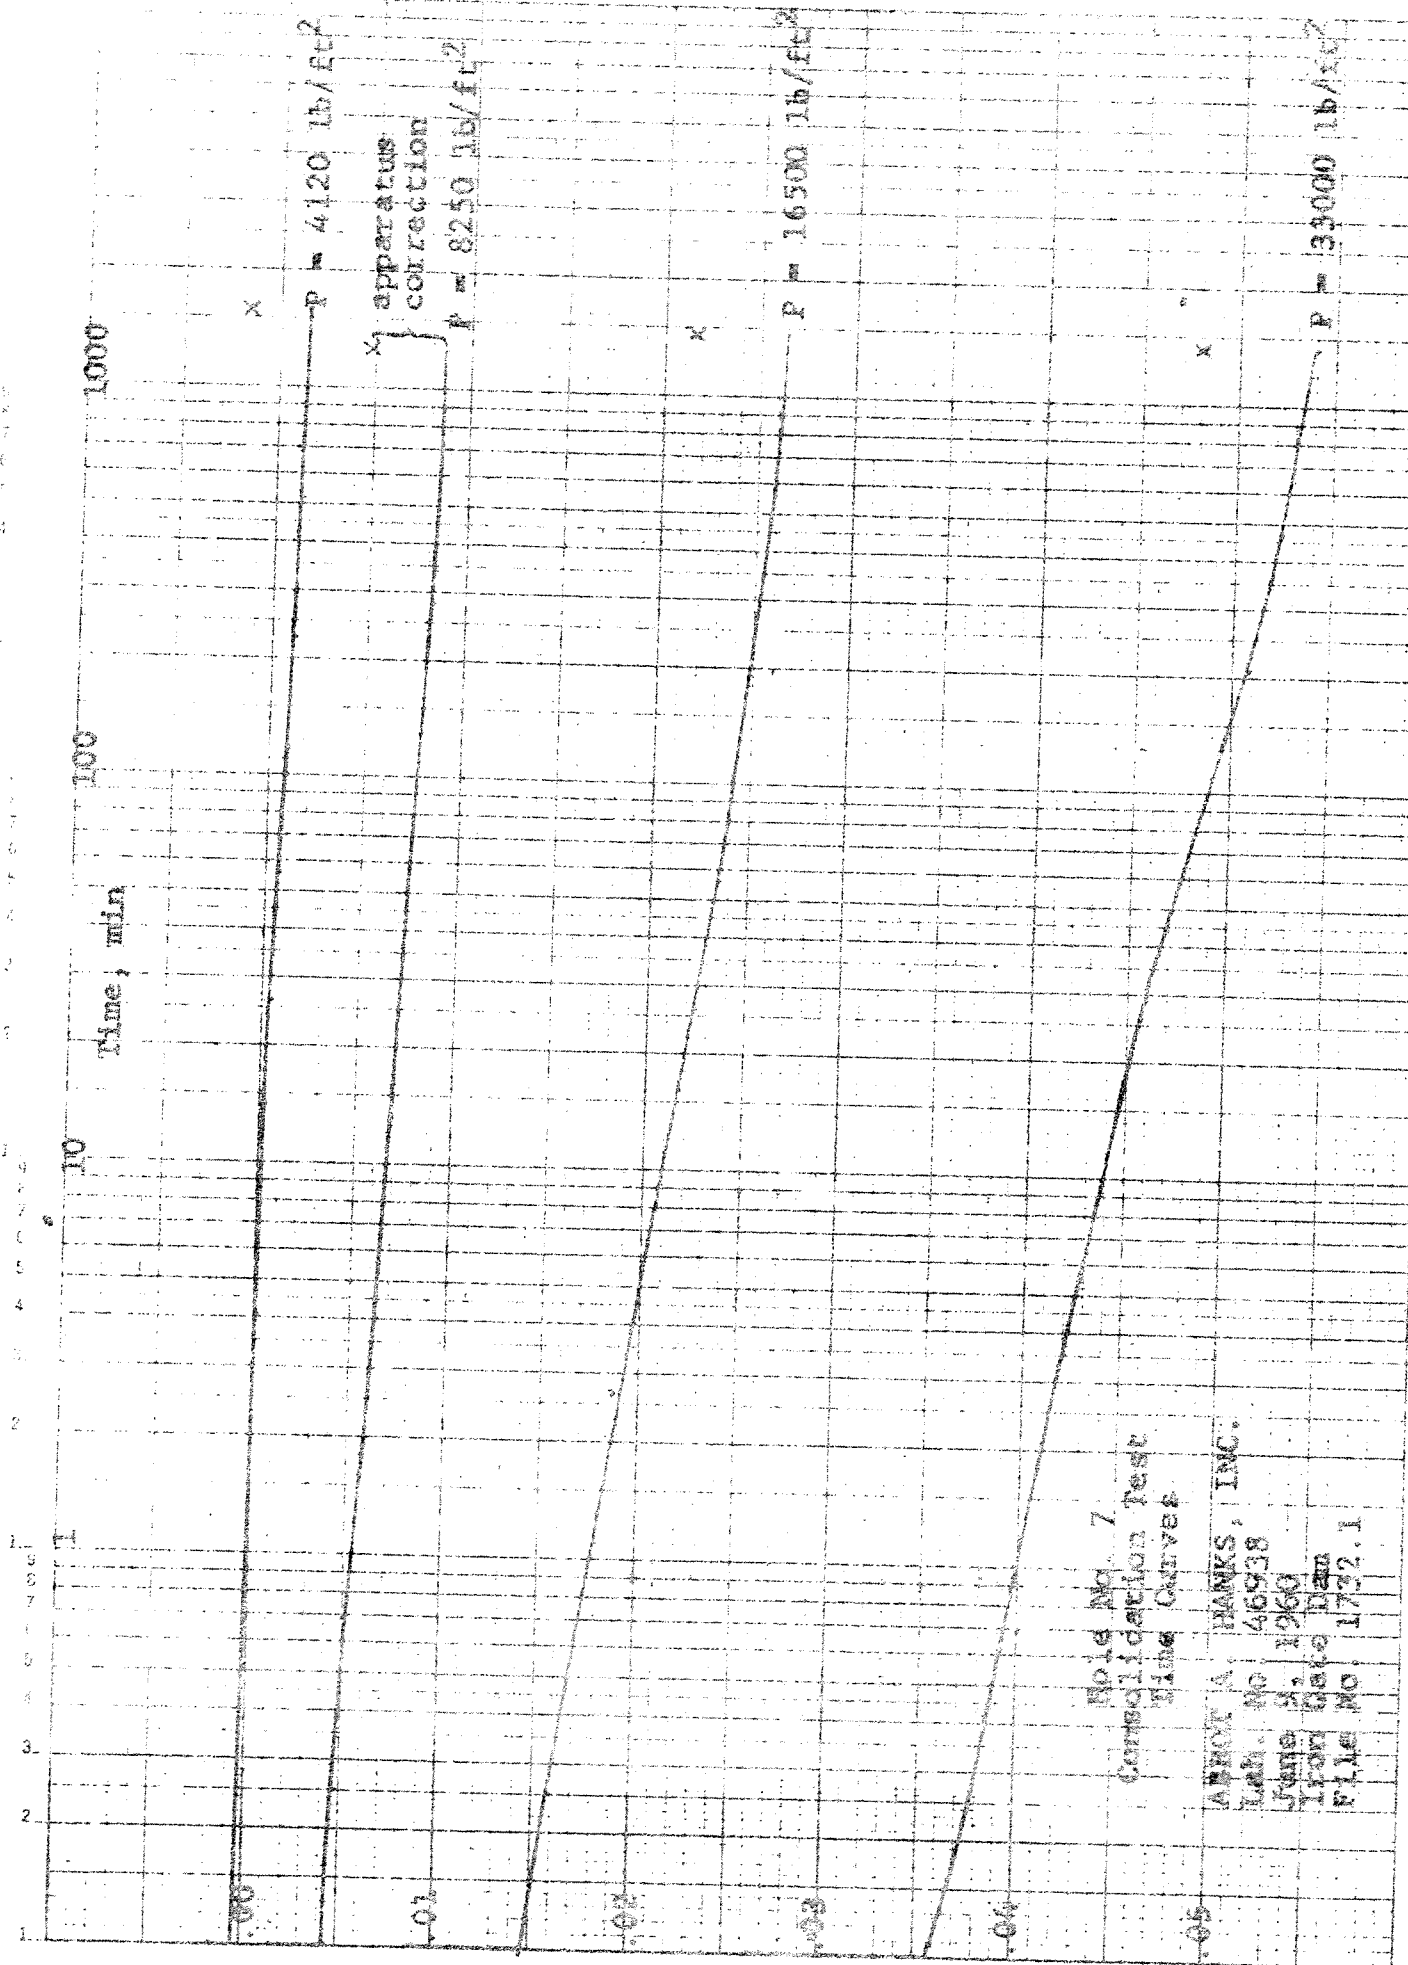
Soil No. 7
Consolidation Test
Time Curves

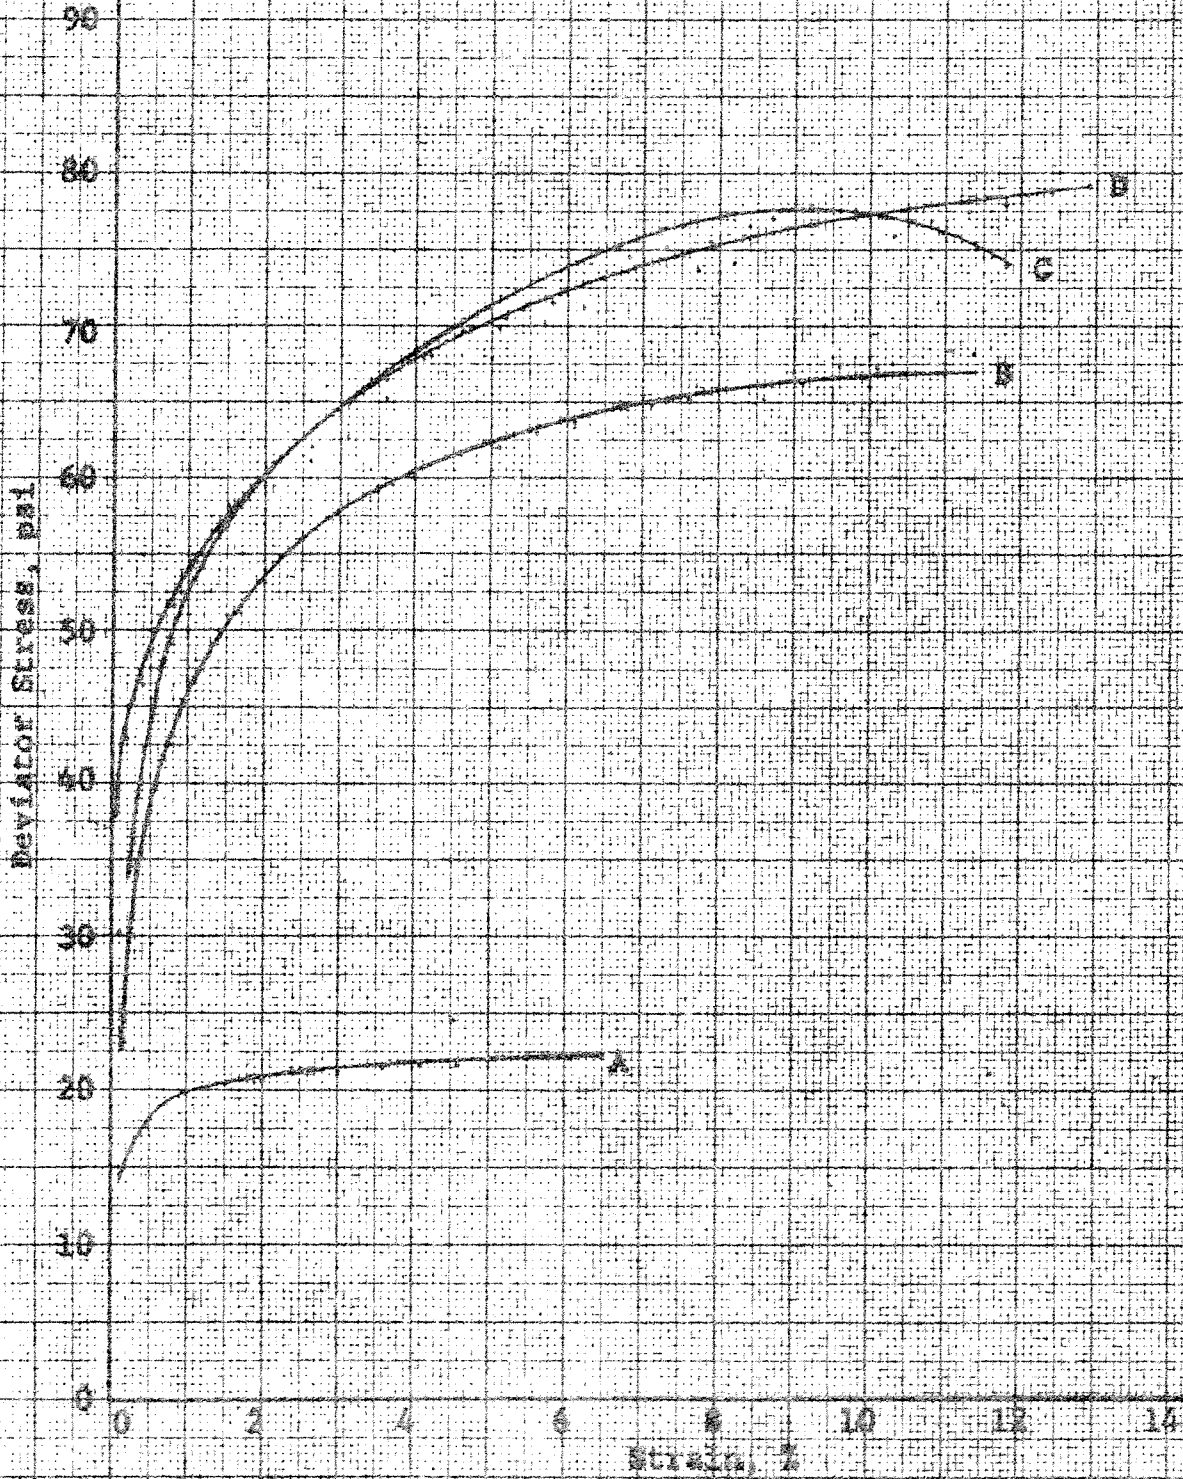
Hole No. 7
Triaxial Shear Test
Stress-Strain Relationships

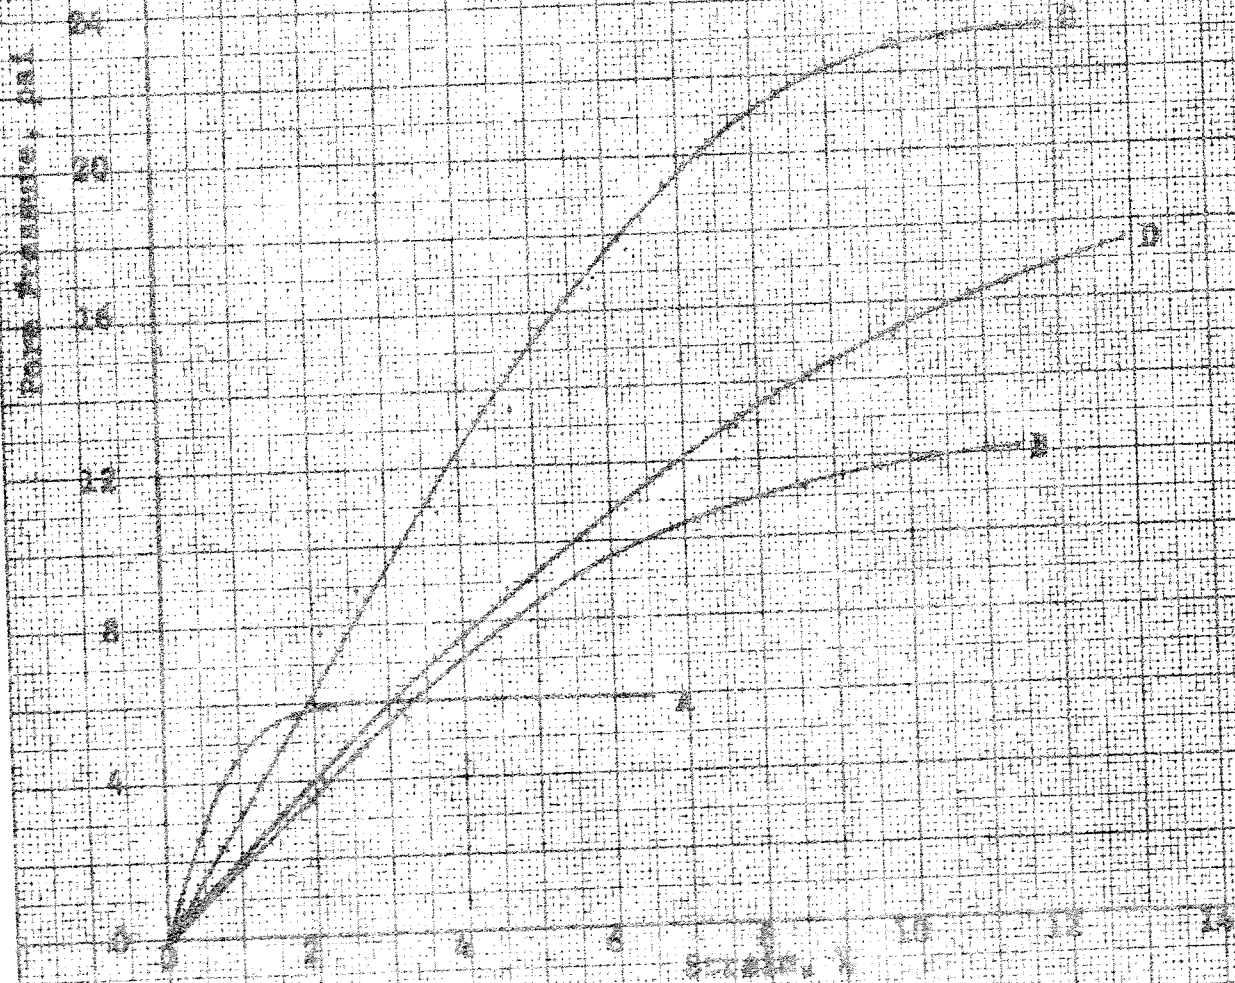
Hole No. 7
 Triaxial Shear Test
 Pore Pressure-Strain Relationships

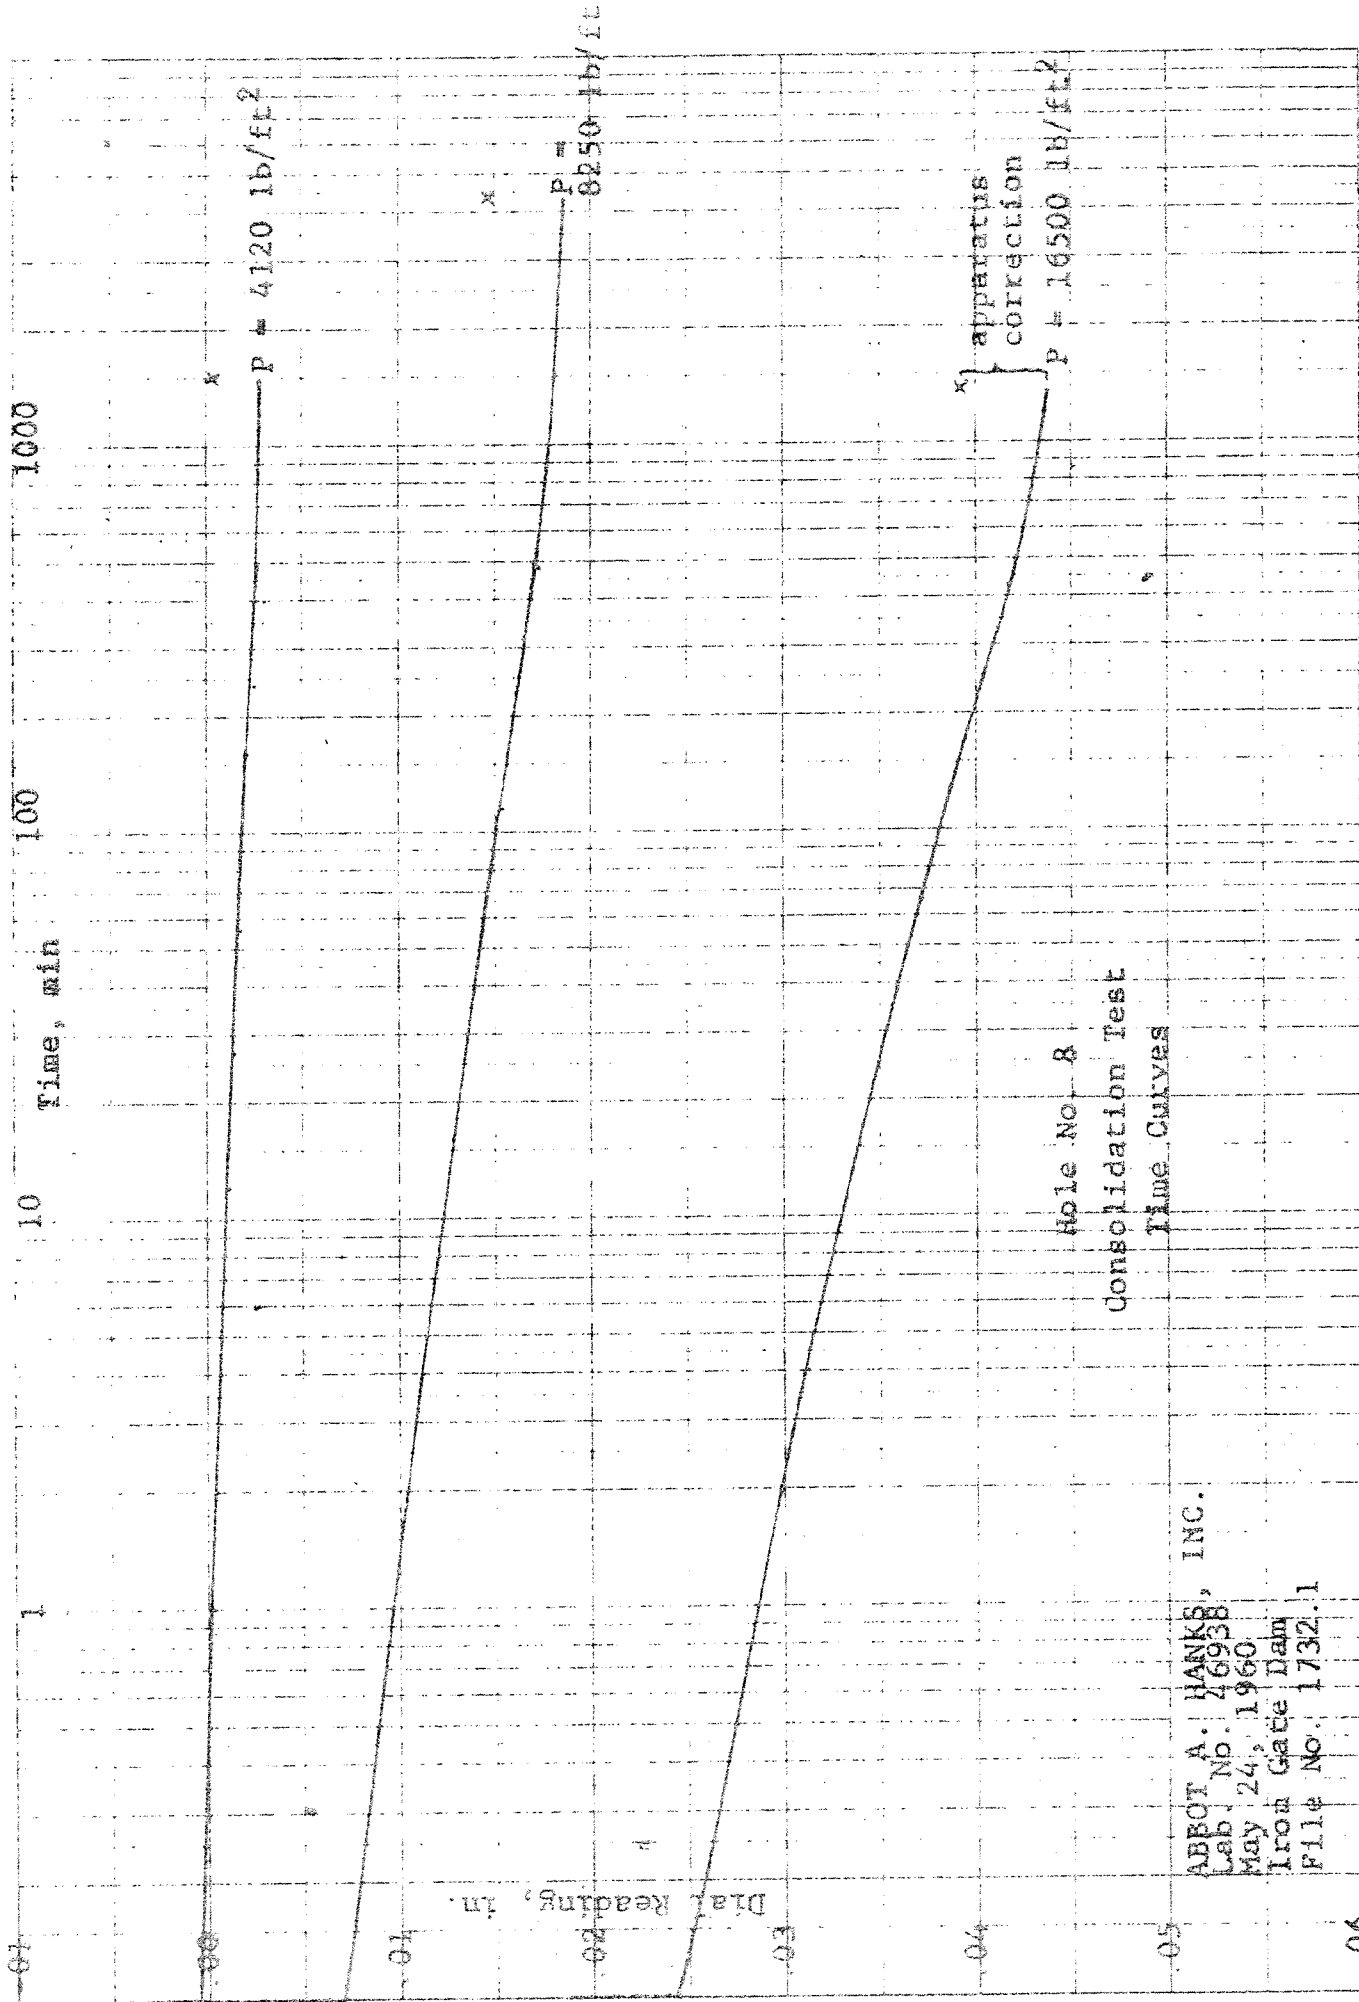
Hole No. 8
Consolidation Test
Time Curves

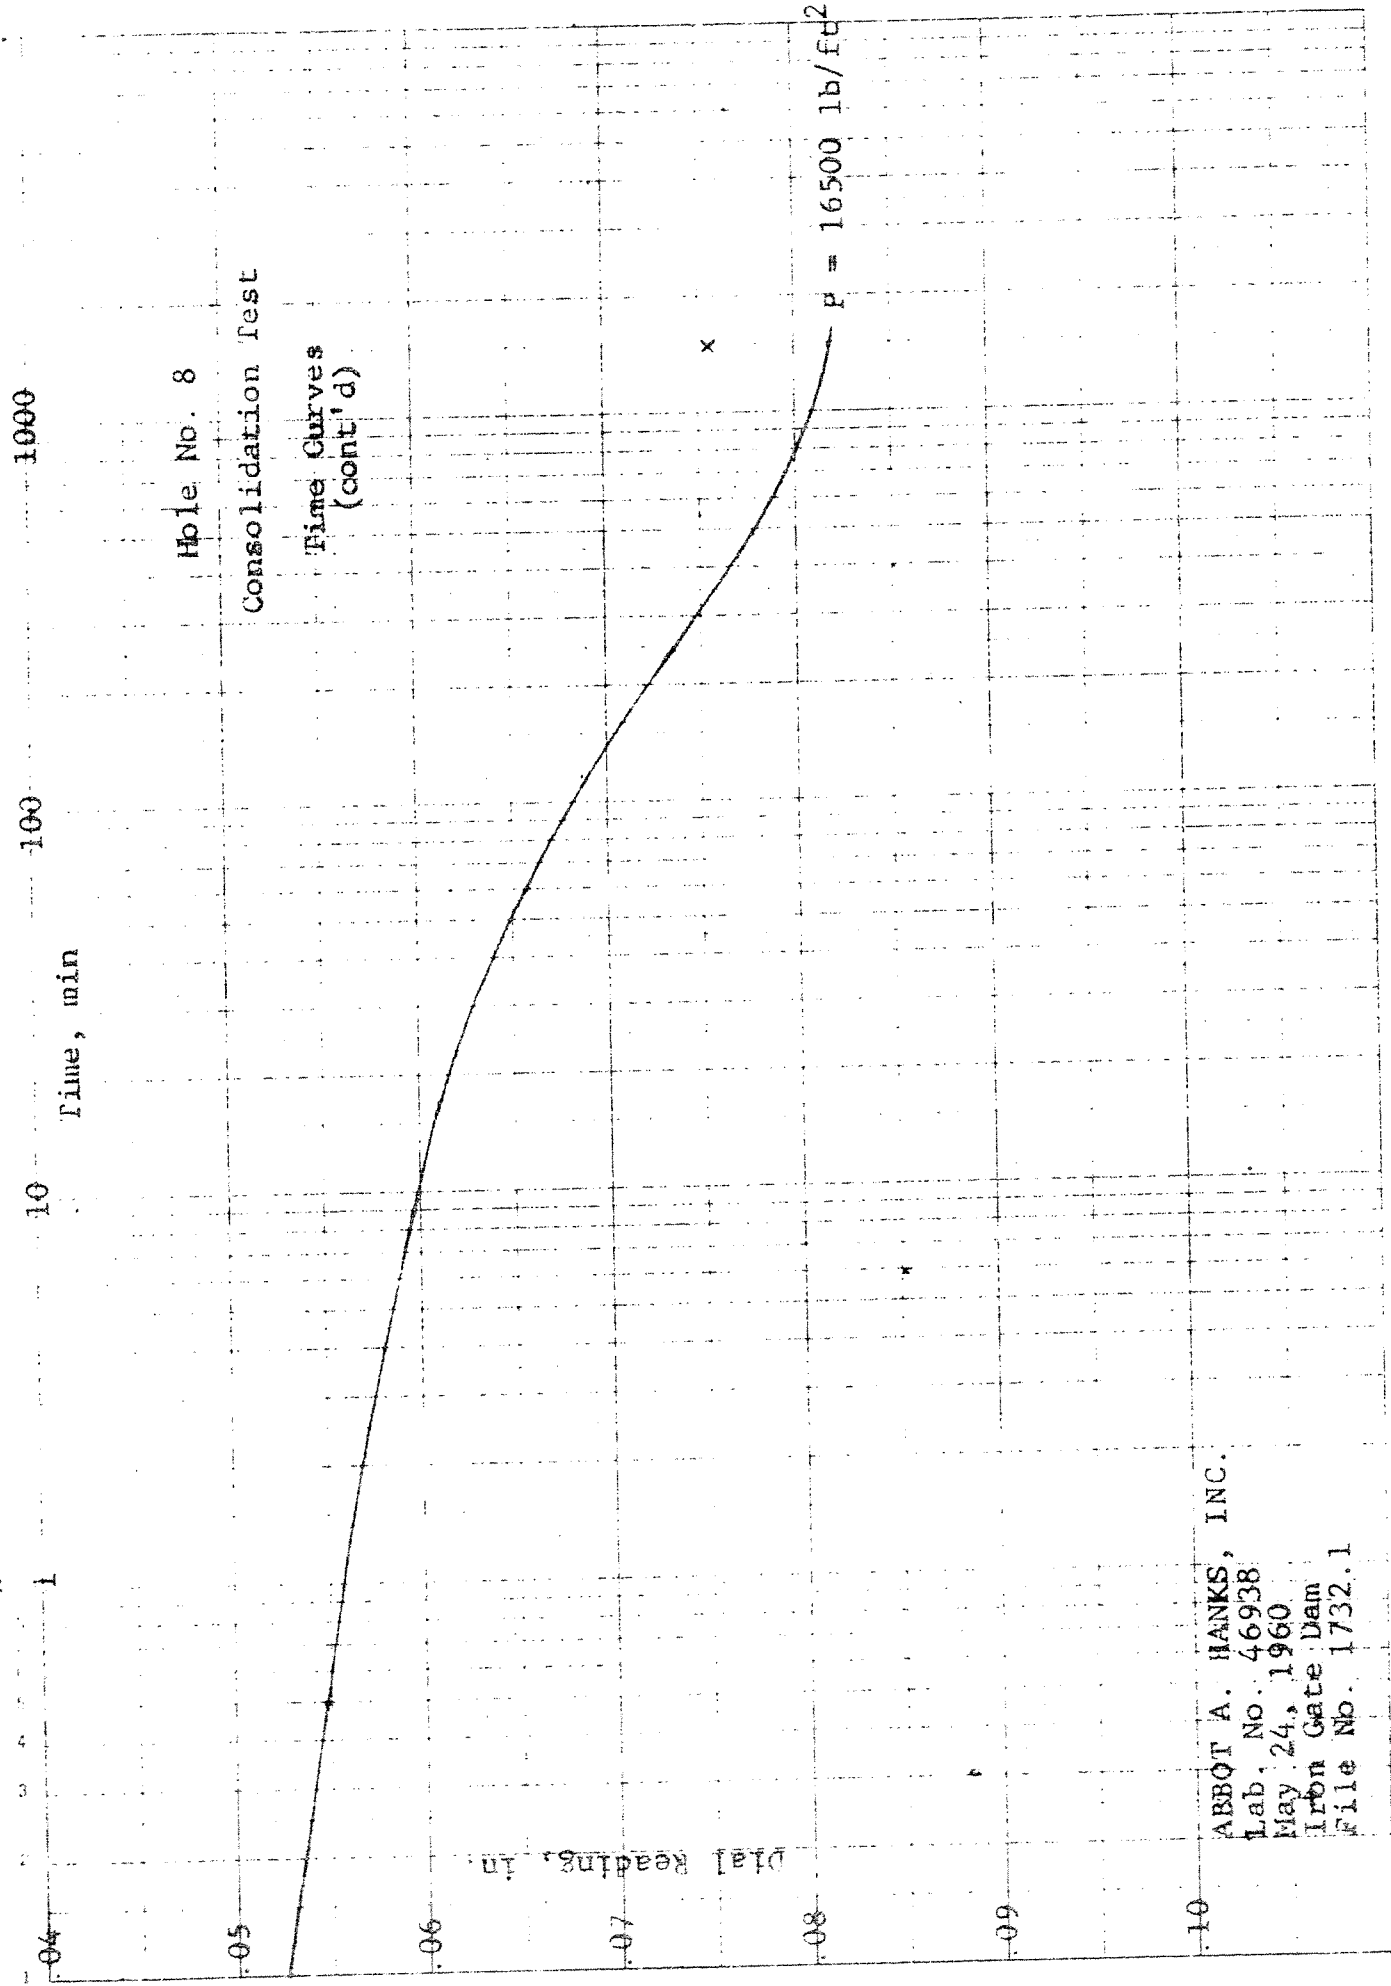
ABEOT A. HANKS, INC.
Lab. No. 46958
May 24, 1960
Iron Gate Dam
File No. 1732.1

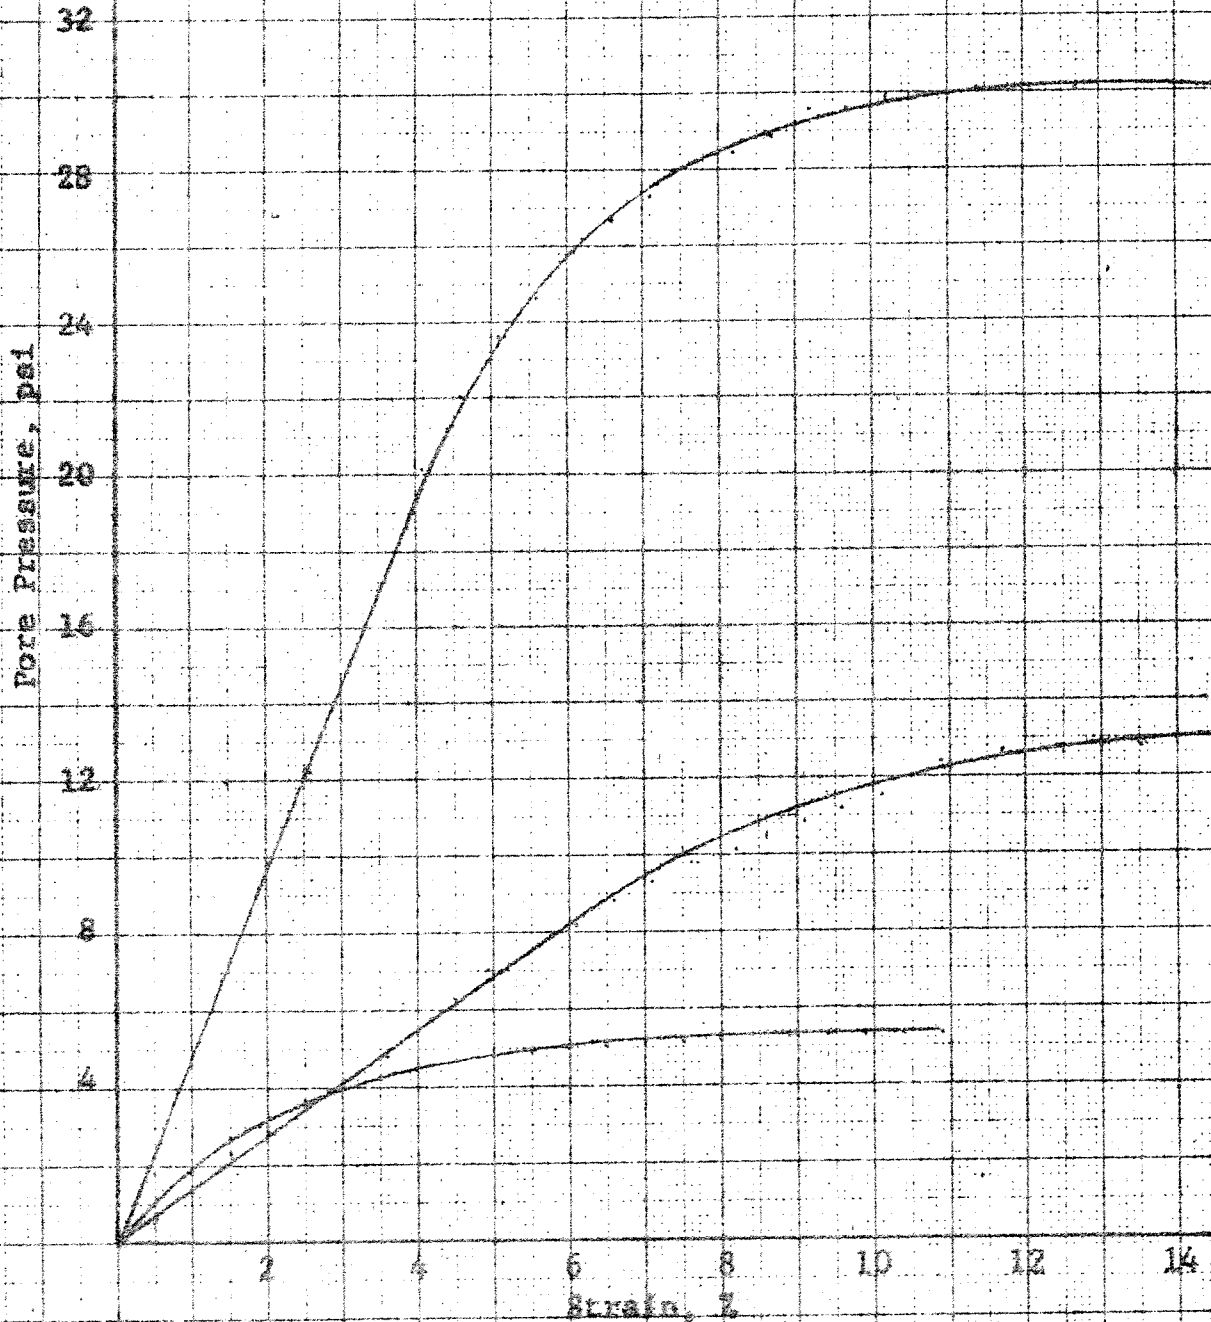
Triaxial Shear Test

Pore Pressure-Strain Relationships
