Definite Plan for the Lower Klamath Project

Appendix A – Risk Management Plan

June 2018

Klamath River Renewal Corporation

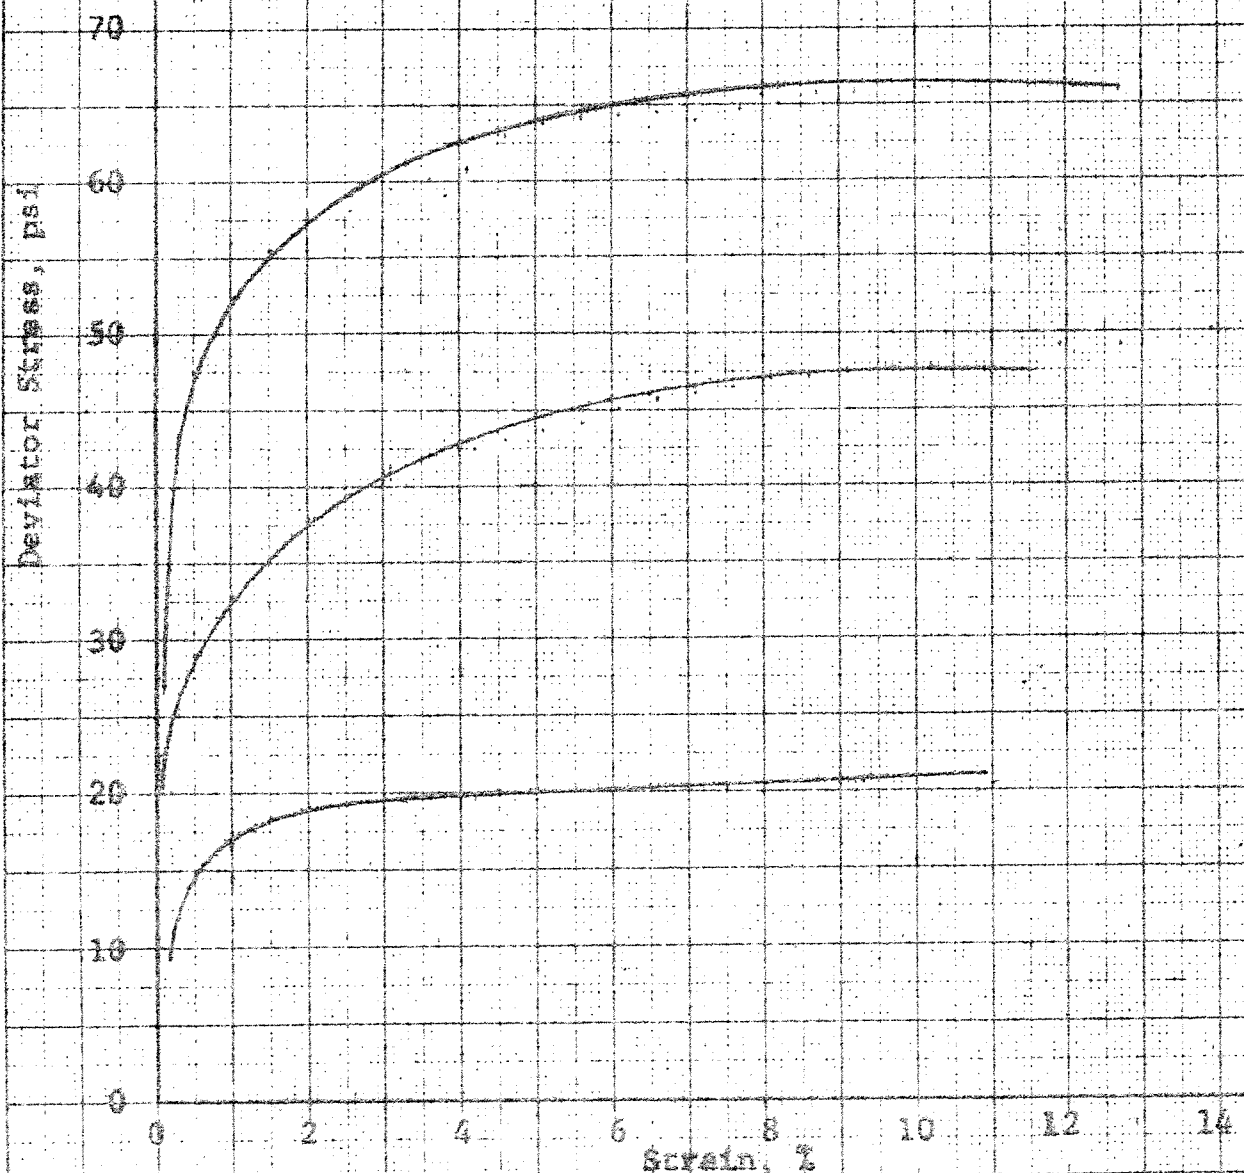
Hole No. 8
Triaxial Shear Test
Stress-Strain Relationships

Iron Gate Dam
Klamath River
File No. 1732.1

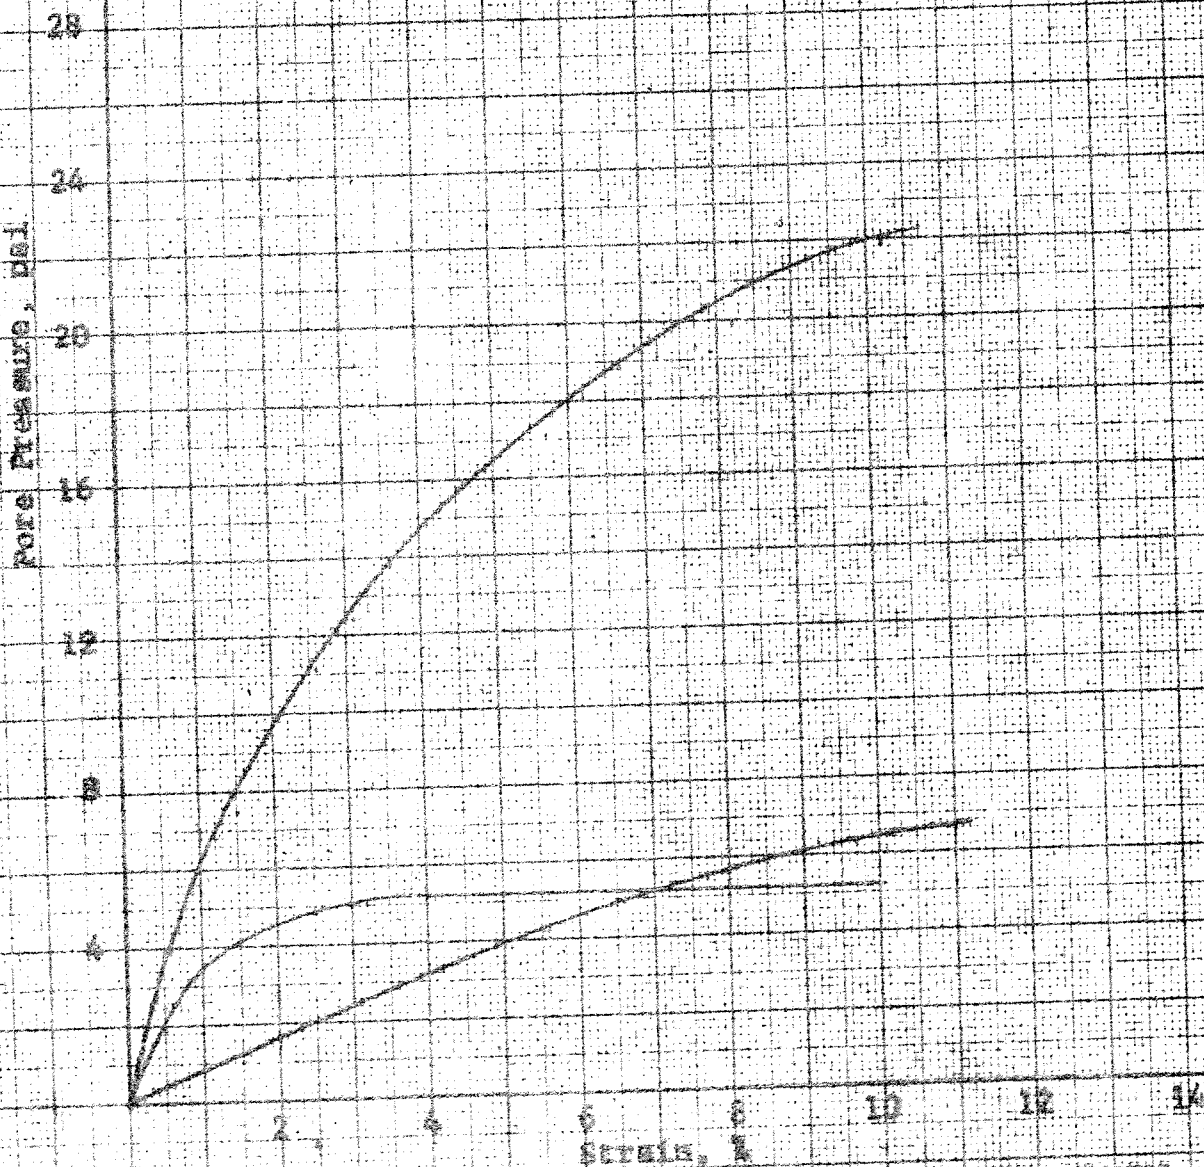
Triaxial Shear Test

Pore Pressure-Strain Relationships

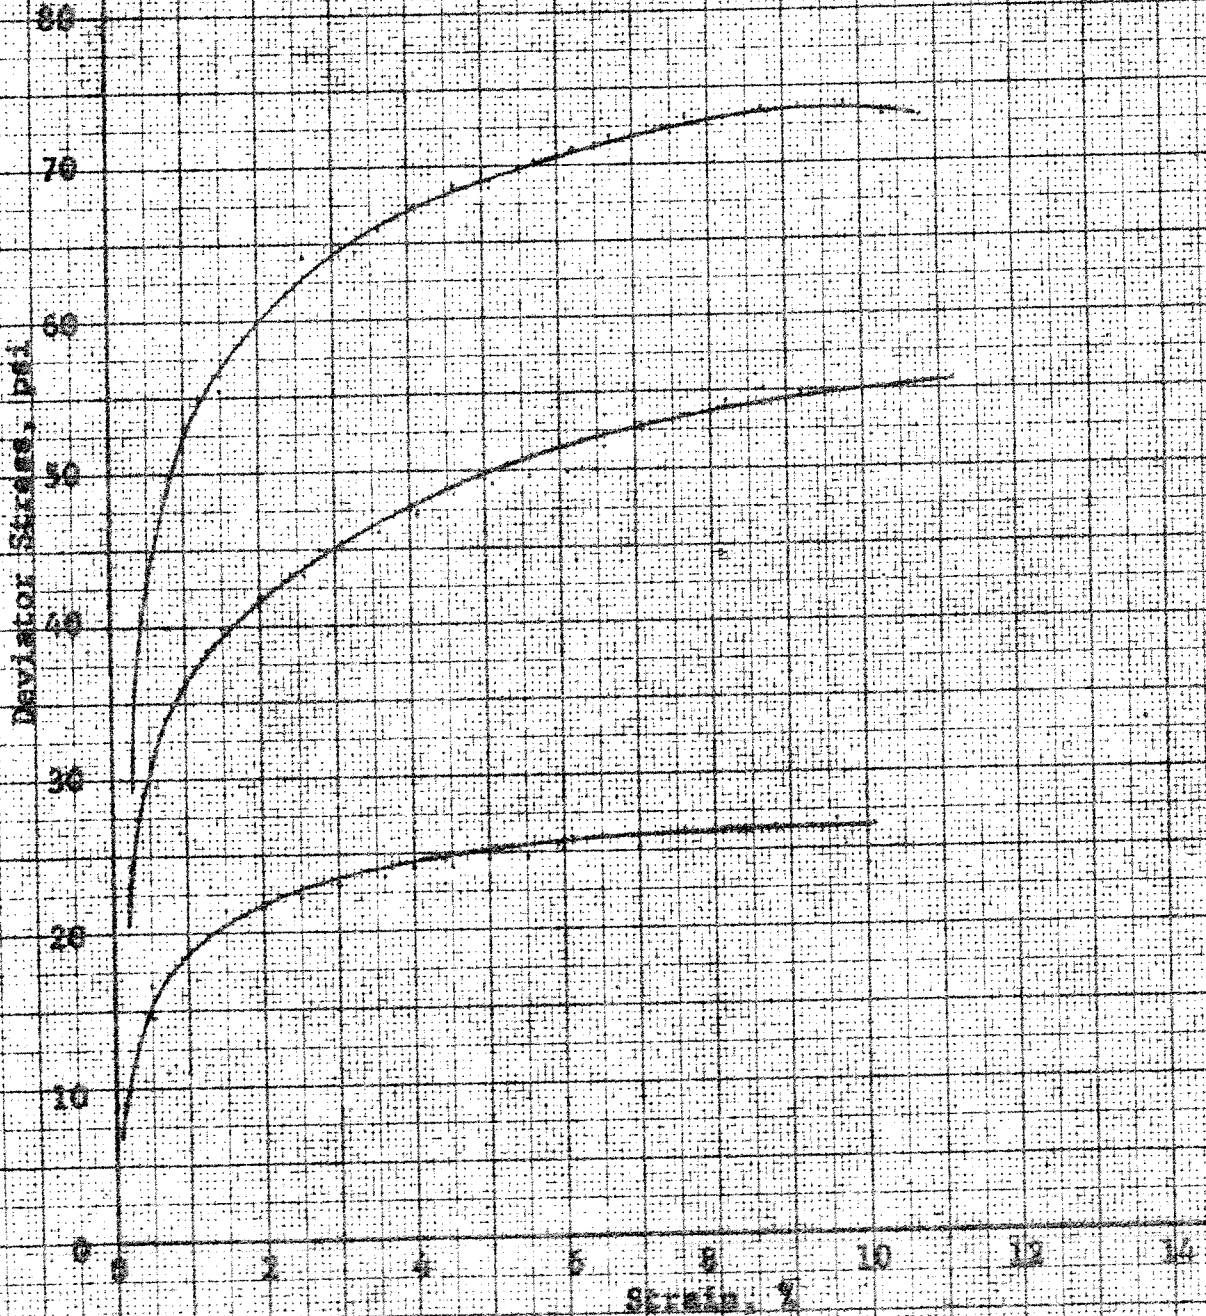
Hole No. 11
Triaxial Shear Test
Stress-Strain Relationships

Iron Gate Dam
Klamath River
Film No. 1732.1

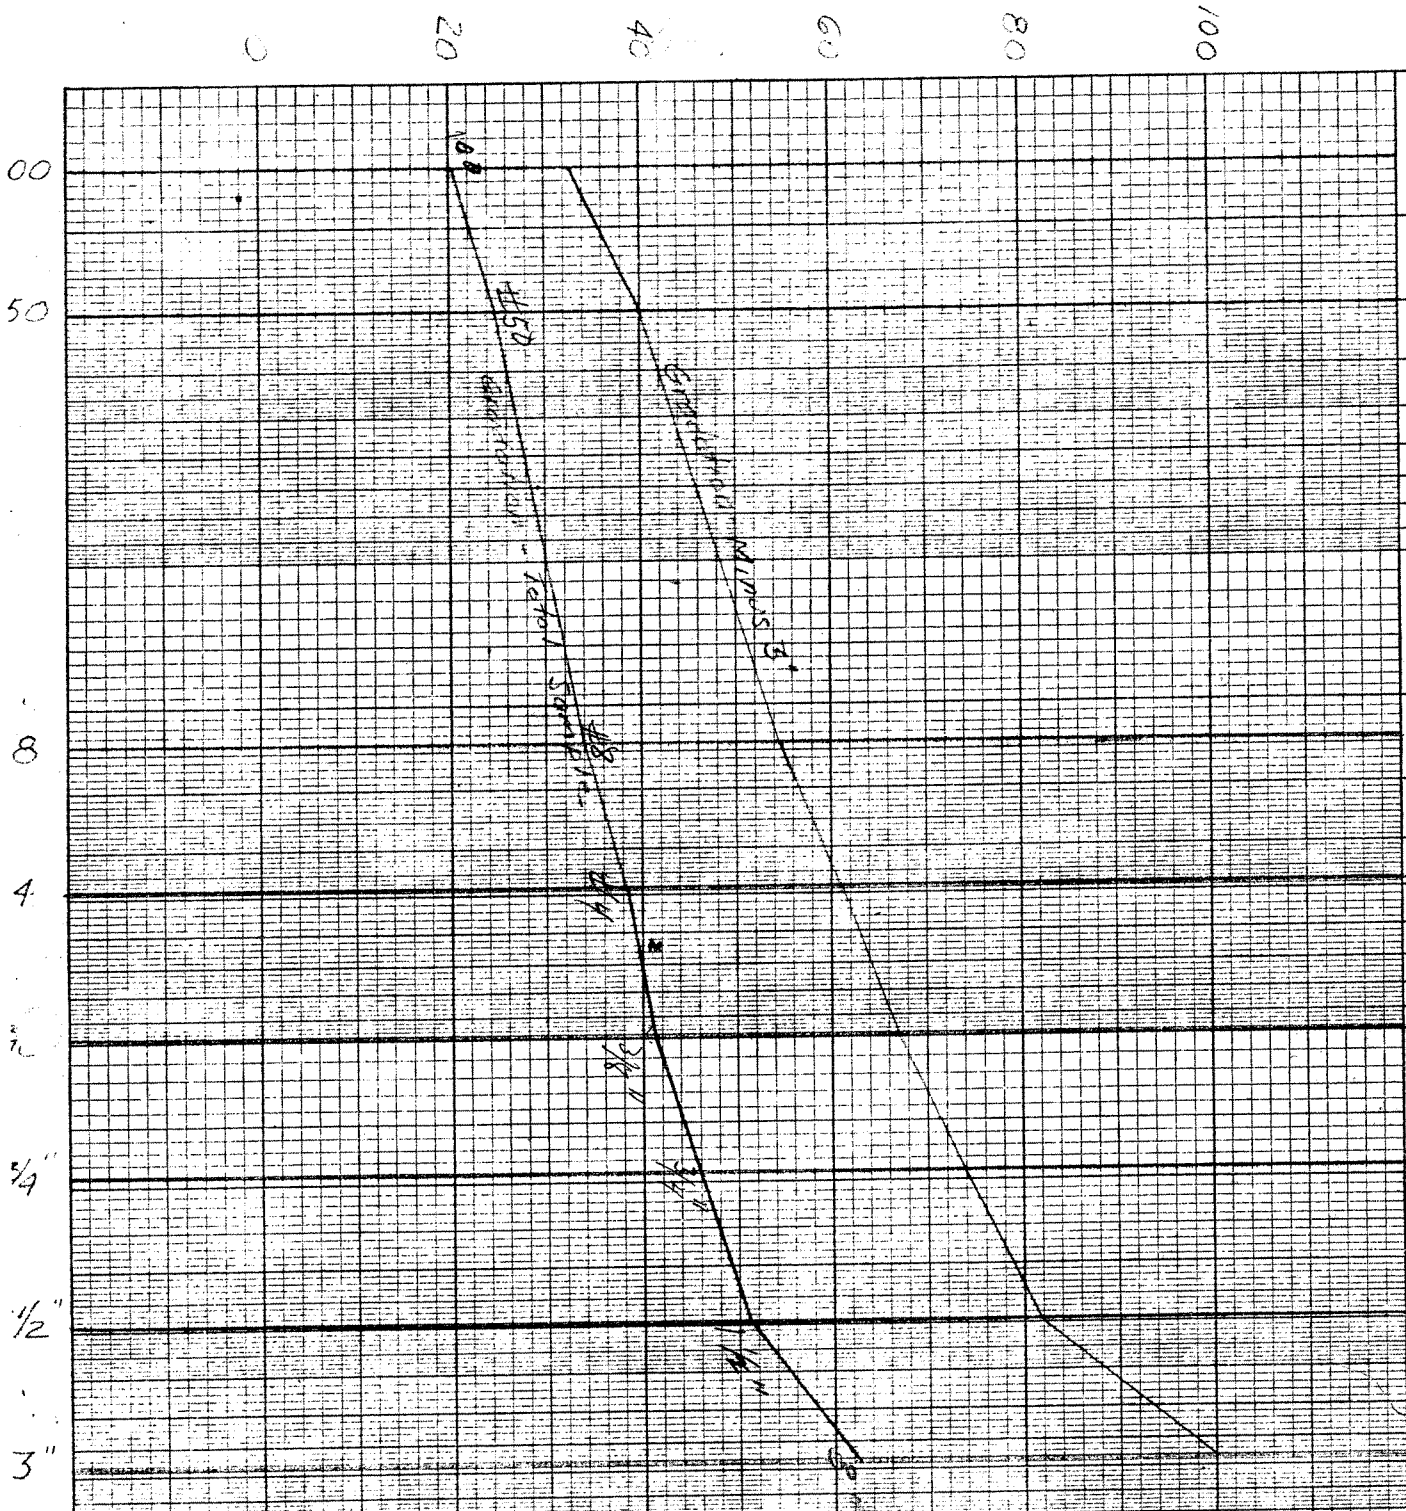
Pit No 3 Area No 1
River Run Rock & Gravel
THE CALIFORNIA OREGON POWER COMPANY
IRON GATE DAM
GRAIN SIZE CURVE

NOTE: Curves obtained by dry shaking sample through nest of sieves.

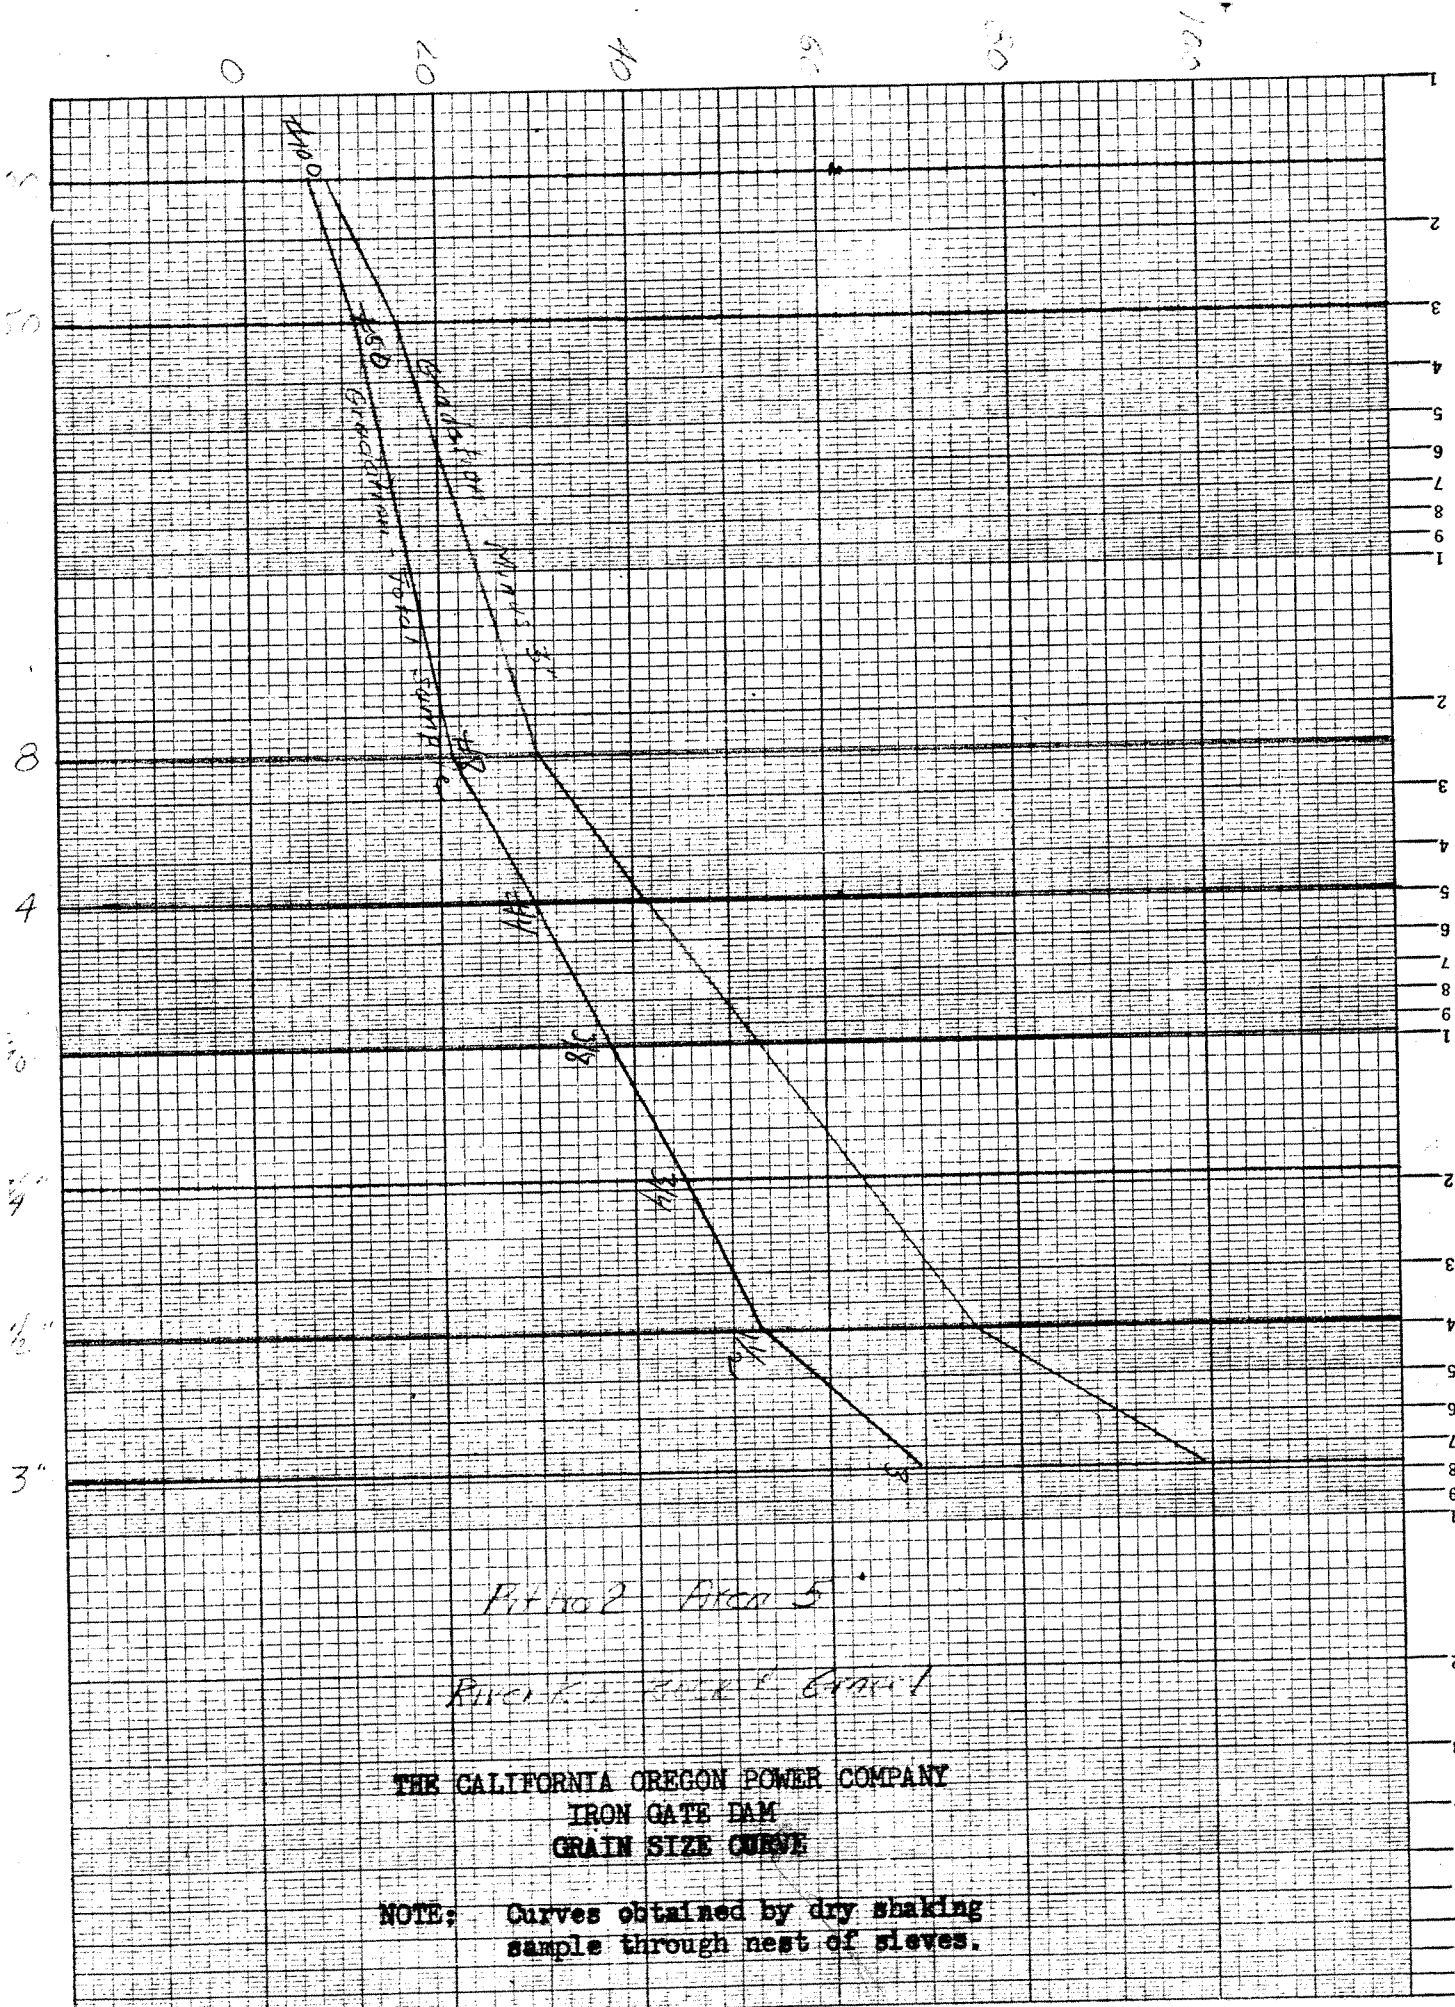
Pit No. 2 Pit No. 5
 River K... ..

THE CALIFORNIA OREGON POWER COMPANY
 IRON GATE DAM
 GRAIN SIZE CURVE

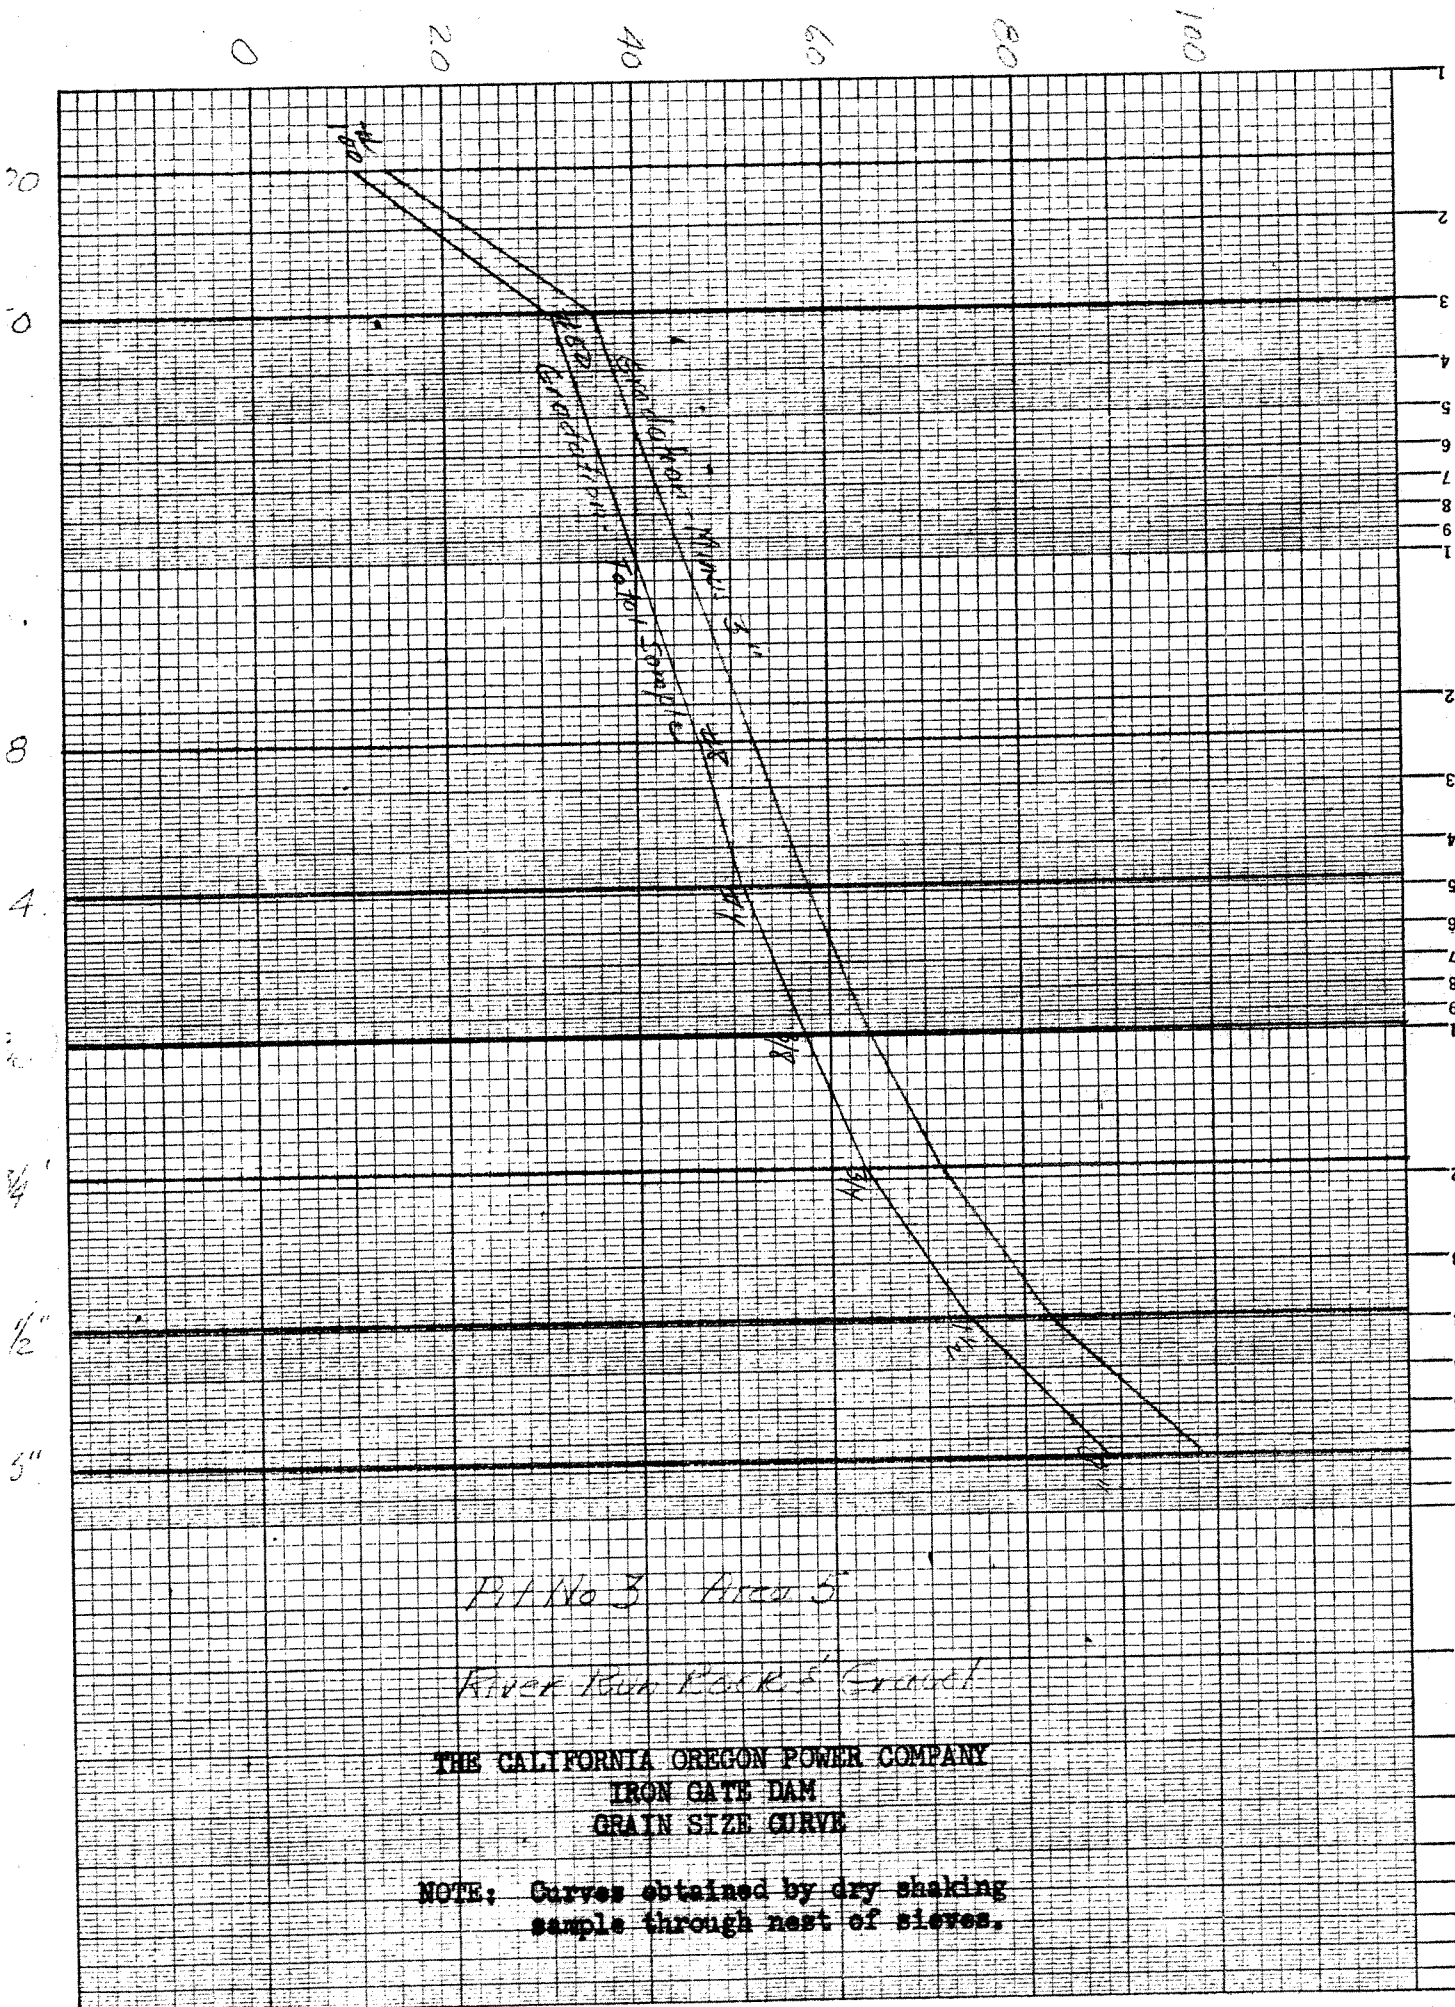
PT. No 3 Area 5
River Run Rock & Gravel

THE CALIFORNIA OREGON POWER COMPANY
IRON GATE DAM
GRAIN SIZE CURVE

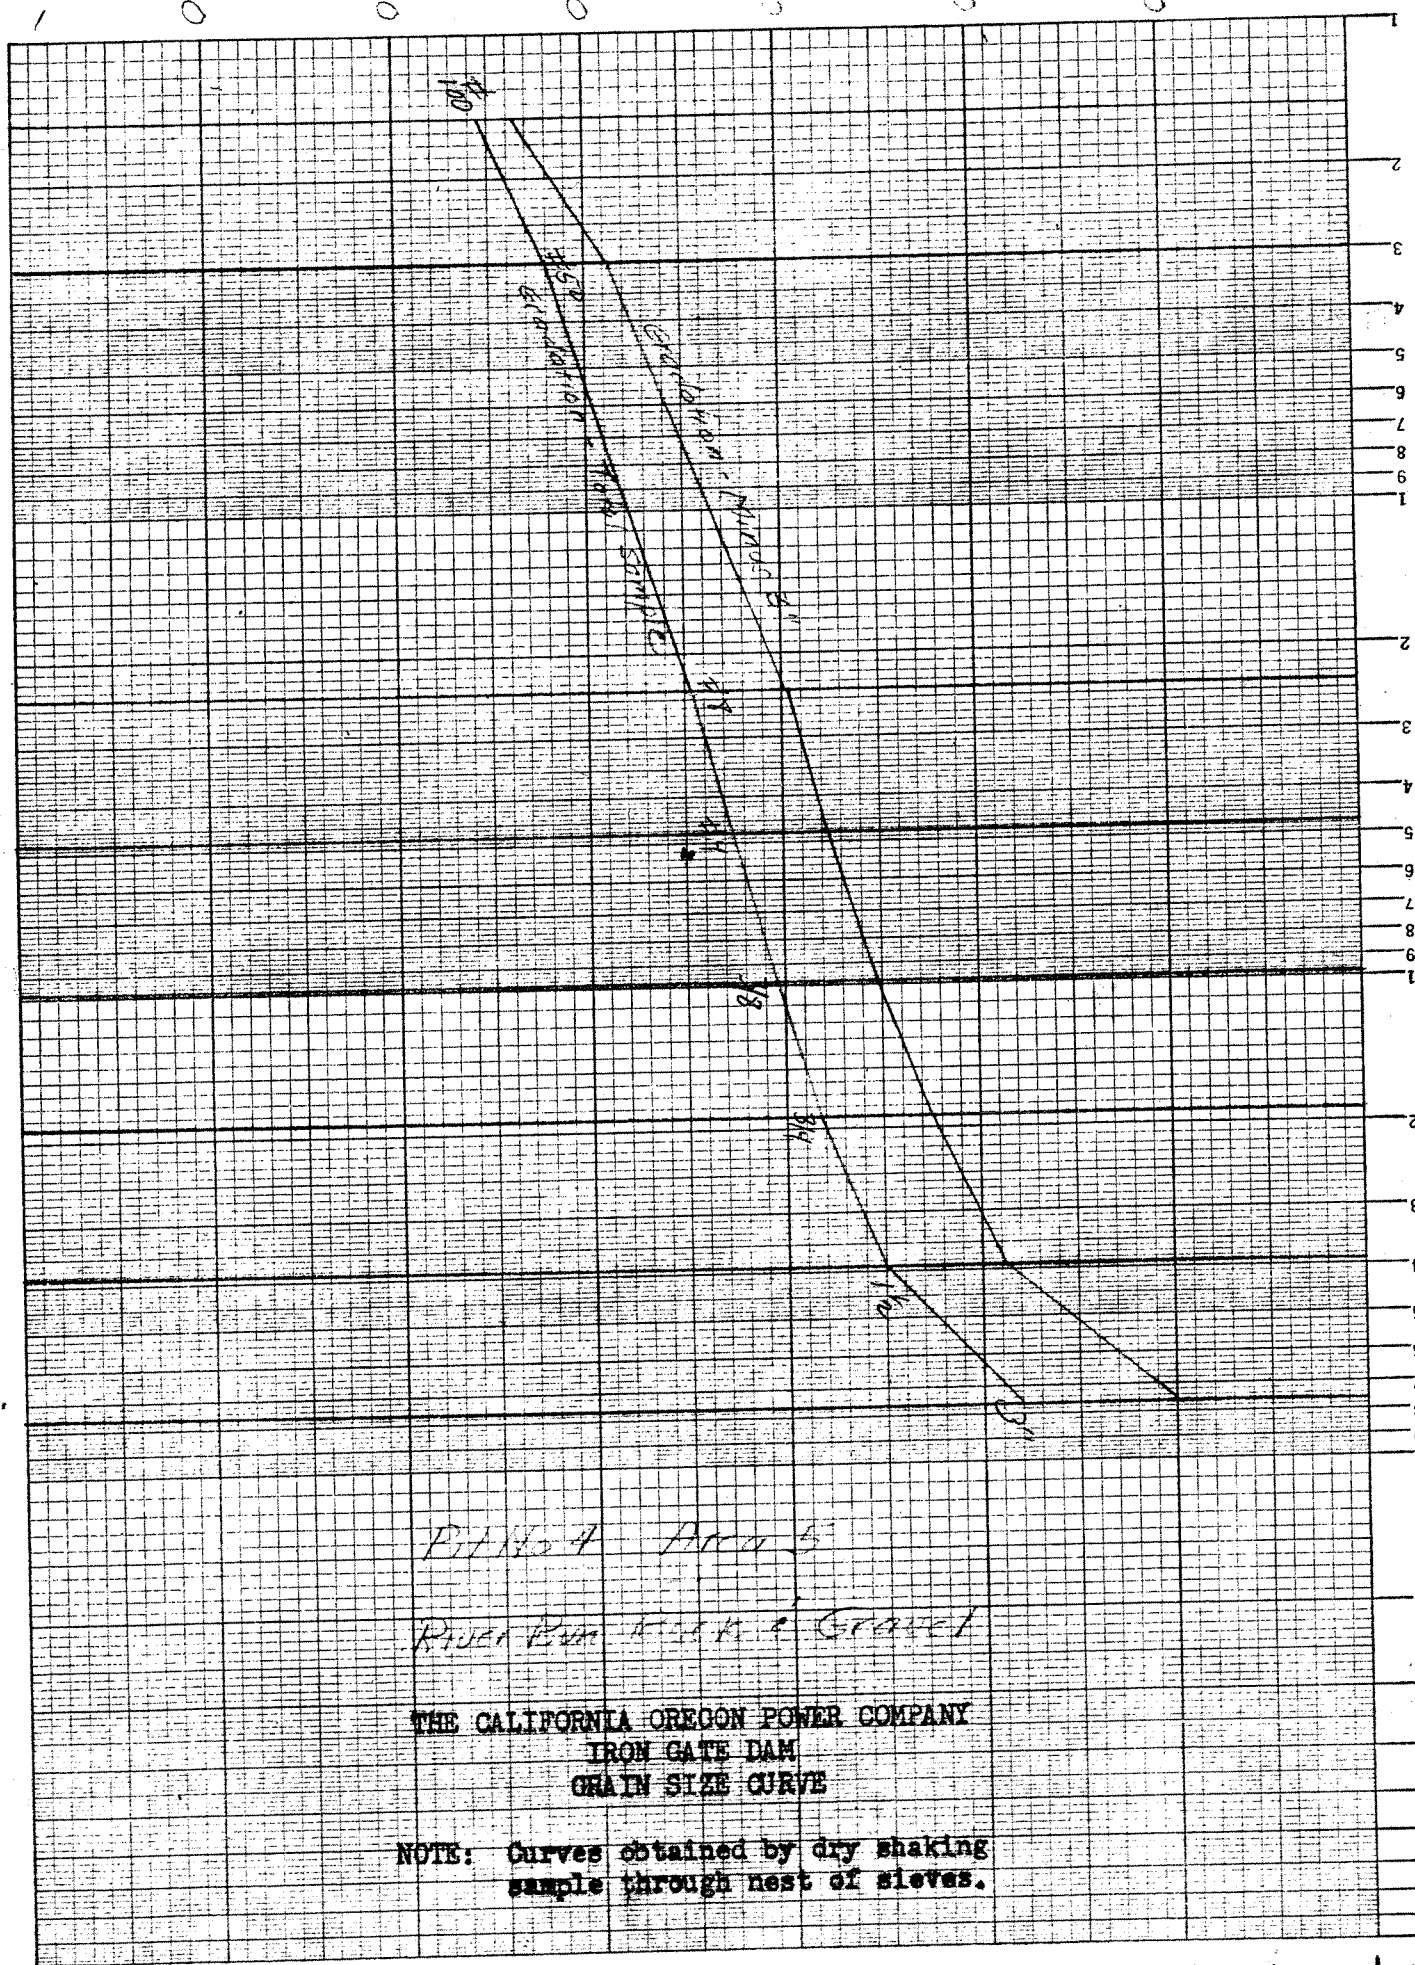
Pit No. 4 Area 5
River Bank Wash & Gravel

THE CALIFORNIA OREGON POWER COMPANY
IRON GATE DAM
GRAIN SIZE CURVE

NOTE: Curves obtained by dry shaking
sample through nest of sieves.

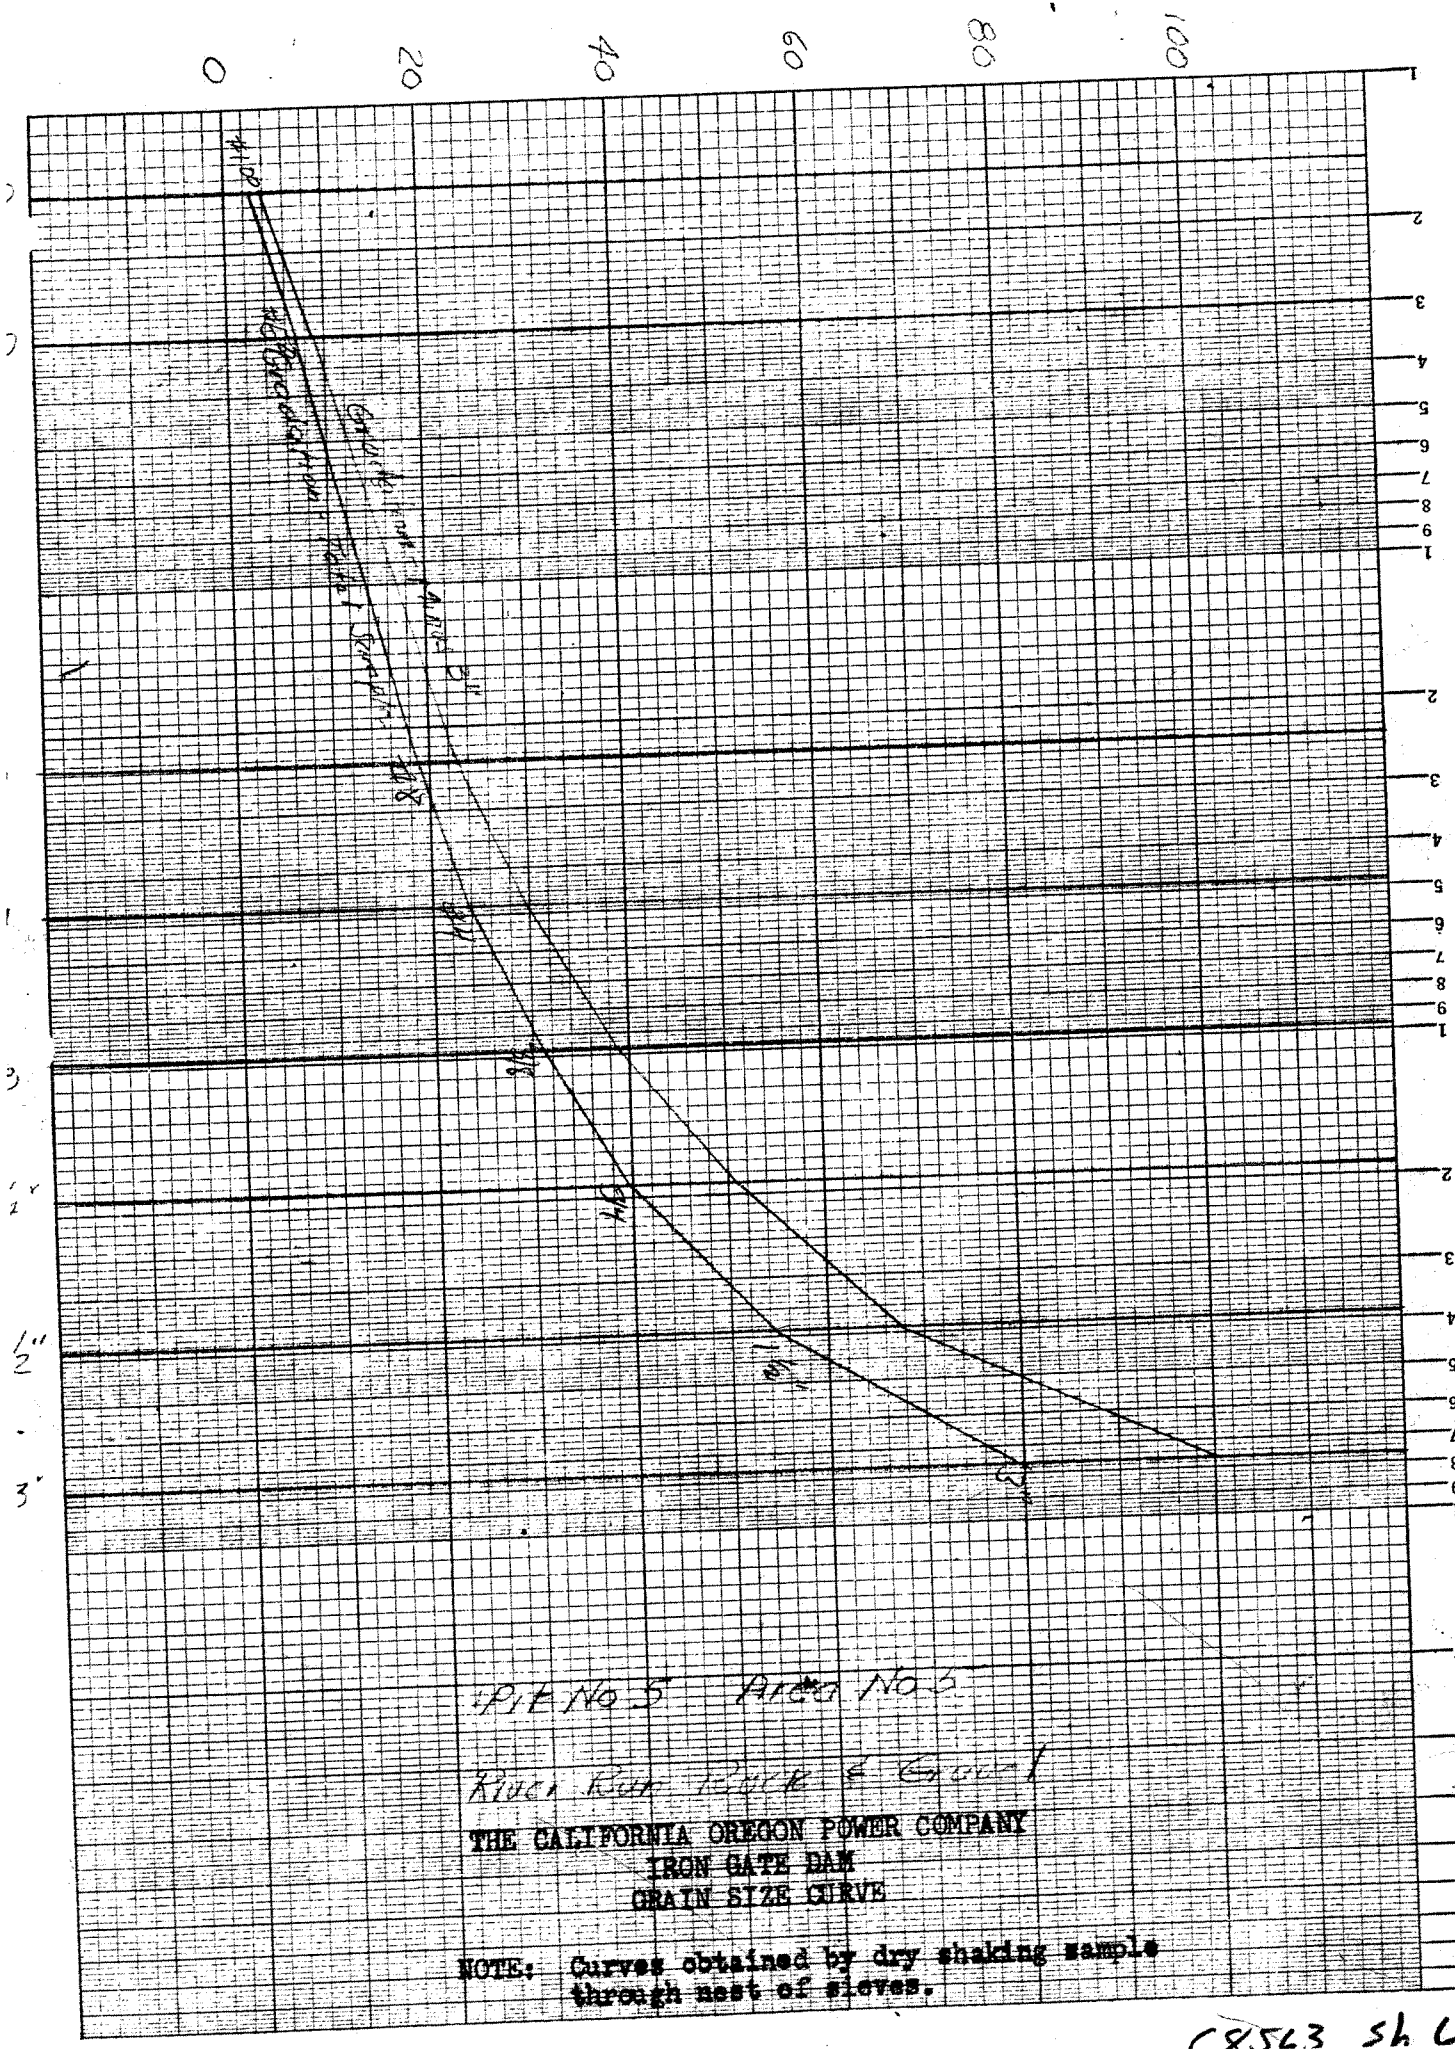
PIE No 5 AREA No 5
KUCH ROCK PUCK & GRAVEL
THE CALIFORNIA OREGON POWER COMPANY
IRON GATE DAM
GRAIN SIZE CURVE

NOTE: Curves obtained by dry shaking sample through nest of sieves.

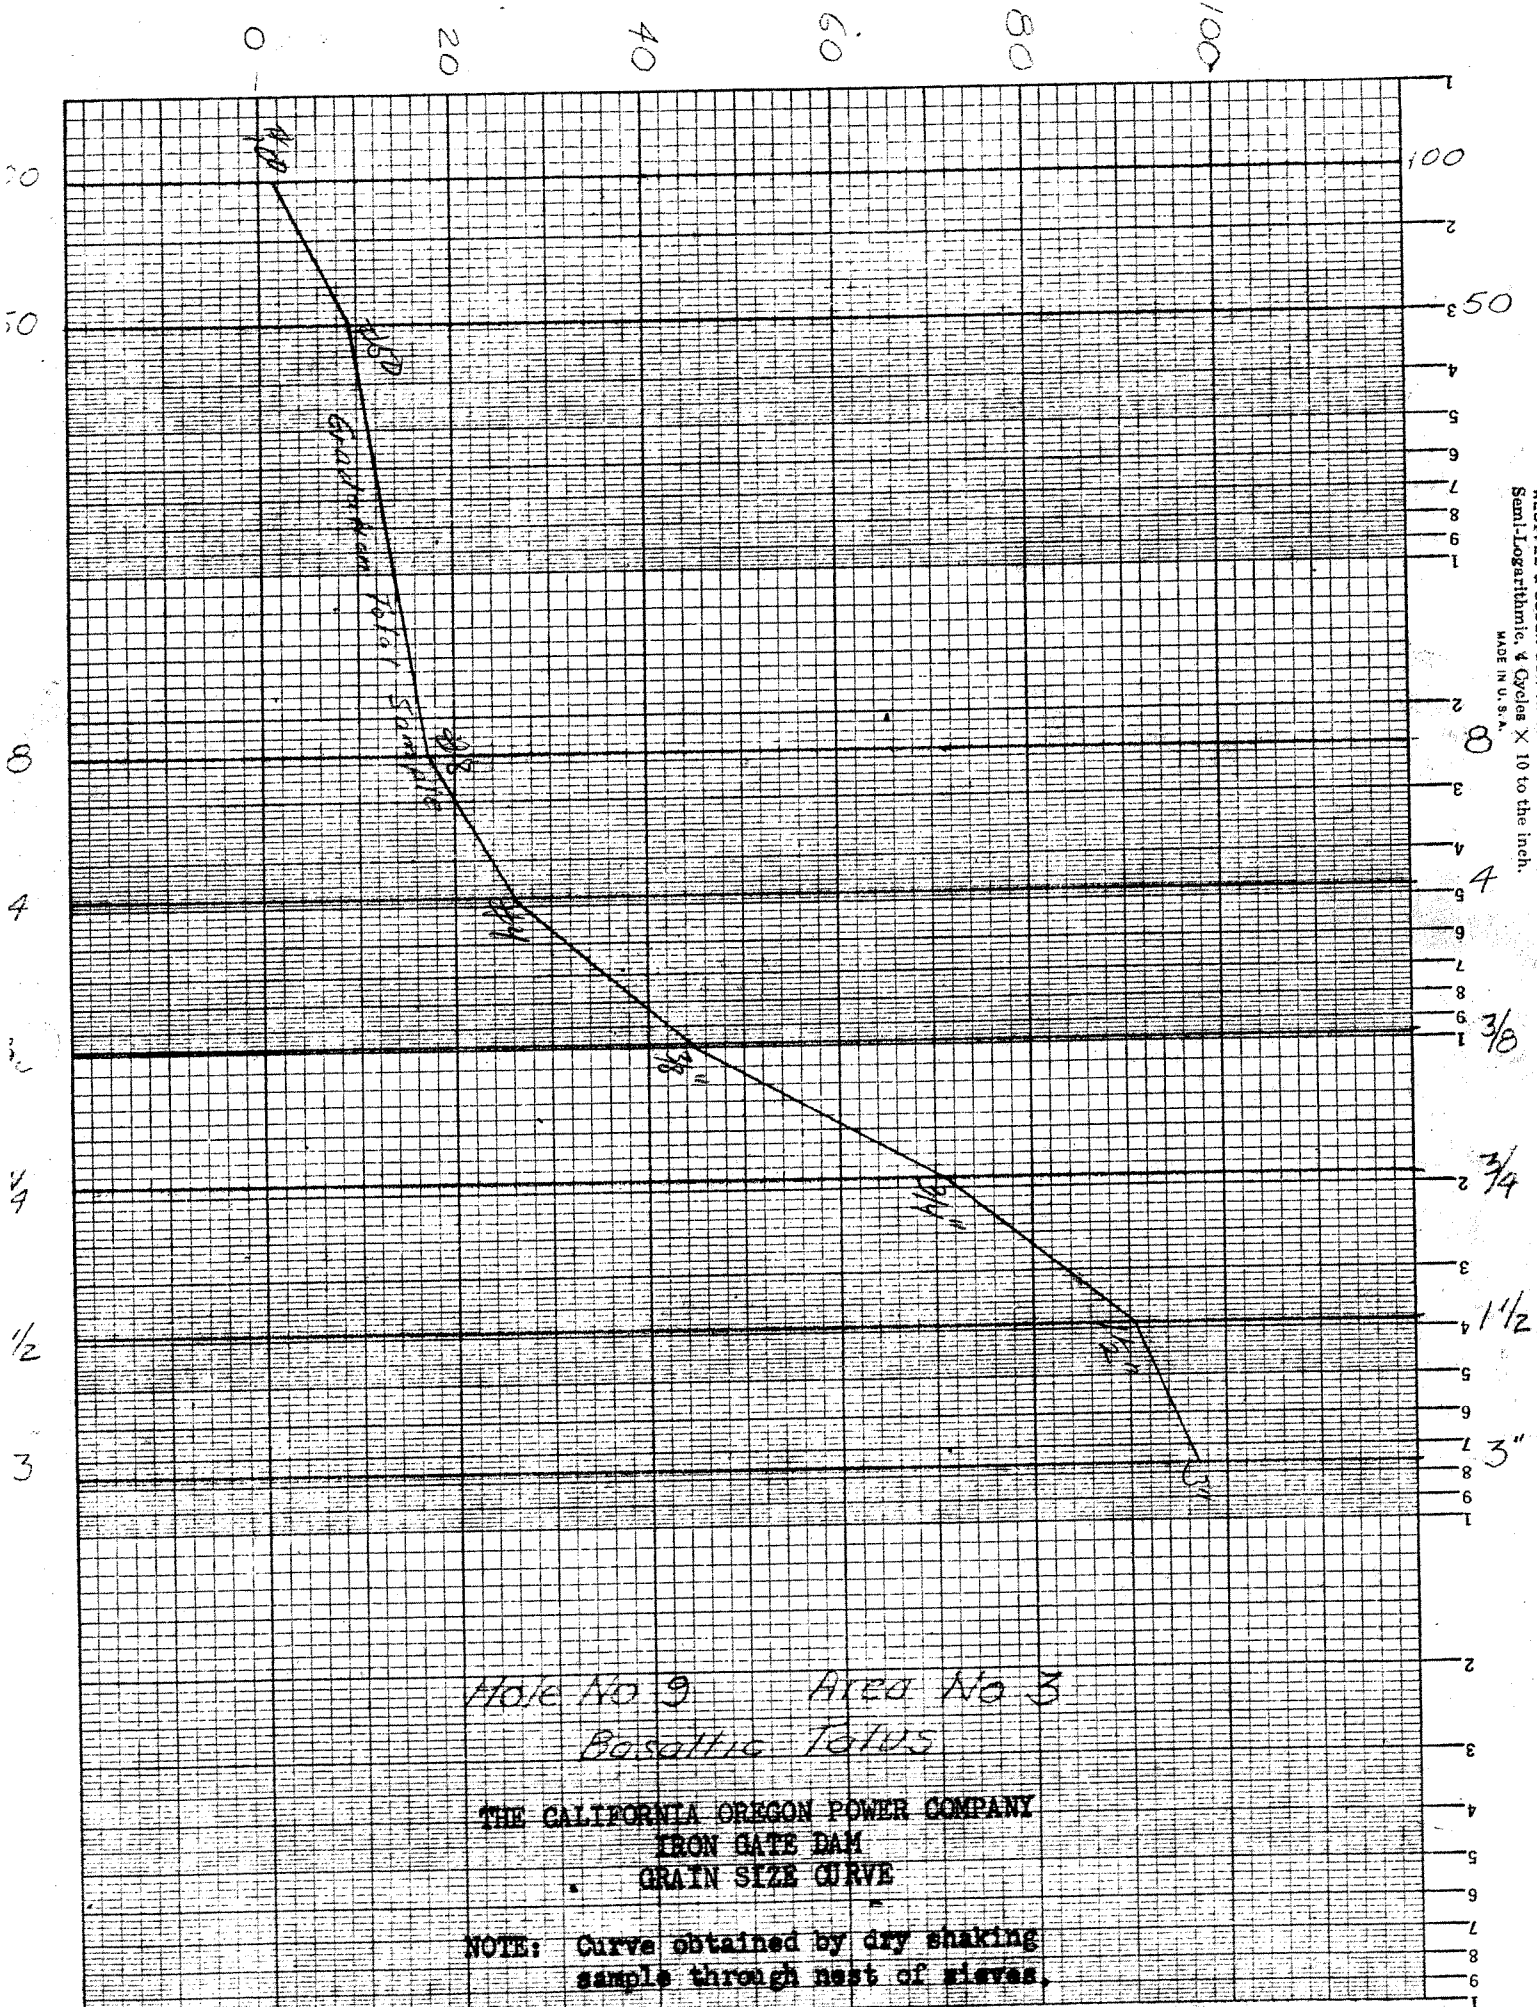
Mole No 9 Area No 3
Basaltic Talus

THE CALIFORNIA OREGON POWER COMPANY
IRON GATE DAM
GRAIN SIZE CURVE

NOTE: Curve obtained by dry shaking
sample through nest of sieves.

The talus material was tested in a manner similar to that described in the section headed "Gravels". No settlement was noted after the permeability test on any of the samples of talus material. The results of the grain size distribution tests are shown on Drawing C-8563, Sheets 7 through 11, and attached hereto as Plate V. The results of the permeability tests are tabulated below:
