Definite Plan for the Lower Klamath Project

Appendix A – Risk Management Plan

June 2018

Klamath River Renewal Corporation

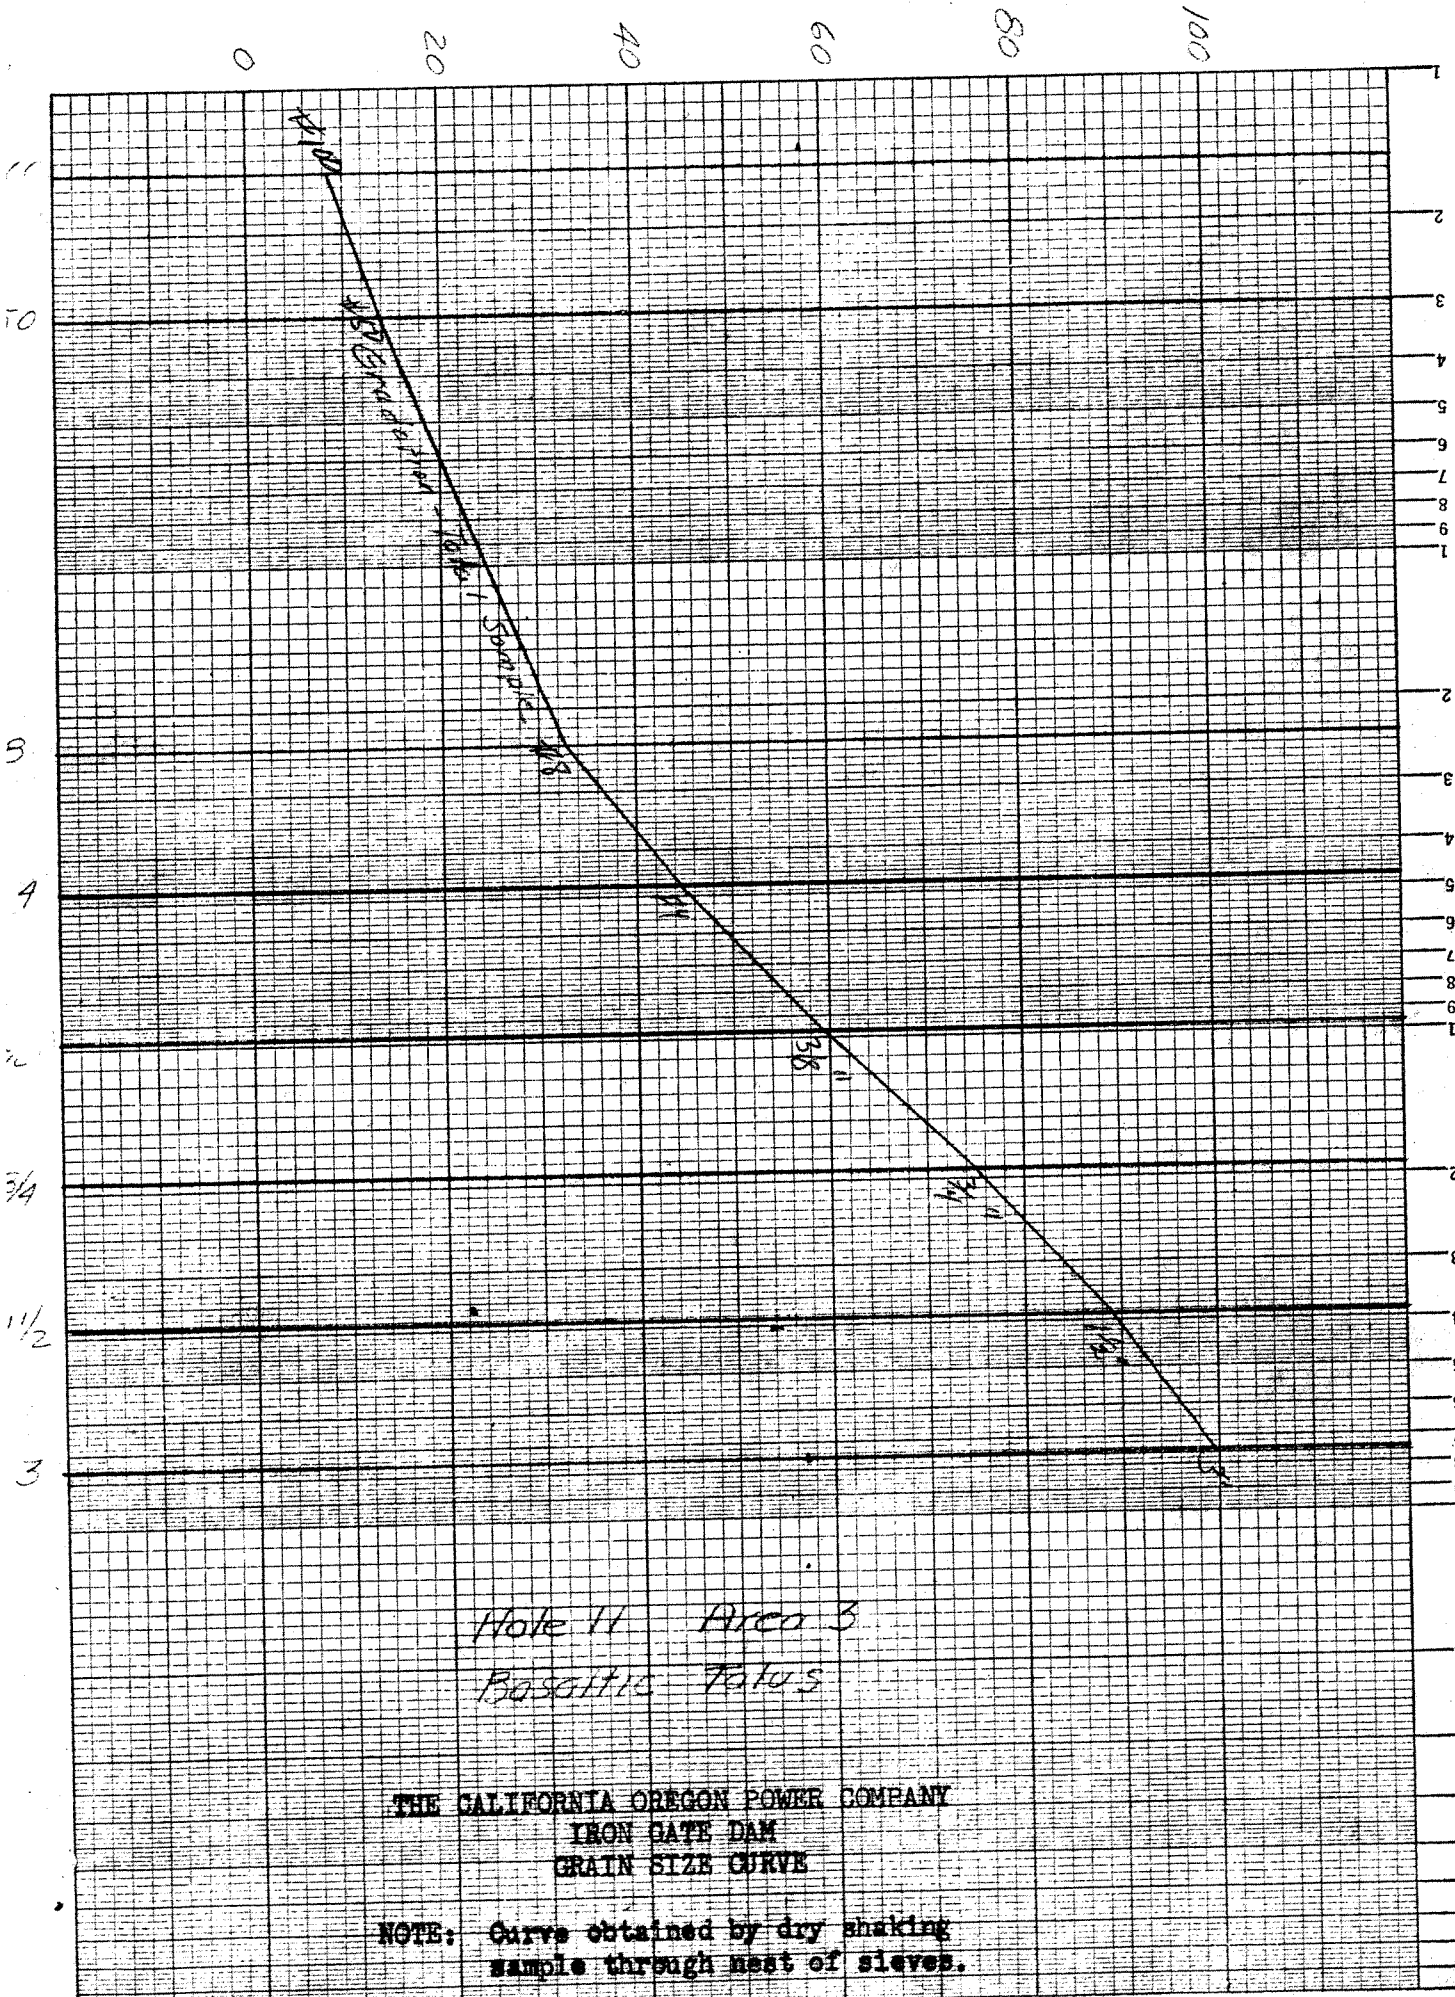
Hole 11 Area 3
Basaltic Talus

THE CALIFORNIA OREGON POWER COMPANY
IRON GATE DAM
GRAIN SIZE CURVE

NOTE: Curve obtained by dry shaking
sample through nest of sieves.

The talus material was tested in a manner similar to that described in the section headed "Gravels". No settlement was noted after the permeability test on any of the samples of talus material. The results of the grain size distribution tests are shown on Drawing C-8563, Sheets 7 through 11, and attached hereto as Plate V. The results of the permeability tests are tabulated below:

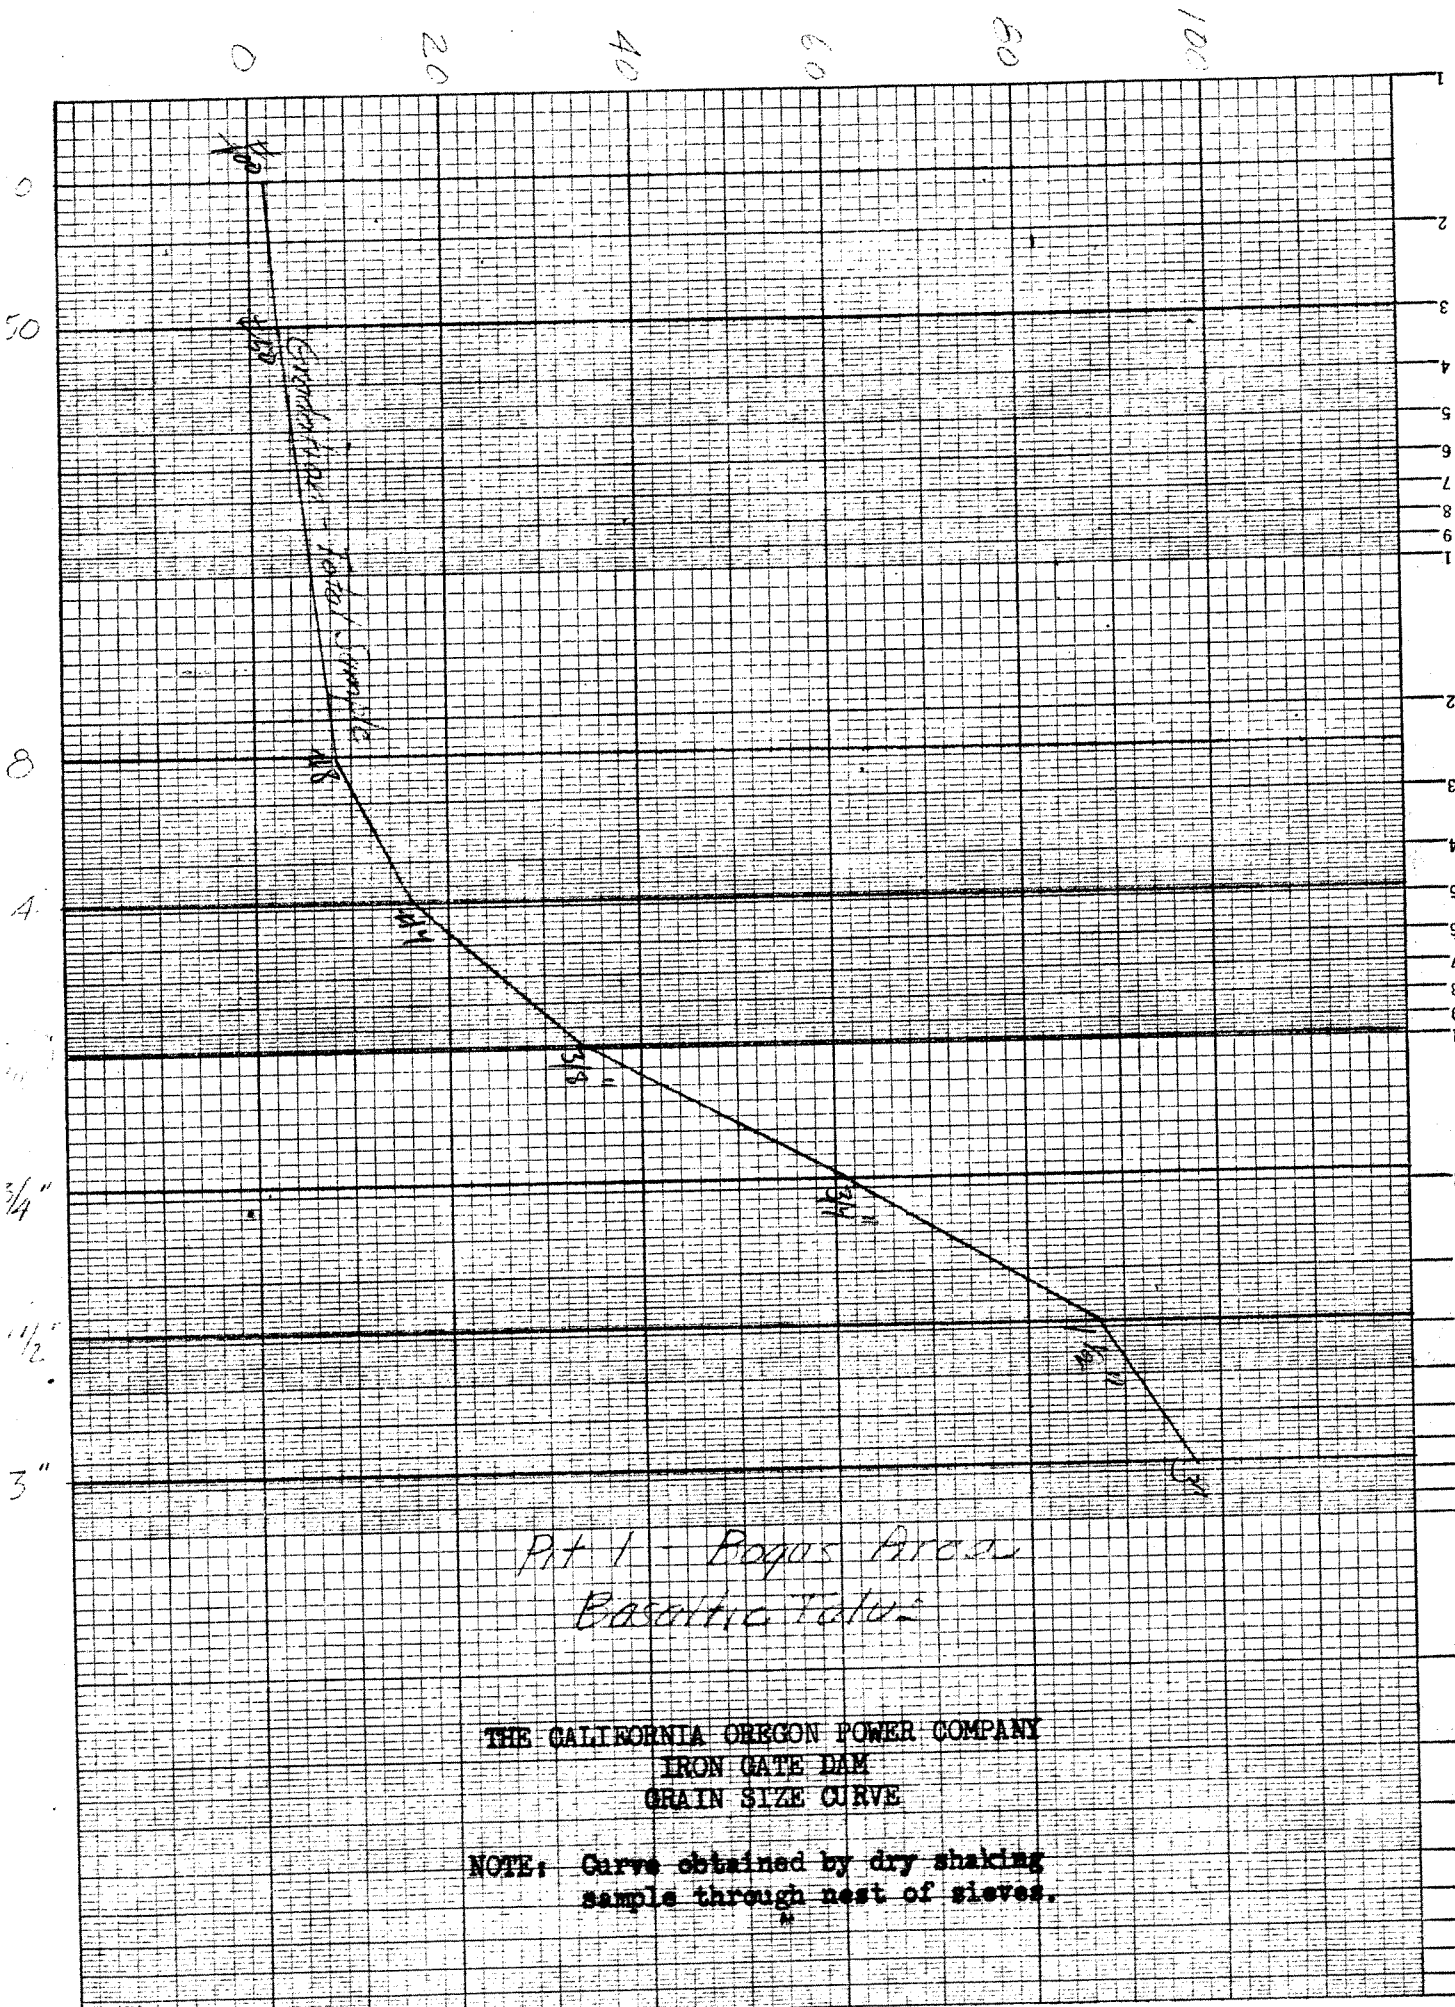
Pit 1 - Bogus Area
Basaltic Tuff

THE CALIFORNIA OREGON POWER COMPANY
IRON GATE DAM
GRAIN SIZE CURVE

NOTE: Curve obtained by dry shaking
sample through nest of sieves.

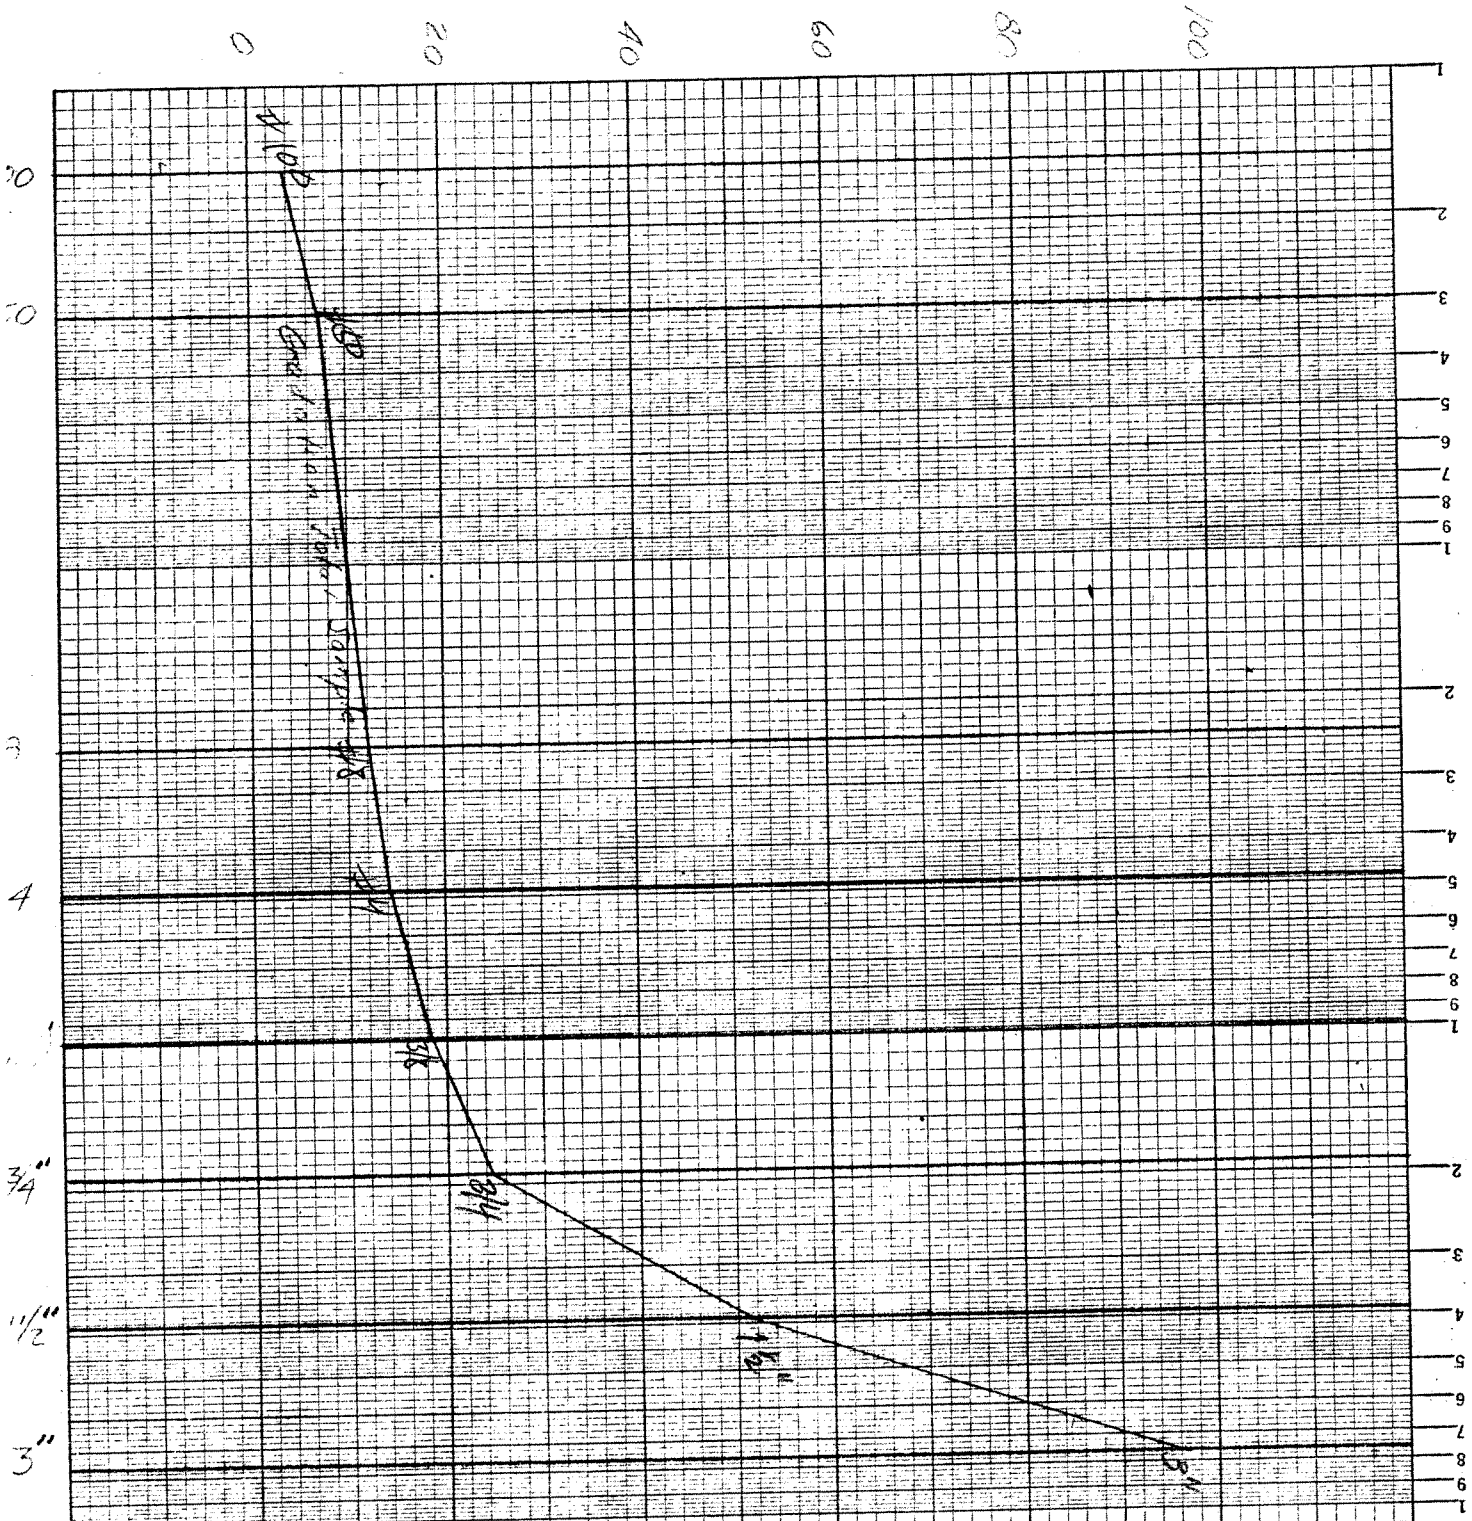
*Part Summit Area
 Basaltic Tuffs*

**THE CALIFORNIA OREGON POWER COMPANY
 IRON GATE DAM
 GRAIN SIZE CURVE**

NOTE: Curve obtained by dry shaking sample through nest of sieves.

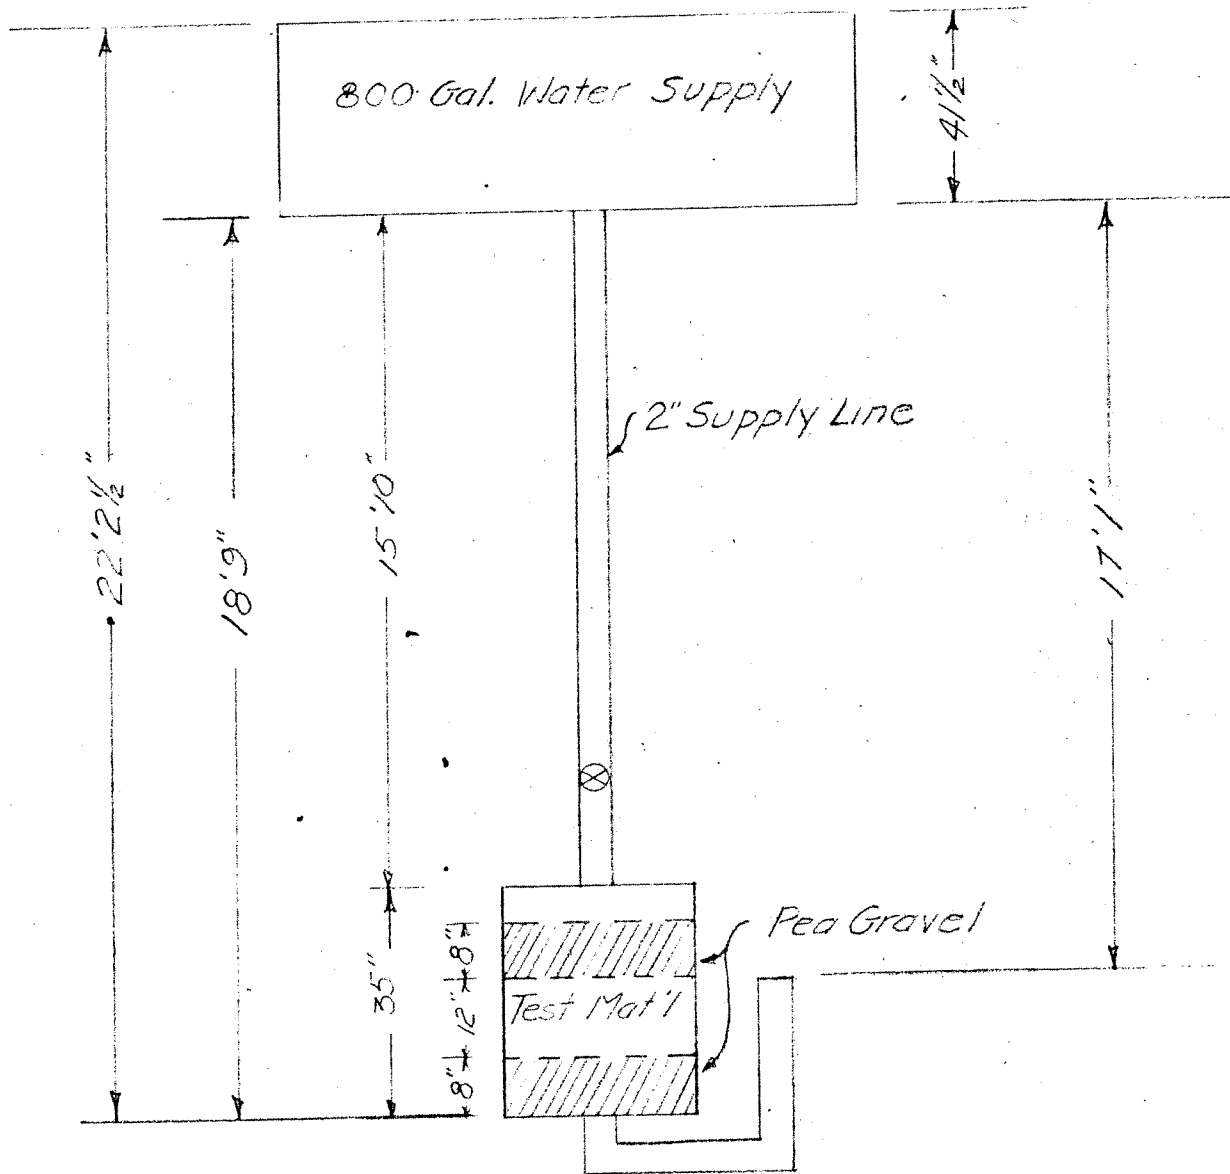
Permeability Test Method
 No Scale
 Iron Gate Project

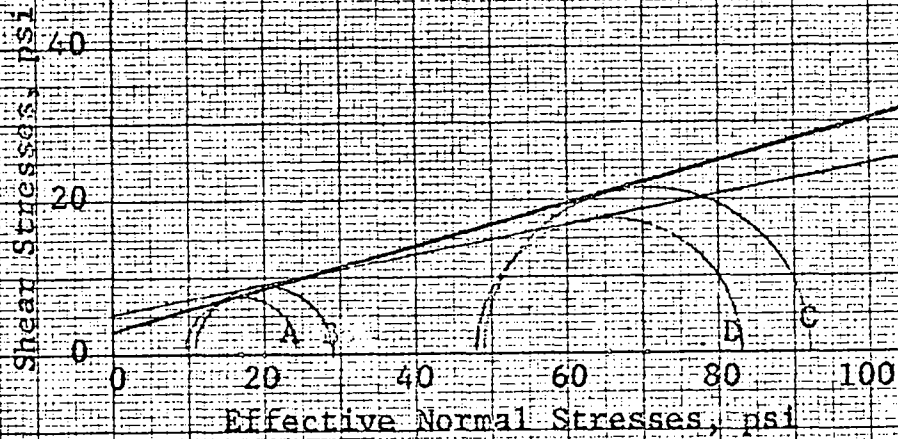
MOHR DIAGRAM

$c = 3-5\frac{1}{2}$ psi
 $\phi = 11-15^\circ$

Iron Gate Dam
File No. 1732.2

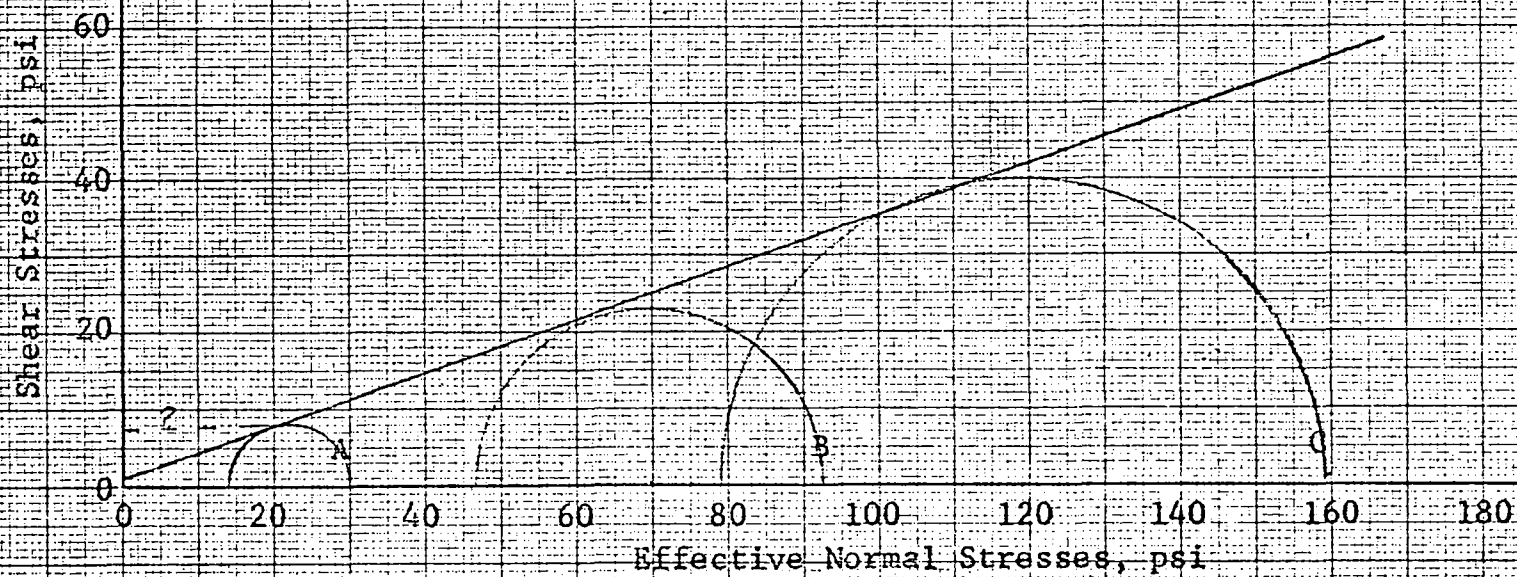
MOHR DIAGRAM

$c = 1 \text{ psi}$
 $\phi = 20^\circ$

Iron Gate Dam
File No. 1732.2

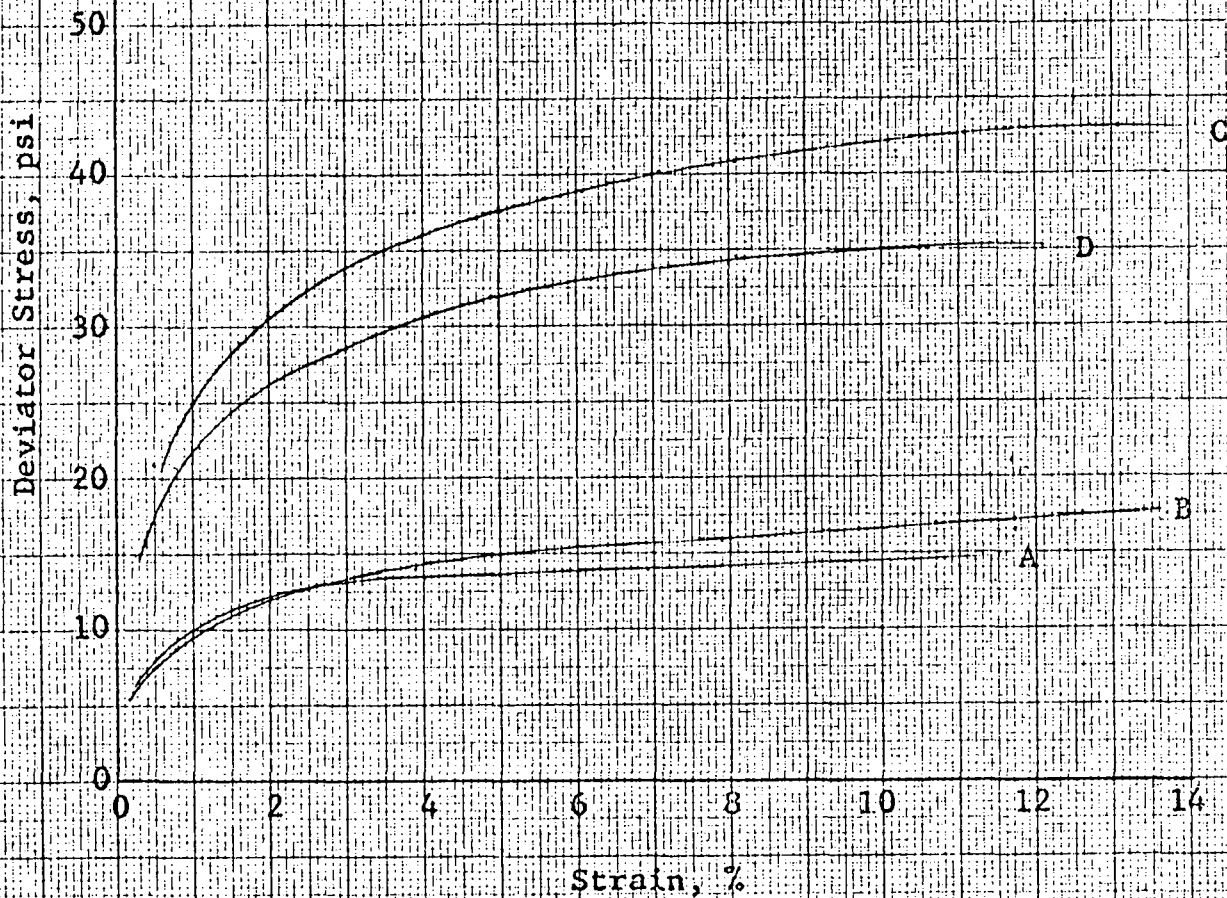
TRIAXIAL SHEAR TEST

Stress-Strain Relationships

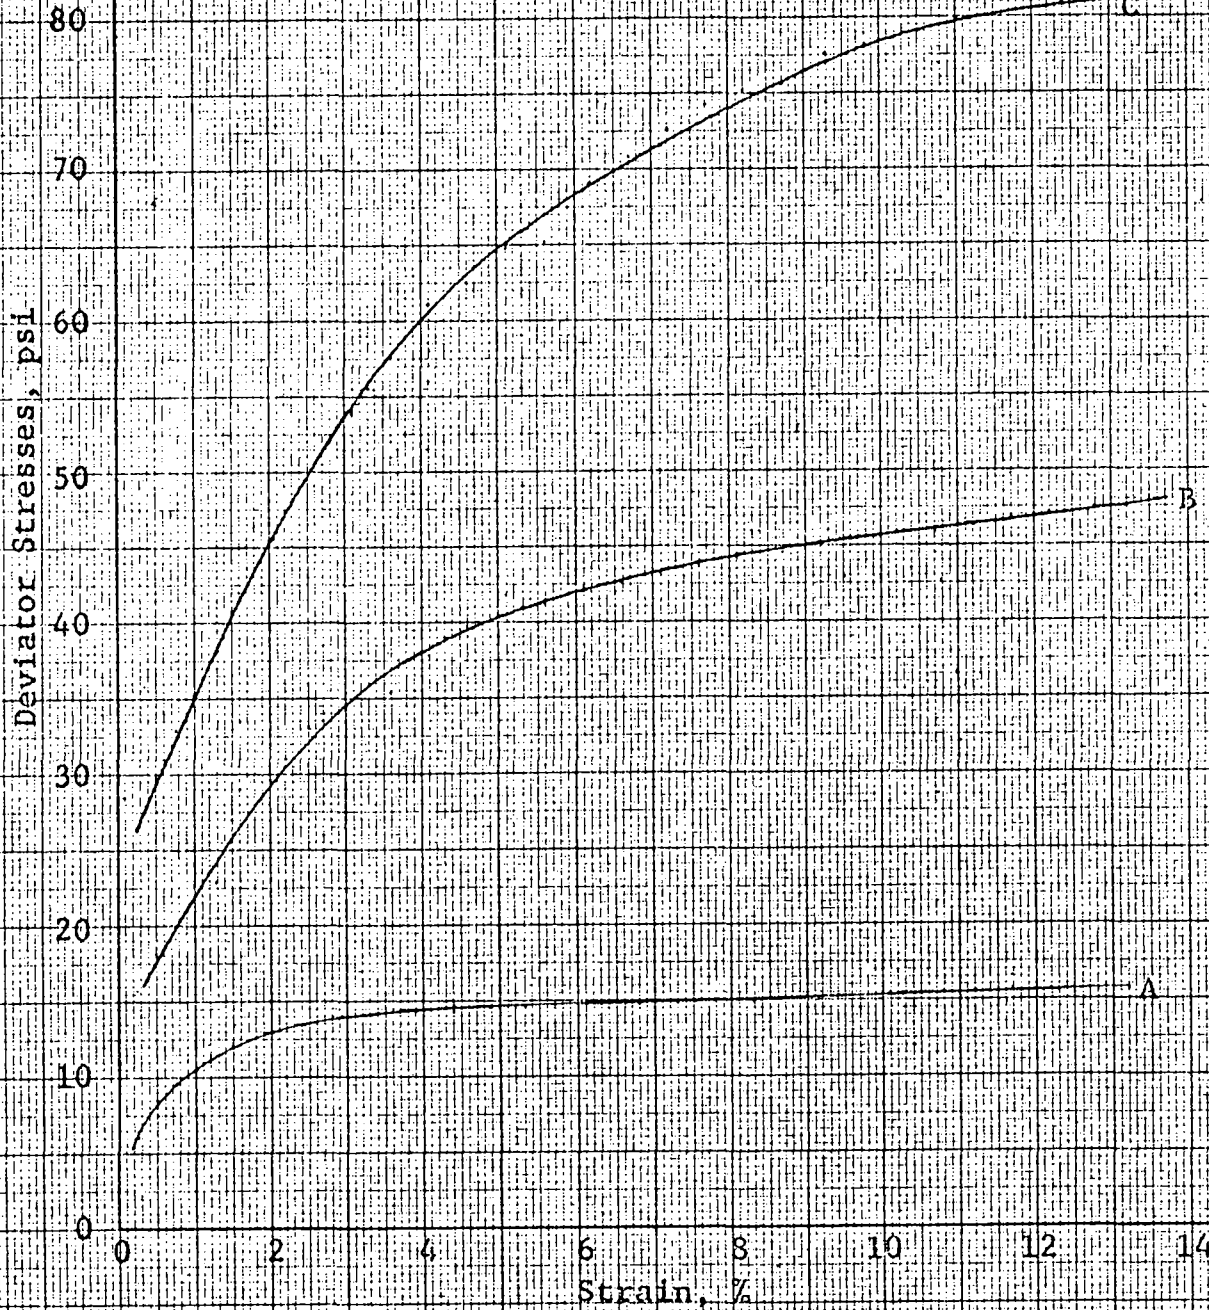
TRIAxIAL SHEAR TEST

Stress-Strain Relationships

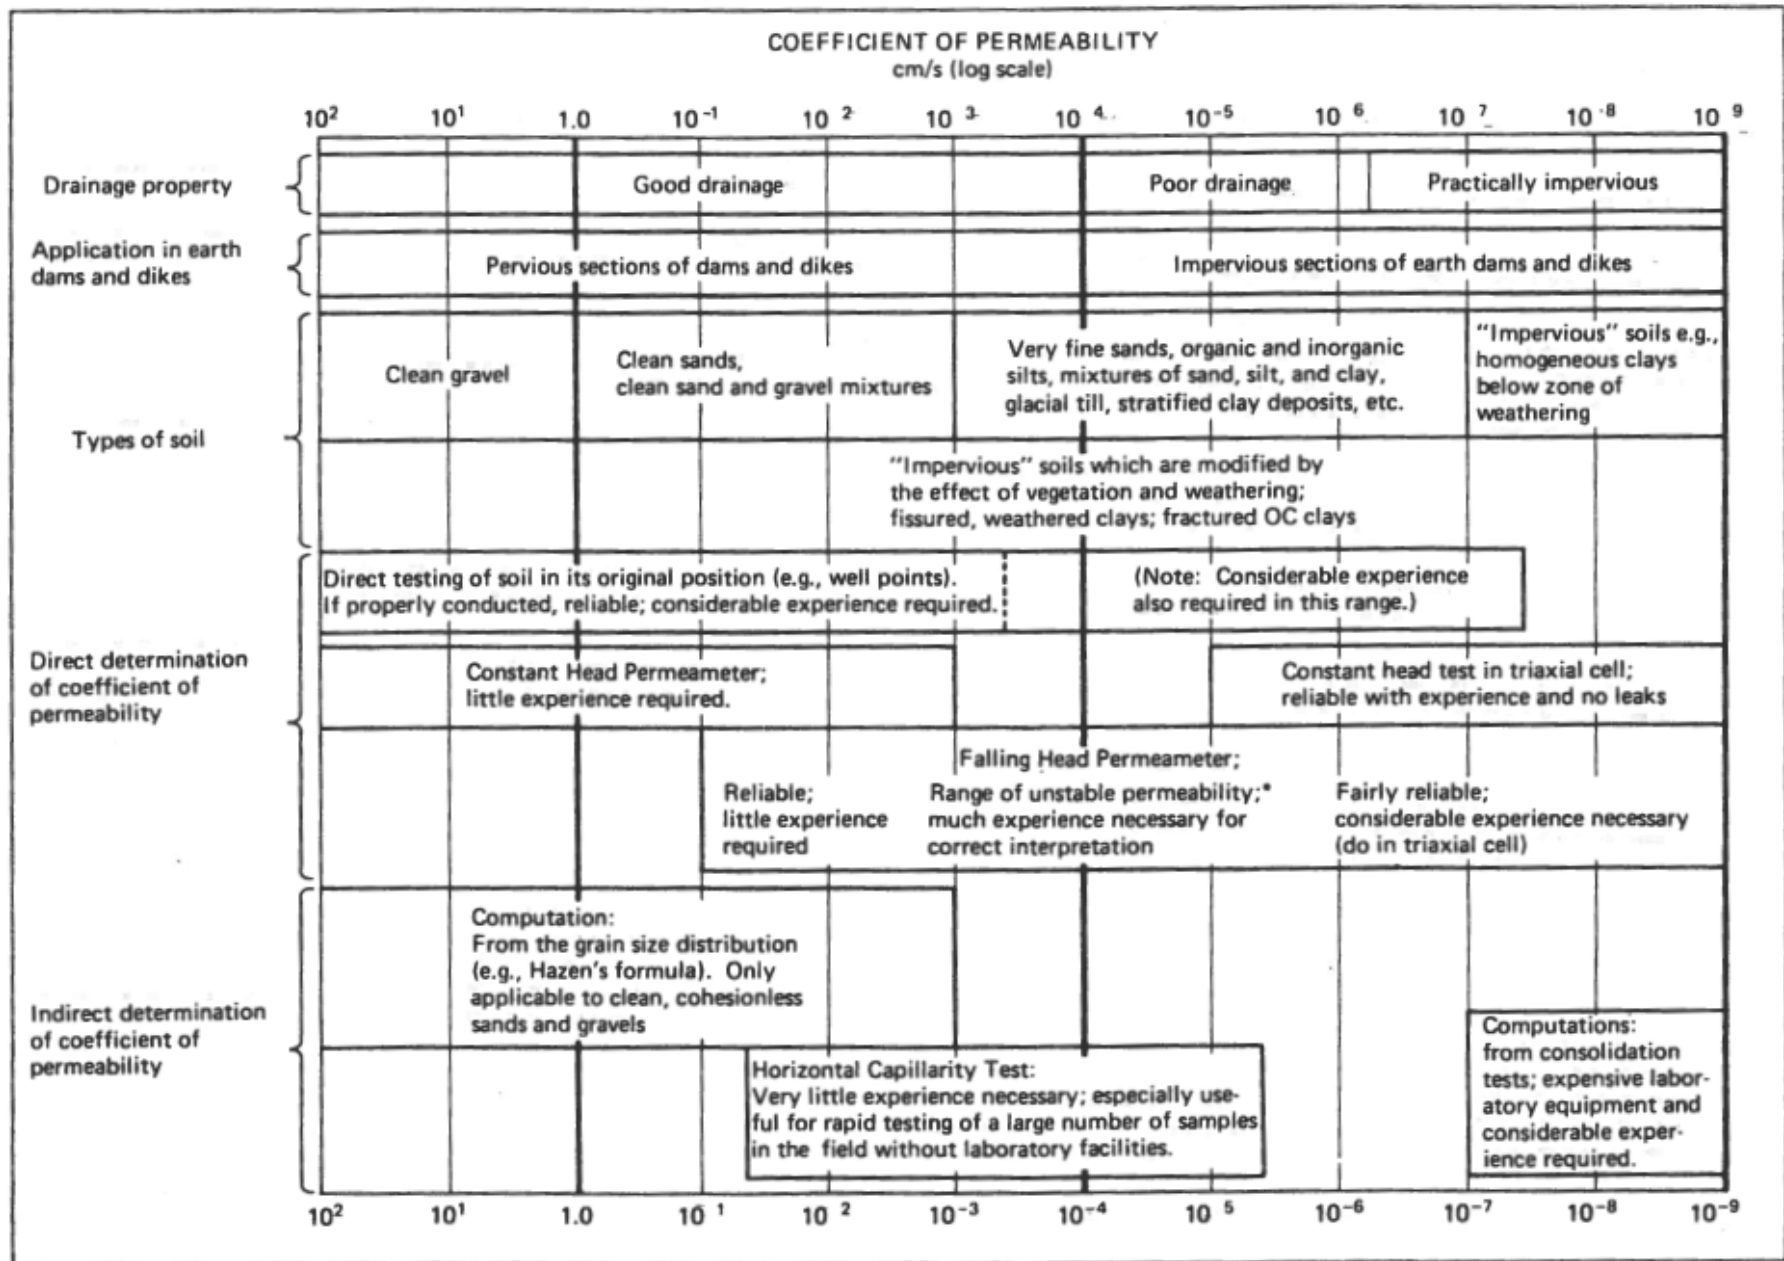
Attachment C Typical Permeability Ranges

*Due to migration of fines, channels, and air in voids.

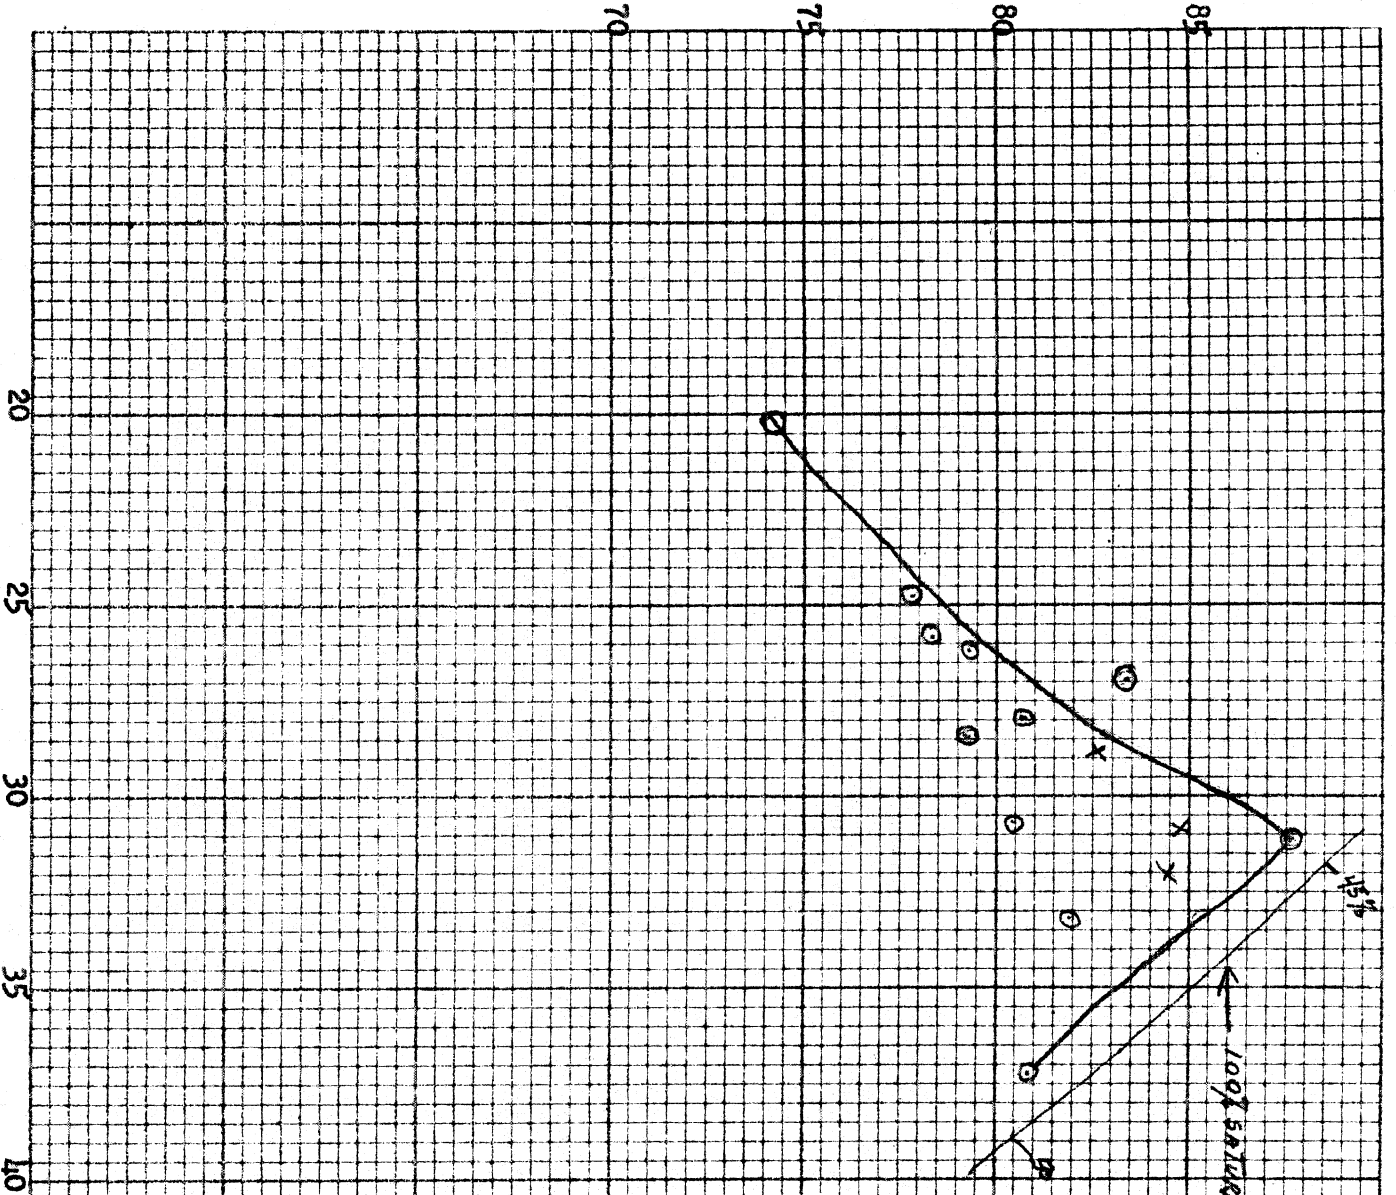
CALIFORNIA OREGON POWER COMPANY
BIG BEND DAM

CURVE OF MOISTURE CONTENT VS DRY DENSITY

MAXIMUM DRY DENSITY	87.6 LB/CU FT.
OPTIMUM MOISTURE CONTENT	31.1 %
SPECIFIC GRAVITY	2.58
VOIDS	15.5 %
CLAY CONTENT	50.0 %
PLASTIC LIMIT	10.0 %

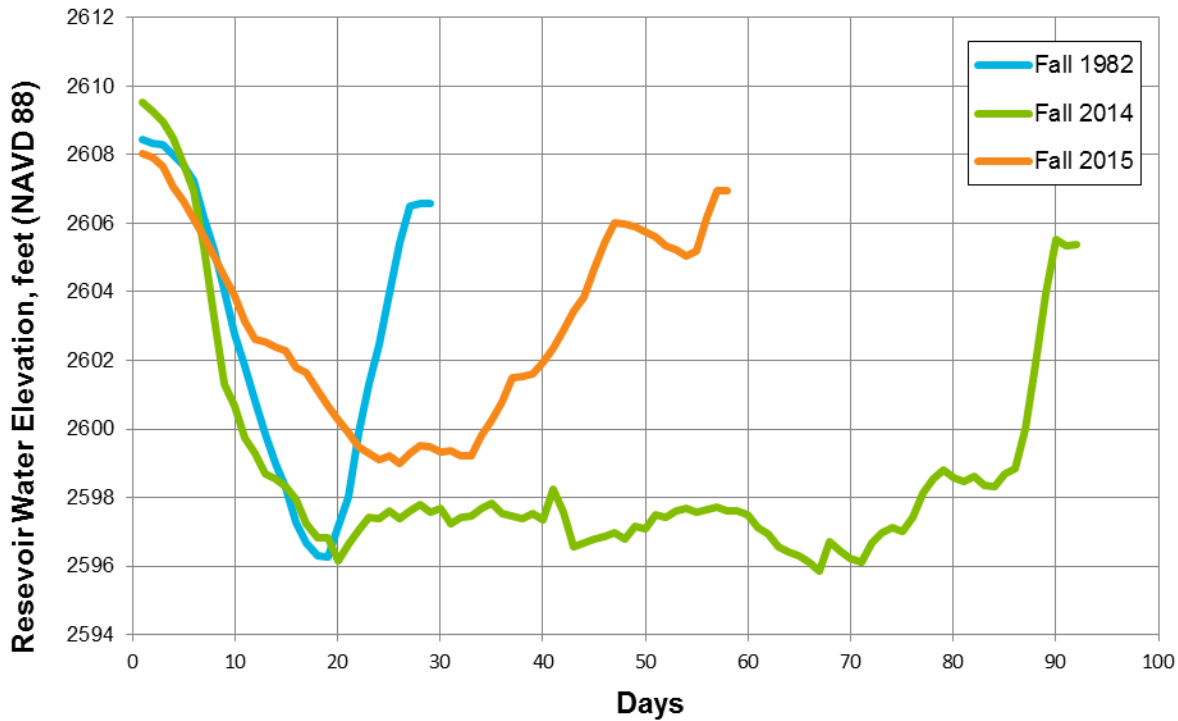
Figure 3-1 Copco Lake Maximum Historical Drawdown Events (1978 to 2016)

Copco No. 1 reservoir levels between November 1, 1978, and December 31, 2016, were reviewed by the KRRRC for historical occurrences of reservoir drawdown. The three most significant drawdown events occurred in 1982, 2014, and 2015 (see Figure 3-1).

The maximum daily drawdown rate of 2 feet per day occurred in 2014 when the reservoir was drawn down nearly 14 feet. Based on inquiries made to PacifiCorp, slope failures were not observed in connection with the three reservoir drawdown events, although there was no specific effort made to determine whether slope failures occurred (email with Demian Ebert August 2, 2017).

Based on the historical drawdown information shown in Figure 3-1, KRRC performed a rapid drawdown analysis using the same method as the rapid drawdown analyses above but with a water level drop from Elevation +2,610 to +2,596. KRRC used this analysis to verify the model due to the fact that no landslides were observed during any of the previous drawdown events.

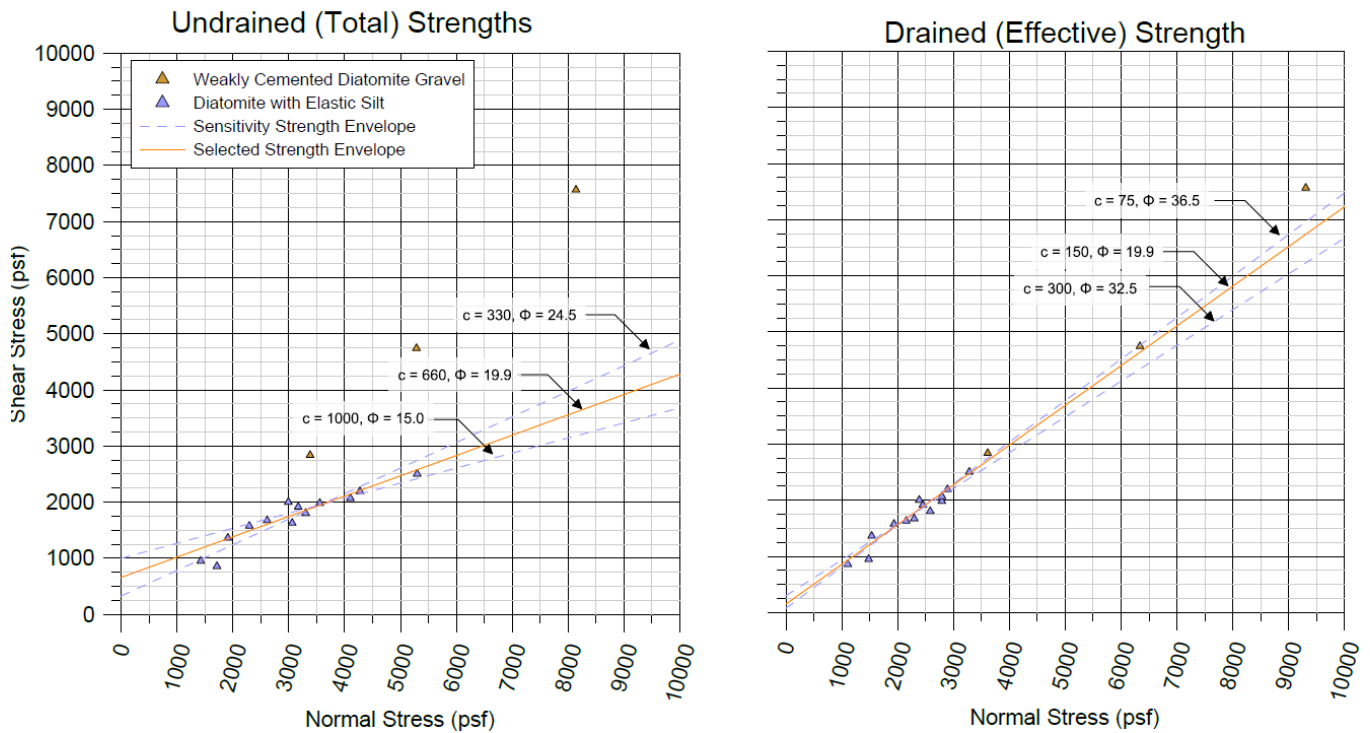
Φ = friction angle

C = cohesion

Figure 3-3 Selected Strength Envelopes

The diatomite consists of a low density material that is significantly weaker than the underlying bedrock materials. In addition, the material has a low permeability (about 1×10^{-6} cm/s) and will behave as an undrained material during reservoir drawdown, regardless of the drawdown rate. Several different types of diatomite were observed including a rock like diatomite (referred to as diatomite in the boring logs), diatomite that had more of an elastic silt like behavior (referred to as diatomite with elastic silt in the boring logs), and a weakly cemented diatomite. Properties of the diatomite with elastic silt were chosen to represent all the types of diatomite since it was the most common type observed. Table 3-2 and Figure 3-3 summarize strength testing of the diatomite.

The shear strength of the diatomite is the parameter that has the greatest influence on the slope stability analysis results. Therefore, sensitivity analyses will be performed by assuming different interpretations of the laboratory strength test results for samples of diatomite, as shown in Figure 3-3 and summarized in Table 3-5. Using the strengths shown, any sections with factors of safety between 1.15 and 1.3 will be analyzed and included in the final report.

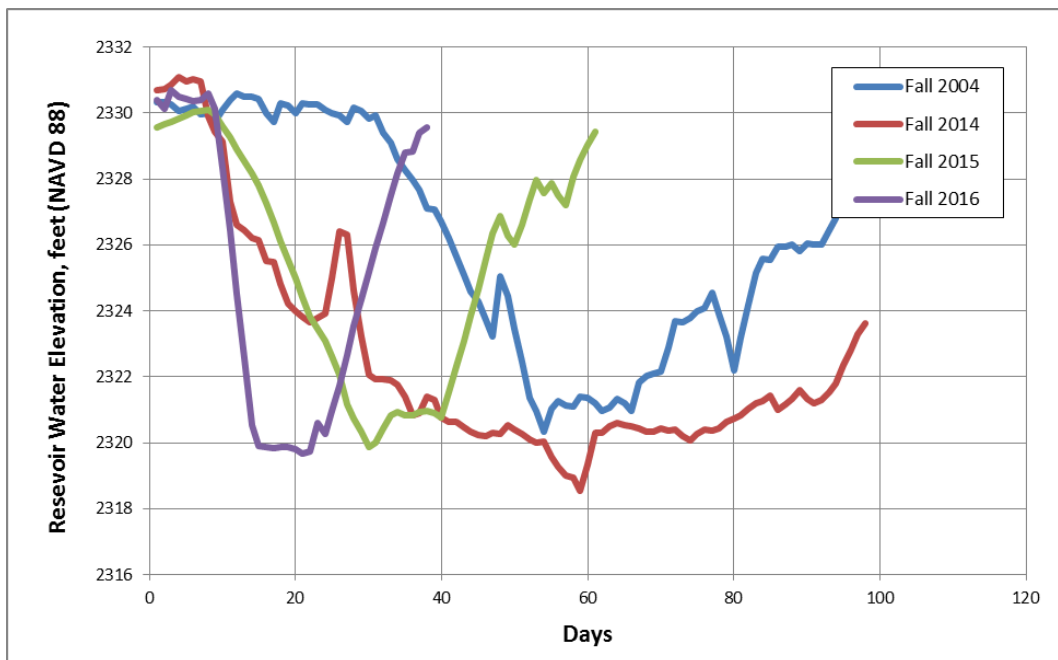
Figure 4-1 Iron Gate Reservoir Maximum Historical Drawdown Events (1979 to 2016)

Iron Gate Reservoir levels between January 1, 1979, and December 31, 2016, KRRC reviewed for historical occurrences of reservoir drawdown. The four most significant drawdown events occurred in the falls of 2004, 2014, 2015, and 2016 (see Figure 4-1).

The magnitude of the drawdowns ranged from about 9 feet to 14.5 feet. The maximum daily drawdown rate of 2 feet per day occurred in 2014. Based on inquiries made to PacifiCorp, there were no reported slope failures resulting from these drawdowns (email with Demian Ebert August 2, 2017).
