Definite Plan for the Lower Klamath Project

Appendix A – Risk Management Plan

June 2018

Klamath River Renewal Corporation

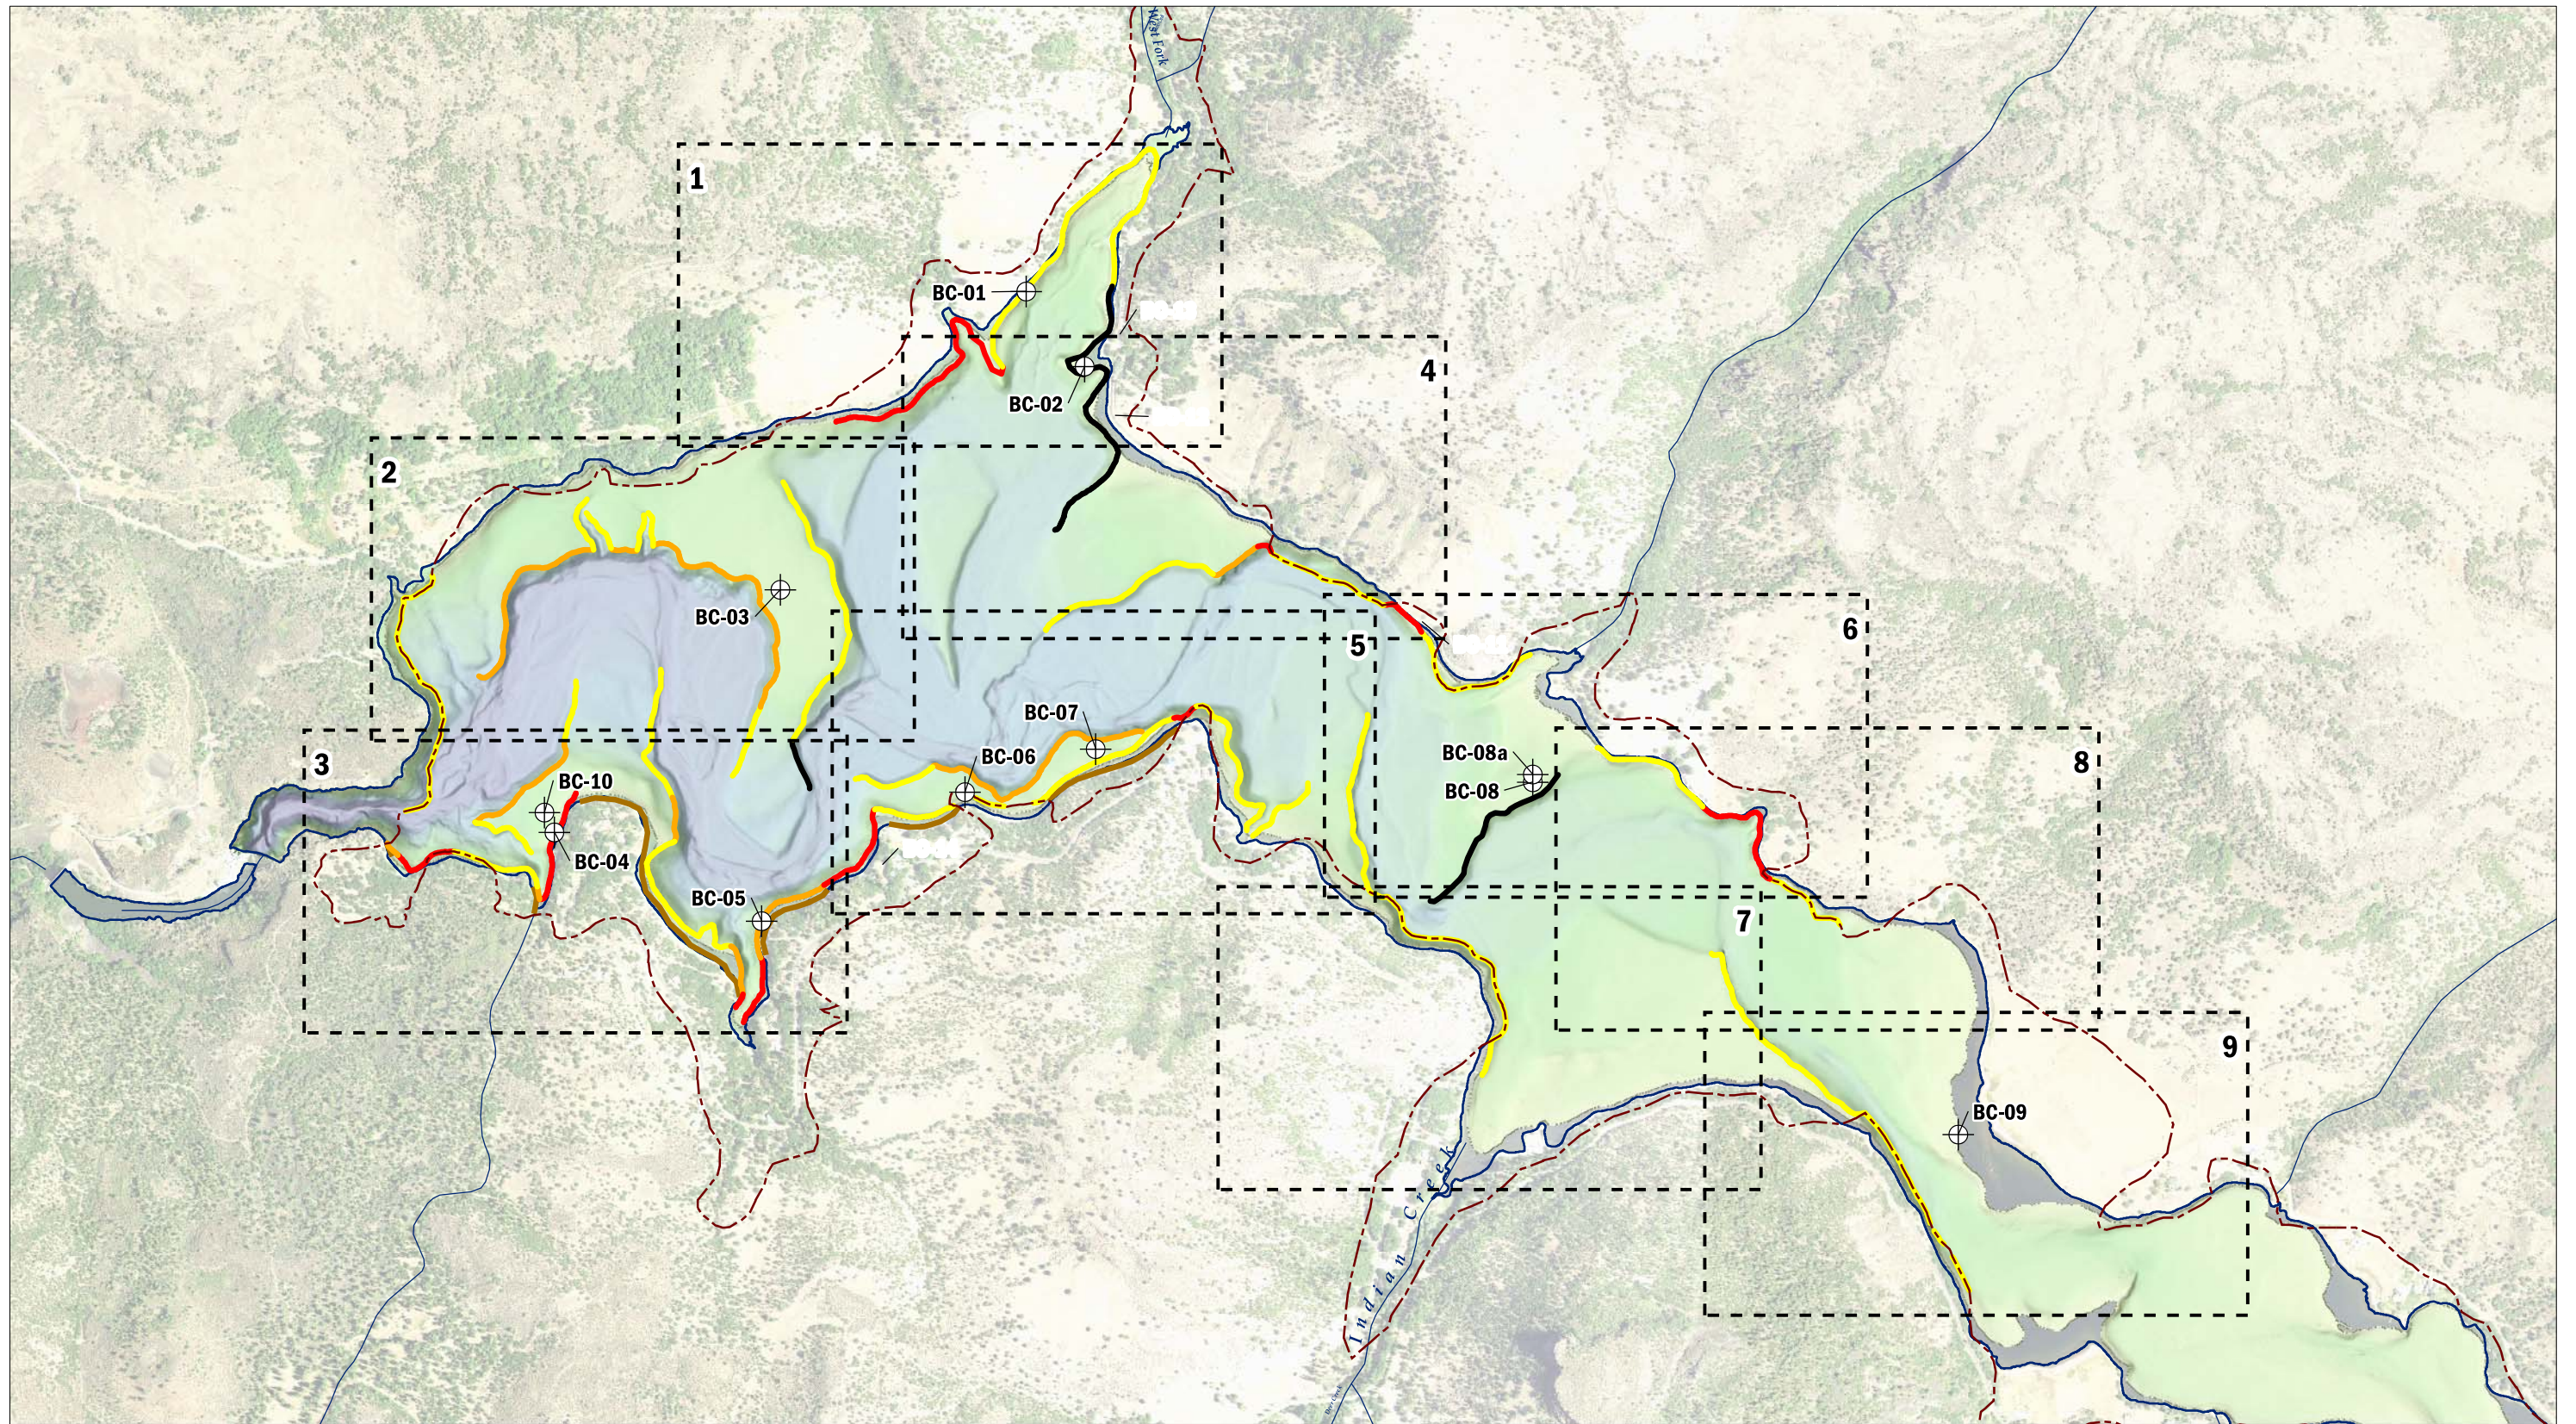
| ┌ ┐ Current Reservoir Shoreline | — Potentially Unstable Slope |

FIGURE 3-4
 Copco Dam - Slope Failure Analysis
 Overview Map

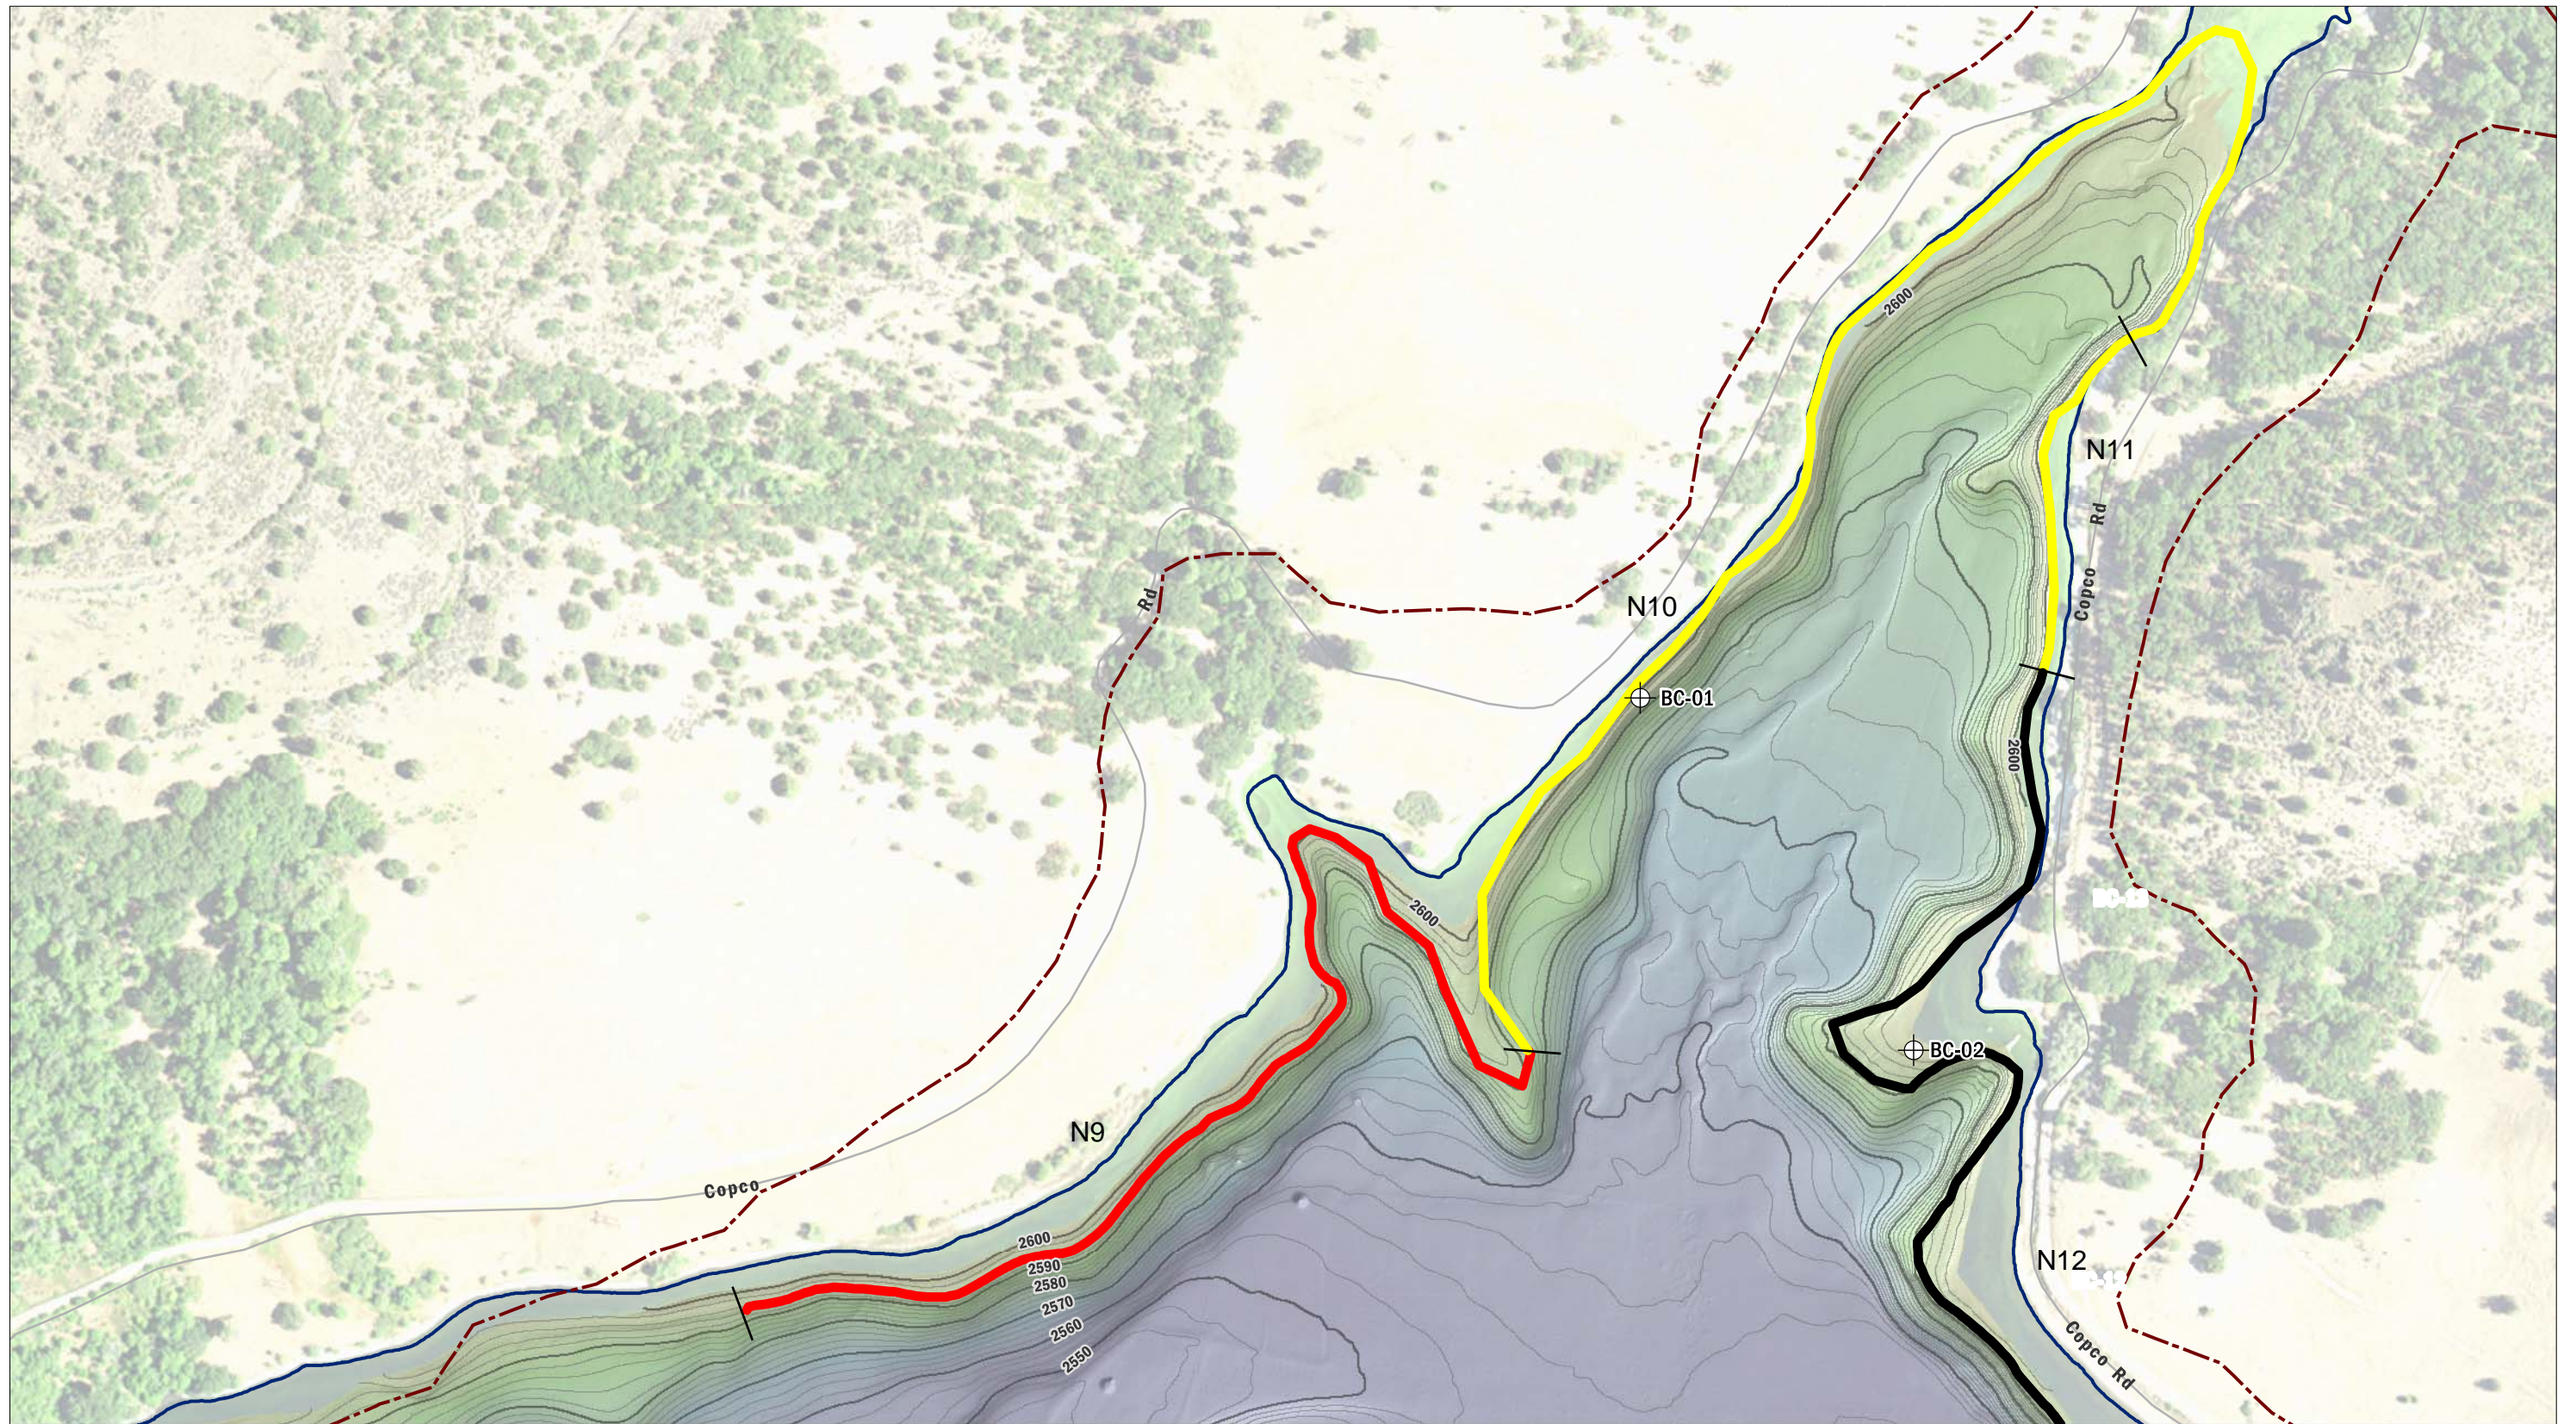
Sheet 1 of 9

Copco Dam - Slope Failure Analysis

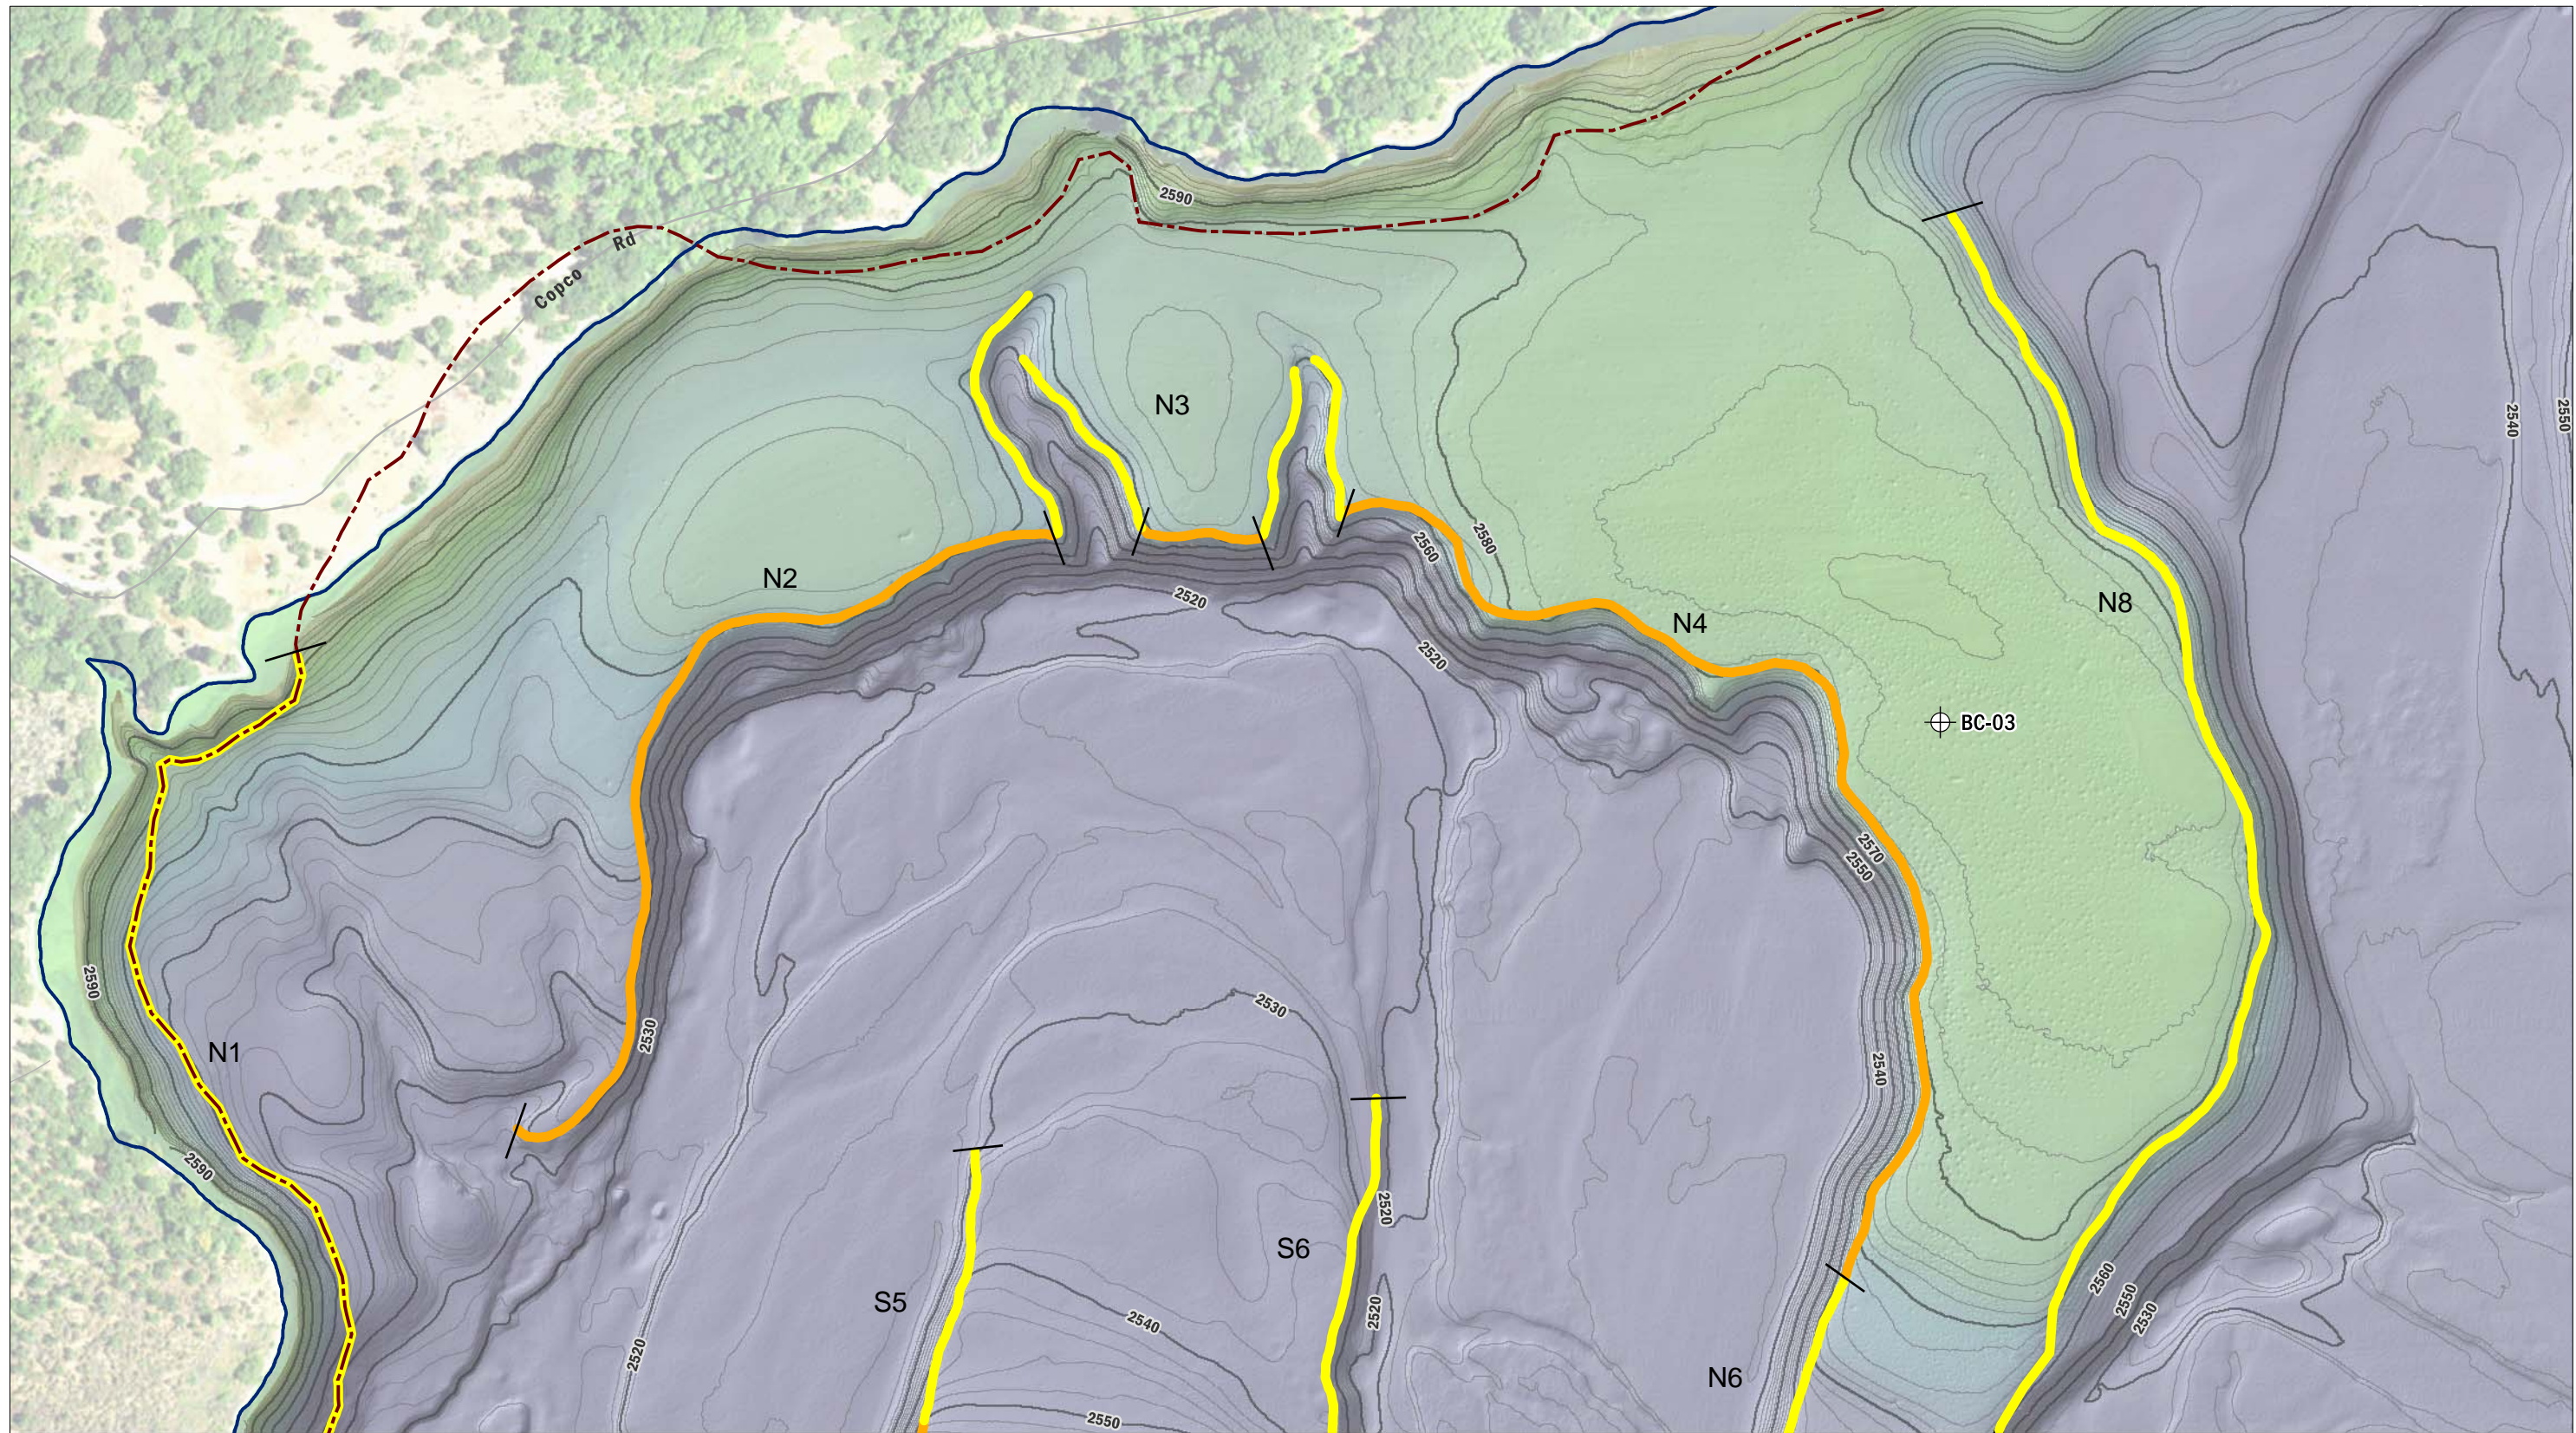
FIGURE 3-4

Copco Dam - Slope Failure Analysis
Sheet 2 of 9

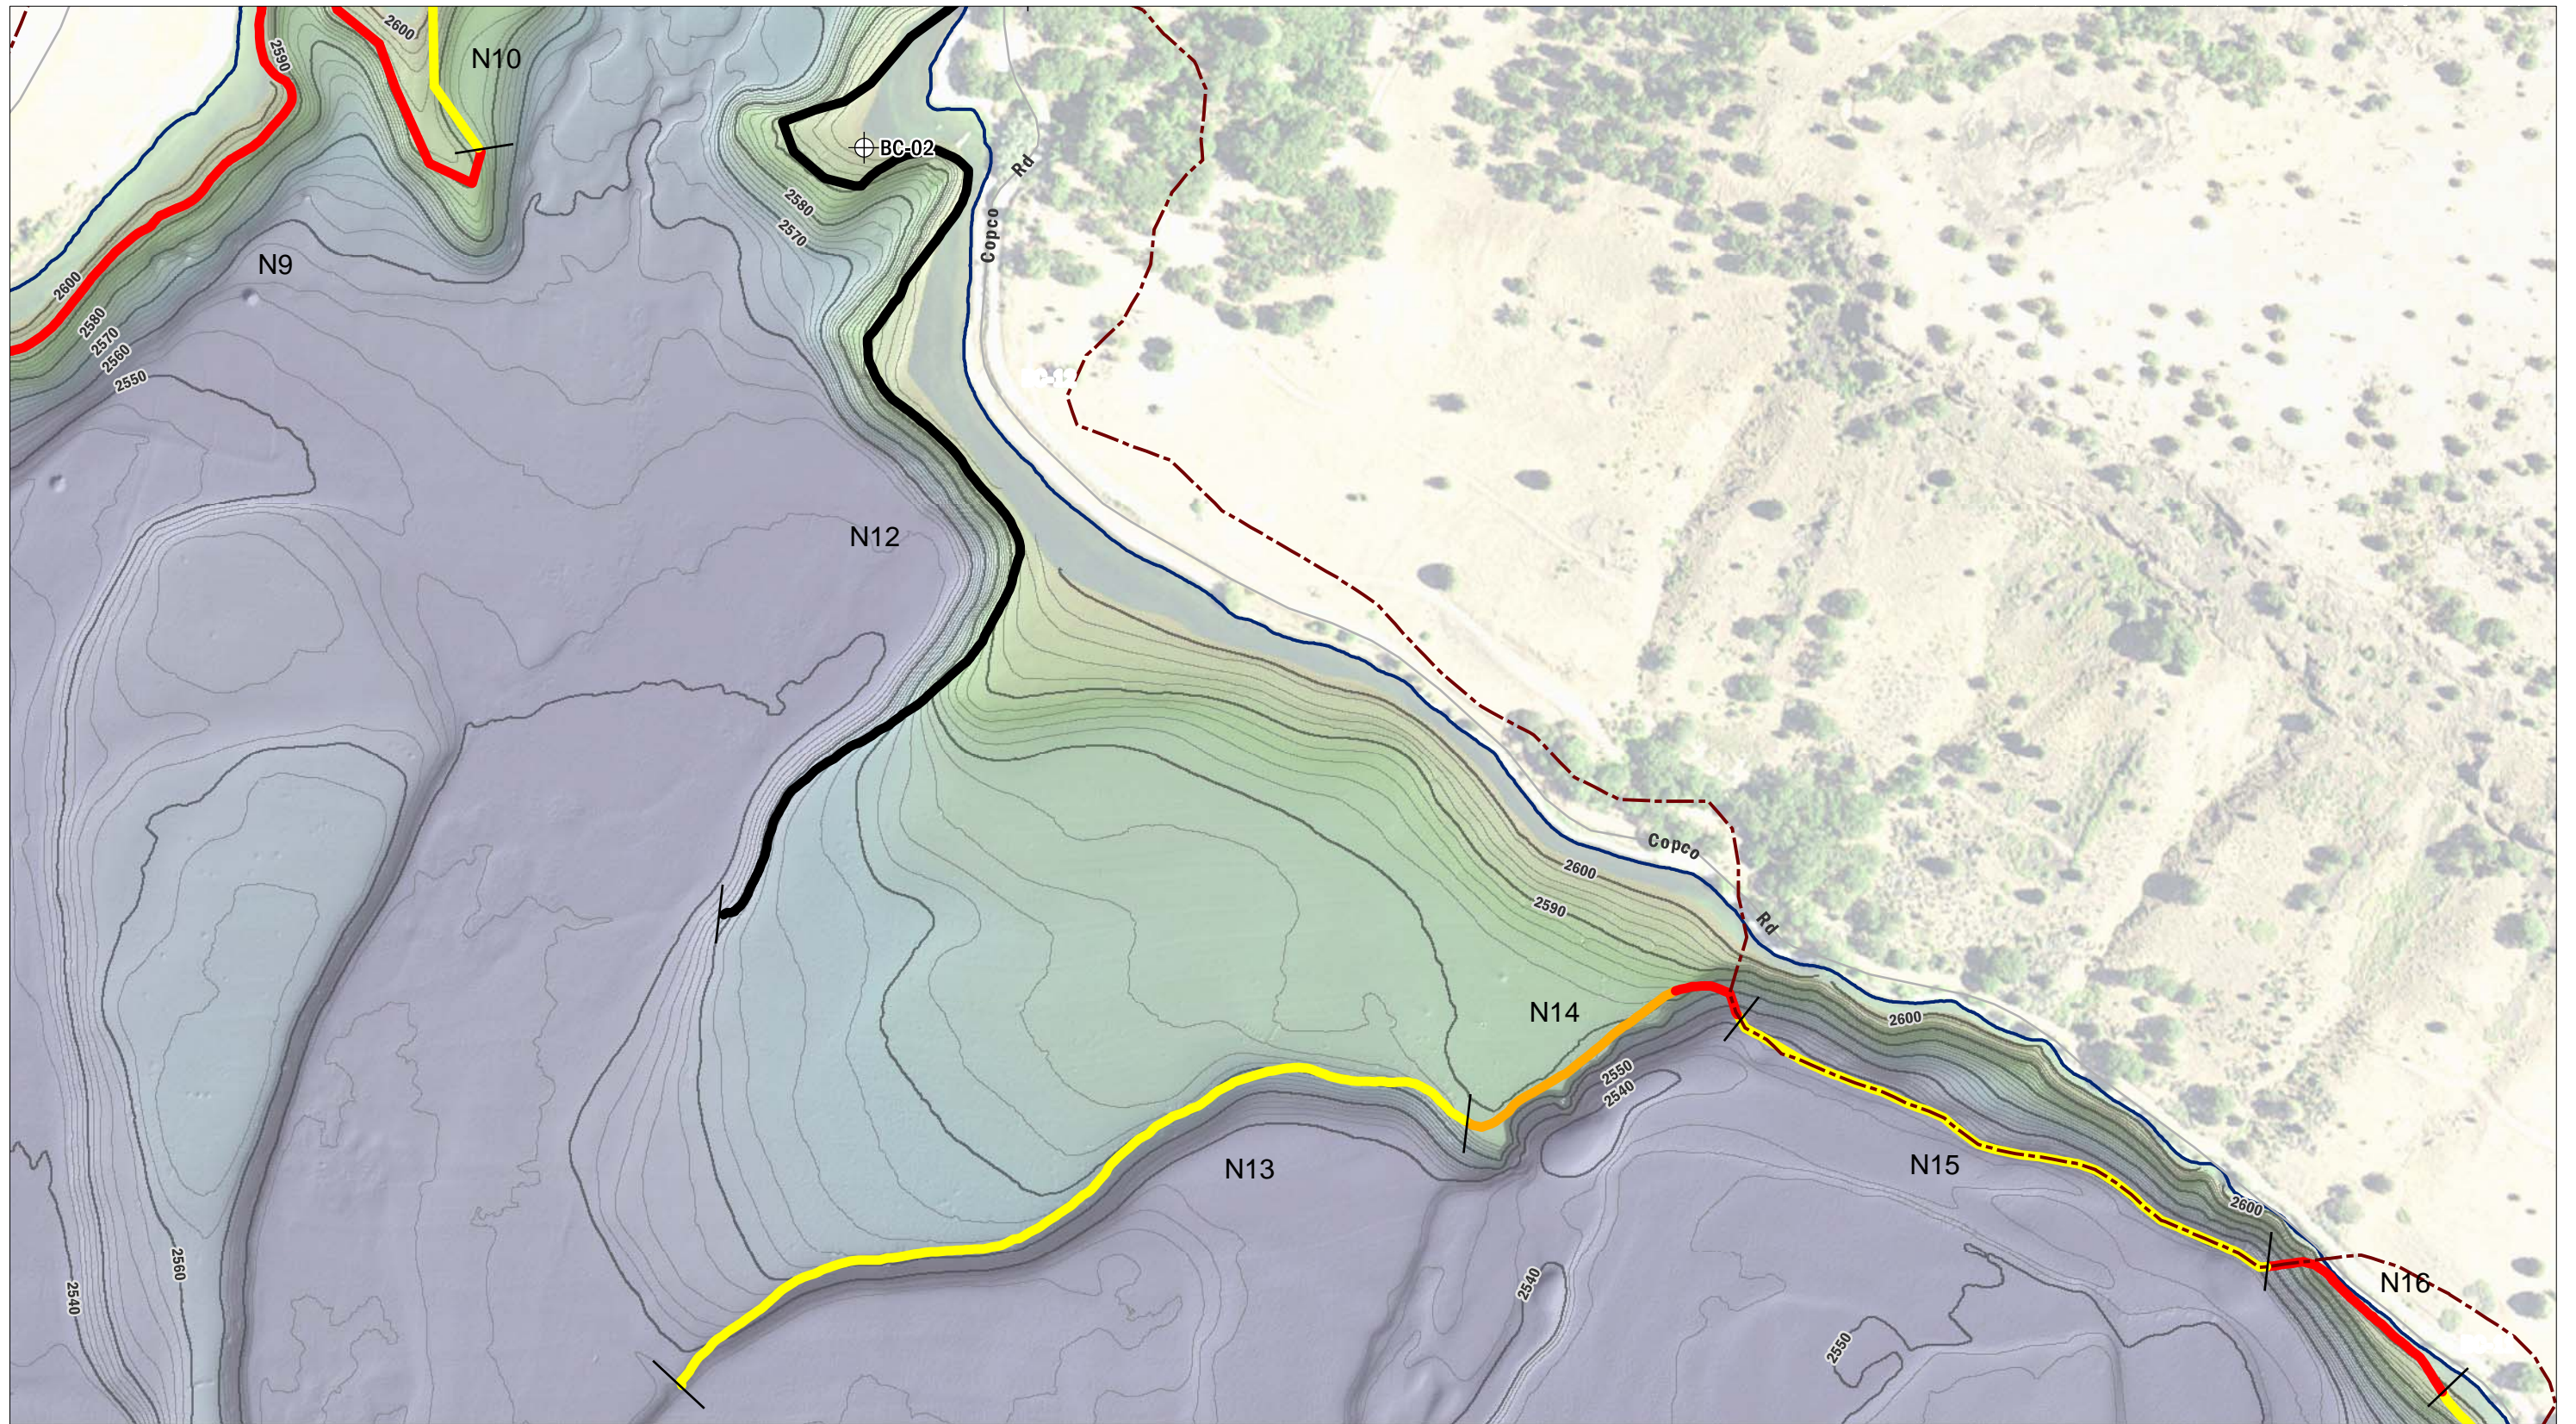
Sheet 3 of 9

Copco Dam - Slope Failure Analysis

- Borings
 - Extent of Fluvio-Lacustrine Deposits
 - Current Reservoir Shoreline
-
- Slope Failure Analysis Features**
 - Incomplete Analysis
 - Stable Slope
 - Potentially Unstable Slope (failure contained within reservoir)
 - Potentially Unstable Slope
-
- Bathymetric Contours**
 - 2 ft.
 - 10 ft.
-
- Segment Information**
 - Segment Extents
 - Segment Names

A summary of the results of the slope stability analyses are presented below. KRRC used a factor of safety of 1.15 as the pass/fail criteria due to the critical nature of some areas and the lack of specific data at most of these locations. Figure 3-4 shows a plan view of the current analysis results, and Figure 3-5 shows cross section results for the rapid drawdown analyses.

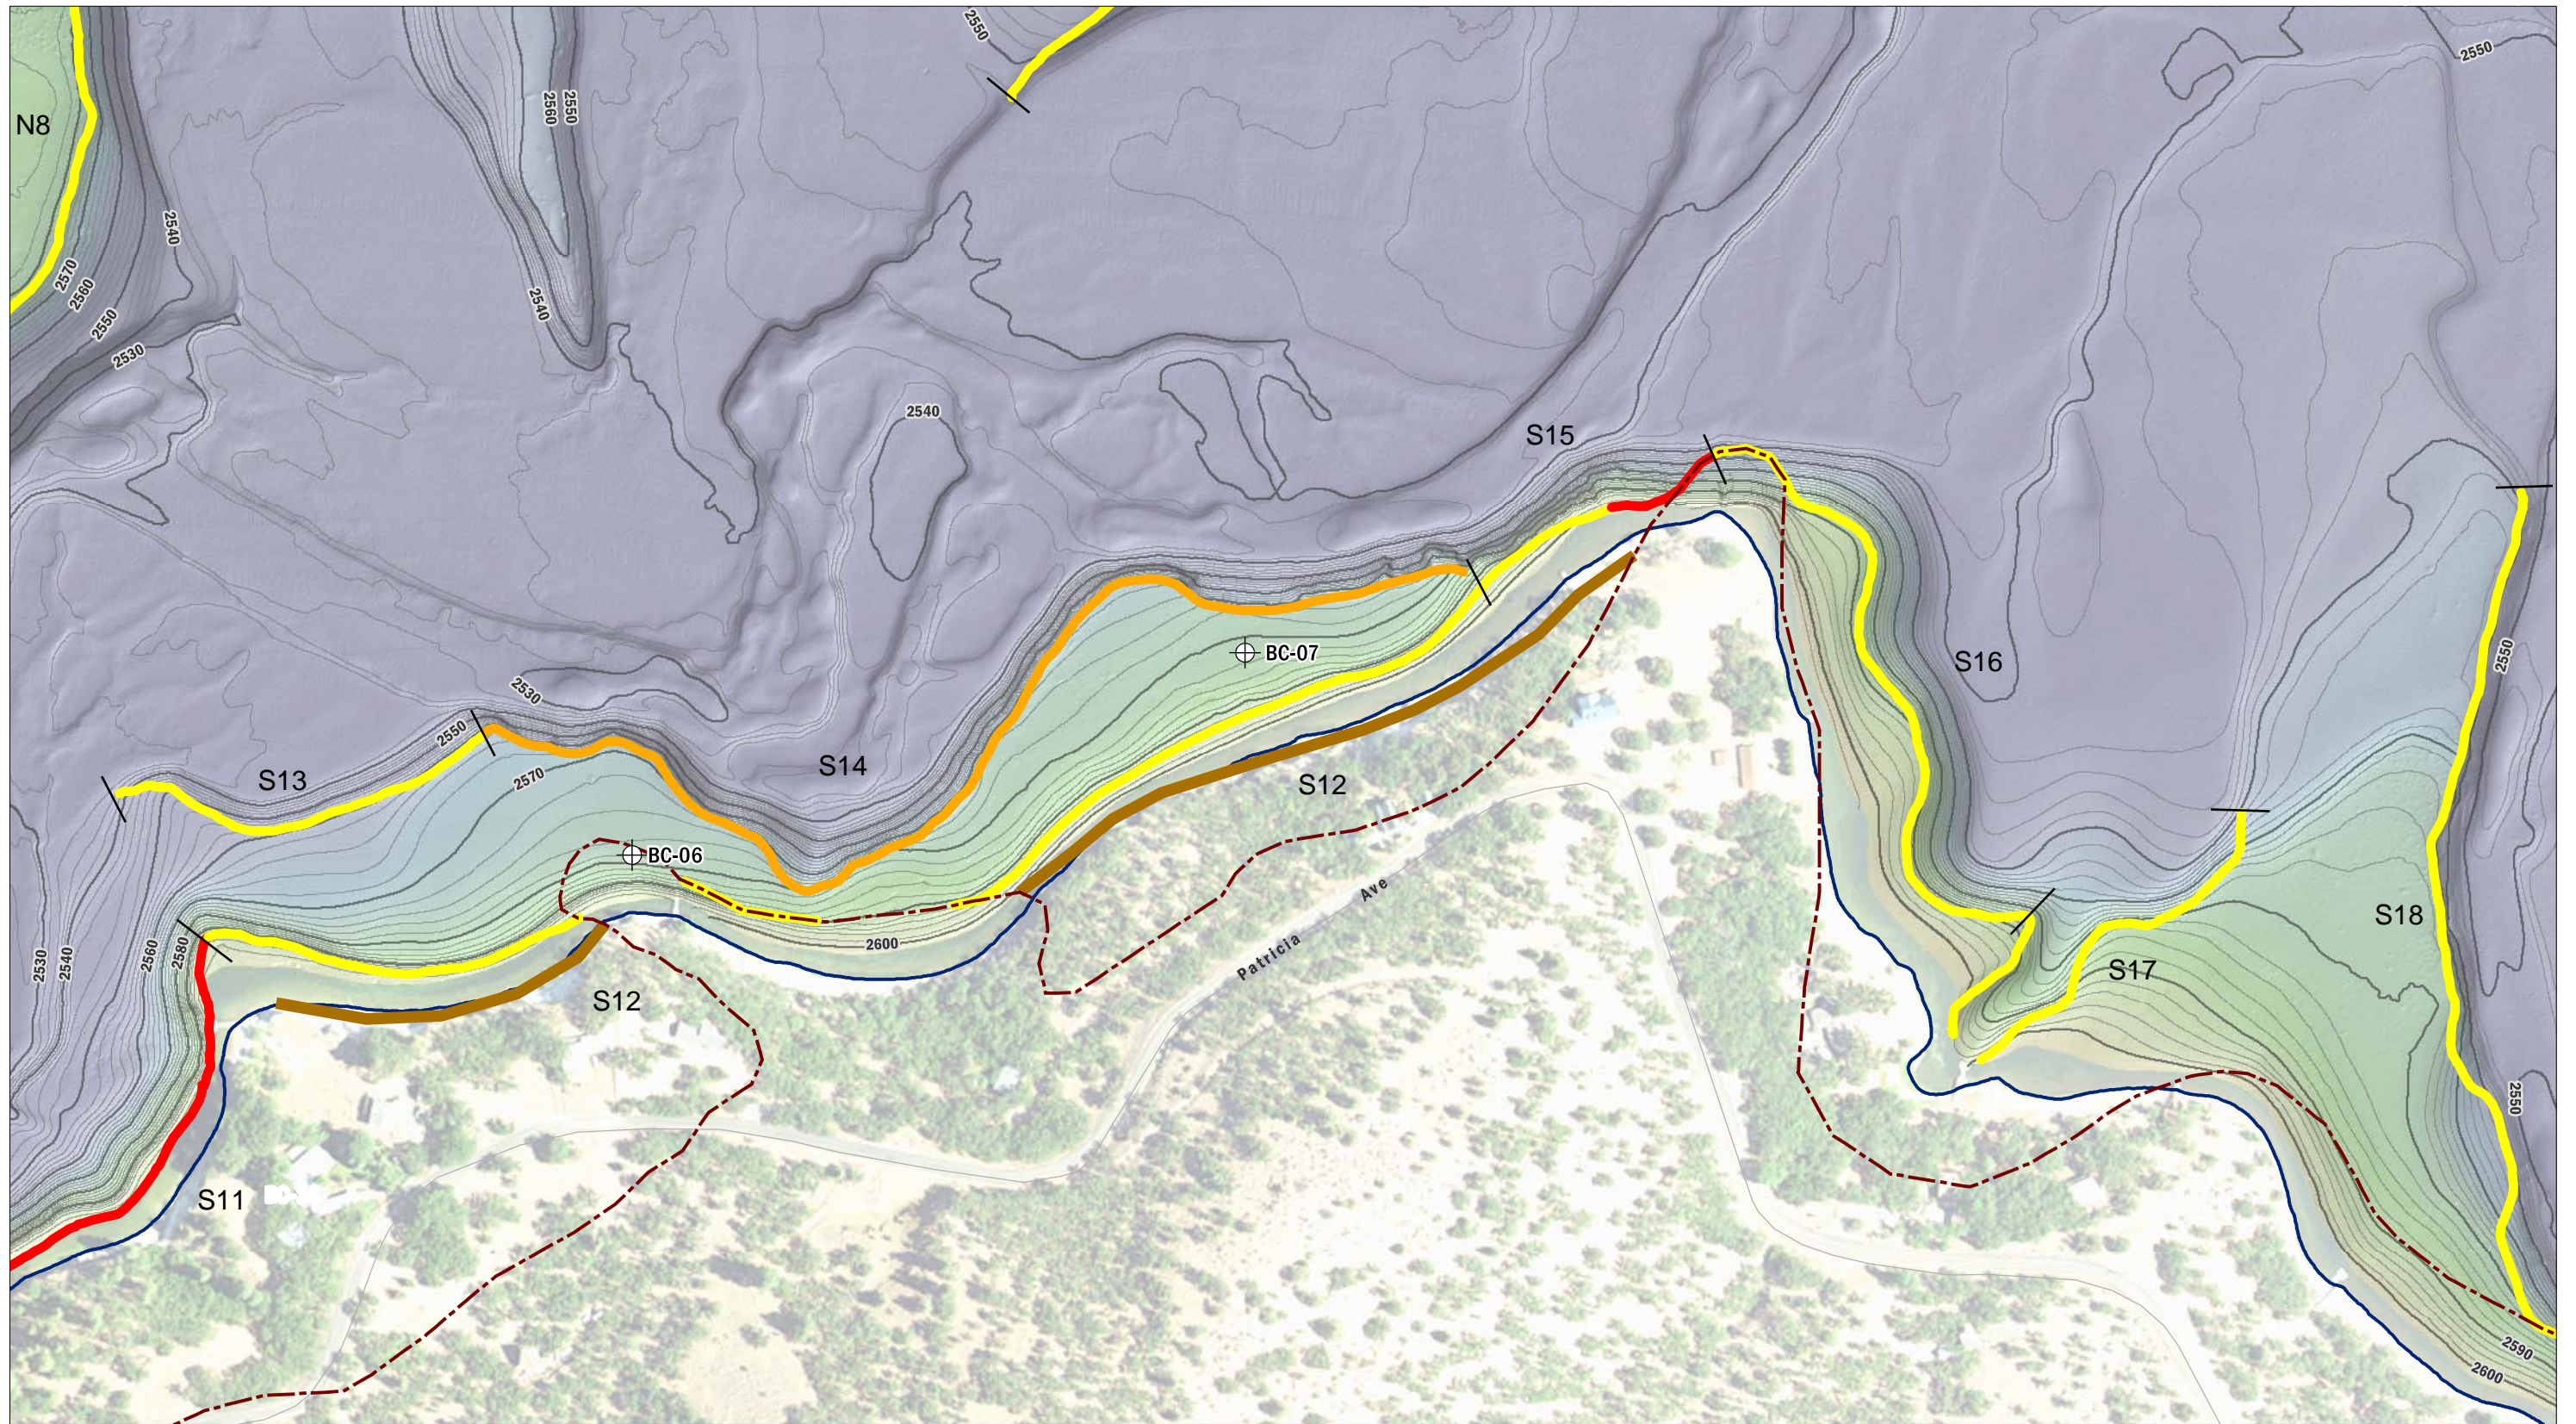
Sheet 4 of 9

Copco Dam - Slope Failure Analysis

- Borings
 - Extent of Fluvio-Lacustrine Deposits
 - Volcanic Rock Exposed in Shoreline Notch
 - Current Reservoir Shoreline
- Slope Failure Analysis Features**
 - Stable Slope
 - Potentially Unstable Slope (failure contained within reservoir)
 - Potentially Unstable Slope
- Bathymetric Contours**
 - 2 ft.
 - 10 ft.
- Segment Information**
 - Segment Extents
 - Segment Names

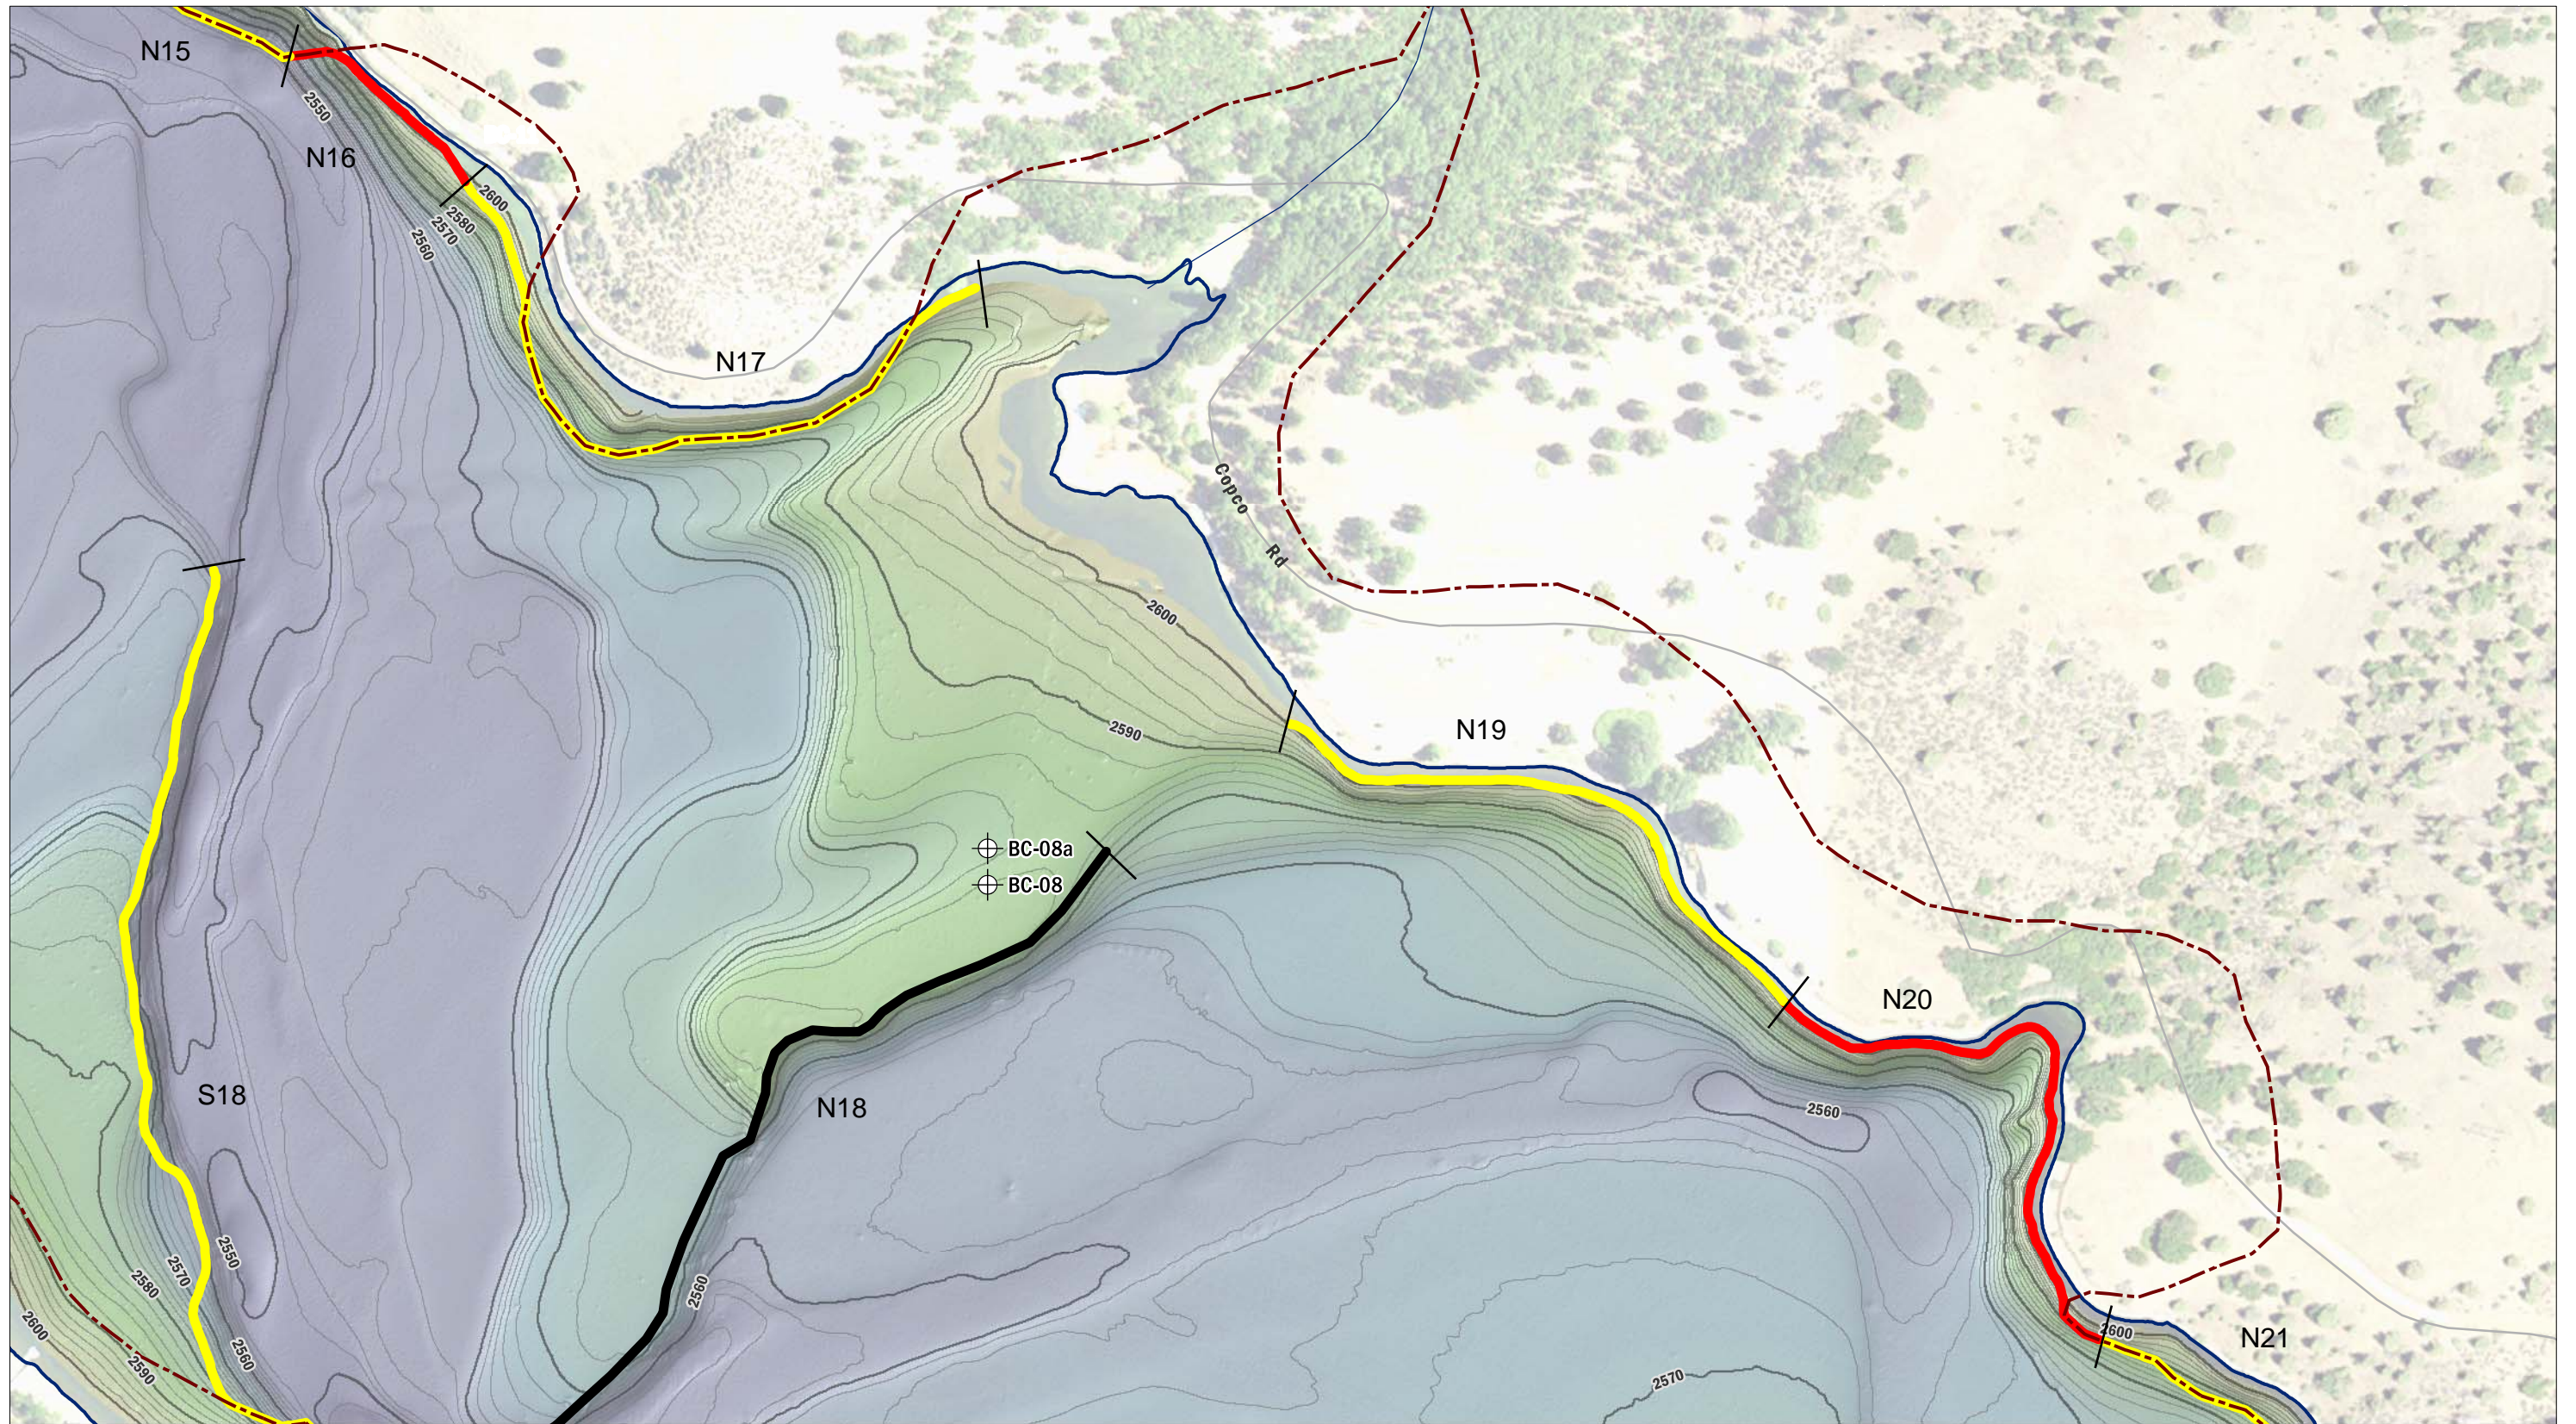
Copco Dam - Slope Failure Analysis
Sheet 5 of 9

Slope Failure Analysis Features
 — Incomplete Analysis
 — Stable Slope
 — Potentially Unstable Slope
