Definite Plan for the Lower Klamath Project

Appendix A – Risk Management Plan

June 2018

Klamath River Renewal Corporation

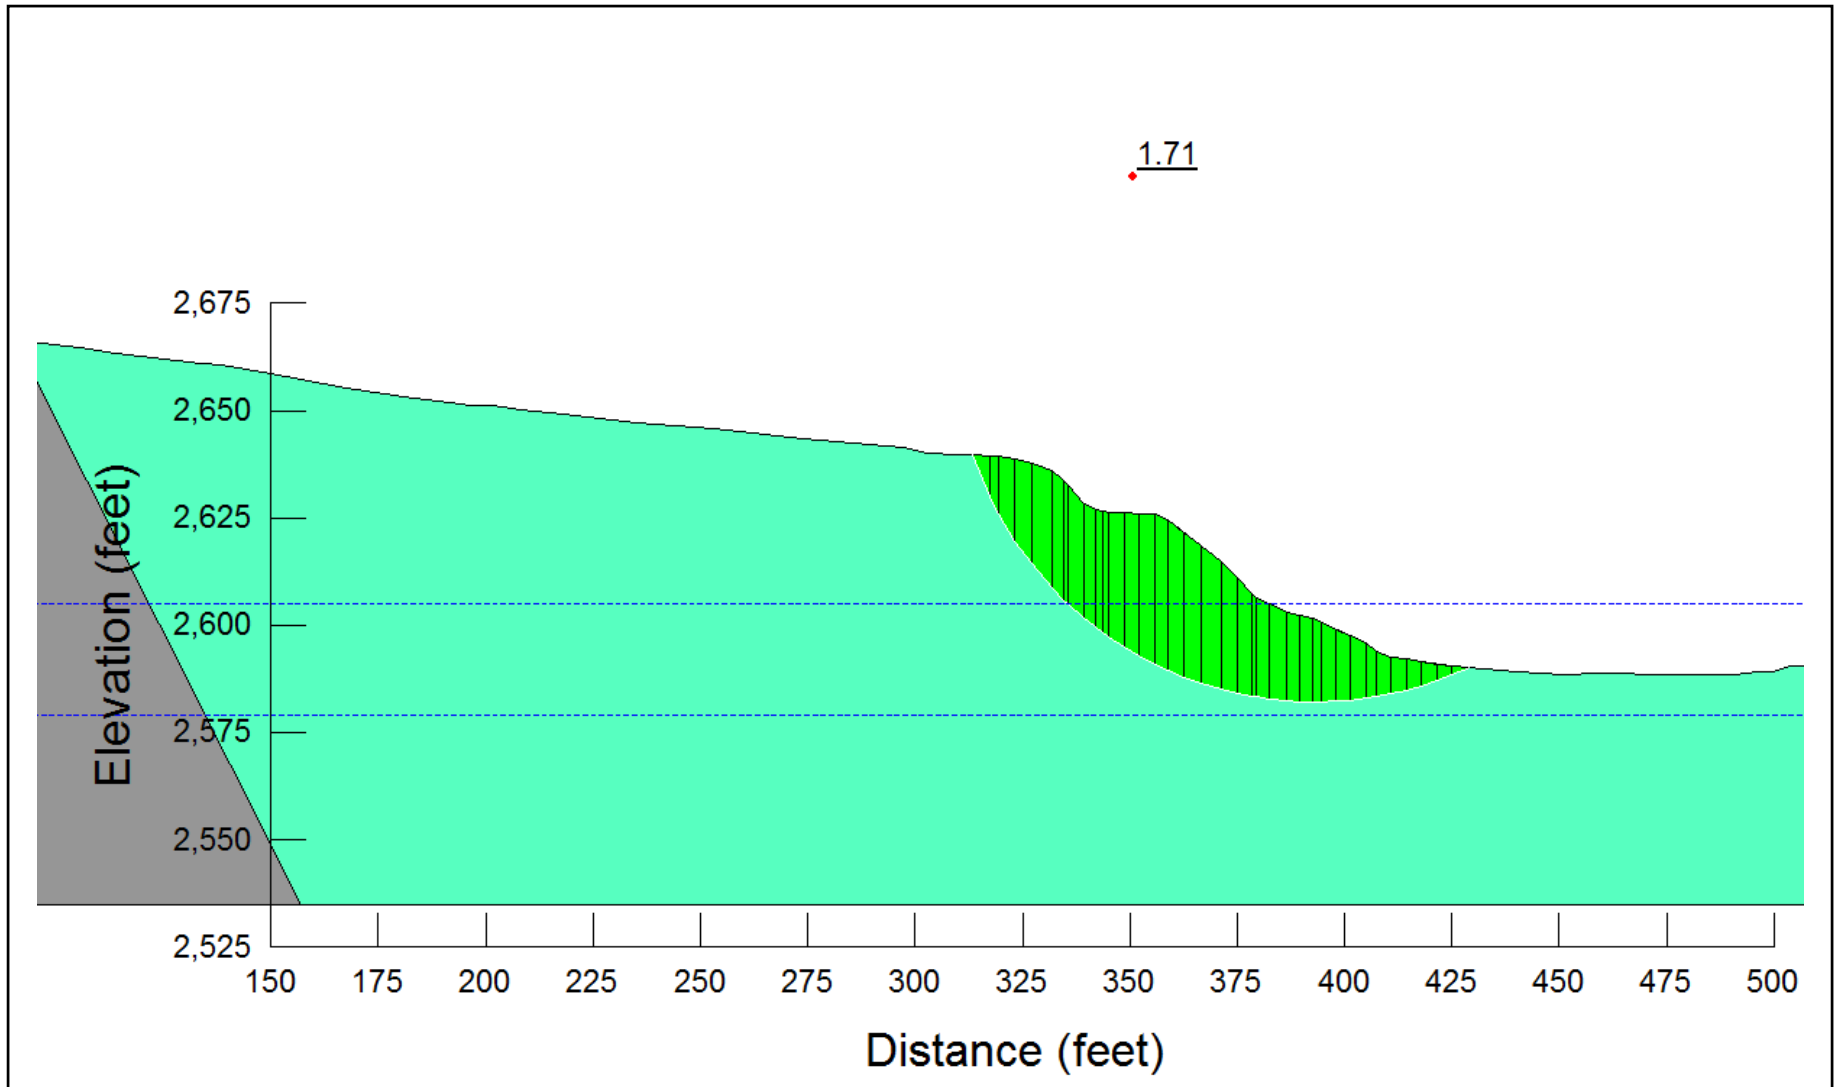
Klamath River Renewal Corporation	Copco Reservoir Slope Stability Segment N11, Section 1	Figure
AECOM	Rapid Drawdown Analysis	3-5b

A summary of the results of the slope stability analyses are presented below. KRRC used a factor of safety of 1.15 as the pass/fail criteria due to the critical nature of some areas and the lack of specific data at most of these locations. Figure 3-4 shows a plan view of the current analysis results, and Figure 3-5 shows cross section results for the rapid drawdown analyses.

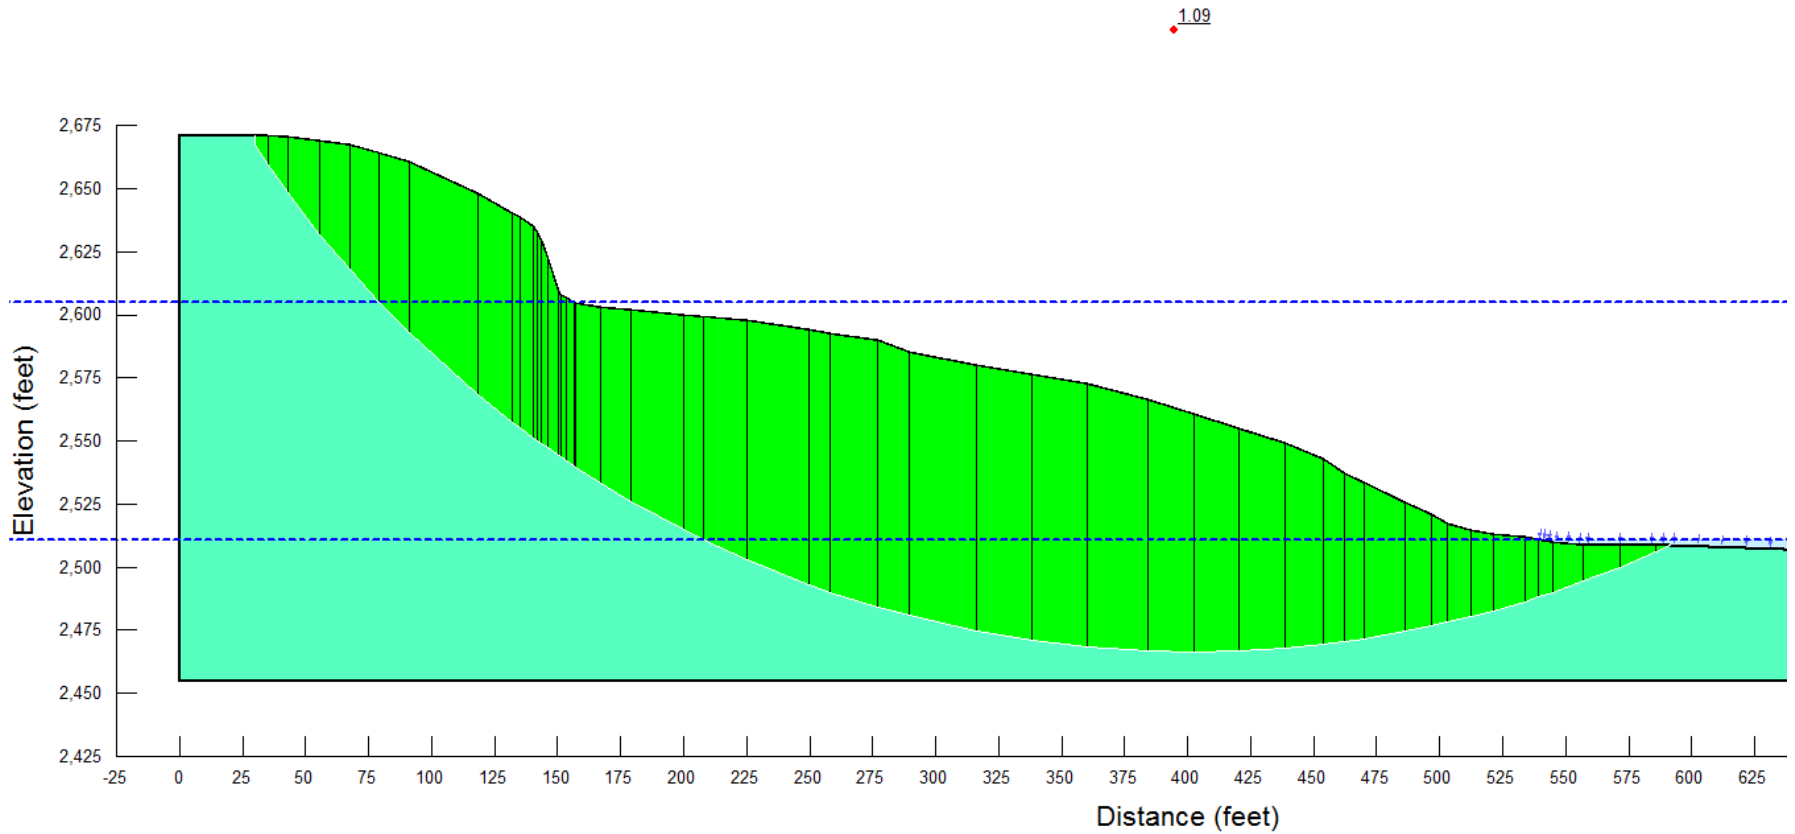
Figure
3-5c

Copco Reservoir Slope Stability
Segment S1, Section 1
Rapid Drawdown Analysis

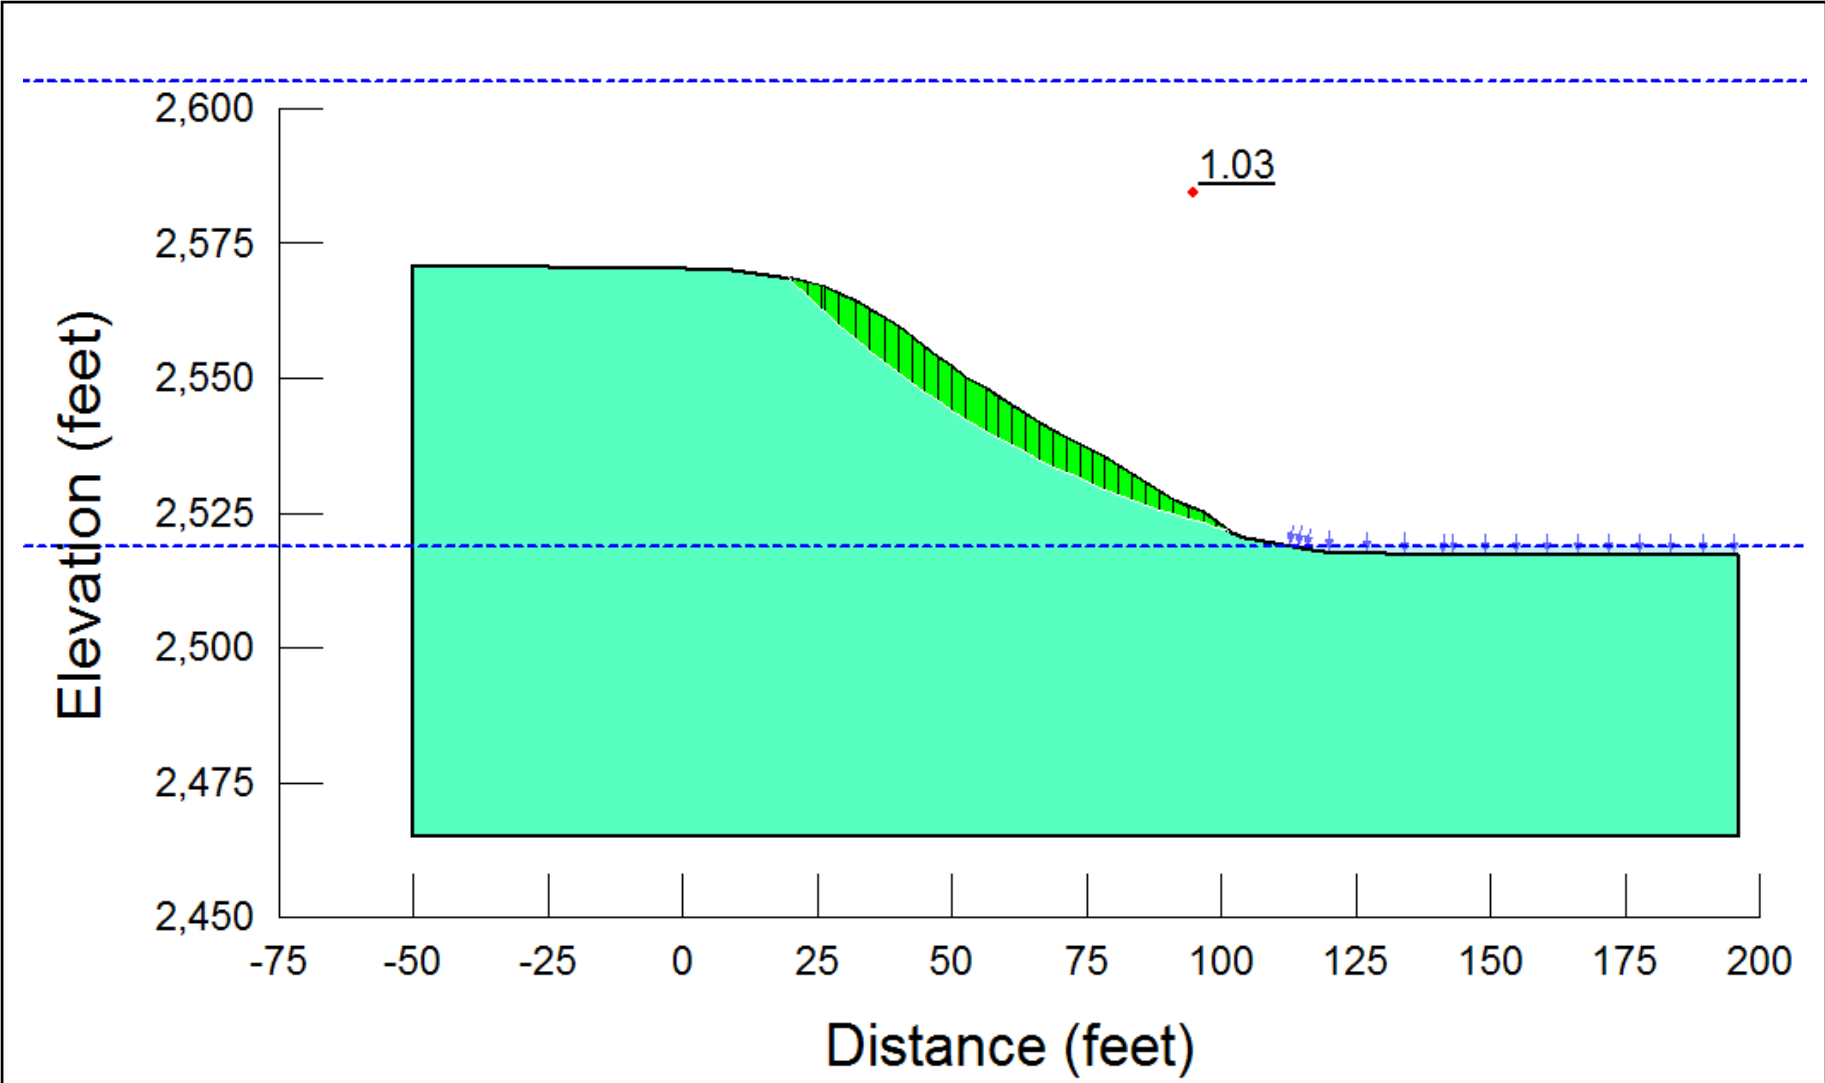
Klamath River Renewal Corporation	Copco Reservoir Slope Stability Segment S3, Section 1 Rapid Drawdown Analysis	Figure 3-5d
AECOM

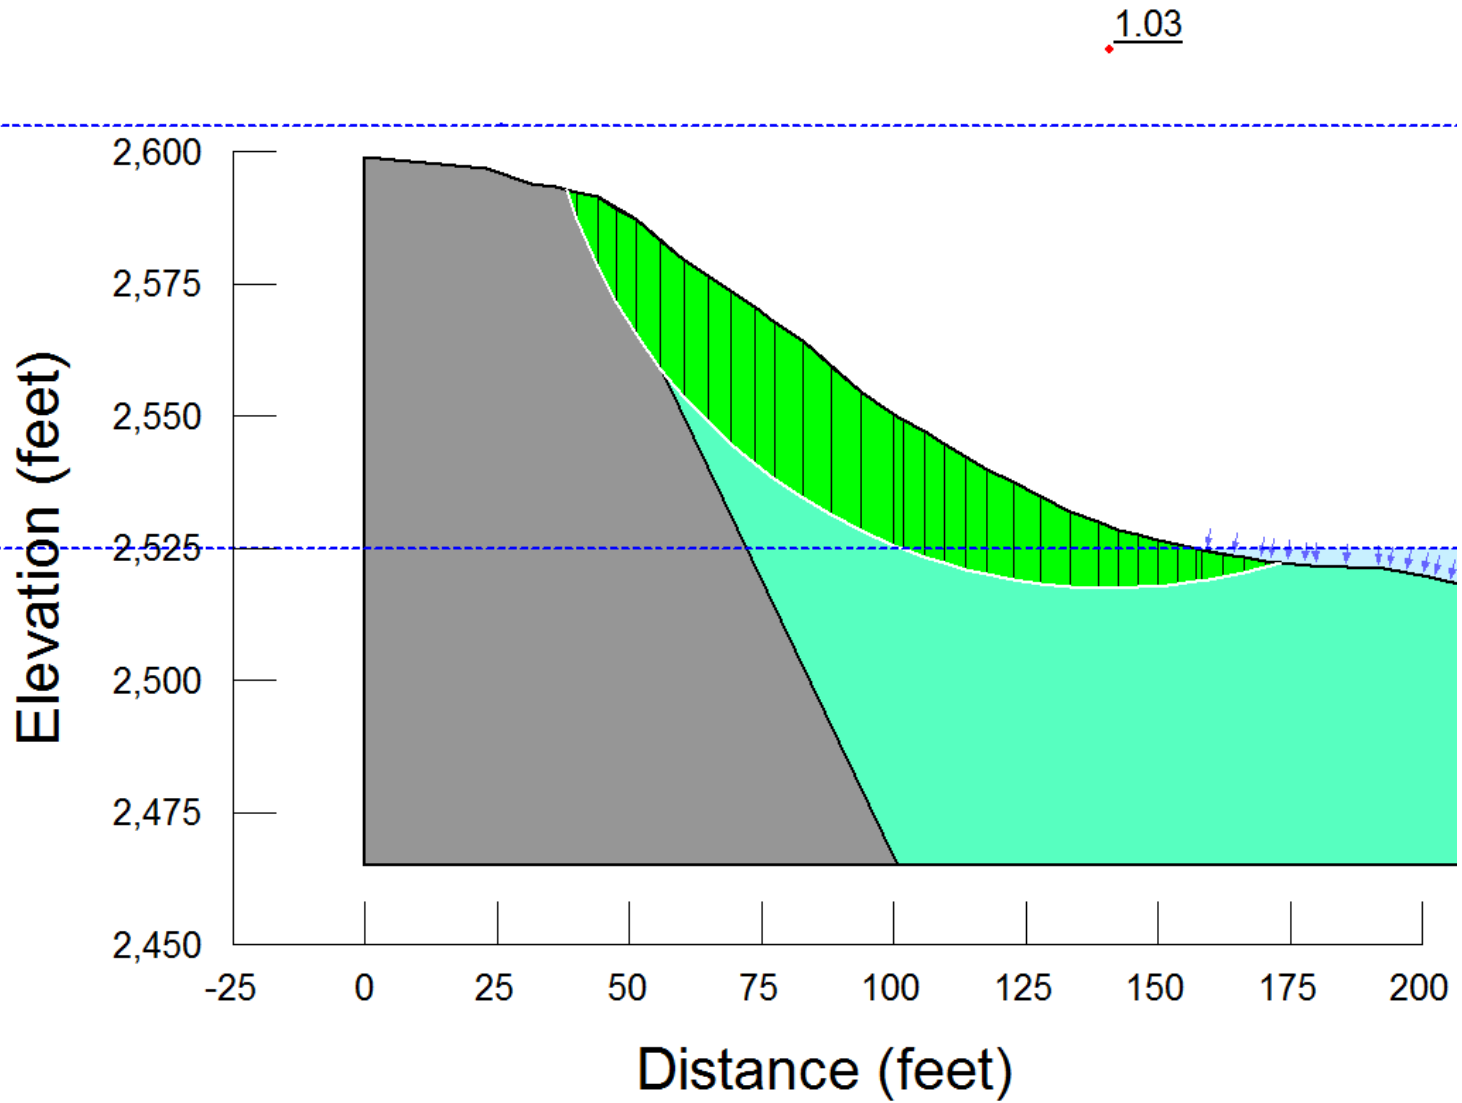
Klamath River Renewal Corporation	Copco Reservoir Slope Stability Segment S10, Section 1	Figure
AECOM	Rapid Drawdown Analysis	3-5e

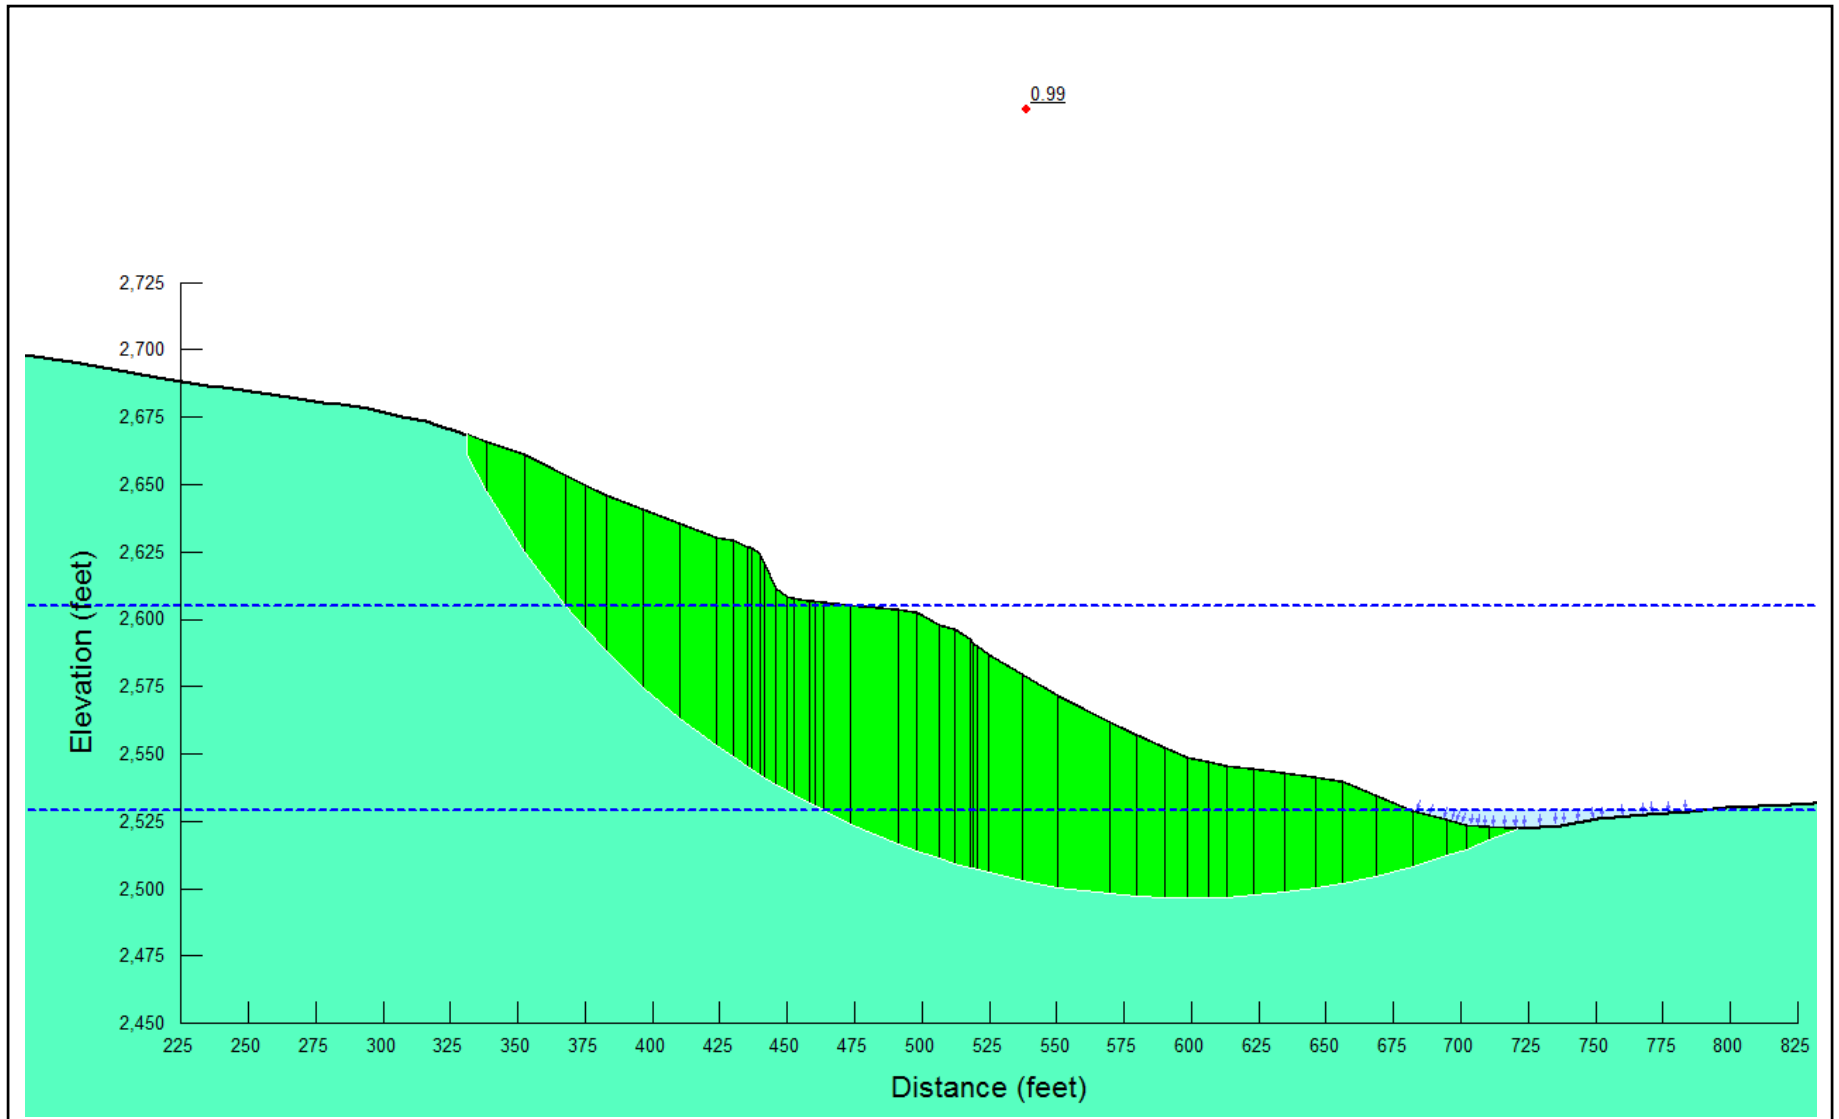
Klamath River Renewal Corporation	Copco Reservoir Slope Stability Segment S11, Section 1	Figure

Rapid Drawdown Analysis	3-5f

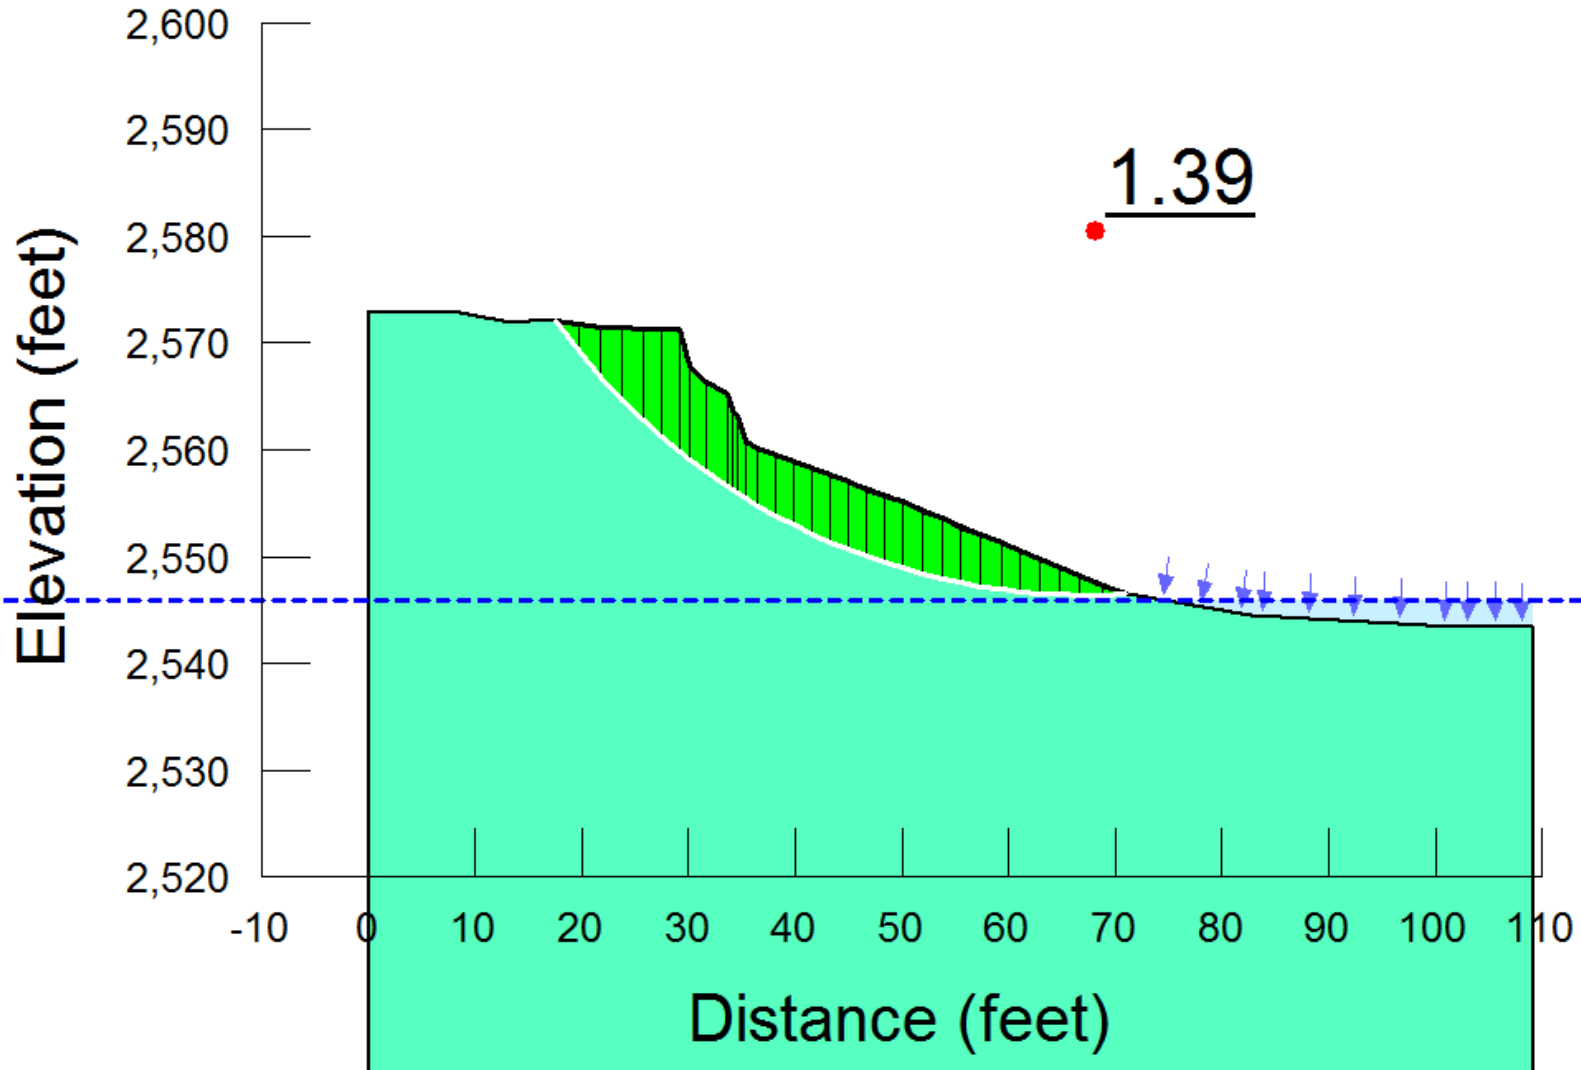
Klamath River Renewal Corporation	Copco Reservoir Slope Stability Segment S18, Section 1	Figure
AECOM	Rapid Drawdown Analysis	3-5g

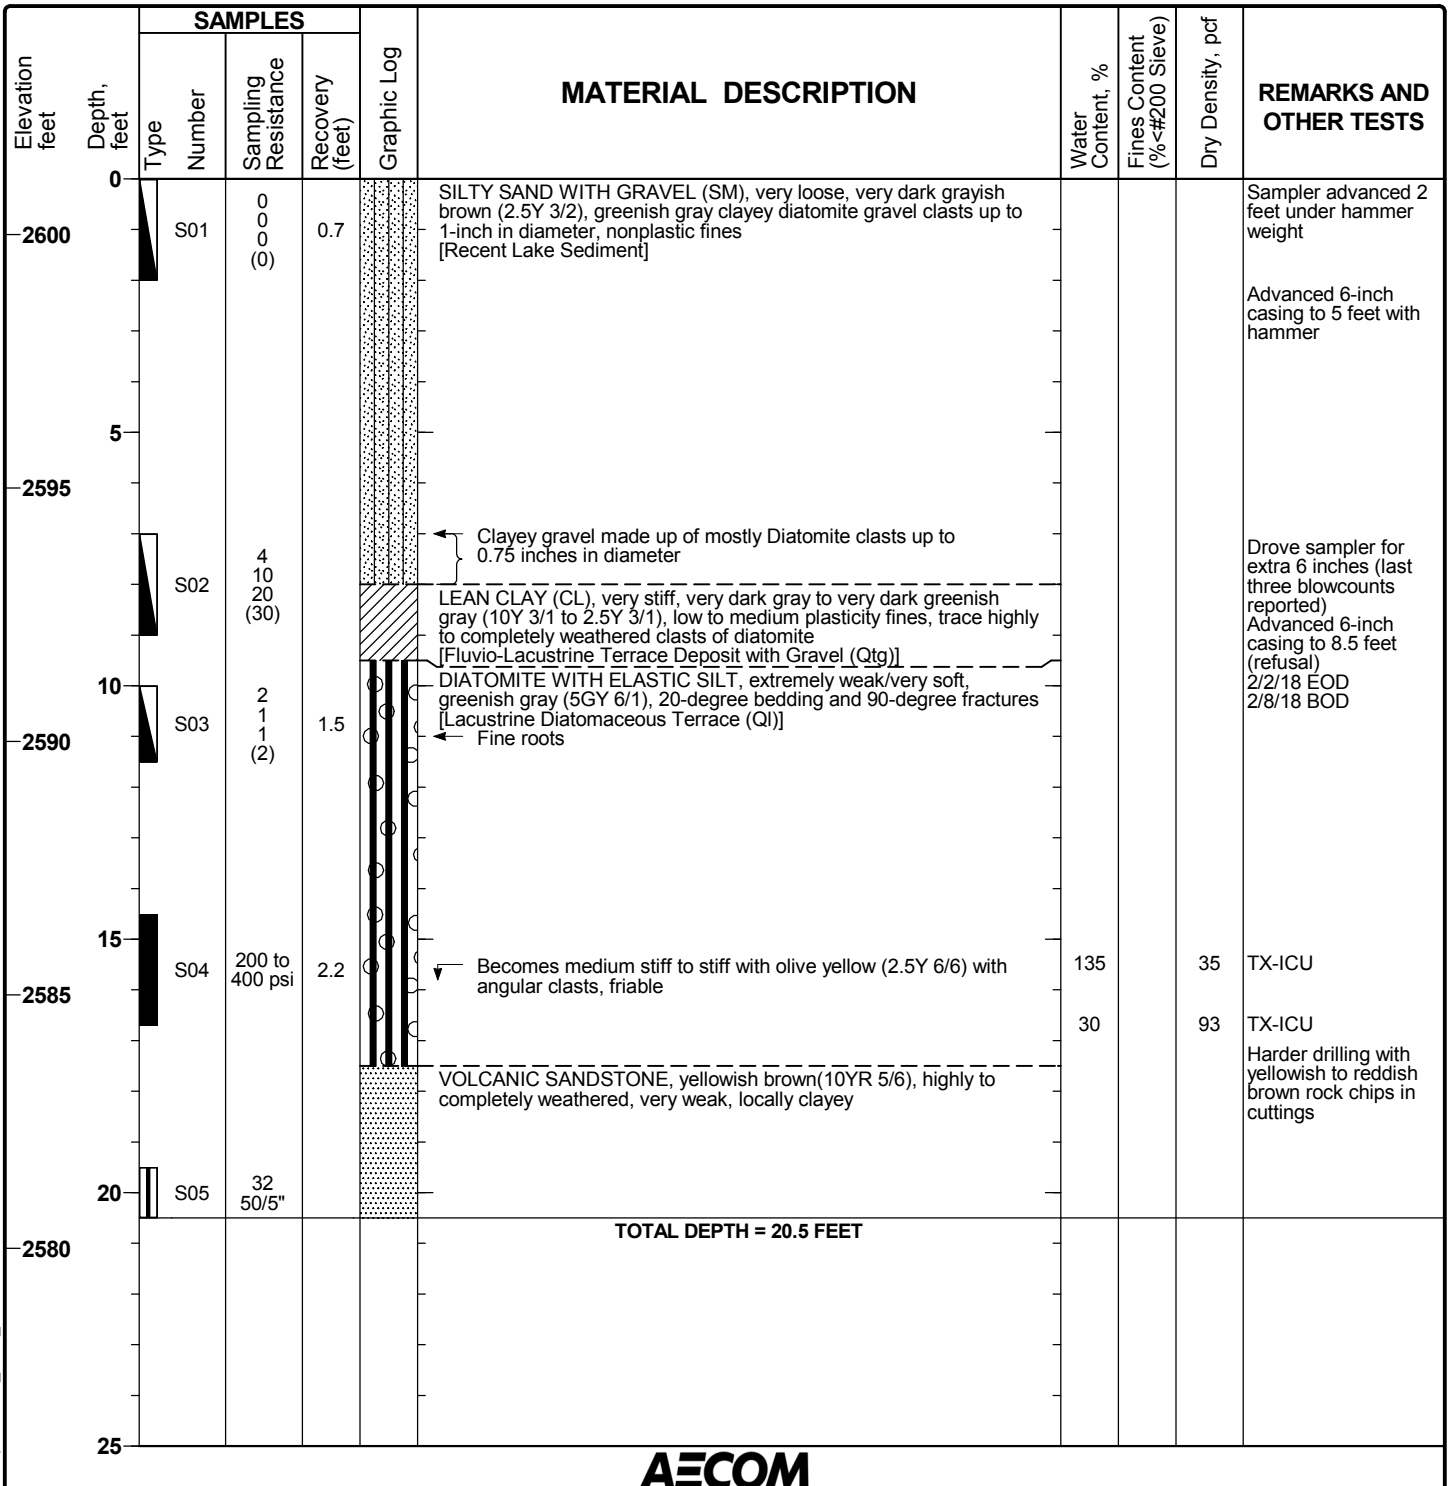
Report: GEO_10B1_OAK; File: BORING LOGS.GPJ; 6/21/2018 BC-05

Date(s) Drilled	2/2/2018, 2/8/2018	Logged By	B. Kozlowicz	Checked By	D. Simpson
Drilling Method	Rotary Wash	Drill Bit Size/Type	4-inch Tricone	Total Depth of Borehole	20.5 feet
Drill Rig Type	Barge Mounted CME-45	Drilling Contractor	Taber Drilling	Surface Elevation	2601.1
Groundwater Level(s)	8.2 feet (2/2 at 11:00) and 6.6 (2/8 at 12:15) feet above ground surface	Sampling Method(s)	2.5-inch ID Mod Cal, SPT, 3-inch Shelby Tube	Hammer Data	Auto hammer (140 lb, 30-inch drop)
Borehole Backfill	Bentonite cement grout to 10 feet bgs	Location		Coordinates	N 2604139 E 6474515

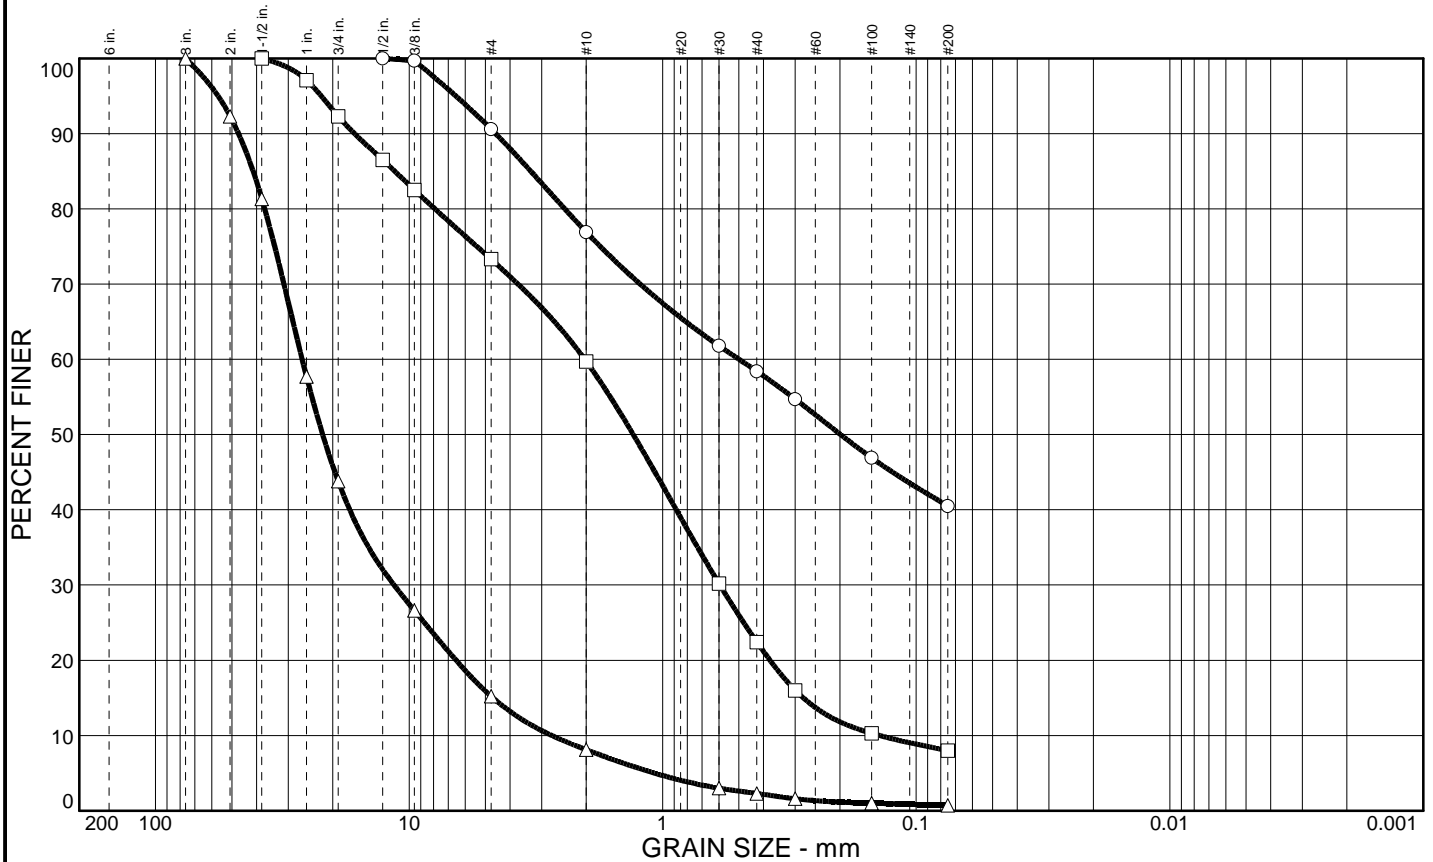
Particle Size Distribution Report

% COBBLES	% GRAVEL	% SAND	% SILT	% CLAY	USCS	AASHTO	PL	LL
○		9.4	50.1		40.5				
□		26.7	65.3		8.0				
△		84.8	14.5		0.7

SIEVE inches size	PERCENT FINER			SIEVE number size	PERCENT FINER			SOIL DESCRIPTION
	○	□	△		○	□	△	
3			100.0	#4	90.6	73.3	15.2	○ Reddish Brown Clayey SAND □ Dark Olive Brown Well-Graded SAND w/ Silt & Gravel △ Dark Olive Brown Well-Graded GRAVEL
2			92.3	#10	76.9	59.7	8.1	
1.5"		100.0	81.3	#30	61.8	30.2	3.0	
1"		97.1	57.7	#40	58.4	22.4	2.3	
3/4"		92.3	43.8	#50	54.7	16.0	1.6	
1/2"	100.0	86.5		#100	46.9	10.3	1.0	
3/8"	99.7	82.5	26.6	#200	40.5	8.0	0.7	
GRAIN SIZE								
D ₆₀	0.500	2.03	26.4					
D ₃₀		0.595	11.5					
D ₁₀		0.139	2.74					
COEFFICIENTS								
C _c		1.25	1.82					
C _u		14.56	9.65

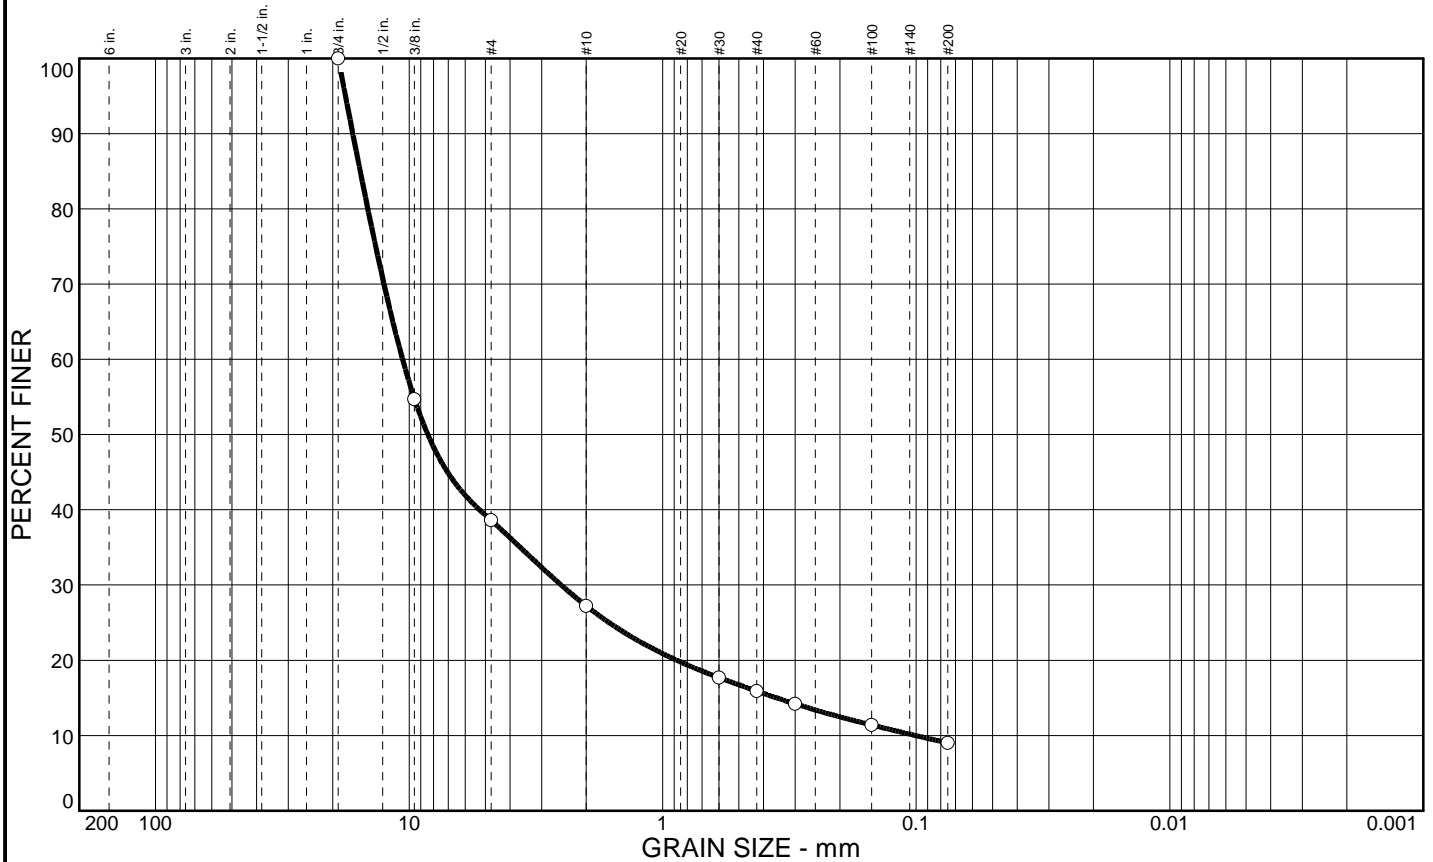
Particle Size Distribution Report

% COBBLES	% GRAVEL	% SAND	% SILT	% CLAY	USCS	AASHTO	PL	LL
0	61.4	29.6	9.0		GP-GM		26	41

SIEVE	PERCENT FINER			SIEVE	PERCENT FINER			SOIL DESCRIPTION
inches size	○			number size	○			○ Olive Gray Poorly Graded GRAVEL w/ Silt & Sand
3/4"	100.0			#4	38.6			
3/8"	54.7			#10	27.2			
				#30	17.7			
				#40	15.9			
				#50	14.2			
				#100	11.4			
				#200	9.0			
GRAIN SIZE								
D60	10.6							REMARKS: ○
D30	2.52							
D10	0.101							
COEFFICIENTS								
C _c	5.92							
C _u	105.44

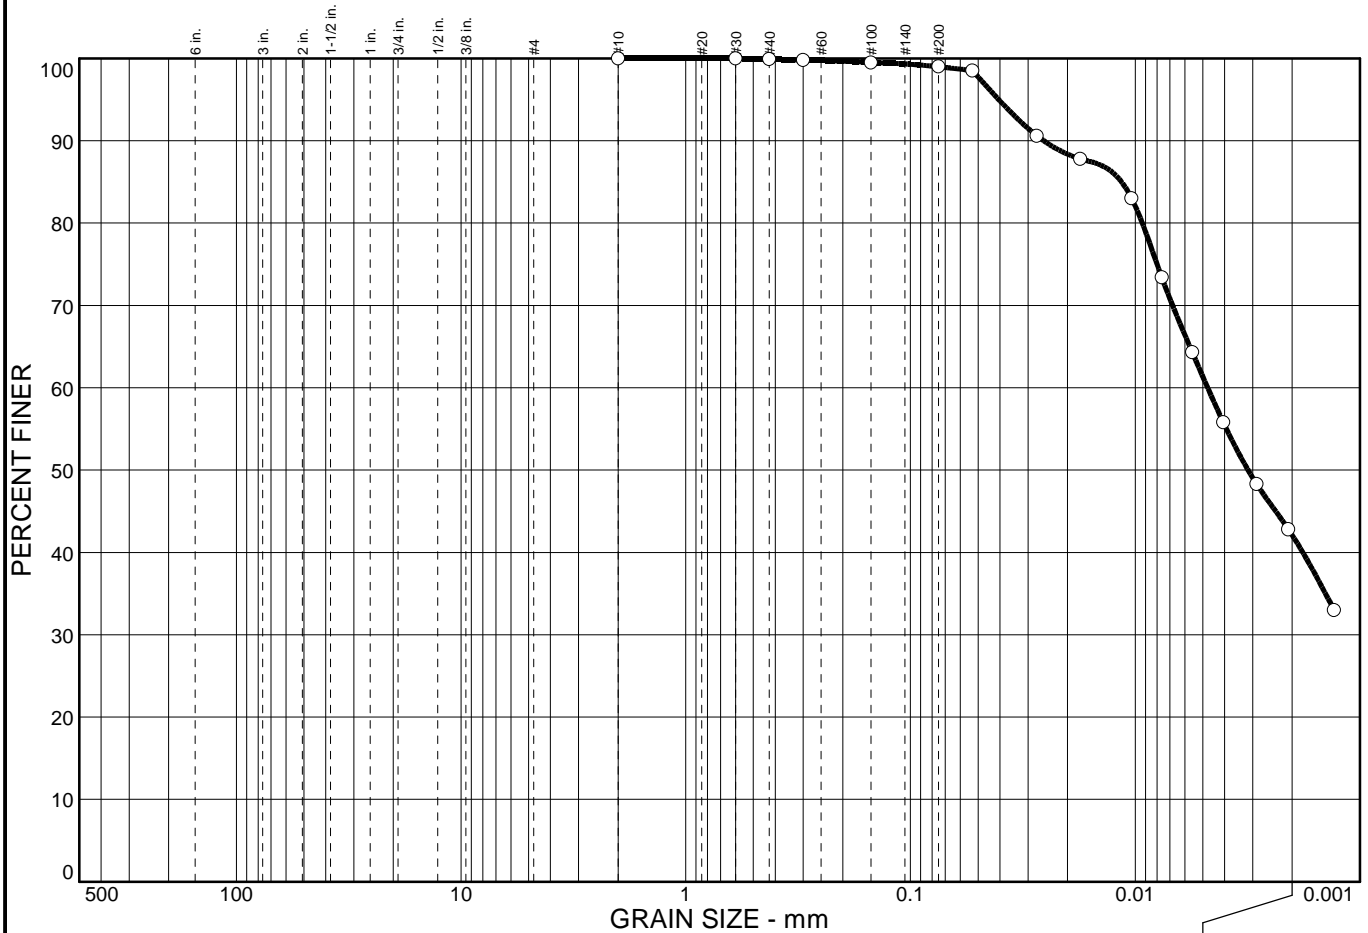
Particle Size Distribution Report

% COBBLES	% GRAVEL	% SAND	% SILT	% CLAY
0.0	0.0	1.0	56.9	42.1

SIEVE SIZE	PERCENT FINER	SPEC.* PERCENT	PASS? (X=NO)
#10	100.0		
#30	100.0		
#40	99.9		
#50	99.8		
#100	99.5		
#200	99.0		
#270	98.5		
0.0274 mm.	90.6		
0.0176 mm.	87.8		
0.0104 mm.	83.0		
0.0076 mm.	73.4		
0.0056 mm.	64.3		
0.0041 mm.	55.8		
0.0029 mm.	48.3		
0.0021 mm.	42.8		
0.0013 mm.	33.0

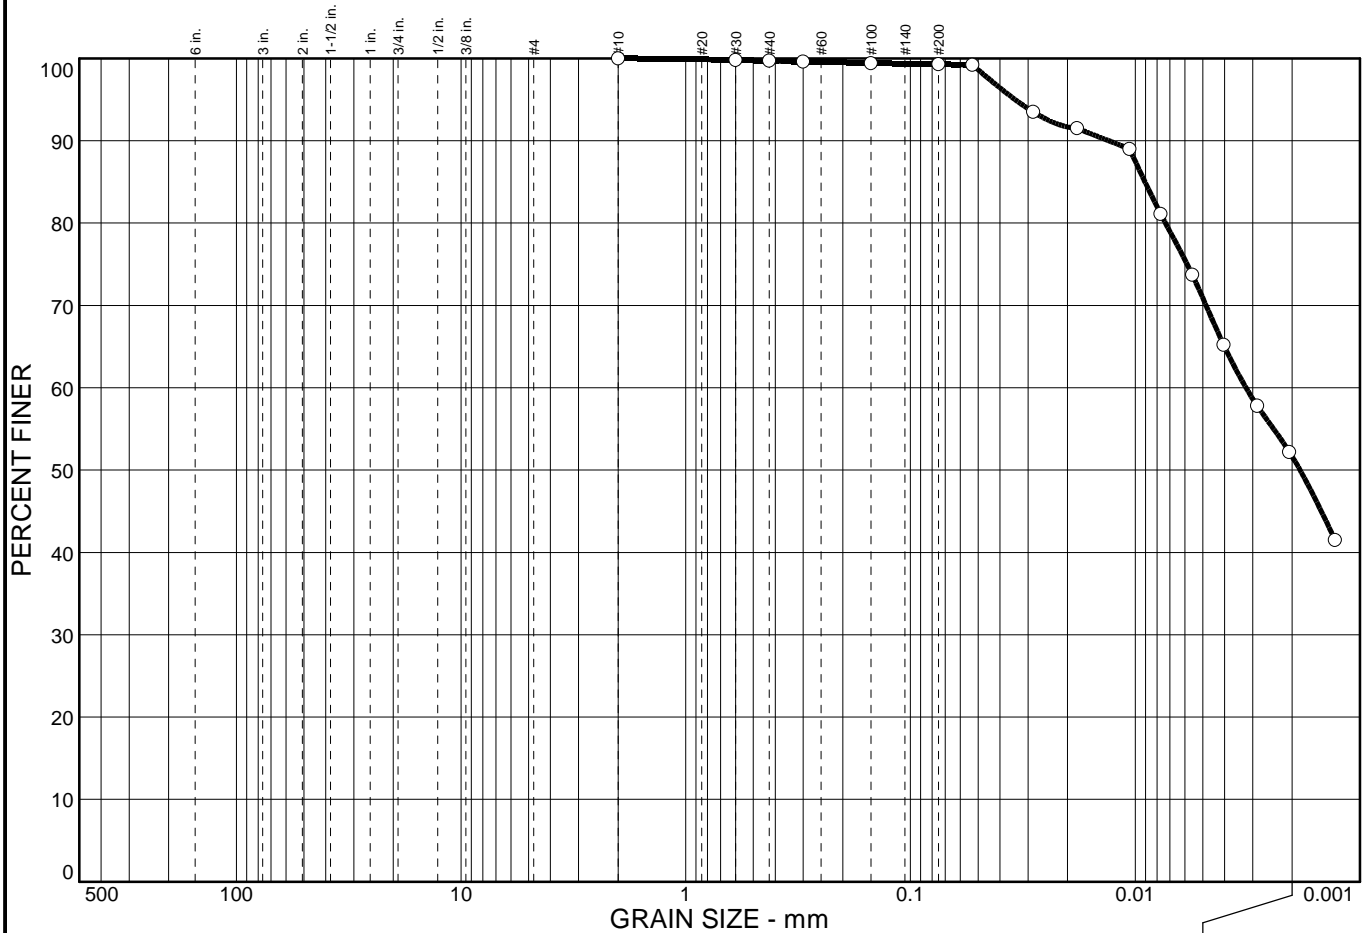
Particle Size Distribution Report

% COBBLES	% GRAVEL	% SAND	% SILT	% CLAY
0.0	0.0	0.7	47.7	51.6

SIEVE SIZE	PERCENT FINER	SPEC.* PERCENT	PASS? (X=NO)
#10	100.0		
#30	99.8		
#40	99.7		
#50	99.6		
#100	99.4		
#200	99.3		
#270	99.2		
0.0285 mm.	93.5		
0.0182 mm.	91.5		
0.0106 mm.	89.0		
0.0077 mm.	81.1		
0.0056 mm.	73.7		
0.0040 mm.	65.2		
0.0029 mm.	57.8		
0.0021 mm.	52.2		
0.0013 mm.	41.5

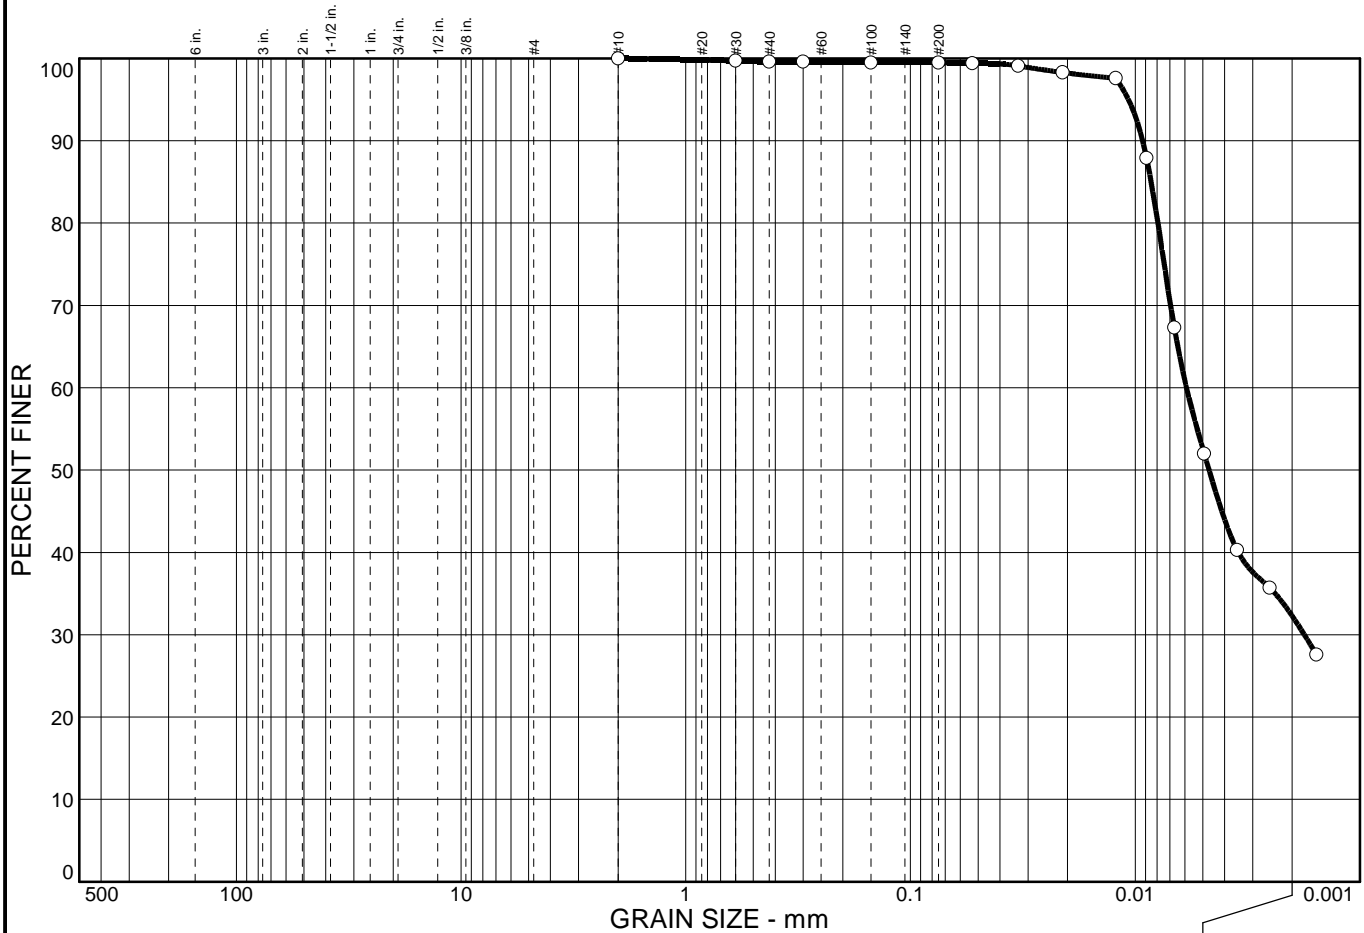
Particle Size Distribution Report

% COBBLES	% GRAVEL	% SAND	% SILT	% CLAY
0.0	0.0	0.5	67.2	32.3

SIEVE SIZE	PERCENT FINER	SPEC.* PERCENT	PASS? (X=NO)
#10	100.0		
#30	99.7		
#40	99.6		
#50	99.6		
#100	99.5		
#200	99.5		
#270	99.4		
0.0331 mm.	99.1		
0.0210 mm.	98.3		
0.0122 mm.	97.6		
0.0089 mm.	87.9		
0.0067 mm.	67.3		
0.0049 mm.	52.0		
0.0035 mm.	40.3		
0.0025 mm.	35.7		
0.0016 mm.	27.6

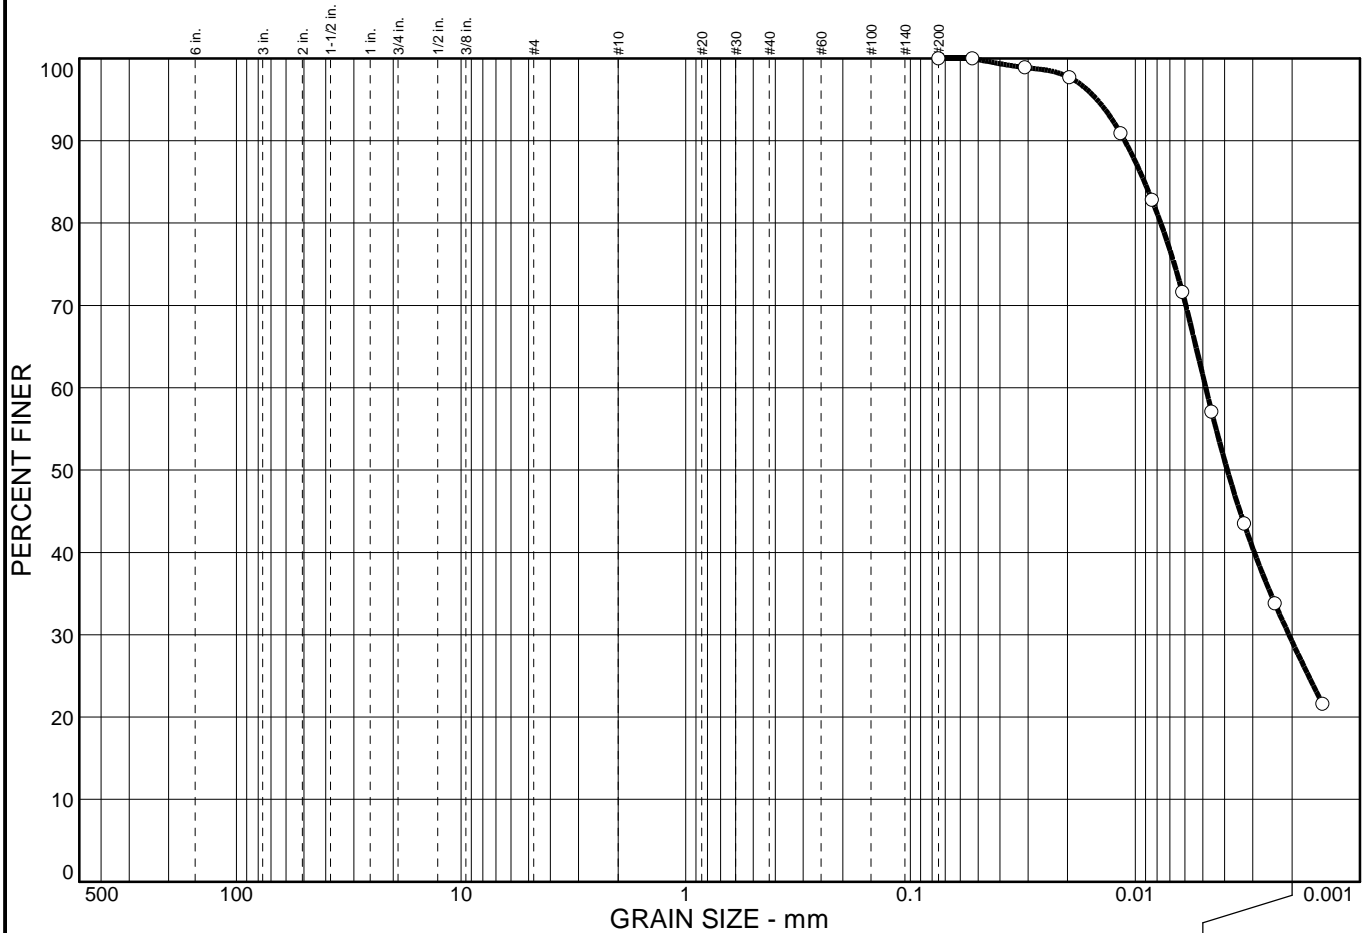
Particle Size Distribution Report

% COBBLES	% GRAVEL	% SAND	% SILT	% CLAY
0.0	0.0	0.0	70.9	29.1

SIEVE SIZE	PERCENT FINER	SPEC.* PERCENT	PASS? (X=NO)
#200	100.0		
#270	100.0		
0.0309 mm.	98.9		
0.0196 mm.	97.7		
0.0116 mm.	90.9		
0.0084 mm.	82.8		
0.0062 mm.	71.6		
0.0046 mm.	57.1		
0.0033 mm.	43.5		
0.0024 mm.	33.8		
0.0015 mm.	21.6

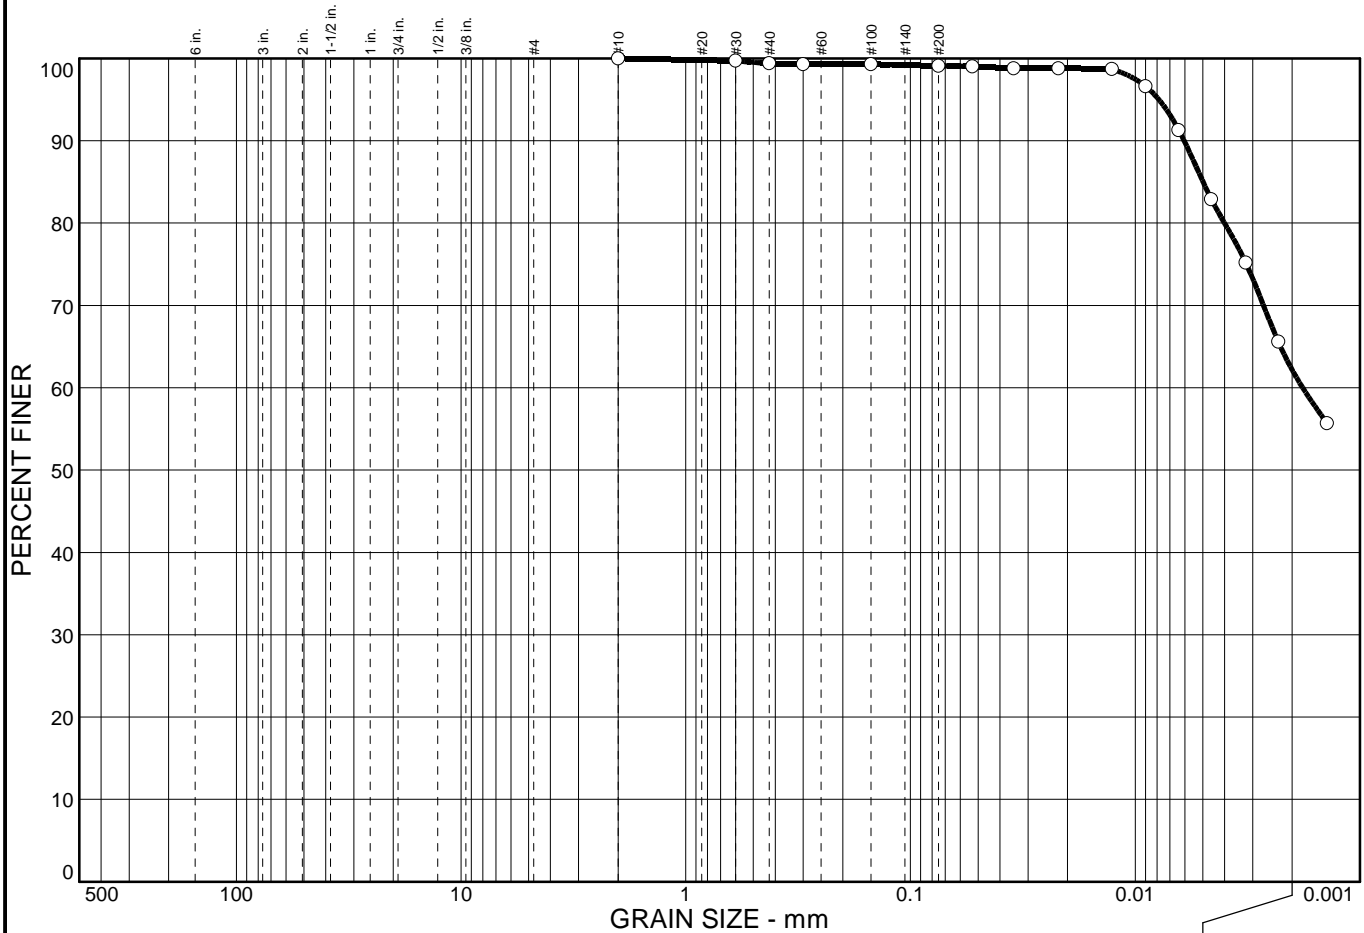
Particle Size Distribution Report

% COBBLES	% GRAVEL	% SAND	% SILT	% CLAY
0.0	0.0	0.9	37.0	62.1

SIEVE SIZE	PERCENT FINER	SPEC.* PERCENT	PASS? (X=NO)
#10	100.0		
#30	99.7		
#40	99.4		
#50	99.3		
#100	99.3		
#200	99.1		
#270	99.0		
0.0347 mm.	98.8		
0.0219 mm.	98.8		
0.0127 mm.	98.7		
0.0090 mm.	96.6		
0.0064 mm.	91.3		
0.0046 mm.	82.9		
0.0032 mm.	75.2		
0.0023 mm.	65.6		
0.0014 mm.	55.7
