Definite Plan for the Lower Klamath Project

Appendix A – Risk Management Plan

June 2018

Klamath River Renewal Corporation

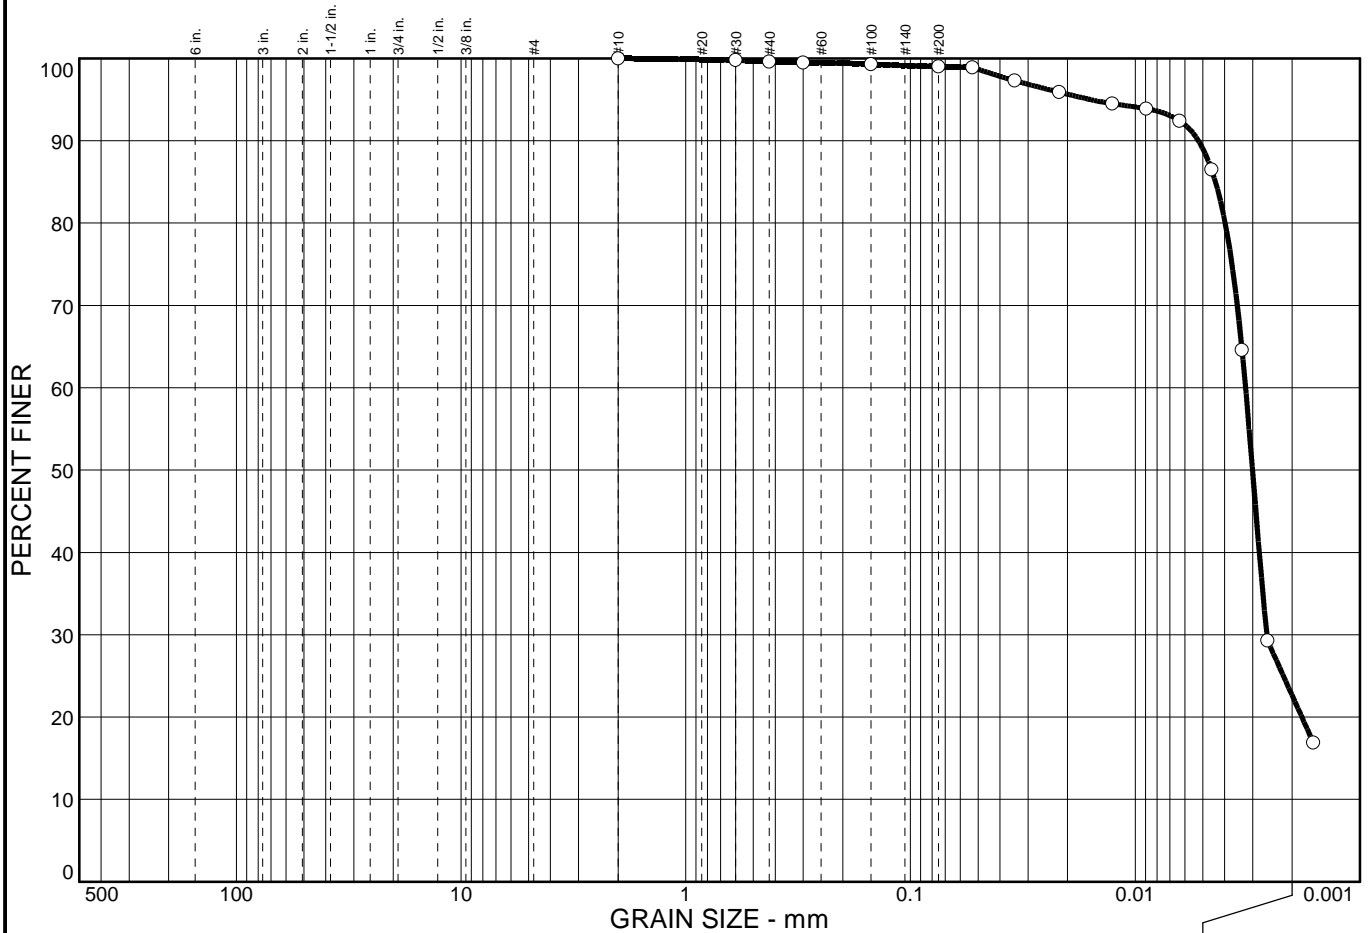
Particle Size Distribution Report

% COBBLES	% GRAVEL	% SAND	% SILT	% CLAY
0.0	0.0	1.0	76.4	22.6

SIEVE SIZE	PERCENT FINER	SPEC.* PERCENT	PASS? (X=NO)
#10	100.0		
#30	99.8		
#40	99.6		
#50	99.5		
#100	99.3		
#200	99.0		
#270	98.9		
0.0343 mm.	97.3		
0.0218 mm.	95.9		
0.0126 mm.	94.5		
0.0089 mm.	93.9		
0.0063 mm.	92.4		
0.0046 mm.	86.5		
0.0034 mm.	64.6		
0.0026 mm.	29.3		
0.0016 mm.	16.9

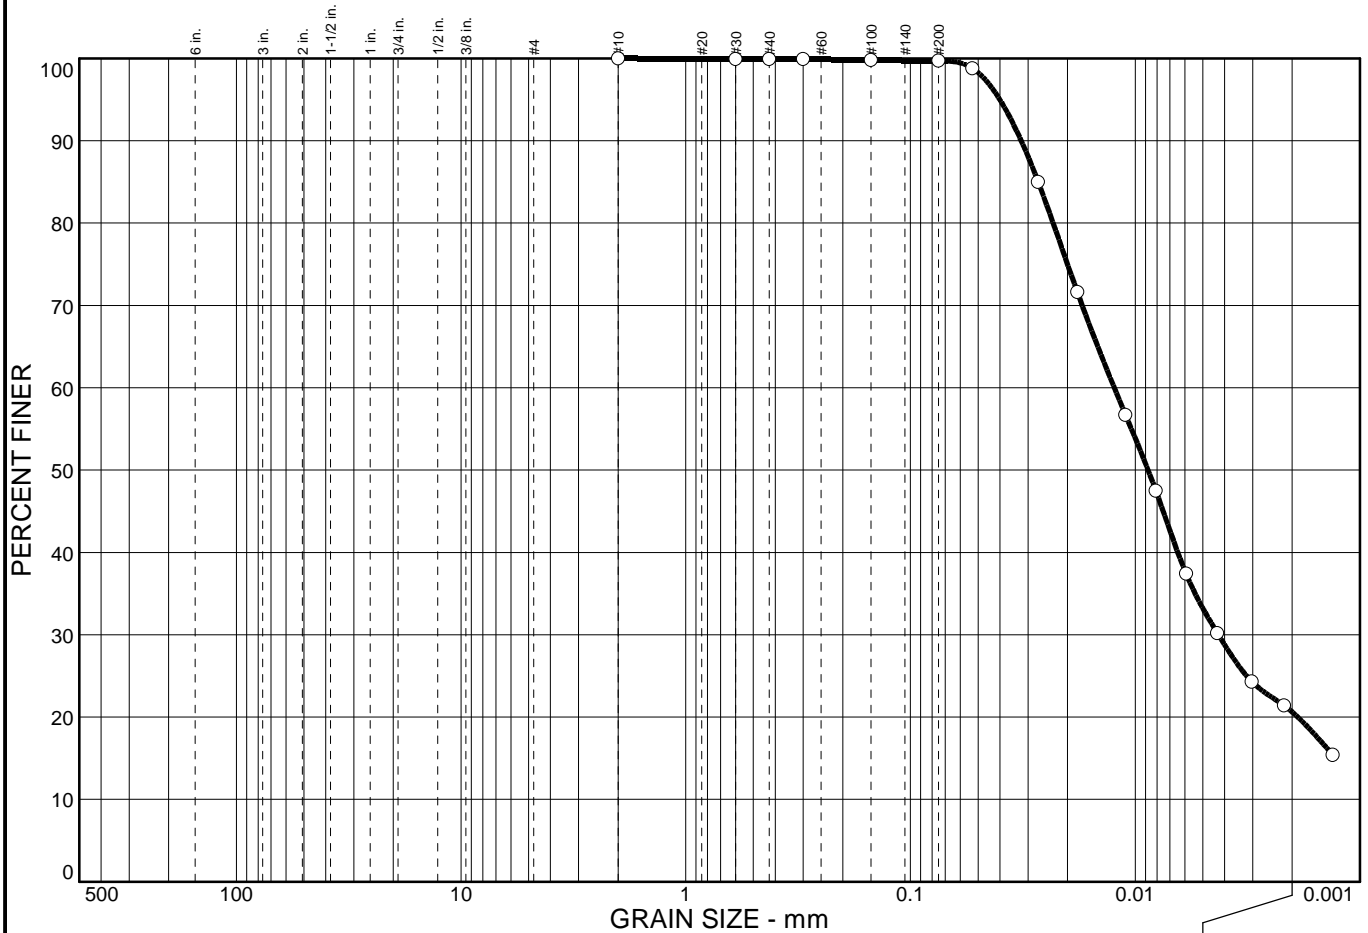
Particle Size Distribution Report

% COBBLES	% GRAVEL	% SAND	% SILT	% CLAY
0.0	0.0	0.3	79.1	20.6

SIEVE SIZE	PERCENT FINER	SPEC.* PERCENT	PASS? (X=NO)
#10	100.0		
#30	99.9		
#40	99.9		
#50	99.9		
#100	99.8		
#200	99.7		
#270	98.8		
0.0270 mm.	85.0		
0.0181 mm.	71.6		
0.0110 mm.	56.7		
0.0081 mm.	47.5		
0.0059 mm.	37.4		
0.0043 mm.	30.2		
0.0030 mm.	24.3		
0.0022 mm.	21.4		
0.0013 mm.	15.4

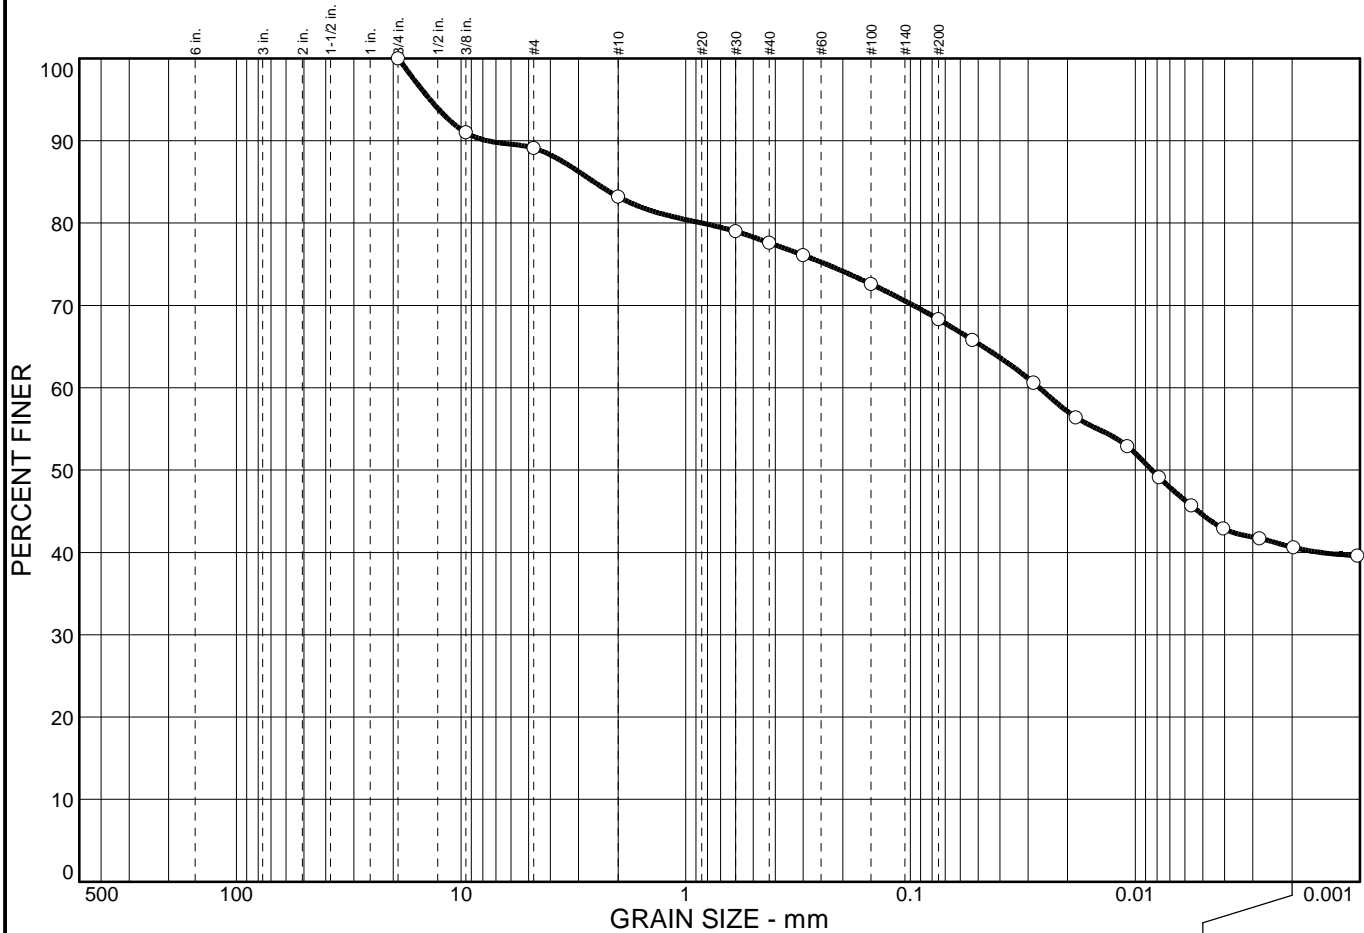
Particle Size Distribution Report

% COBBLES	% GRAVEL	% SAND	% SILT	% CLAY
0.0	10.9	20.8	27.7	40.6

SIEVE SIZE	PERCENT FINER	SPEC.* PERCENT	PASS? (X=NO)
3/4 in.	100.0		
3/8 in.	91.0		
#4	89.1		
#10	83.2		
#30	79.0		
#40	77.6		
#50	76.1		
#100	72.6		
#200	68.3		
#270	65.8		
0.0284 mm.	60.6		
0.0184 mm.	56.4		
0.0108 mm.	52.9		
0.0078 mm.	49.1		
0.0056 mm.	45.7		
0.0041 mm.	42.9		
0.0028 mm.	41.7		
0.0020 mm.	40.6		
0.0010 mm.	39.6

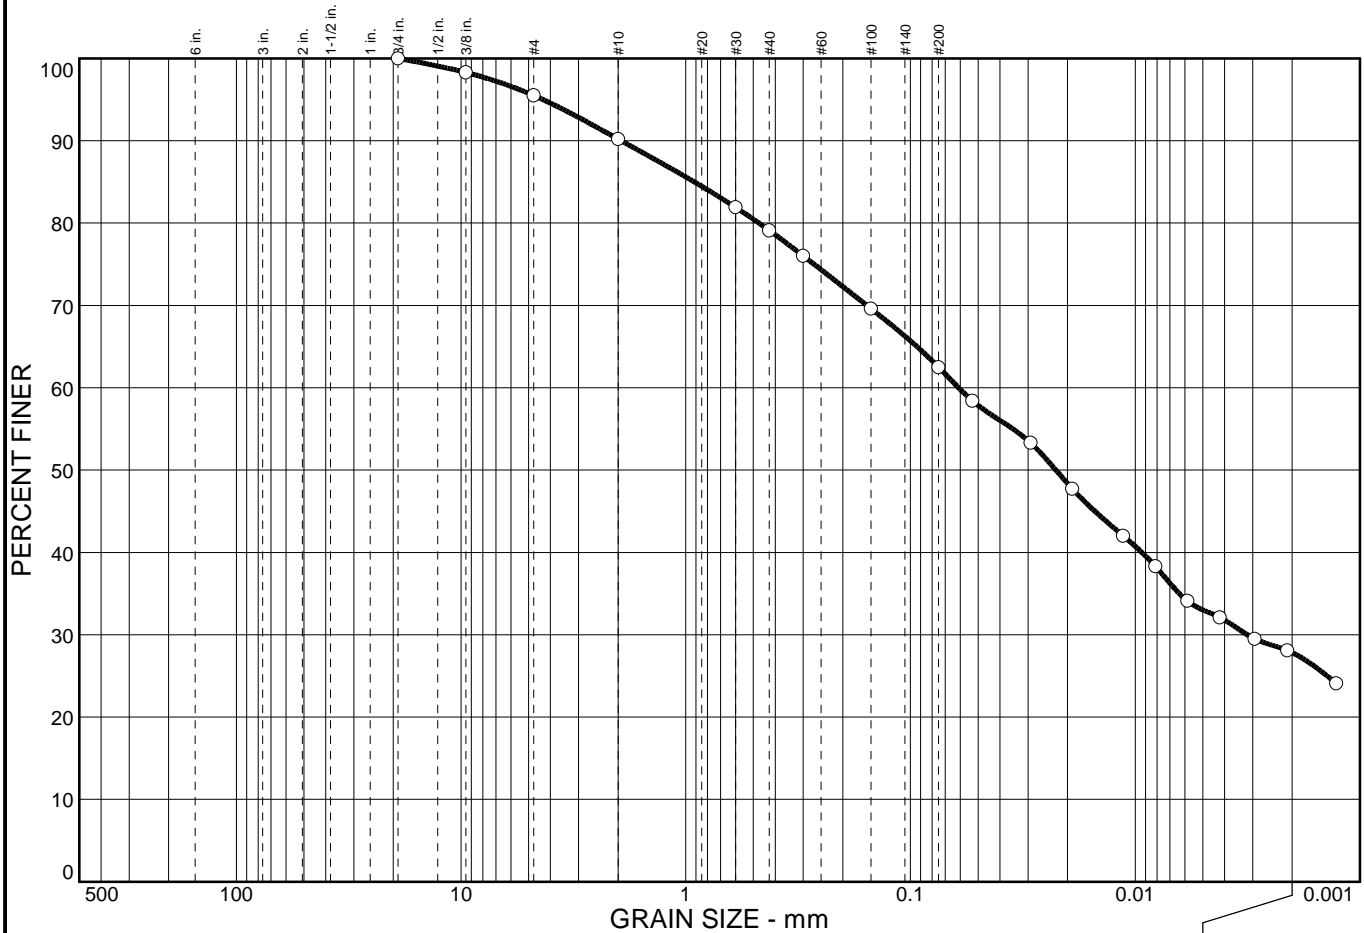
Particle Size Distribution Report

% COBBLES	% GRAVEL	% SAND	% SILT	% CLAY
0.0	4.5	33.0	34.7	27.8

SIEVE SIZE	PERCENT FINER	SPEC.* PERCENT	PASS? (X=NO)
3/4 in.	100.0		
3/8 in.	98.3		
#4	95.5		
#10	90.2		
#30	81.9		
#40	79.1		
#50	76.0		
#100	69.6		
#200	62.5		
#270	58.4		
0.0292 mm.	53.3		
0.0190 mm.	47.7		
0.0113 mm.	42.0		
0.0081 mm.	38.3		
0.0059 mm.	34.1		
0.0042 mm.	32.1		
0.0029 mm.	29.5		
0.0021 mm.	28.1		
0.0013 mm.	24.1

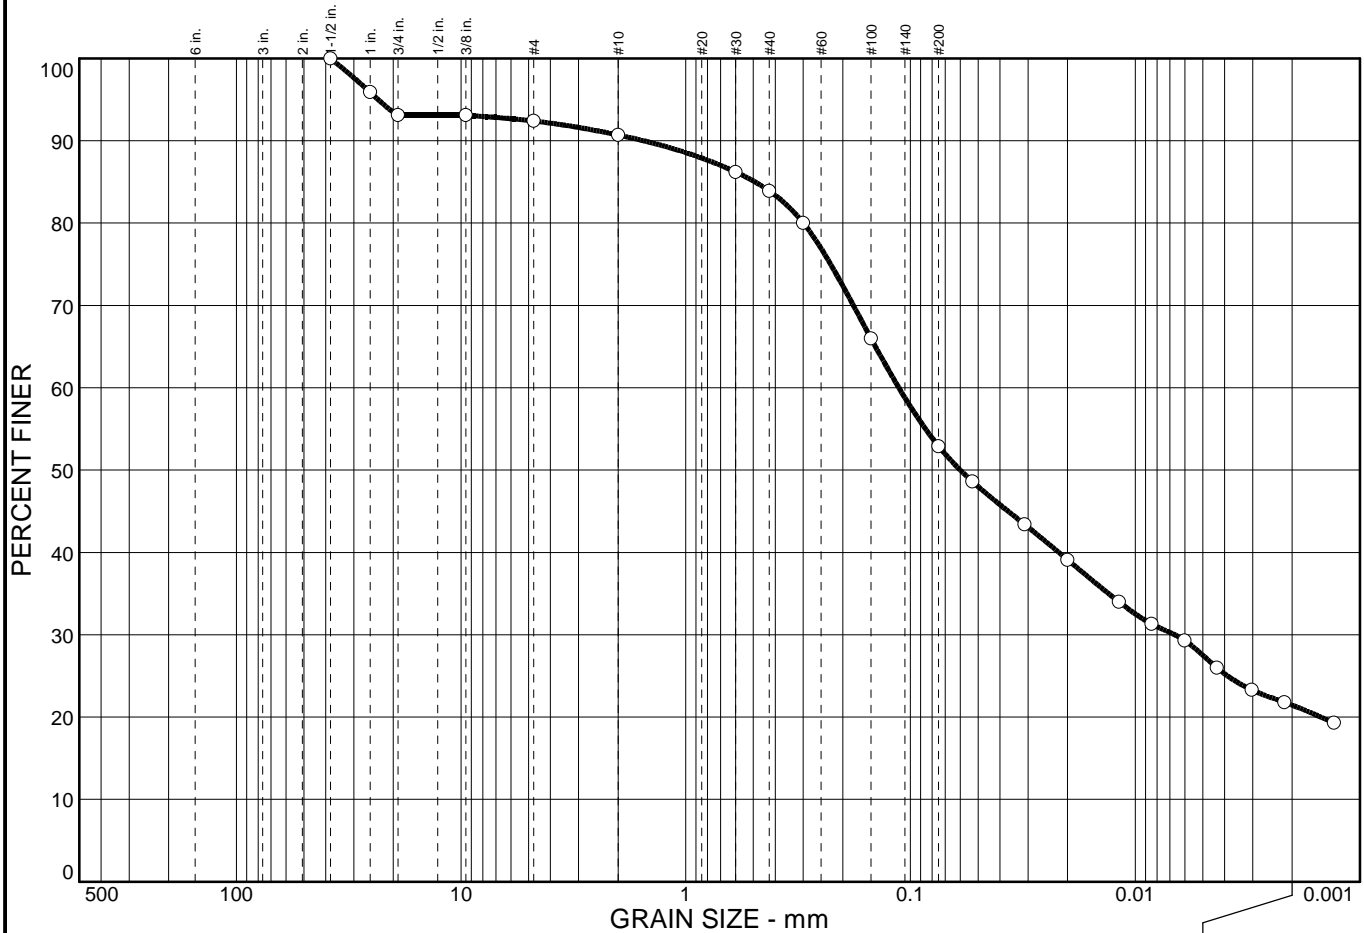
Particle Size Distribution Report

% COBBLES	% GRAVEL	% SAND	% SILT	% CLAY
0.0	7.6	39.5	31.5	21.4

SIEVE SIZE	PERCENT FINER	SPEC.* PERCENT	PASS? (X=NO)
1.5 in.	100.0		
1 in.	95.9		
3/4 in.	93.1		
3/8 in.	93.1		
#4	92.4		
#10	90.7		
#30	86.2		
#40	83.9		
#50	80.0		
#100	66.0		
#200	52.9		
#270	48.6		
0.0311 mm.	43.4		
0.0200 mm.	39.1		
0.0118 mm.	34.0		
0.0084 mm.	31.3		
0.0060 mm.	29.3		
0.0043 mm.	26.0		
0.0030 mm.	23.3		
0.0022 mm.	21.8		
0.0013 mm.	19.3

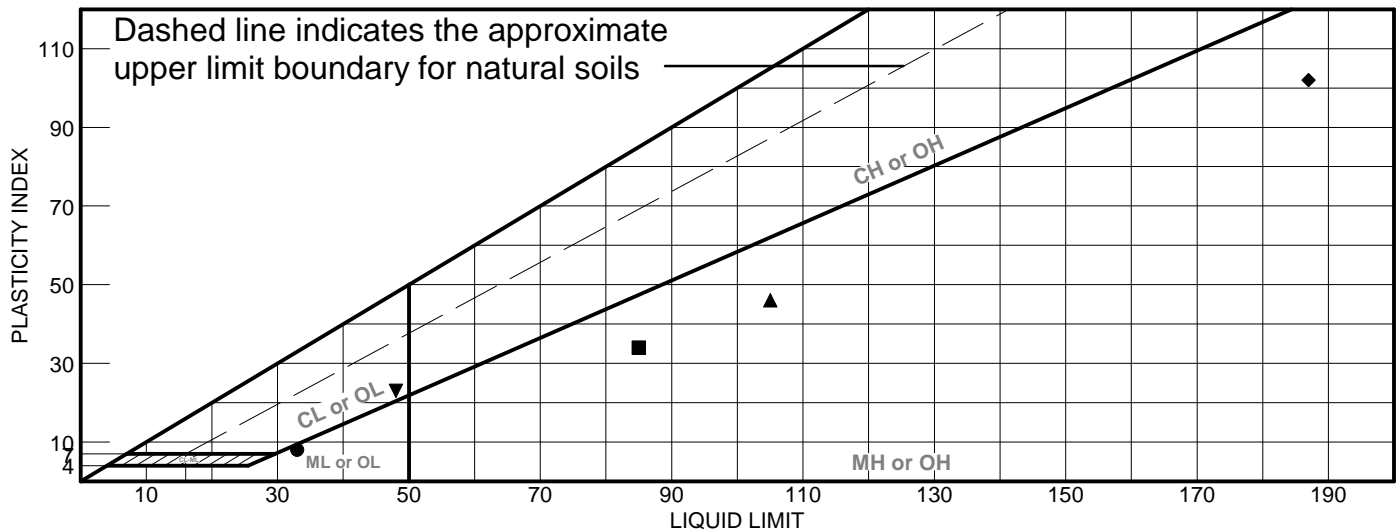
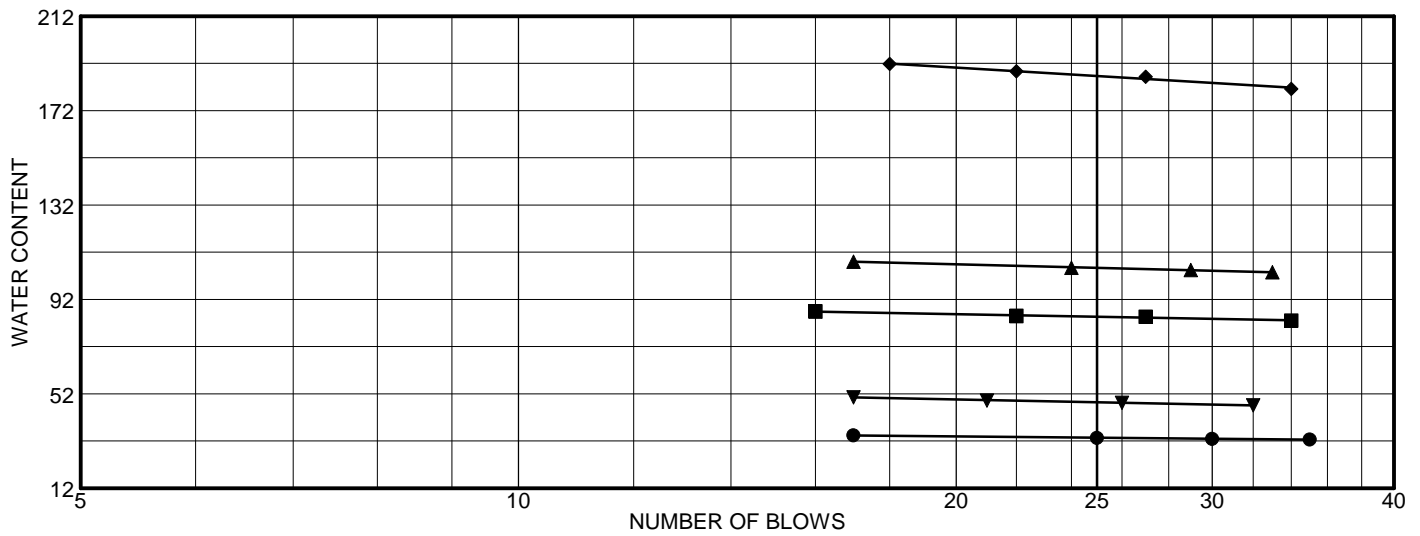
LIQUID AND PLASTIC LIMITS TEST REPORT

MATERIAL DESCRIPTION	LL	PL	PI	%<#40	%<#200	USCS
●	Dark Olive Gray Sandy SILT	33	25	8			
■	Olive Gray Elastic SILT	85	51	34	99.9	99.0	MH
▲	Gray Elastic SILT	105	59	46	99.7	99.3	MH
◆	Gray Elastic SILT	187	85	102	99.6	99.5	MH
▼	Dark Olive Brown Sandy Lean CLAY	48	25	23

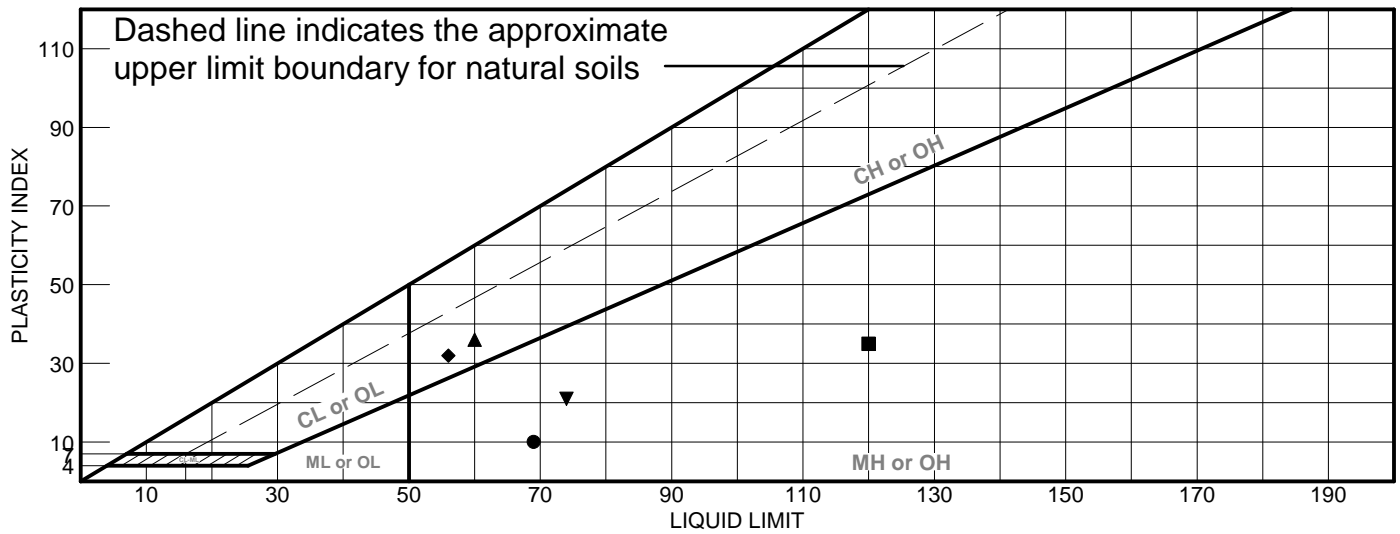
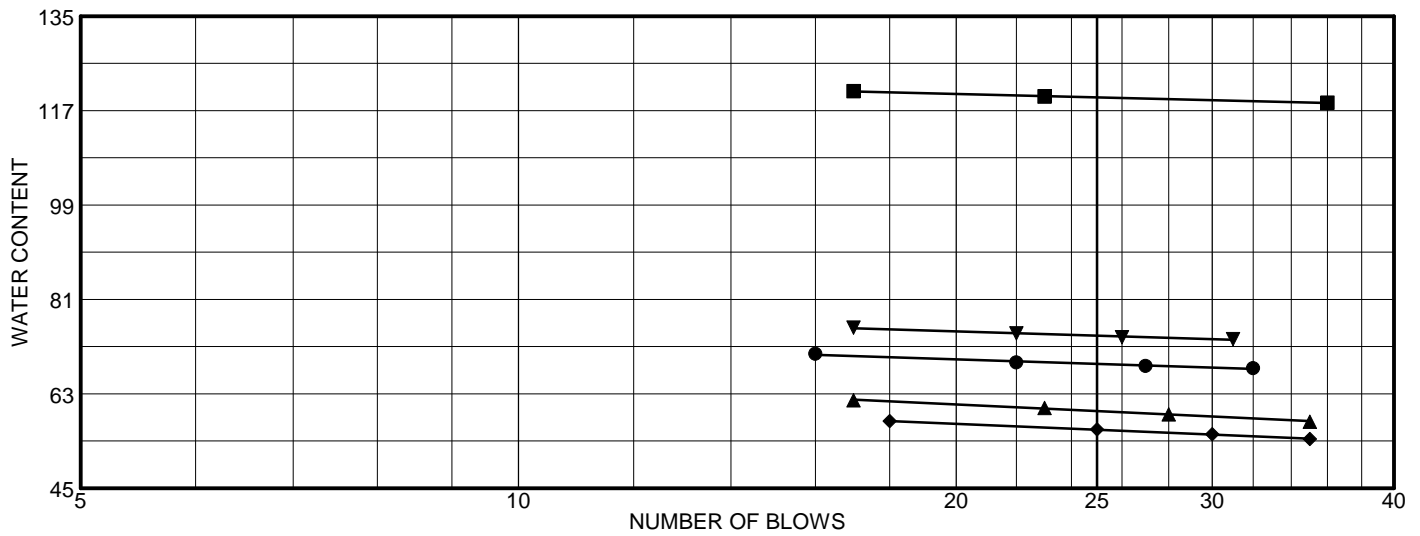
LIQUID AND PLASTIC LIMITS TEST REPORT

MATERIAL DESCRIPTION	LL	PL	PI	%<#40	%<#200	USCS
●	Light Olive Brown Elastic SILT	69	59	10	100.0	100.0	MH
■	Pale Brown Mottled Gray Elastic SILT	120	85	35	99.4	99.1	MH
▲	Very Dark Olive Brown Sandy Fat CLAY w/ Gravel	60	24	36			
◆	Dark Reddish Brown Sandy Fat CLAY	56	24	32			
▼	Dark Gray Elastic SILT	74	53	21	99.9	99.7	MH

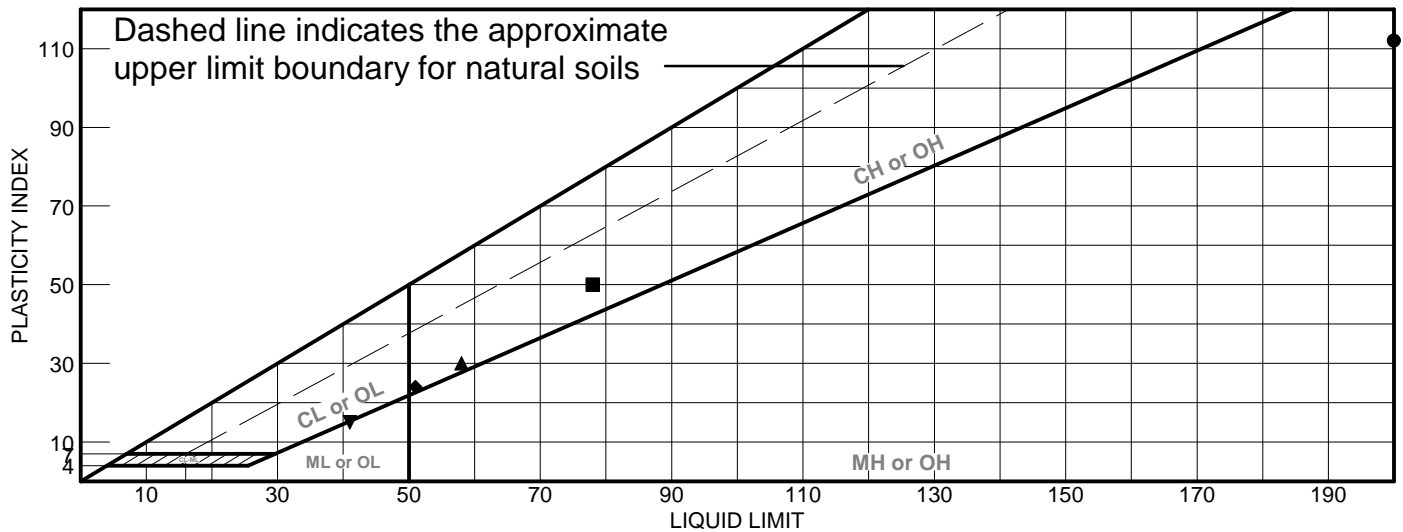
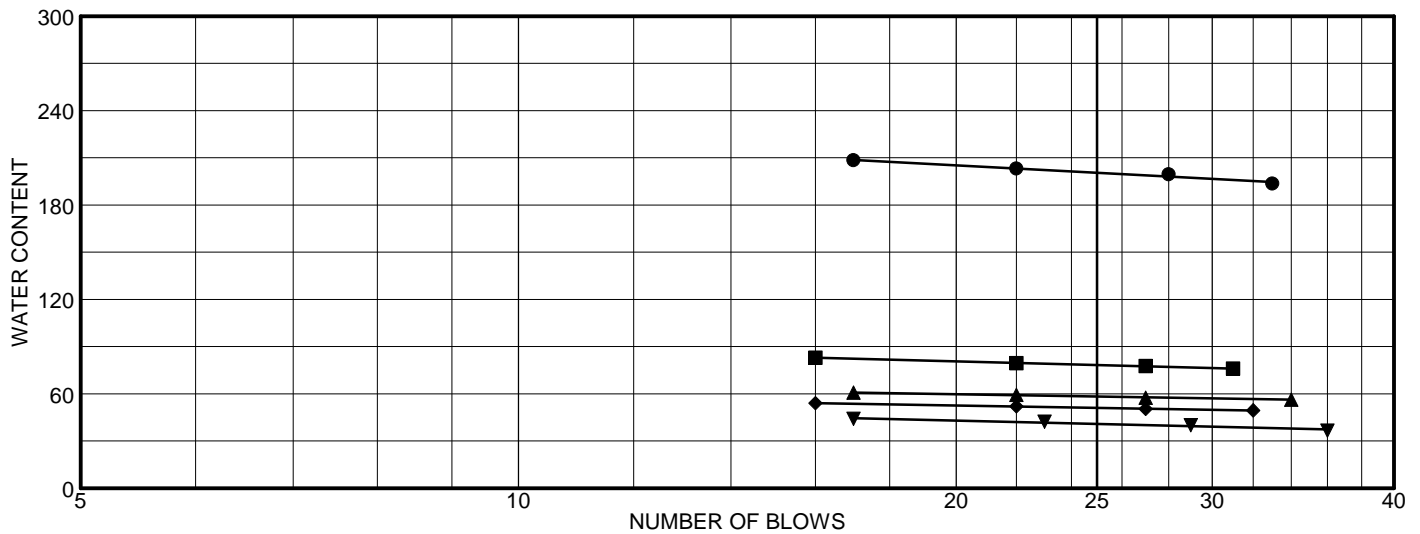
LIQUID AND PLASTIC LIMITS TEST REPORT

MATERIAL DESCRIPTION	LL	PL	PI	%<#40	%<#200	USCS
●	Light Olive Brown Elastic SILT	200	88	112	99.6	99.0	MH
■	Dark Reddish Brown Sandy Fat CLAY	78	28	50	77.6	68.3	CH
▲	Yellowish Brown Sandy Fat CLAY	58	28	30	79.1	62.5	CH
◆	Yellowish Brown Sandy Fat CLAY	51	27	24	83.9	52.9	CH
▼	Olive Gray Poorly Graded GRAVEL w/ Silt & Sand	41	26	15	15.9	9.0	GP-GM

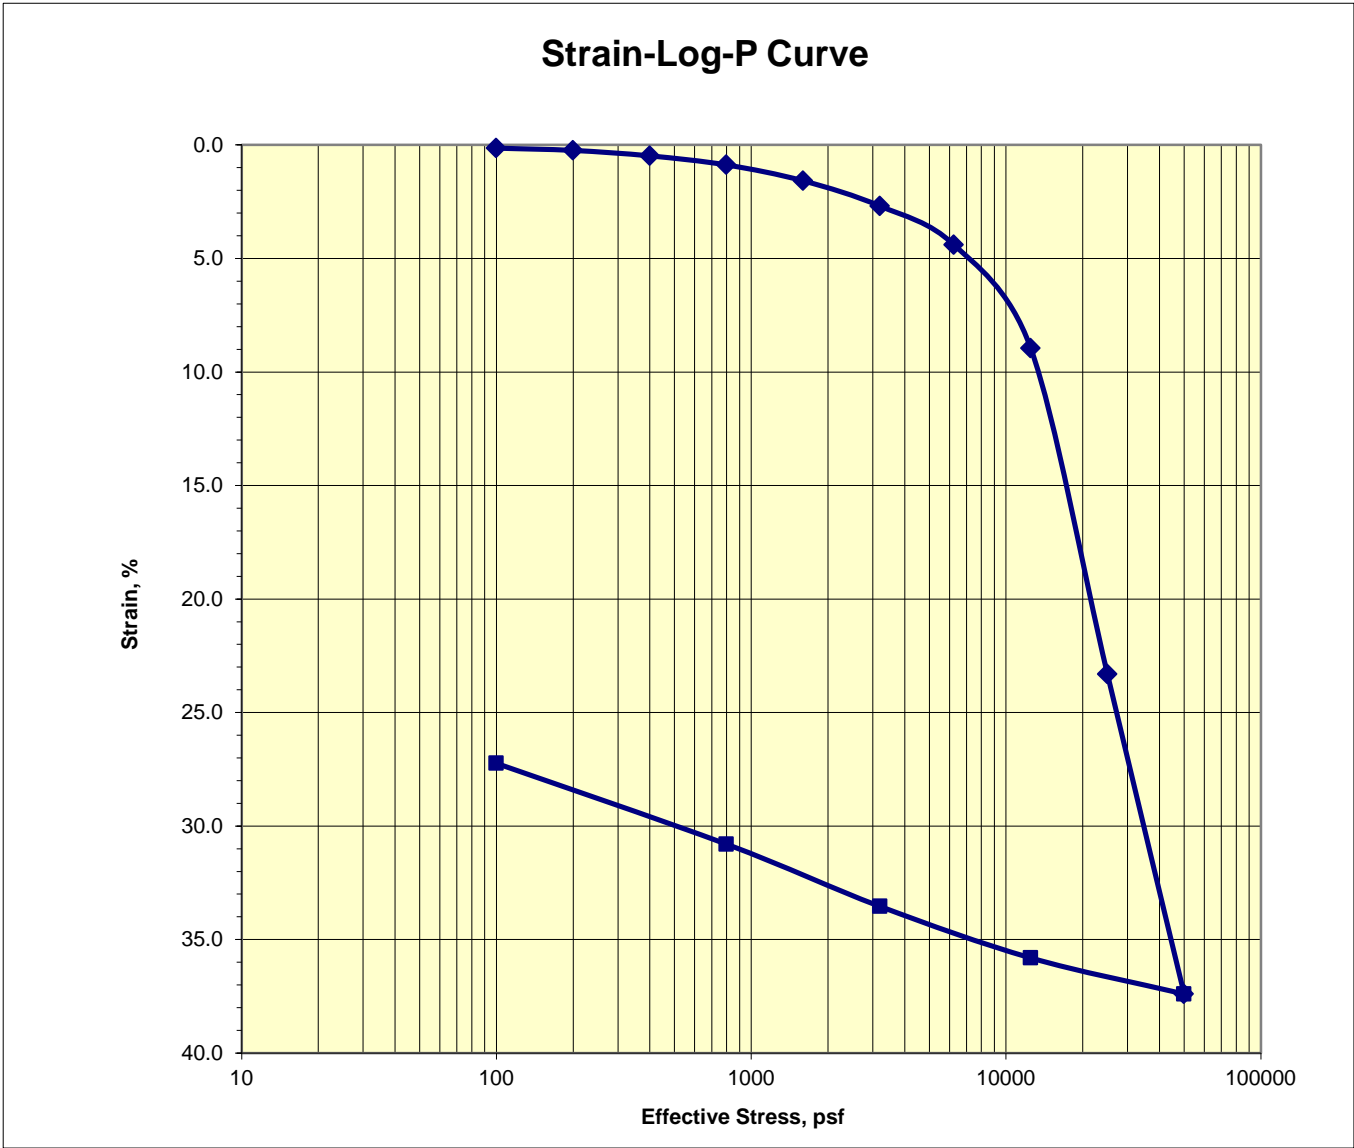
ASTM D2435

Job No.: 020-251	Boring: BC-04	Run By: MD
Client: AECOM	Sample: S-08	Reduced: PJ
Project: 60537920	Depth, ft.: 32.5(Tip-2")	Checked: PJ/DC
Soil Type: Pale Brown Mottled Gray Elastic SILT		Date: 6/1/2018

Assumed Gs	2.6	Initial	Final	Remarks:
Moisture %:		149.5	104.4	
Dry Density, pcf:		32.1	43.7	
Void Ratio:		4.058	2.715	
% Saturation:		95.8	100.0

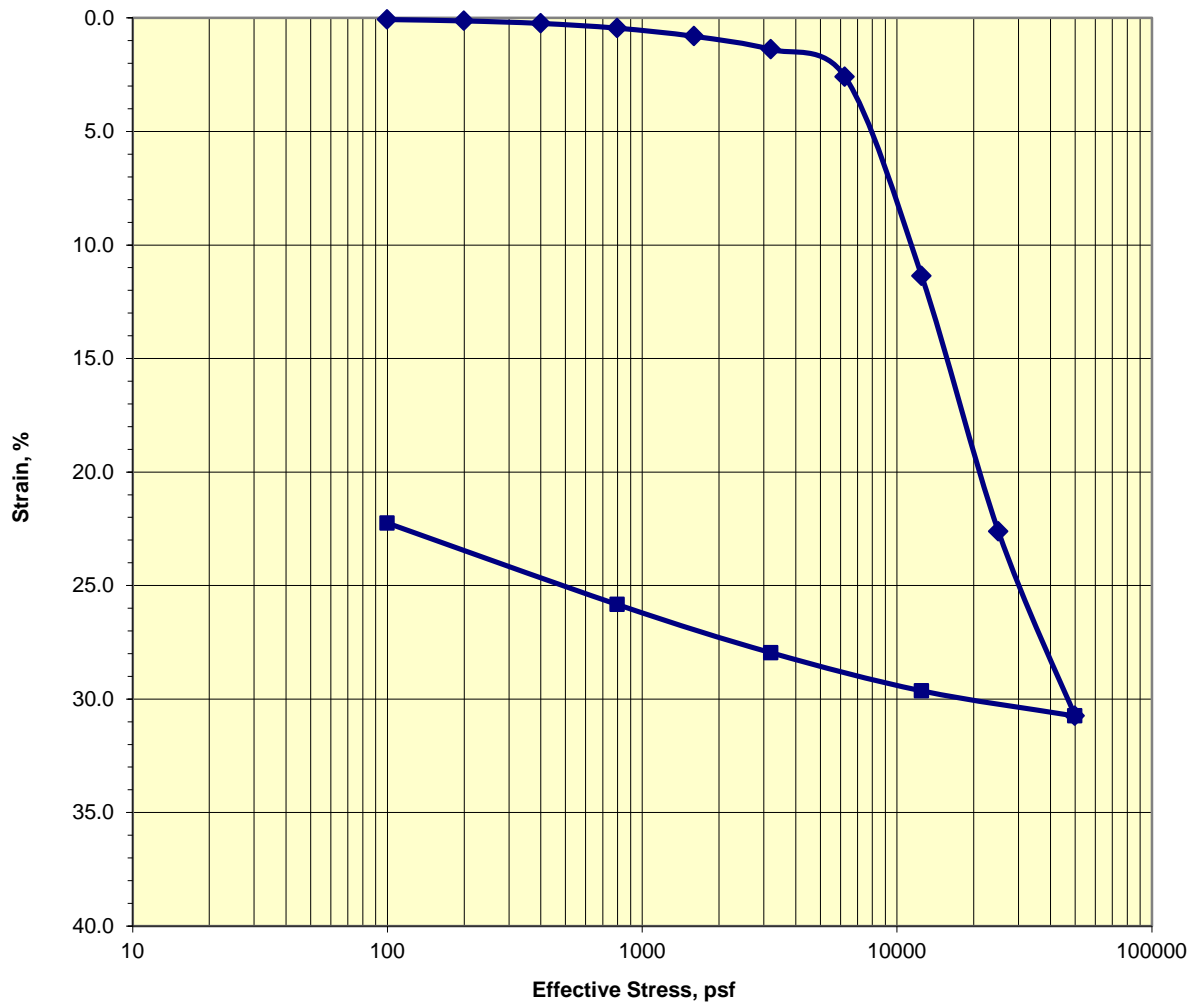
Strain-Log-P Curve

Job No.: 020-251	Boring: BC-09	Run By: MD
Client: AECOM	Sample: S-09	Reduced: PJ
Project: 60537920	Depth, ft.: 68-70.5(Tip-20")	Checked: PJ/DC
Soil Type: Dark Greenish Gray CLAY (Silty)		Date: 6/1/2018

Assumed Gs	2.6	Initial	Final
Moisture %:		88.4	60.3
Dry Density, pcf:		48.6	63.2
Void Ratio:		2.340	1.568
% Saturation:		98.2	100.0

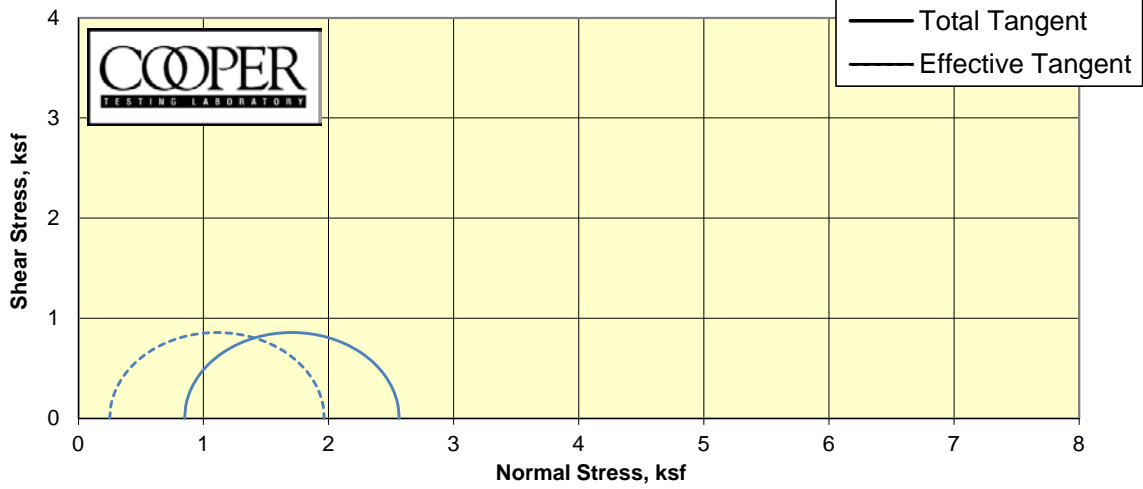
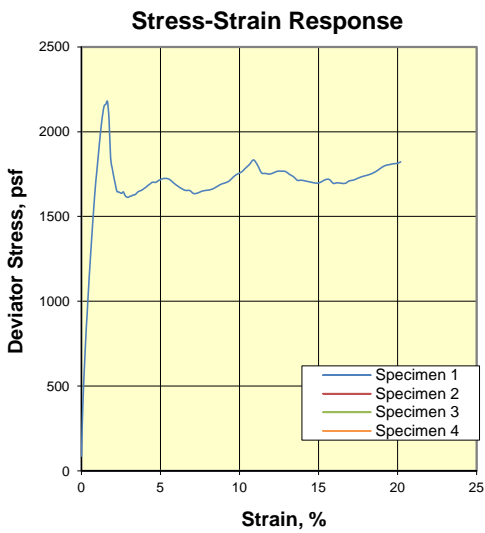
**Consolidated Undrained Triaxial Compression with Pore Pressure
ASTM D4767**

1	2	3	4
Specimen				
Boring	BC-02			
Sample	S-06			
Depth	19.5(Tip-2")			
Visual Description	Gray CLAY (Silty)			
MC (%)	147.5			
Dry Density (pcf)	31.6			
Saturation (%)	92.6			
Void Ratio	4.139			
Diameter (in)	2.86			
Height (in)	6.07			
	Final			
MC (%)	147.6			
Dry Density (pcf)	33.6			
Saturation (%)	100.0			
Void Ratio	3.838			
Diameter (in)	2.79			
Height (in)	6.02			
Cell Pressure (psi)	86.4			
Back Pressure (psi)	80.5			
	Effective Stresses At:			
Strain (%)	5.0			
Deviator (ksf)	1.716			
Excess PP (psi)	4.2			
Sigma 1 (ksf)	1.966			
Sigma 3 (ksf)	0.250			
P (ksf)	1.108			
Q (ksf)	0.858			
Stress Ratio	7.869			
Rate (in/min)	0.0005

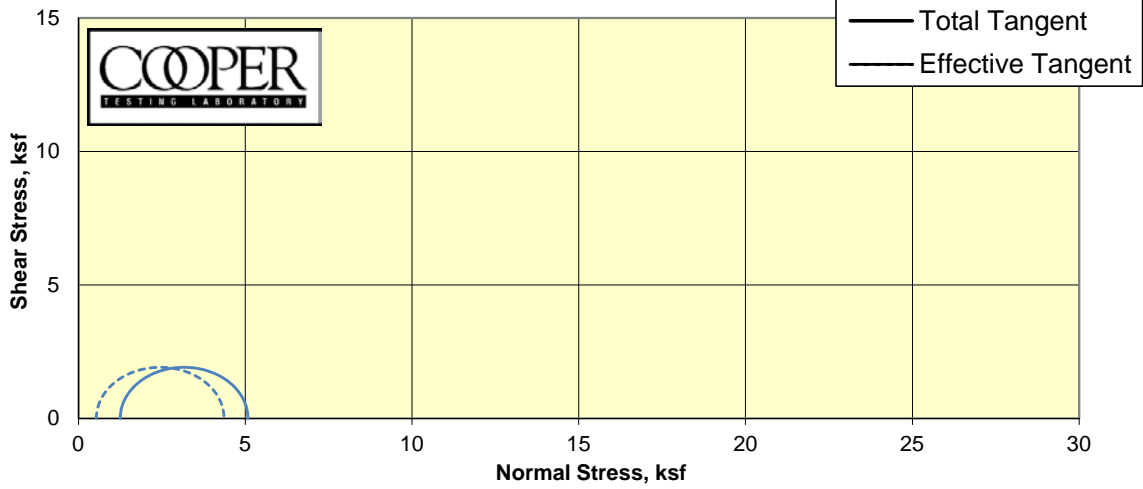
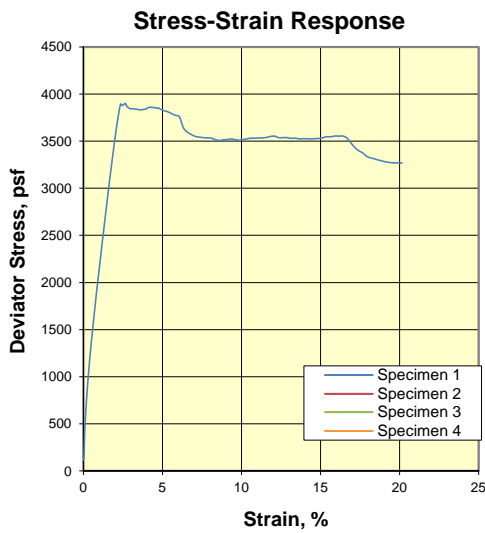
**Consolidated Undrained Triaxial Compression with Pore Pressure
ASTM D4767**

1	2	3	4
Specimen				
Boring	BC-02			
Sample	S-08			
Depth	34.5(Tip-6")			
Visual Description	Pale Brown CLAY (Silty)			
MC (%)	148.8			
Dry Density (pcf)	32.7			
Saturation (%)	96.6			
Void Ratio	4.158			
Diameter (in)	2.87			
Height (in)	6.07			
	Final			
MC (%)	148.5			
Dry Density (pcf)	33.6			
Saturation (%)	100.0			
Void Ratio	4.010			
Diameter (in)	2.84			
Height (in)	6.02			
Cell Pressure (psi)	88.8			
Back Pressure (psi)	80.1			
	Effective Stresses At:			
Strain (%)	5.0			
Deviator (ksf)	3.832			
Excess PP (psi)	5.0			
Sigma 1 (ksf)	4.368			
Sigma 3 (ksf)	0.536			
P (ksf)	2.452			
Q (ksf)	1.916			
Stress Ratio	8.153			
Rate (in/min)	0.0005

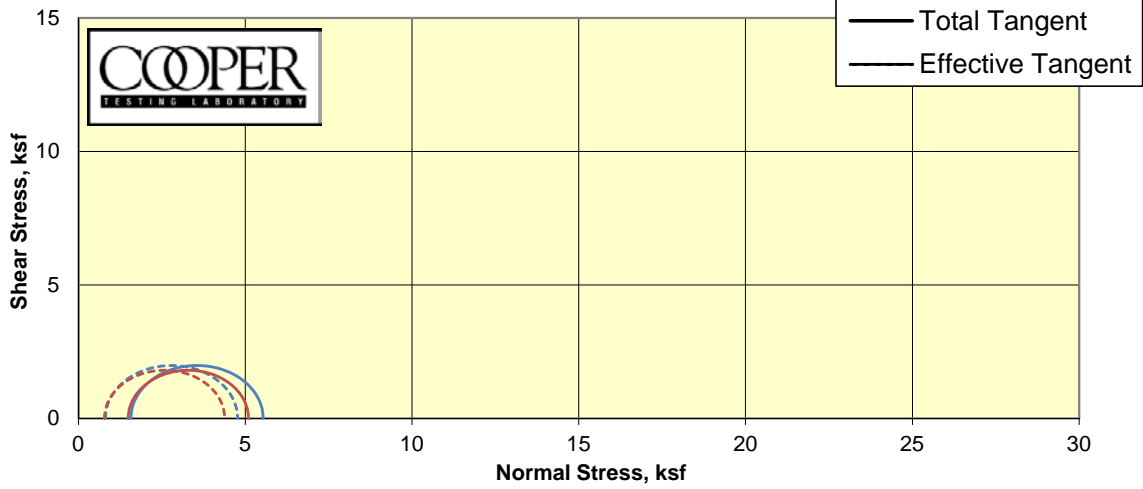
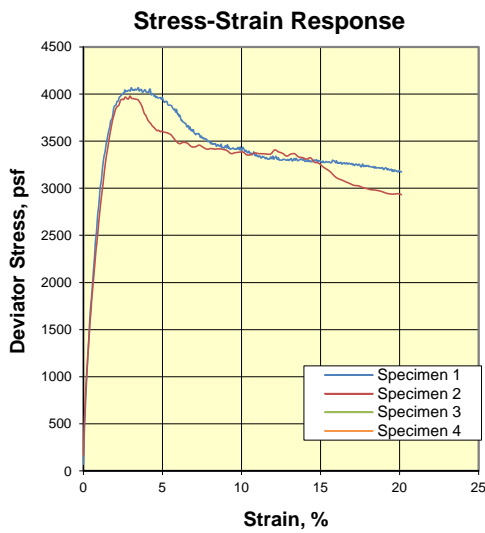
**Consolidated Undrained Triaxial Compression with Pore Pressure
ASTM D4767**

Specimen	1	2	3	4
Boring	BC-03	BC-03		
Sample	S-06	S-06		
Depth	39.5-42(Tip-11")	39.5-42(Tip-4")		
Visual Description	Dark Gray CLAY (Silty)	Dark Gray CLAY		
MC (%)	84.9	90.1		
Dry Density (pcf)	50.2	47.7		
Saturation (%)	99.0	97.6		
Void Ratio	2.230	2.402		
Diameter (in)	2.87	2.87		
Height (in)	6.06	6.08		
	Final			
MC (%)	83.0	87.9		
Dry Density (pcf)	51.4	49.4		
Saturation (%)	100.0	100.0		
Void Ratio	2.158	2.285		
Diameter (in)	2.85	2.83		
Height (in)	6.02	6.04		
Cell Pressure (psi)	90.5	91.6		
Back Pressure (psi)	79.5	81.2		
	Effective Stresses At:			
Strain (%)	5.0	5.0		
Deviator (ksf)	3.966	3.607		
Excess PP (psi)	5.3	5.0		
Sigma 1 (ksf)	4.775	4.386		
Sigma 3 (ksf)	0.809	0.779		
P (ksf)	2.792	2.582		
Q (ksf)	1.983	1.804		
Stress Ratio	5.901	5.632		
Rate (in/min)	0.0005	0.0005

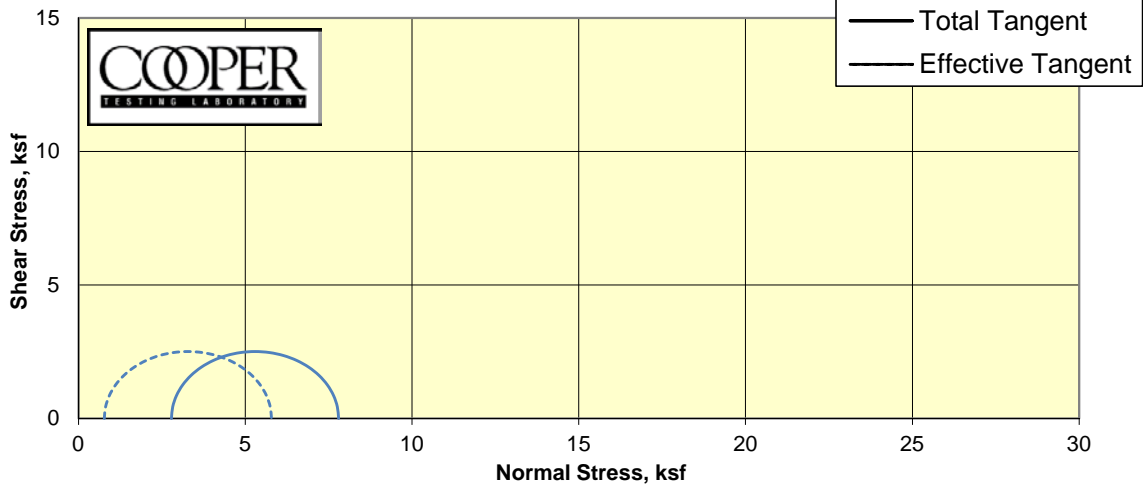
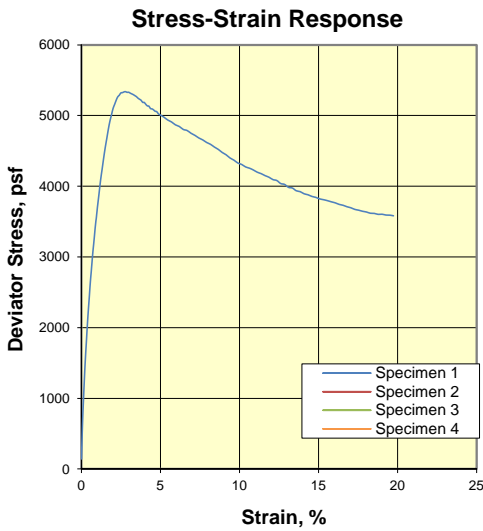
**Consolidated Undrained Triaxial Compression with Pore Pressure
ASTM D4767**

1	2	3	4
Specimen				
Boring	BC-03			
Sample	S-10			
Depth	90(Tip-13')			
Visual Description	Dark Gray CLAY			
MC (%)	119.8			
Dry Density (pcf)	35.8			
Saturation (%)	88.1			
Void Ratio	3.533			
Diameter (in)	2.87			
Height (in)	6.08			
	Final			
MC (%)	116.3			
Dry Density (pcf)	40.3			
Saturation (%)	100.0			
Void Ratio	3.023			
Diameter (in)	2.69			
Height (in)	6.16			
Cell Pressure (psi)	99.9			
Back Pressure (psi)	80.5			
	Effective Stresses At:			
Strain (%)	5.0			
Deviator (ksf)	5.012			
Excess PP (psi)	14.0			
Sigma 1 (ksf)	5.788			
Sigma 3 (ksf)	0.777			
P (ksf)	3.283			
Q (ksf)	2.506			
Stress Ratio	7.452			
Rate (in/min)	0.0005

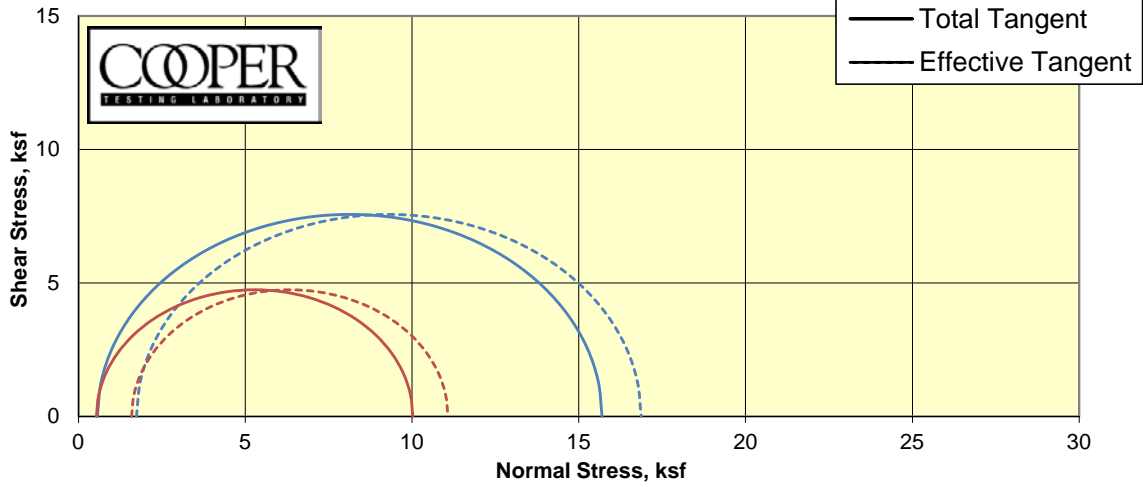
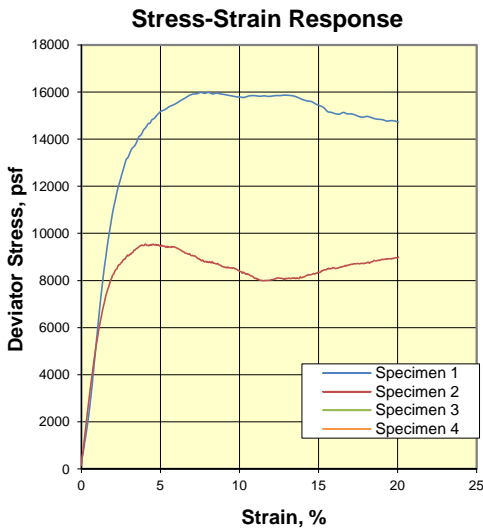
**Consolidated Undrained Triaxial Compression with Pore Pressure
ASTM D4767**

1	2	3	4
Boring	BC-04	BC-04		
Sample	S-04	S-04		
Depth	12.5-14(Tip-15")	12.5-14.5(Tip-4")		
Visual Description	Brown Weathered Rock	Dark Brown Clayey GRAVEL (Weathered Rock)		
MC (%)	60.8	53.9		
Dry Density (pcf)	59.2	65.0		
Saturation (%)	90.8	93.7		
Void Ratio	1.740	1.497		
Diameter (in)	2.87	2.86		
Height (in)	6.06	6.06		
	Final			
MC (%)	61.4	54.7		
Dry Density (pcf)	62.5	67.0		
Saturation (%)	100.0	100.0		
Void Ratio	1.597	1.422		
Diameter (in)	2.80	2.82		
Height (in)	6.04	6.04		
Cell Pressure (psi)	83.2	82.9		
Back Pressure (psi)	79.2	79.1		
	Effective Stresses At:			
Strain (%)	5.0	5.0		
Deviator (ksf)	15.130	9.485		
Excess PP (psi)	-8.1	-7.3		
Sigma 1 (ksf)	16.872	11.080		
Sigma 3 (ksf)	1.741	1.594		
P (ksf)	9.306	6.337		
Q (ksf)	7.565	4.743		
Stress Ratio	9.688	6.949		
Rate (in/min)	0.0005	0.0005

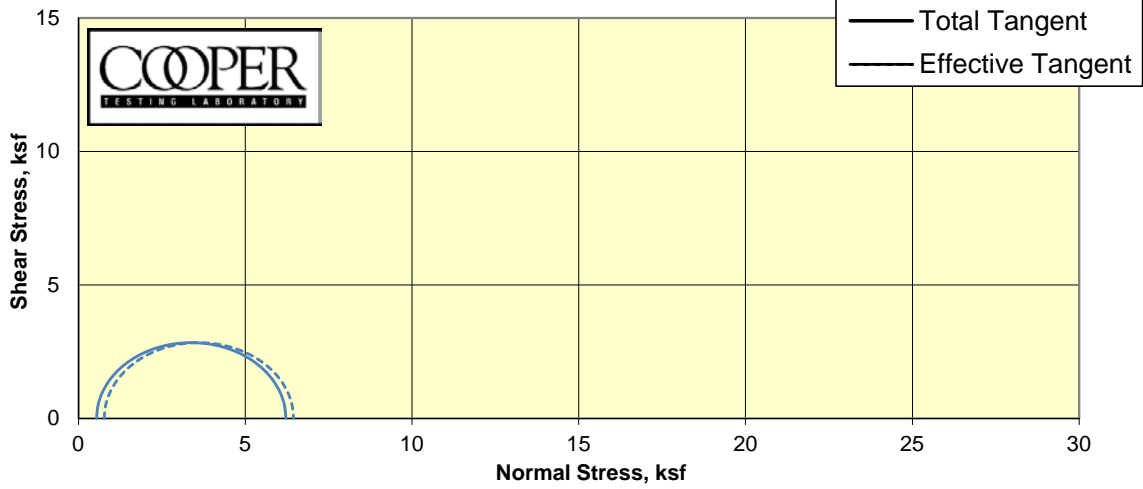
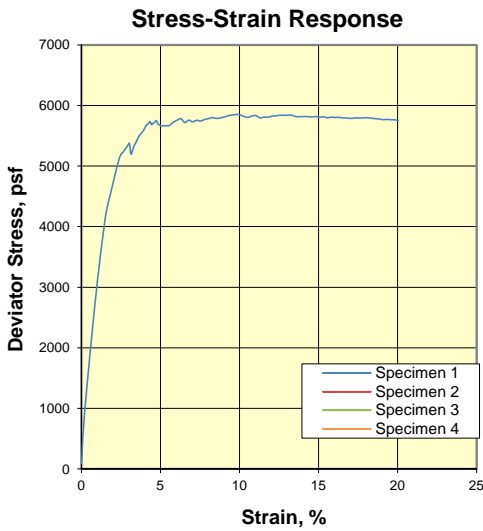
**Consolidated Undrained Triaxial Compression with Pore Pressure
ASTM D4767**

1	2	3	4
Specimen				
Boring	BC-04			
Sample	S-5			
Depth	17.5(Tip-6")			
Visual Description	Light Gray CLAY			
MC (%)	104.7			
Dry Density (pcf)	42.1			
Saturation (%)	94.2			
Void Ratio	3.000			
Diameter (in)	2.87			
Height (in)	6.08			
	Final			
MC (%)	105.4			
Dry Density (pcf)	43.8			
Saturation (%)	100.0			
Void Ratio	2.846			
Diameter (in)	2.82			
Height (in)	6.07			
Cell Pressure (psi)	84.0			
Back Pressure (psi)	80.2			
	Effective Stresses At:			
Strain (%)	5.0			
Deviator (ksf)	5.677			
Excess PP (psi)	-1.6			
Sigma 1 (ksf)	6.450			
Sigma 3 (ksf)	0.774			
P (ksf)	3.612			
Q (ksf)	2.838			
Stress Ratio	8.336			
Rate (in/min)	0.0005

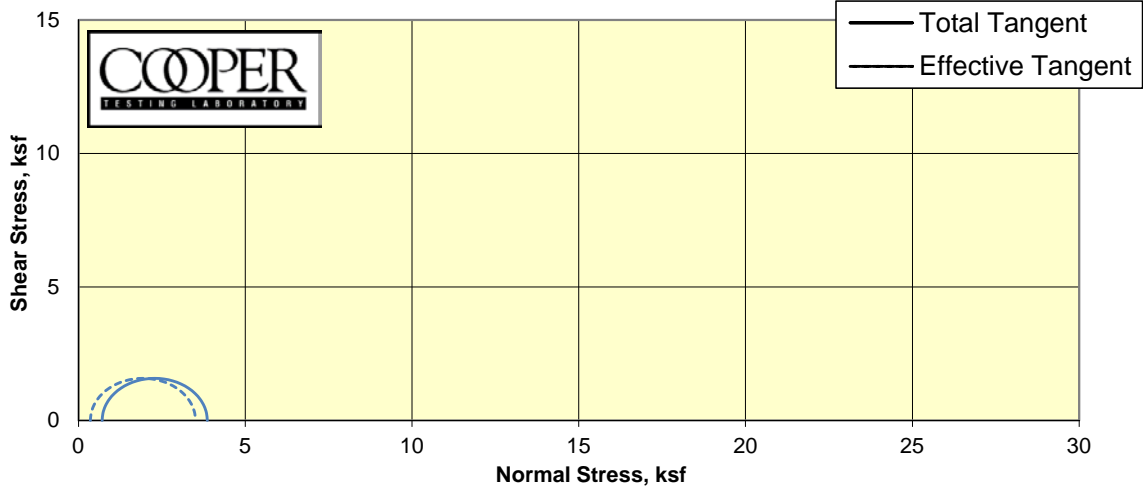
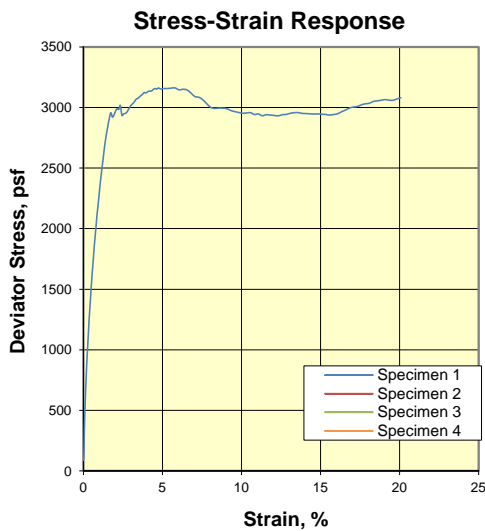
**Consolidated Undrained Triaxial Compression with Pore Pressure
ASTM D4767**

1	2	3	4
Boring	BC-04			
Sample	S-06			
Depth	22.5(Tip-2")			
Visual Description	Greenish Gray CLAY (Silty)/ SILT (slightly plastic)			
MC (%)	154.6			
Dry Density (pcf)	31.7			
Saturation (%)	97.4			
Void Ratio	4.127			
Diameter (in)	2.87			
Height (in)	6.07			
	Final			
MC (%)	152.8			
Dry Density (pcf)	32.6			
Saturation (%)	100.0			
Void Ratio	3.974			
Diameter (in)	2.83			
Height (in)	6.05			
Cell Pressure (psi)	85.0			
Back Pressure (psi)	80.1			
	Effective Stresses At:			
Strain (%)	5.0			
Deviator (ksf)	3.153			
Excess PP (psi)	2.5			
Sigma 1 (ksf)	3.511			
Sigma 3 (ksf)	0.358			
P (ksf)	1.935			
Q (ksf)	1.576			
Stress Ratio	9.796			
Rate (in/min)	0.0005

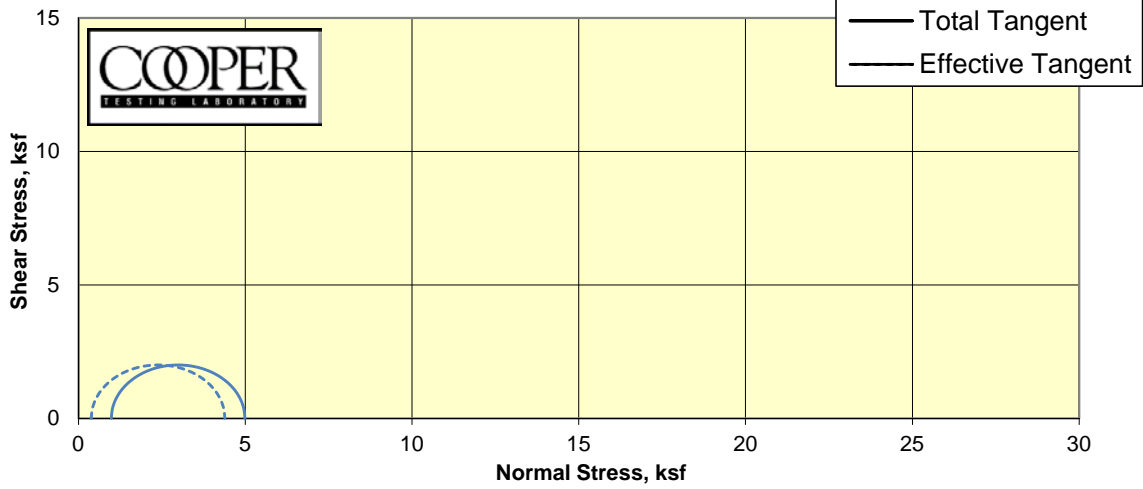
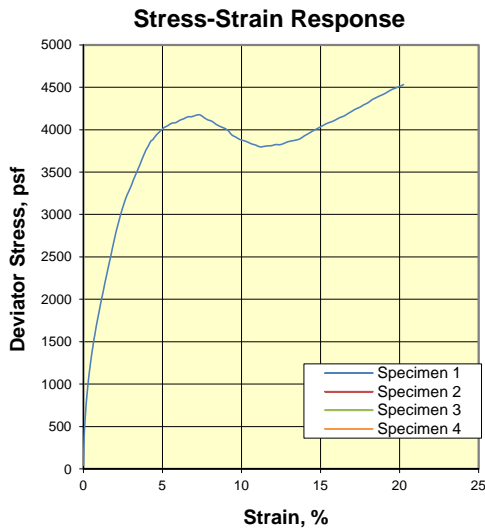
**Consolidated Undrained Triaxial Compression with Pore Pressure
ASTM D4767**

1	2	3	4
Boring	BC-04			
Sample	S-08			
Depth	32.5(Tip-10")			
Visual Description	Pale Brown Mottled Gray Elastic SILT			
MC (%)	117.2			
Dry Density (pcf)	36.9			
Saturation (%)	89.7			
Void Ratio	3.397			
Diameter (in)	2.87			
Height (in)	6.08			
	Final			
MC (%)	115.5			
Dry Density (pcf)	40.5			
Saturation (%)	100.0			
Void Ratio	3.004			
Diameter (in)	2.76			
Height (in)	6.01			
Cell Pressure (psi)	86.8			
Back Pressure (psi)	80.0			
	Effective Stresses At:			
Strain (%)	5.0			
Deviator (ksf)	4.005			
Excess PP (psi)	4.2			
Sigma 1 (ksf)	4.390			
Sigma 3 (ksf)	0.385			
P (ksf)	2.388			
Q (ksf)	2.003			
Stress Ratio	11.403			
Rate (in/min)	0.0005
