Definite Plan for the Lower Klamath Project

Appendix A – Risk Management Plan

June 2018

Klamath River Renewal Corporation

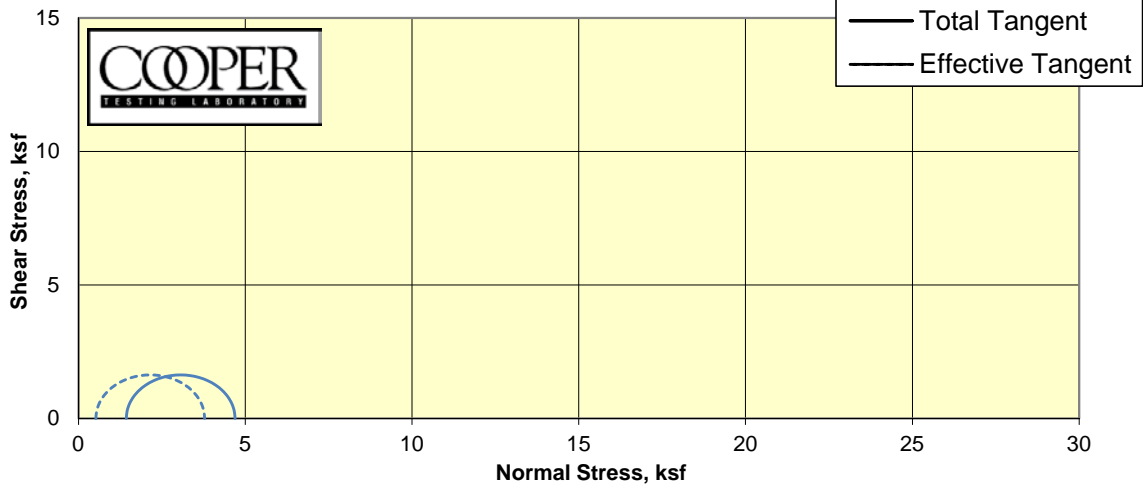
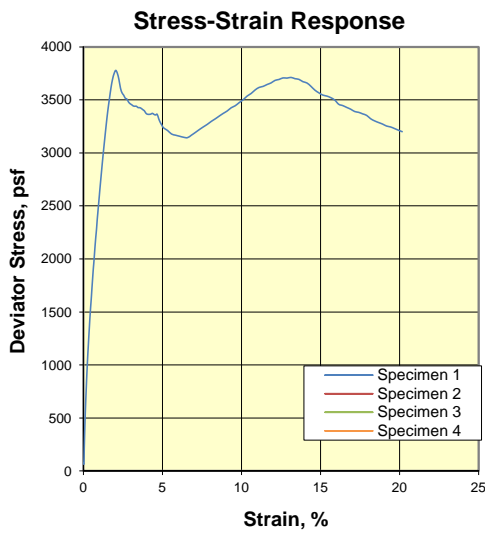
**Consolidated Undrained Triaxial Compression with Pore Pressure
ASTM D4767**

1	2	3	4
Specimen				
Boring	BC-04			
Sample	S-10			
Depth	52.5(Tip-4")			
Visual Description	Bluish Gray CLAY (Silty)/ SILT (slightly plastic)			
MC (%)	153.6			
Dry Density (pcf)	32.1			
Saturation (%)	97.9			
Void Ratio	4.156			
Diameter (in)	2.87			
Height (in)	6.08			
	Final			
MC (%)	151.2			
Dry Density (pcf)	33.0			
Saturation (%)	100.0			
Void Ratio	4.007			
Diameter (in)	2.84			
Height (in)	6.03			
Cell Pressure (psi)	90.6			
Back Pressure (psi)	80.6			
	Effective Stresses At:			
Strain (%)	5.0			
Deviator (ksf)	3.260			
Excess PP (psi)	6.3			
Sigma 1 (ksf)	3.784			
Sigma 3 (ksf)	0.523			
P (ksf)	2.154			
Q (ksf)	1.630			
Stress Ratio	7.229			
Rate (in/min)	0.0005

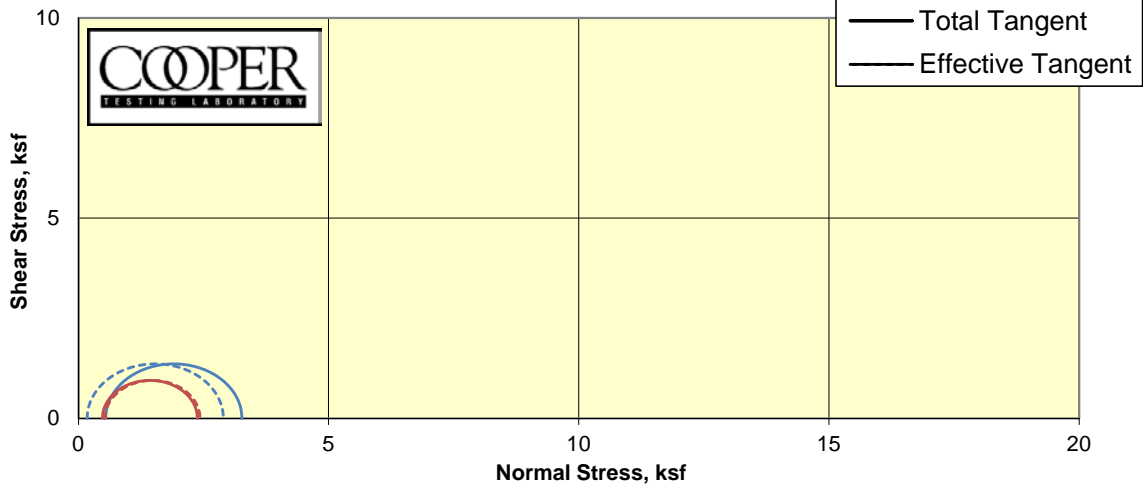
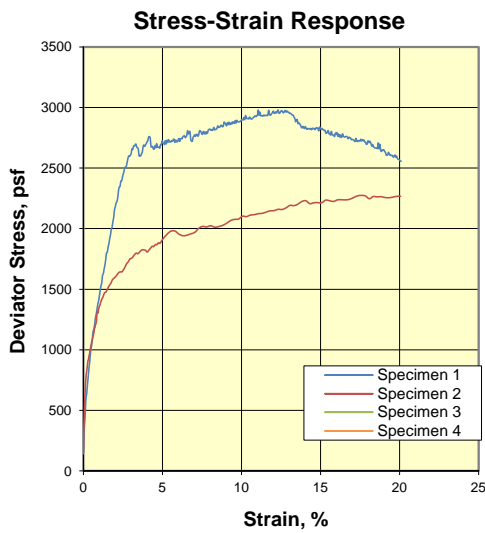
**Consolidated Undrained Triaxial Compression with Pore Pressure
ASTM D4767**

Specimen	1	2	3	4
Boring	BC-05	BC-05		
Sample	S-04	S-04		
Depth	14.5(Tip-16")	14.5(Tip-1")		
Visual Description	Olive CLAY (Silty)/SILT (slightly plastic)	Olive Mottled Yellow Clayey SAND/ Sandy CLAY		
MC (%)	135.1	30.0		
Dry Density (pcf)	35.4	92.8		
Saturation (%)	97.0	99.2		
Void Ratio	3.760	0.816		
Diameter (in)	2.87	2.87		
Height (in)	5.83	6.09		
	Final			
MC (%)	135.4	29.8		
Dry Density (pcf)	36.2	93.4		
Saturation (%)	100.0	100.0		
Void Ratio	3.656	0.805		
Diameter (in)	2.85	2.87		
Height (in)	5.80	6.07		
Cell Pressure (psi)	84.2	84.1		
Back Pressure (psi)	80.4	80.8		
	Effective Stresses At:			
Strain (%)	5.0	5.0		
Deviator (ksf)	2.725	1.900		
Excess PP (psi)	2.6	-0.4		
Sigma 1 (ksf)	2.899	2.431		
Sigma 3 (ksf)	0.173	0.531		
P (ksf)	1.536	1.481		
Q (ksf)	1.363	0.950		
Stress Ratio	16.726	4.577		
Rate (in/min)	0.0005	0.0005

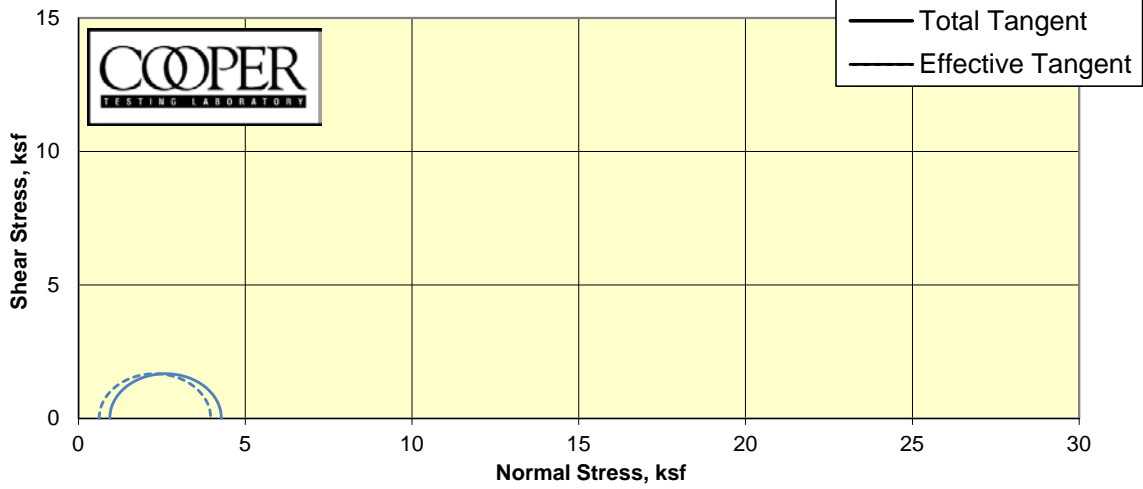
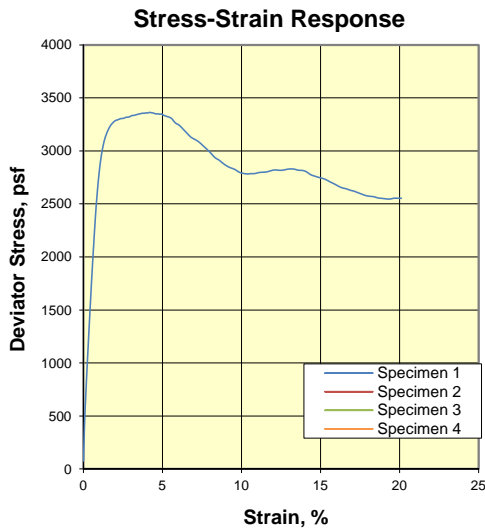
**Consolidated Undrained Triaxial Compression with Pore Pressure
ASTM D4767**

1	2	3	4
Boring	BC-09			
Sample	S-05			
Depth	23(Tip-5")			
Visual Description	Dark Gray Elastic SILT			
MC (%)	79.5			
Dry Density (pcf)	51.9			
Saturation (%)	97.1			
Void Ratio	2.130			
Diameter (in)	2.87			
Height (in)	6.07			
	Final			
MC (%)	79.4			
Dry Density (pcf)	53.0			
Saturation (%)	100.0			
Void Ratio	2.065			
Diameter (in)	2.85			
Height (in)	6.04			
Cell Pressure (psi)	86.8			
Back Pressure (psi)	80.3			
	Effective Stresses At:			
Strain (%)	5.0			
Deviator (ksf)	3.348			
Excess PP (psi)	2.2			
Sigma 1 (ksf)	3.969			
Sigma 3 (ksf)	0.621			
P (ksf)	2.295			
Q (ksf)	1.674			
Stress Ratio	6.396			
Rate (in/min)	0.0005

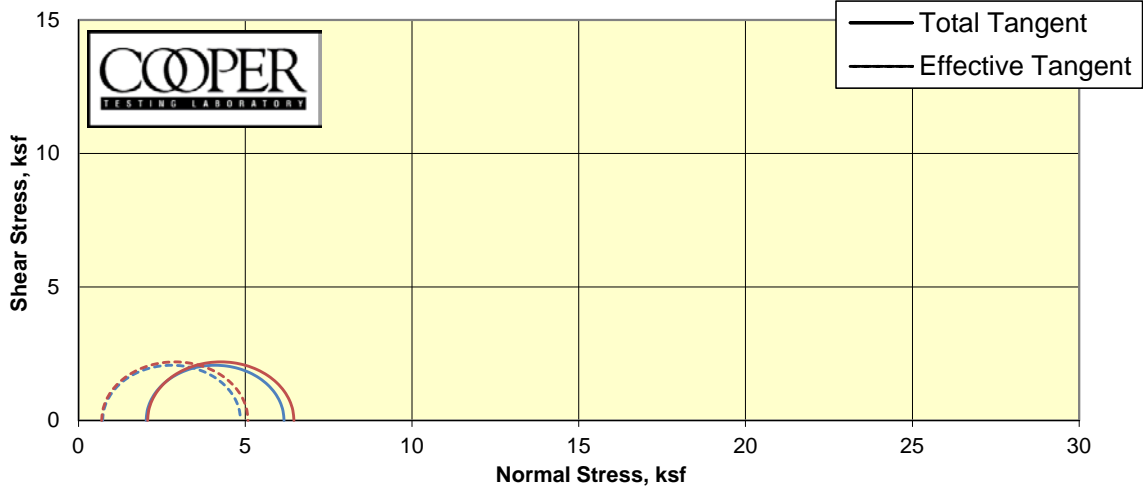
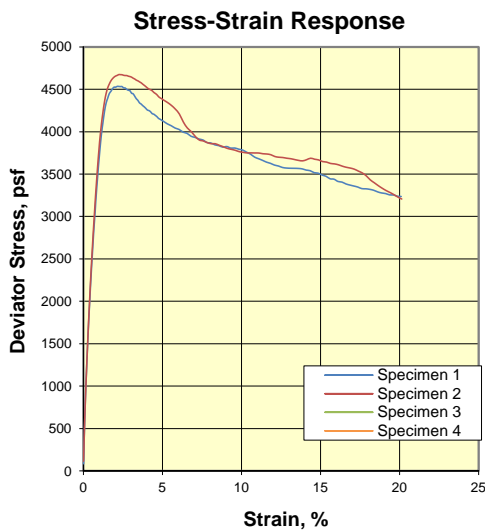
**Consolidated Undrained Triaxial Compression with Pore Pressure
ASTM D4767**

Specimen	1	2	3	4
Boring	BC-09	BC-09		
Sample	S-09	S-09		
Depth	68-70.5(Tip-10")	68-70.5(Tip-4")		
Visual Description	Dark Greenish Gray CLAY (Silty)/ SILT (slightly plastic)	Dark Greenish Gray CLAY (Silty)/ SILT (slightly plastic)		
MC (%)	92.0	95.5		
Dry Density (pcf)	47.2	46.1		
Saturation (%)	98.2	98.5		
Void Ratio	2.436	2.520		
Diameter (in)	2.87	2.87		
Height (in)	6.06	6.06		
	Final			
MC (%)	90.6	93.7		
Dry Density (pcf)	48.4	47.2		
Saturation (%)	100.0	100.0		
Void Ratio	2.355	2.436		
Diameter (in)	2.84	2.85		
Height (in)	6.03	6.02		
Cell Pressure (psi)	94.2	94.1		
Back Pressure (psi)	80.1	79.7		
	Effective Stresses At:			
Strain (%)	5.0	5.0		
Deviator (ksf)	4.134	4.387		
Excess PP (psi)	9.1	9.6		
Sigma 1 (ksf)	4.860	5.084		
Sigma 3 (ksf)	0.726	0.697		
P (ksf)	2.793	2.891		
Q (ksf)	2.067	2.194		
Stress Ratio	6.693	7.293		
Rate (in/min)	0.0005	0.0005

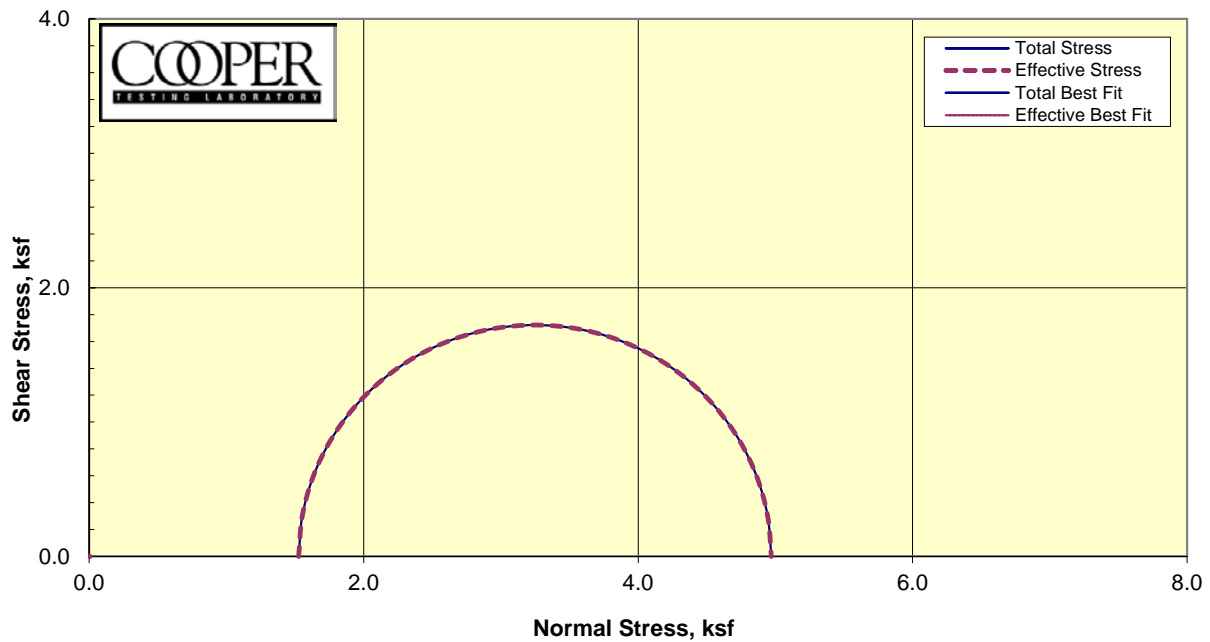
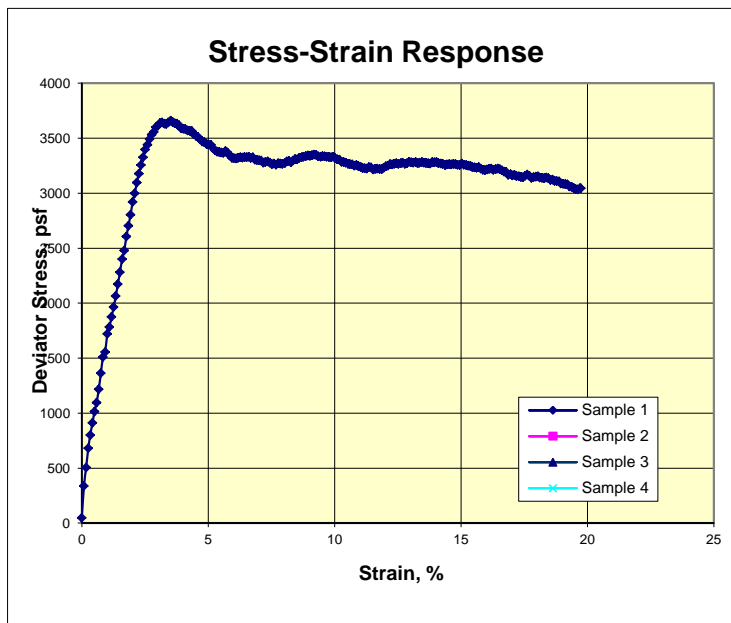
Triaxial Unconsolidated-Undrained (ASTM D2850m)

Sample:	1	2	3	4
MC, %	160.5			
Dry Dens, pcf	30.5			
Sat. %	95.9			
Void Ratio	4.519			
Diameter, in	2.87			
Height, in	6.08			
Final				
MC, %	163.5			
Dry Dens, pcf	31.1			
Sat. %	100.0			
Void Ratio	4.414			
Diameter, in	2.84			
Height, in	6.08			
Cell, psi	49.1			
BP, psi	38.5			
Effective Stresses At:				
Strain, %	5.0			
Deviator ksf	3.444			
Excess PP	0.000			
Sigma 1	4.970			
Sigma 3	1.526			
P, ksf	3.248			
Q, ksf	1.722			
Stress Ratio	3.256			
Rate in/min	0.0588			
Total C	N/A	ksf		
Total Phi	N/A	Degrees		
Eff. C	N/A	ksf		
Eff. Phi	N/A	Degrees

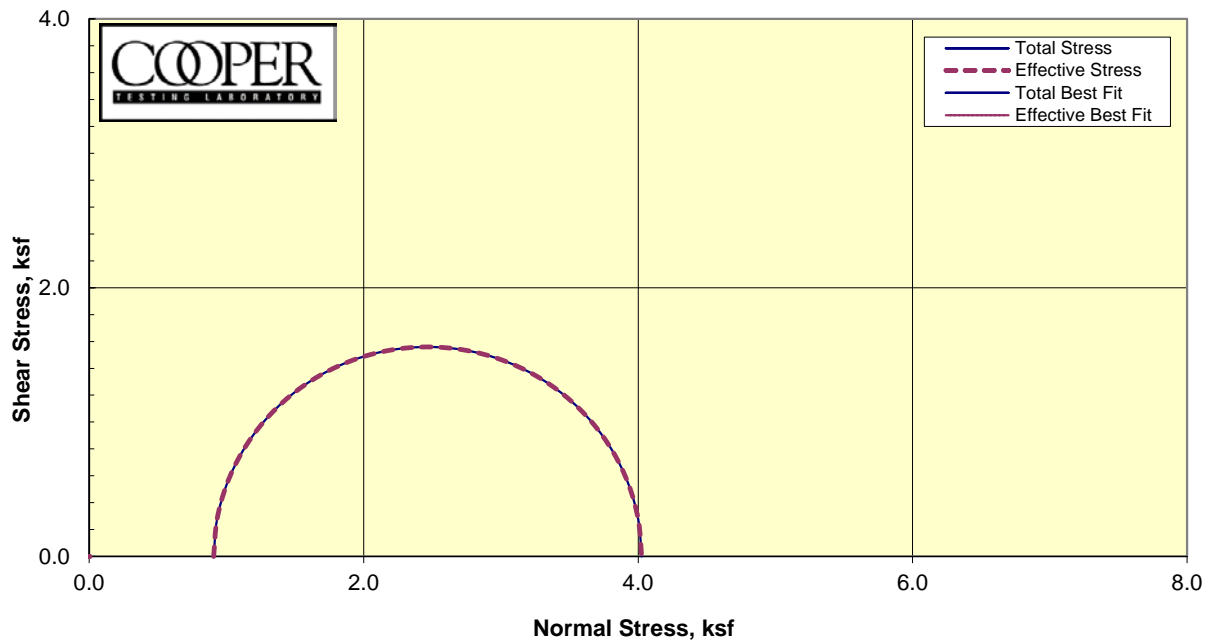
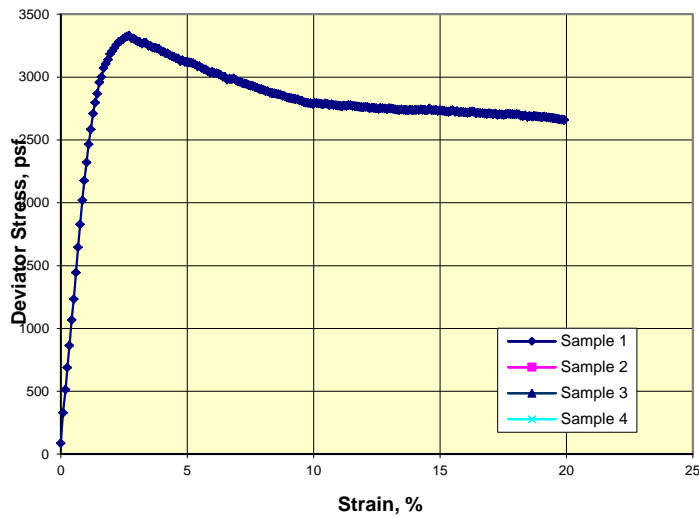
Triaxial Unconsolidated-Undrained (ASTM D2850m)

Stress-Strain Response

Sample:	1	2	3	4
MC, %	76.3			
Dry Dens, pcf	54.0			
Sat. %	97.1			
Void Ratio	2.121			
Diameter, in	2.87			
Height, in	6.05			
Final				
MC, %	76.6			
Dry Dens, pcf	54.9			
Sat. %	100.0			
Void Ratio	2.068			
Diameter, in	2.85			
Height, in	6.03			
Cell, psi	54.8			
BP, psi	48.5			
Effective Stresses At:				
Strain, %	5.0			
Deviator ksf	3.118			
Excess PP	0.000			
Sigma 1	4.025			
Sigma 3	0.907			
P, ksf	2.466			
Q, ksf	1.559			
Stress Ratio	4.437			
Rate in/min	0.0588			
Total C	N/A	ksf		
Total Phi	N/A	Degrees		
Eff. C	N/A	ksf		
Eff. Phi	N/A	Degrees

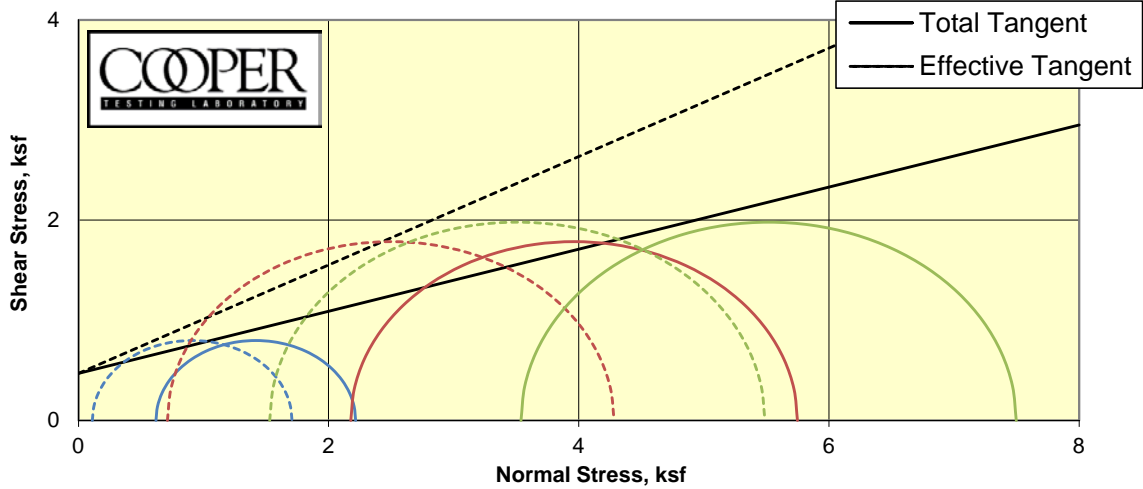
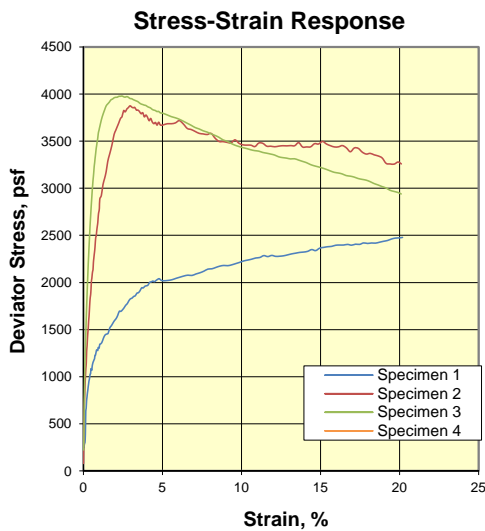
**Consolidated Undrained Triaxial Compression with Pore Pressure
ASTM D4767**

Specimen	1	2	3	4
Boring	Outcrop #1	Outcrop #1	Outcrop #1	
Sample				
Depth				
Visual Description	Pale Brown Siltstone (Diatomite)	Pale Brown Siltstone (Diatomite)	Pale Brown Siltstone (Diatomite)	
MC (%)	8.2	7.1	5.9	
Dry Density (pcf)	53.1	56.9	58.0	
Saturation (%)	10.2	9.7	8.4	
Void Ratio	2.176	1.961	1.907	
Diameter (in)	1.86	1.86	1.85	
Height (in)	4.00	4.00	4.00	
	Final			
MC (%)	78.4	73.5	71.9	
Dry Density (pcf)	54.1	56.5	57.3	
Saturation (%)	100.0	100.0	100.0	
Void Ratio	2.116	1.984	1.942	
Diameter (in)	1.85	1.87	1.87	
Height (in)	3.96	3.98	3.98	
Cell Pressure (psi)	124.0	135.0	144.9	
Back Pressure (psi)	119.7	119.8	120.4	
	Effective Stresses At:			
Strain (%)	2.0	2.0	2.0	
Deviator (ksf)	1.596	3.571	3.959	
Excess PP (psi)	3.5	10.2	14.0	
Sigma 1 (ksf)	1.708	4.282	5.488	
Sigma 3 (ksf)	0.111	0.712	1.529	
P (ksf)	0.909	2.497	3.509	
Q (ksf)	0.798	1.785	1.980	
Stress Ratio	15.338	6.018	3.589	
Rate (in/min)	0.0003	0.0003	0.0003

CTL Number:	020-232		
Client Name:	AECOM		
Project Name:	Klamath		
Project Number:	60537920		
Date:	9/25/2017	By:	MD/DC
Total C	0.470	ksf	
Total phi	17.2	degrees	
Eff. C	0.470	ksf	
Eff. Phi	28.4	degrees	©

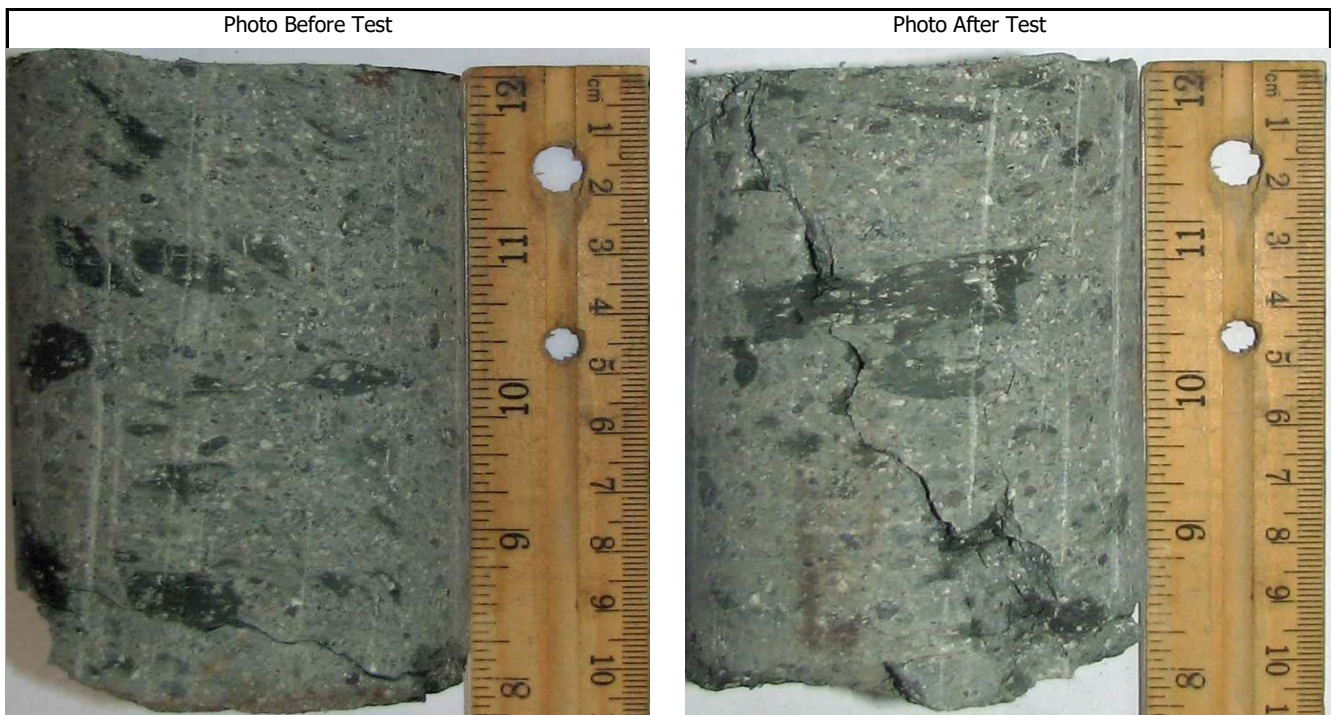
Project Name	Klamath River Dam Removal
Location	Klamath River
Client	Klamath River Renewal Corporation
Client Project No.	60537920
Registry No.	2018-22
Report No.	2018-22-1-1
Report Date	5/17/2018
Drill hole and Depth	BI-02; 27-27.9 ft
Rock Type	Volcanic Breccia
Geologic Unit	N/A
Moisture Condition	As-received

Stress Rate	0.5 MPa/s	
Diameter of Specimen	60.54 mm	2.38 in
Height of Specimen	97.72 mm	3.85 in
Load at Peak	16.69 kN	3,752 lbf
Unconfined Compressive Strength	5.80 MPa	841 psi
Type of Failure	Non-Structural

Note: The provided sample had a height-to-diameter ratio less than 2

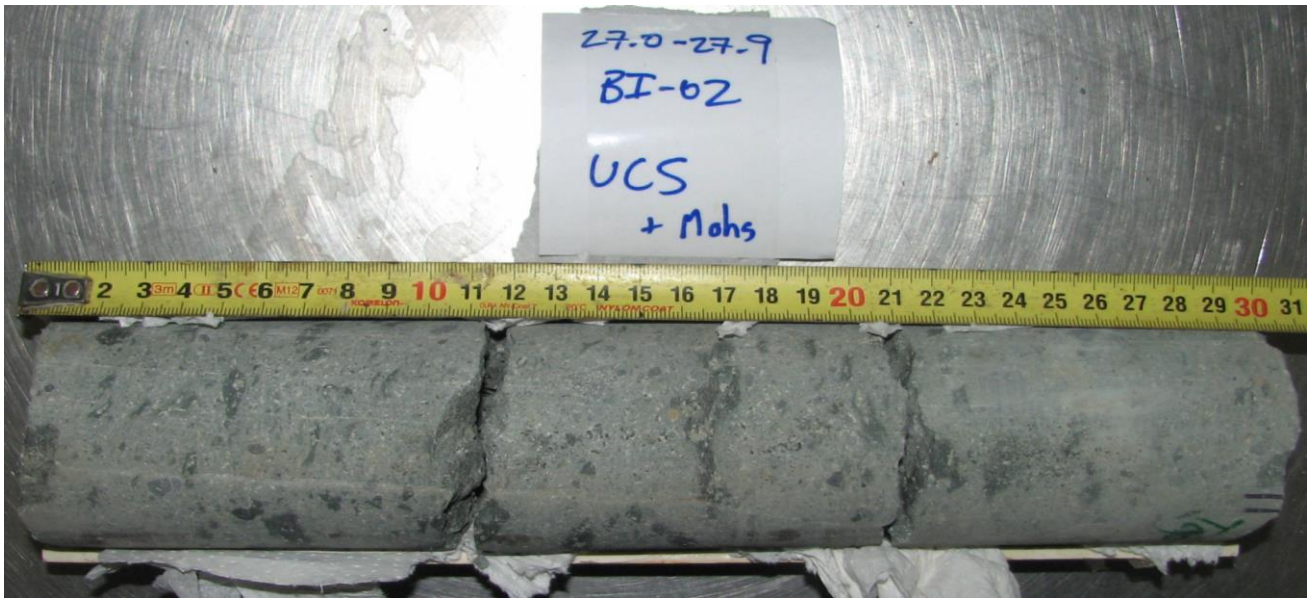
Picture of the sample upon arrival at Tonon USA Laboratory: no core piece allowed preparation of a specimen with a height-to-diameter ratio between 2 and 2.5.

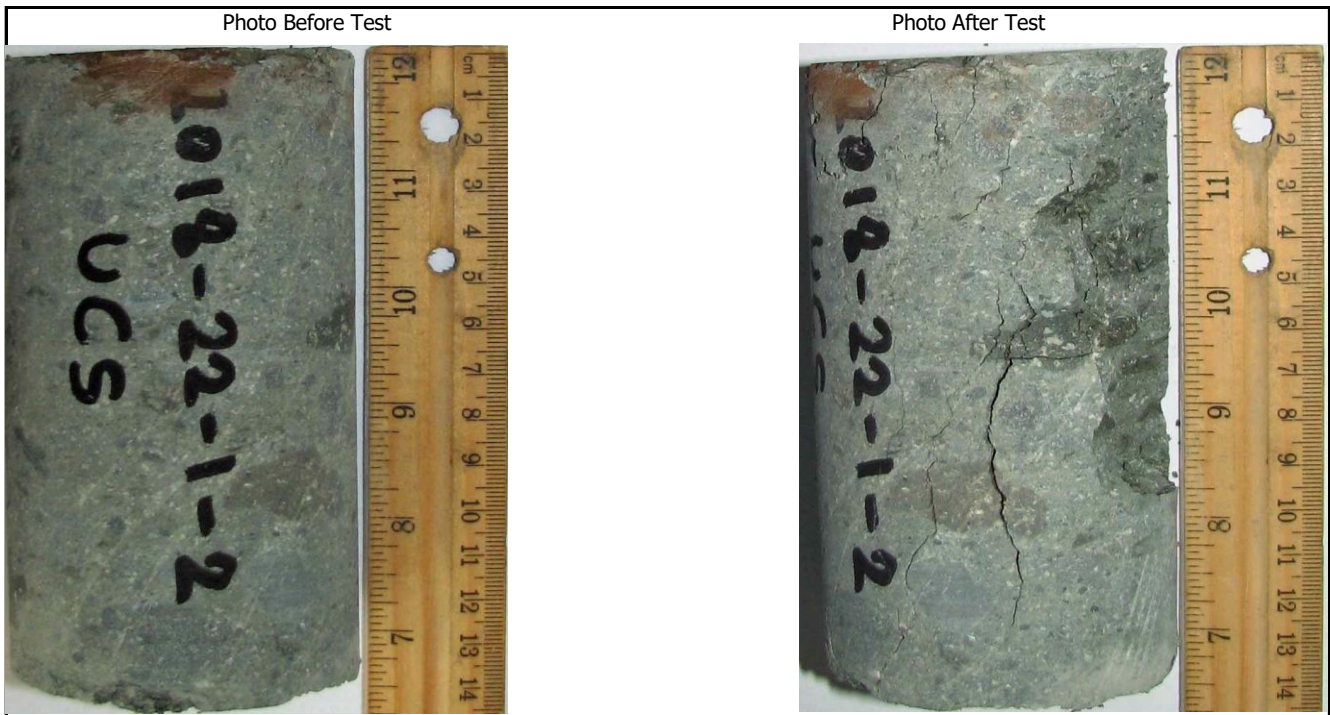
Project Name	Klamath River Dam Removal
Location	Klamath River
Client	Klamath River Renewal Corporation
Client Project No.	60537920
Registry No.	2018-22
Report No.	2018-22-1-2
Report Date	5/17/2018
Drill hole and Depth	BI-02; 48.9-50.3 ft
Rock Type	Volcanic Breccia
Geologic Unit	N/A
Moisture Condition	As-received

Stress Rate	0.5 MPa/s	
Diameter of Specimen	60.85 mm	2.40 in
Height of Specimen	127.87 mm	5.03 in
Load at Peak	34.80 kN	7,823 lbf
Unconfined Compressive Strength	11.97 MPa	1,736 psi
Type of Failure	Non-Structural

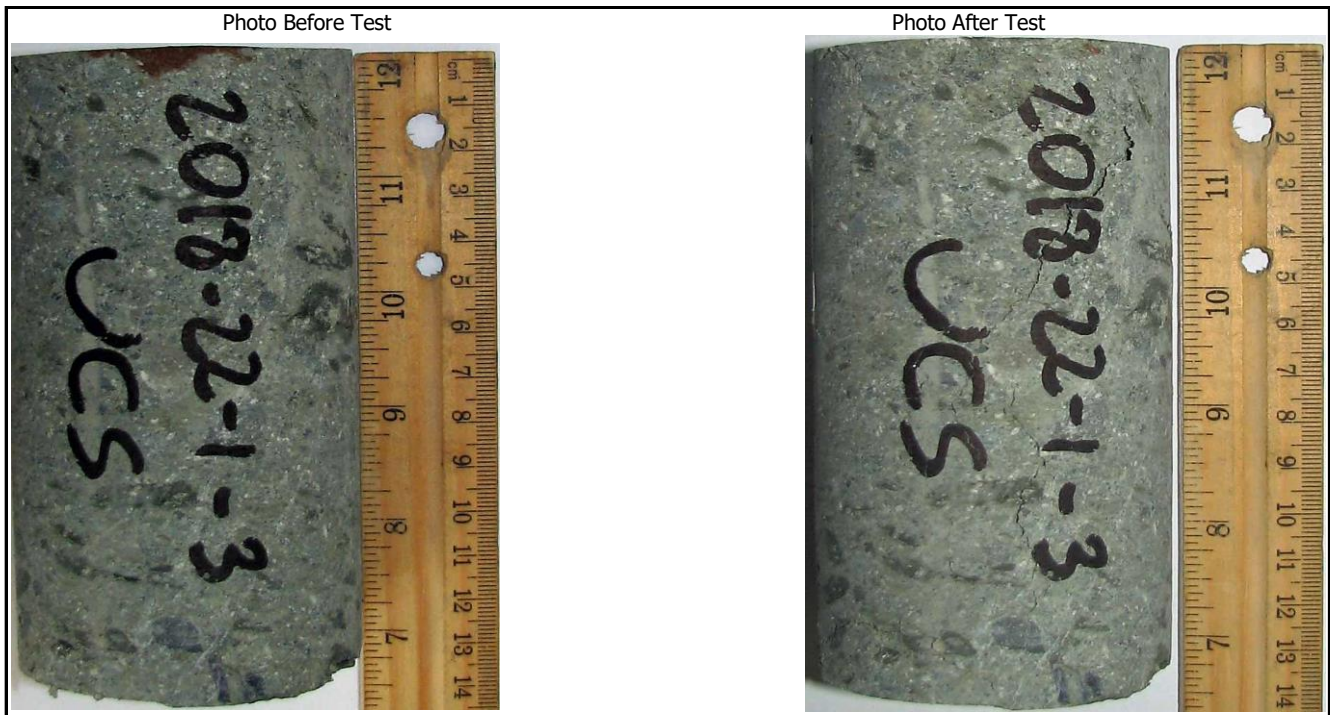
Project Name	Klamath River Dam Removal
Location	Klamath River
Client	Klamath River Renewal Corporation
Client Project No.	60537920
Registry No.	2018-22
Report No.	2018-22-1-3
Report Date	5/17/2018
Drill hole and Depth	BI-02; 55.4-56.3 ft
Rock Type	Volcanic Breccia
Geologic Unit	N/A
Moisture Condition	As-received

Stress Rate	0.5 MPa/s	
Diameter of Specimen	60.68 mm	2.39 in
Height of Specimen	128.33 mm	5.05 in
Load at Peak	45.59 kN	10,248 lbf
Unconfined Compressive Strength	15.77 MPa	2,288 psi
Type of Failure	Non-Structural

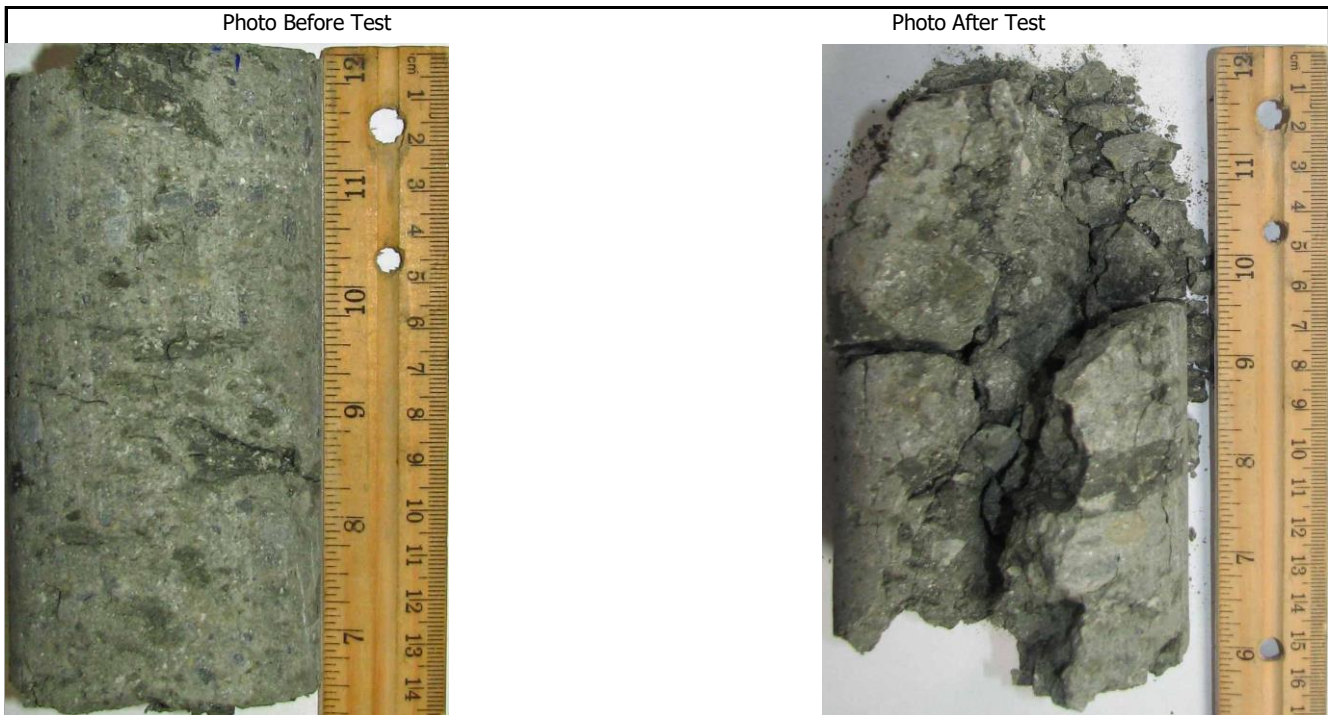
Project Name	Klamath River Dam Removal
Location	Klamath River
Client	Klamath River Renewal Corporation
Client Project No.	60537920
Registry No.	2018-22
Report No.	2018-22-1-4
Report Date	5/17/2018
Drill hole and Depth	BI-03; 17.4-18.4 ft
Rock Type	Volcanic Breccia
Geologic Unit	N/A
Moisture Condition	As-received

Stress Rate	0.5 MPa/s	
Diameter of Specimen	60.59 mm	2.39 in
Height of Specimen	129.81 mm	5.11 in
Load at Peak	4.39 kN	987 lbf
Unconfined Compressive Strength	1.52 MPa	221 psi
Type of Failure	Non-Structural

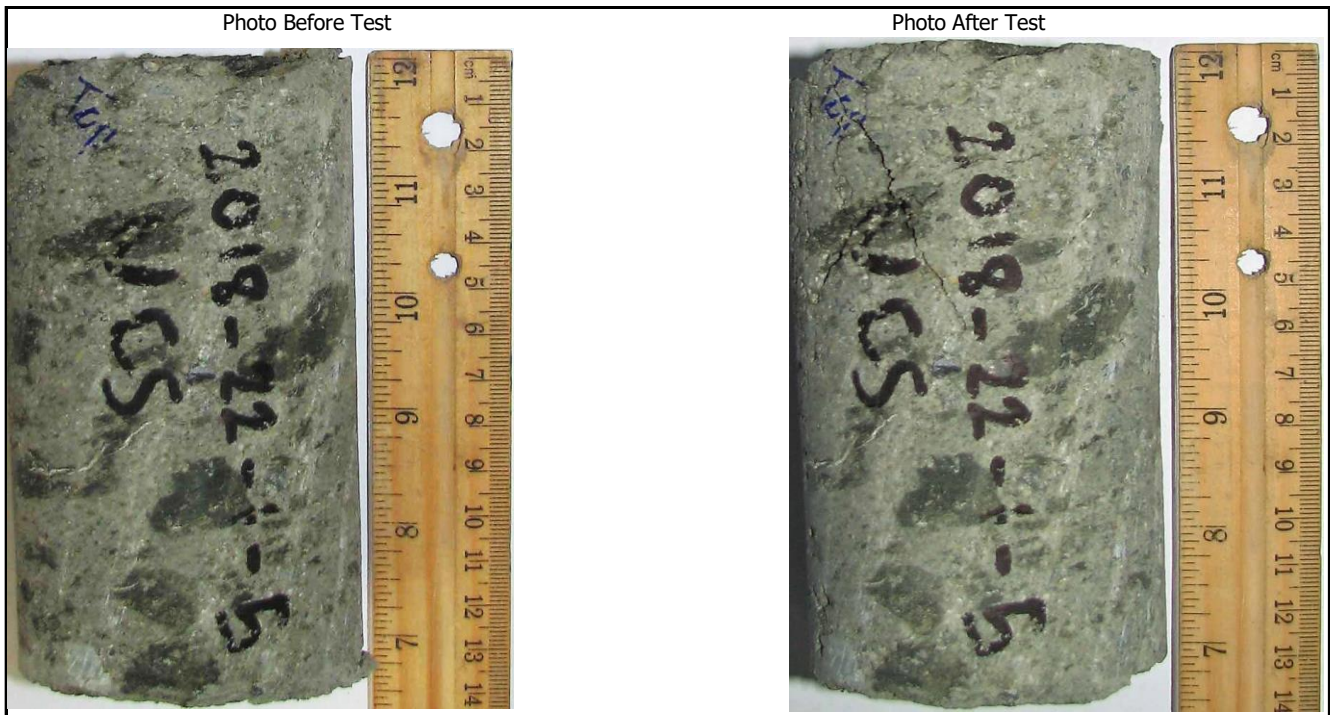
Project Name	Klamath River Dam Removal
Location	Klamath River
Client	Klamath River Renewal Corporation
Client Project No.	60537920
Registry No.	2018-22
Report No.	2018-22-1-5
Report Date	5/17/2018
Drill hole and Depth	BI-03; 21.5-22.9 ft
Rock Type	Volcanic Breccia
Geologic Unit	N/A
Moisture Condition	As-received

Stress Rate	0.5 MPa/s	
Diameter of Specimen	60.58 mm	2.39 in
Height of Specimen	125.67 mm	4.95 in
Load at Peak	6.99 kN	1,571 lbf
Unconfined Compressive Strength	2.43 MPa	352 psi
Type of Failure	Non-Structural

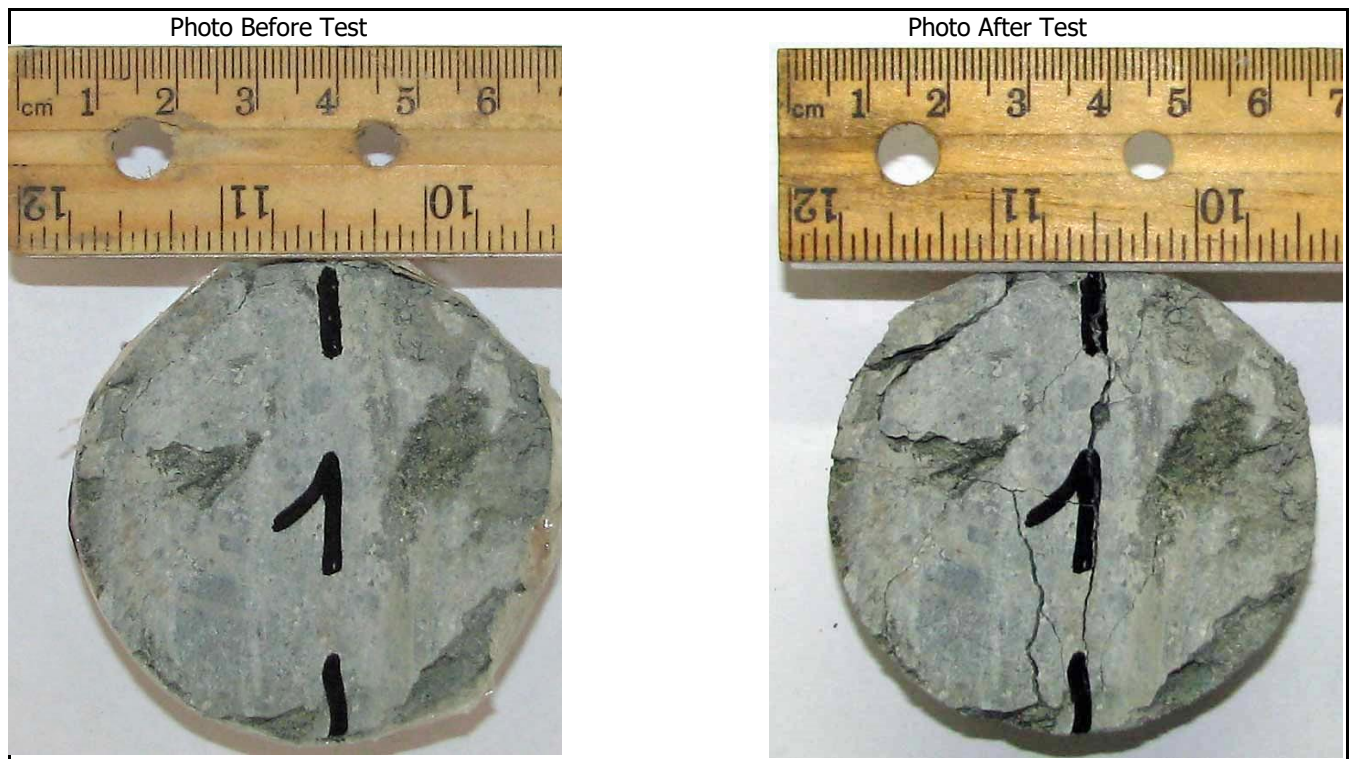
Project Name	Klamath River Dam Removal	Rate of loading (0.05-0.35 MPa/s or 500-3,000 psi/min)	0.11 MPa/sec	957 psi/min
Location	Klamath River	Diameter (D)	60.94 mm	2.40 in
Client	Klamath River Renewal Corporation	Thickness (t)	22.88 mm	0.90 in
Client Project No.	60537920	Maximum Load (P)	6.53 kN	1,468 lbf
Registry No.	2018-22	Tensile strength (flat platens) $\sigma_t = 2P / \pi t D$	N/A	N/A
Report No.	2018-22-2-1	Tensile strength (curved platens) $\sigma_t = 1.272P / \pi t D$	1.90 MPa	275 psi
Report Date	5/17/2018	Direction of Loading	Orthogonal to the Borehole Axis	
Drill Hole and Depth	BI-02; 47-48.9 ft	Type of Failure	Non-Structural	
Rock Type	Volcanic Breccia	Conformance to dimensional Requirements $0.2 \leq \frac{t}{D} \leq 0.75$	$\frac{t}{D} = 0.38$	OK
Geologic Unit	N/A			
Moisture Condition	As-received

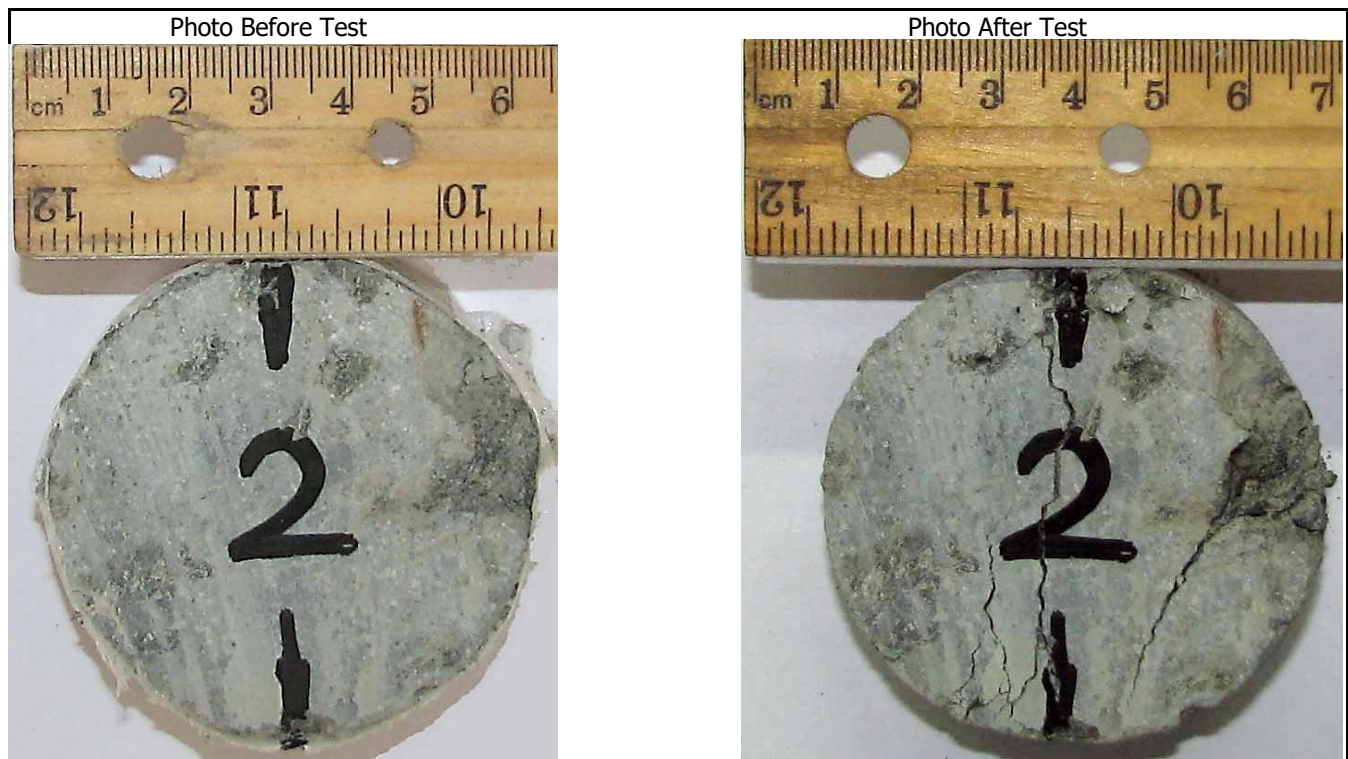
Project Name	Klamath River Dam Removal	Rate of loading (0.05-0.35 MPa/s or 500-3,000 psi/min)	0.11 MPa/sec	957 psi/min
Location	Klamath River	Diameter (D)	60.84 mm	2.40 in
Client	Klamath River Renewal Corporation	Thickness (t)	24.67 mm	0.97 in
Client Project No.	60537920	Maximum Load (P)	5.25 kN	1,180 lbf
Registry No.	2018-22	Tensile strength (flat platens) $\sigma_f = 2P / \pi t D$	N/A	N/A
Report No.	2018-22-2-2	Tensile strength (curved platens) $\sigma_c = 1.272P / \pi t D$	1.42 MPa	206 psi
Report Date	5/17/2018	Direction of Loading	Orthogonal to the Borehole Axis	
Drill Hole and Depth	BI-02; 52-54.7 ft	Type of Failure	Non-Structural	
Rock Type	Volcanic Breccia	Conformance to dimensional Requirements $0.2 \leq \frac{t}{D} \leq 0.75$	$\frac{t}{D} = 0.41$	OK
Geologic Unit	N/A			
Moisture Condition	As-received

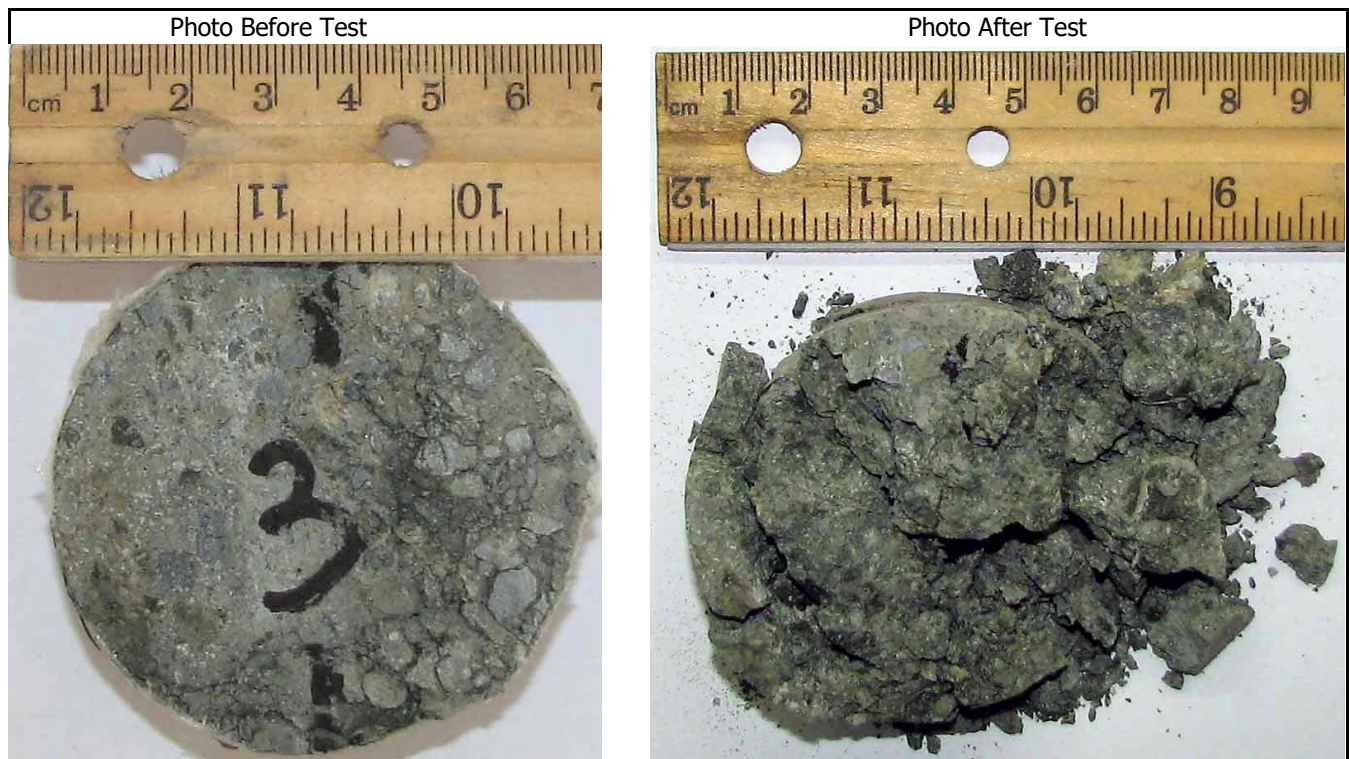
Project Name	Klamath River Dam Removal	Rate of loading (0.05-0.35 MPa/s or 500-3,000 psi/min)	0.11 MPa/sec	957 psi/min
Location	Klamath River	Diameter (D)	60.74 mm	2.39 in
Client	Klamath River Renewal Corporation	Thickness (t)	26.84 mm	1.06 in
Client Project No.	60537920	Maximum Load (P)	1.51 kN	339 lbf
Registry No.	2018-22	Tensile strength (flat platens) $\sigma_t = 2P / \pi t D$	N/A	N/A
Report No.	2018-22-2-3	Tensile strength (curved platens) $\sigma_t = 1.272P / \pi t D$	0.38 MPa	54 psi
Report Date	5/17/2018	Direction of Loading	Orthogonal to the Borehole Axis	
Drill Hole and Depth	BI-03; 18.4-20.1 ft	Type of Failure	Non-Structural	
Rock Type	Volcanic Breccia	Conformance to dimensional Requirements	$\frac{t}{D} = 0.44$	OK
Geologic Unit	N/A	$0.2 \leq \frac{t}{D} \leq 0.75$		
Moisture Condition	As-received

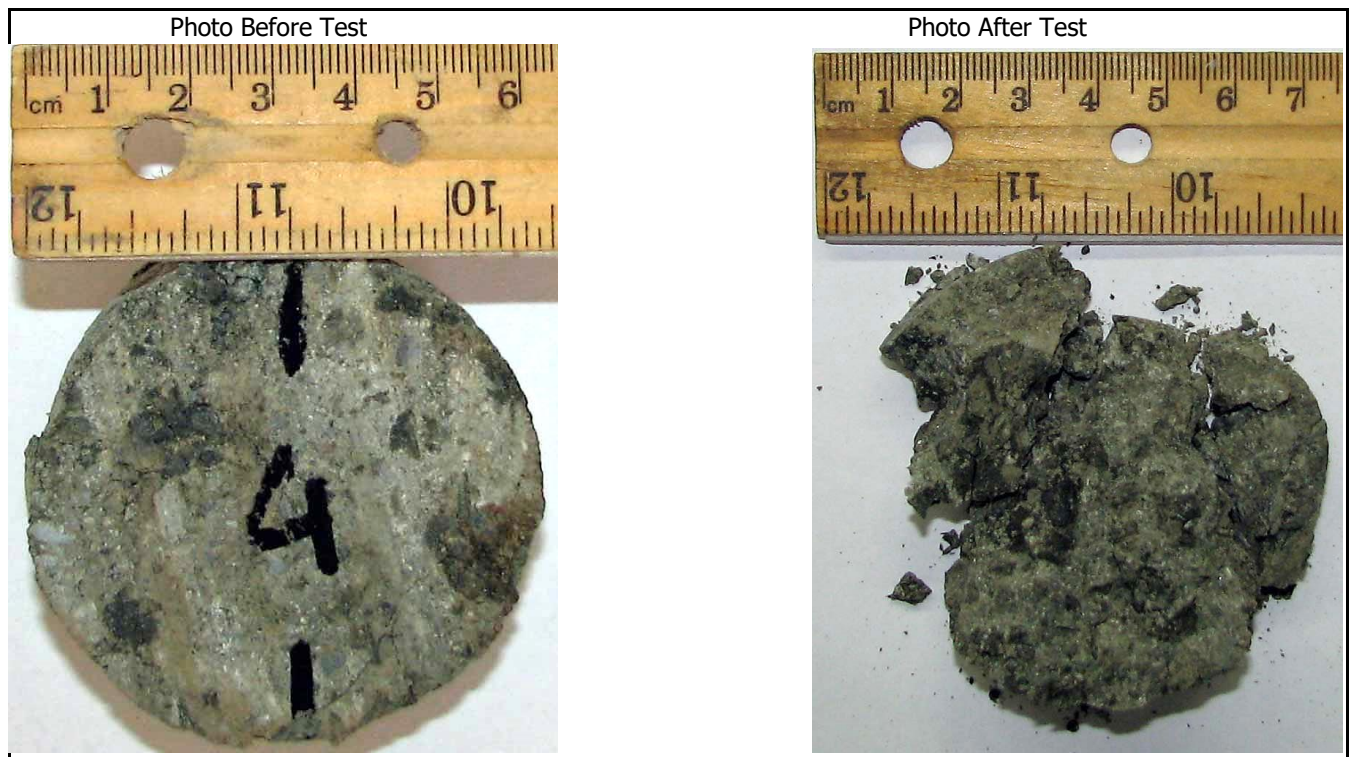
Project Name	Klamath River Dam Removal	Rate of loading (0.05-0.35 MPa/s or 500-3,000 psi/min)	0.11 MPa/sec	957 psi/min
Location	Klamath River	Diameter (D)	60.26 mm	2.37 in
Client	Klamath River Renewal Corporation	Thickness (t)	33.83 mm	1.33 in
Client Project No.	60537920	Maximum Load (P)	0.55 kN	124 lbf
Registry No.	2018-22	Tensile strength (flat platens) $\sigma_t = 2P / \pi t D$	N/A	N/A
Report No.	2018-22-2-4	Tensile strength (curved platens) $\sigma_t = 1.272P / \pi t D$	0.11 MPa	16 psi
Report Date	5/17/2018	Direction of Loading	Orthogonal to the Borehole Axis	
Drill Hole and Depth	BI-03; 22.9-24.2 ft	Type of Failure	Non-Structural	
Rock Type	Volcanic Breccia	Conformance to dimensional Requirements	$\frac{t}{D} = 0.56$	OK
Geologic Unit	N/A	$0.2 \leq \frac{t}{D} \leq 0.75$		
Moisture Condition	As-received

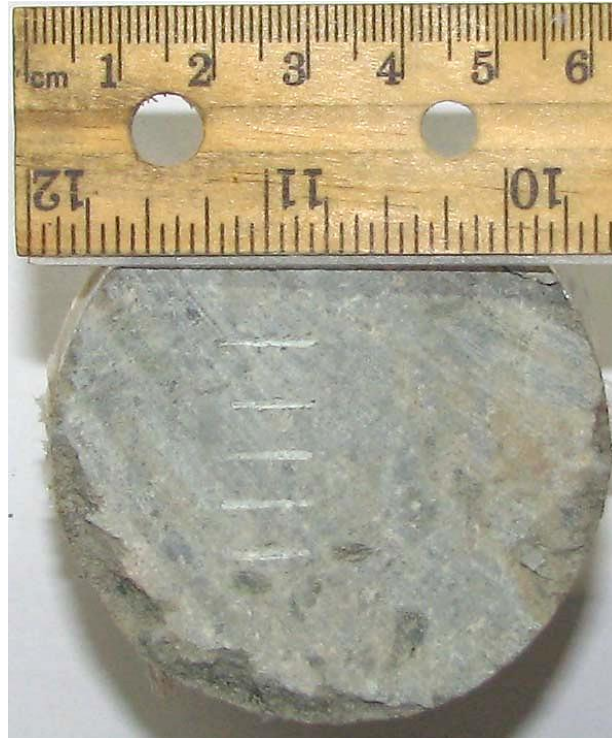
Photo After Test

Project Name	Klamath River Dam Removal
Location	Klamath River
Client	Klamath River Renewal Corporation
Client Project No.	60537920
Registry No.	2018-22
Report No.	2018-22-5-1
Report Date	5/17/2018
Drill Hole and Depth	BI-02; 51.3-51.7 ft
Rock Type	Volcanic Breccia
Formation	N/A
Surface Condition	Cut by Slab Saw

Apparatus, Pin R.-H.	West Cerchar, 55/56	
Direction of Scratch	Perpendicular to Core Axis	
Pin Wear (mm)	0.156	0.145
	0.142	0.124
	0.144	0.133
	0.162	0.129
	0.150	0.140
Average (mm)	0.143	
CAIs	1.43	
CAI	1.89	
Classification	Medium Abrasiveness

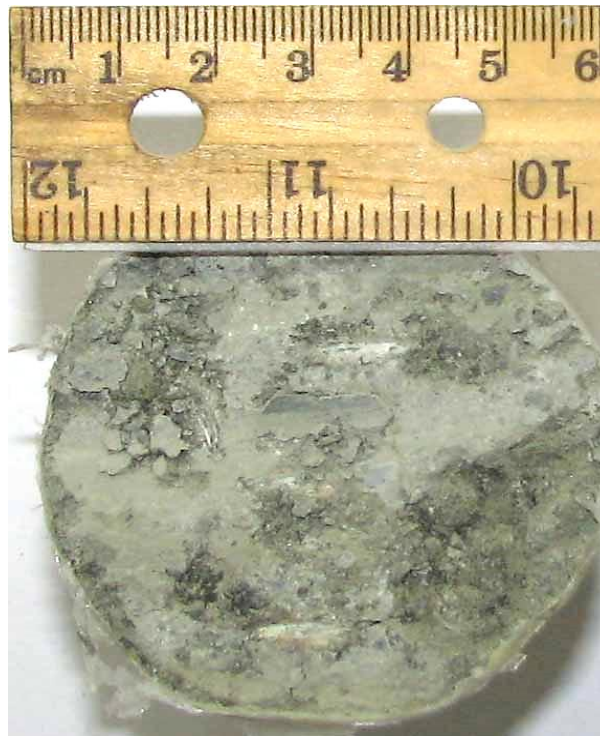
Photo After Test

Project Name	Klamath River Dam Removal	Apparatus, Pin R.-H.	West Cerchar, 55/56	
Location	Klamath River	Direction of Scratch	Perpendicular to Core Axis	
Client	Klamath River Renewal Corporation	Pin Wear (mm)	0.046	0.037
Client Project No.	60537920		0.083	0.069
Registry No.	2018-22		0.104	0.090
Report No.	2018-22-5-2		0.087	0.098
Report Date	5/17/2018		0.100	0.093
Drill Hole and Depth	BI-03; 25.1-26.1 ft	Average (mm)	0.081	
Rock Type	Volcanic Breccia	CAIs	0.81	
Formation	N/A	CAI	1.28	
Surface Condition	Cut by Slab Saw	Classification	Medium Abrasiveness

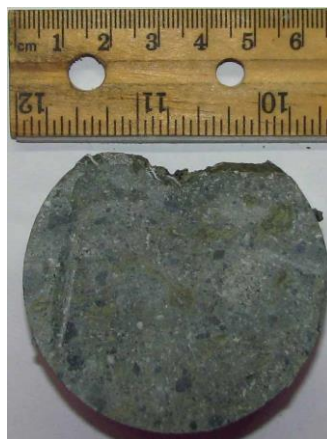
ROCK NAME: BRECCIATED-ALTERED BASALT (according to EN 12670).

Fig. 1 - Aspect of the studied sample (hand specimen).

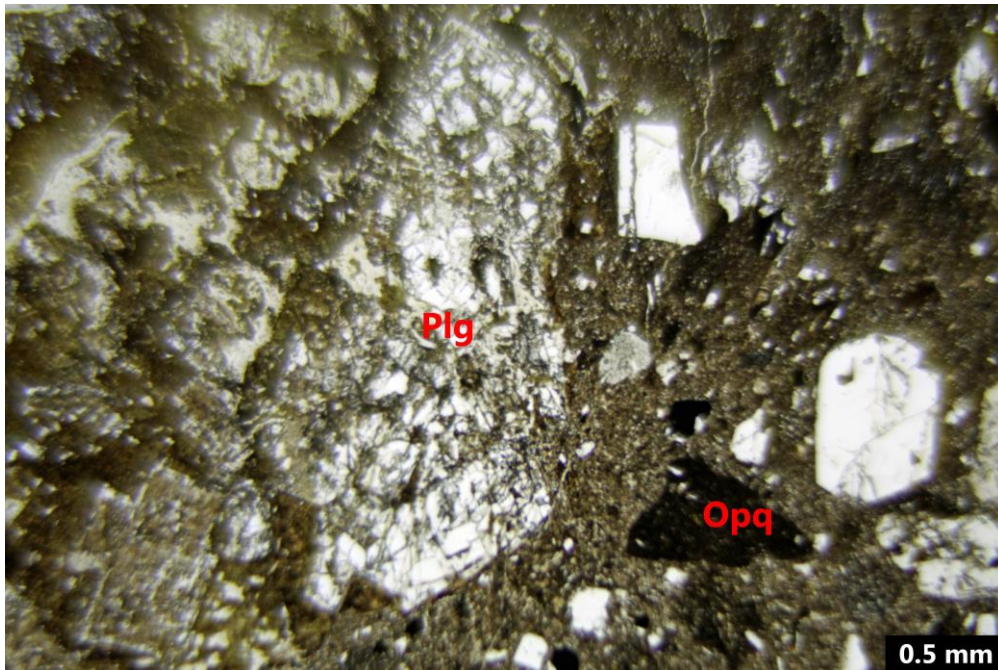
Fig. 2 - Plane polarized light. Field of view = 4 mm wide (magnification 4X). A view of the studied sample, showing an altered Plagioclase (Plg) crystal near to a big Hematite crystal (Opq).

Alteration and Mineral Suture Condition: The rock is highly altered: even the largest phenocrysts show traces of intense alteration acted upon by clayey minerals; Plagioclase crystals are intensively fractured. These fractures are commonly filled with secondary clayey material in a "quasi-styrolithic" pattern.

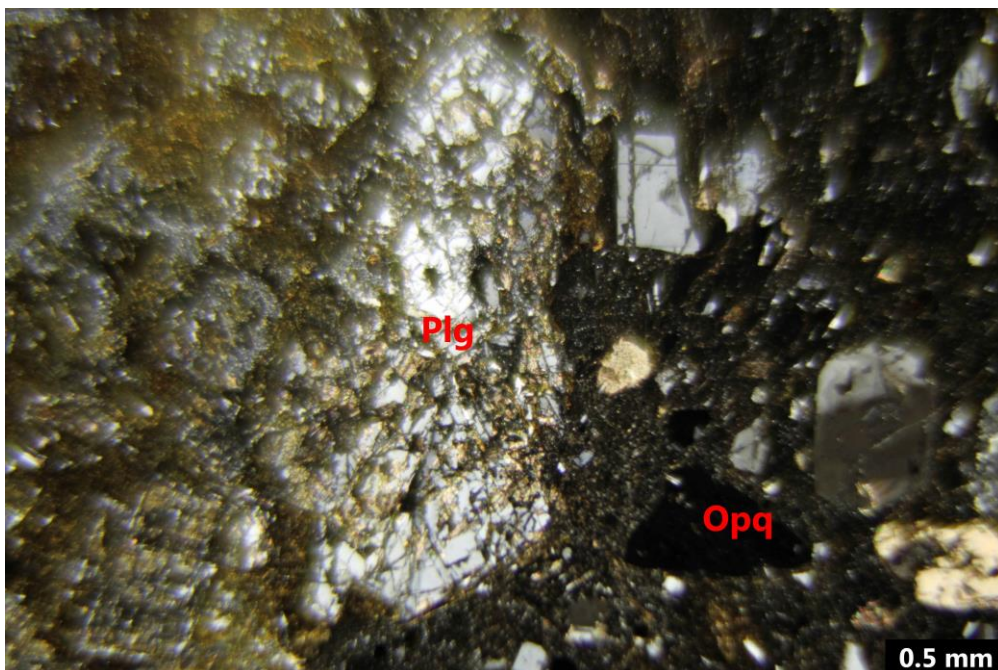
Fig. 3 - Cross polarized light. Field of view = 4 mm wide (magnification 4X). Same as Figure 2, but under crossed polars.
