Definite Plan for the Lower Klamath Project

Appendix A – Risk Management Plan

June 2018

Klamath River Renewal Corporation

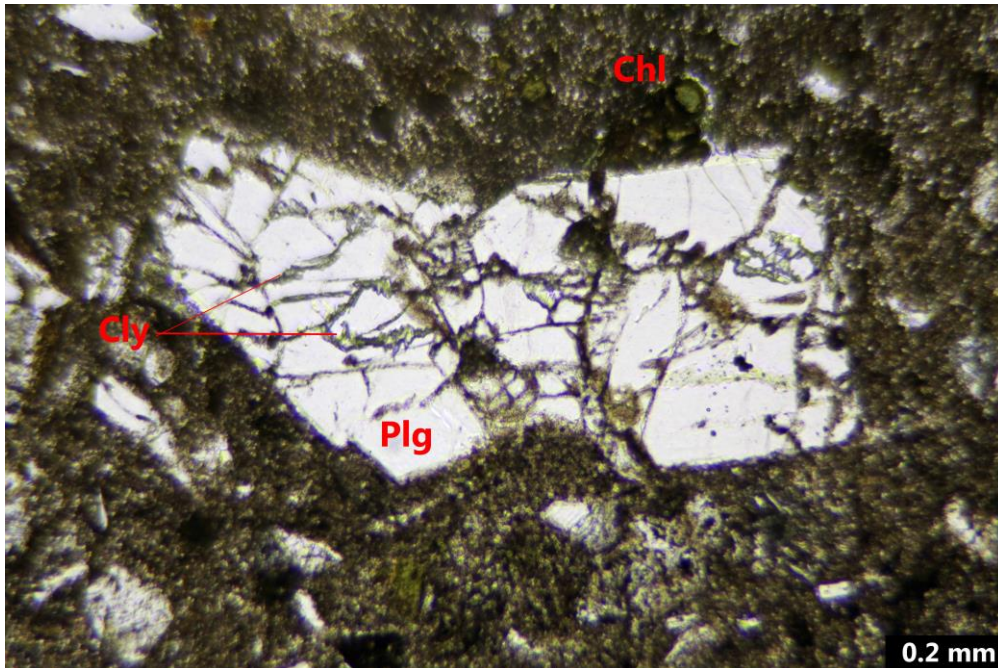
Fig. 4 - Plane polarized light. Field of view = 1.7 mm wide (magnification 10X). A detail of a Plagioclase grain, crossed by many fractures, all filled with Clay Minerals (Cly). Some Chlorite individuals (Chl) may be identified in the upper part of the picture.

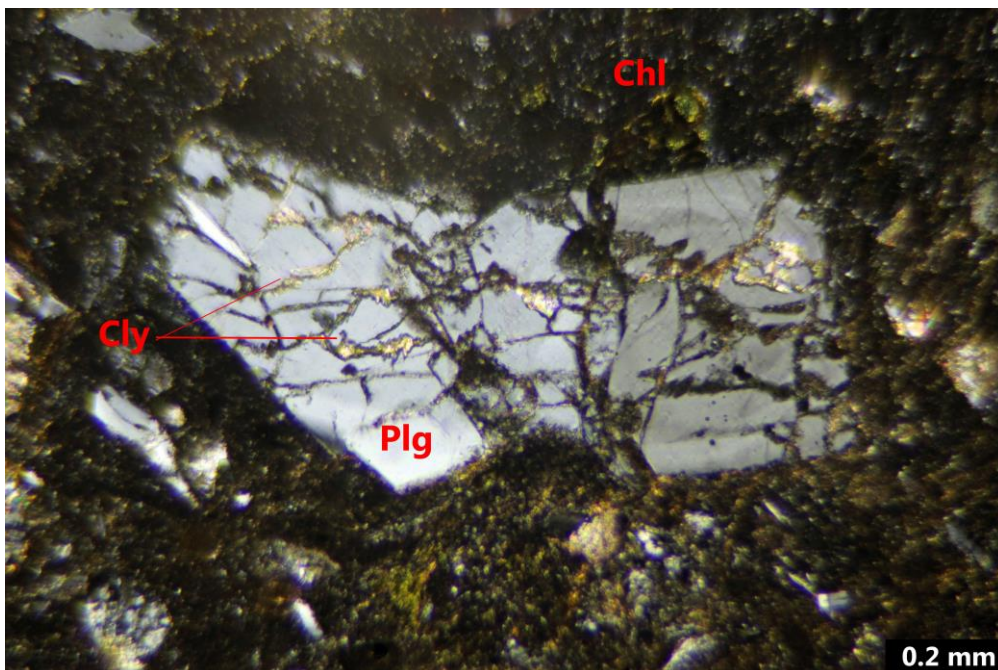
Fig. 5 - Cross polarized light. Field of view = 1.7 mm wide (magnification 10X). Same as Figure 4, but under crossed polars.

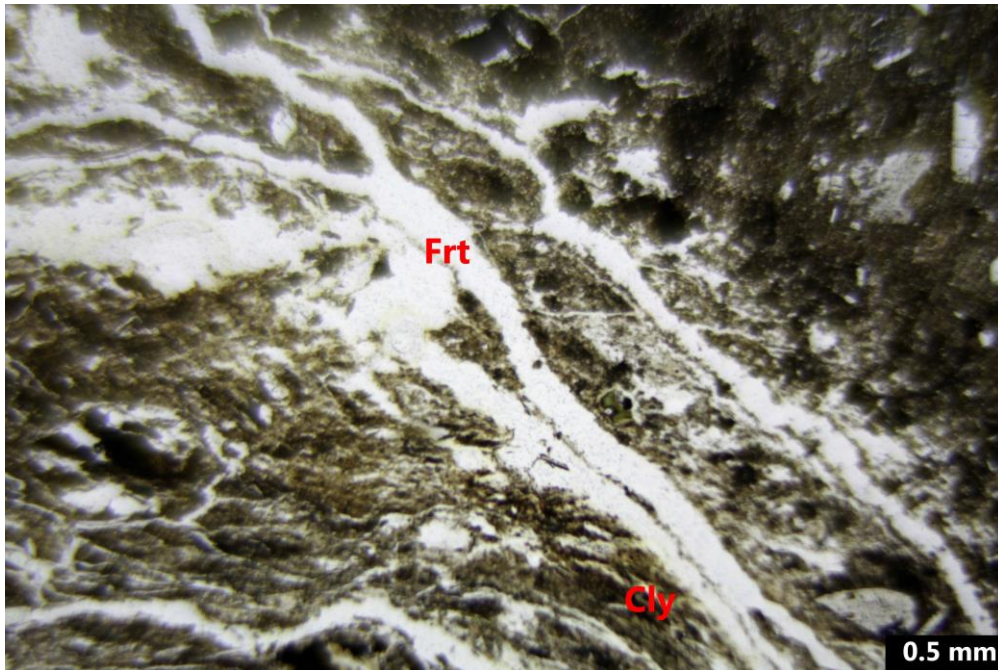
Fig. 6 - Plane polarized light. Field of view = 4 mm wide (magnification 4X). A selected area of the section with a well-developed fracture system (Frt).

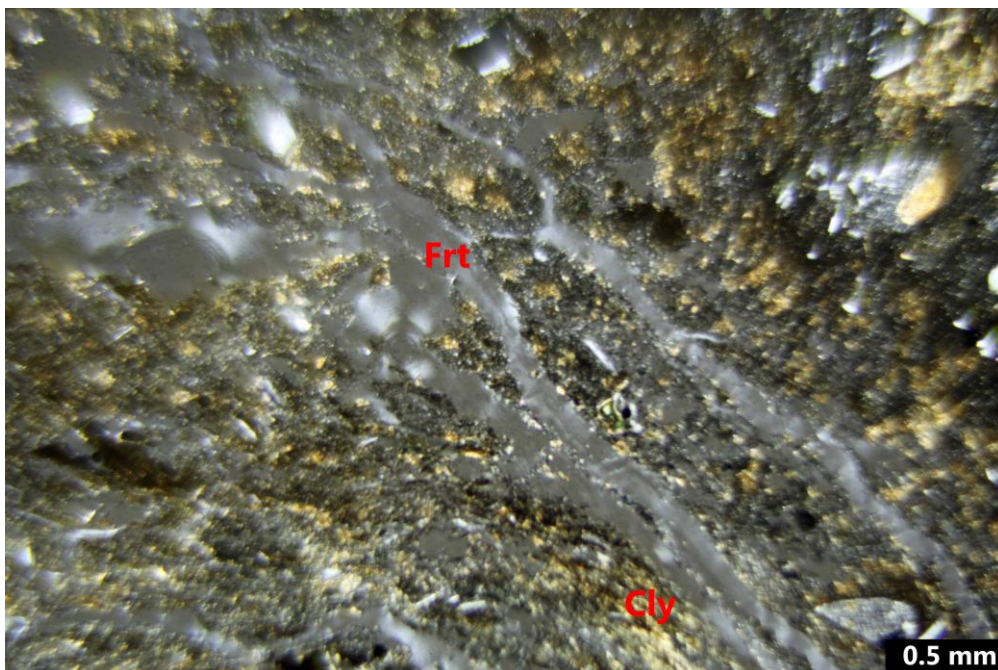
Fig. 7 - Cross polarized light. Field of view = 4 mm wide (magnification 4X). Same as Figure 6, but under crossed polars.

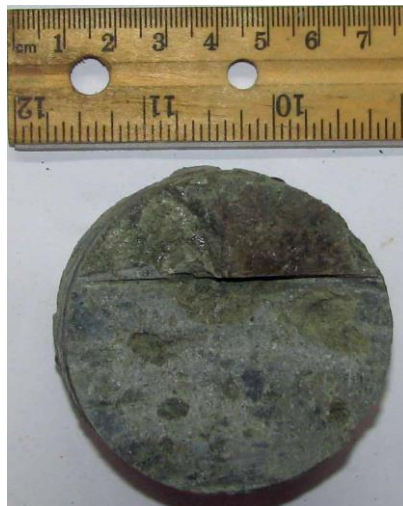
ROCK NAME: ALTERED VOLCANIC BRECCIA (according to EN 12670).

Fig. 1 - Aspect of the studied sample (hand specimen).

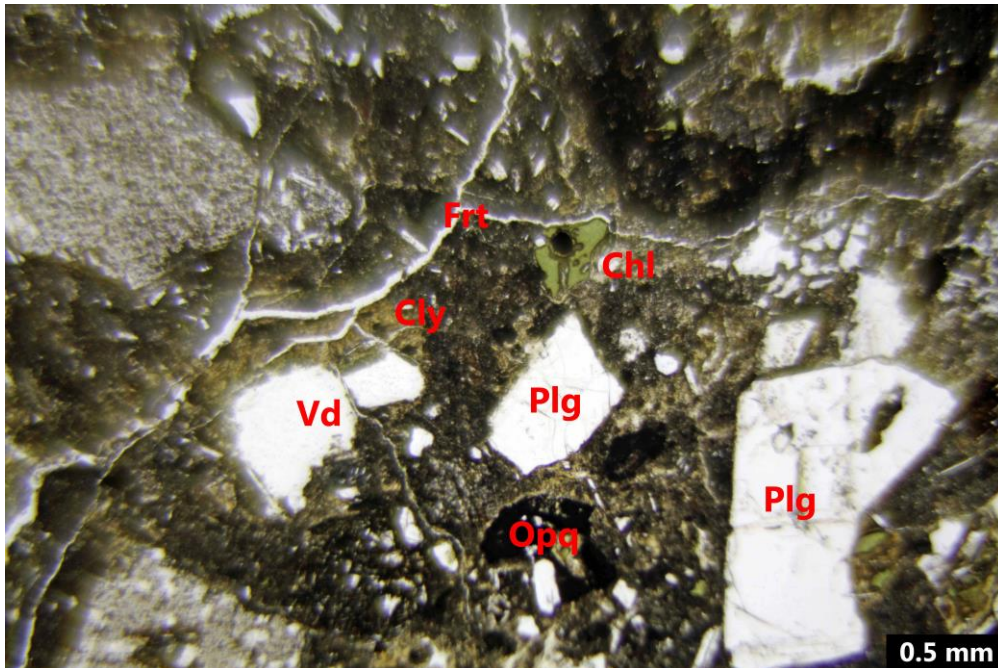
Fig. 2 - Plane polarized light. Field of view = 4 mm wide (magnification 4X). A view of the studied sample. The most common minerals are: Plagioclase (Plg), Clay Minerals (Cly), Opaque Minerals (Opq), and Chlorite (Chl). Also highlighted here are some structural features, such as fractures (Frt) and voids (Vd).

Crystals in this thin section have well defined rims, but they are also affected by pervasive fractures both within the crystals and all around their boundaries.

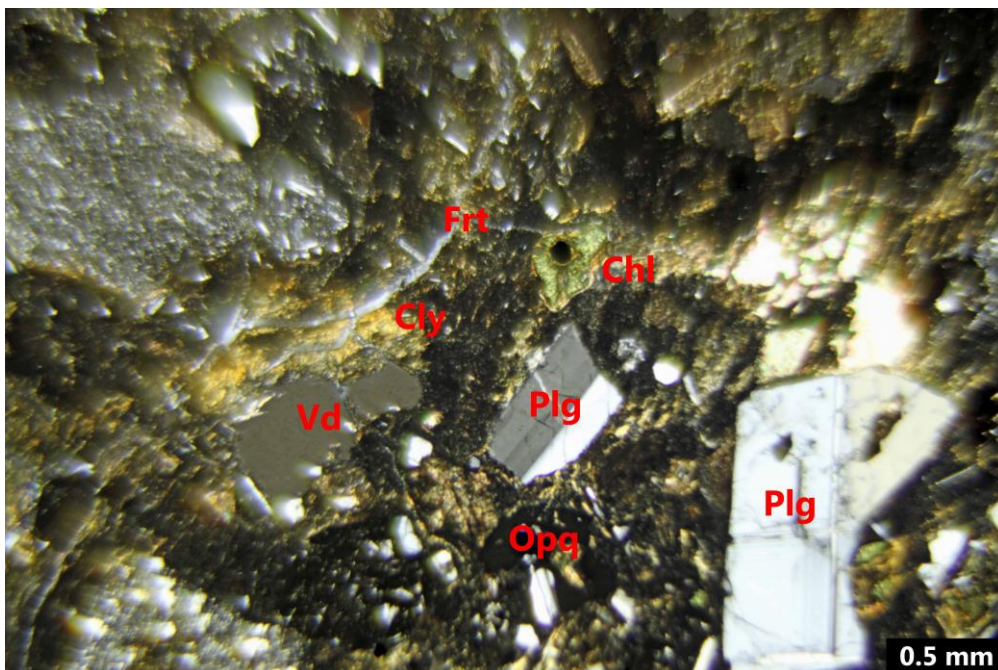
Fig. 3 - Cross polarized light. Field of view = 4 mm wide (magnification 4X). Same as Figure 2, but under crossed polars.

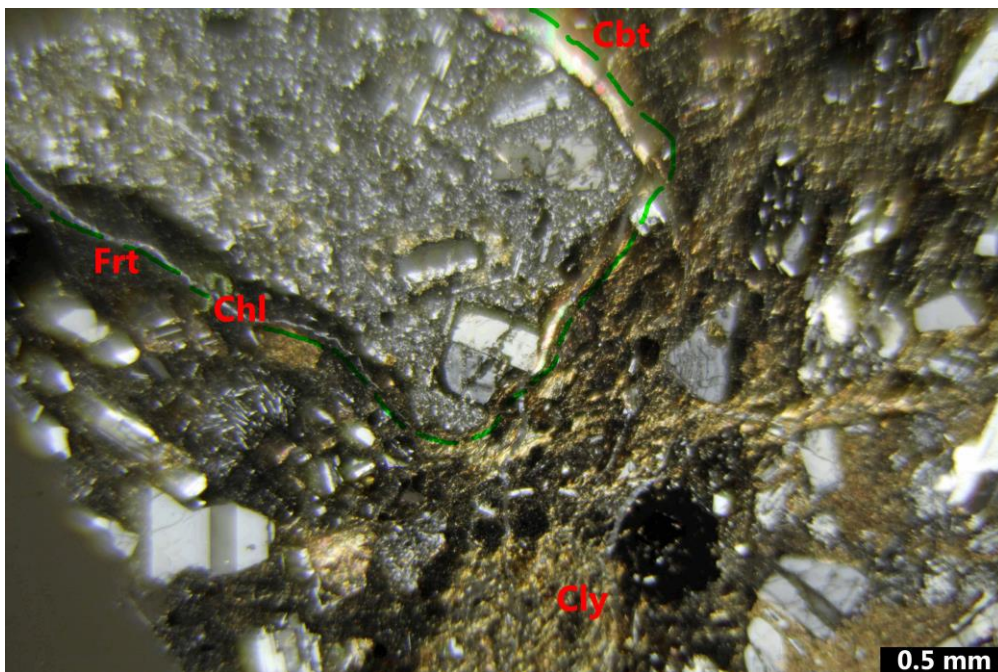
Fig. 5 - Cross polarized light. Field of view = 4 mm wide (magnification 4X). Same as Figure 4, but under crossed polars.

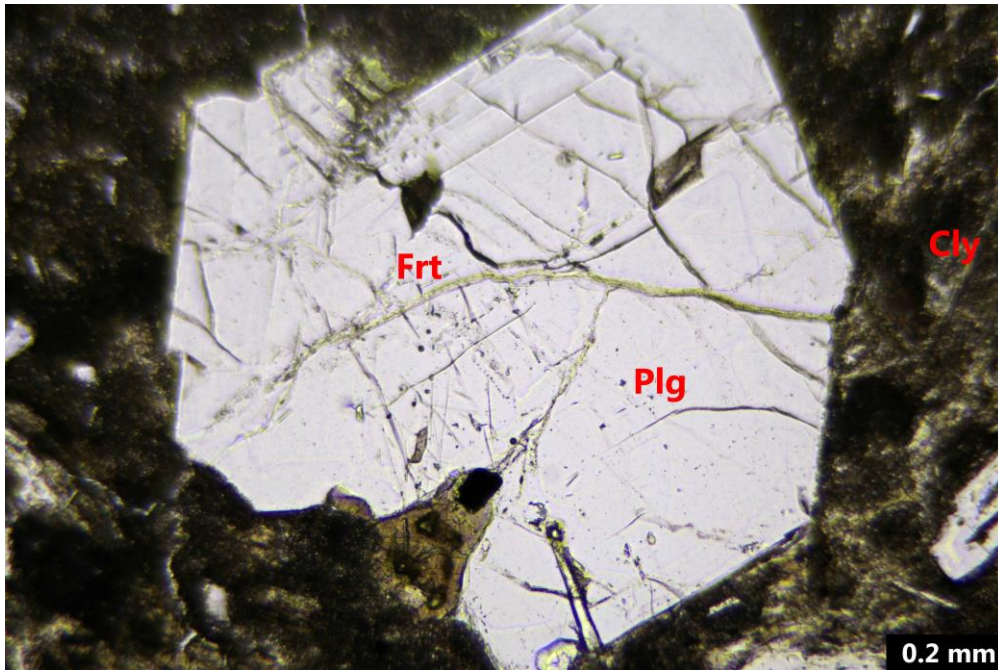
Fig. 6 - Plane polarized light. Field of view = 1.7 mm wide (magnification 10X). A detail of a Plagioclase crystal, showing grain alteration and suturing features: fractures cross the crystal and are also filled with Clay Minerals.

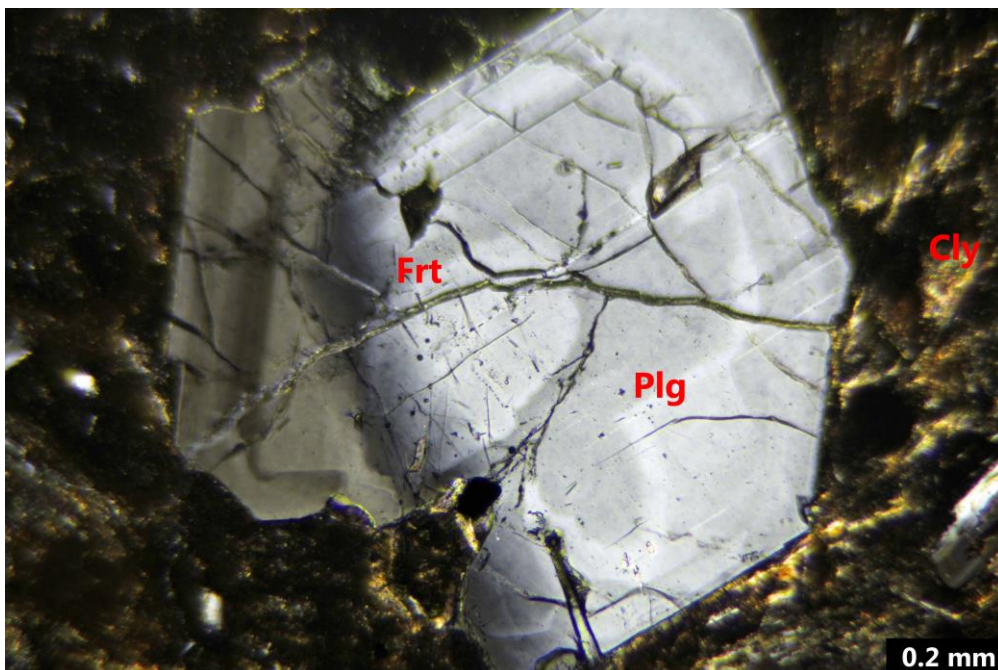
Fig. 7 - Cross polarized light. Field of view = 1.7 mm wide (magnification 10X). Same as Figure 6, but under crossed polars.

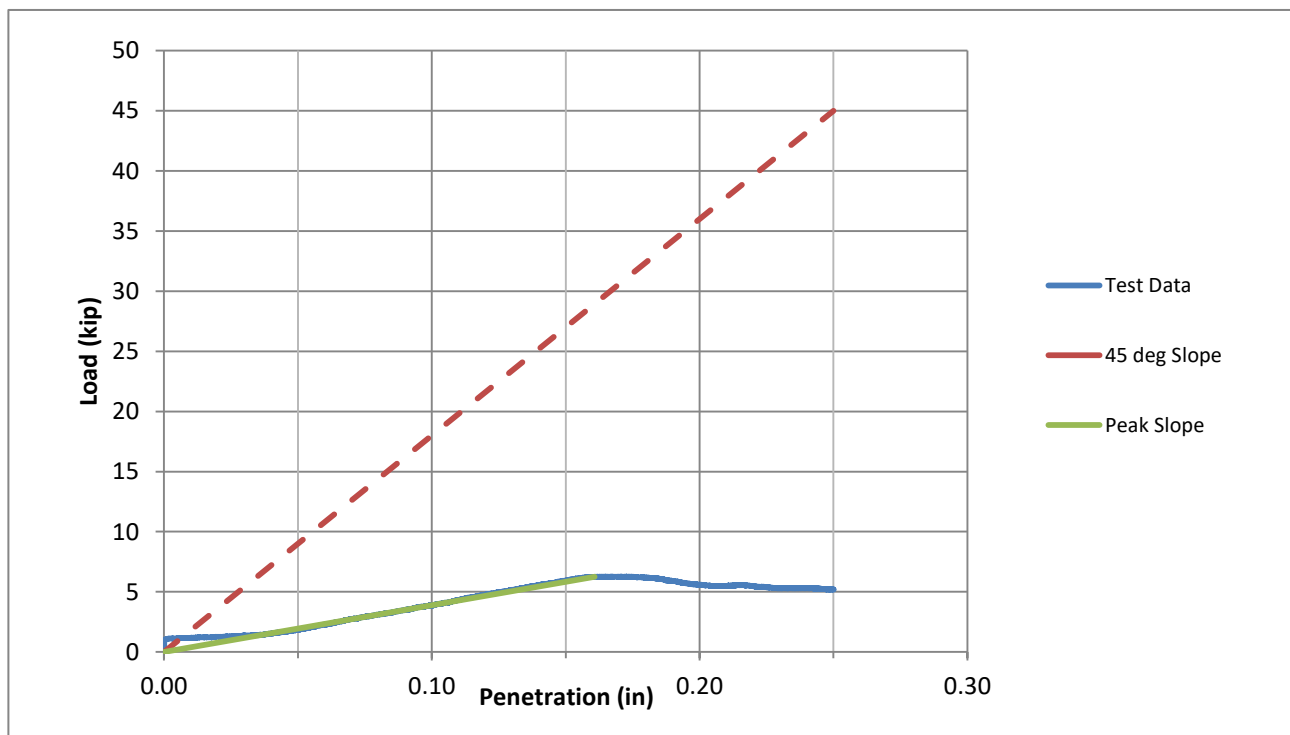
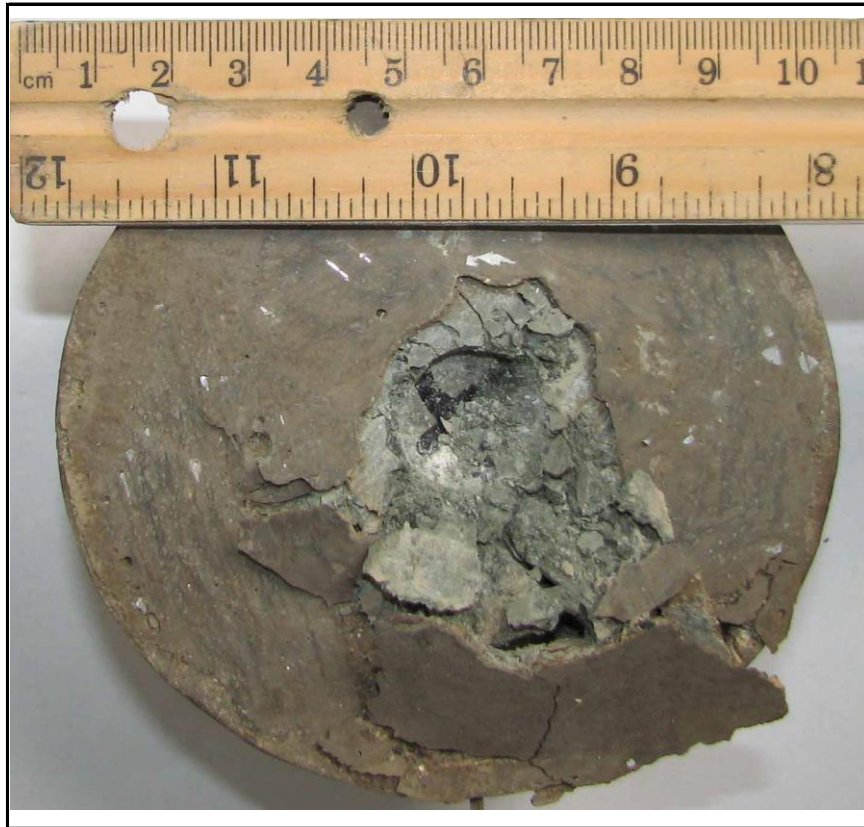
Photo After Test

Project Name	Klamath River Dam Removal	Penetration rate	0.001 in/sec			
Location	Klamath River	Diameter of specimen	60.65	mm	2.39	in
Client	Klamath River Renewal Corporation	Height of specimen	64.62	mm	2.54	in
Client Project No.	60537920	Load at peak	27.81	kN	6,251	lbf
Registry No.	2018-22	45 Degree (Standard) Index	175			
Report No.	2018-22-8-1	Peak Slope Index	39			
Report Date	5/17/2018					
Drill Hole and Depth	BI-02; 50.3-51.3 ft					
Rock Type	Volcanic Breccia					
Geologic Unit	N/A					
Moisture Condition	As-received

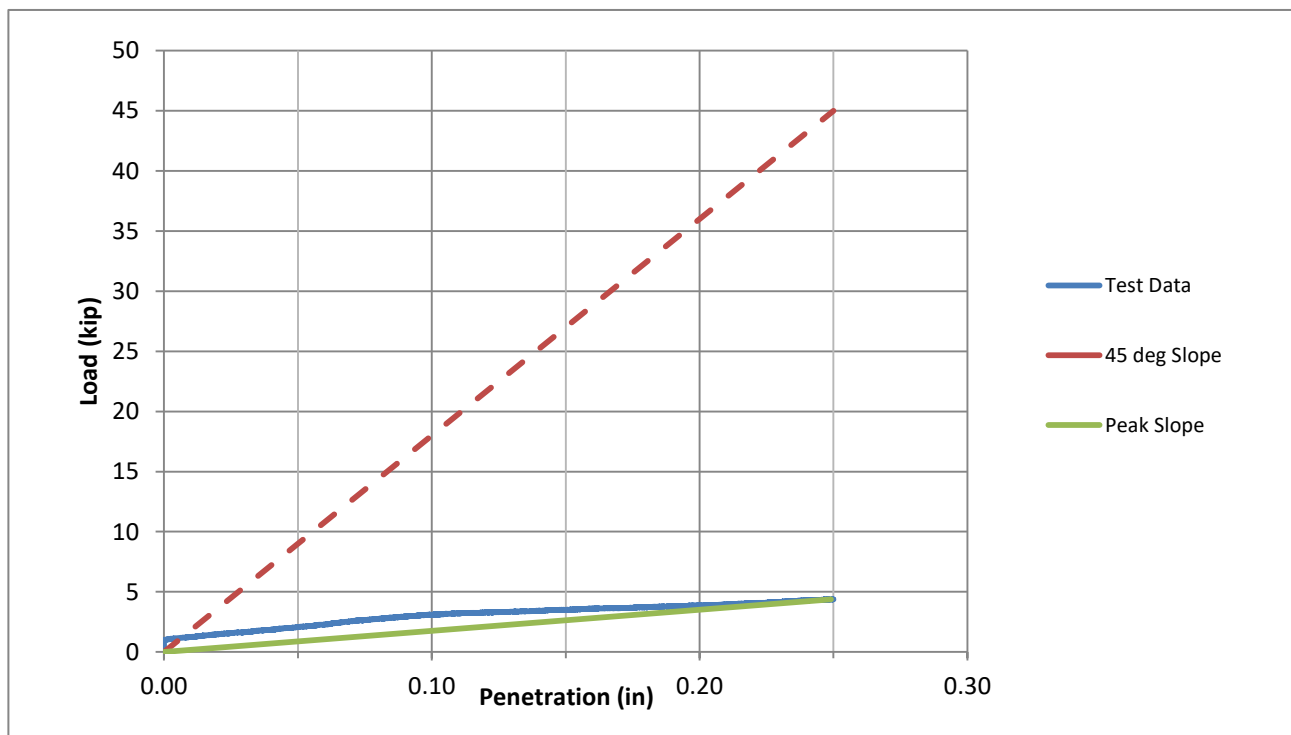
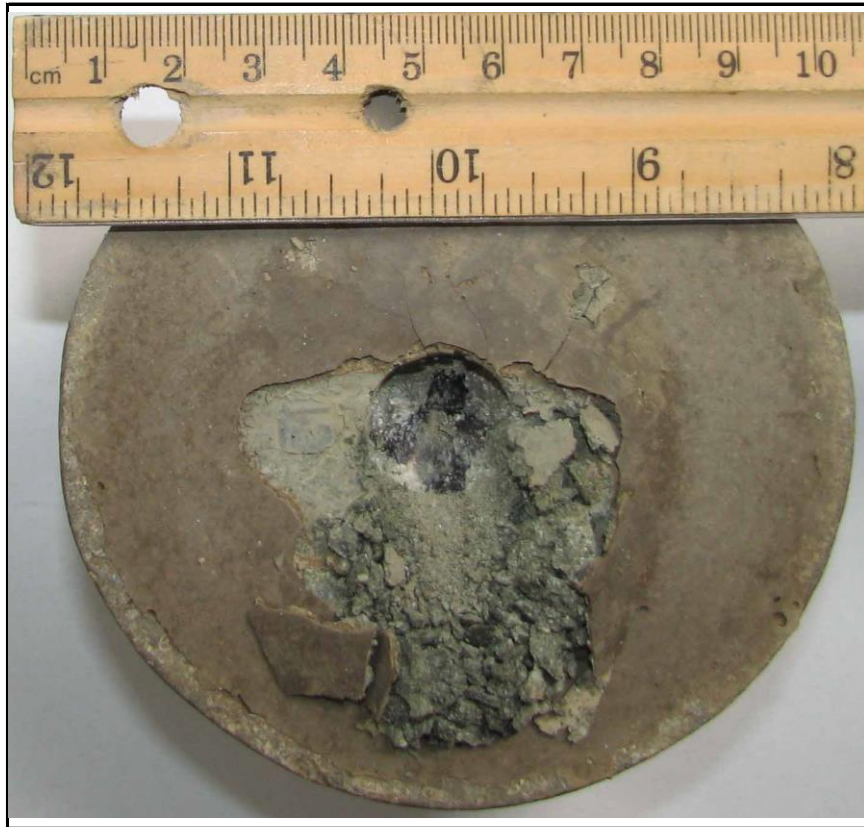
Photo After Test

Project Name	Klamath River Dam Removal	Penetration rate	0.001 in/sec			
Location	Klamath River	Diameter of specimen	60.4	mm	2.38	in
Client	Klamath River Renewal Corporation	Height of specimen	67.53	mm	2.66	in
Client Project No.	60537920	Load at peak	19.46	kN	4,373	lbf
Registry No.	2018-22	45 Degree (Standard) Index	175			
Report No.	2018-22-8-2	Peak Slope Index	18			
Report Date	5/17/2018					
Drill Hole and Depth	BI-03; 24.2-25.1 ft					
Rock Type	Volcanic Breccia					
Geologic Unit	N/A					
Moisture Condition	As-received
