## ALAMITOS BAY MARINA REHABILITATION

City of Long Beach  
Department of Parks, Recreation, and Marine  
205 Marina Drive  
Long Beach, California 90815

Anchor QEA, L.P.  
28202 Cabot Road, Suite 425  
Laguna Niguel, California 92677

**November 2009**

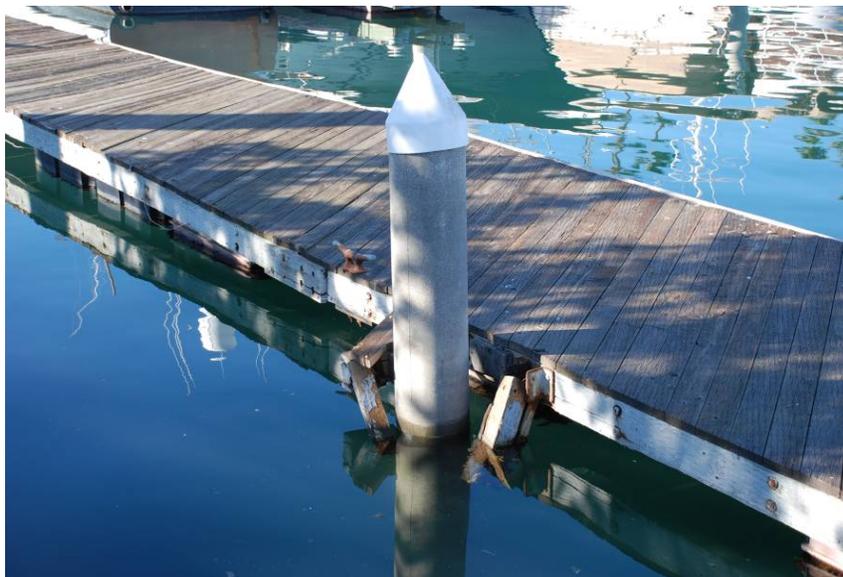
**Photograph 1. Example of Broken Pile Bracket at Alamitos Bay Marina.**

Because the ABM opened nearly 60 years ago, the marina is in a deteriorated condition (Photographs 1 and 2) and in need of upgrades to make the marina consistent with current market demands. Examples of needed repairs include spalled piles, broken pile brackets, broken utilities, unsafe deck surfaces, and shoaling. The Alamitos Bay Marina rehabilitation project will replace the existing marina and upgrade several aspects of the marina. The proposed project includes renovations to Basins 1 through 7, which will exclude Basin 8. Locations of all basins are shown on Figure 1. Basin 6 is comprised of two separate areas: Basin 6-North (6N) and Basin 6-South (6S). Each of the seven basins has a different number of slips (ranging in size from 20 to 120 feet in length) available to boaters. No boaters will be displaced during project construction activities. Boaters will be temporarily relocated to other basins within Alamitos Bay until their basin is complete, and all current tenants are guaranteed a slip upon completion of the project. The marina project is proposed to take place in 12 phases that will span 6 years.

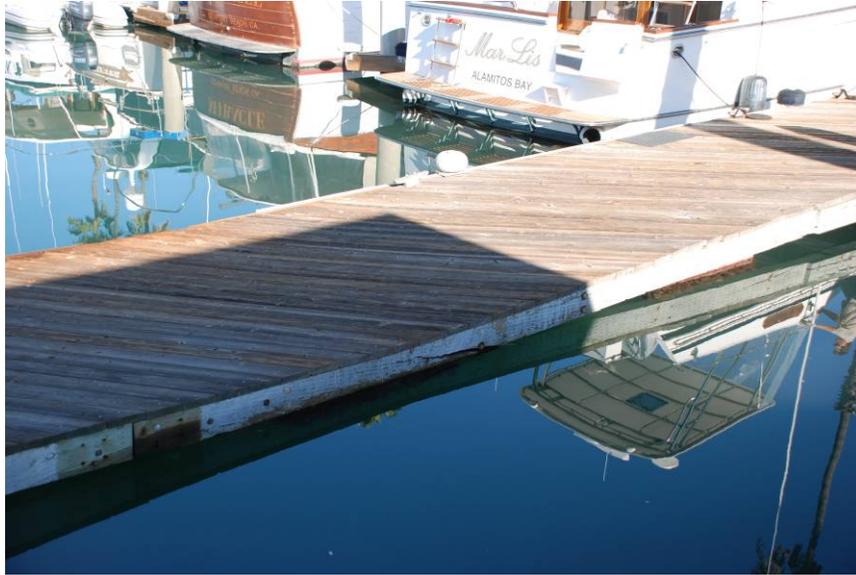
**Photograph 2. Example of Dock Conditions at Alamitos Bay Marina.**

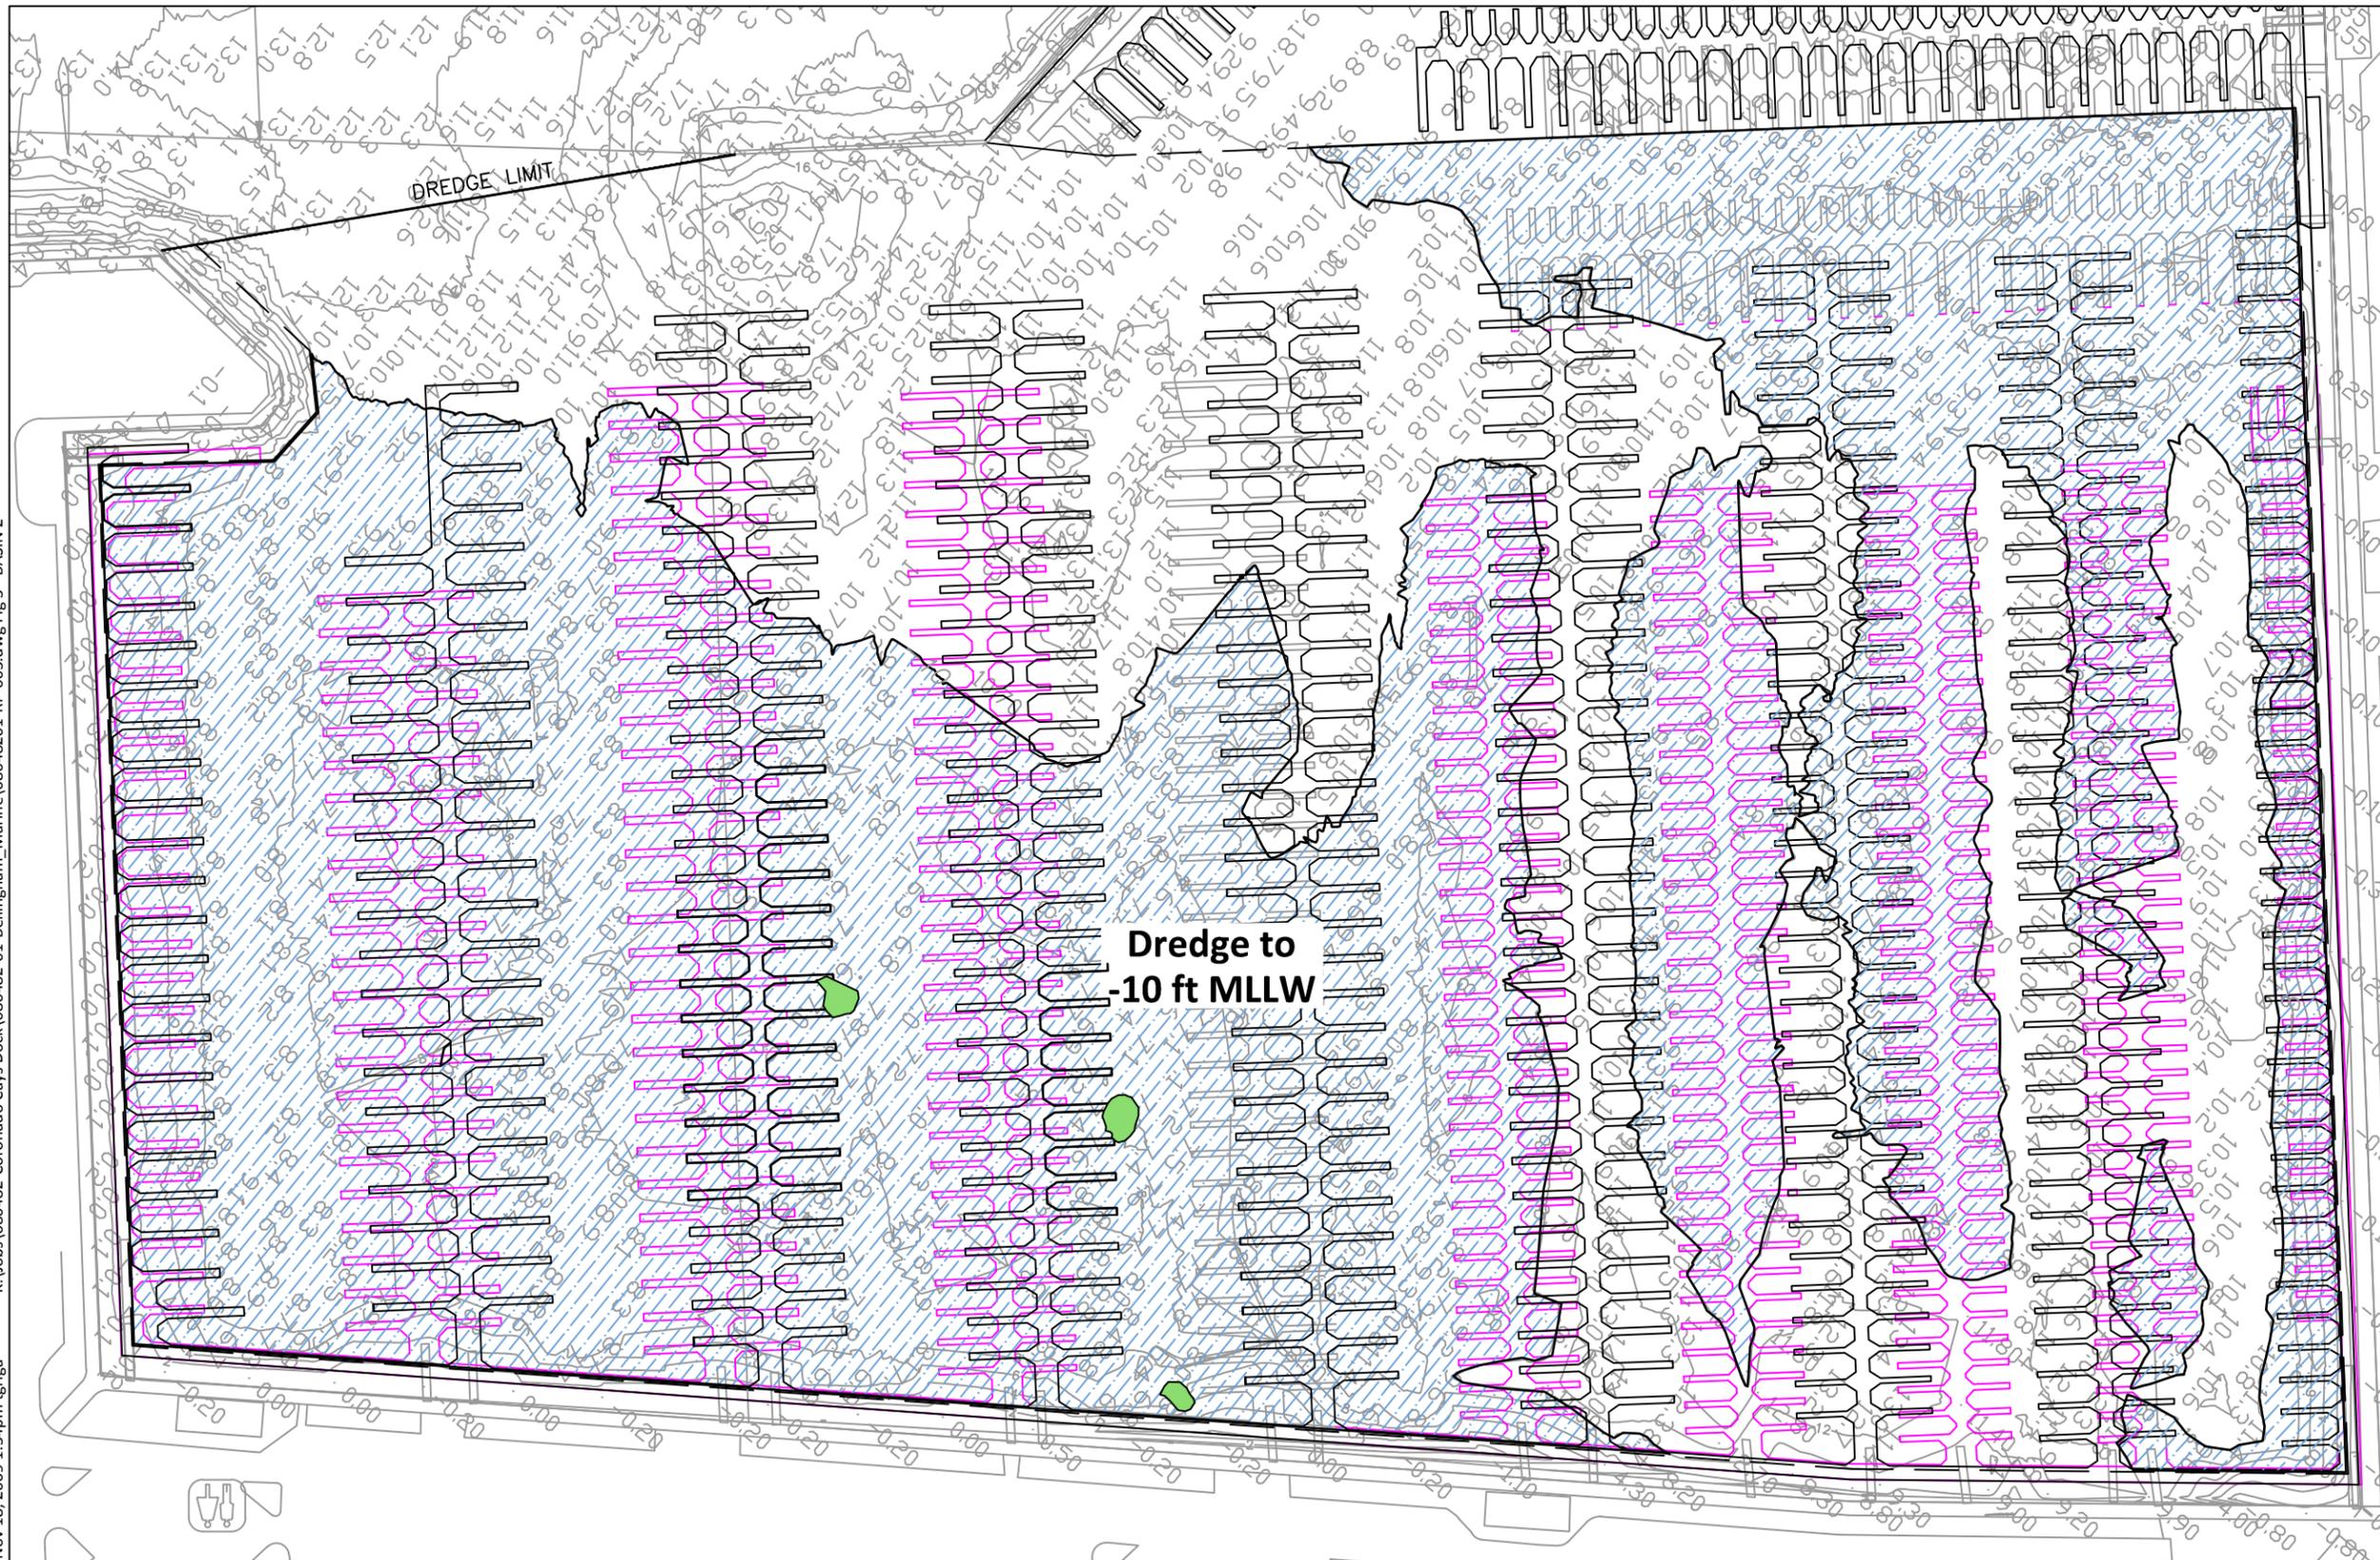
Nov 18, 2009 1:34pm tgriga K:\jobs\080482-Coronado Cays Dock\080482-01-Bellingham\_Marine\08048201-RP-003.dwg Fig 3 - BASIN 2

- LEGEND:**
- Dredge Area at -10 ft MLLW
  - Proposed Dock
  - Existing Dock
  - Eelgrass

Currently, there are 1,967 existing slips in Basins 1 through 7 that account for approximately 476,839 sf of overwater coverage (Figures 2 through 9). The proposed project includes the removal and replacement of the existing docks with 1,646 slips that total approximately 474,239 sf of overwater coverage (Figures 2 through 9). The proposed project would result in a reduction in the number of slips (by 321 slips) and a reduction in overwater coverage of 2,600 sf.

As a part of the proposed project, ABM would be dredged to the original design depths. These depths vary by basin and include 2 feet of overdredge allowance (1 foot of paid overdepth and 1 foot of unpaid). Figures 2 through 9 show each basin's dredge footprint, dredge volume, and design depth plus overdredge depth. In sum, 287,120 cubic yards (cy) of sediment will be dredged.

Based on two surveys conducted by CRM in October of 2007 and 2008, eelgrass will be removed through dredging where it is present in the dredge footprint of Basins 1, 4, and 6N. Eelgrass locations in relation to dock replacement activities and the dredge footprints in each basin are shown in Figures 3, 5, and 8. Table 5 below shows the amount of eelgrass per basin expected to be impacted. In sum, approximately 1,373.4 sf of eelgrass is expected to be removed during project activities, based on current surveys. The final amount of eelgrass impacted will be determined given the results of pre-construction, post-construction, and control site surveys. Mitigation for losses of eelgrass will occur at Marine Stadium (Figure 10).

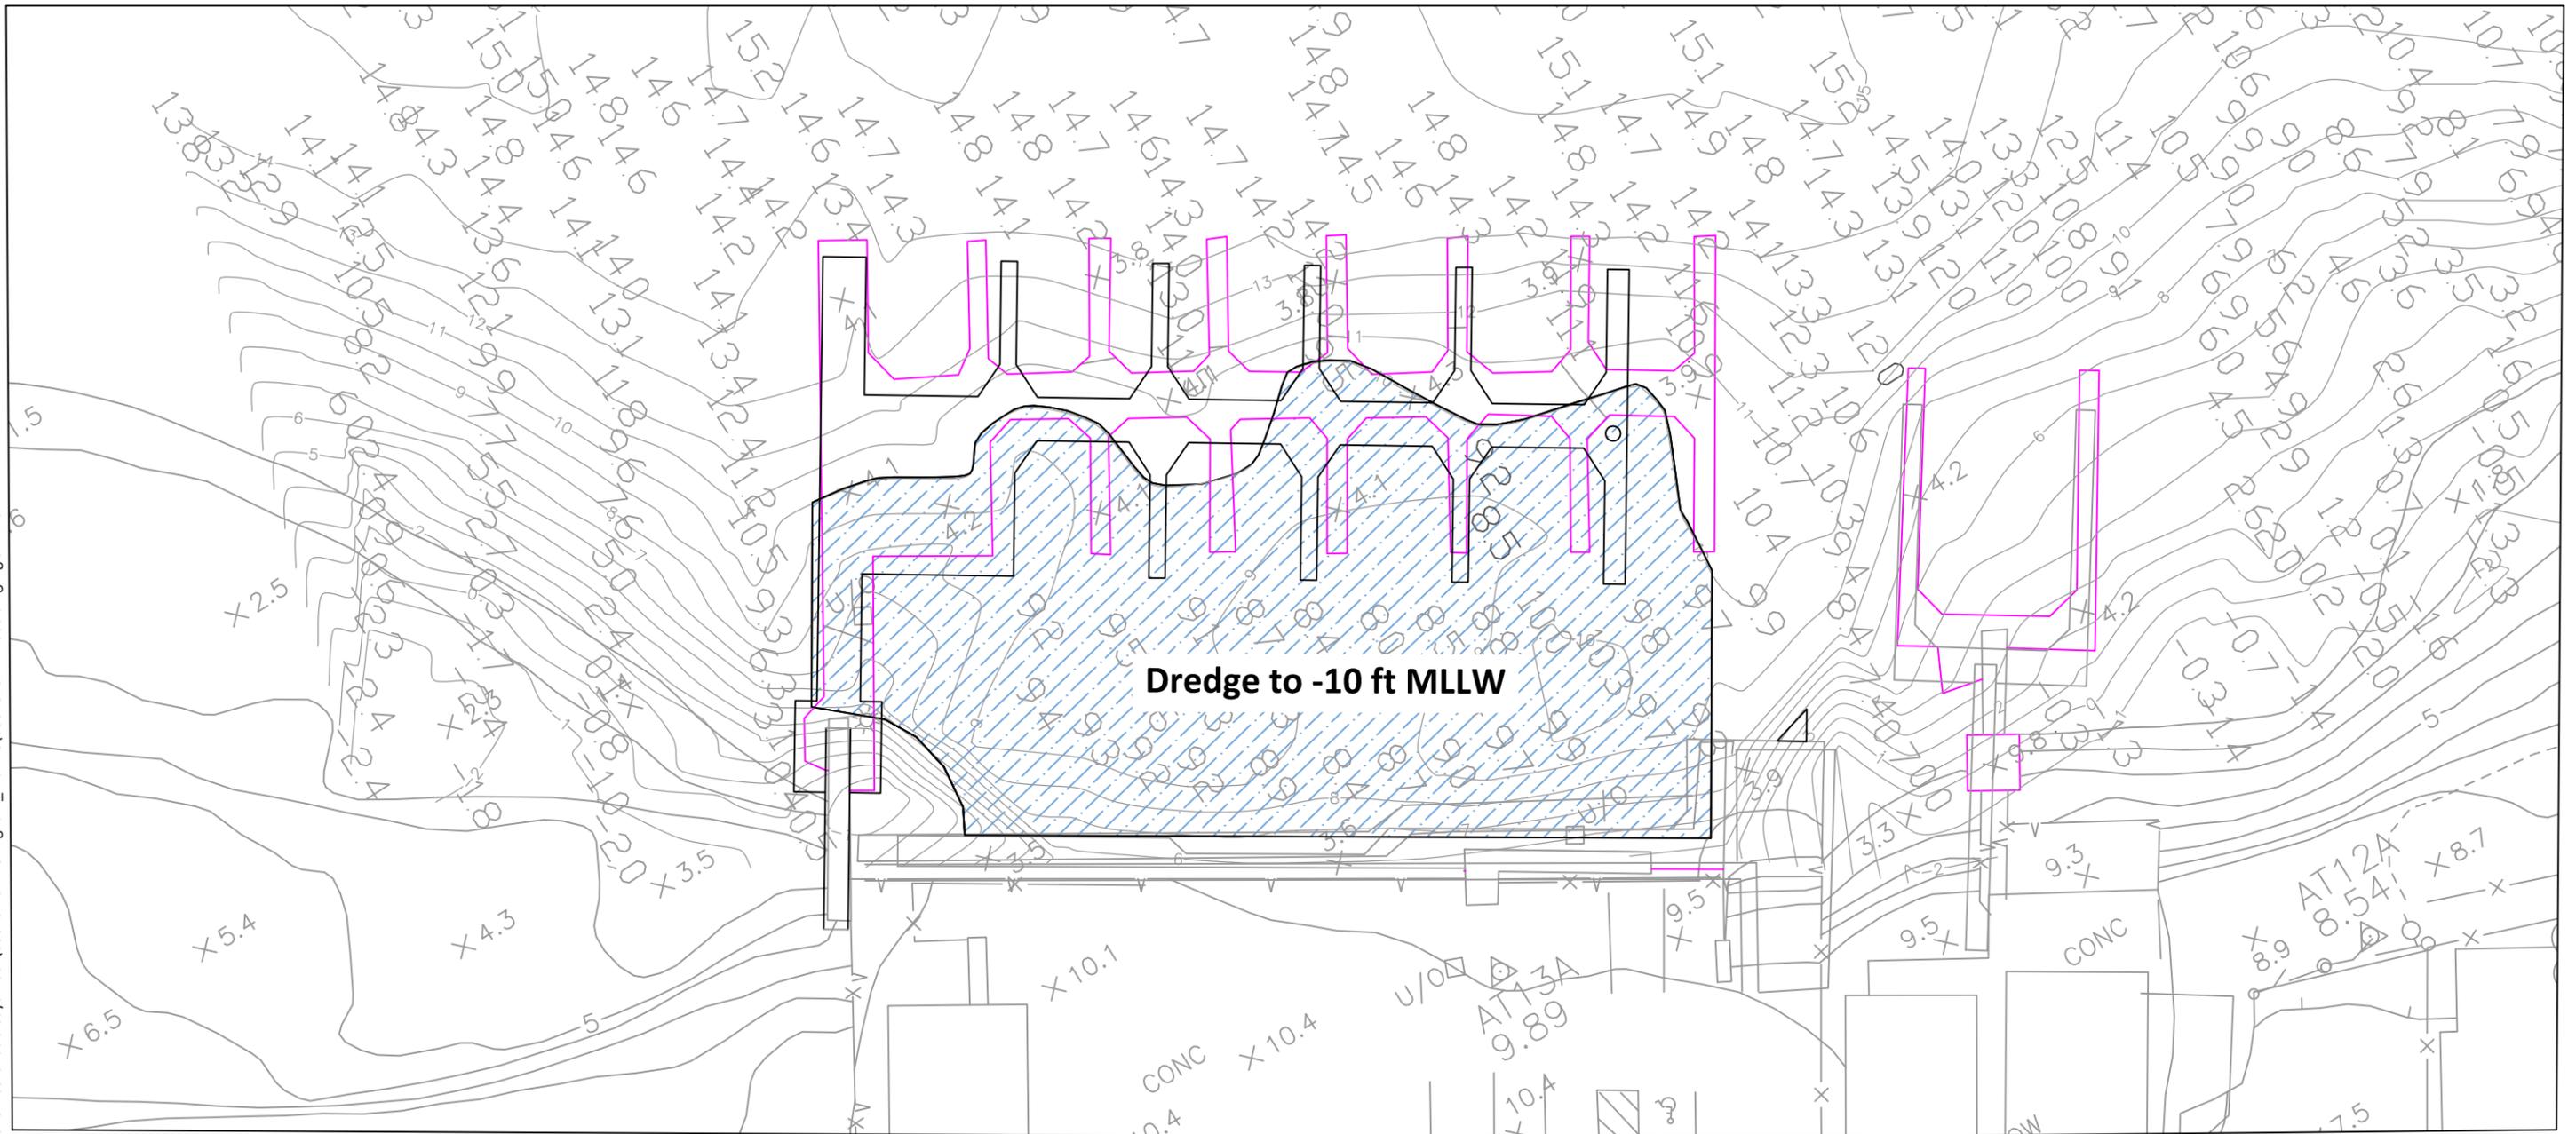
Nov 18, 2009 1:36pm tgriga K:\Jobs\080482-Coronado Cays Dock\080482-01-Bellingham\_Marine\08048201-RP-007.dwg Fig.8 - BASIN 6S

**VERTICAL DATUM:** Mean Lower Low Water (MLLW).
