3.1 Geology, Soils and Mineral Resources

This section of the Final Environmental Impact Report (EIR) discusses the current geologic and soil conditions at the proposed Eagle Mountain Pumped Storage Project (Project) site and identifies the potential geologic and soil-related impacts based on the construction and operational activities associated with the Project. Mitigation measures (MMs) are provided in order to reduce significant impacts to less than significant, where applicable. Information for this section was obtained primarily from existing reports, public and agency contacts, and Project area reconnaissance.

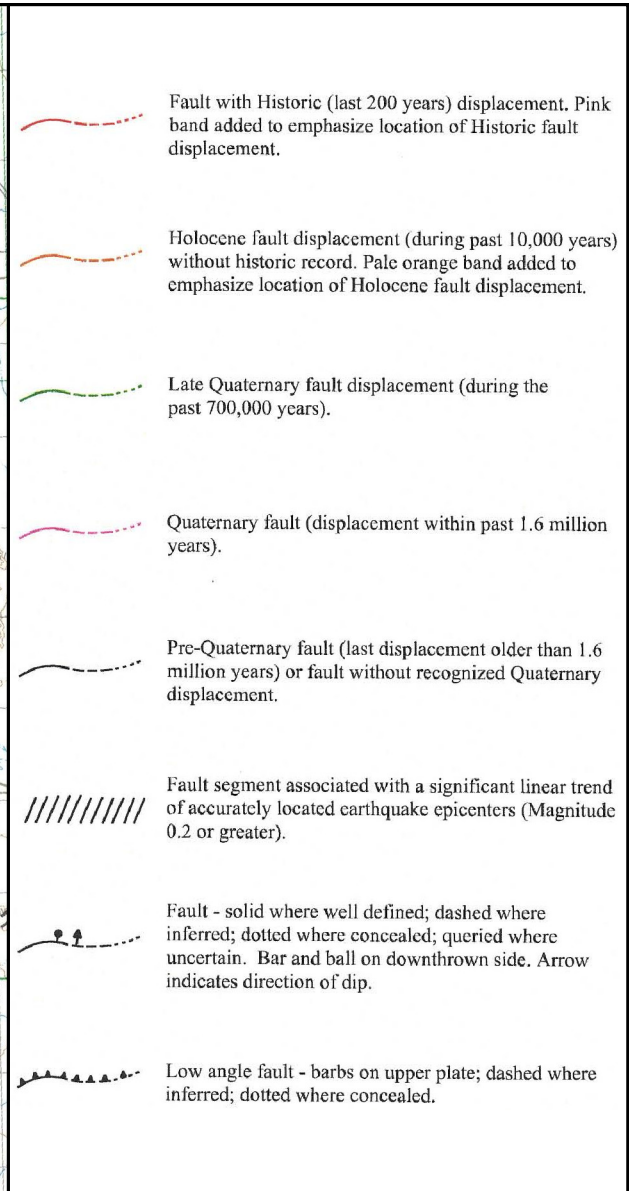
July 2013 Figure 3.1-5

SOURCE: Faults from Jennings, 1994

REGIONAL FAULTS
