**STATE OF CALIFORNIA
REGIONAL WATER QUALITY CONTROL BOARD
CENTRAL COAST REGION**

STAFF REPORT FOR REGULAR MEETING OF JULY 10, 2009

SUBJECT: Perchlorate Cases Update

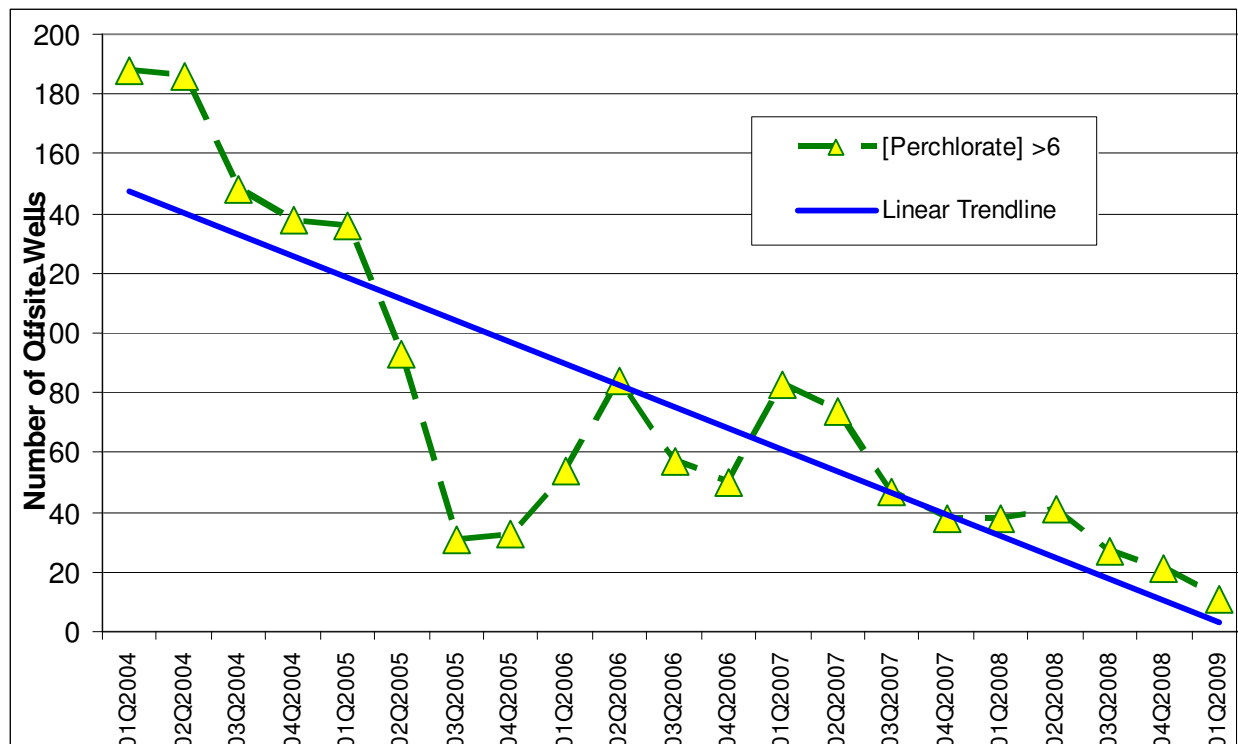
Attachments 2A and 2B of the staff report show perchlorate groundwater plumes in the intermediate aquifer (70 – 200 feet below the surface) for the first quarter 2006 and the first quarter of 2009. These figures reveal a dramatic reduction in the size of the perchlorate plume outside the area of the plume core (area with perchlorate concentrations above 24.5 $\mu\text{g}/\text{L}$ within 1.5 miles south of the site). We expect these decreases in perchlorate concentrations at domestic wells will continue, and will likely accelerate once offsite hydraulic control of Priority Zones A and B (perchlorate concentrations greater than 11 $\mu\text{g}/\text{L}$) is initiated with extraction well IEW-1.
