Report of Waste Discharge

Stitz Creek Watershed

Humboldt County, CA

Submitted by: Humboldt Redwood Company, LLC Scotia, California

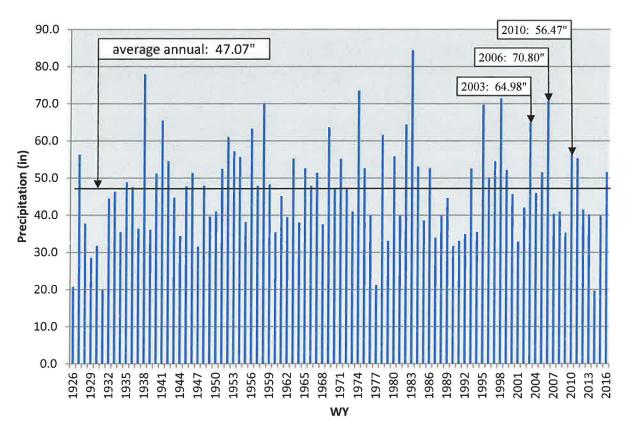
Figure 1: Annual Precipitation at the Scotia CA, NOAA Weather Station from 1926 to 2016.

Average annual rainfall in Scotia California, through 2016 WY, is 47.07 inches. This average is 1.63 inches less than the average reported by Oswald Geologic (2008a and 2008b). Two factors contribute to this discrepancy: the four year drought occurring between 2011 and 2015, and this record begins in 1926 rather than 1932. The 2003 and 2006 WY brought above average rainfall and rank 9th and 5th respectively for wettest on record. The 2010 WY was also above average (ranking 16th wettest on record) but was only 9.4 inches above average while 2003 and 2006 were 17.91 inches and 23.73 inches above average respectively. Figure 1 shows annual precipitation totals recorded at the Scotia weather station from 1926 to 2016 with the 2003, 2006, and 2010 WY totals labeled, as well as the average annual rainfall for reference.

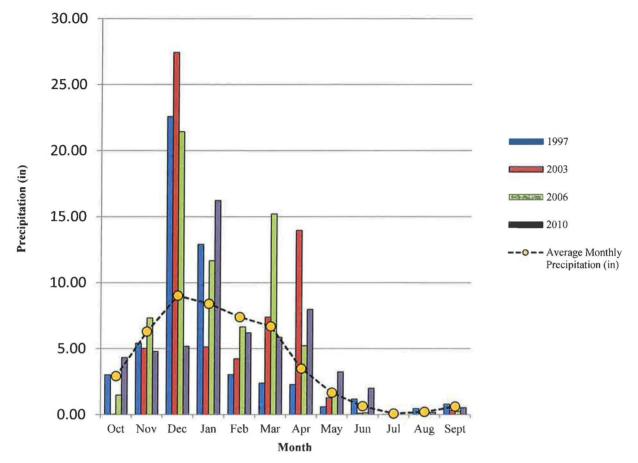
Figure 2: Monthly rainfall totals for 1997, 2003, 2006, and 2010 HY with 90 year average.

The 2010 HY produced above average annual precipitation. The monthly totals, presented in Figure 2, show January and April made the two larges departures above monthly averages. May and June also had above average totals but less than 4 inches of rain fell during each of those months. The months of October through December each received 4 to 5 inches of rain and February and March recorded 5 to 6 inches. Although the annual total was above average, there were not consecutive months of percistent, torrential rainfall that lead to saturated soil conditions.

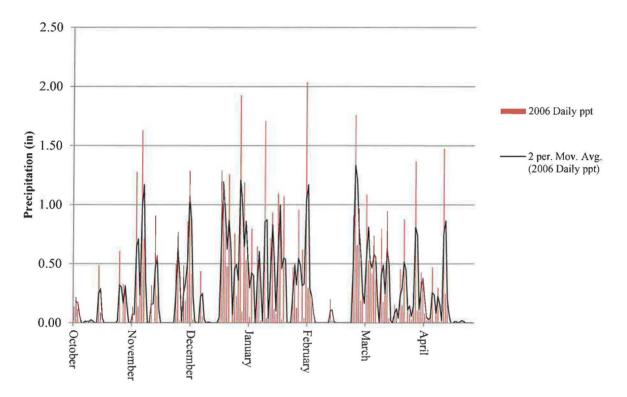
Figure 3: Daily precipitation totals measured at the NOAA weather station in Eureka for the 2006 WY with 2-day moving average.

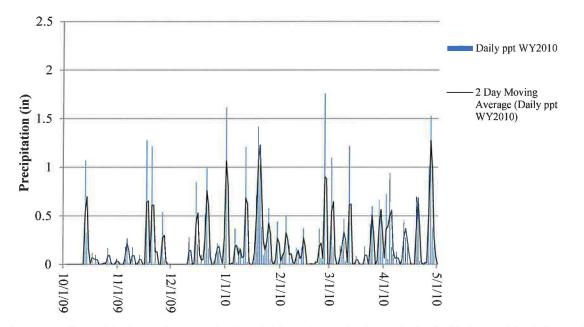
Figure 4: Daily precipitation totals mesured at the NOAA weather station in Eureka for the 2010 WY with a 2-day moving average.

The daily precipitation data compiled for 2010 WY are displayed in Figure 4. The 2-day moving average shows that one inch of precipitation in a 24 hour period was exceeded 3 times; twice as many occurrences took place in 2006. Although several daily precipitation totals exceeded one inch during 2010, the temporal distribution of these events appears relatively evenly spaced throughout the wet season. The sustained precipitation between late December and early February noted in the 2006 record is absent in 2010, and no time-period in 2010 had significant sustained precipitation between large storms comparable to the 2006 wet season. The total annual rainfall in 2006 WY was 14.33 inches greater than in 2010 WY.

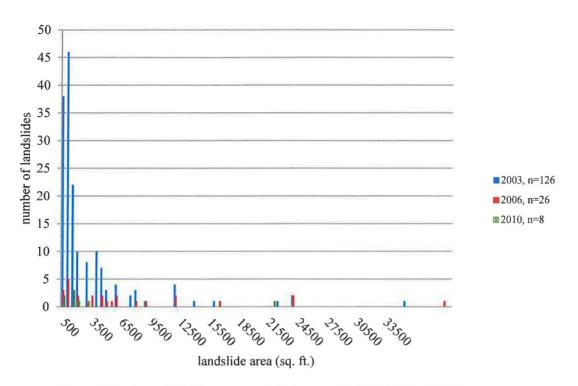
Figure 5: Number of landslides per area of displacement for 2003, 2006, and 2010.

Landslide frequency and magnitude in the Stitz Creek drainage-area dramatically decreased from 2003 to 2010. Mapping of the aerial photographic identified landslides is presented in Appendices A, B, and C for each year of review with the corresponding attribute tables presented in Appendices D, E, and F. Figure 5 plots the frequency against the estimated area of each landslide for each year of study. The distribution of landslide sizes is heavily skewed towards smaller landslides with few outliers of larger landslides. This skewed distribution is a characteristic of landslide inventories worldwide (Guzzetti et al., 2002; Malamud et al., 2004; Oswald, 2008a and 2008b). The largest landslide observed in 2003 was approximately $\frac{4}{5}$ of an acre and the largest in 2006 was $\frac{9}{10}$ of an acre. The largest landslide is also tend to be the largest contributors to the landslide sediment budget.

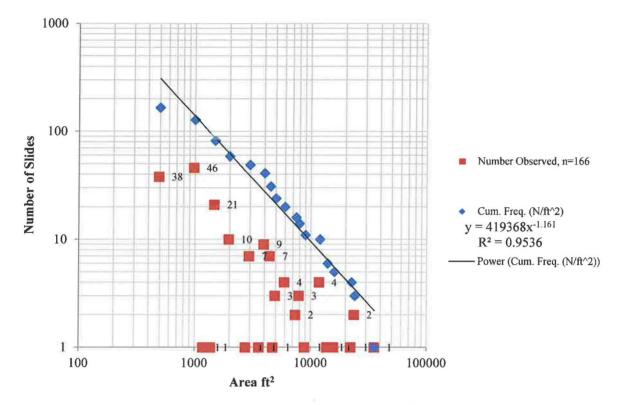
Figure 6: Log-log area-frequency distribution for 2003 landslide inventory. Trend line is a log transformed power function.

Figures 6-8 show the landslide area-frequency distribution plotted on a log-log graph and, demonstrate completeness of the inventory. The cumulative area-frequency curve for the 2003 season follows a straight line over the larger area landslides. A straight line on a log-log graph can be referred to as a logtransformed power law curve. This is advantageous for 2 reasons: it is easier to visualize the data, and it is easier to work with a linear function when doing statistical analysis. The deviation from the logtransformed power law correlation at the smaller landslide size is a result of the physical lower limit of landslide size before surface erosion processes dominate, and to some extent the ability to detect small landslides in a forested landscape, and also in part to limitations in observing small landslides in aerial photography (Malamud et al., 2004). A fall off of values from the power law at the larger sized landslides would indicate an incomplete catalog or under sampling in the mid-size range. Large earthflows/compound failures can be difficult to observe in aerial photography when rotational movement occurs with minimal translational displacement. This is not observed for the 2003 and 2006 inventory vears. Due to the small sample size of landslides observed for the 2010 inventory the cumulative areafrequency graph is not well developed relevant to the power law correlation. It should be noted that significantly more small landslides were observed in 2003, with approximately 50% being less than 1,000 ft². Approximately 30% of 2006 landslide areas and 25% of the 2010 landslide areas were under 1,000 ft^2 .

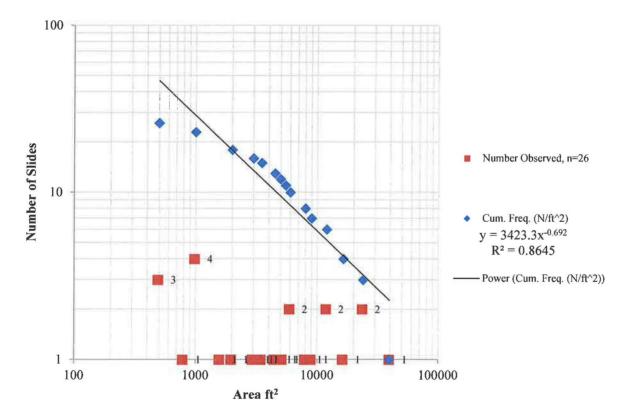
Figure 7: Log-log area-frequency distribution for 2006 landslide inventory. Trend line is a log transformed power function

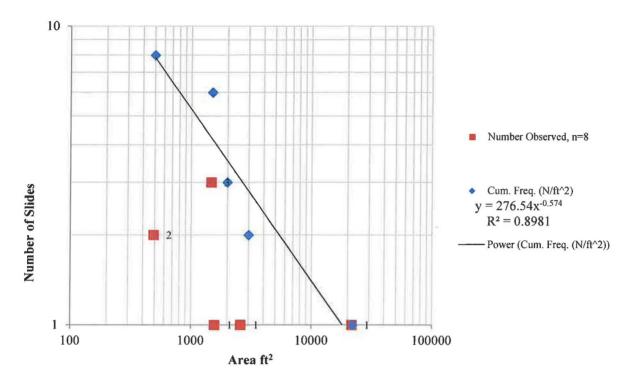
Figure 8: Log-log area-frequency distribution for 2010 landslide inventory. Trend line is a log transformed power function

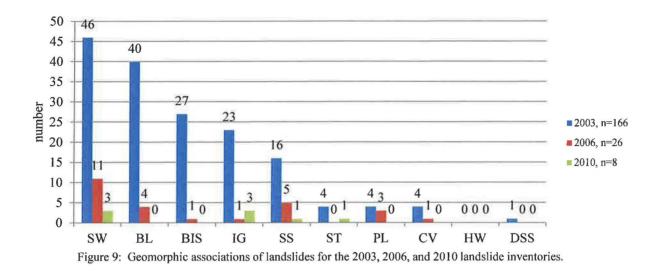
Figure 9 is a graphical representation of landslide population and its relationship to the identified geomorphic associations. While intuitive that the slope gradient of landslide initiation sites are predominantly located on steep to very steep slopes, this data set reinforces that geomorphic landforms identified as associated with failure are more likely to occur on steeper slopes.

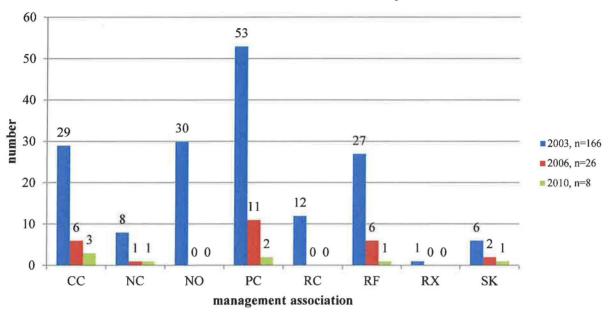
Stitz Creek: Landuse Association by WY

Figure 10: Land use associations for the 2003, 2006, and 2010 landslide inventories.

Several attributes presented in Figures 10-12 and discussed below, were gathered to compare landslide occurrences with management associations. Management activities included silvivulutral prescription and grading activities (i.e road/skid trail construction). In order to acquire a clearer picture of the influence of management-related activities on landslides, it is necessary to determine if each landslide is a reactivation, and its temporal relationship to management activities. The data indicates 56%, 73%, and 88% of the landslides were reactivations of pre-existing failures for the 2003, 2006, and 2010 WYs respectively. The significance of this relationship to current and future management strategies will be discussed later.

Land use categorizes included general levels of harvest (clearcut [CC], partial [PC], etc.,) noted through aerial imagery and review of past harvest plans in addition to instabilities that are directly linked to roadbuilding activities (road cut [RC], road fill [RF], etc.). Land use association refers to the land use activity observed at the site of failure and is shown in Figure 10. Several types of road associations are listed but differ from road condition associations discussed below. When used in this category road associations indicate actual observed failure on a road prism, whereas road condition associations indicate roads that cross or lead to a failure and have a possible association with the failure that may only be spatial in nature.

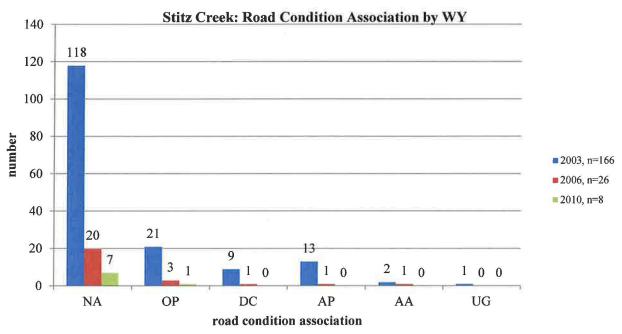
Figure 11: Road condition association for the 2003, 2006, and 2010 landslide inventories.

Approximately 71%, 77%, and 88% of failures in the 2003, 2006, and 2010 seasons, respectively, were categorized as not being road-related (Figure 11). Our survey also shows a decline in road-related failures during the inventory period. This is not surprising because of the sizable amount of decommissioning, upgrading, and storm proofing conducted since the implementation of the HCP.

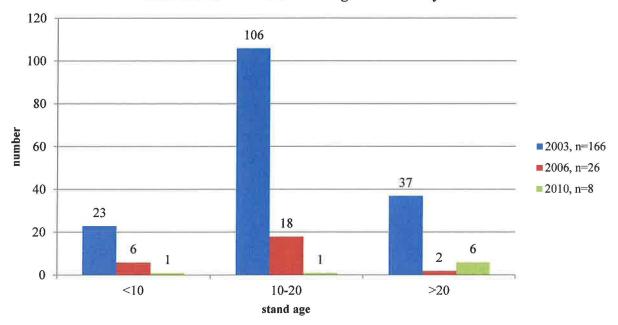
Stitz Creek: Air Photo Stand Age at Failure by WY

Figure 12: Air photo determined stand age at landslide locations for the 2003, 2006, and 2010 landslide inventories. Time intervals for histogram are <10, t=10 yr; <20, t=10, >20, t=30 ± 10yr; initial harvest circa 1900-1920.

The 2003 season significantly increased the number of failures in the 10-20 year stand age class over the less than 10-year stand age (Figure 12). This is consistent with studies showing maximum loss of root strength cohesion occurs during the 7-10 year post harvest time range at which point the timing of large rain events is critical (Ziemer, 1981). The data shows a similar pattern for the 2006 season. This pattern is not present in 2010, likely due to the reduced number of observed landslides coupled with reduced acreage of stands less than 20 years old.

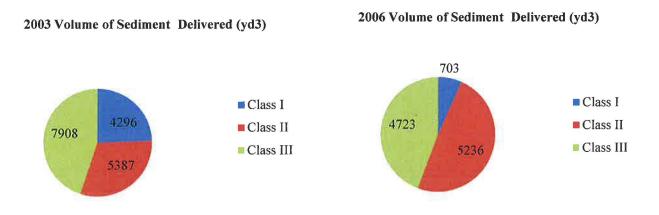
Figure 13: Volume of sediment delivered to watercourse by class for the 2003 and 2006 landslide inventories.

The aerial photographic inventory compiled the watercourse classification of streams that receive sediment using existing stream data. Figures 13 and 14 show delivered sediment volumes to watercourses by class. For the 2003 season, 24% of delivered sediment entered a Class I reach, 31% to Class II reaches, and 45% to Class III watercourses. Delivery characteristics for the 2006 season show 7% of delivered sediment entering a Class I reach, 49% entered a Class II reach, and 44% to a Class III. Continuing to 2010, 3% of delivered sediment entered a Class I reach, 1% to a Class II, and 96% entered a Class III watercourse. The 2010 delivery characteristics are heavily skewed due to a very small sample size (only four landslides delivered) with one large landslide entering a Class III watercourse. A potential reason for the reduced delivery volumes to the Class I streams in the 2006 season may be due the existing colluvium in the valley bottom, much of it transported there in the late 1990's. In many locations, it appears the watercourse is down-cutting within the colluvial wedge and not scouring the base of hillslopes forming the valley walls.
