## **Site Management Plan**

Sierra Pacific Industries

Arcata Division Sawmill

Arcata, California

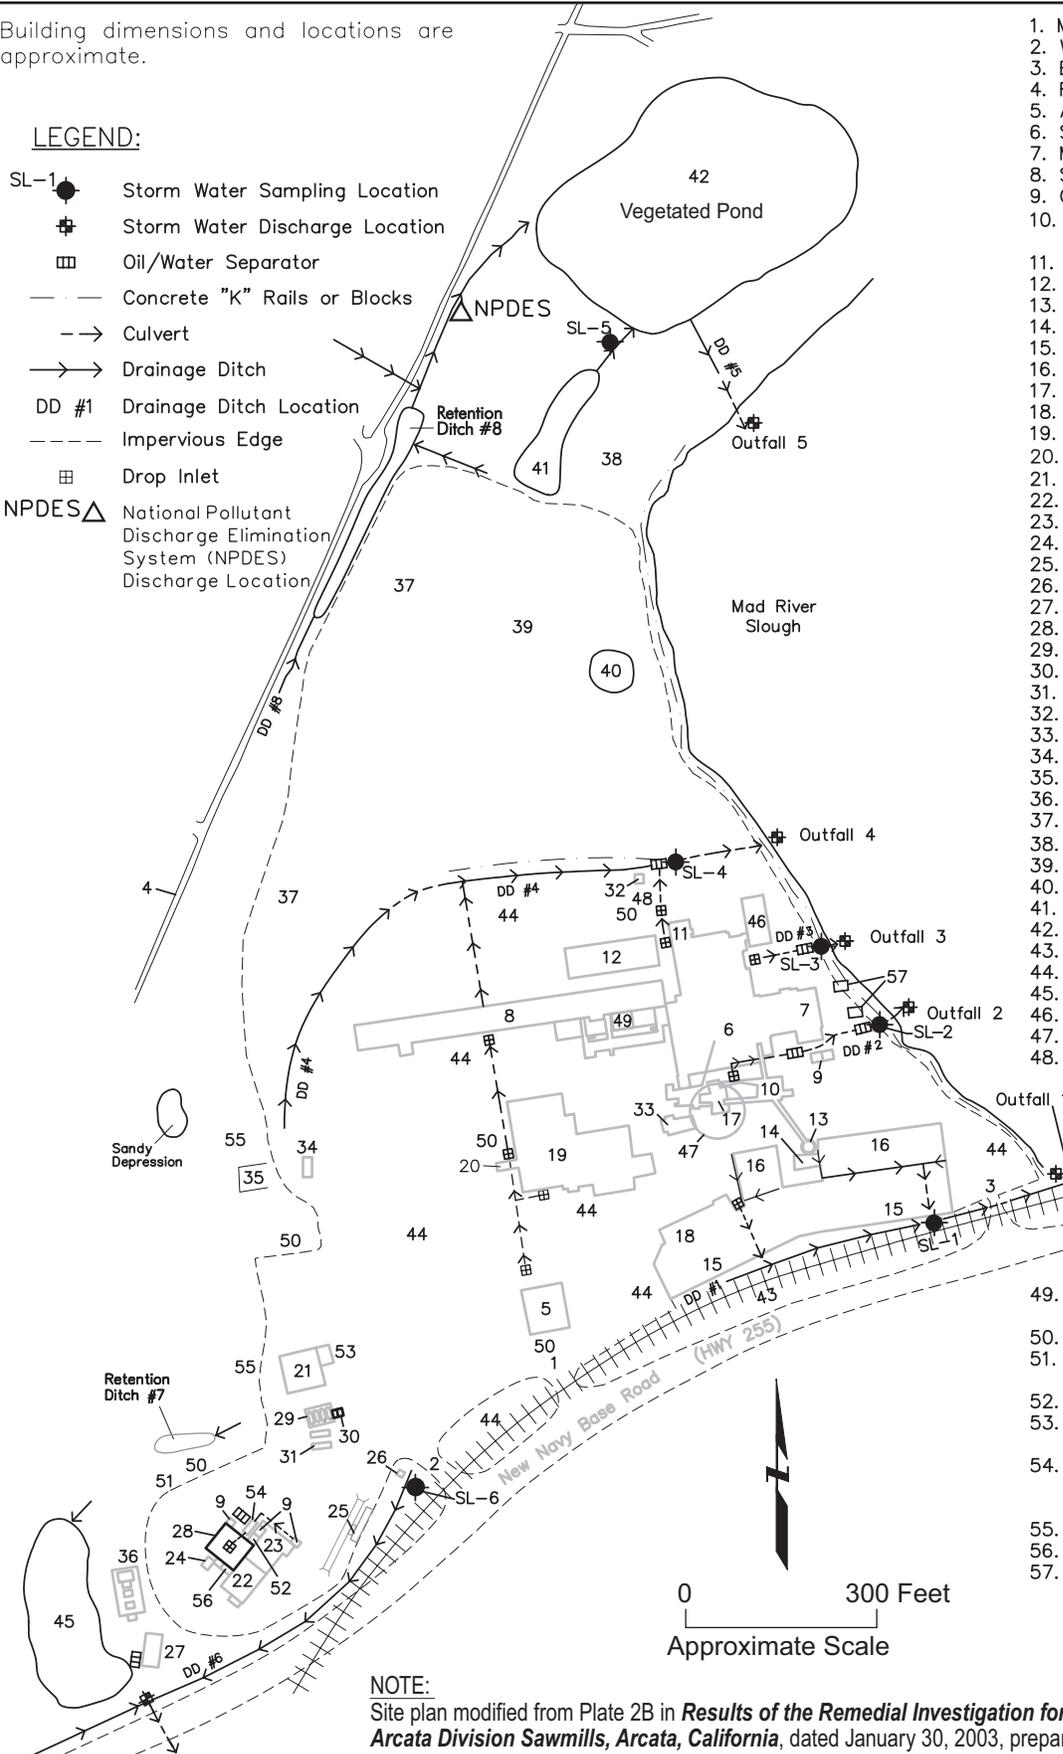
Project No. <b>9329</b>
Figure <b>2</b>

**NOTE:**  
 Site plan modified from Plate 2B in *Results of the Remedial Investigation for Sierra Pacific Industries - Arcata Division Sawmills, Arcata, California*, dated January 30, 2003, prepared by EnviroNet.

**SITE PLAN**  
 Sierra Pacific Industries  
 Arcata Division Sawmill  
 Arcata, California

The site is currently an active sawmill; features are shown on Figure 2. The current mill facility consists of an administrative building, a main sawmill building, numerous wood-processing buildings, log storage areas, milled lumber storage areas, loading/unloading areas, and the truck shop area for vehicle maintenance and fueling. A 140-foot-deep water supply well (Feature 48 on Figure 2) provides water for log sprinkling.

The former green chain area is located in the eastern portion of the site and coincides with the current sorter building (Feature 8 on Figure 2). Figure 3 presents a plan map of the former green chain area. The truck shop area is located in the southwestern portion of the site and includes the truck shop building (Feature 22 on Figure 2) and the immediately surrounding features and pavement. Figure 4 presents a plan map of the truck shop area.

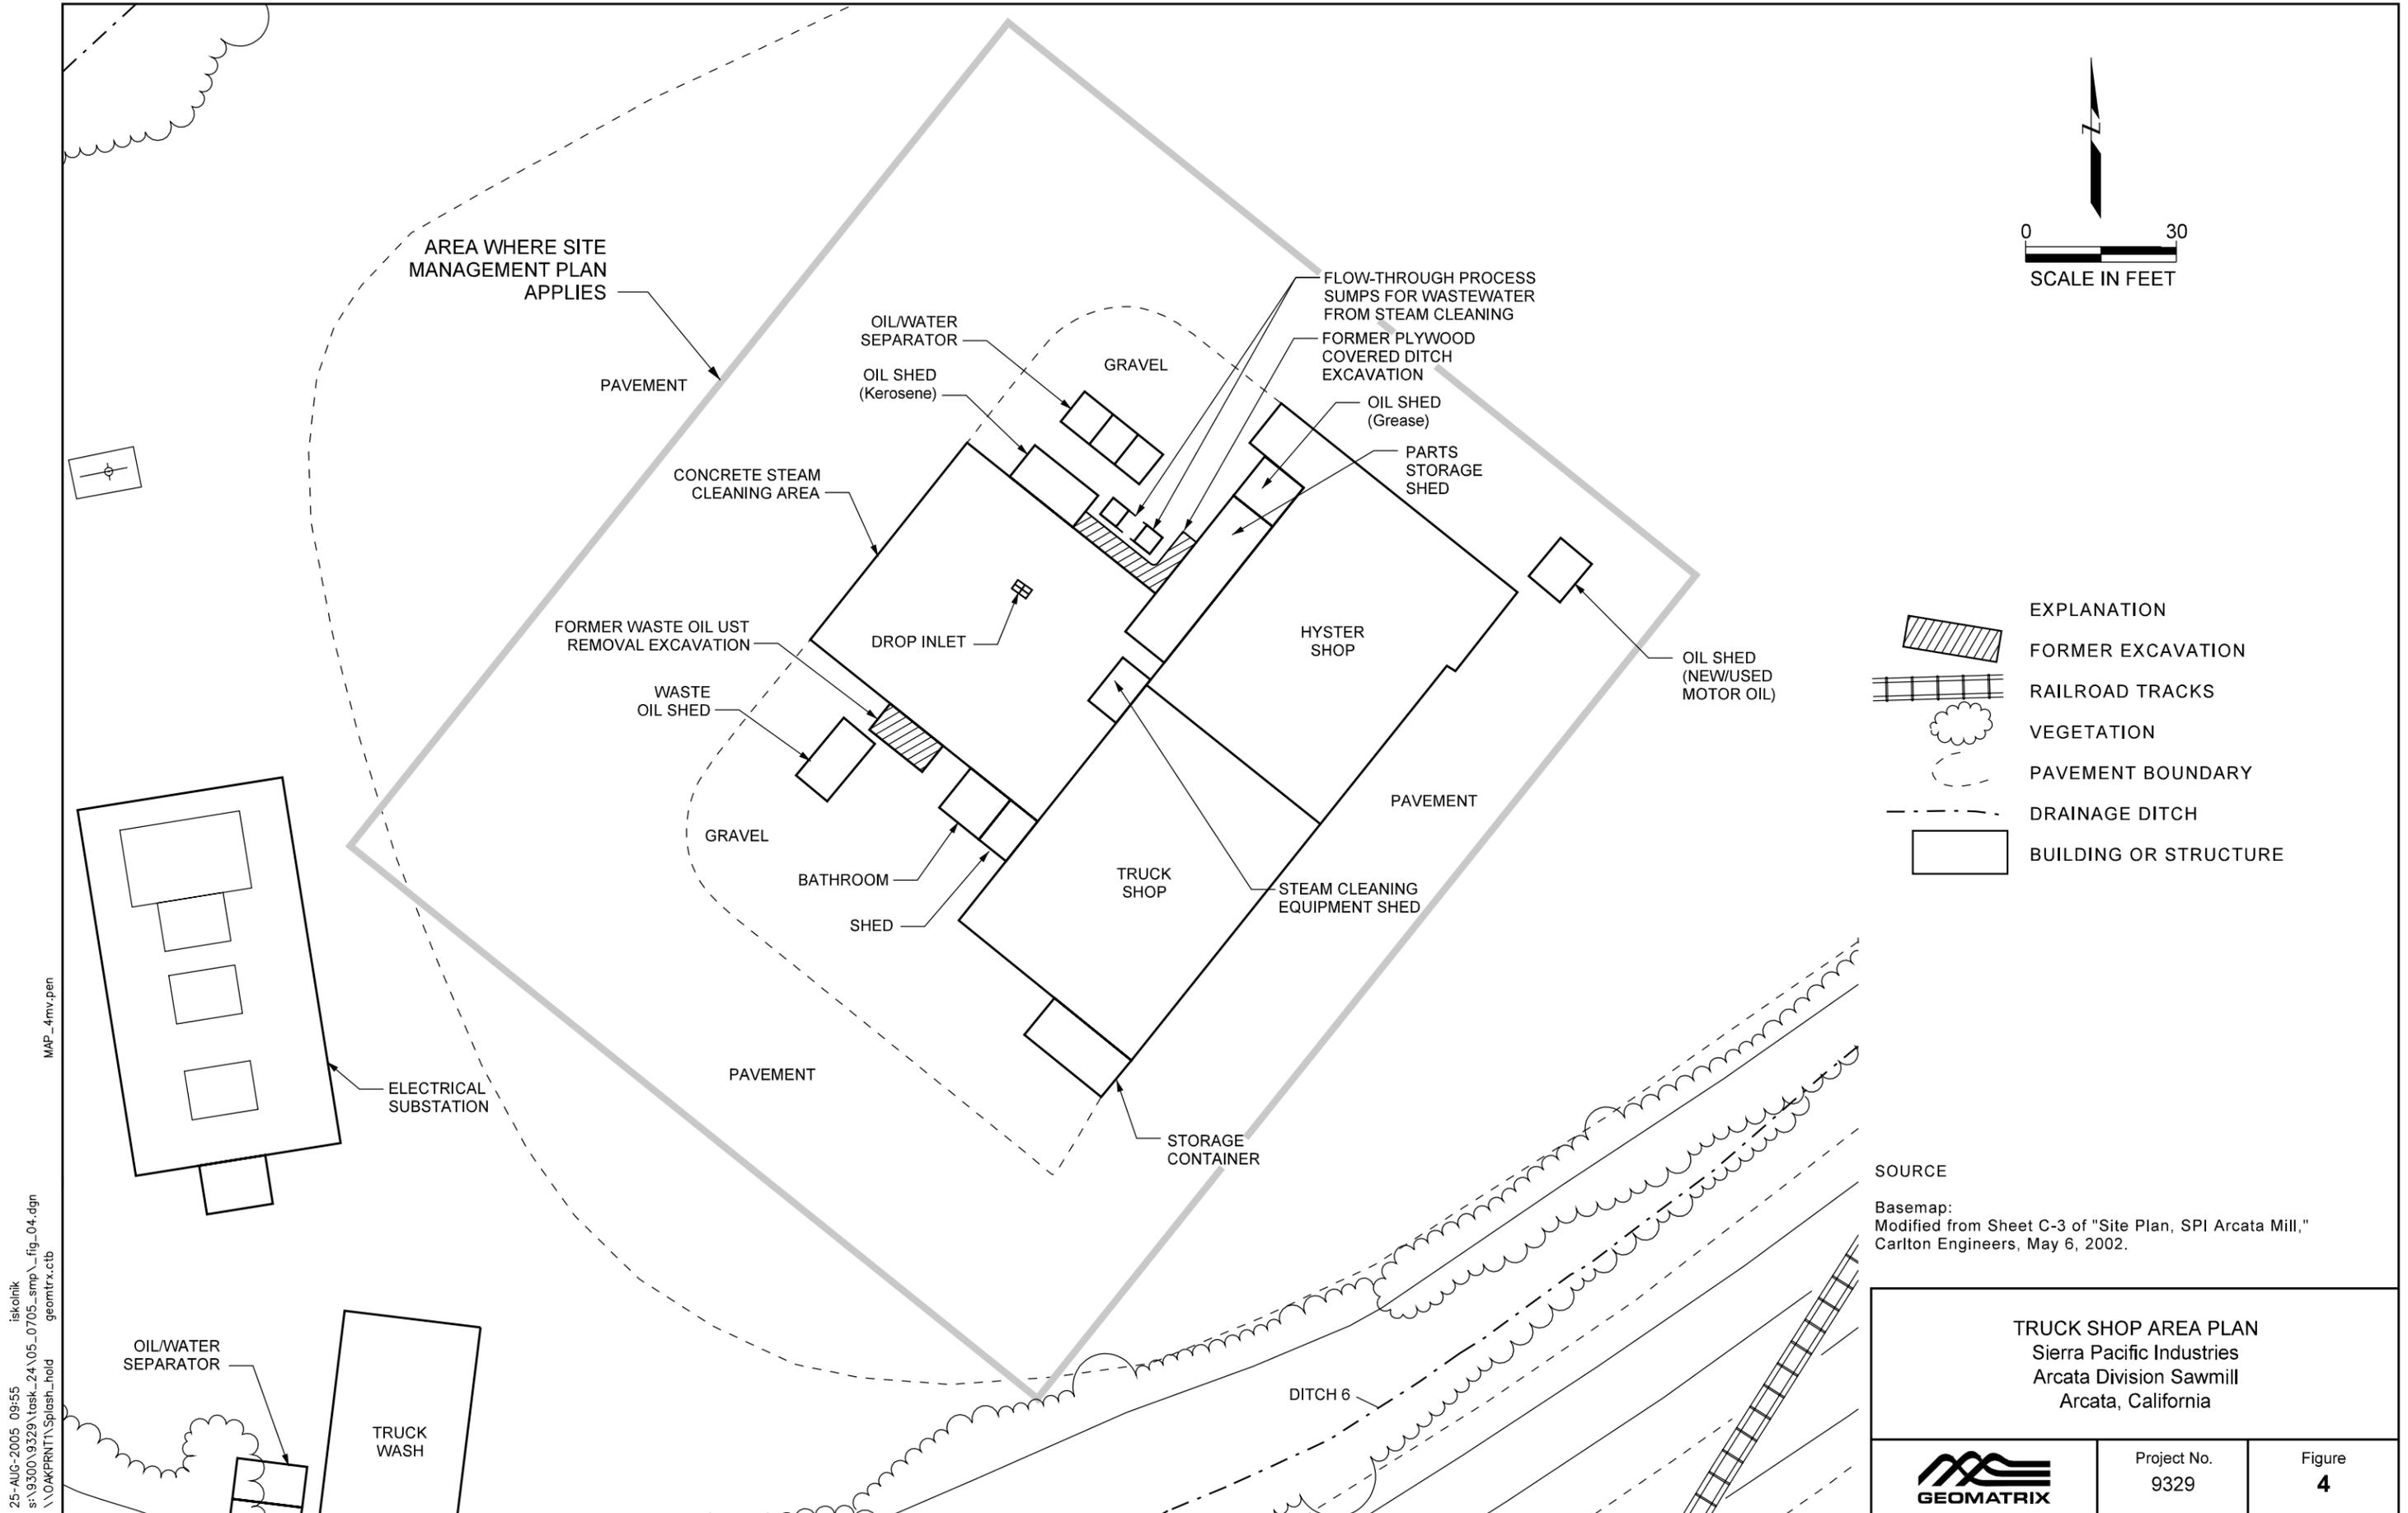
Project No. 9329	Figure <b>4</b>

SOURCE  
 Basemap:  
 Modified from Sheet C-3 of "Site Plan, SPI Arcata Mill,"  
 Carlton Engineers, May 6, 2002.

In the truck shop area, ongoing maintenance activities are not expected to encounter significant volumes of affected soil, although some residual chemicals are present in soil and groundwater (Figures 7 and 8, respectively). The area near and including the truck shop where affected soil and/or groundwater may be encountered and where the *Site Management Plan* applies is illustrated on Figures 4, 7, and 8.

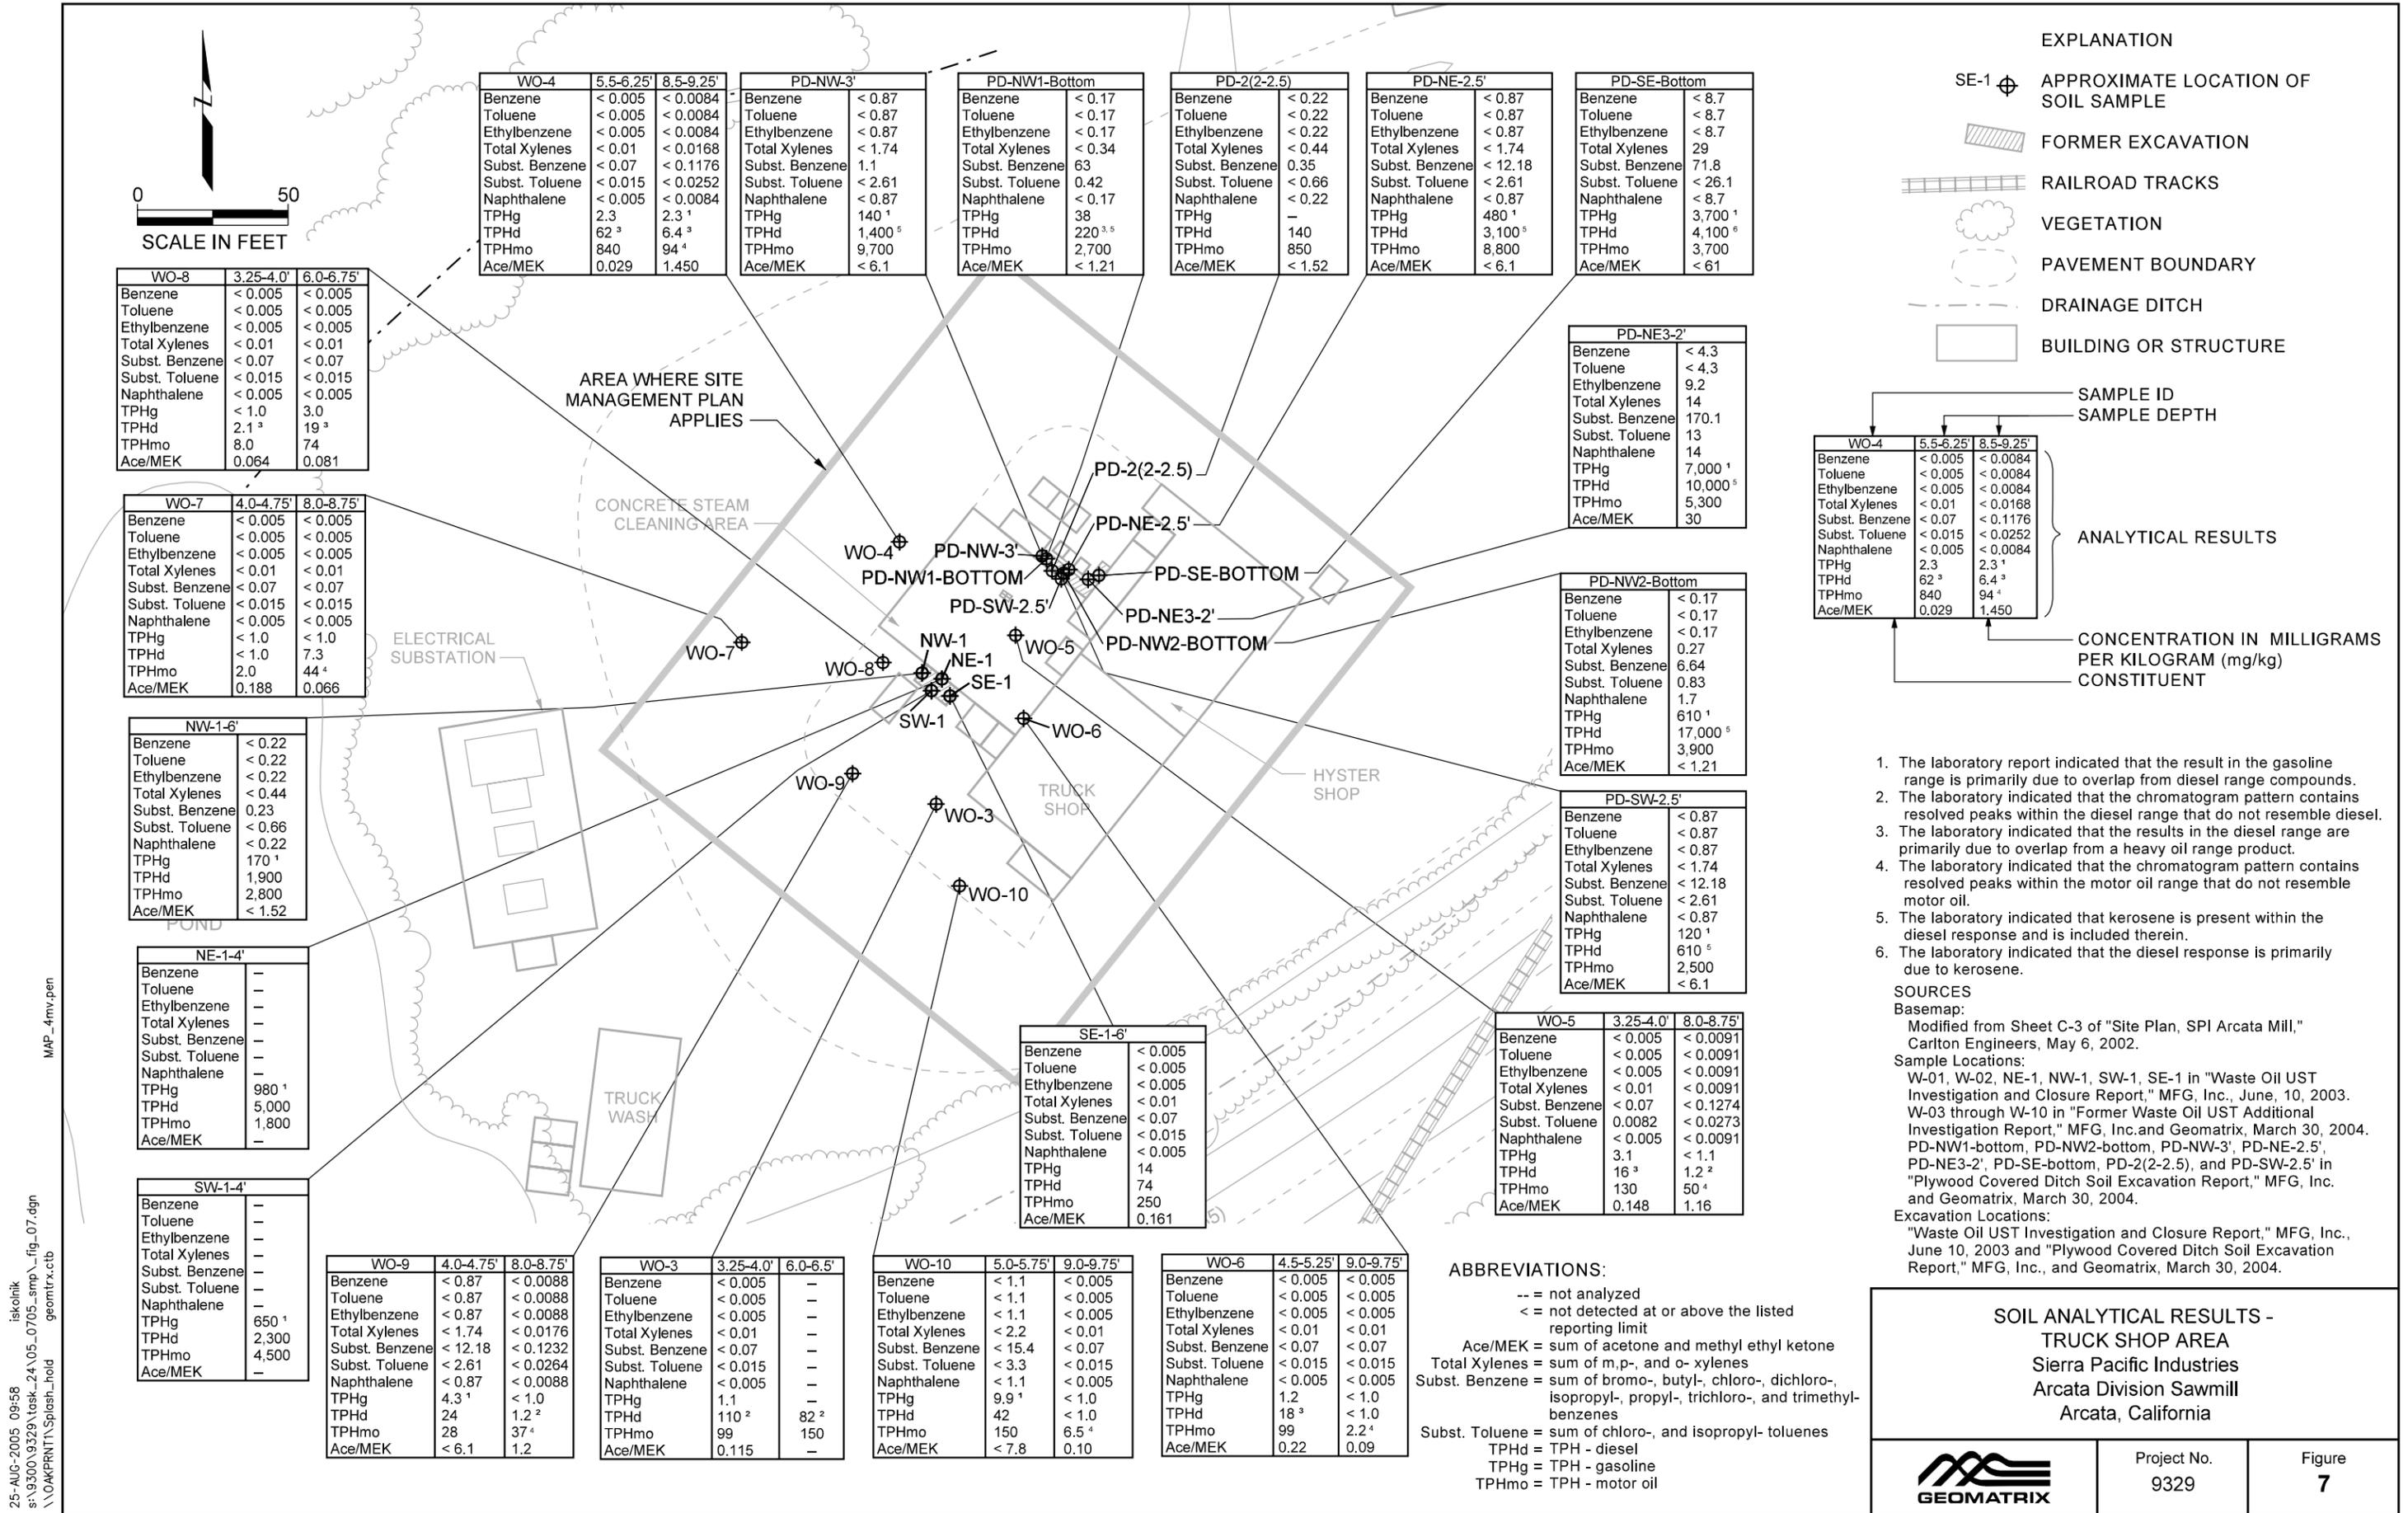
<b>SOIL ANALYTICAL RESULTS - TRUCK SHOP AREA</b> Sierra Pacific Industries Arcata Division Sawmill Arcata, California		
	Project No. 9329	Figure 7

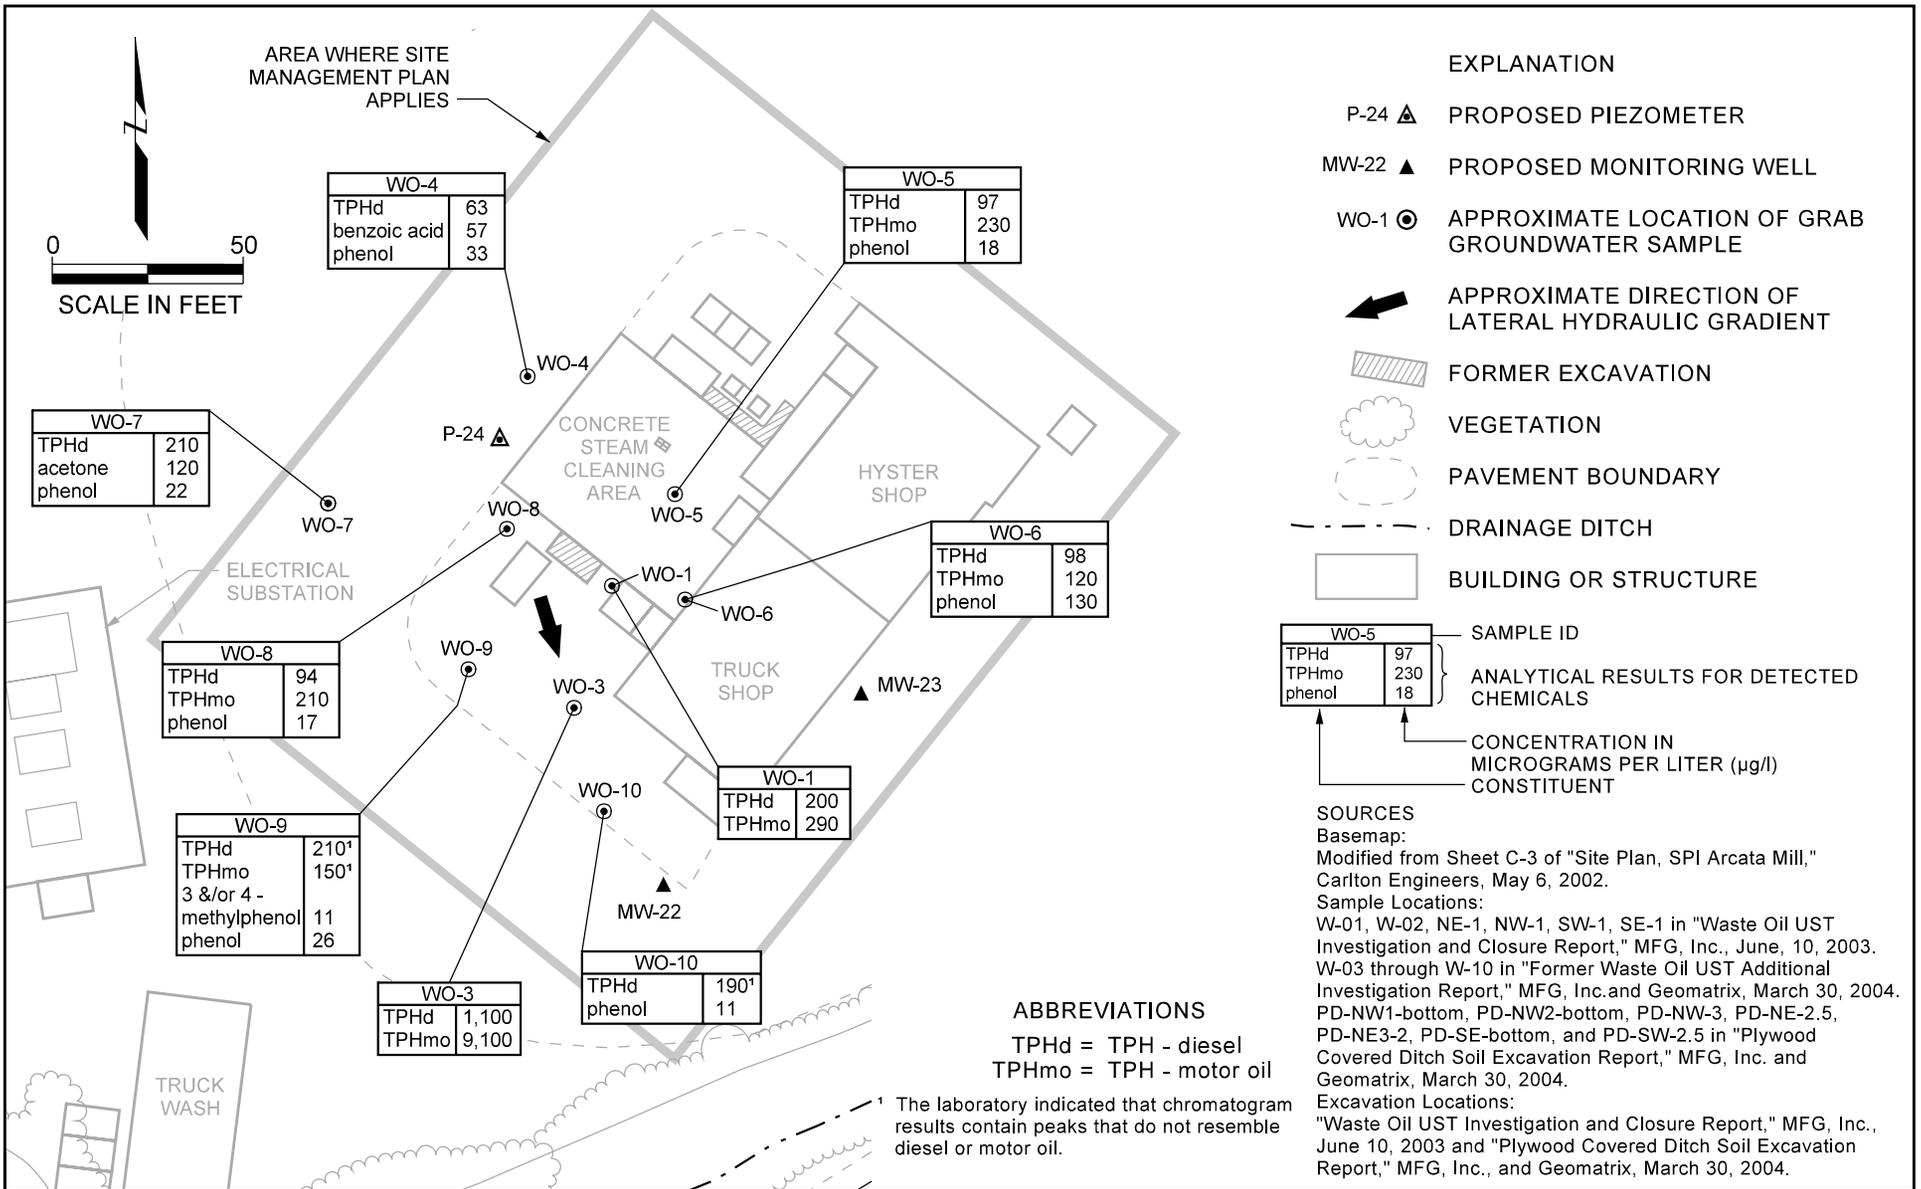
**8**

**GRAB GROUNDWATER ANALYTICAL RESULTS - TRUCK SHOP AREA**

April, July, and August 2003

In 2003, soil and groundwater investigations were performed in the truck shop area to assess the presence of chemicals at two locations: the waste oil UST and the former plywood-covered ditch. Usage of the waste oil UST was believed to have been discontinued during the 1970s, but it was uncertain whether the UST had been removed. The former plywood-covered ditch is located in the truck shop area and is approximately 20 feet long and about 3 feet wide. The ditch runs between the parts storage area and the oil shed, immediately northwest of the Hyster Shop (Figure 4). The ditch was excavated to install an underground electrical conduit and temporarily was covered with plywood during the installation process. The ditch currently contains an electrical conduit and is backfilled with native soil. Because the ditch is no longer covered with plywood, it is referred to as the former plywood-covered ditch. Figure 7 illustrates the laboratory analytical results for soil samples from the truck shop area, and Figure 8 illustrates the laboratory analytical results for grab groundwater samples from the truck shop area.
