Interagency Mitigation Monitoring Program Pilot Project Final Report

September 2008

Protocol Field Guide

September 2007

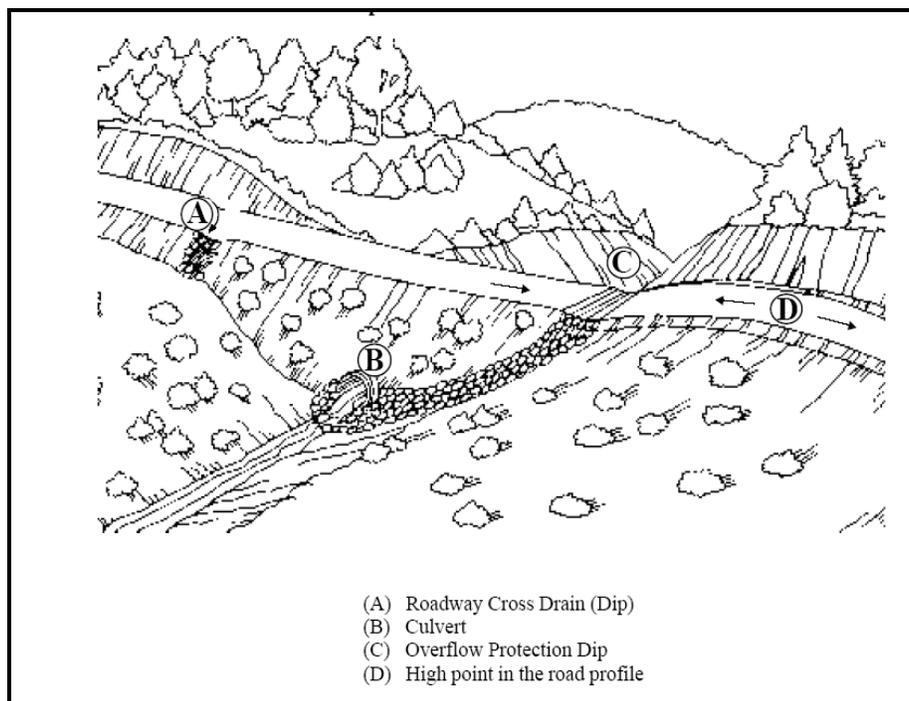
Figure 1. Diagram of a watercourse crossing and road segments draining to the crossing. Figure 7.11 in Keller and Sherar 2003.

The IMMP pilot project promoted agency consensus on the development and use of monitoring methods to be used in a full scale monitoring program, as recommended by MacDonald (1994). The IMMP Subcommittee determined that the pilot should be focused on watercourse crossings and road segments draining to crossings (Figure 1), since past monitoring and research work has shown that these are particularly high risk sites for sediment delivery to watercourse channels (Pyles and others 1989, Wemple and others 1996, Furniss and others 1998, BOF 1999, Cafferata and Munn 2002, Bundros and others 2003, MacDonald and others 2004, USFS 2004, Coe 2006, Brandow and others 2006).

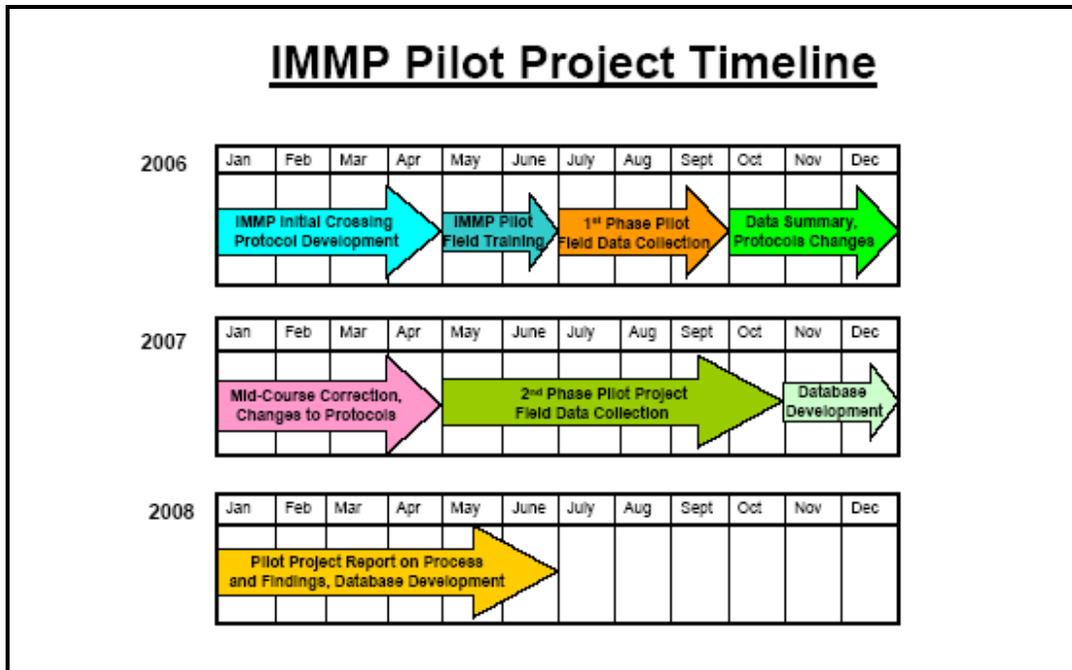
Figure 2. The pilot project timeline from January 2006 through June 2008.

Based on the need for greater acceptance of monitoring results and direction from the California Resources Agency for improved interagency cooperation, CAL FIRE proposed forming the Interagency Mitigation Monitoring Program (IMMP) in the fall of 2004. Following agreement by Department of Fish and Game (DFG), California Geological Survey (CGS), the North Coast Regional Water Quality Control Board (NCRWQCB), and the Central Valley Regional Water Quality Control Board (CVRWQCB) to participate in this new program, the first MSG IMMP Subcommittee meeting was held in March 2005. Prior to initiating field studies, a “general framework report” was prepared to document agreed-to IMMP concepts (CRA and others 2006). A timeline for the pilot project is presented in Figure 2.

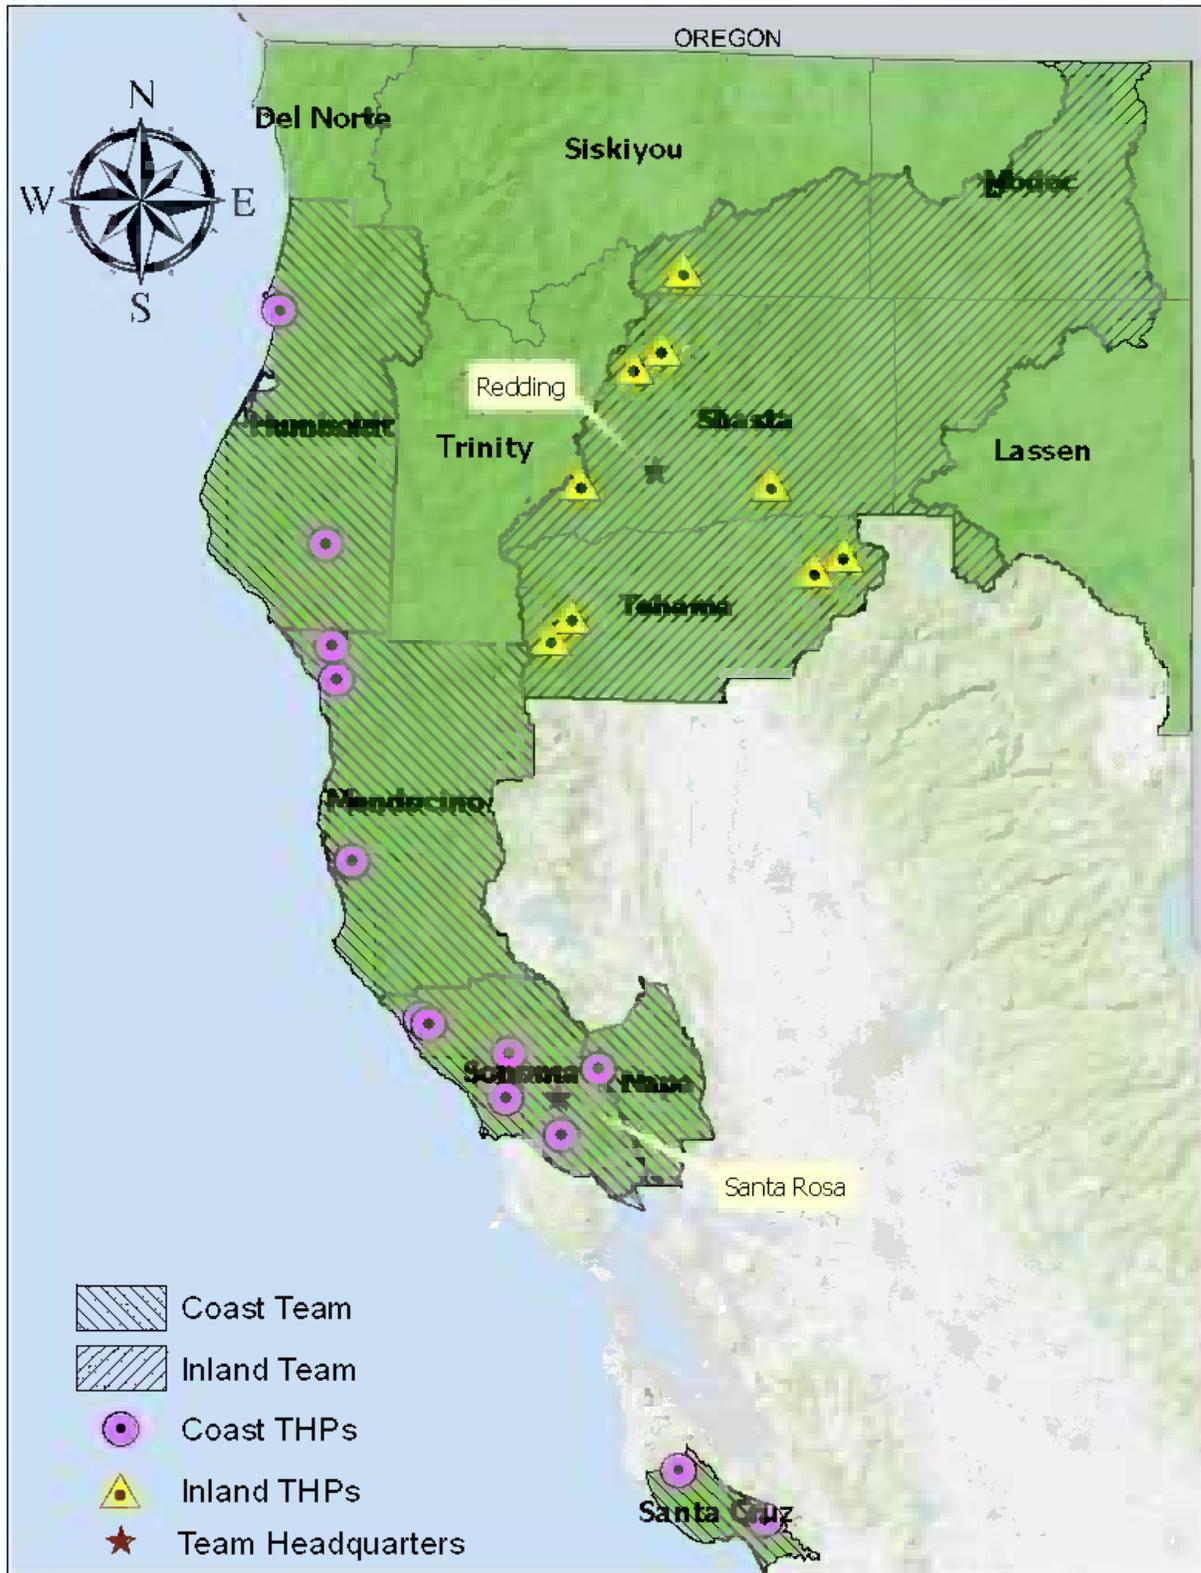
Figure 3. Map displaying locations of 22 plans sampled as part of the pilot project during 2006 and 2007.

The study area for the pilot phase of the IMMP was located in northern California and was divided into two sub-units defined primarily by the participating agency districts (Figure 3). Site evaluations within each area were conducted by separate teams of agency representatives.

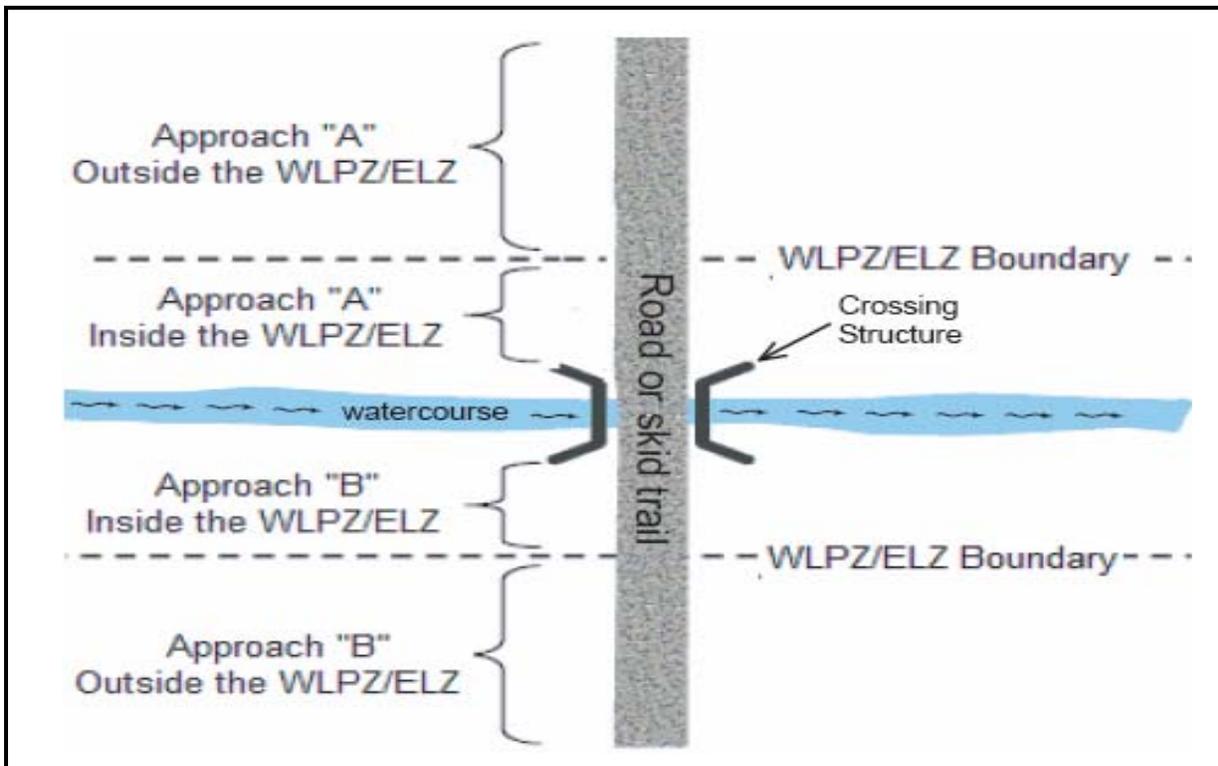
Figure 6. Typical protocol survey area, including approach areas A and B inside and outside the WLPZ/ELZ, and the crossing structure (Figure 2 in the IMMP Protocol Field Guide).

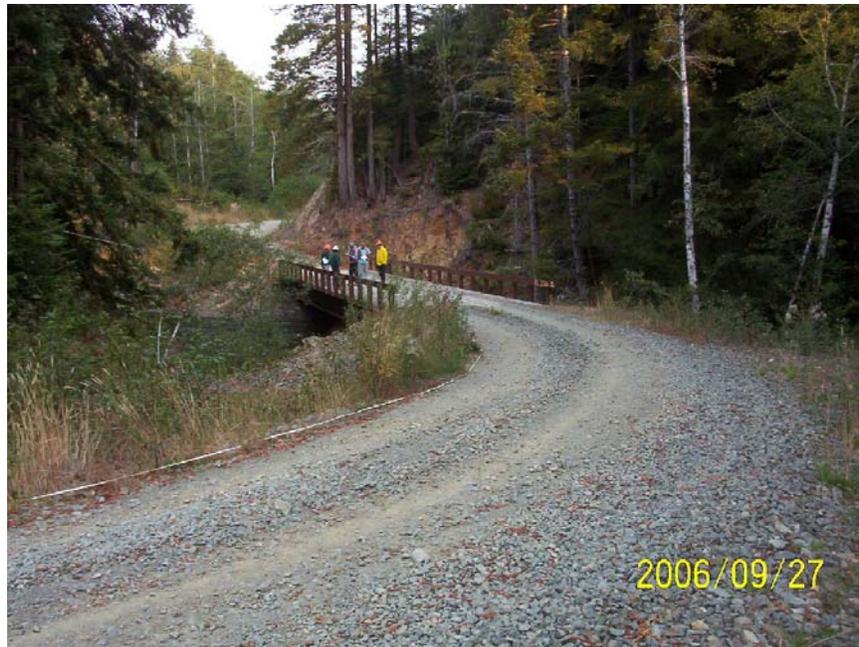
Figure 9. Bridge evaluated in Humboldt County by the Coast team during the 2006 field season. Note the tape stretched along the road approach to measure road length in the WLPZ.

Field sampling typically began by driving and/or walking to a pre-selected high risk watercourse crossing. After answering general questions, the portion of the “A” side road approach that was outside of the WLPZ/ELZ was identified using a cloth or nylon tape (Figure 9). Questions in the protocol about this portion of road approach were then answered. Next, road approach side “A” within the WLPZ/ELZ was observed and questions related to this segment were answered. The crossing structure itself was then evaluated, followed by an evaluation of road approach side “B” (inside and outside the WLPZ/ELZ). Finally, summary questions about total sediment delivery and overall performance of the crossing and approaches were answered. Late in the second field season, additional questions about water drafting sites within approach areas A and B were added to the protocol.

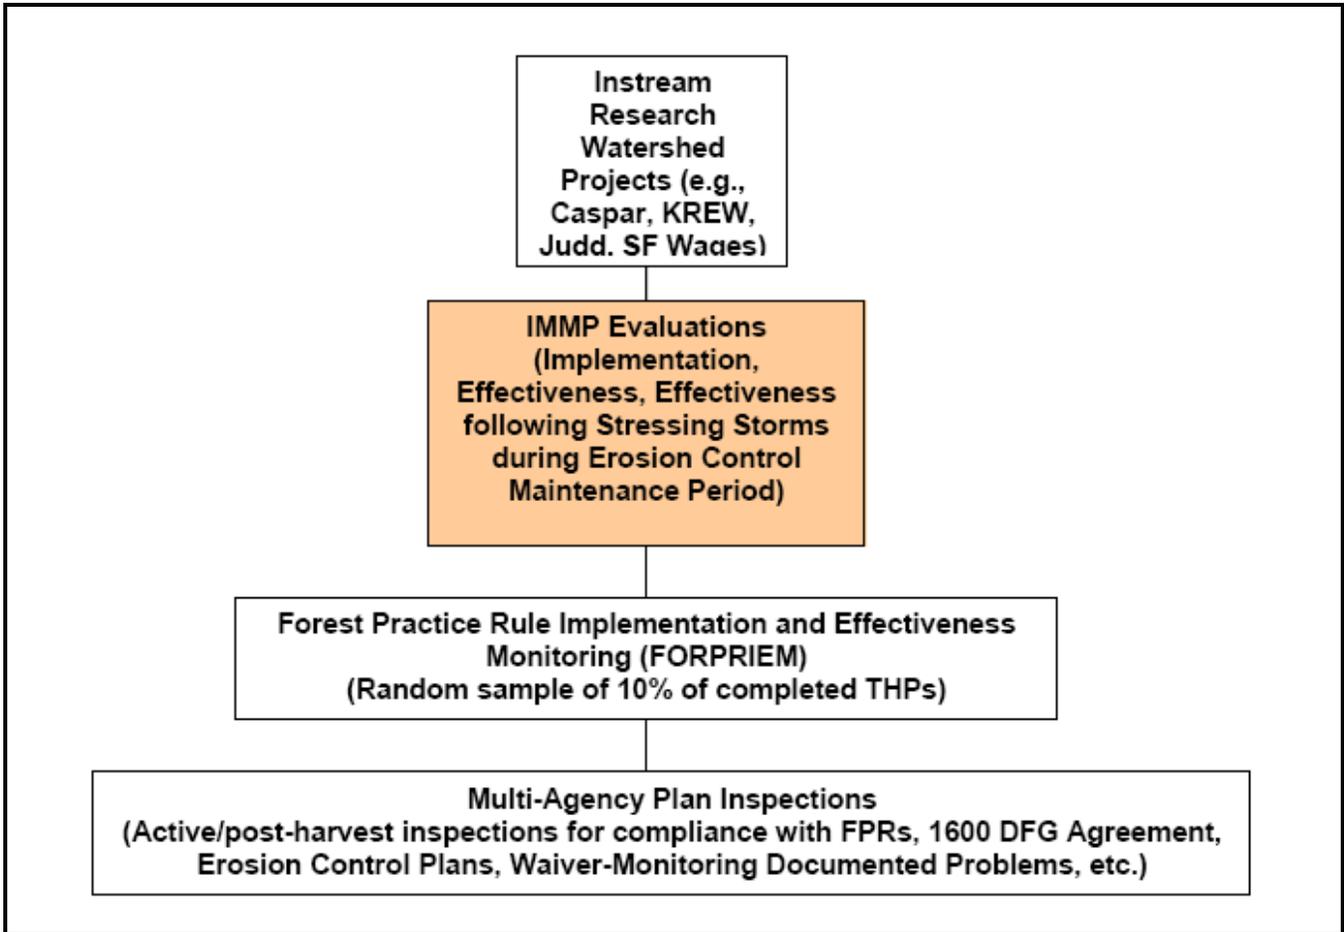
Figure 14. Diagram illustrating the relationship of IMMP work to other water quality-related monitoring approaches currently underway in California.

While the pilot project may be used to evaluate the implementation and effectiveness of practices at high risk, non-random watercourse crossings in California, it cannot answer all relevant water quality-related monitoring questions. To put the results of the IMMP work into proper context, it must be viewed as only one part of several additional monitoring projects already being undertaken in California (Figure 14). These efforts include monitoring work that occurs on all or a large percentage of plans (e.g., Forest Practice inspections conducted by CAL FIRE, DFG 1600 permit inspections), a random 10 percent selection of plans for crossing, road, and WLPZ monitoring known as FORPRIEM (Forest Practice Rule Implementation and Effectiveness Monitoring) conducted by CAL FIRE, and a limited number of instream watershed-scale research projects/instream channel monitoring studies (e.g., Caspar Creek, Kings River Experimental Watershed [KREW] study, South Fork Wages Creek, Judd Creek, etc.).

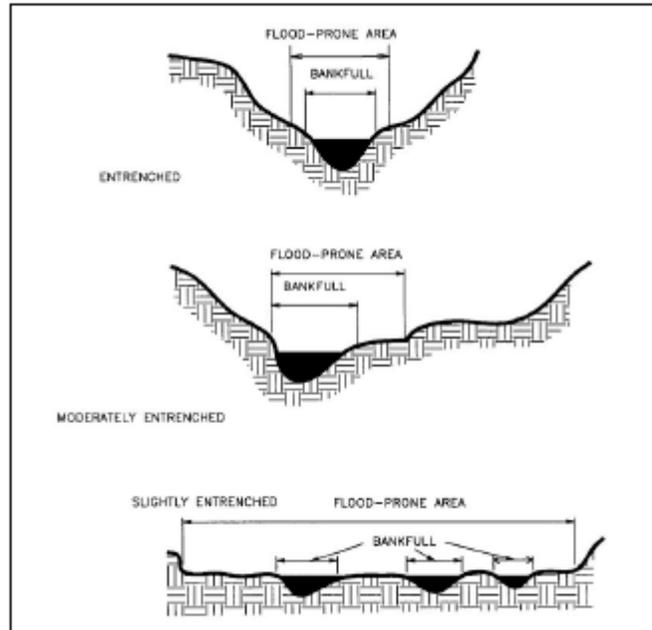
GC-107 Enter the code best describing the entrenchment of the natural watercourse channel above the crossing.

1. Entrenched (Confined)
2. Moderately entrenched (Unconfined)
3. Slightly entrenched (Braided)

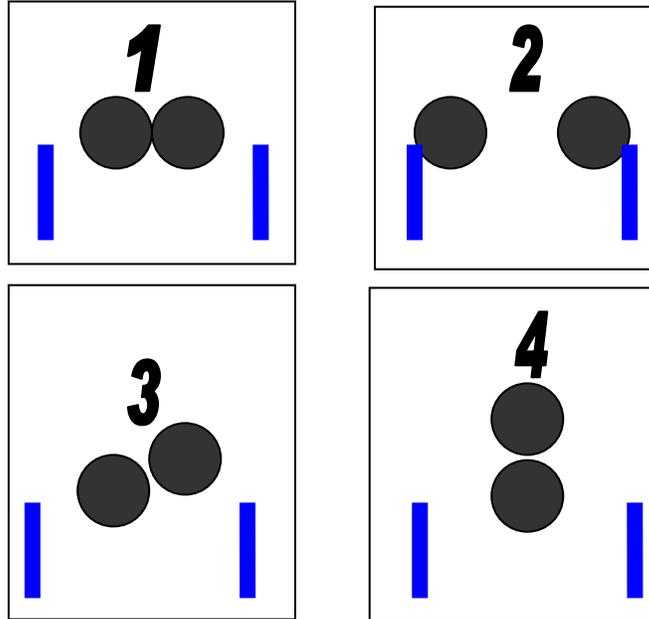
Which diagram below most closely resembles the arrangement of the multiple pipes at the crossing location relative to bankfull (vertical, parallel lines)?

1. 1
2. 2
3. 3
4. 4

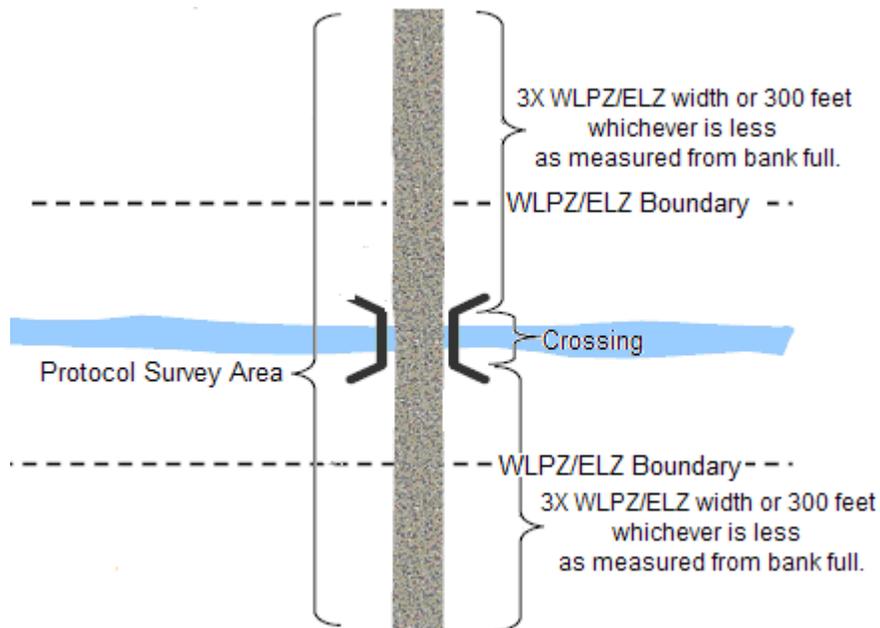
Figure 1. Typical Protocol Survey Area, see discussion under the **Approaches to stream crossings** heading for a-typical approach discussions.

The protocol survey area is the outer boundary of the approaches that will be considered for evaluation in this protocol. Establish the protocol survey on both sides of the watercourse by measuring the distance on the road surface equivalent to three (3) times the WLPZ/ELZ width or 300 feet, whichever is less. This distance is measured from bank full.

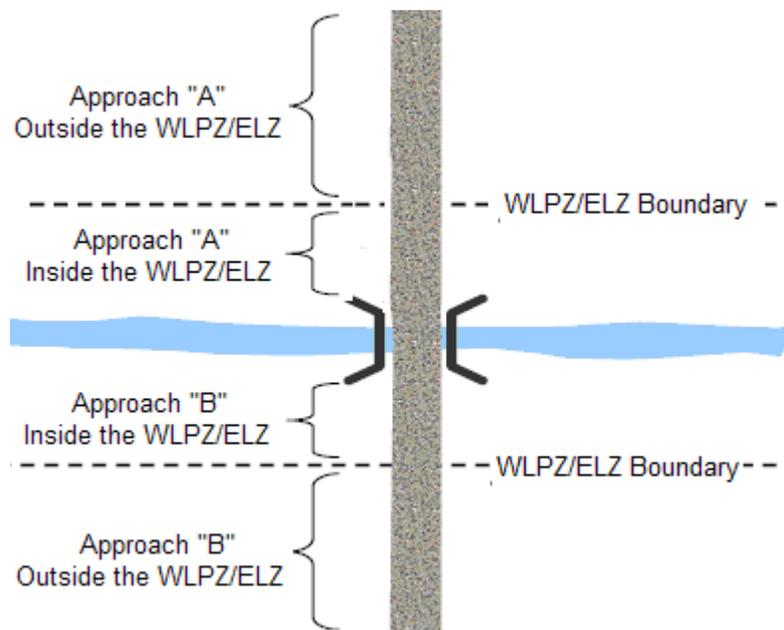
Figure 2. Typical Protocol Survey Area including approach areas A and B inside and outside the WLPZ/ELZ. Approach area A is always on the left looking downstream and B is always on the right; therefore the watercourse in the figure is flowing to the right.

The approaches, designated A and B, need to be identified in a consistent manner to facilitate re-sampling for quality control. Therefore, approach Area A will be the approach on the left bank as the investigator faces downstream.

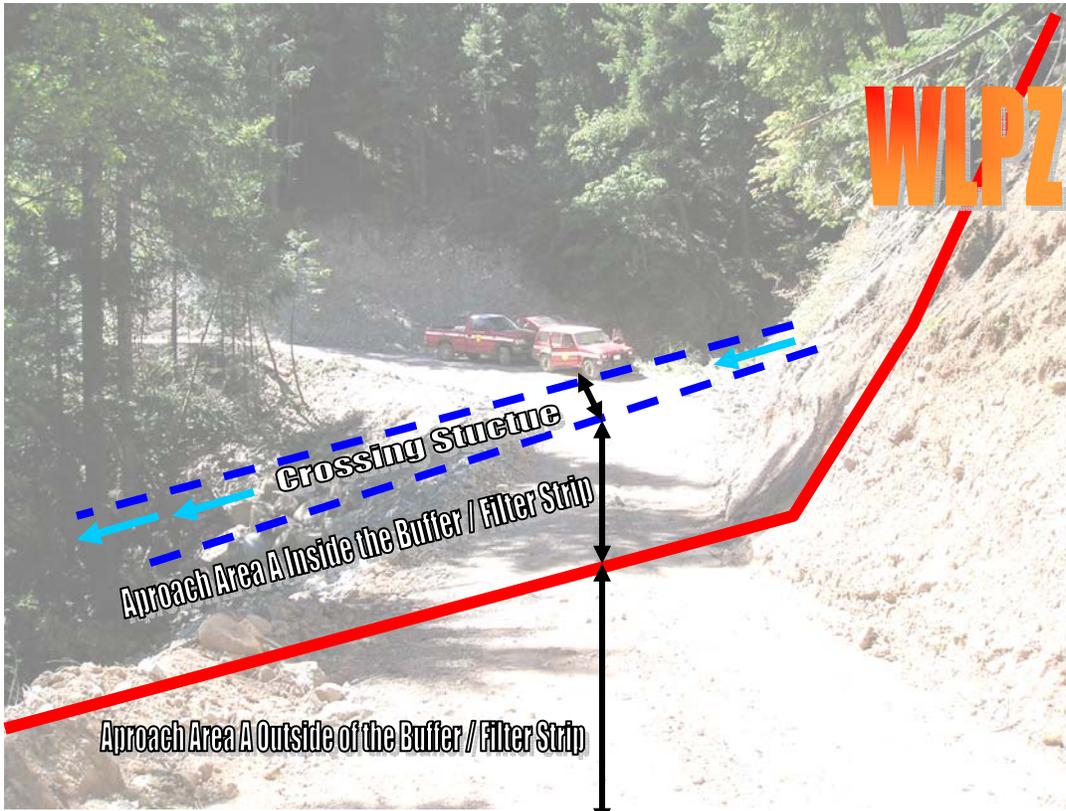
Figure 3. Approach area A inside and outside the WLPZ/ELZ. Approach area A is always on the left looking downstream.

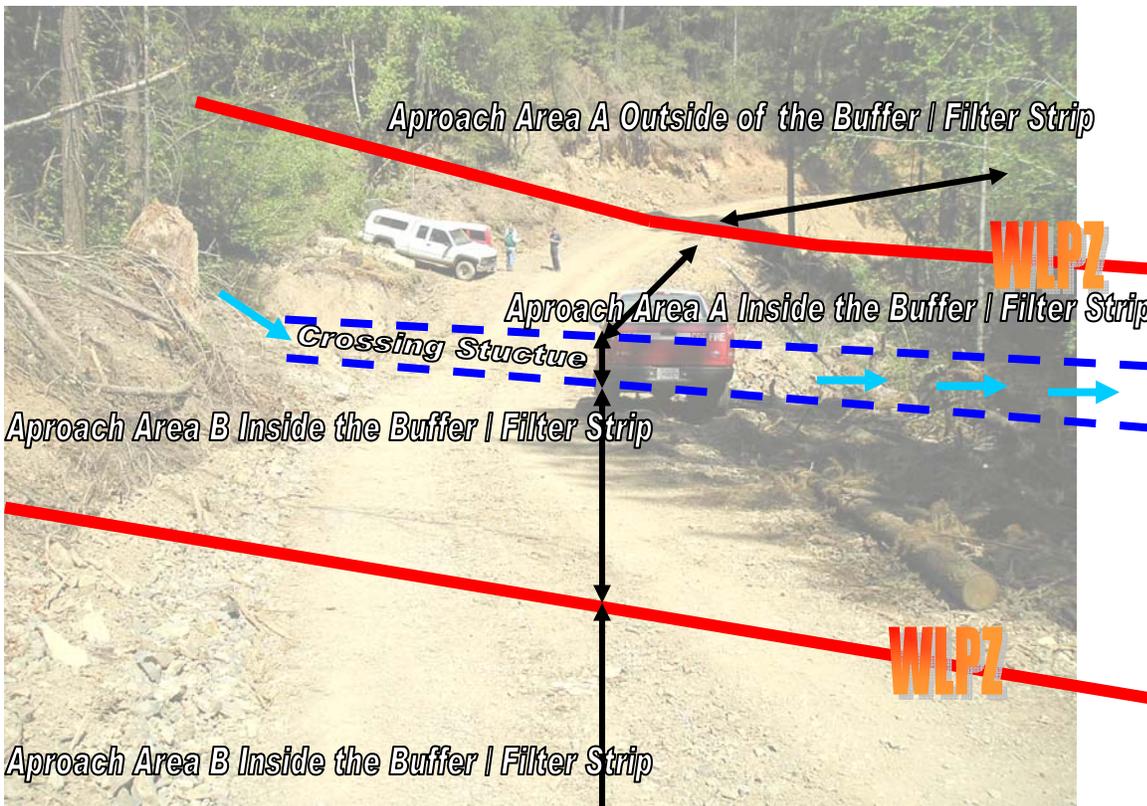
Figure 4. Approach area A and B inside and outside the WLPZ/ELZ. Approach area A is always on the left looking downstream and B is always on the right.

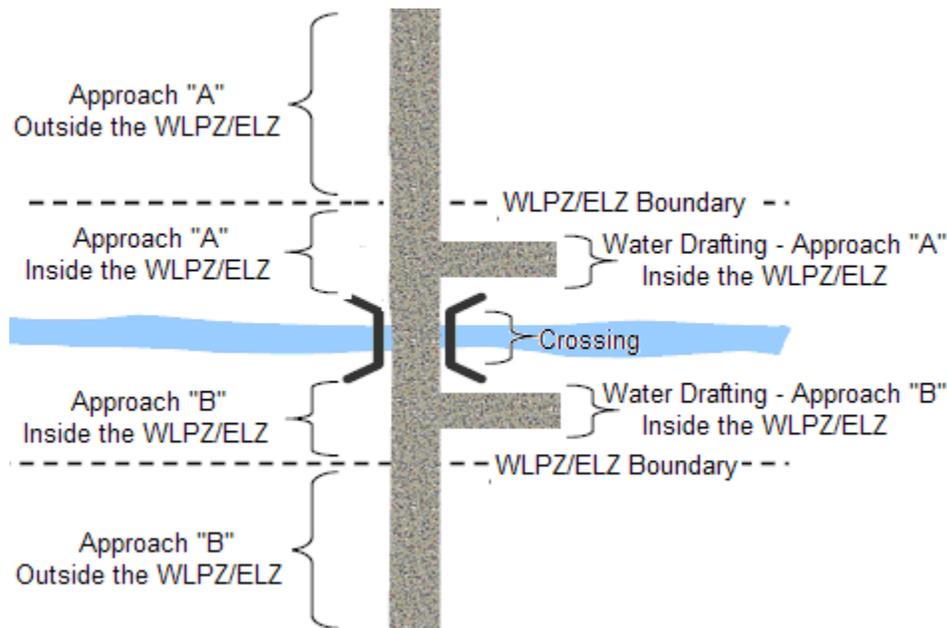
Figure 5. Typical Protocol Survey Area including approach areas A and B inside and outside the WLPZ/ELZ as well as water drafting approaches. Approach area A is always on the left looking downstream and B is always on the right; therefore the watercourse in the figure is flowing to the right.

- Approach Area A -Outside the WLPZ/ELZ
- Approach Area A-Inside the WLPZ/ELZ
- Water Drafting - Approach Area-A, Inside the WLPZ/ELZ
- Crossing Structure
- Approach Area B-Outside the WLPZ/ELZ
- Approach Area B-Inside the WLPZ/ELZ
- Water Drafting - Approach Area-B, Inside the WLPZ/ELZ

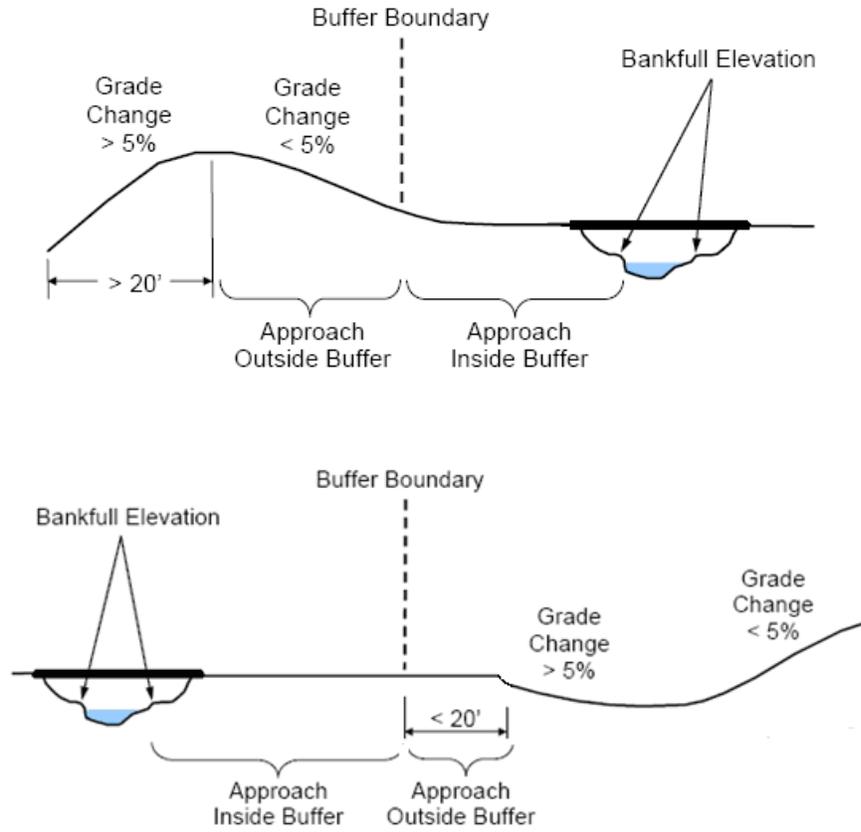
Figure 6. Graphical examples that result in a change in grade that prohibits road drainage from draining to the subject watercourse resulting in, the upland boundary of the protocol survey area being established at that point less than what is described above.

If within this distance, there are topographic features or a change in grade that prohibits road drainage from draining to the subject watercourse, the upland boundary of the protocol survey area is established at that point. This change is not applicable for drainage facilities including waterbreaks or rolling dips and the change must be continuous throughout the remainder of the measured distance.

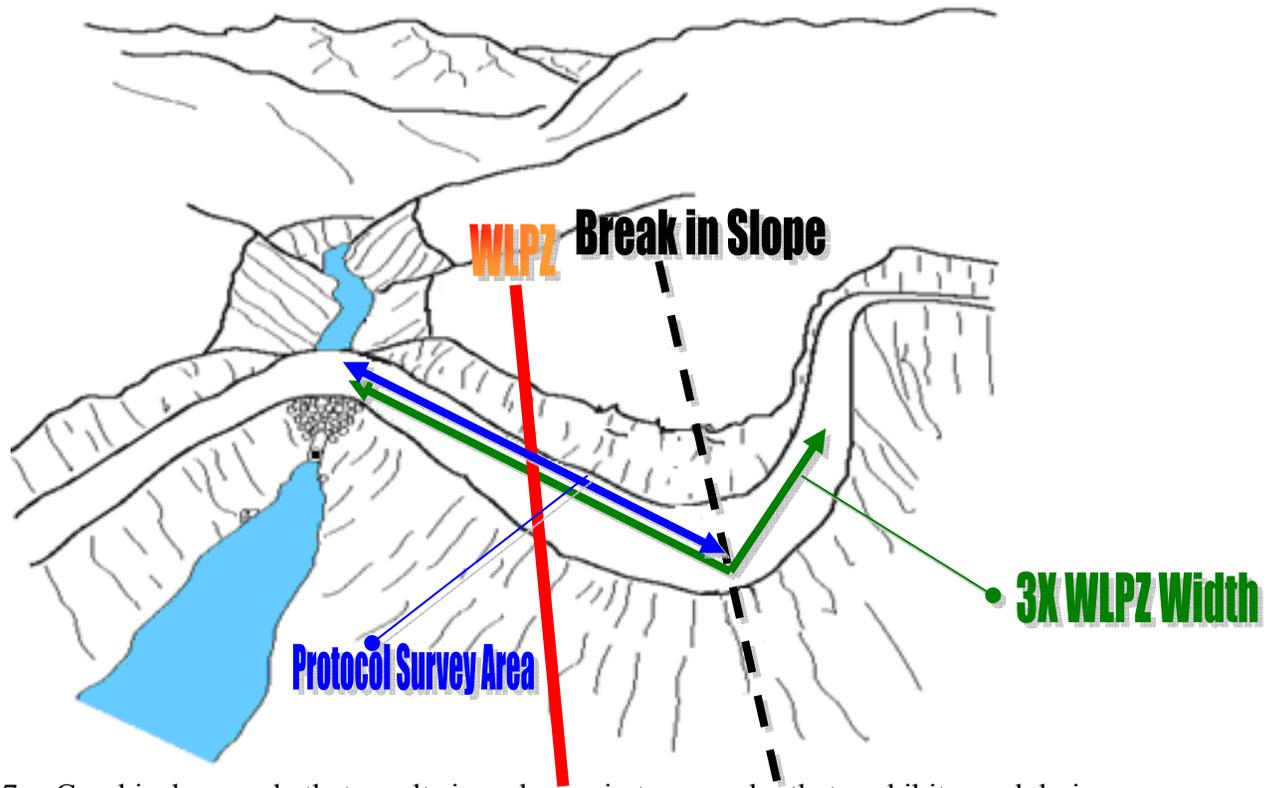
Figure 7. Graphical example that results in a change in topography that prohibits road drainage from draining to the subject watercourse resulting in, the upland boundary of the protocol survey area being established at that point less than what is described above.

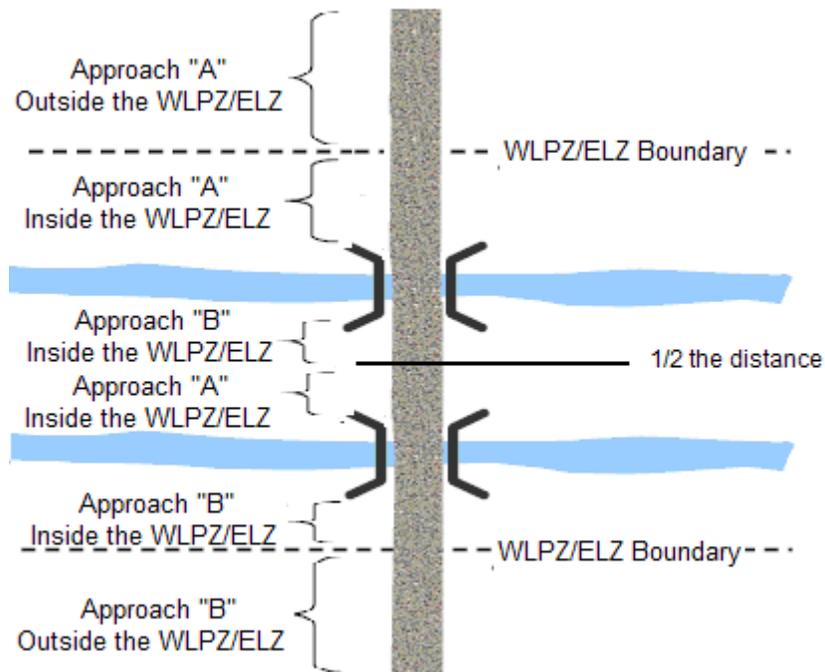
1. Where two crossings are located very close to one another (e.g., a road crosses two forks/branches of a stream upstream of their confluence) and if both stream crossings are to be included, then it is appropriate to split the distance in half. For example, if there is 100 ft between crossings, use 50 ft for each approach.

Figure 8. Example of where two crossings are located very close to one another and both are subjected to the protocol.

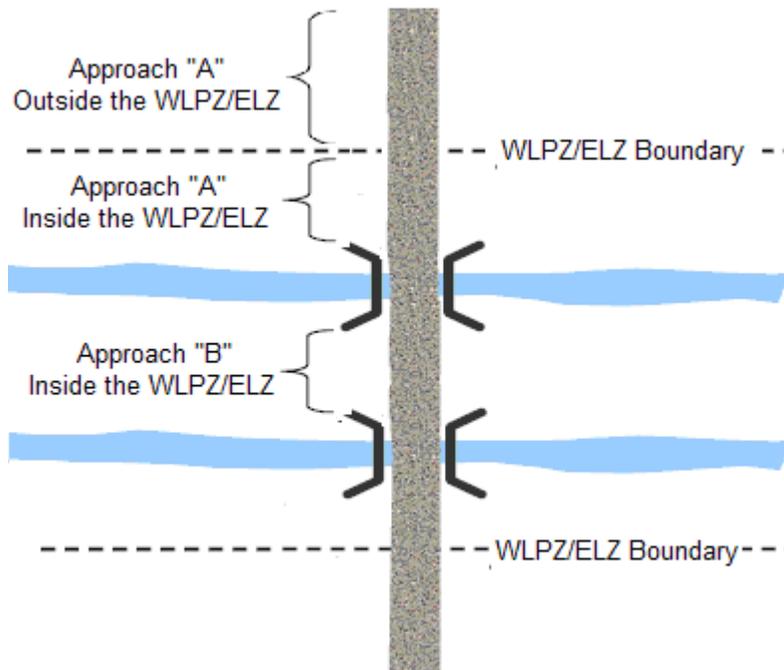
- Where two crossings are located very close to one another (e.g., a road crosses two forks/branches of a stream upstream of their confluence) and only one crossing is to be included, then it is appropriate to use the normal procedure, but stop at the second stream. For example, if there is 100 ft between crossings, use 100 ft for each approach if the study area is greater than 100 feet.

Figure 9. Example of where two crossings are located very close to one another and southern crossings is not subjected to the protocol.

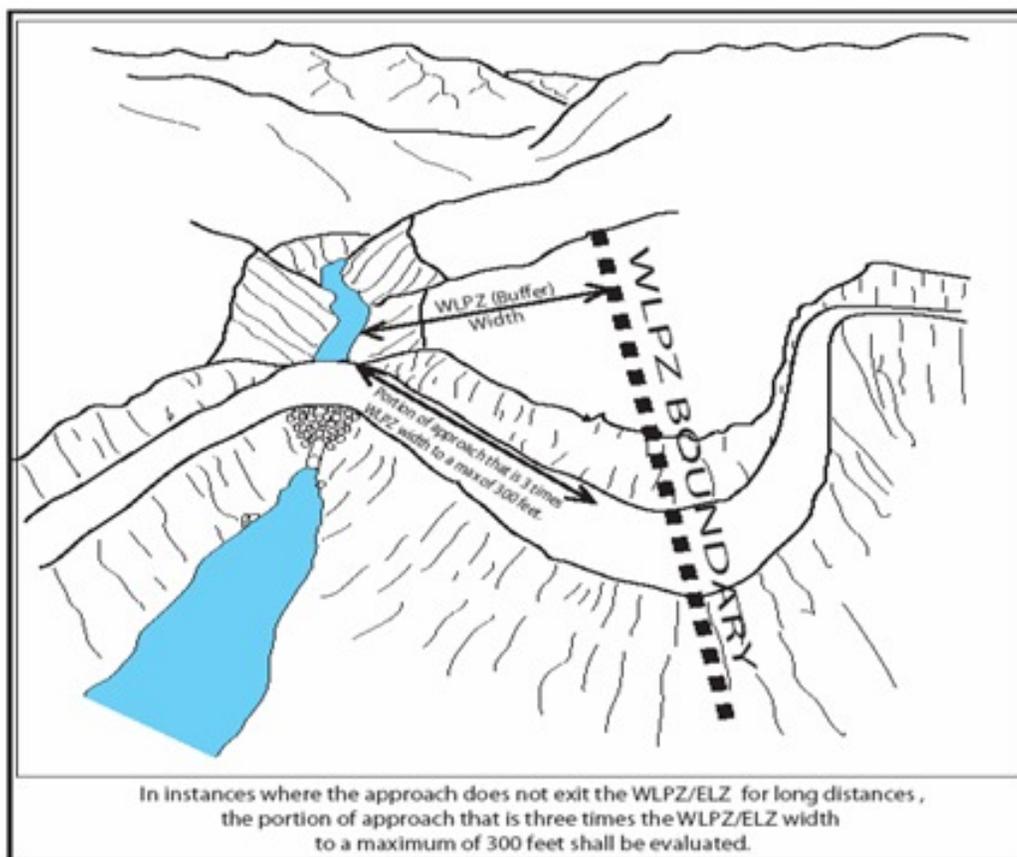
If the approach does not exit the WLPZ/ELZ for a lineal distance greater than three times the WLPZ/ELZ width, the maximum distance for evaluation shall be three times the buffer filter strip width or 300 feet, whichever is less. Distances are measured from bank full. There will be no responses to the questions pertaining to the approach outside of the WLPZ/ELZ as one does not exist within the protocol survey area.

Figure 10. Graphical depiction of a road that does not exist the WLPZ within three (3) times the WLPZ width or 300 feet as measured from bankfull.

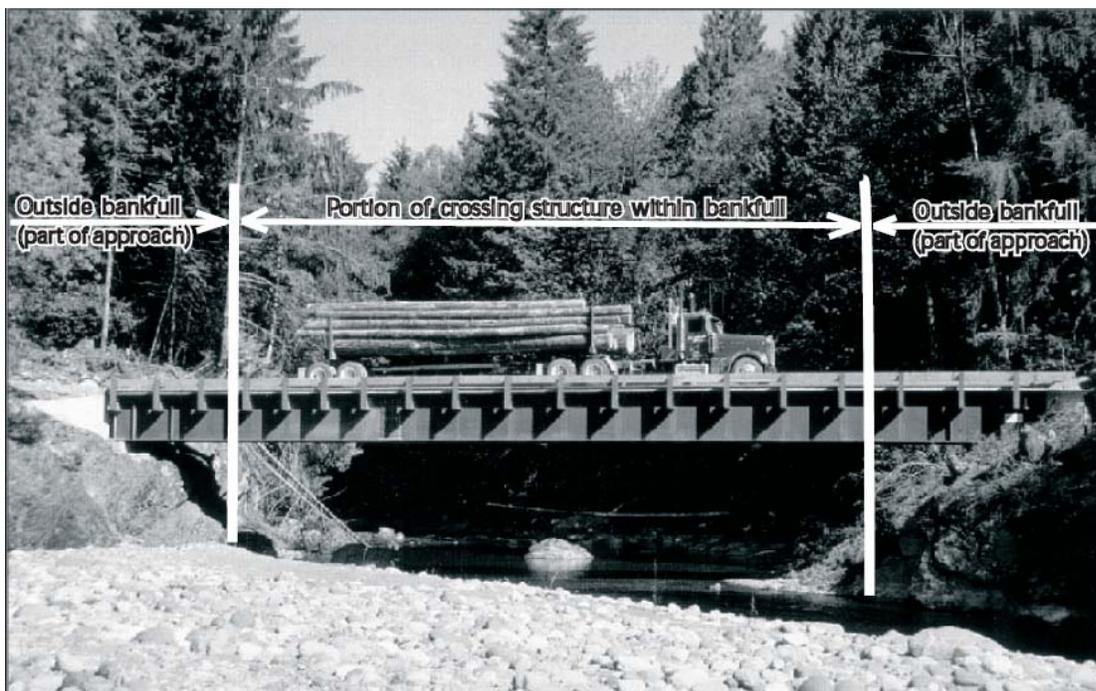
The crossing structure includes only those parts of the structure that are within the bankfull width of the channel. Structures or parts thereof that are outside the bankfull width of the channel must be considered part of the approaches for the purposes of the protocol.

Figure 11. The ends of the bridge pictured above are outside of the crossing area as illustrated by the lines.

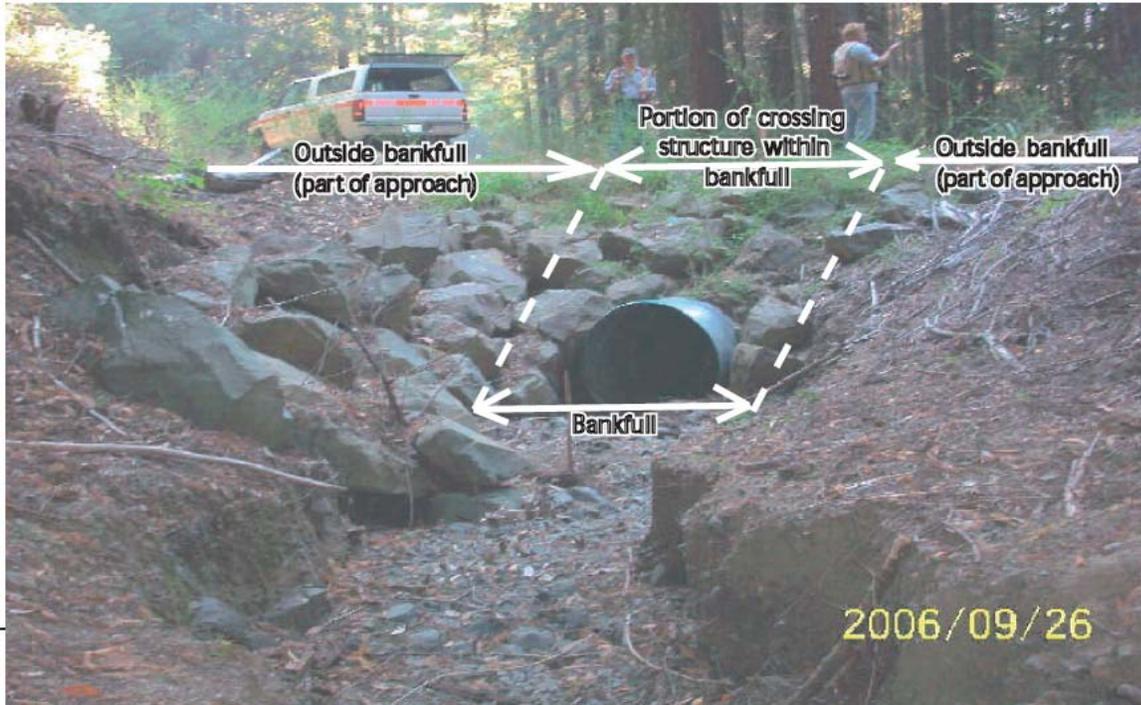
Figure 12. The fill material from the hinge points to the dashed lines is considered part of the approach. The crossing itself is only the area between the dashed lines.

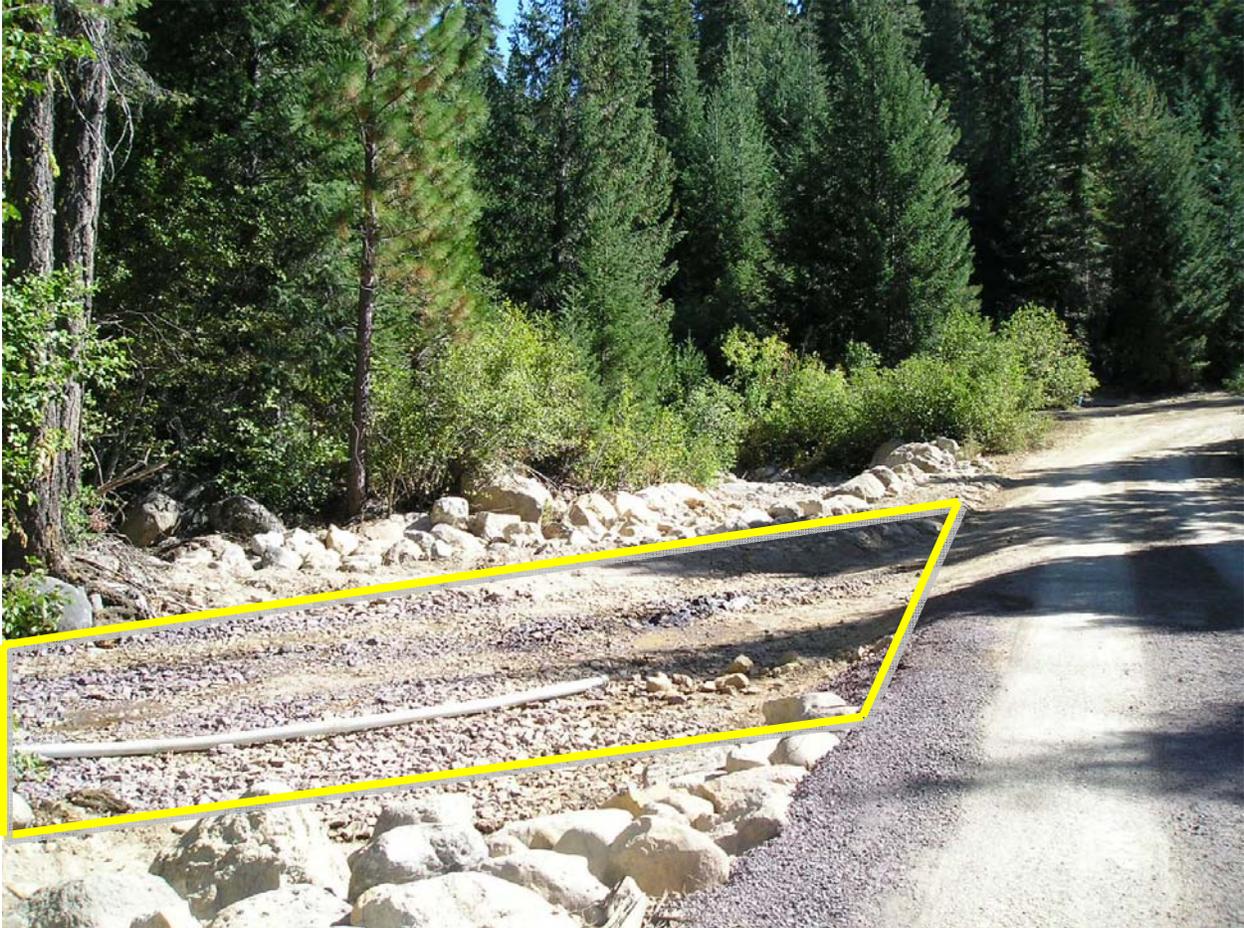
Constructed water drafting approaches at watercourse crossings are common place. These constructed features are usually designed to allow a water truck to leave the roadway and pull or back onto a short spur where it is parked to facilitate water drafting activities. These water drafting approaches may be dirt pads or rocked.

Figure 13. A water drafting approach on approach area A, inside the WLPZ/ELZ.

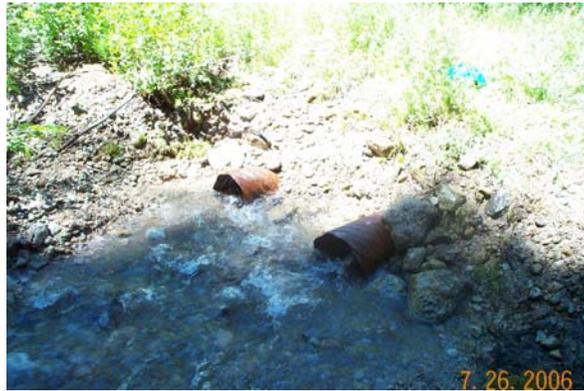
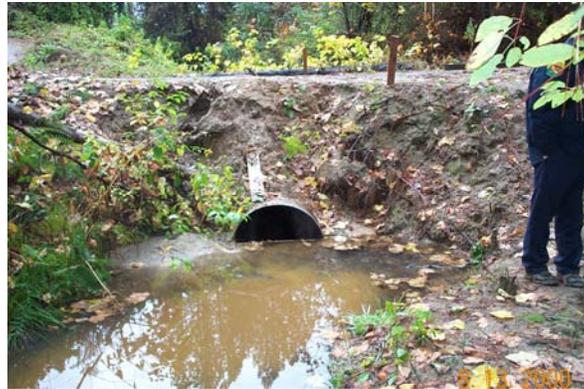
Aggrading means a stream channel in which the streambed is rising in elevation due to the deposition of sediment and other natural materials.

Aggradation refers to the accumulation of sediments on a surface which thereby raise its level.

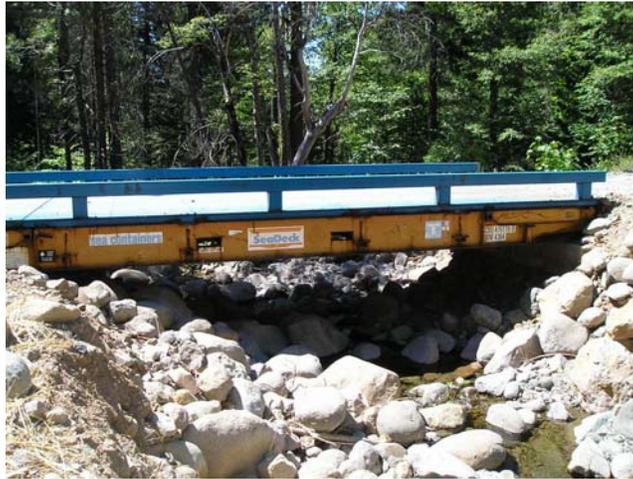
Bridge, Closed Top A bridge with a continuous surface structure that would prevent soil and related debris from falling through the surface structure into the water below.

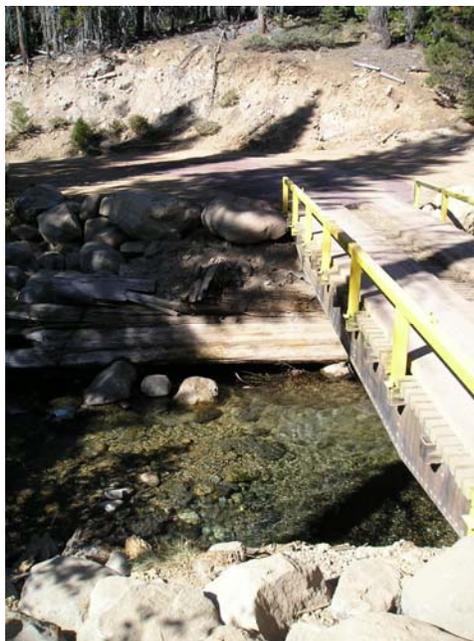
Bridge, Open Planked Top A bridge with a discontinuous surface structure that would permit soil and related debris to fall through into the water body below.

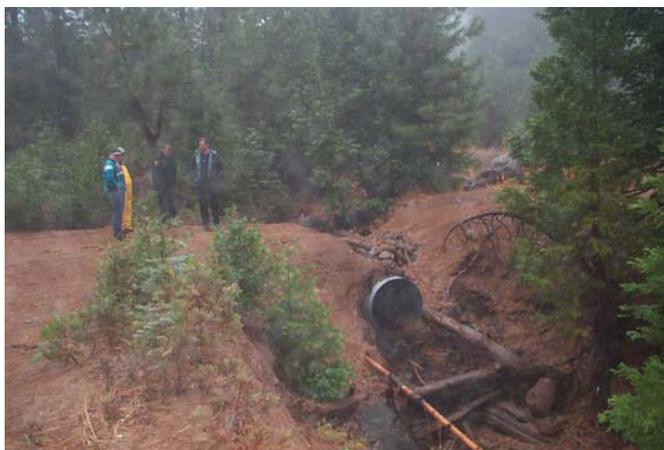
Critical Dip A dip in the road, usually installed in the crossing fill, which would prevent diversion of the stream course down the road should the crossing structure become obstructed.

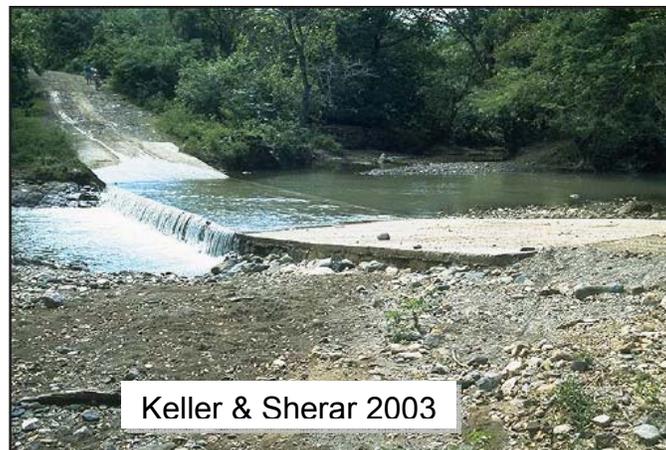
Ford, Concrete Apron This type of ford is constructed of concrete slabs or prefabricated concrete slabs which form the running surface.

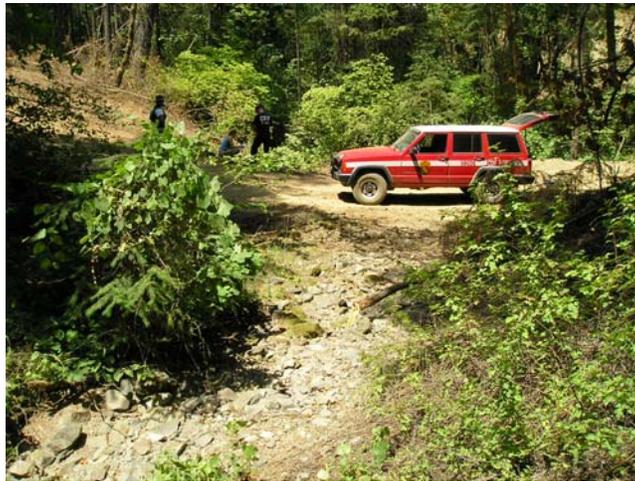
Ford, Native Surface This type of ford crossing is commonly utilized in Class III watercourses that are proposed for use when water is not present. Commonly language in the plan will require that the crossing be “dipped” upon completion of use.

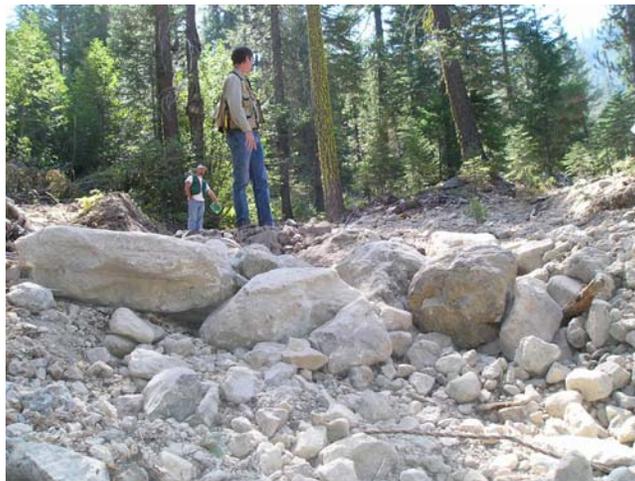
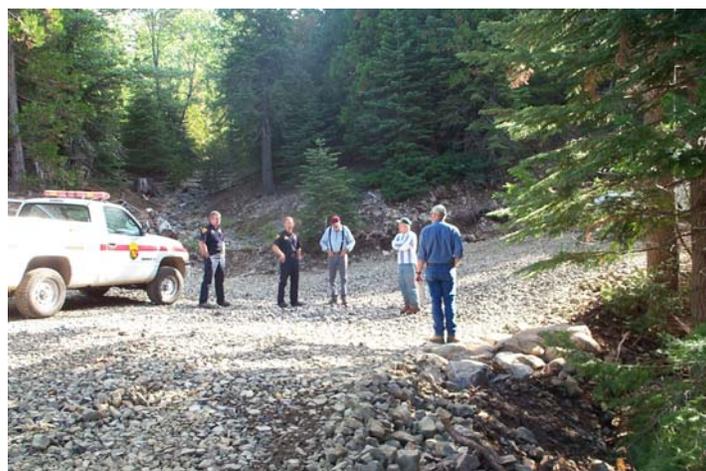
Ford, Wet Regardless of plan specification, if the crossing has a rocked running surface and a rock armored outfall, it qualifies as a wet ford crossing for purposes of this protocol.
