Interagency Mitigation Monitoring Program Pilot Project Final Report

September 2008

Protocol Field Guide

September 2007

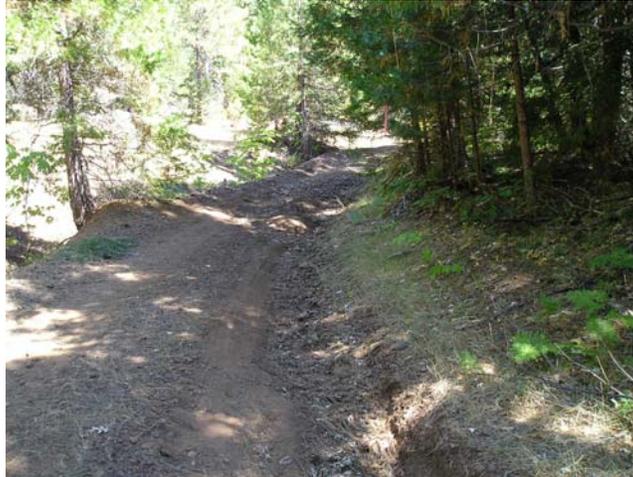
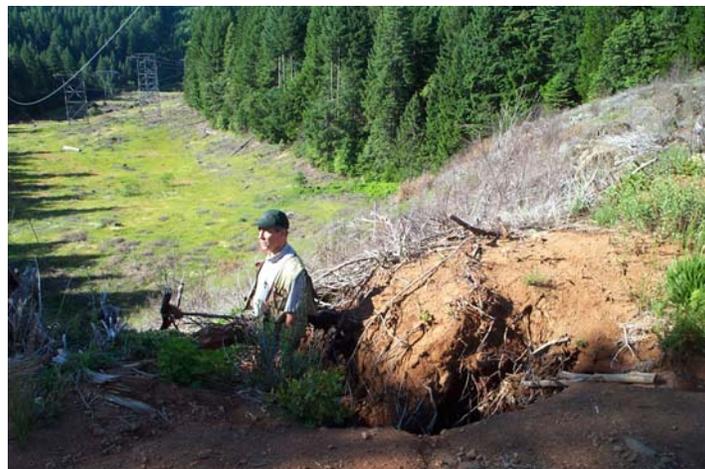
Gully An erosion channel cut into the soil along a line of water flow with a minimum depth of 6 inches and a minimum length of 12 feet. The length requirement does not apply if the gully terminates in a water body before reaching twelve feet in length. Gully erosion produces channels larger than rills. (Schwab et al. Soil and Water Engineering 1993 and Soil Survey Manual, USDA 1993).

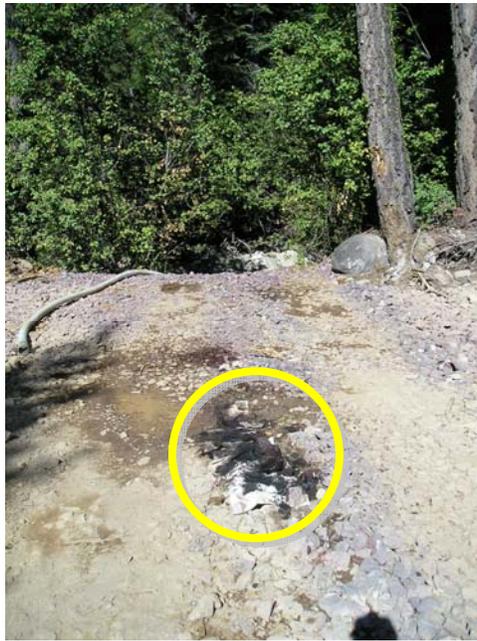
Petroleum or Petroleum Residue means oil staining or pooling of oil. It may also include grease, transmission fluid or hydraulic fluid.

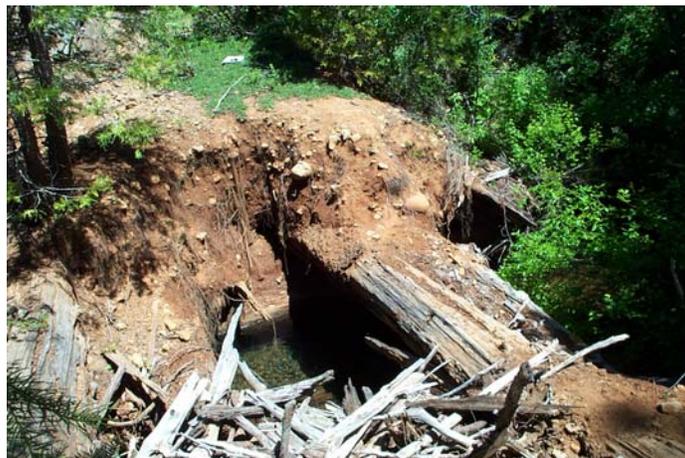
Piping Erosion of fill material as from a bridge abutment or around a culvert as a result of water flowing through the abutment or outside the culvert and carrying entrained soil particles resulting in tunnels or “pipes” through the fill material potentially resulting in collapse and further erosion of the fill material. (Survey Manual, USDA 1993)

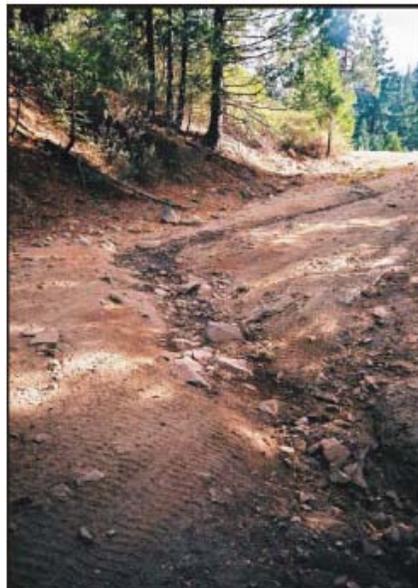
Rill An erosion channel cut into the soil along a line of water flow often resembling a braided stream pattern with a minimum depth of 1 inch, a minimum length of 12 feet, and a depth change of at least 25% over the 12 foot length. The length requirement does not apply if the rill terminates in a water body before reaching twelve feet in length. Rill erosion is the detachment and transport of soil by a concentrated flow of water. Rill erosion is the predominate form of erosion under most conditions (Schwab et al. Soil and Water Engineering 1993) (Packer P.E. 1967 “Criteria for designing and locating logging roads to control sediment” Forest Science Vol. 13No 1.). A rill becomes a gully when the depth exceeds 6 inches. (See: Gully)

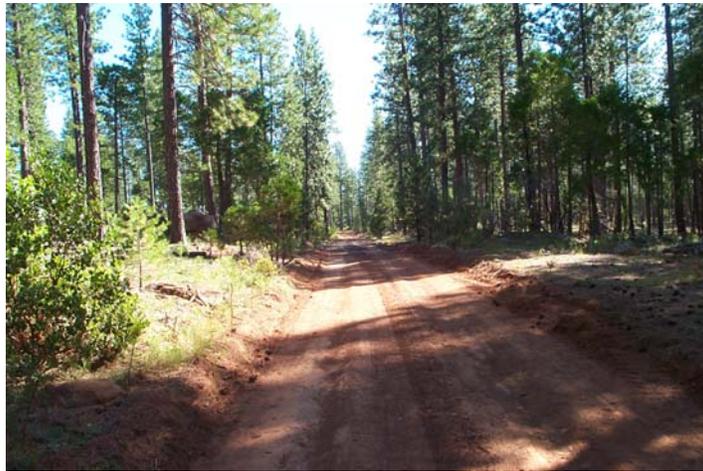
Road/Trail Inverted Below General Grade of Adjoining Land is a term used in the protocol to describe the road prism within the approaches. It usually occurs in flat topography through continued use and grading of the road.

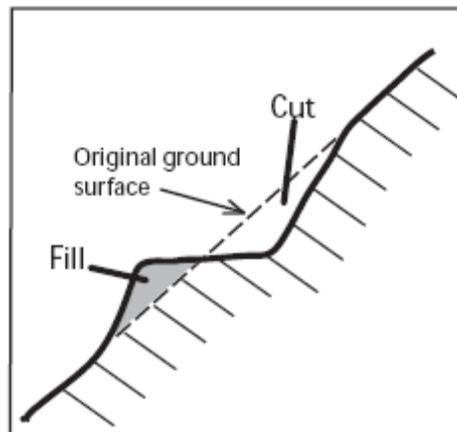
Road/trail profile created by cut and fill construction.

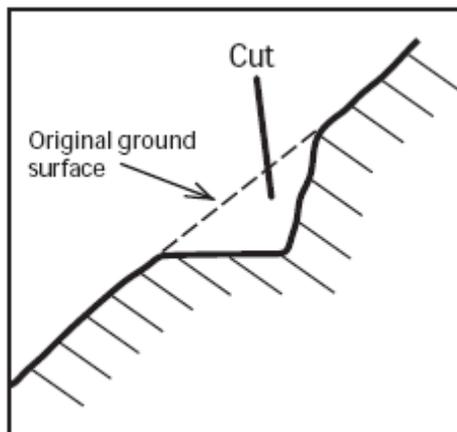
Road/trail profile created by full bench construction.

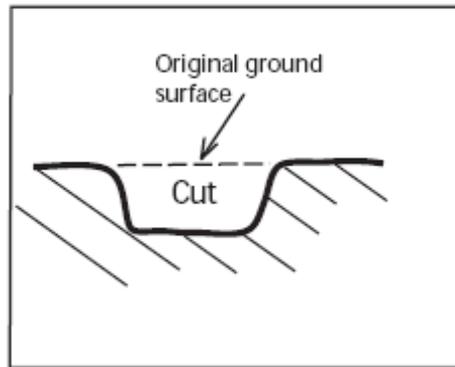
Road/trail created by through cut.

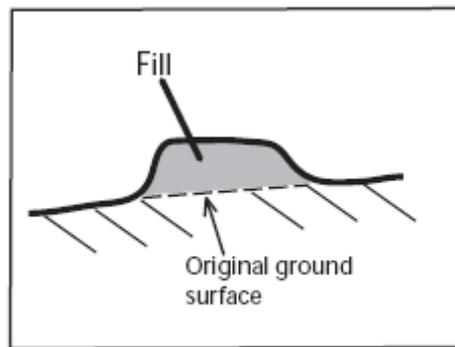
Road/trail profile created by through fill.

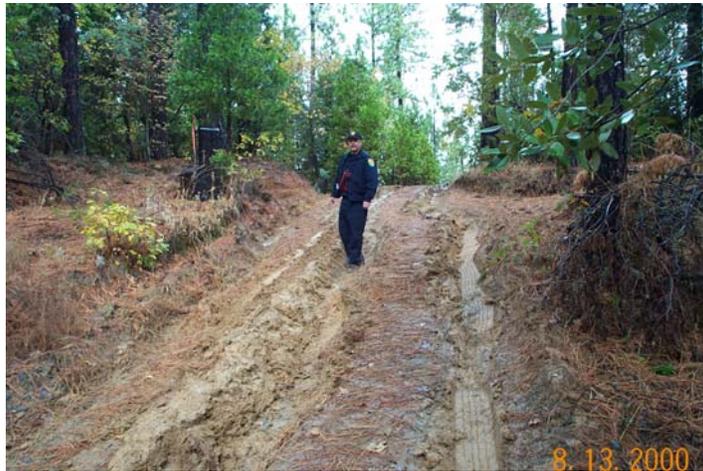
Rut Elongated depressions in a trail or roadway caused by dragged logs or wheels or tracks of harvesting machinery and often exacerbated by erosion from uncontrolled runoff waters. Continuous ruts with lengths equal to or greater than the lesser of one wheel circumference or 12 feet will be recorded for this protocol. Ruts ending within the bankfull channel width of the stream will be recorded regardless of length.

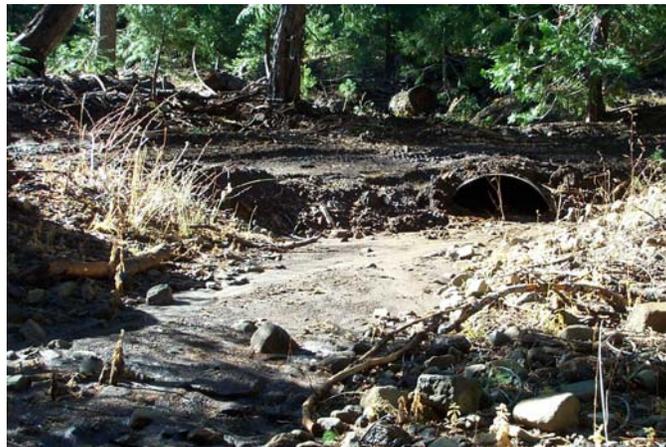
Sedimentation, Deposit to a water body Soil or fill material, not specified in the design, that is considered to have entered the water body when it has been deposited within the bankfull width of the stream channel or below the normal high water level of lakes or within the boundaries of wetlands whether or not water is present at the time of sampling.

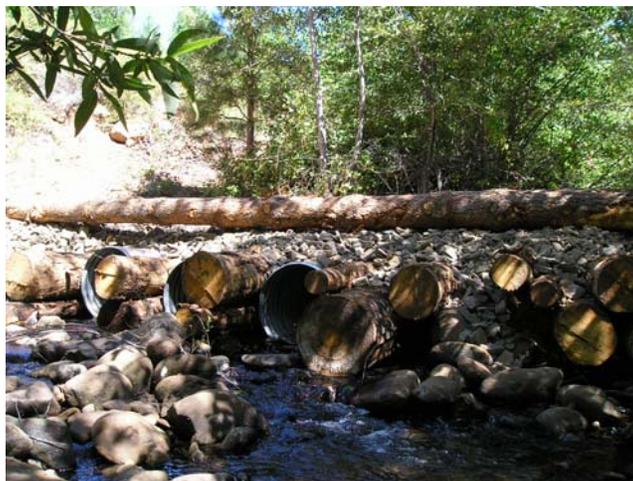
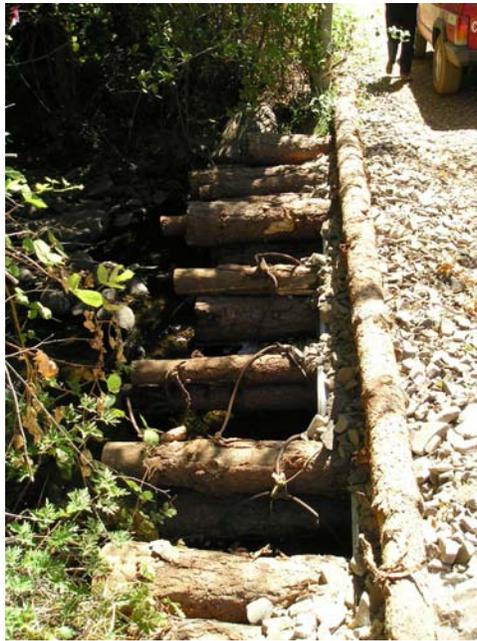
Temporary Culvert with Log and Rock Fill – On perennial streams, low gradient with continuous flow, temporary modified Spittler type crossing have been utilized. Pipes are placed across the active channel, logs are then used to fill the voids, followed by a rock cap. Each bundle of logs used in the fill are cabled together to facilitate removal.

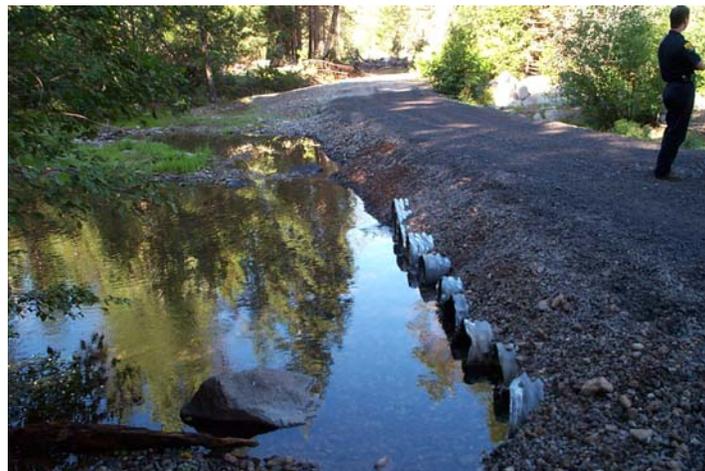
Temporary Culvert with Rock Fill – On perennial streams, low gradient streams, temporary rock fill with the incorporation of numerous small diameter pipes may be used.

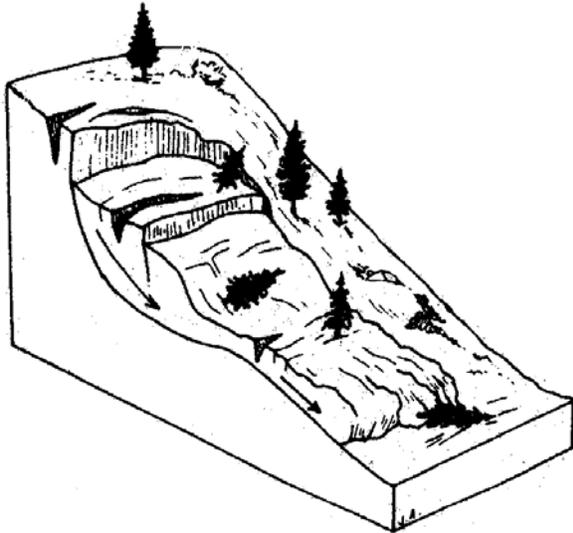
ROCK SLIDE: A slide involving bedrock in which much of the original structure is preserved. Strength of the rock is usually controlled by zones of weakness such as bedding planes or joints. Movement occurs primarily by sliding on a narrow zone of weakness as an intact block. Typically these landslides move downslope on one or several shear surfaces, called slide planes. The failure surface(s) may be curved or planar.

diagram by J. Appleby, R. Kilbourne, and T. Spittler after Varnes, 1978

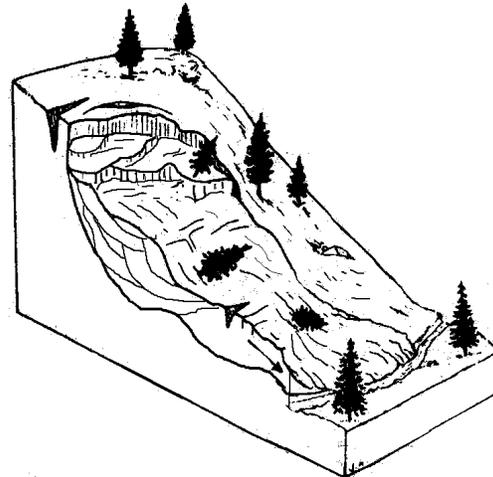
diagram by J. Appleby, and R. Kilbourne, after Varnes,

EARTH FLOW: A landslide composed of fine grained soil, consisting of surficial deposits and deeply weathered, disrupted bedrock. The material strength is low through much of the slide mass, and movement occurs on many discontinuous shear surfaces throughout the landslide mass. Although the landslide may have a main slide plane at the base, many internal slide planes disrupt the landslide mass leading to movement that resembles the flow of a viscous liquid.

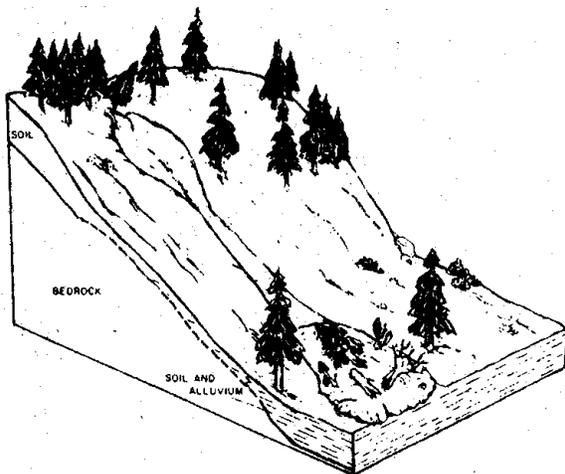
diagram by J. Appleby, and R. Kilbourne, after Varnes,

DEBRIS FLOW: A landslide in which a mass of coarse-grained soil flows downslope as a slurry. Material involved is commonly a loose combination of surficial deposits, rock fragments, and vegetation. High pore water pressures, typically following intense rain, cause the soil and weathered rock to rapidly lose strength and flow downslope.

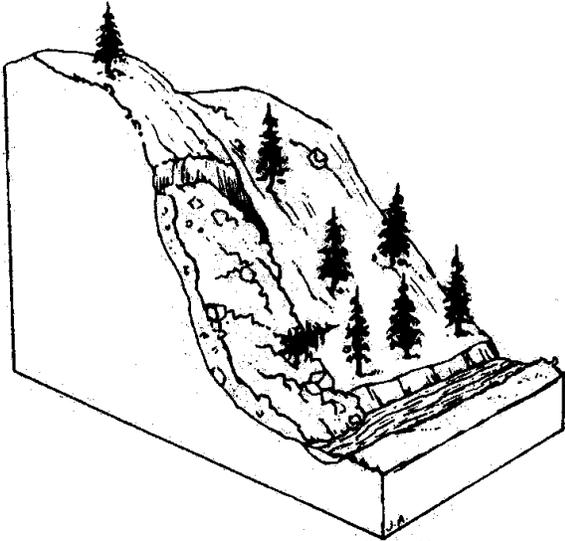
diagram by J. Appleby, and R. Kilbourne, after Varnes, 1978

DEBRIS SLIDE: A slide of coarse grained soil, commonly consisting of a loose combination of surficial deposits, rock fragments, and vegetation. Strength of the material is low, but there may be a very low strength zone at the base of the soil or within the weathered bedrock. Debris slides typically move initially as shallow intact slabs of soil and vegetation, but break up after a short distance into rock and soil falls and flows.

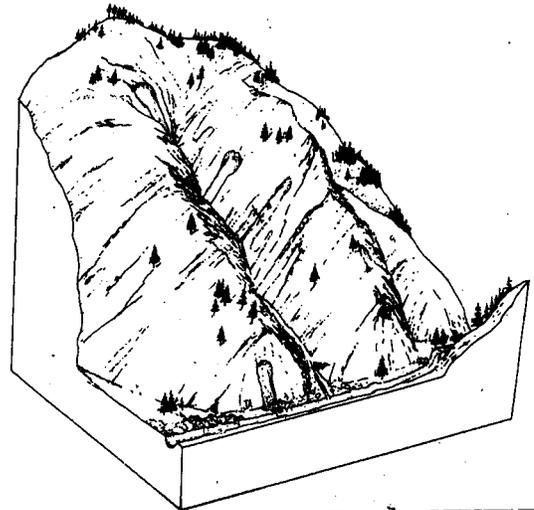
diagram by J. Appleby, and R. Kilbourne, after Varnes,

DEBRIS SLIDE SLOPE: Debris slides and debris flows are commonly found on a landform called a **DEBRIS SLIDE SLOPE**, which represents the coalesced scars of numerous landslides that are too small to depict on a geologic map. These landforms are generally very steep, and have developed in areas of weak bedrock mantled with loose, thin soils and covered with sparse vegetation.

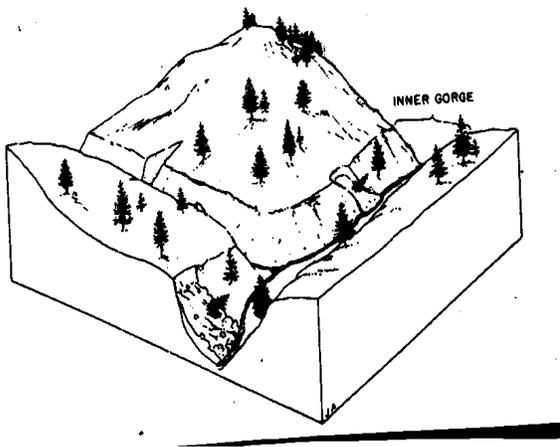
diagram by J. Appleby, and R. Kilbourne, after Varnes,

INNER GORGE: A landform formed by coalescing scars originating from mass wasting and erosional processes caused by active stream erosion. The landform is identified as that area of stream bank situated immediately adjacent to the stream, having a slope generally of over 65% and being situated below the first break in slope above the channel.

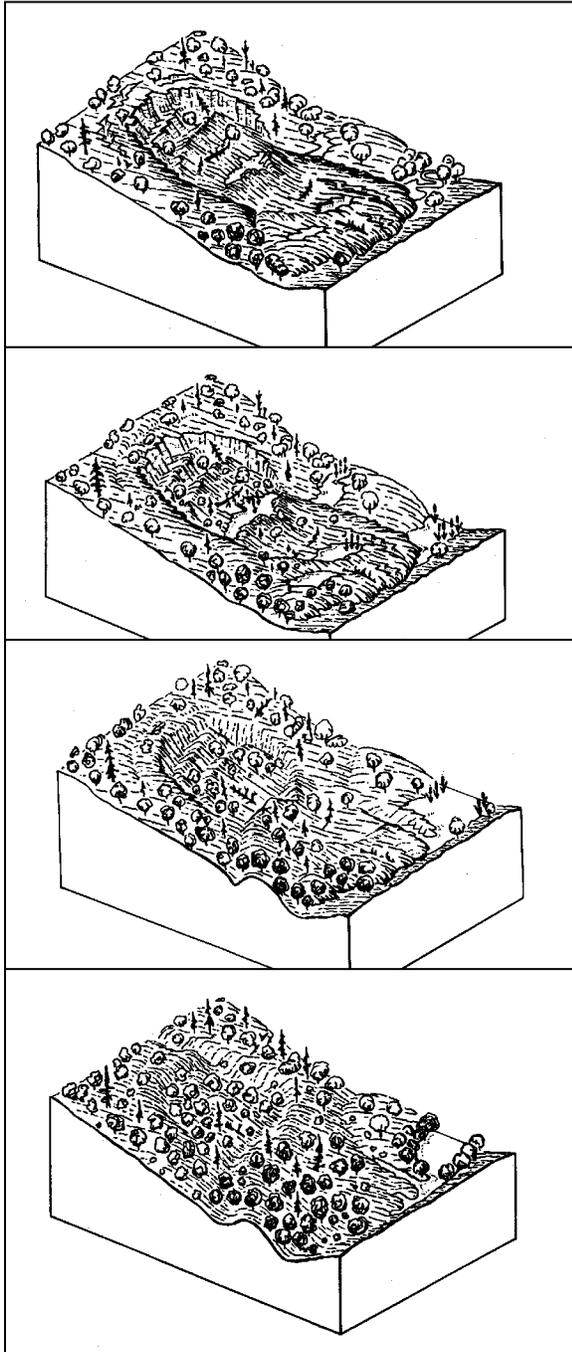
(diagrams from Wieczorek, 1984)

DEFINITION OF LANDSLIDE ACTIVITY

Active or Historic: The landslide appears to be currently moving or movements have been recorded in the past. Fresh cracks, disrupted vegetation or displaced or damaged man-made features indicate recent activity. Water may be ponded in depressions created by rotation of the slide mass or blockage of stream drainage.

Dormant-young: The landforms related to the landslide are relatively fresh, but there is no record of historic movement. Cracks in the slide mass are generally absent or greatly eroded; scarps may be prominent but are slightly rounded. Depressions or ponds may be partly filled in with sediment, but still show phreatophytic vegetation.

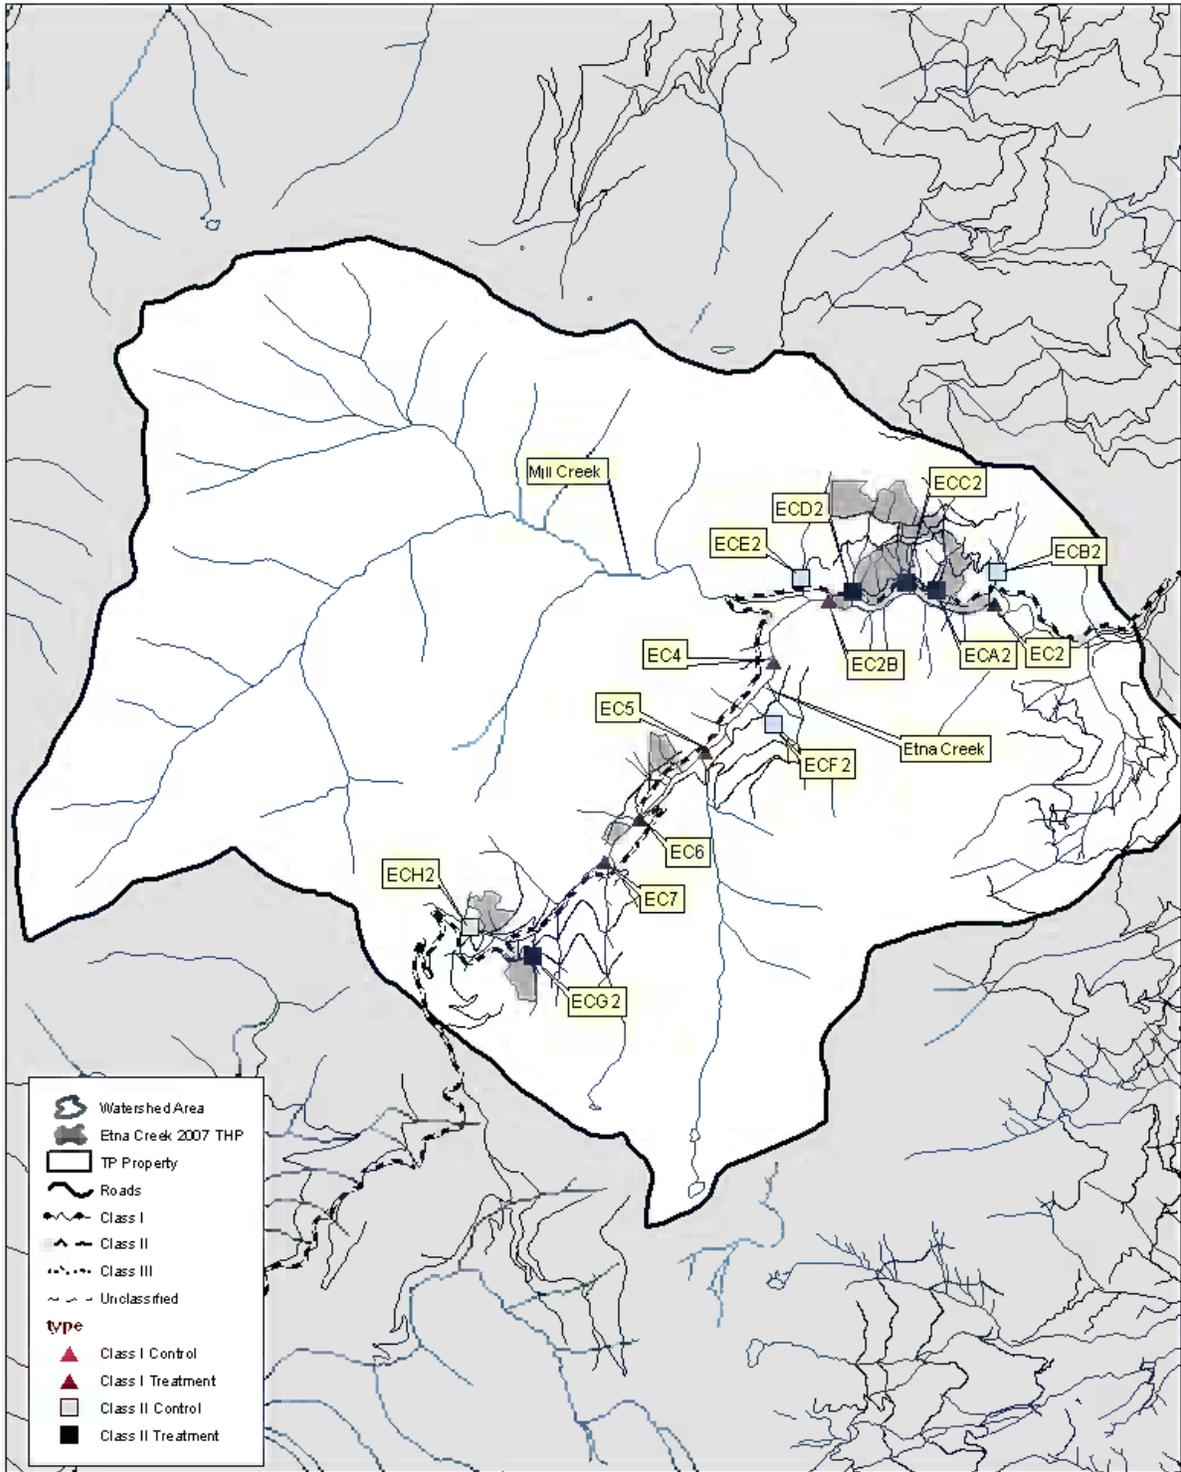
Figure 1 Alternative WLPZ monitoring sites along Etna Creek 2006 to 2010

As described in Appendix B and C, the before-and-after design included two Class I stream reaches and the before-after-control design included four Class II stream reaches with four control reaches. At all these reaches stream water temperature, air temperature and humidity were collected. For the Class I alternative WLPZ, site TEC2 was located immediately down stream and TEC2B was upstream of the selection silviculture Unit #8 (Figure 1). And Site TEC6 was located immediately down stream and TEC7 upstream of the clearcut silviculture Unit #12. For the Class II alternative WLPZ, sites A2, C2, D2 and G2 were treatment sites where the alternative WLPZ was harvested and sites B2, E2, F2 and H2 served as Class II controls (Figure 1).

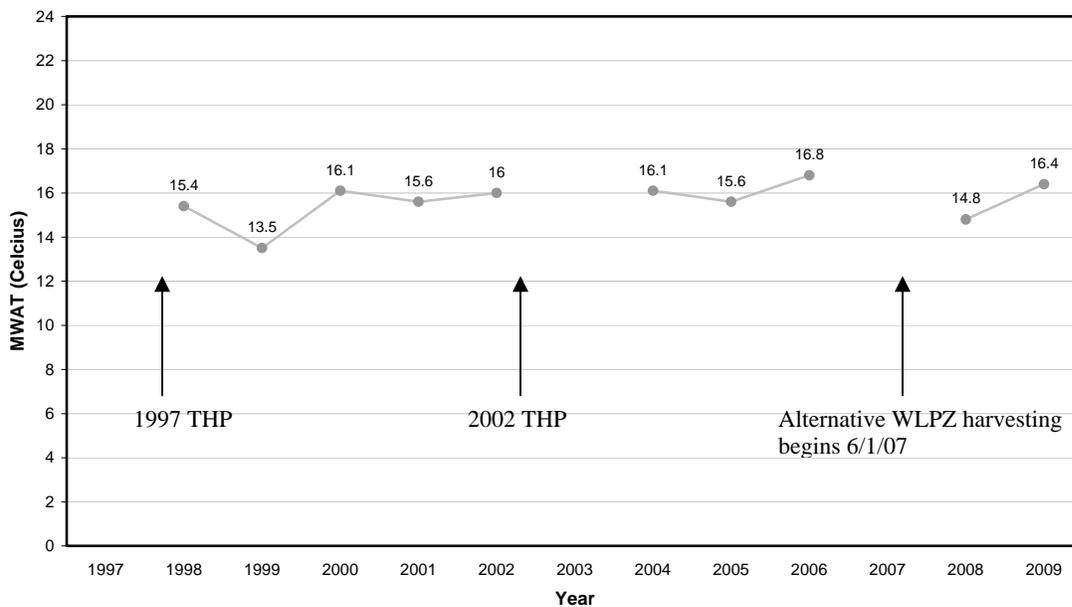
Figure 2 Lower Etna Creek (TEC2) (Downstream of Harvest)

Stream water temperatures have been collected at one location in the upper Etna Creek watershed since 1998. Since Etna Creek is a very popular for recreational swimming and fishing, over the years equipment has been lost to curious recreationists. While equipment was lost in 1997, 2003 and 2007 at monitoring site TEC2, watershed level monitoring has been completed 10 out of 13 years between 1997 and 2009 (Figure 2 and Appendix D).

During the 13 years of watershed level monitoring three separate THP's have been completed. Following timber harvesting in 1997 and 2004 downstream water temperatures remained relatively unchanged. And in this current study pre harvest MWAT temperatures downstream of the alternative WLPZ (Unit #8) was 16.8 C. Following timber harvest MWAT temperatures decreased to 14.8 C and 16.4 in 2008 and 2009, respectively (Figure 2 and Appendix E).

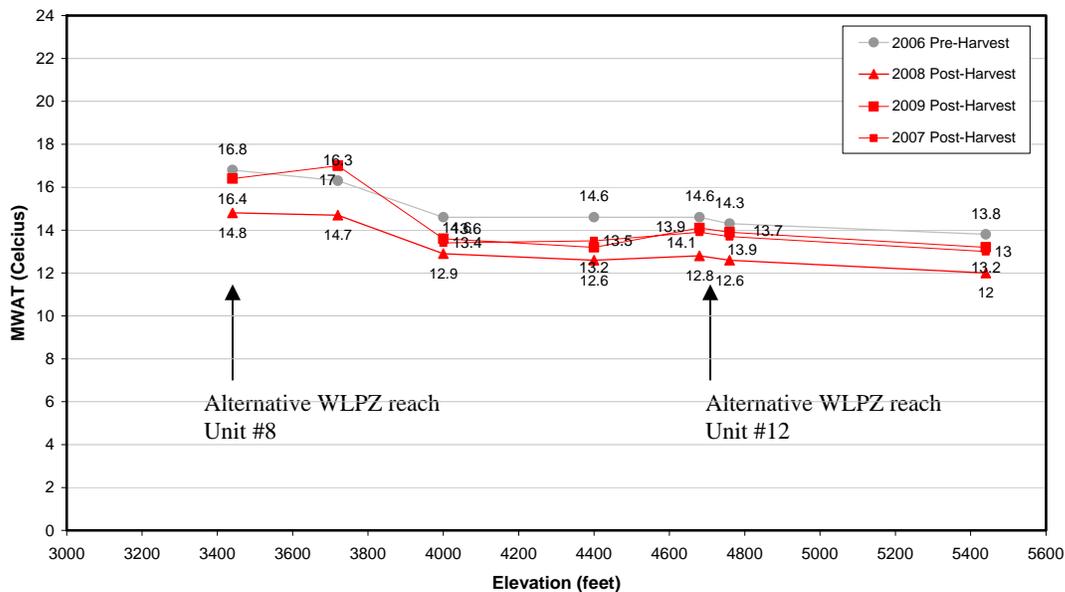
Figure 3 Reach Level above and below harvest

At the reach level, two separate Class I alternative WLPZ reaches, Unit #8 and Unit #12, were measured. Relative to a control upstream of the alternative WLPZ adjacent to the thinning unit (Unit #8), downstream MWAT temperatures were 0.5 C higher pre harvest. MWAT temperatures were 0.1C higher post harvest in 2008 and 0.6 C lower post harvest in 2009 (Figure 3, Table 3 and Appendix E).

At monitoring site TEC6 which was located downstream of the alternative WLPZ adjacent to the clearcut unit (Unit #12), pre harvest MWAT temperature was 14.6 C. MWAT temperatures decreased to 13.9 C, 12.8 C and 14.1 C following harvest in 2007, 2008 and 2009, respectively. Relative to a control upstream of Unit #12, downstream MWAT temperatures was 0.3 C higher pre harvest. MWAT temperatures were 0.2C higher post harvest in 2007, 2008 and 2009 (Table 3, Figure 3 and Appendix E).
