**TECHNICAL ASSESSMENT REPORT IN RESPONSE TO
SF BAY REGIONAL WATER QUALITY CONTROL BOARD
CEASE AND ABATEMENT ORDER NO. R2-2017-0025
RE: CONSTRUCTION IMPACTS
TO AN UNNAMED EPHEMERAL CREEK AND HABITAT
AT THE BREMER FAMILY WINERY VINEYARD
BLOCKS K-EE, 881 DEER PARK ROAD,
NAPA COUNTY, CA**

Sept. 15, 2017

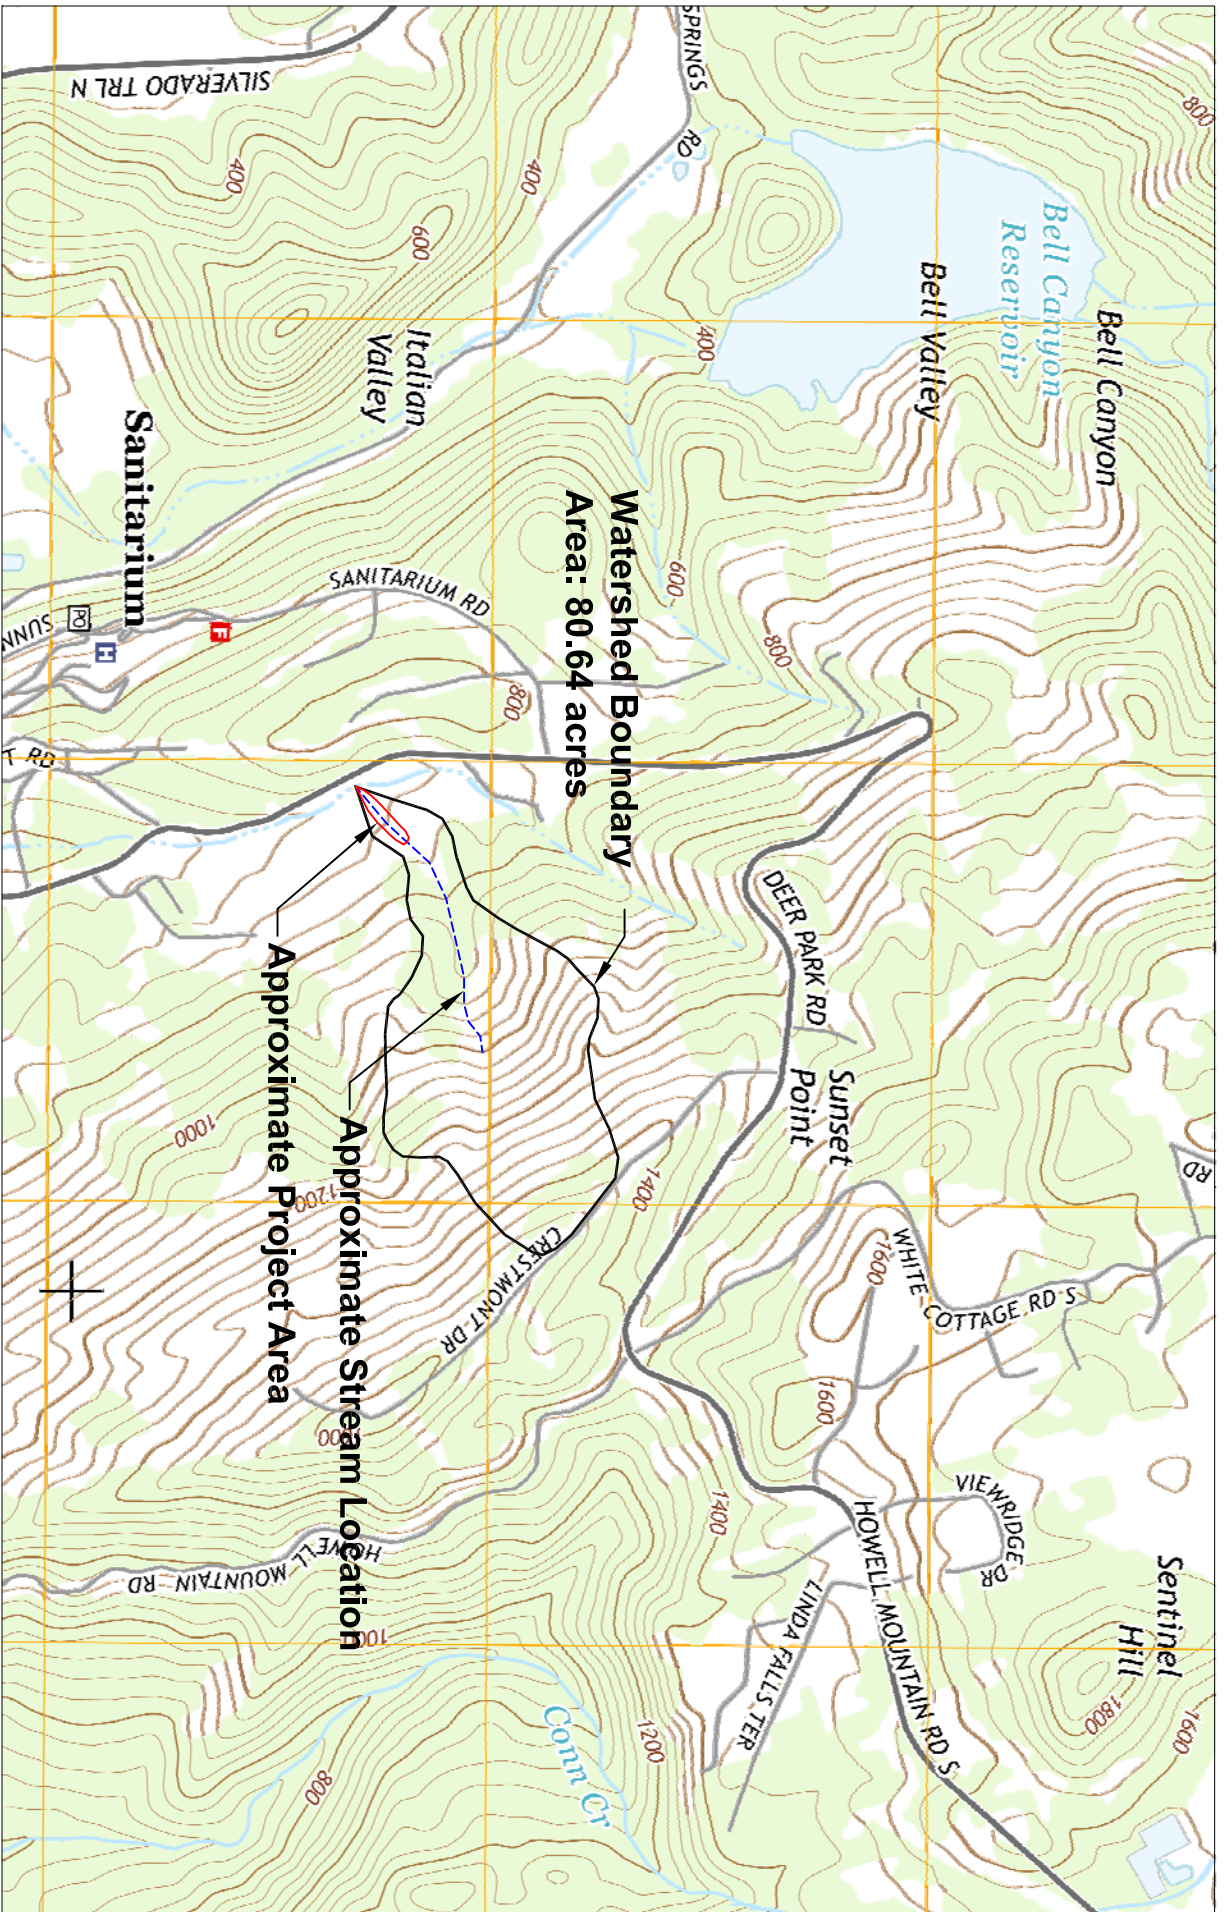
Figure 3 : Watershed/Project Area Map

Figure 3 is a watershed map showing the tributary area for the subject channel reach at its confluence with the intermittent Canon Creek tributary. The watershed encompasses an area of roughly 80 acres. Elevations in the watershed range from approximately 710 ft. NAVD88 at the confluence to 1,480 ft. along the ridgeline. As noted in the approved ECP, (NVVE 2010-2013), pre-project ground slopes ranged from 6% to 40%. Mean annual precipitation for the St. Helena gage (047643, elev. 230 ft. NAVD88) is 34.6 inches (WRCC, wrcc@dri.edu). For the higher elevation project watershed, the MAP was estimated at 40 inches based on the Sulphur Creek gaging station data cited in Rantz (USGS 1971, Table 2).

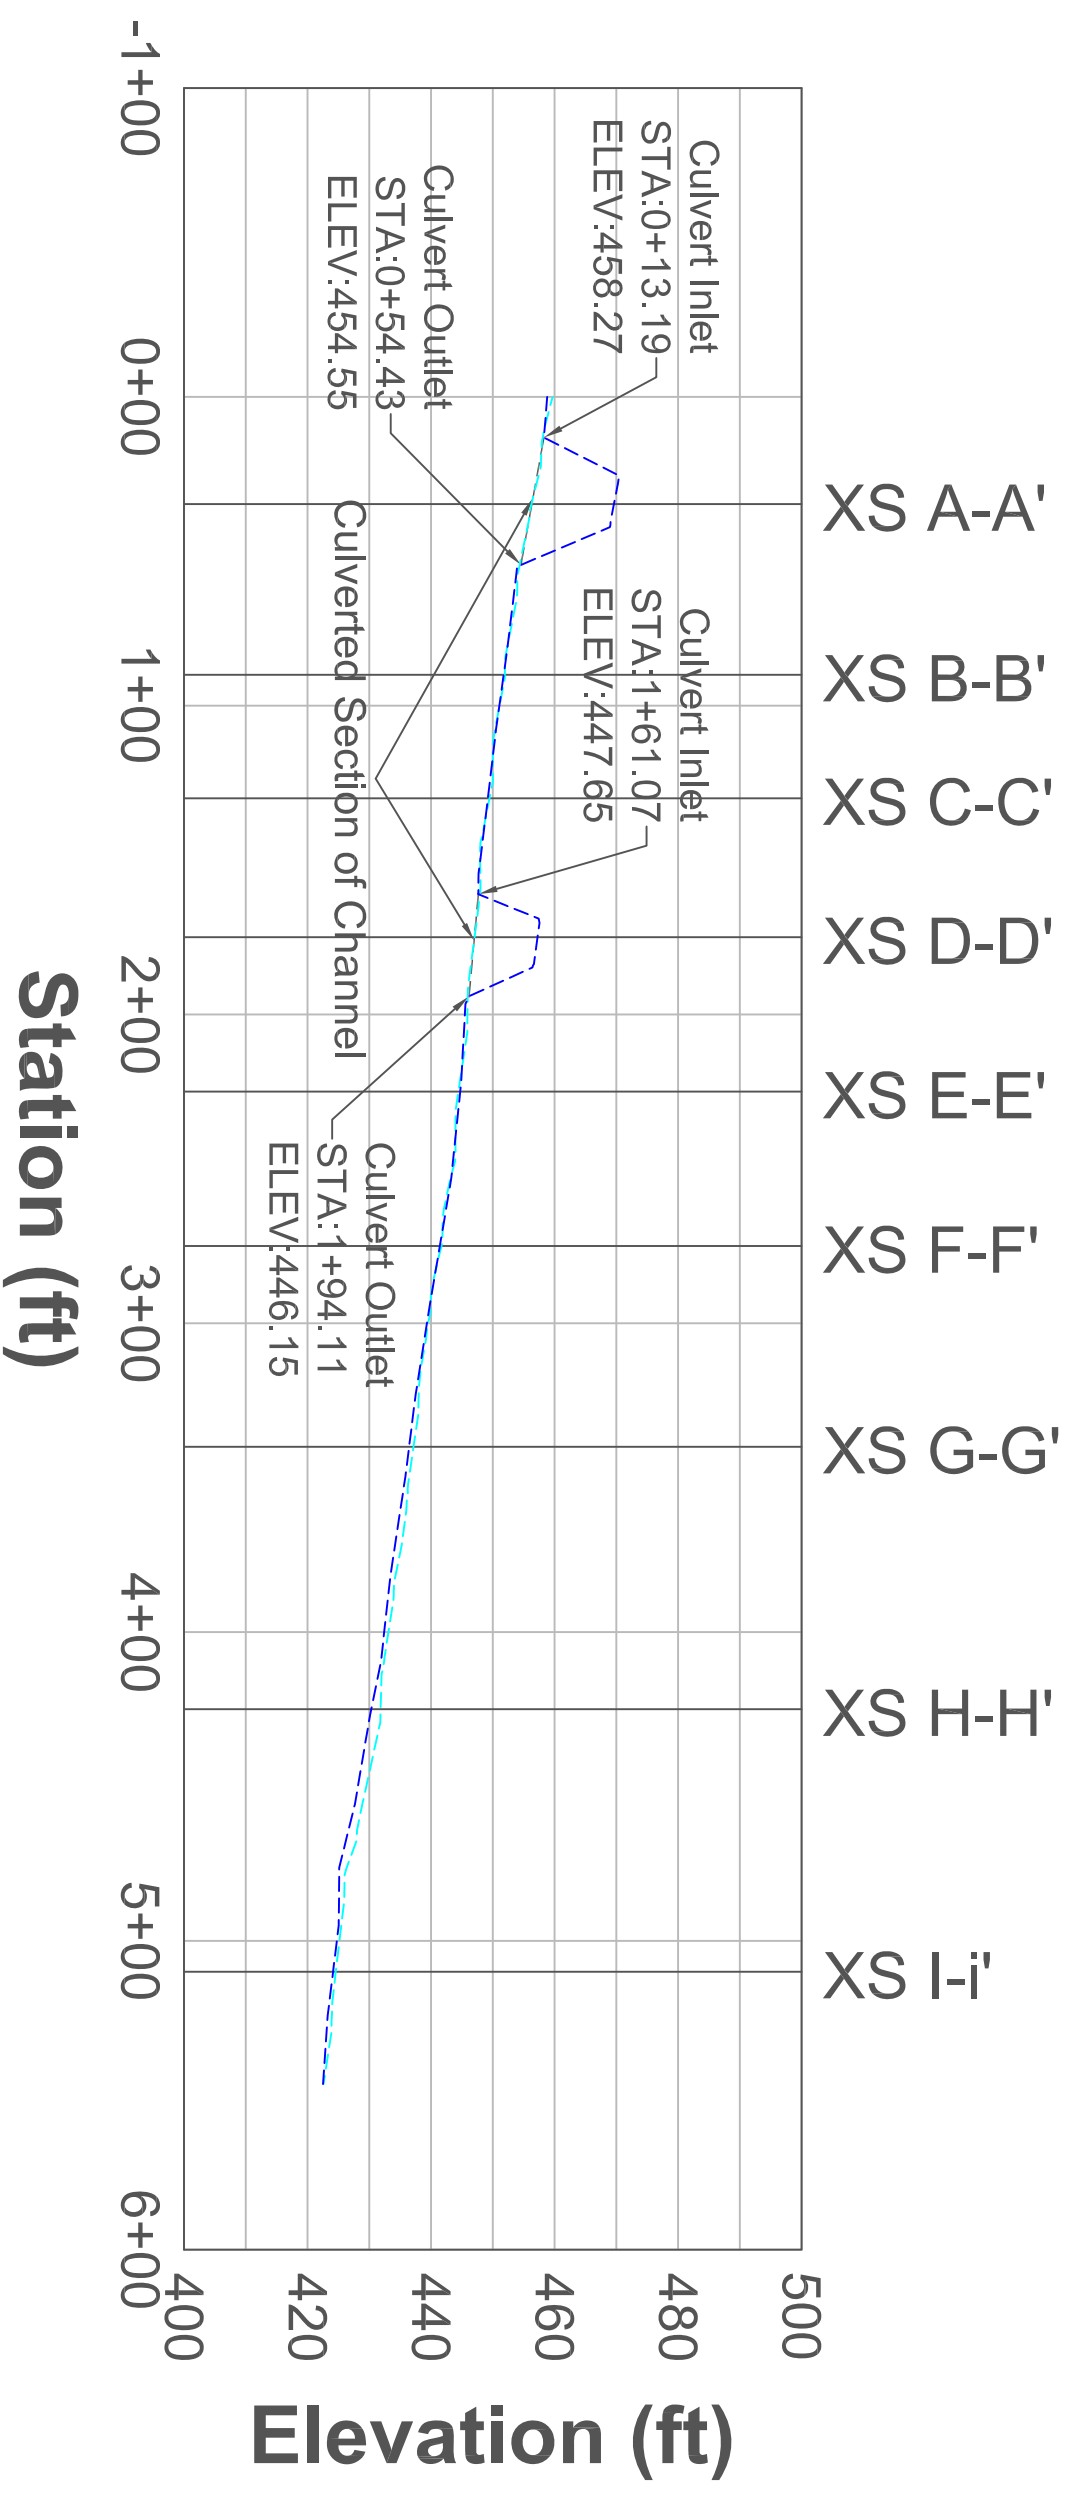
Figure 5 : Pre- and Post- Longitudinal Profiles

As depicted by the nearly coincident longitudinal profiles in Figure 5, the post-project channel bed was retained for the most part. It is likely that the minor divergences that are evident occur where the as-built channel alignment negotiates a previous dual thalweg or the straighter project thalweg replaced a segment of irregular (i.e. bending) pre-project thalweg. Both the pre-project and as-built thalwegs are shown in Figures 4 and 6. The most obvious divergences from the original thalweg alignment occur at the mid-reach road crossing (Station 1+75), in the vicinity of the main channel bend (Sta. 2+30 to 3+80). Downstream of Sta. 3+80, the as-built thalweg is more consistently aligned with the pre-project thalweg. It is in this lower reach of the project that the channel approaches or exceeds the 10 ft. bottom width prescribed in the approved ECP.

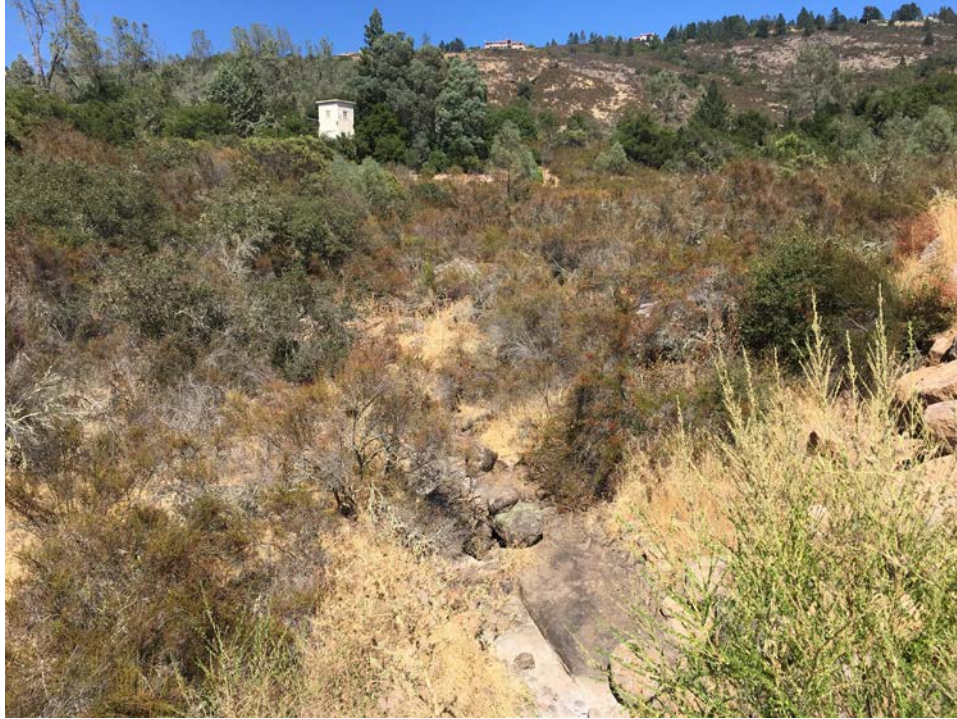
Photo 1: Upstream view along subject channel from just upstream of culverted road crossing along N. boundary of Blocks K and L/M.

Photos 1-4 in the attached Photo Log describe the existing (Aug.-Sept 2017) condition of the subject channel in the undisturbed reach upstream of the north project boundary (Blocks K, L/M) as observed and surveyed by CH. Pertinent hydrogeomorphic features of the channel include the following:

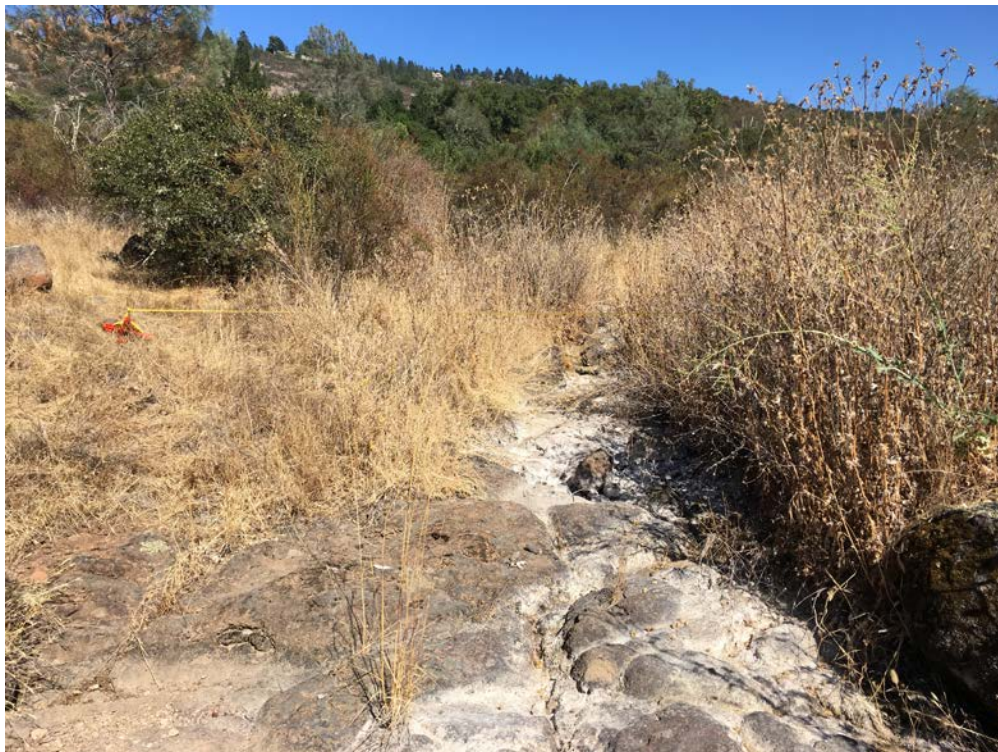
Photo 2: Upstream view through CH surveyed cross-section XS-1, approx. 100 ft. upstream of upper culverted road crossing. Tape line is visible mid-photo left.

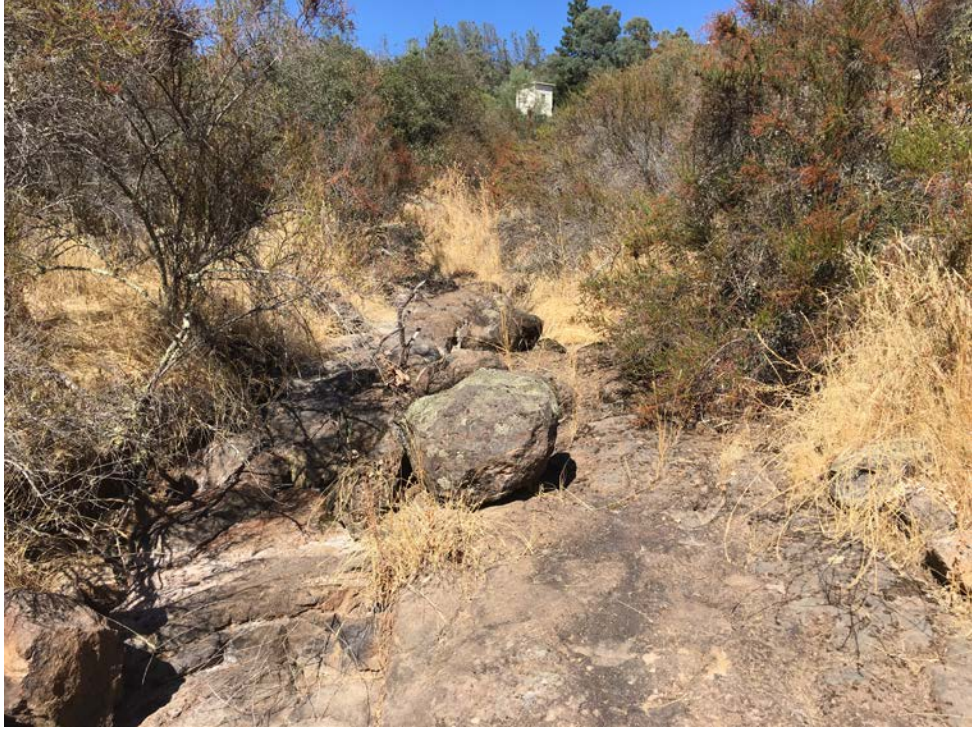
Photo 3: Upstream view from narrower, confined sub-reach upstream of the upper culverted road crossing.

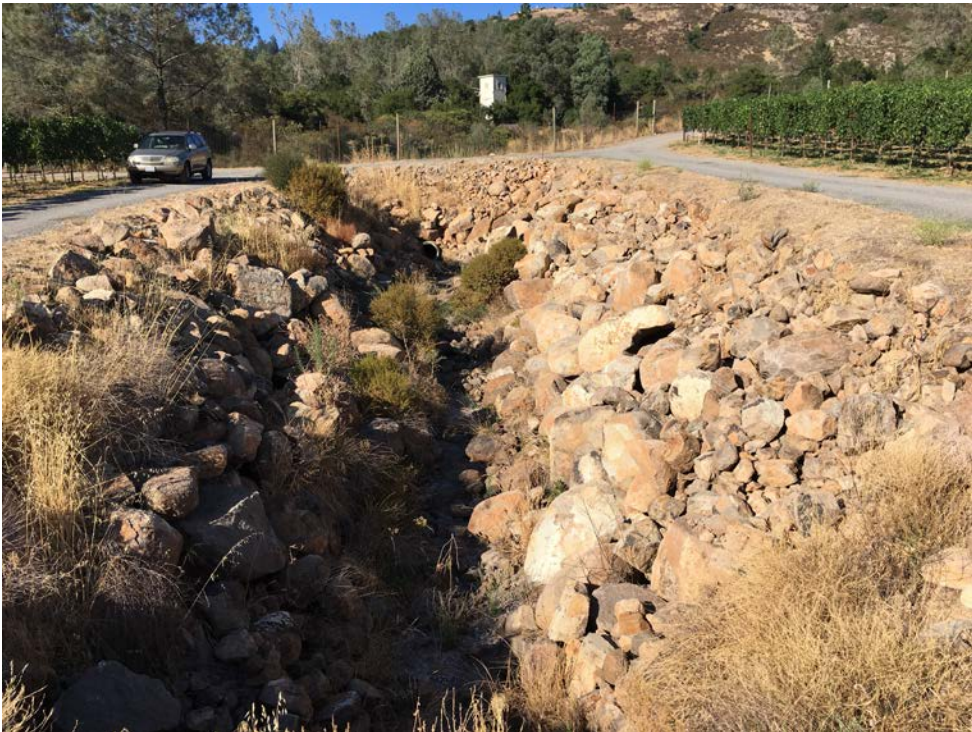
Photo 4: Upstream view along upper, disturbed project reach, with previously cited road crossing at N. block boundary visible in background.

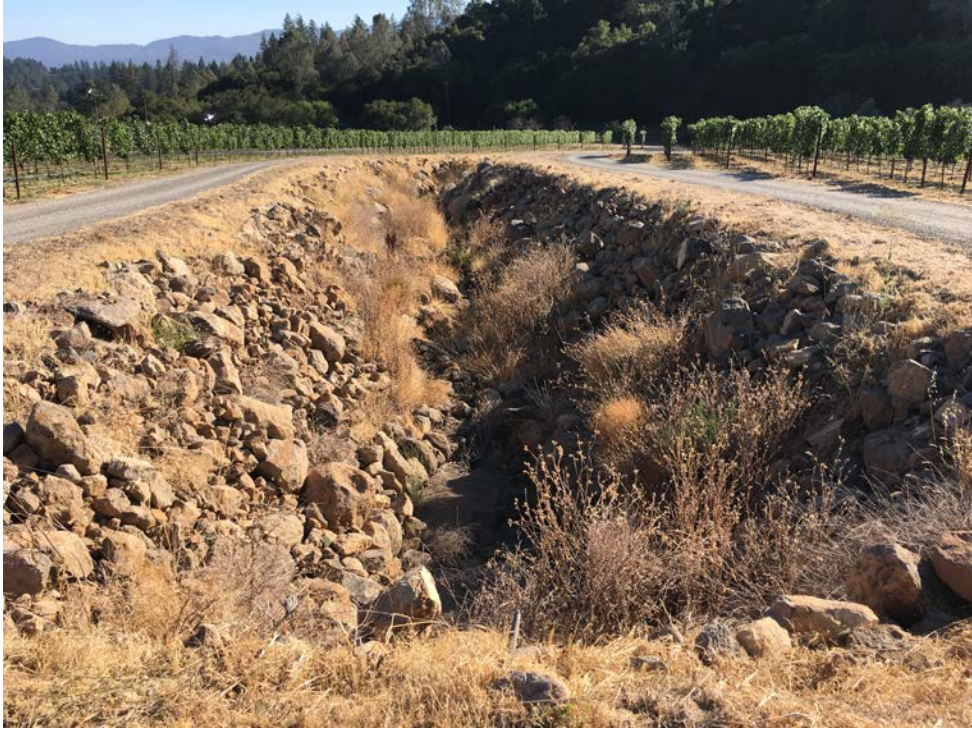
Photo 5: Downstream view along the upper portion of the lower disturbed channel reach, taken from the second (downstream) culverted road crossing.

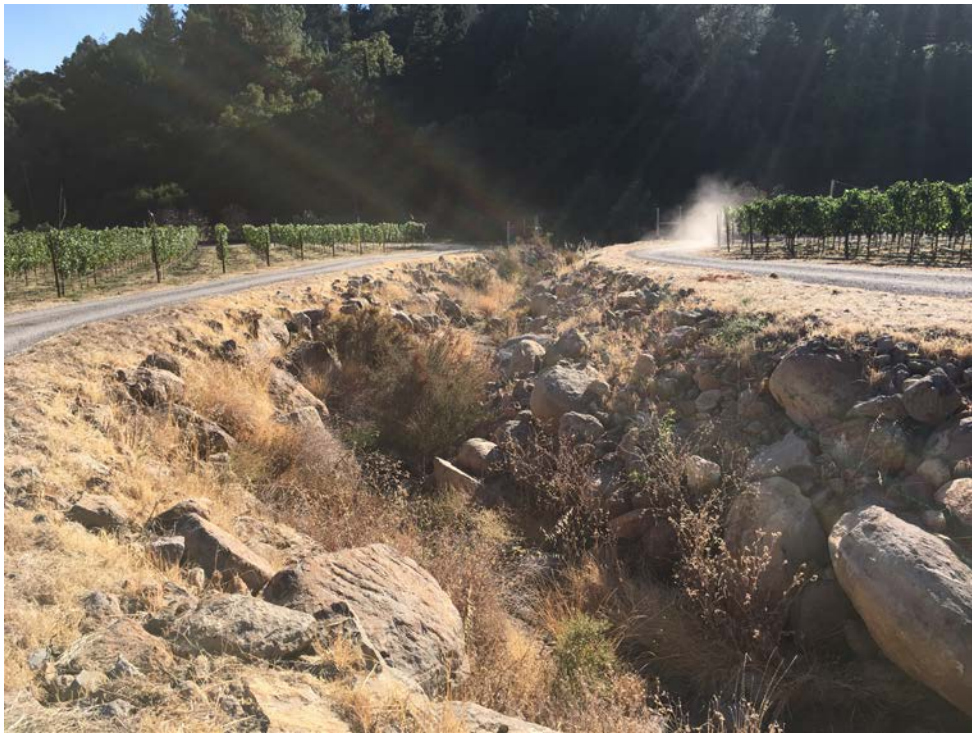
Photo 6: Downstream view of lower reach below a bend in the modified channel alignment.

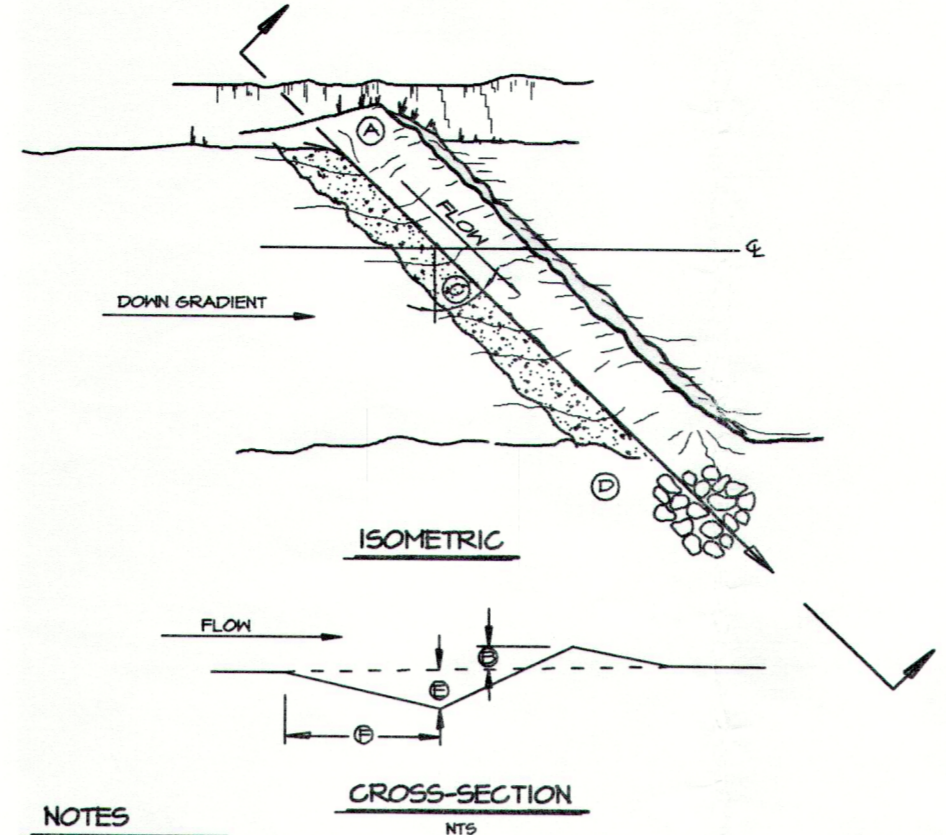
2/4 WATERBAR (TYP) N.T.S.

NOTES
 WATERBAR CONSTRUCTION FOR LITTLE OR NO TRAFFIC. SPECIFICATIONS ARE AVERAGE AND SHALL BE ADJUSTED TO CONDITIONS.
 (A) TIE-IN TO BANK IF APPROPRIATE.
 (B) CROSS DRAIN BERM HEIGHT 4" TO 6" ABOVE THE ROADBED.
 (C) ANGLE DRAIN 30° TO 45° DEGREES DOWNGRADE WITH ROAD CENTERLINE.
 (D) OUTFALL STRUCTURE AS SHOWN IN PLAN.
 (E) DEPTH MINIMUM 6".
 (F) 3' TO 4'.

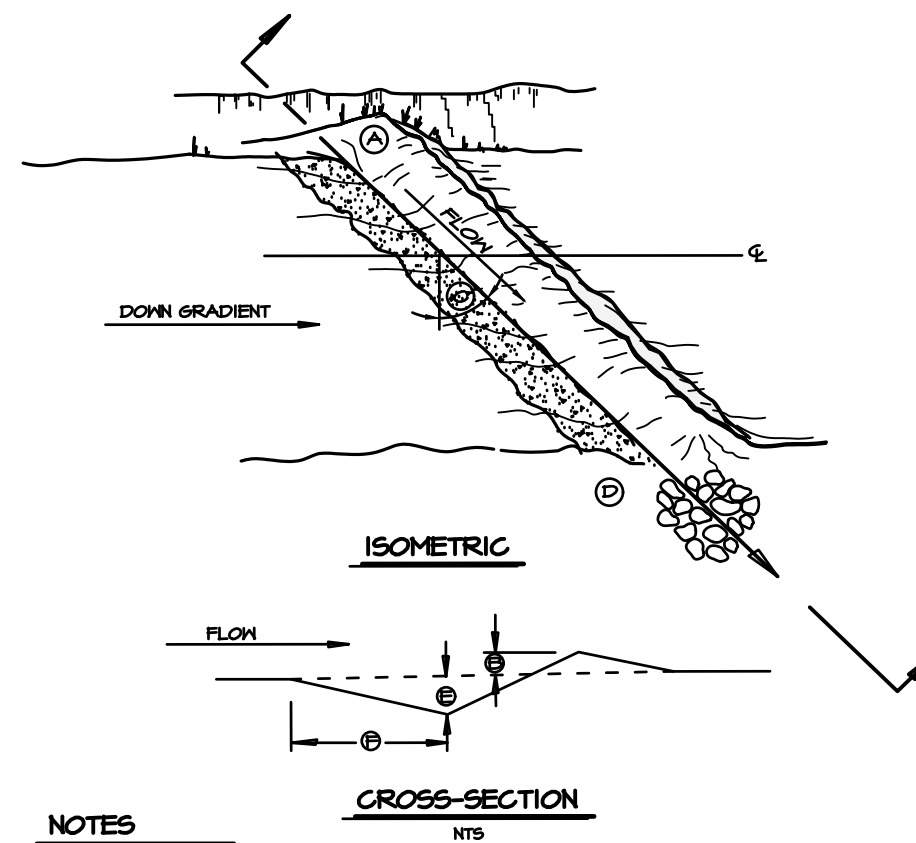
2 4 WATERBAR (TYP) N.T.S.

NOTES:
 WATERBAR CONSTRUCTION FOR LITTLE OR NO TRAFFIC. SPECIFICATIONS ARE AVERAGE AND SHALL BE ADJUSTED TO CONDITIONS.
 (A) TIE-IN TO BANK IF APPROPRIATE.
 (B) CROSS DRAIN BERM HEIGHT 4" TO 6" ABOVE THE ROADBED.
 (C) ANGLE DRAIN 30° TO 45° DEGREES DOWNGRADE WITH ROAD CENTERLINE.
 (D) OUTFALL STRUCTURE AS SHOWN IN PLAN.
 (E) DEPTH MINIMUM 8".
 (F) 3' TO 4'.

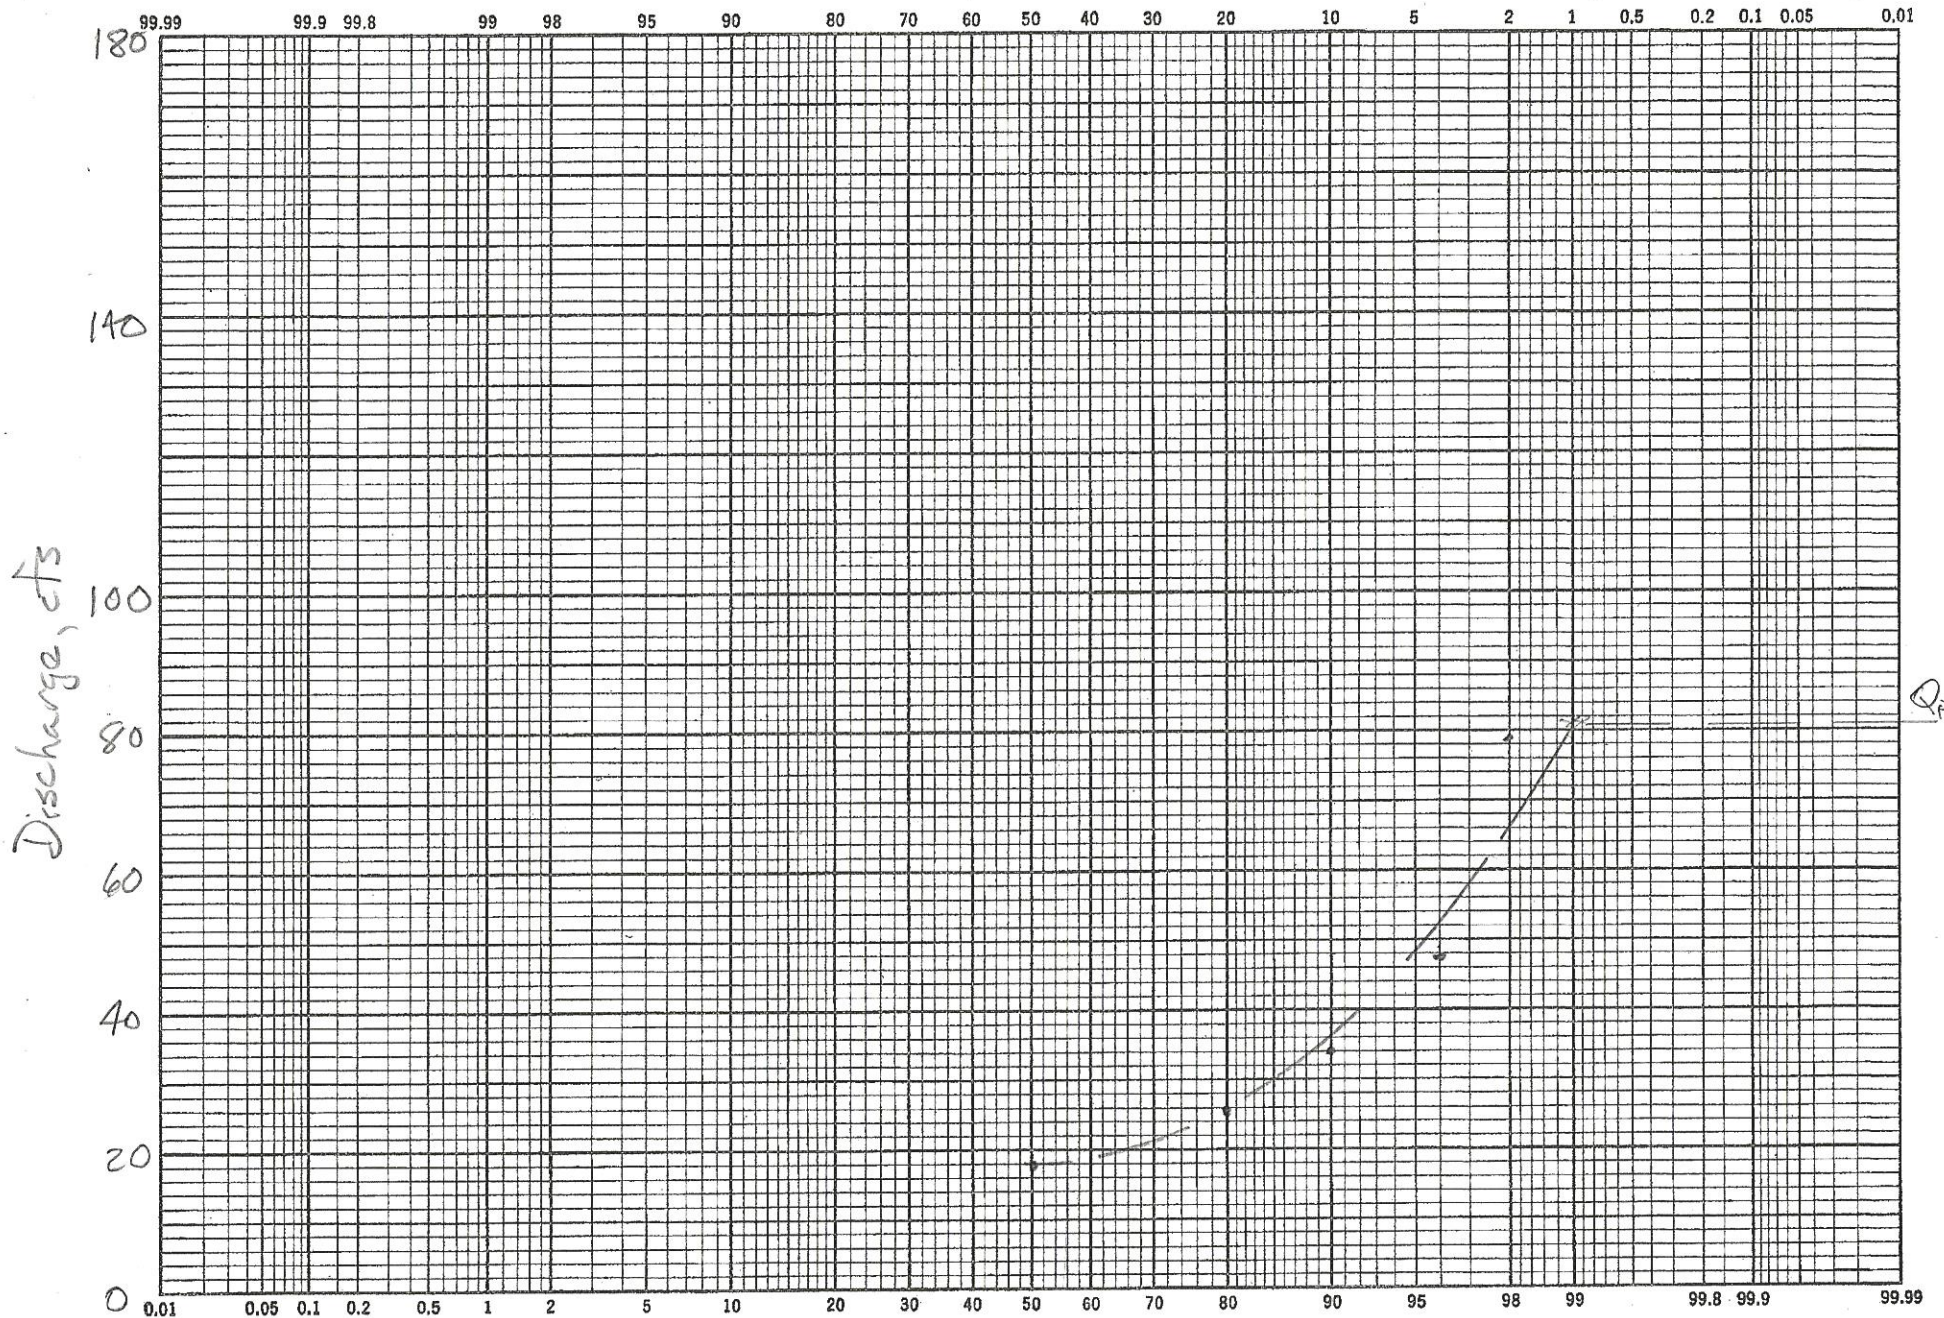
<Q2 at XS 1 - 100 ft Upstream of Upstream Culvert (Field)>

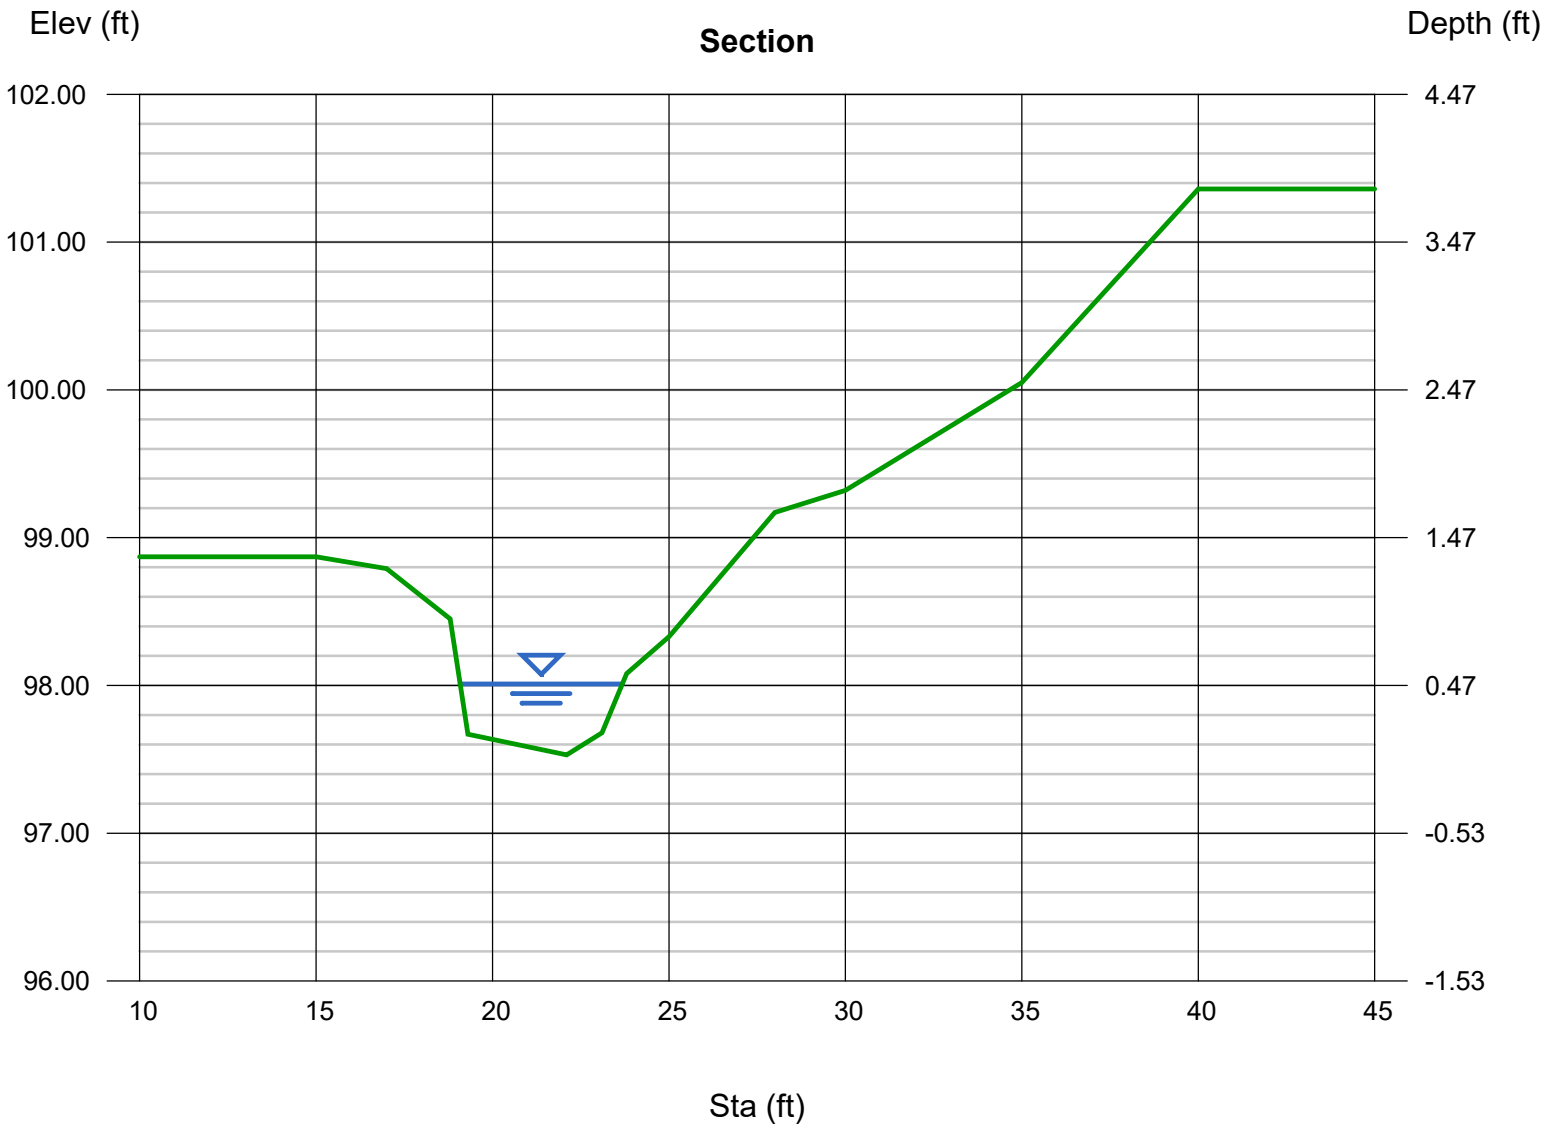
<Q100 at XS 1 - 100 ft Upstream of Upstream Culvert (Field)>

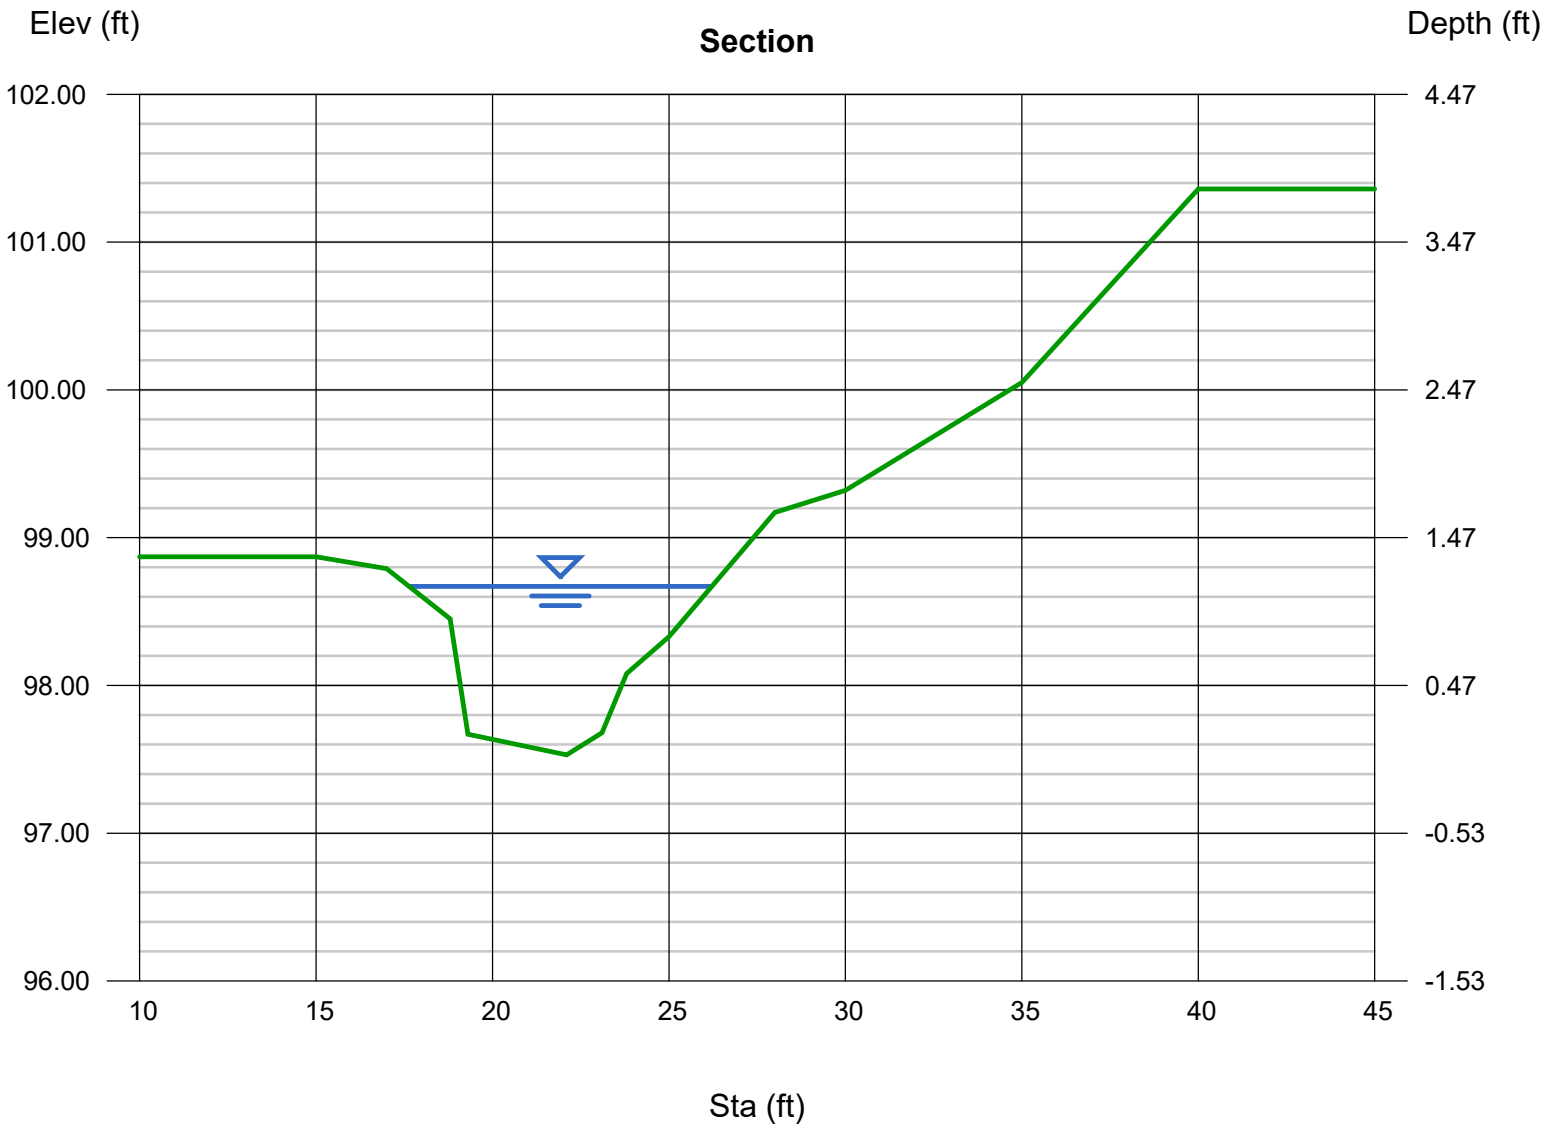
<Q2 at XS C-C' (1 + 30.00)>

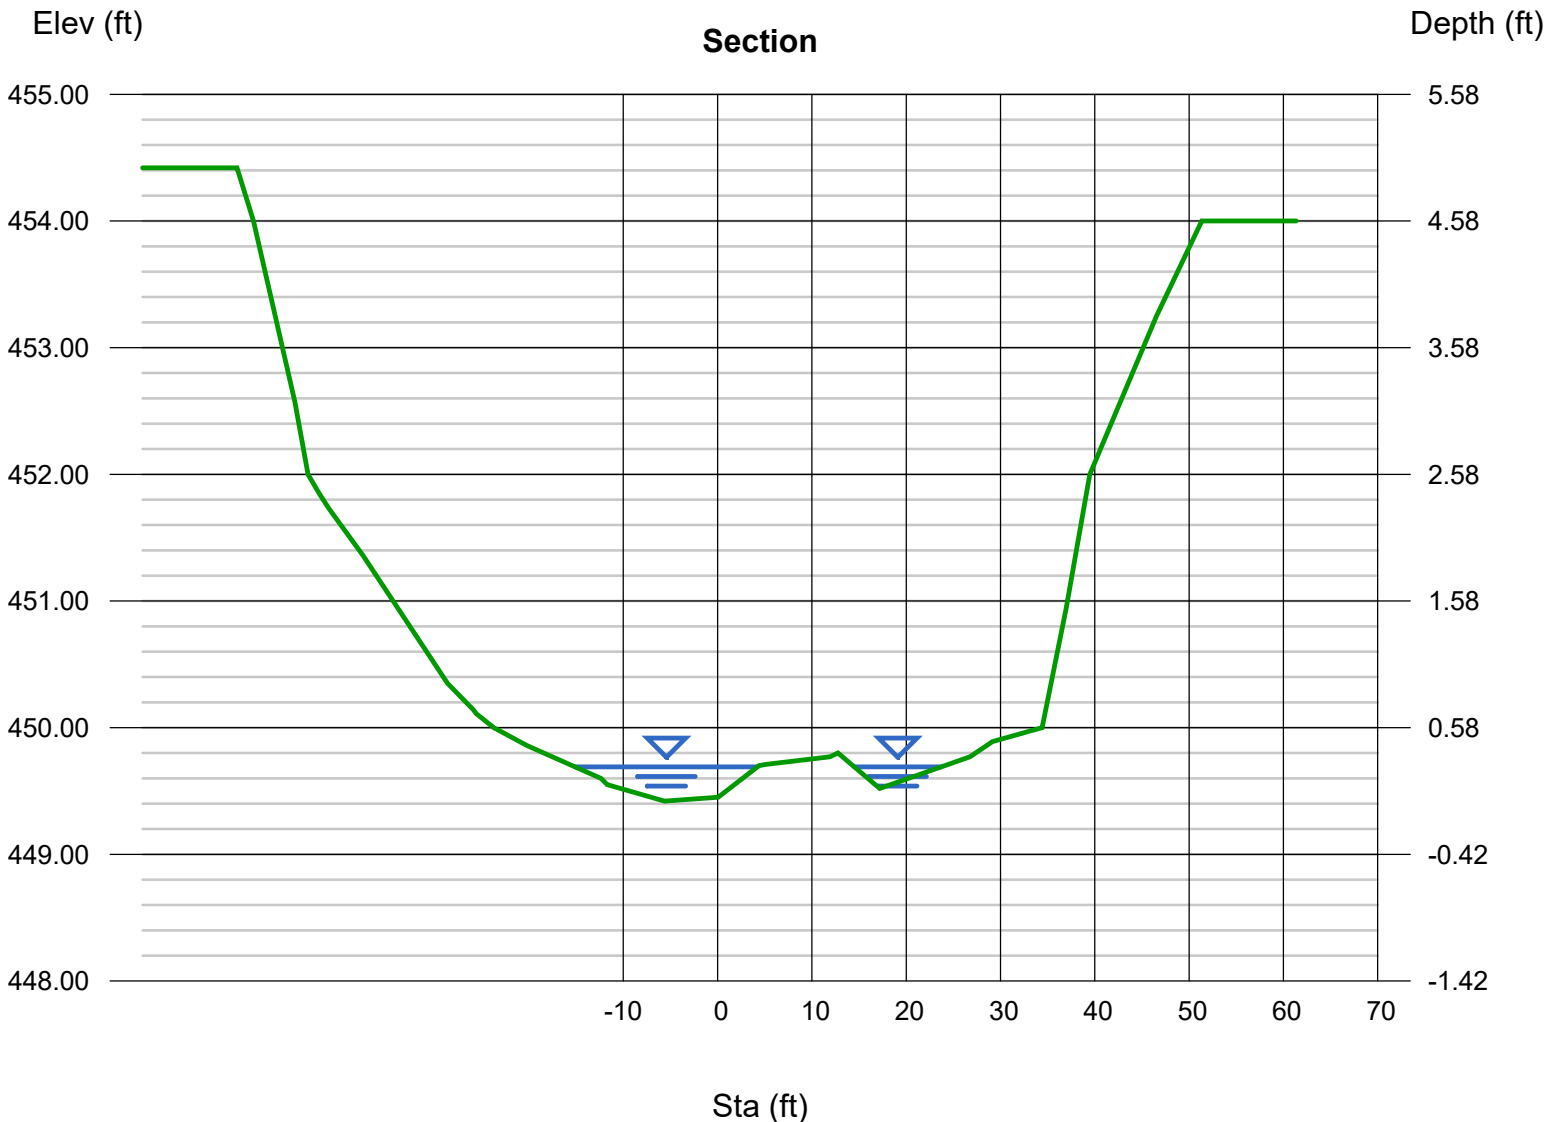
<Q100 at XS C-C' (1 + 30.00)>

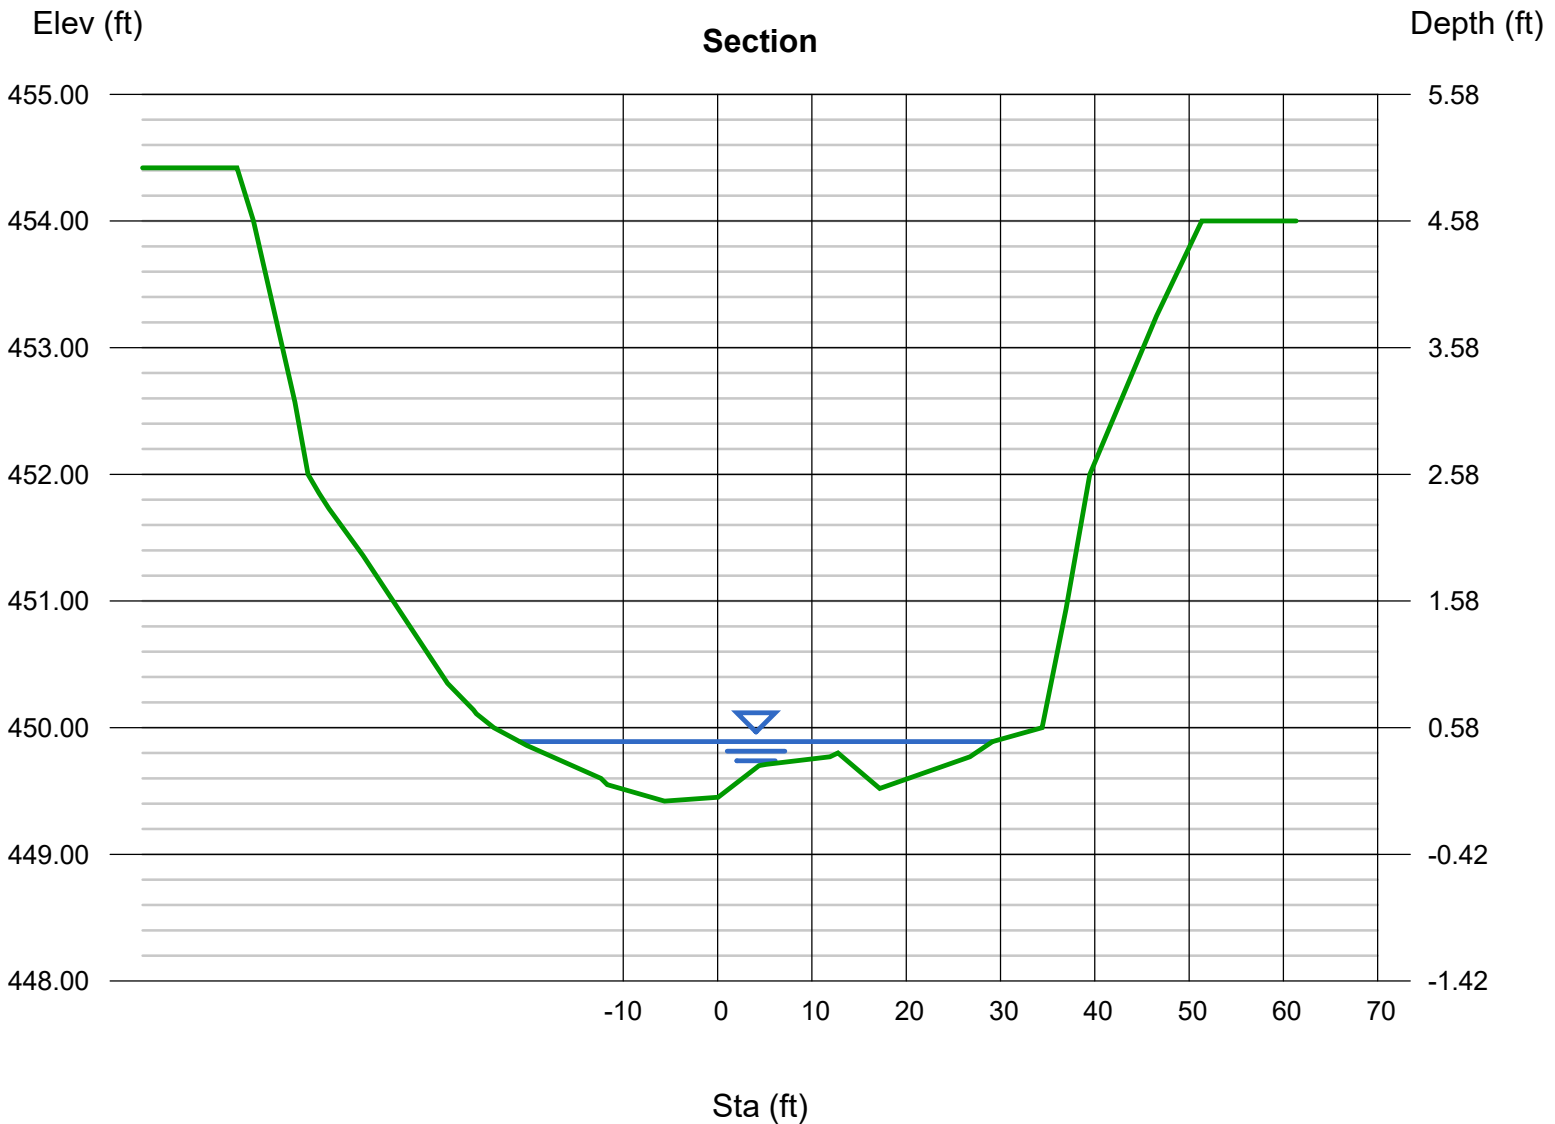
<Q2 at XS G-G' (3 + 40.00)>

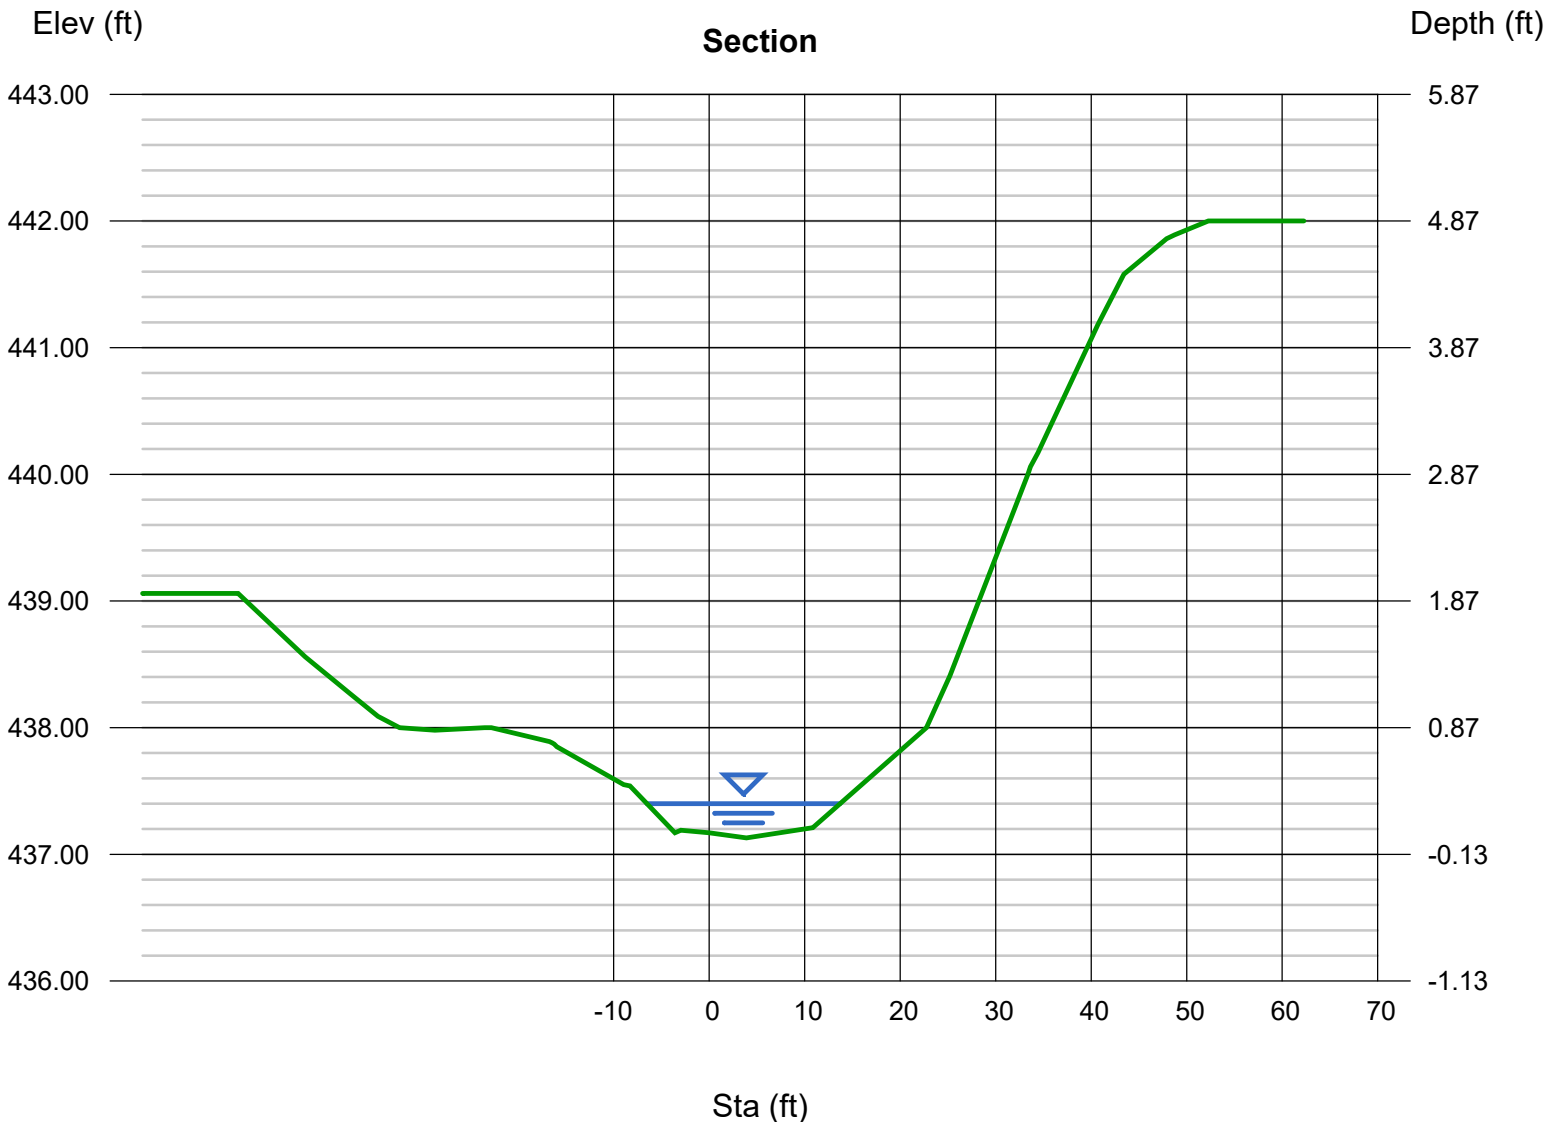
<Q100 at XS G-G' (3 + 40.00)>
