**TECHNICAL ASSESSMENT REPORT IN RESPONSE TO
SF BAY REGIONAL WATER QUALITY CONTROL BOARD
CEASE AND ABATEMENT ORDER NO. R2-2017-0025
RE: CONSTRUCTION IMPACTS
TO AN UNNAMED EPHEMERAL CREEK AND HABITAT
AT THE BREMER FAMILY WINERY VINEYARD
BLOCKS K-EE, 881 DEER PARK ROAD,
NAPA COUNTY, CA**

Sept. 15, 2017

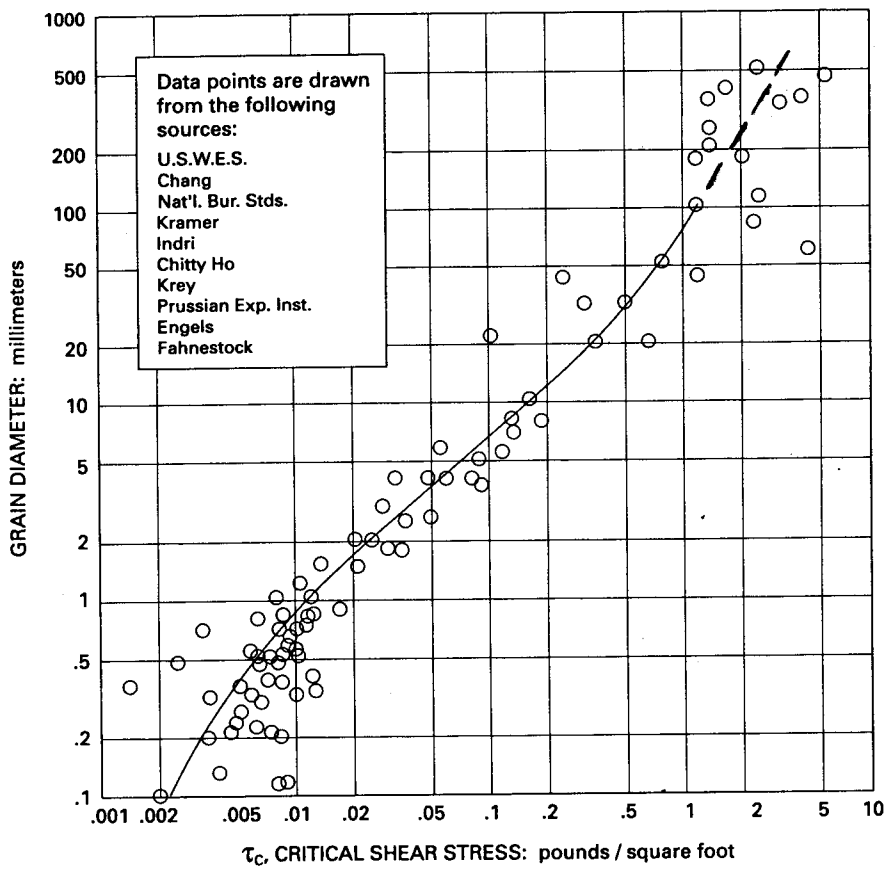
Figure 11.4 Laboratory and field data on critical shear stress required to initiate movement of grains (Leopold, Wolman, and Miller 1964, p. 170). The solid line is the Shields curve of the threshold of motion transposed from the θ versus R_g form into the present form, in which critical shear stress is plotted as a function of grain diameter.

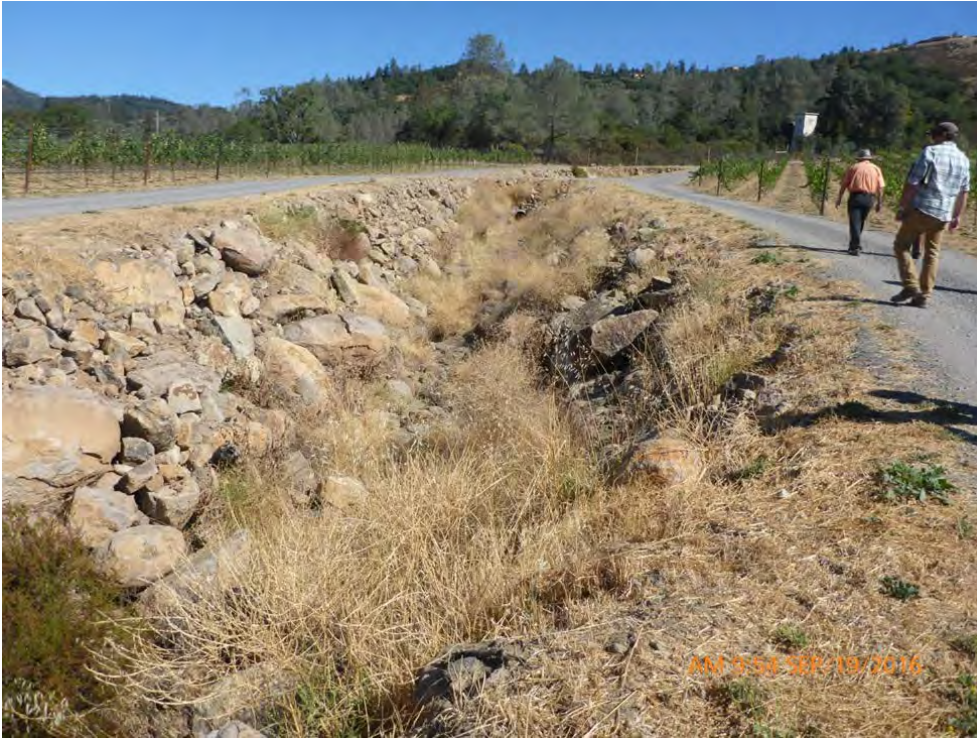
Photo 1. Lower portion of unnamed intermittent stream that was channelized (looking upstream).
