RE: Revised LA County MS4 Permit - North Santa Monica Bay Coastal Watersheds  
Enhanced Watershed Management Program Submittal

# ENHANCED WATERSHED MANAGEMENT PROGRAM (EWMP) FOR NORTH SANTA MONICA BAY COASTAL WATERSHEDS

**March 2016**

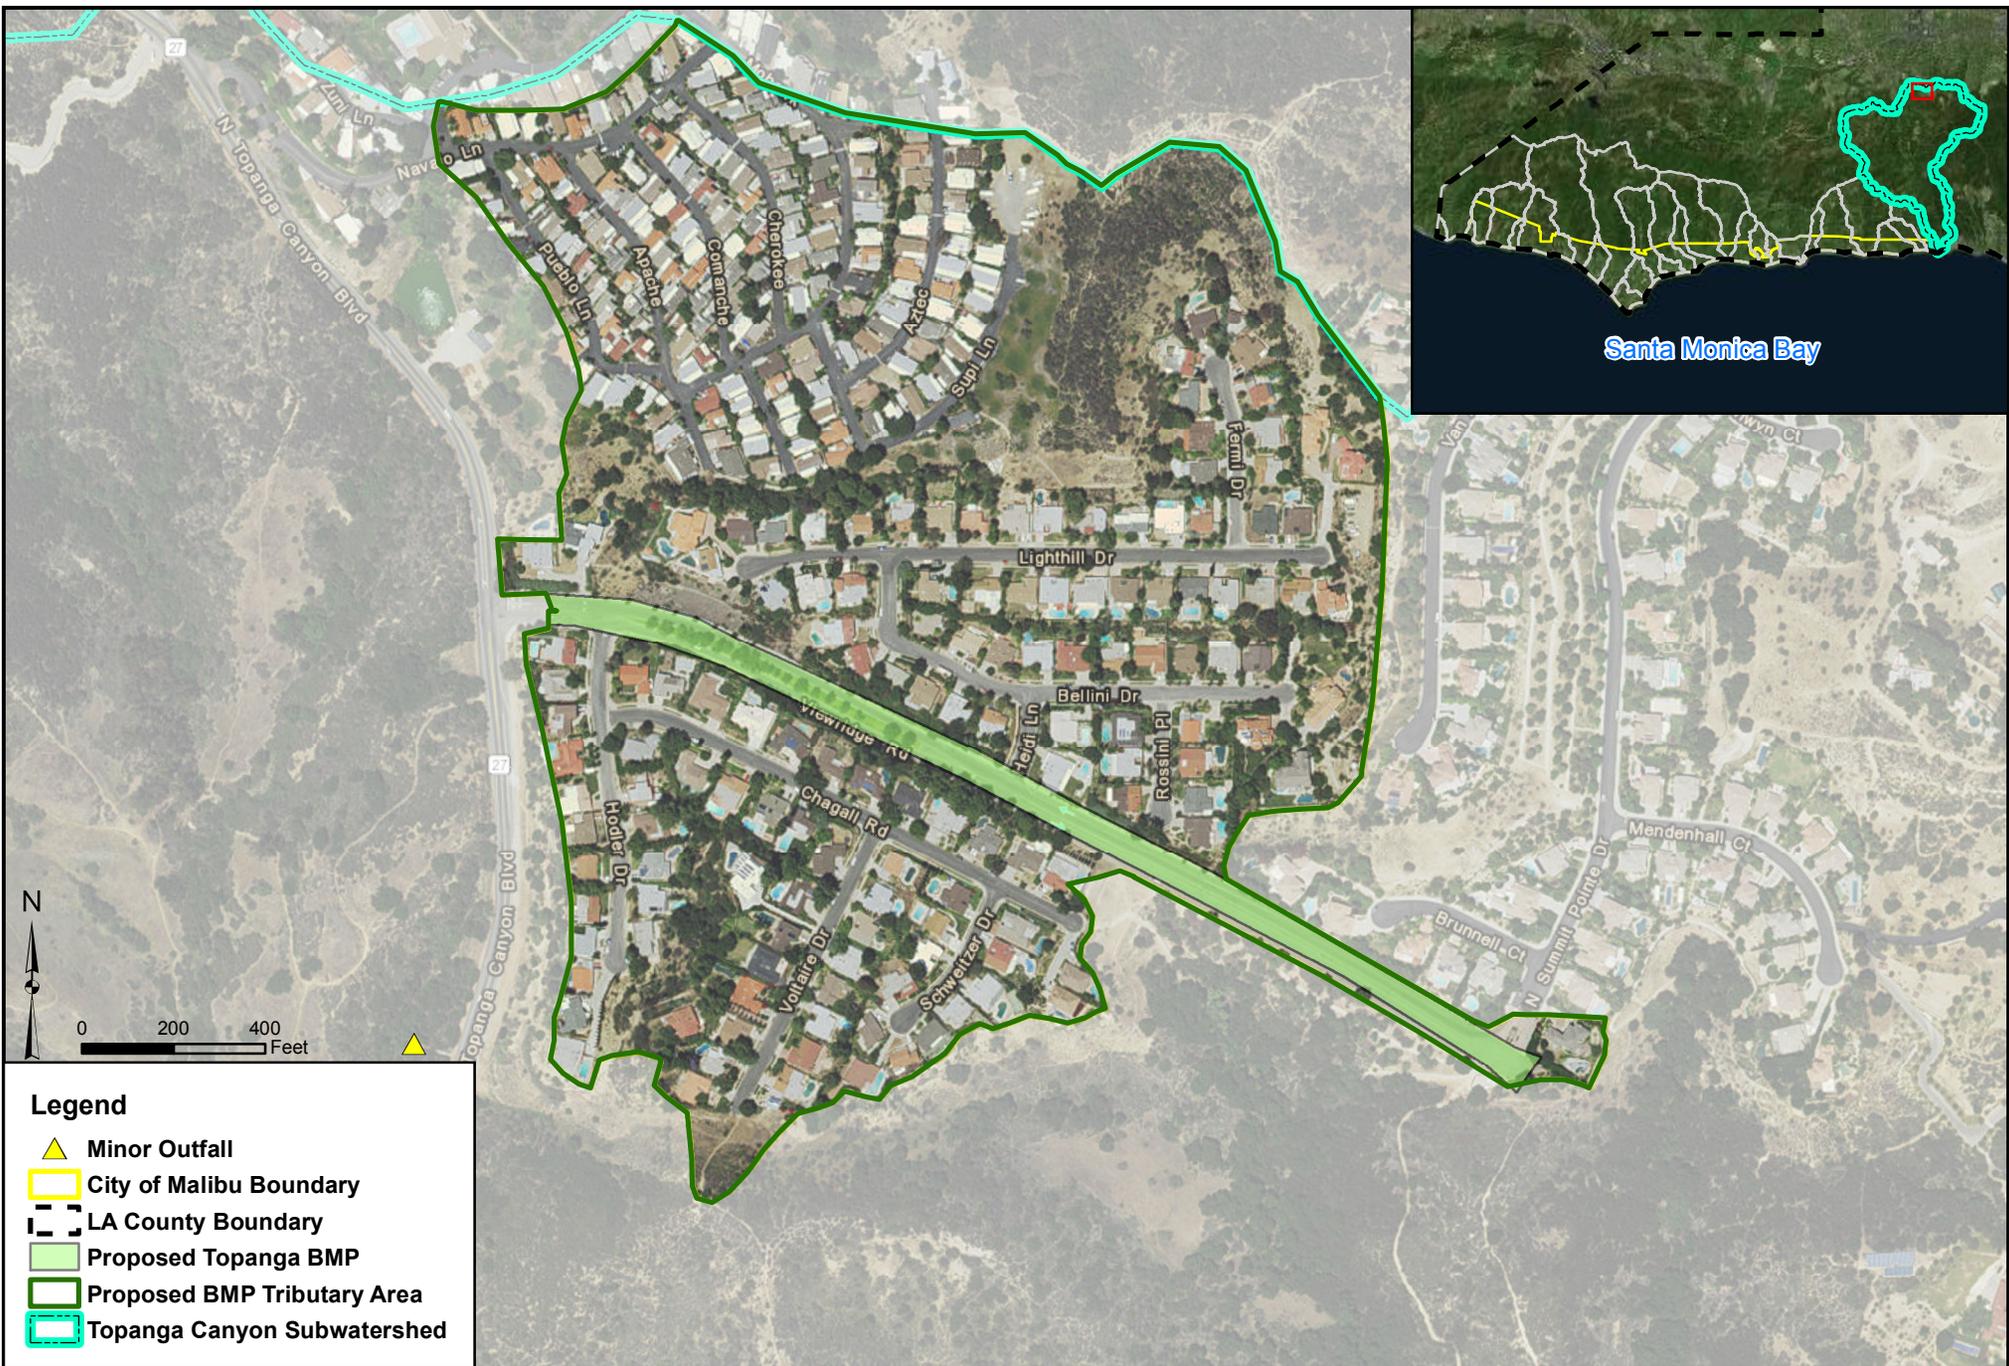
**Figure 15. Topanga Canyon Subwatershed (Analysis Region S1-18)  
Proposed Regional BMP  
NSMBCW EWMP**

The Topanga Canyon Regional Super Green Street EWMP Project is a Los Angeles County project. The County has initiated the planning phase for this project. The proposed project is estimated to be completed by 2021.

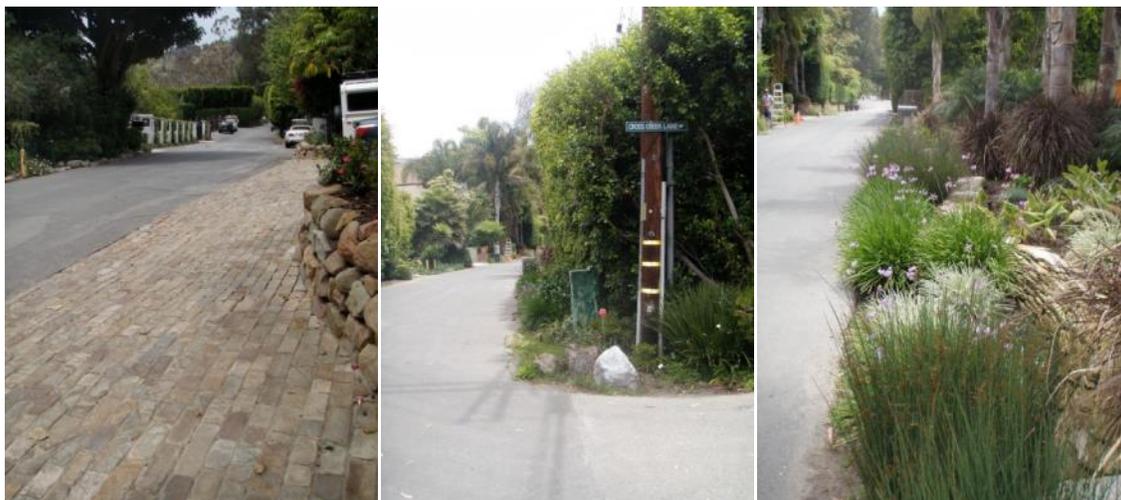
**Figure 27. Photographs showing the private Serra Canyon Neighborhood on the eastern side of Malibu Creek within the City of Malibu.**

To represent this disconnected imperviousness, baseline conditions for the developed areas in this analysis region were modeled as being tributary to vegetated swales. This modeling procedure is similar to the downspout disconnect modeling procedure described in Section 5.2.3.3.

Of the 618 acres of land within the NSMBCW EWMP Area tributary to Malibu Creek, approximately 306 acres is tributary to Malibu Legacy Park, a regional EWMP project on the western side of Malibu Creek (see Section 6.2.4.1). The remaining area, which is almost entirely on the eastern side of Malibu Creek, is a uniquely developed area requiring special consideration when modeling as part of the RAA. This area (identified as the “MCW” analysis region, as shown in **Figure 26**) contains approximately 312 acres of sparsely developed space, with a total impervious coverage of approximately 12 percent. The development in this analysis region contains mostly low density (rural) single family residential. There are no NSMBCW Agency-owned storm drains in this analysis region and streets do not have curbs or gutters. Besides the 85 acres of state- and federally-owned land, the developed neighborhood is privately owned property, including private roads. None of the developed area is directly connected to Malibu Creek. Instead, all impervious areas are disconnected via densely vegetated fields and flow paths. **Figure 27** photos show a few of the streets in this analysis region.

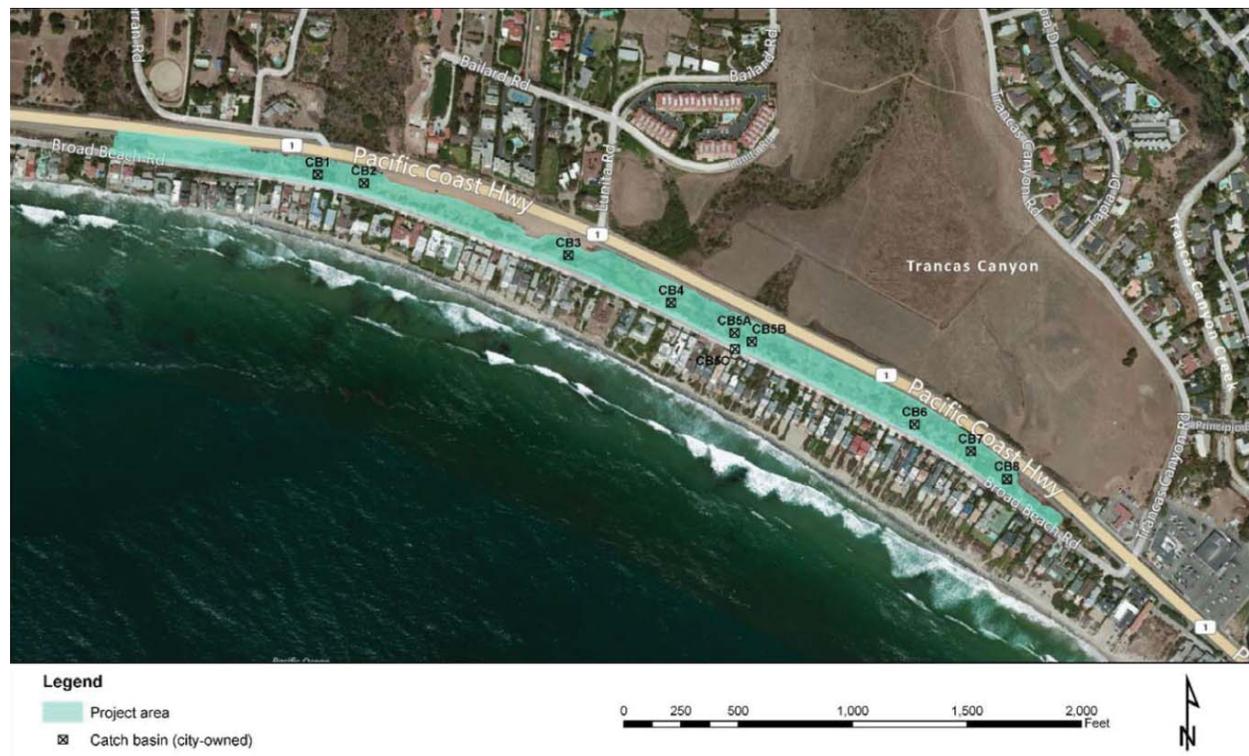
**Figure 1. Broad Beach Project Locations**

The Broad Beach Biofiltration Project is located in JG1 in Northern Malibu on Broad Beach, near the intersection of Pacific Coast Highway (PCH) and Trancas Canyon Road, adjacent to ASBS areas. Broad Beach Road parallels and is located at the toe of the PCH embankment slope. Single family residential homes separate Broad Beach Road from the Pacific Ocean. The Project consists of the installation of different types of biofilters at nine catch basins within the City Right of Way, treating stormwater and urban runoff prior to the entering of flows into City-owned catch basins, which discharge to privately owned storm drain systems. The project location is shown below in Figure 1.

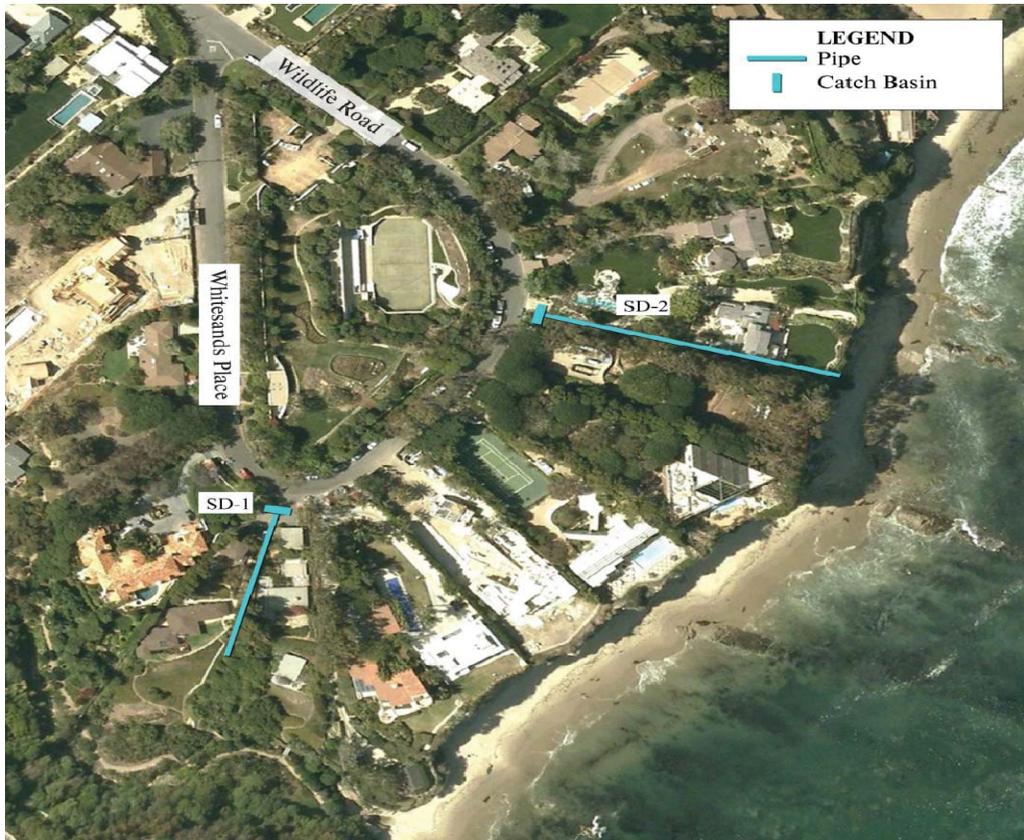
Figure 5. Wildlife Road Storm Drain Improvements Locations

The Wildlife Road Storm Drain Improvements Project is located in JG1 in Northern Malibu on Wildlife Road and Whitesands Place, adjacent to ASBS areas. This project is located within a developed residential neighborhood. Two existing storm drain inlets, SD-1 and SD-2 are located on Whitesands Place and Wildlife Road. The project site map is shown on Figure 5. The Project consists of the installation of bioretention swales and biofilters within the City Right of Way, treating stormwater and urban runoff prior to the entering of flows into City-owned catch basins.

Due to the limited about of space within the City's Right of Way, the project will include a combination of bioretention swales and biofilters.

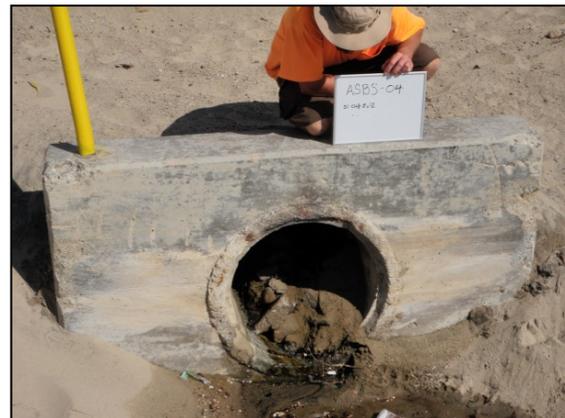
Figure 2-5. ASBS-004 Outfall

ASBS-004 is a 24-inch outfall located at the northern end of Zuma Beach, adjacent to the northernmost parking lot along Zuma Beach Access Road (Figure 2-5). This outfall is accessible during all tides and was sampled during three monitored storm events (February 19 and March 8, 2013 and February 28, 2014). The watershed draining to ASBS-004 is 9.8 acres in size and the surrounding landscape at ASBS-004 consists of a gradually sloping, broad sandy beach.

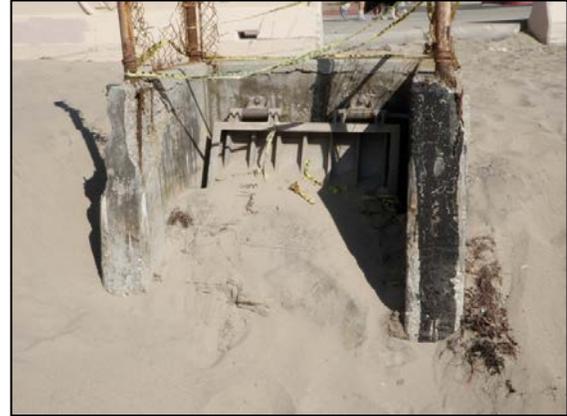
Figure 2-6. ASBS-005 Outfall

ASBS-005 is a 36-inch outfall located at the northern end of Zuma Beach, adjacent to the northernmost parking lot along Zuma Beach Access Road, and directly across from the intersection of Guernsey Avenue with PCH (Figure 2-6). This outfall is accessible during all tides and was sampled during the February 19, March 8, 2013, and February 28, 2014, storm events. The watershed draining to ASBS-005 is 65.8 acres in size and the surrounding landscape at ASBS-005 consists of a gradually sloping, broad sandy beach.

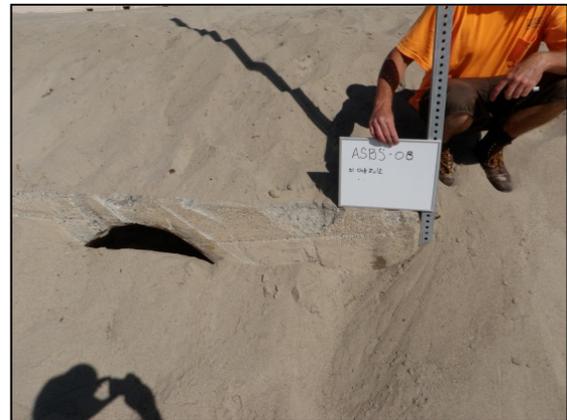
Figure 2-7. ASBS-008 Outfall

ASBS-008 is a 24-inch outfall located at the northern end of Zuma Beach, near a parking lot along Zuma Beach Access Road (Figure 2-7). This outfall is accessible during all tides and was sampled during the March 8, 2013, storm event (it was added to the list of monitored sites following the February 19, 2013, storm event). The watershed draining to ASBS-008 is 114.8 acres in size and the surrounding landscape at ASBS-008 consists of a gradually sloping, broad sandy beach.

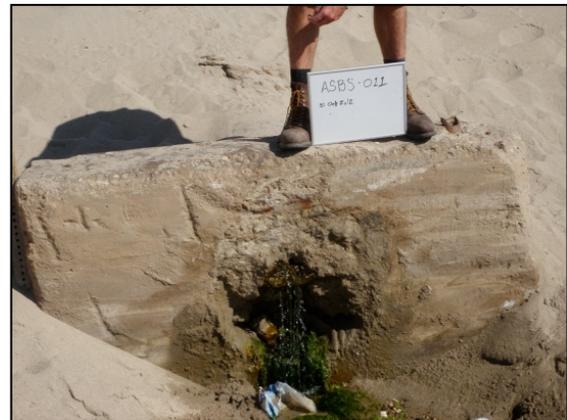
Figure 2-8. ASBS-011 Outfall

ASBS-011 is a 24-inch outfall located in middle portion of Zuma Beach, adjacent to a parking lot along Zuma Beach Access Road (Figure 2-8). This outfall is accessible during all tides and was sampled during three monitored storm events (February 19 and March 8, 2013, and February 28, 2014). The watershed draining to ASBS-011 is 7.0 acres in size and the surrounding landscape at ASBS-011 consists of a gradually sloping, broad sandy beach.

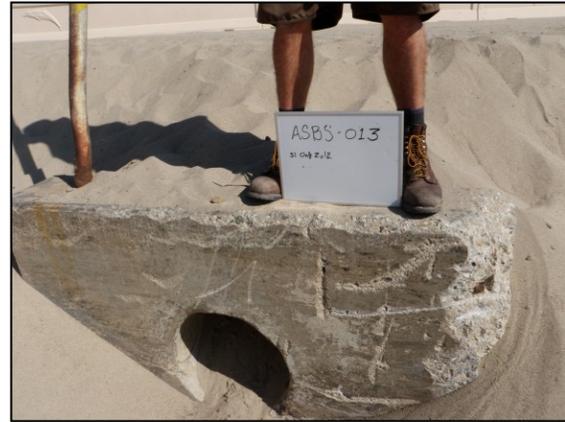
Figure 2-9. ASBS-013 Outfall

ASBS-013 is an 18-inch outfall located in middle portion of Zuma Beach, adjacent to a parking lot along Zuma Beach Access Road (Figure 2-9). This outfall is accessible during all tides and was sampled during only the March 8, 2013, and February 28, 2014, storm events, as it did not flow during the February 19, 2013, storm event. The watershed draining to ASBS-013 is 10.4 acres in size and the surrounding landscape at ASBS-013 consists of a gradually sloping, broad sandy beach.

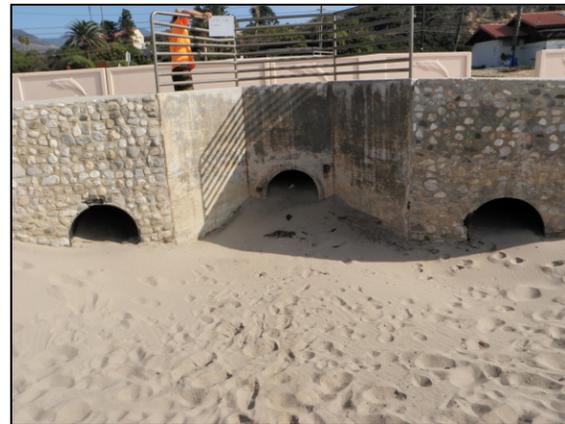
Figure 2-10. ASBS-016 Outfall

ASBS-016 is a 60-inch outfall located in middle portion of Zuma Beach, adjacent to a parking lot along Zuma Beach Access Road (Figure 2-10). This box culvert outfall is accessible during all tides and was sampled during only the March 8, 2013, and February 28, 2014, storm events, as it did not flow during the February 19, 2013, storm event. Flow monitoring equipment was installed in this outfall. The watershed draining to ASBS-016 is 115.1 acres in size and the surrounding landscape at ASBS-016 consists of a gradually sloping, broad sandy beach.

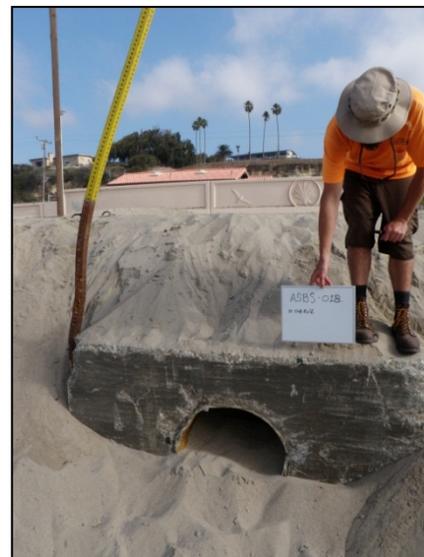
Figure 2-11. ASBS-018 Outfall

ASBS-018 is a 24-inch outfall located at the southern end of Zuma Beach, adjacent to a lifeguard station in the middle of the beach off Zuma Beach Access Road (Figure 2-11). This outfall is accessible during all tides and was sampled during three monitored storm events (February 19 and March 8, 2013, and February 28, 2014). The watershed draining to ASBS-018 is 10.0 acres in size and the surrounding landscape consists of a gradually sloping, broad sandy beach.

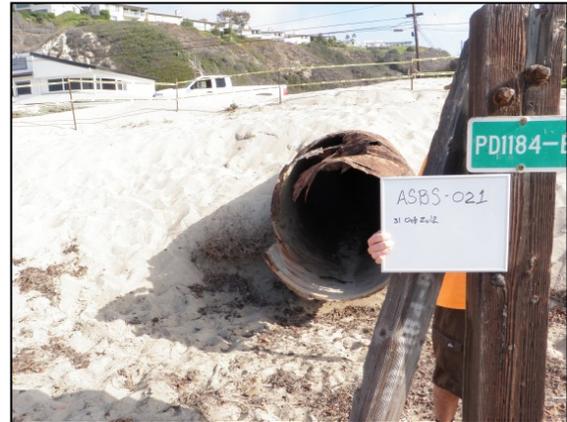
Figure 2-12. ASBS-021 Outfall

ASBS-021 is a 48-inch outfall located at the northern end of Westward Beach, adjacent to an entrance gate near the intersection of Birdview Ave. and Westward Beach Road (Figure 2-12). This outfall is accessible during all tides and was sampled during three monitored storm events (February 19 and March 8, 2013, and February 28, 2014). The watershed draining to ASBS-021 is 170 acres in size and the surrounding landscape at ASBS-021 consists of a gradually sloping, broad sandy beach.

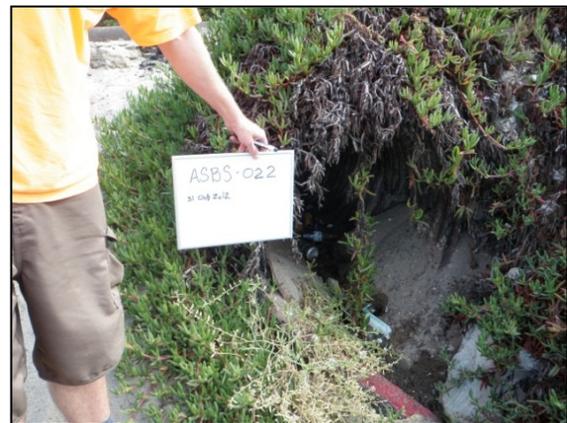
Figure 2-13. ASBS-022 Outfall

ASBS-022 is a 36-inch outfall located at the northern end of Westward Beach, midway between the entrance gate and the edge of the parking lot on Westward Beach Road (Figure 2-13). This outfall is accessible during all tides and was sampled during three monitored storm events (February 19 and March 8, 2013, and February 28, 2014).. The watershed draining to ASBS-022 is 18.4 acres in size and the surrounding landscape at ASBS-022 consists of a gradually sloping, broad sandy beach.

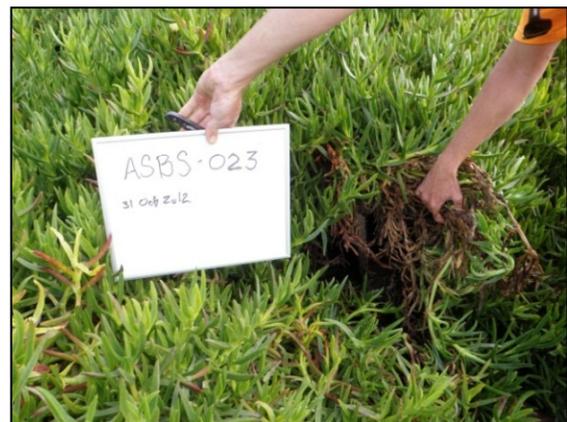
Figure 2-14. ASBS-023 Outfall

ASBS-023 is a 42-inch outfall located in the middle portion of Westward Beach, approximately 100 meters (m) north of the parking lot on Westward Beach Road (Figure 2-14). This outfall is difficult to find since it is hidden by ice plant. ASBS-023 is accessible during all tides and was sampled during three monitored storm events (February 19 and March 8, 2013, and February 28, 2014). The watershed draining to ASBS-023 is 18.4 acres in size and the surrounding landscape at ASBS-023 consists of a gradually sloping, broad sandy beach.

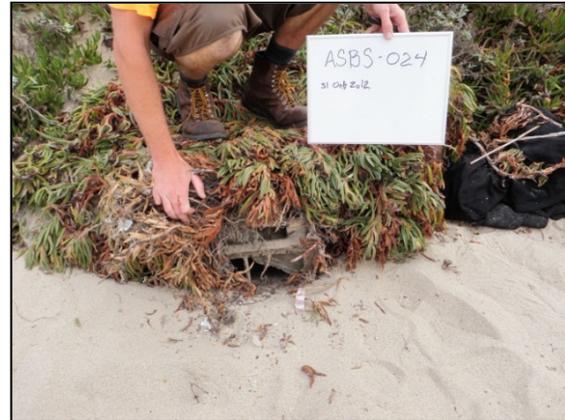
Figure 2-15. ASBS-024 Outfall

ASBS-024 is a 24-inch outfall located in the middle portion of Westward Beach, approximately 100 m south of the edge of the parking lot on Westward Beach Road (Figure 2-15). This outfall is accessible during all tides and was sampled during three monitored storm events (February 19 and March 8, 2013, and February 28, 2014). The watershed draining to ASBS-024 is 34.9 acres in size and the surrounding landscape at ASBS-024 consists of a gradually sloping, broad sandy beach.

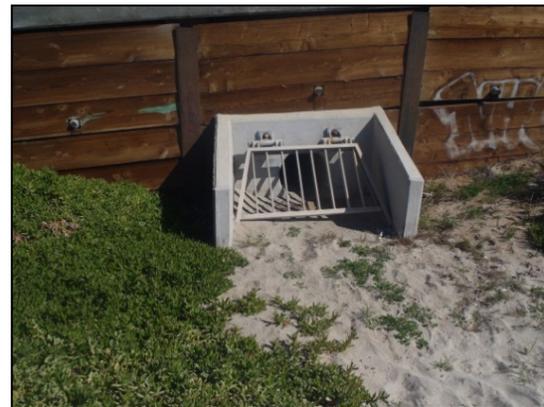
Figure 2-16. ASBS-031 Outfall

ASBS-031 is a 22-inch outfall located in the middle portion of Nicholas Beach, at the base of Nicholas Beach Road (Figure 2-16). This outfall is accessible during all tides; however, no flow was observed during either of the monitored storm events. The watershed draining to ASBS-031 is 30.1 acres in size and the surrounding landscape at ASBS-031 consists of a gradually sloping, broad sandy beach.

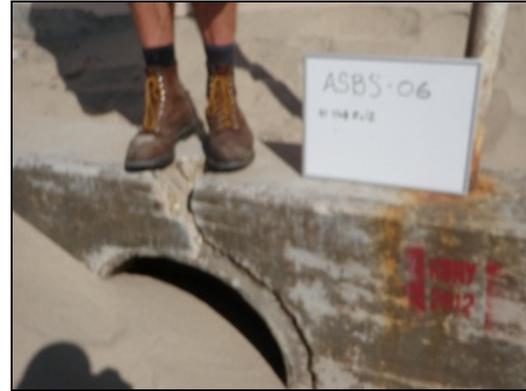
Figure 2-18. ASBS-006 Outfall

ASBS-006 is a 24-inch outfall located in the northern portion of Zuma Beach, adjacent to a parking lot along Zuma Beach Access Road (Figure 2-18). The watershed draining to ASBS-006 is 10.2 acres in size and the surrounding landscape at ASBS-006 consists of a gradually sloping, broad sandy beach.

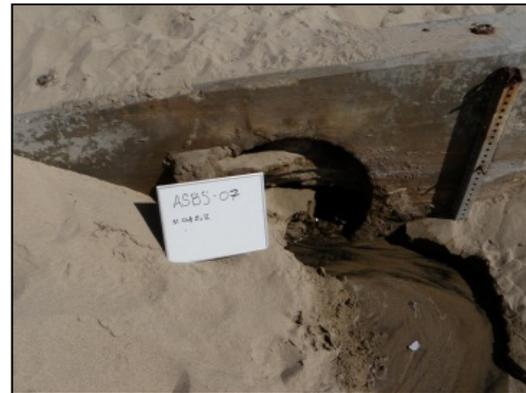
Figure 2-19. ASBS-007 Outfall

ASBS-007 is a 24-inch outfall located in the northern portion of Zuma Beach, adjacent to a parking lot along Zuma Beach Access Road (Figure 2-19). The watershed draining to ASBS-007 is 7.8 acres in size and the surrounding landscape at the outfall consists of a gradually sloping, broad sandy beach.

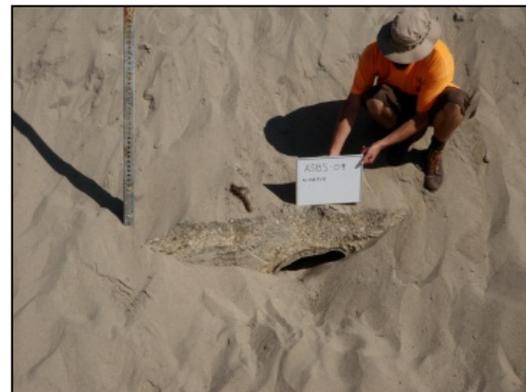
Figure 2-20. ASBS-009 Outfall

ASBS-009 is a 24-inch outfall located in the middle portion of Zuma Beach, adjacent to a parking lot along Zuma Beach Access Road, approximately 90 m south of Seadrift Cove (Figure 2-20). The watershed draining to ASBS-009 is 78.6 acres in size and the surrounding landscape at ASBS-009 consists of a gradually sloping, broad sandy beach.

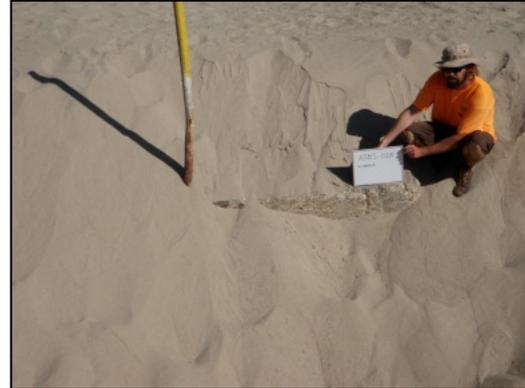
Figure 2-21. ASBS-010 Outfall

ASBS-010 is an 18-inch outfall located in the middle portion of Zuma Beach, adjacent to a parking lot along Zuma Beach Access Road, approximately 170 m south of Seadrift Cove (Figure 2-21). The watershed draining to ASBS-010 is 2.4 acres in size and the surrounding landscape at ASBS-010 consists of a gradually sloping, broad sandy beach.

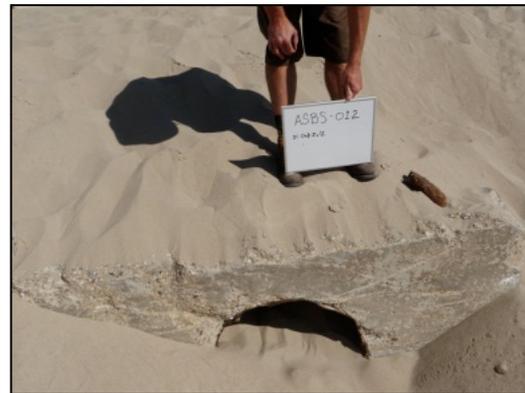
Figure 2-22. ASBS-012 Outfall

ASBS-012 is a 24-inch outfall located in the middle portion of Zuma Beach, adjacent to a parking lot along Zuma Beach Access Road, approximately 400 m south of Seadrift Cove (Figure 2-22). The watershed draining to ASBS-012 is 7.0 acres in size and the surrounding landscape at ASBS-012 consists of a gradually sloping, broad sandy beach.

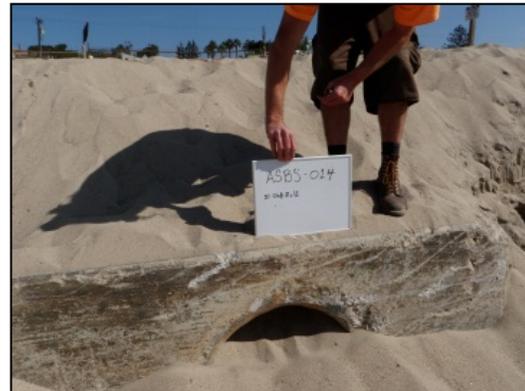
Figure 2-23. ASBS-014 Outfall

ASBS-014 is a 24-inch outfall located in the middle portion of Zuma Beach, adjacent to a parking lot along Zuma Beach Access Road, directly in front of the Beaches and Harbors maintenance yard (Figure 2-23). The watershed draining to ASBS-014 is 12.1 acres in size and the surrounding landscape at ASBS-014 consists of a gradually sloping, broad sandy beach.

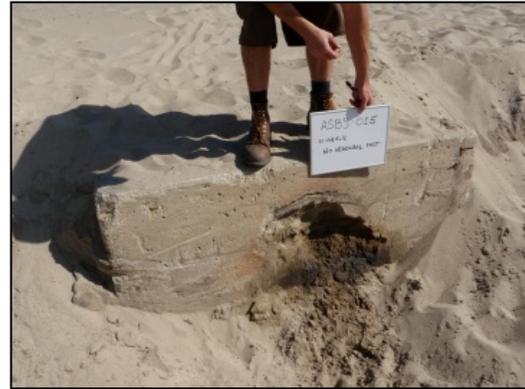
Figure 2-24. ASBS-015 Outfall

ASBS-015 is an 18-inch outfall located in the middle portion of Zuma Beach, adjacent to a parking lot along Zuma Beach Access Road, approximately 65 m south of the Beaches and Harbors maintenance yard (Figure 2-24). The watershed draining to ASBS-015 is 3.0 acres in size and the surrounding landscape at ASBS-015 consists of a gradually sloping, broad sandy beach.

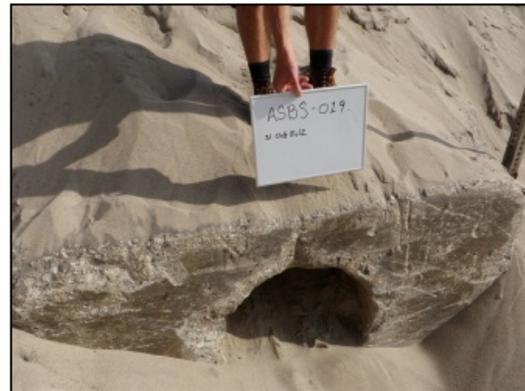
Figure 2-26. ASBS-019 Outfall

ASBS-019 is a 24-inch outfall located in the southern portion of Zuma Beach, adjacent to a parking lot along Zuma Beach Access Road, approximately 420 m north of the Zuma Beach entrance gate (Figure 2-26). The watershed draining to ASBS-019 is 20.8 acres in size and the surrounding landscape at the outfall consists of a gradually sloping, broad sandy beach.

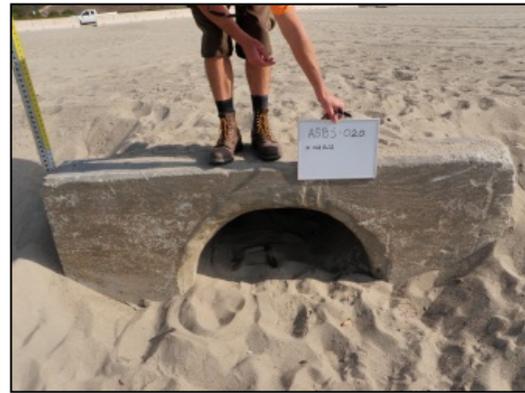
Figure 2-27. ASBS-020 Outfall

ASBS-020 is a 36-inch outfall located in the southern portion of Zuma Beach, adjacent to a parking lot along Zuma Beach Access Road, approximately 200 m north of the Zuma Beach entrance gate, in the center of the beach (Figure 2-27). The watershed draining to ASBS-020 is 12.3 acres in size and the surrounding landscape at ASBS-020 consists of a gradually sloping, broad sandy beach.

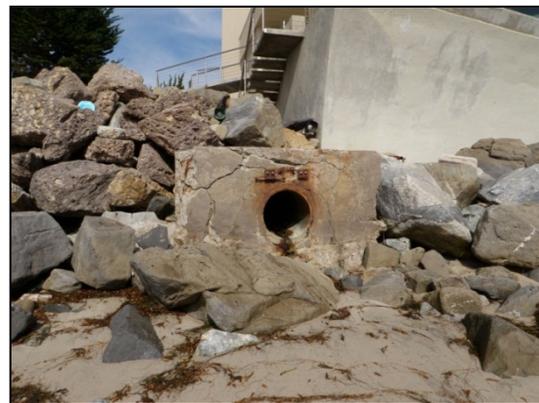
Figure 2-29. ASBS-001 Outfall

ASBS-001 is a 24-inch outfall located at the northern end of Broad Beach, along Point Lechuza, beneath a large residence (Figure 2-29). This outfall is inaccessible during high tide and was sampled during three monitored storm events (February 19 and March 8, 2013, and February 28, 2014) from a manhole located approximately 140 ft. from the beach on Point Lechuza Drive. The watershed draining to ASBS-001 is 9.4 acres in size and the area surrounding the outfall consists of a rocky intertidal area interspersed along a narrow, sandy beach.

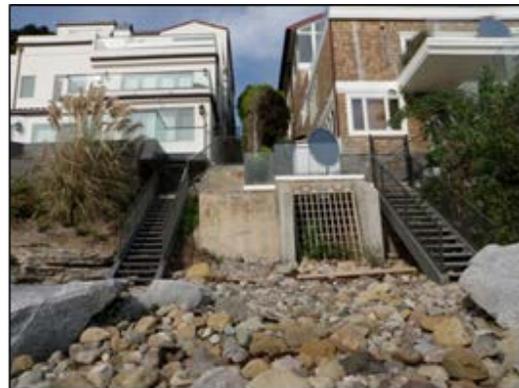
Figure 2-31. ASBS-003 Outfall

ASBS-003 is a 51-inch outfall located at the northern end of Broad Beach, south of Point Lechuza, between two residences (Figure 2-31). This outfall is inaccessible during high tide but was successfully sampled during three monitored storm events (February 19 and March 8, 2013 and February 28, 2014). The watershed draining to ASBS-003 is 253.5 acres in size and a rocky intertidal area is located directly west of the outfall.

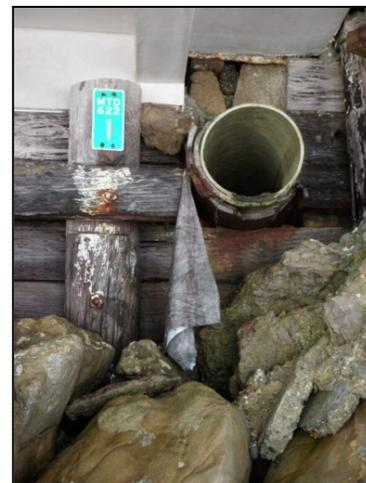
Figure 2-32. ASBS-025 Outfall

ASBS-025 is an 18-inch outfall located at the southern end of Escondido Beach, south of the Malibu Cove Colony Drive entrance off PCH (Figure 2-32). The outfall is integrated with the foundation of a residence and discharges directly onto the sand between two residences. This outfall is inaccessible during high tide but was successfully sampled during three monitored storm events (February 19 and March 8, 2013, and February 28, 2014). The watershed draining to ASBS-025 is 0.8 acres in size and the landscape surrounding the outfall is composed of a steep, sandy beach.

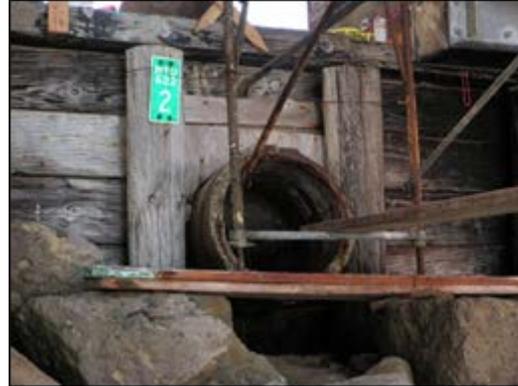
Figure 2-33. ASBS-026 Outfall

ASBS-026 is a 24-inch outfall located at the southern end of Escondido Beach, south of the Malibu Cove Colony Drive entrance off PCH (approximately 30 m southeast of ASBS-025). The outfall is integrated with the foundation of a residence and discharges directly onto the sand beneath the residence (Figure 2-33). This outfall is inaccessible during high tide but was successfully sampled during three monitored storm events (February 19 and March 8, 2013, and February 28, 2014). The watershed draining to ASBS-026 is 2.5 acres in size and the landscape surrounding the outfall is composed of a steep, sandy beach.

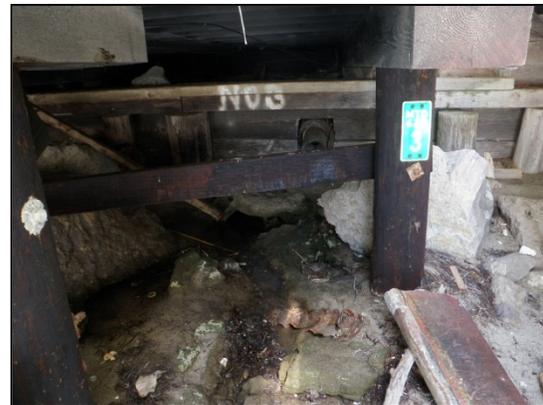
Figure 2-34. ASBS-027 Outfall

ASBS-027 is a 24-inch outfall located at the southern end of Escondido Beach, approximately 300 m east of the Malibu Cove Colony Drive entrance off PCH (Figure 2-34). The outfall is integrated with the foundation of a residence and discharges directly onto the sand beneath the residence. This outfall is inaccessible during high tide but was successfully sampled during three monitored storm events (February 19 and March 8, 2013, and February 28, 2014). The watershed draining to ASBS-027 is 18.9 acres in size and the landscape surrounding the outfall is composed of a steep, sandy beach.

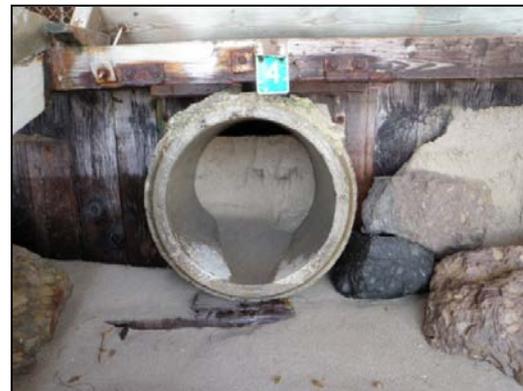
Figure 2-35. ASBS-028 Outfall

ASBS-028 is a 36-inch outfall located at the southern end of Escondido Beach, approximately 500 m east of the Malibu Cove Colony Drive entrance off PCH (Figure 2-35). The outfall is integrated with the foundation of a residence and discharges directly onto the sand beneath the residence. Flow monitoring equipment was installed in this outfall near the inlet on Malibu Cove Colony Drive. This outfall is inaccessible during high tide but was successfully sampled during three monitored storm events (February 19 and March 8, 2013, and February 28, 2014). The watershed draining to ASBS-028 is 36.0 acres in size and the landscape surrounding the outfall is composed of a steep, sandy beach.

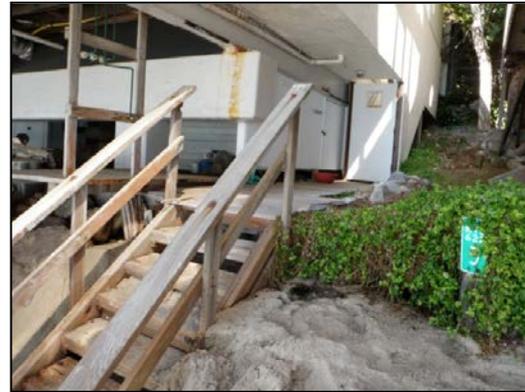
Figure 2-36. ASBS-029 Outfall

ASBS-029 is an 18-inch outfall located at the southern end of Escondido Beach, near the end of Malibu Cove Colony Drive (Figure 2-36). The outfall lies between two residences and discharges directly onto the sand. This outfall is inaccessible during high tide but was successfully sampled three monitored storm events (February 19 and March 8, 2013, and February 28, 2014). The watershed draining to ASBS-029 is 3.8 acres in size and the landscape surrounding the outfall is composed of a steep, sandy beach.

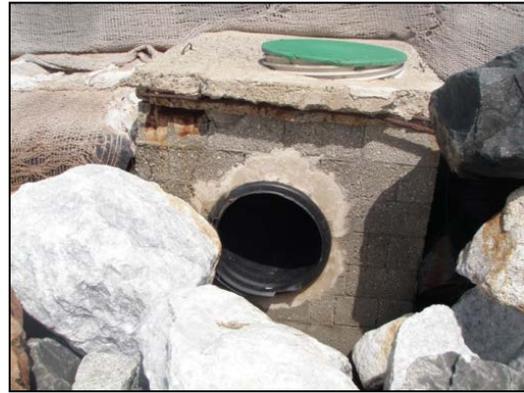
Figure 2-39. 24-BB-01Z Outfall

Site 24-BB-01Z is a 24-inch outfall located at the southern end of Broad Beach, near the intersection of Trancas Canyon Road and PCH (Figure 2-39). The outfall is located behind rock revetment and is inaccessible during high tide or dangerous surf conditions. This outfall was successfully sampled during the February 28, 2014, storm event. The monitoring program will continue into the 2014-2015 wet season and thus, sampling may be performed prior to the submittal of the final Plan. The watershed draining to 24-BB-01Z is 19.9 acres in size and consists primarily of single family residences, commercial, transportation right-of-way (ROW), and PCH ROW land uses. The landscape surrounding the outfall is composed of a rock revetment and narrow, sandy beach with near-shore reef and kelp.

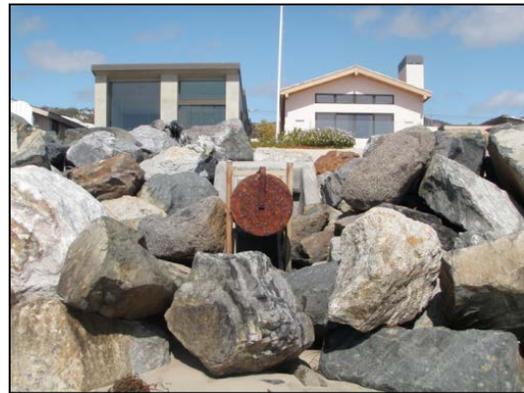
Figure 2-40. 24-BB-02Z Outfall

Site 24-BB-02Z is an 18-inch outfall located at the southern end of Broad Beach, approximately 200 m south of the intersection of Lunita Road and PCH (Figure 2-40). This outfall was successfully sampled during the February 28, 2014, storm event. The monitoring program will continue into the 2014-2015 wet season and thus, sampling may be performed prior to the submittal of the final Plan. The outfall is located among the shoreline rock revetment and is inaccessible during high tide or dangerous surf conditions. The watershed draining to 24-BB-02Z is 13.9 acres in size and consists primarily of single family residences, vacant, transportation ROW, and PCH ROW land uses. The landscape surrounding the outfall is composed of rock revetment a narrow, sandy beach.

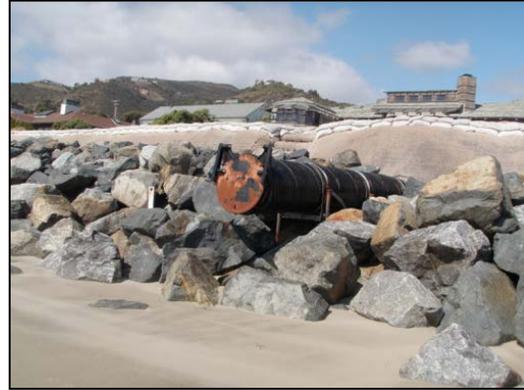
Figure 2-41. 24-BB-03Z Outfall

Site 24-BB-03Z is a 30-inch outfall located at the southern end of Broad Beach, approximately 100 m south of the intersection of Lunita Road and PCH (Figure 2-41). This outfall was successfully sampled during the February 28, 2014, storm event. The monitoring program continues into the 2013-2014 wet season and thus, sampling may be performed prior to the submittal of the Final Plan. The outfall is located among the shoreline rock revetment and is inaccessible during high tide or dangerous surf conditions. The watershed draining to 24-BB-03Z is 127.6 acres in size and consists primarily of rural residential, vacant, single family residences, transportation ROW, and PCH ROW land uses. The landscape surrounding the outfall is composed of rock revetment and a narrow, sandy beach.

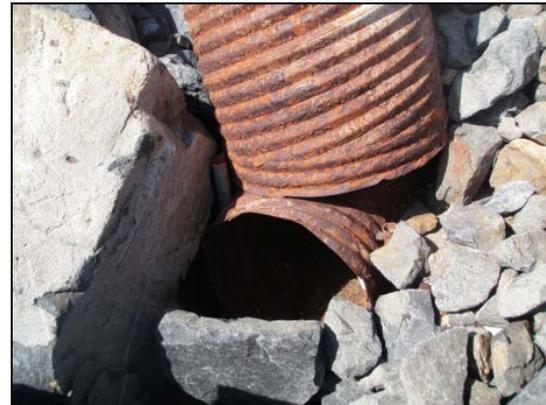
Figure 2-42. ASBS-C Outfall

Site ASBS-C-Z is a 30-inch outfall located at the northern end of Broad Beach, approximately 30 m south of the intersection of La Herran Road and PCH (Figure 2-42). While the City owns the inlet to this outfall, the outfall is considered private. The outfall is located behind and partially buried by the rock revetment and is inaccessible at all times due to the steep rock revetment that surrounds the outfall. No sampling has been performed at this site. The watershed draining to ASBS-C is 66.8 acres in size and consists primarily of single family residences, vacant, transportation ROW, and PCH ROW land uses. The landscape surrounding the outfall is composed of rock revetment and a narrow, sandy beach with some near-shore reef.

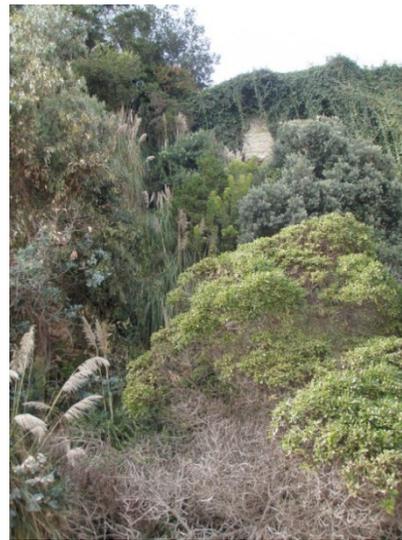
Figure 2-43. ASBS-I Outfall

Site ASBS-I (also referred to as PC02 in other documents) is an 18-inch outfall located on Little Dume Beach, approximately 100 m east of the end of Wildlife Drive (Figure 2-43). The outfall is located on a cliff-side bluff and is inaccessible. No sampling has been performed at this site. The watershed draining to ASBS-I is 6.7 acres in size and the landscape surrounding the outfall is composed of a narrow, sandy beach with near-shore reef and kelp.

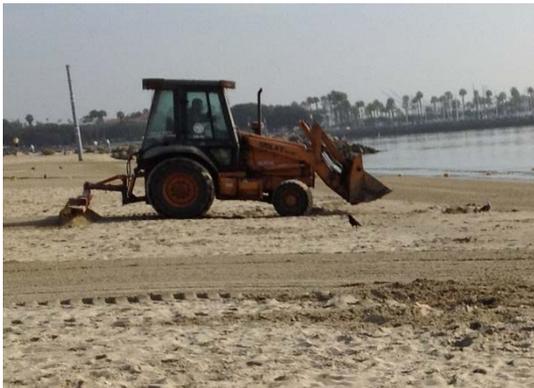
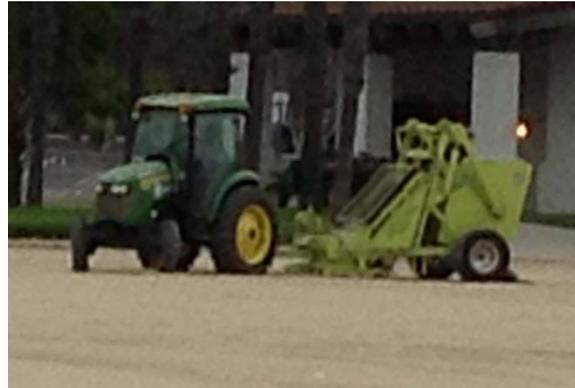
Figure 3-4. County Beach Sand Sanitation Program Equipment at Work

The County's waste management program includes a regional beach sand "sanitation" program that is implemented at the three County Beaches located within ASBS 24. The beach sanitation program involves collecting beach debris in a screened hopper pulled by a tractor and properly disposing of the material. A rake system attached to the back of the tractor turns over the sand and allows solar radiation to "sanitize" the beach sand. Beach sand sanitation activities are implemented three times per week, provided that the beach sand is not wet. The implementation is scheduled during the morning hours to allow for maximal day-light exposure.

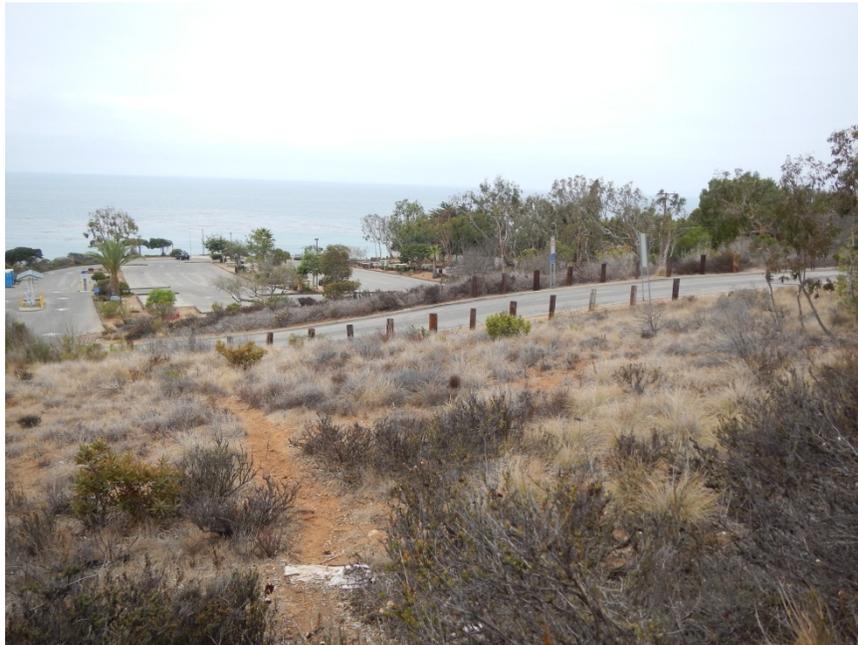
Figure 7-5. Nicholas Canyon County Beach Parking Lot

The photograph depicted in Figure 7-5 was taken looking west and downward towards the Nicholas Canyon County Beach parking lot. The up-gradient area between PCH and the parking lot is shown to have fairly good vegetation cover. A narrow foot/animal path leads down the sloped area. Signs of erosion were not observed in the area. Compared to natural cover, a parking lot with an impervious surface located on a mesa, such as the case here, increases storm water runoff quantity and velocity resulting in the potential to erode soils if not properly designed. The parking lot was observed to have several storm drain inlets with associated piping to convey collected storm water down to the ocean without the potential to increase erosion of the bluffs (i.e., outfall located at sea level along rocky shoreline).

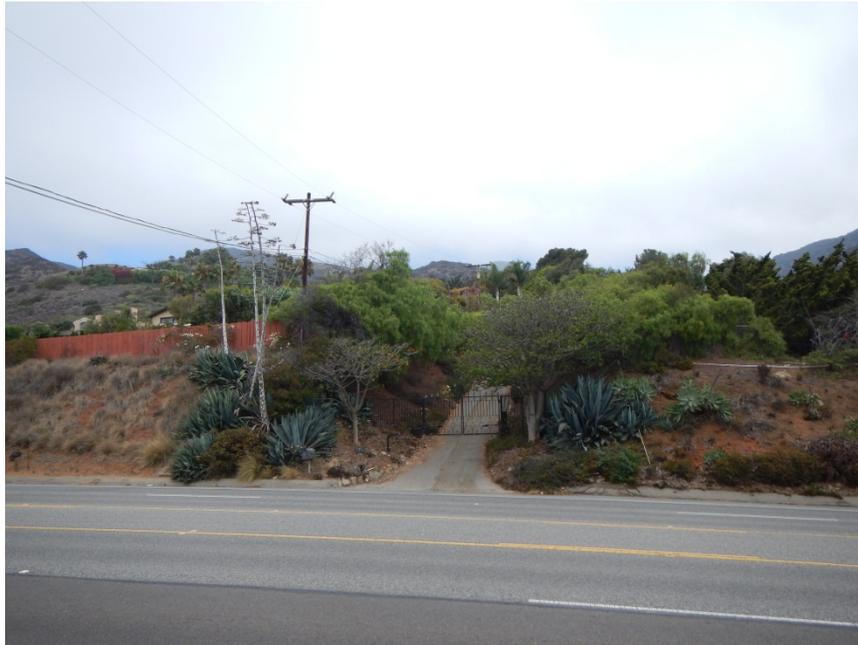
Figure 7-6. Nicholas Canyon Beach Upper Watershed Area

Figure 7-6 shows the area east of the PCH up-gradient from Nicholas Canyon County Beach. PCH and a residence occupy the area, where it appears that the highway and residential access driveway were constructed by cutting away (excavating) some the native materials and creating 2:1 (horizontal: vertical) slopes. These slopes are shown with vegetation cover and without evidence of active erosion.

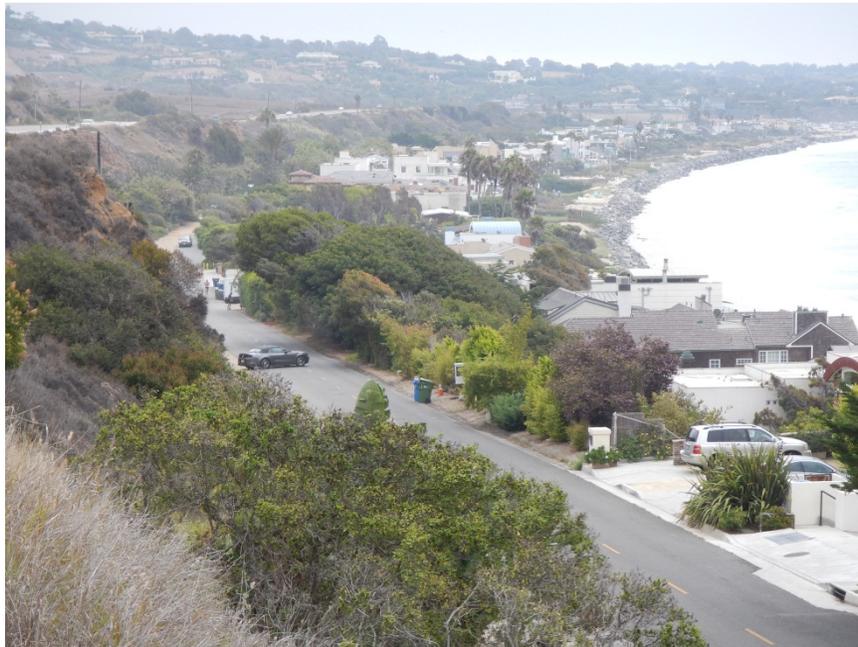
Figure 7-7. Bluff Area Above Broad Beach

The photograph depicted in Figure 7-7 was taken above Broad Beach and shows the bluff area located between PCH and the residences that are situated along the shoreline. During the field reconnaissance, the majority of the bluff appeared to have vegetation cover. Some steep portions were exposed, resembling natural bluffs observed in the area where development has been restricted (e.g., the nearby El Matador State Beach). Signs of erosion from these bare areas were not observed in the bluff along Broad Beach Road.

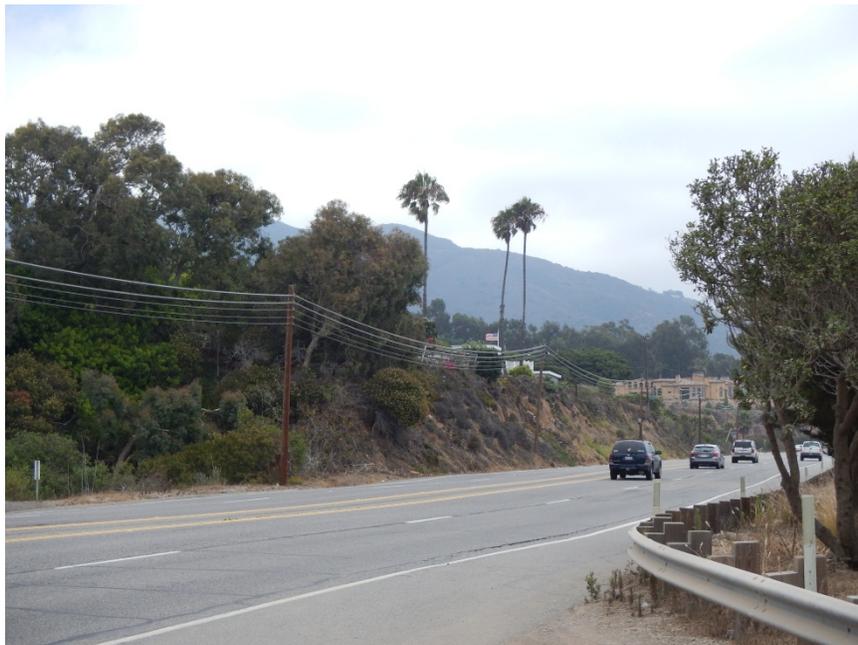
Figure 7-8. Directly Above Broad Beach Area

The photograph depicted in Figure 7-8 shows the area along PCH and directly above Broad Beach. Similar bluff materials, but having lower height, were observed at this location with similar vegetation cover as the bluffs located along Broad Beach. Thick vegetation was observed at the bottom of the bluff material adjacent to the roadway.

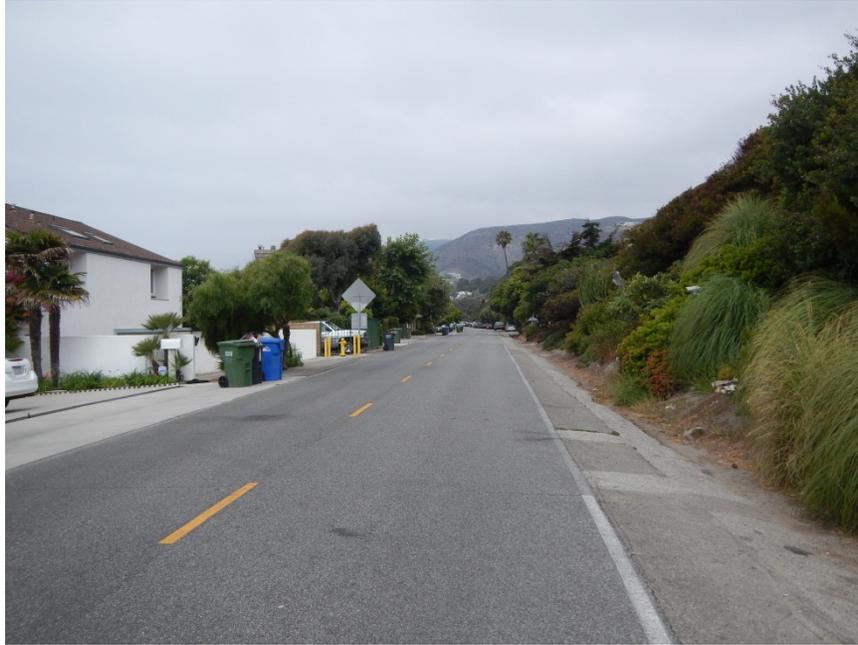
Figure 7-9. East Portion of Broad Beach

The east end of Broad Beach Road has thicker vegetation cover and a lower bluff height compared to the west area. Figure 7-9 shows the typical street composition of residences and associated improvements along the south (seaward) side and off-street parking area along the north side followed by a vegetated sloped area.
