RE: Revised LA County MS4 Permit - North Santa Monica Bay Coastal Watersheds  
Enhanced Watershed Management Program Submittal

# ENHANCED WATERSHED MANAGEMENT PROGRAM (EWMP) FOR NORTH SANTA MONICA BAY COASTAL WATERSHEDS

**March 2016**

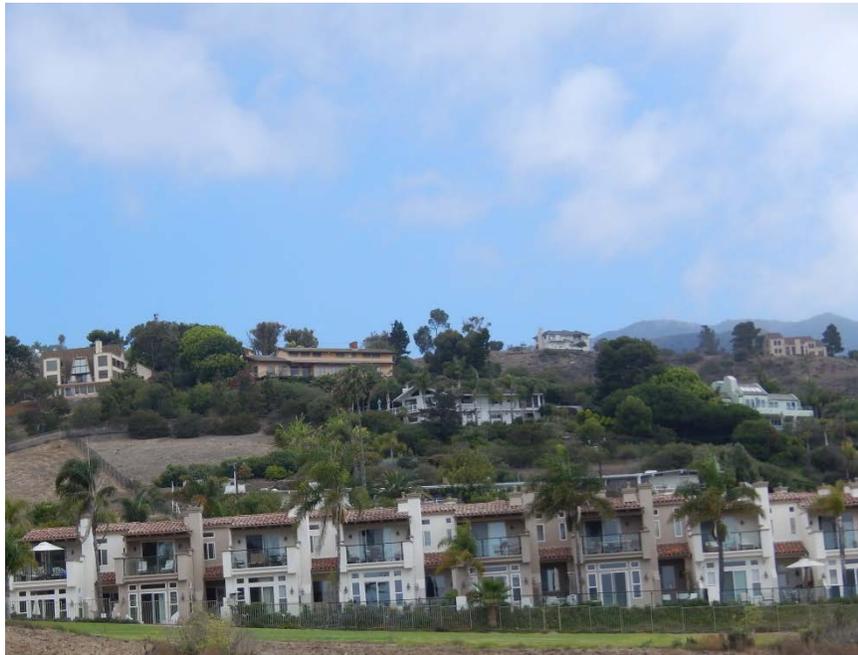
Figure 7-10. Area Up-Gradient of Broad Beach

Further up the watershed to Broad Beach the geology changes to that of the Santa Monica Mountains with hills and valleys. Figure 7-10 shows the residential development and associated landscaping in this area.

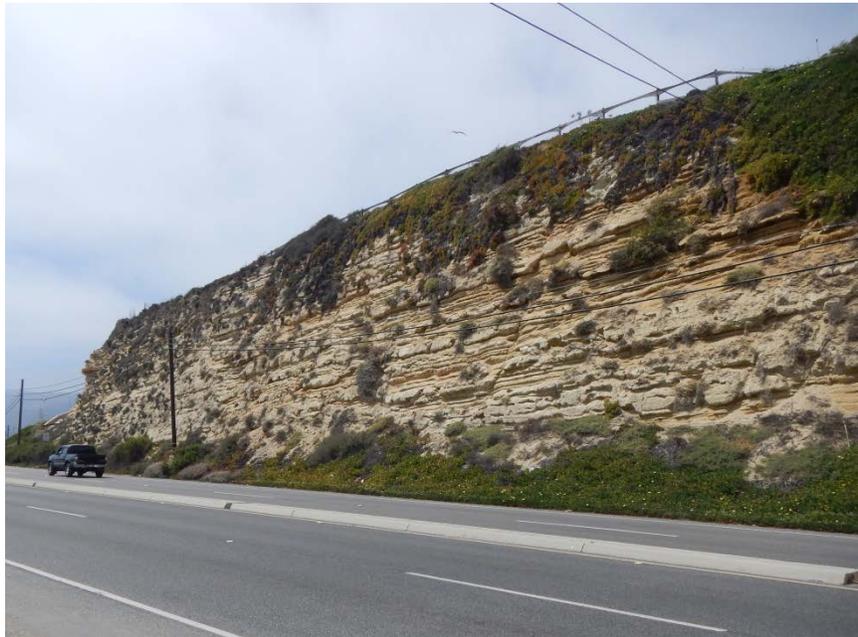
Figure 7-11. Vertical Bluff Across from Zuma Beach

The photograph depicted in Figure 7-11 shows the area across from the southeast side of Zuma County Beach, north of PCH. Field reconnaissance observed a large vertical bluff. This bluff appears to be Miocene age Modelo Formation that may have been a naturally formed vertical wall or a result of grading associated with the construction of PCH. Evidence of erosion was not observed during the reconnaissance. The materials appeared to be very hard and resistant to erosive forces of nature.

The sedimentation assessment indicates that currently there are no areas prone to anthropogenic sedimentation within the drainage areas to the identified outfalls that discharge to ASBS 24. Land use in the drainage areas consists predominantly of residential and vacant (open space) designations with associated roadway connections. The sloped areas associated with residential properties were observed to have good vegetation cover and appeared to be regularly maintained by landscaping professionals (see Figure 7-9). Areas where cuts (excavation) were made during the construction of roadways were observed to have either good vegetation cover that has been maintained by responsible property owners or consist of hard coastal bluff materials resistant to erosive forces (e.g., large bluff along the southeast portion of Zuma County Beach, as shown on Figure 7-11). Therefore, at this time, no additional sediment BMPs are required by this plan.

The conclusion of this sediment identification assessment is that currently there are no areas prone to anthropogenic sedimentation within the drainage areas tributary to the identified outfalls that discharge to ASBS 24. Land use in the drainage areas consists predominantly of residential and vacant (open space) designations with associated roadway connections. The sloped areas associated with residential properties were observed to have good vegetation cover and appeared to be regularly maintained by landscaping professionals. Areas where cuts (excavation) were made during the construction of roadways were observed to have either good vegetation cover that has been maintained by responsible property owners or consist of hard coastal bluff materials resistant to erosive forces (e.g., large bluff along the southeast portion of Zuma County Beach, as shown in Figure 7-11). Therefore, at this time, no additional sediment BMPs are required by this plan.

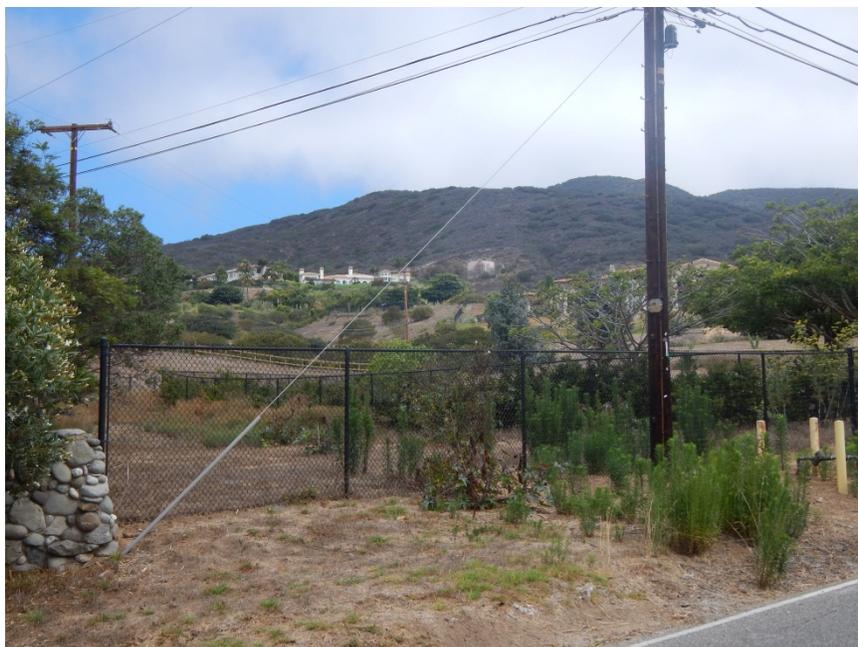
Figure 7-12. Up-Gradient of Zuma Beach Area

As with the other areas evaluated, away from the coast the geology was observed to be Santa Monica Mountains in the watersheds upstream of the Zuma County Beach shoreline. Good vegetation cover was observed in the sloped areas around the existing improvements, which included residences and a water tank (Figure 7-12). Thick native vegetation was observed above the developed areas.

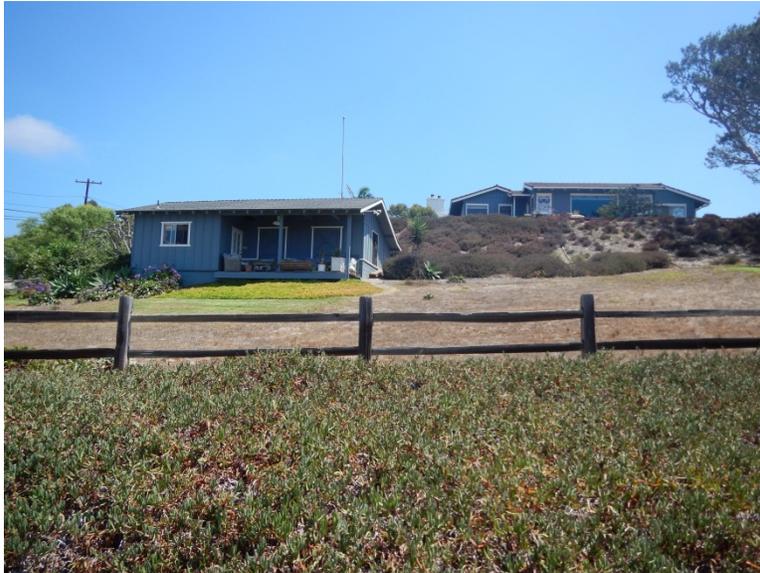
Figure 7-13. Residence Near Birdview Avenue & Bluewater Road

Figure 7-13 shows a residential property located east of the intersection of Birdview Avenue and Bluewater Road. Typical of residences in the area, the landscaping included a mixture of brushes and trees on the sloped areas and turf in the flatter areas.

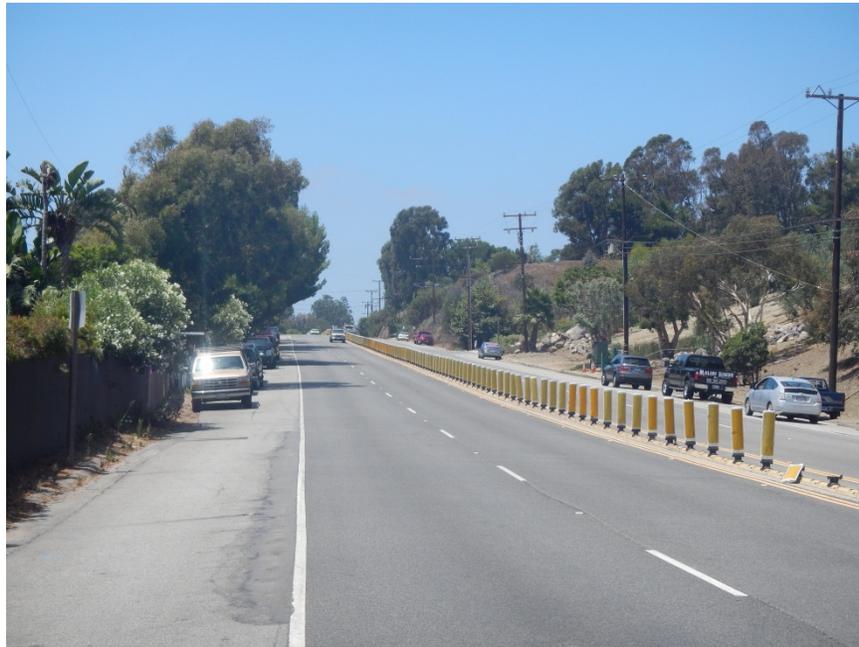
Figure 7-14. Pacific Coast Highway Near Escondido Beach

The photograph depicted in Figure 7-14 shows the area above Escondido Beach. This area was observed to have more gentle slopes of approximately 4:1 (horizontal: vertical) compared to the bluff areas observed near Zuma County Beach and Broad Beach. East of Escondido Creek and north of PCH, thick vegetation cover was observed, consisting primarily of ice plant, palm trees, and eucalyptus trees.

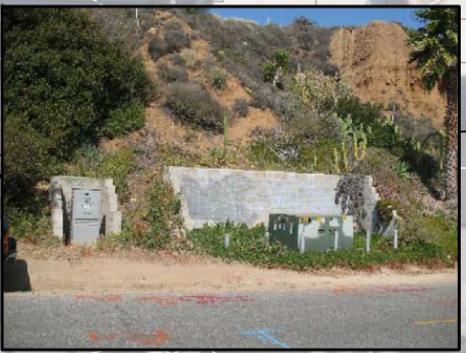
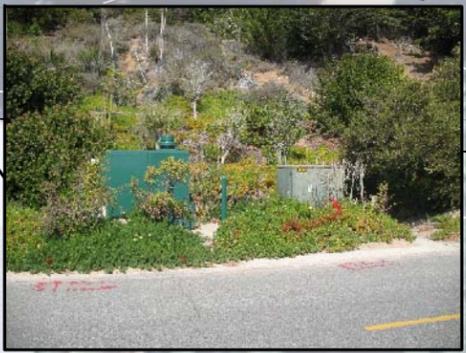
BIOFILTER REQUIRED FOR ALTERNATIVE 1 ONLY. REPLACE BIOFILTER WITH VEGETATED SWALE FOR ALTERNATIVE 2.

ALTERNATIVE 2  
NO BIOFILTER REQUIRED. STORAGE TANK WITH PUMP TO IRRIGATION SYSTEM AND/OR EASTERN BIOFILTER.

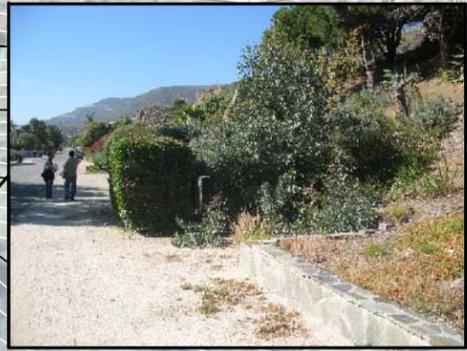
REMOVE EXISTING WALL AND SELECTIVE VEGETATION (TYP.)

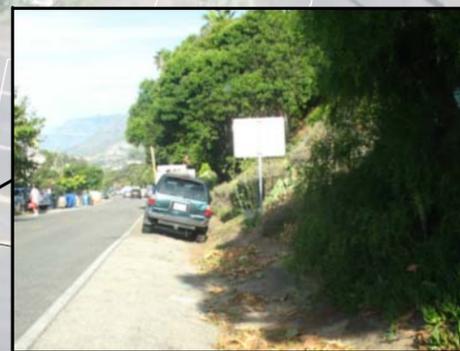
NARROW SHOULDER, PARKING ONLY.  
FUTURE CONSTRUCTION  
IMPROVEMENTS INCLUDE A 10' WIDE  
CONCRETE PAVER PARKING AREA  
WITH A CENTER CONCRETE SWALE
