3.0 Environmental Analysis

Environmental Impact Report
prepared for State Water Resources Control Board
by GEI Consultants, Inc.

Eastern Riverside County, California

AERIAL OVERVIEW
OF PROJECT SITE

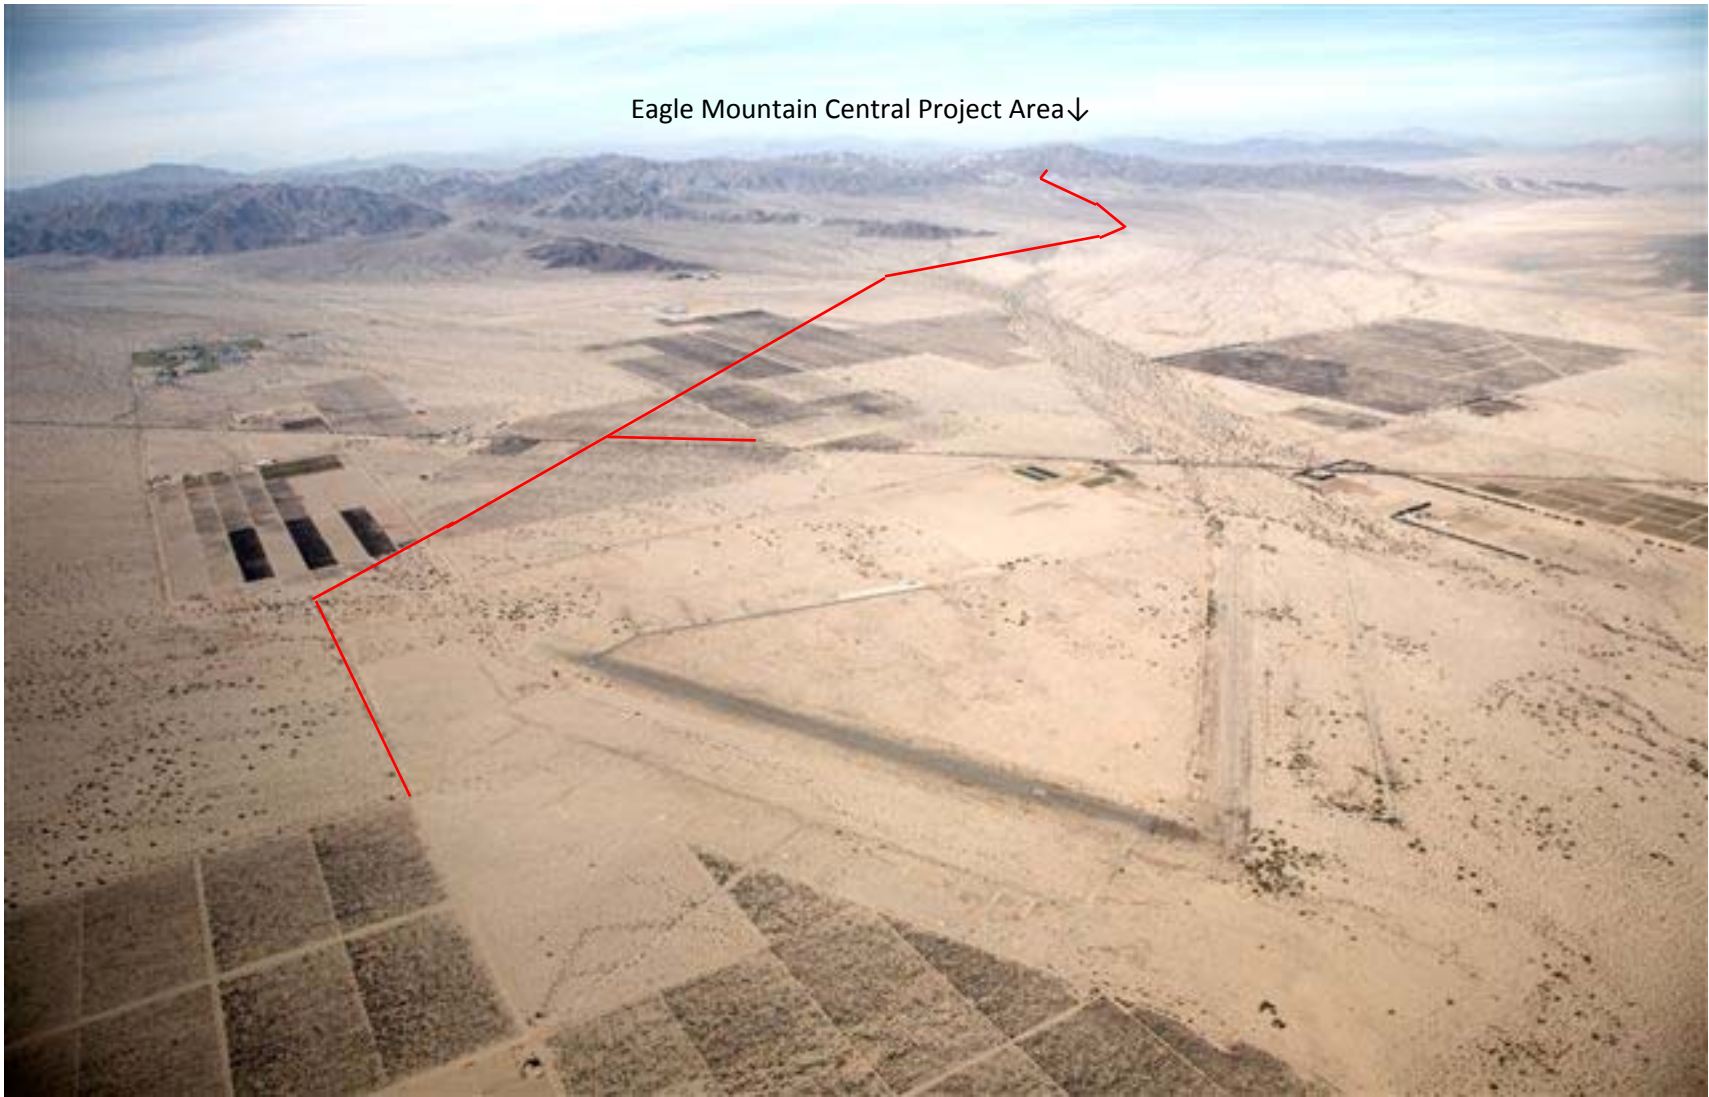
Figure 3.0-2. Aerial view of water pipeline corridor, November 2008, from southeast towards the northwest.

The Central Project Area is visible in the background.

Two basic native plant communities (after Holland, 1986) are intersected by the Project. The reservoir area of the Project site is largely heavily disturbed by prior mining activities, but is bordered by Sonoran Creosote Bush Scrub (County of Riverside and BLM, 1996). An aerial view of the Project area in the Chuckwalla Valley near the proposed water pipeline corridor is shown in Figure 3.0-2. From the reservoir area east, the plant community is characterized by variations of Sonoran Creosote Bush Scrub. Throughout Chuckwalla Valley and in bajadas to the east, the Project also intersects broad plains of contiguous to intermittent, arboreal washes (Desert Dry Wash Woodland).

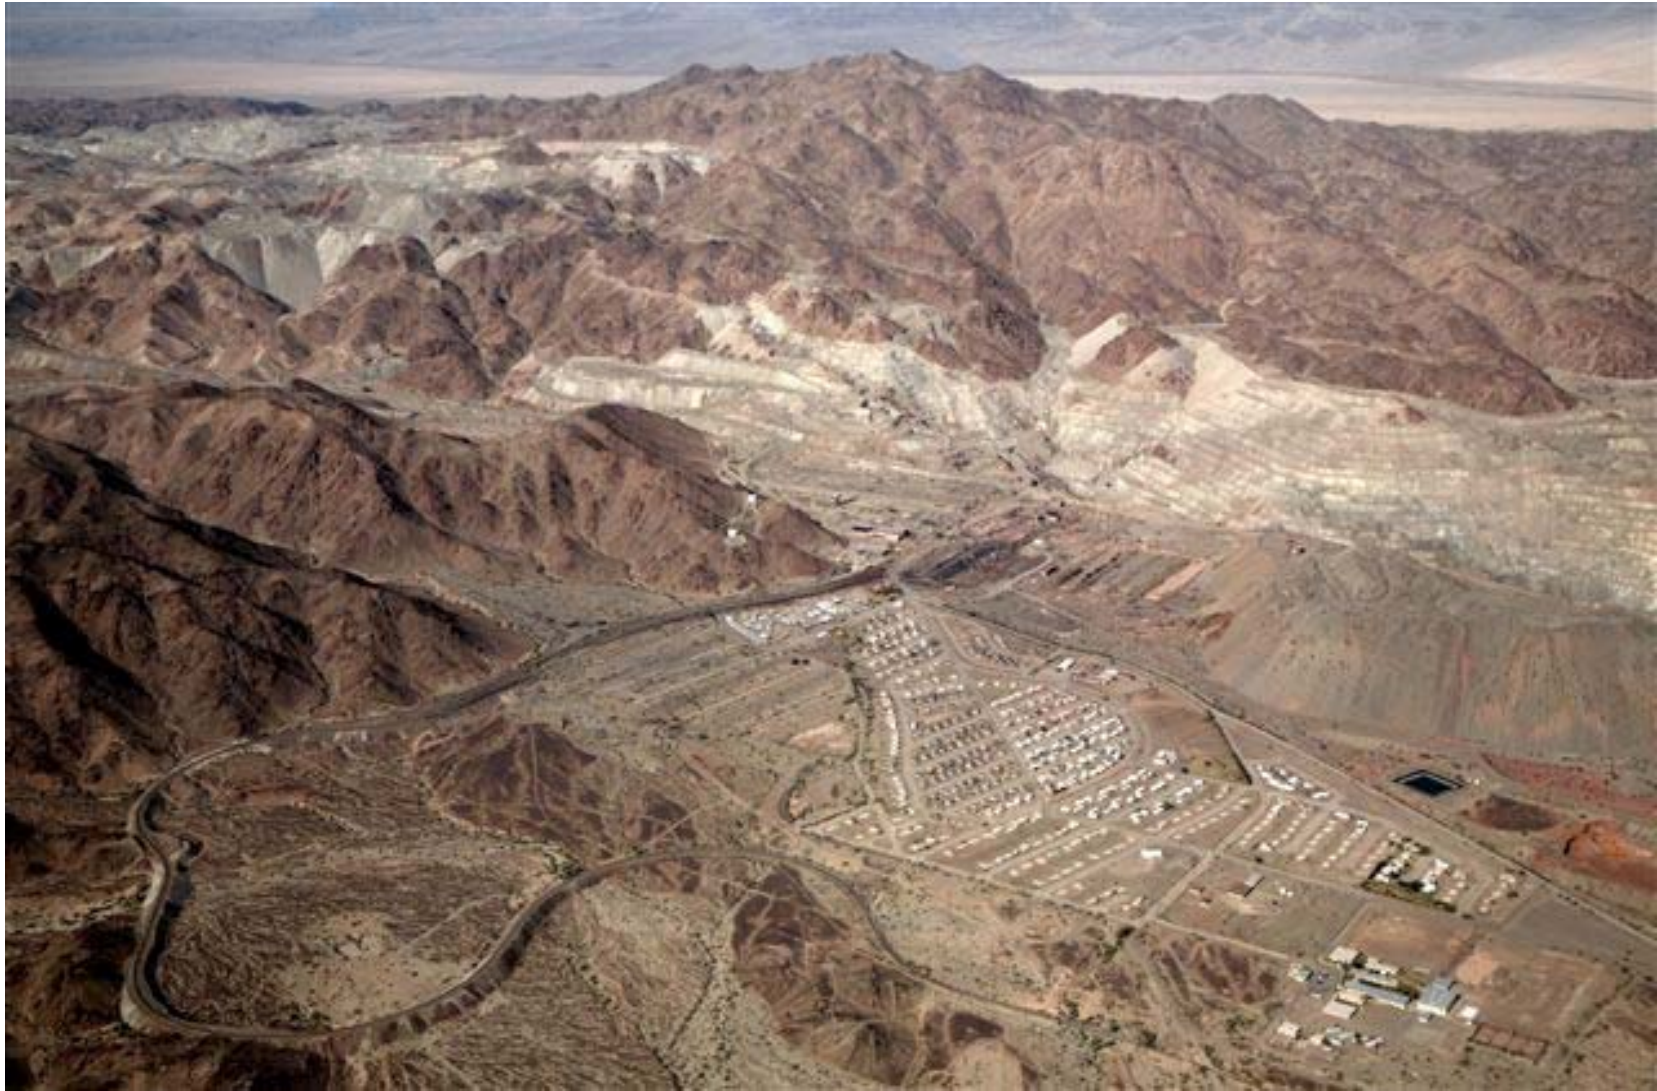
Figure 3.0-3. Aerial view of the town of Eagle Mountain.

The town of Eagle Mountain is a 460-acre townsite, fenced with controlled access, and is now owned by Kaiser (Figure 3.0-3). The townsite is mostly vacant (at the January 16, 2009 site visit conducted as a part of the FERC scoping process a Kaiser representative indicated that as many as nine of the houses may still be occupied).
