Attachment 1  
 Former Western Farm Service  
 405 W. Beach Street, Watsonville  
 Santa Cruz County

**GROUNDWATER INVESTIGATION CONTOUR MAP**  
 PREPARED FOR: [Redacted]  
 DATE: [Redacted]  
 PROJECT NUMBER: [Redacted]

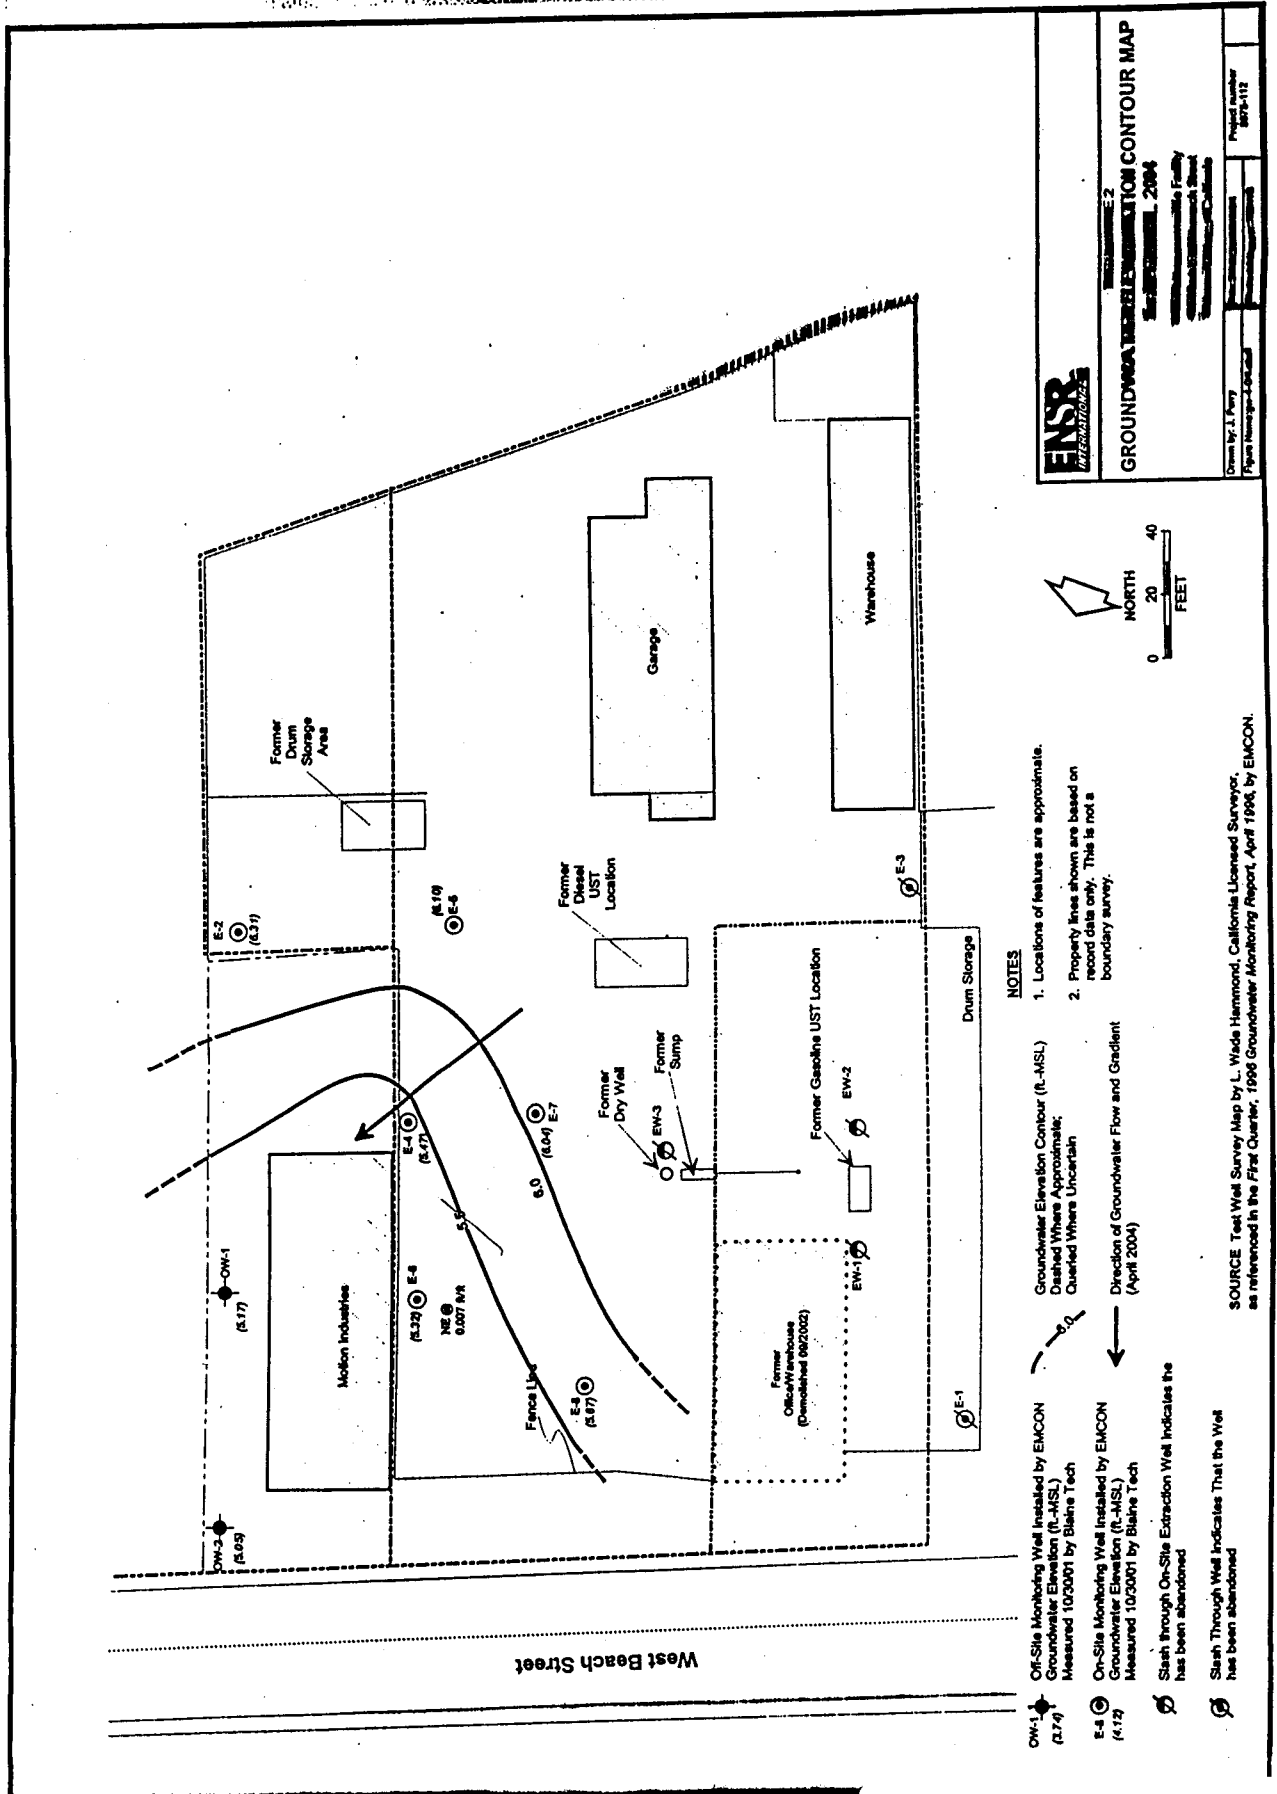
- OW-1 (E-1) On-Site Monitoring Well Installed by EMCON Groundwater Elevation (ft.-MSL) Measured 10/20/01 By Blaine Tech
  - E-4 (E-4) On-Site Monitoring Well Installed by EMCON Groundwater Elevation (ft.-MSL) Measured 10/20/01 By Blaine Tech
  - Stash through On-Site Extraction Well Indicates the Stash has been abandoned
  - Stash through Well Indicates That the Well has been abandoned
- Groundwater Elevation Contour (ft.-MSL) Dashed Where Approximate; Queried Where Uncertain
- Direction of Groundwater Flow and Gradient (April 2004)
- SOURCE: Test Well Survey Map by L. Wade Hammond, California Licensed Surveyor, as referenced in the First Quarter, 1998 Groundwater Monitoring Report, April 1998, by EMCON.
