**FIGURE 4**  
**DETECTED ANALYTES IN SOIL**  
 Toyota of Santa Barbara  
 5611 Hollister Avenue  
 Goleta, California  
 Addendum Additional Soil Characterization

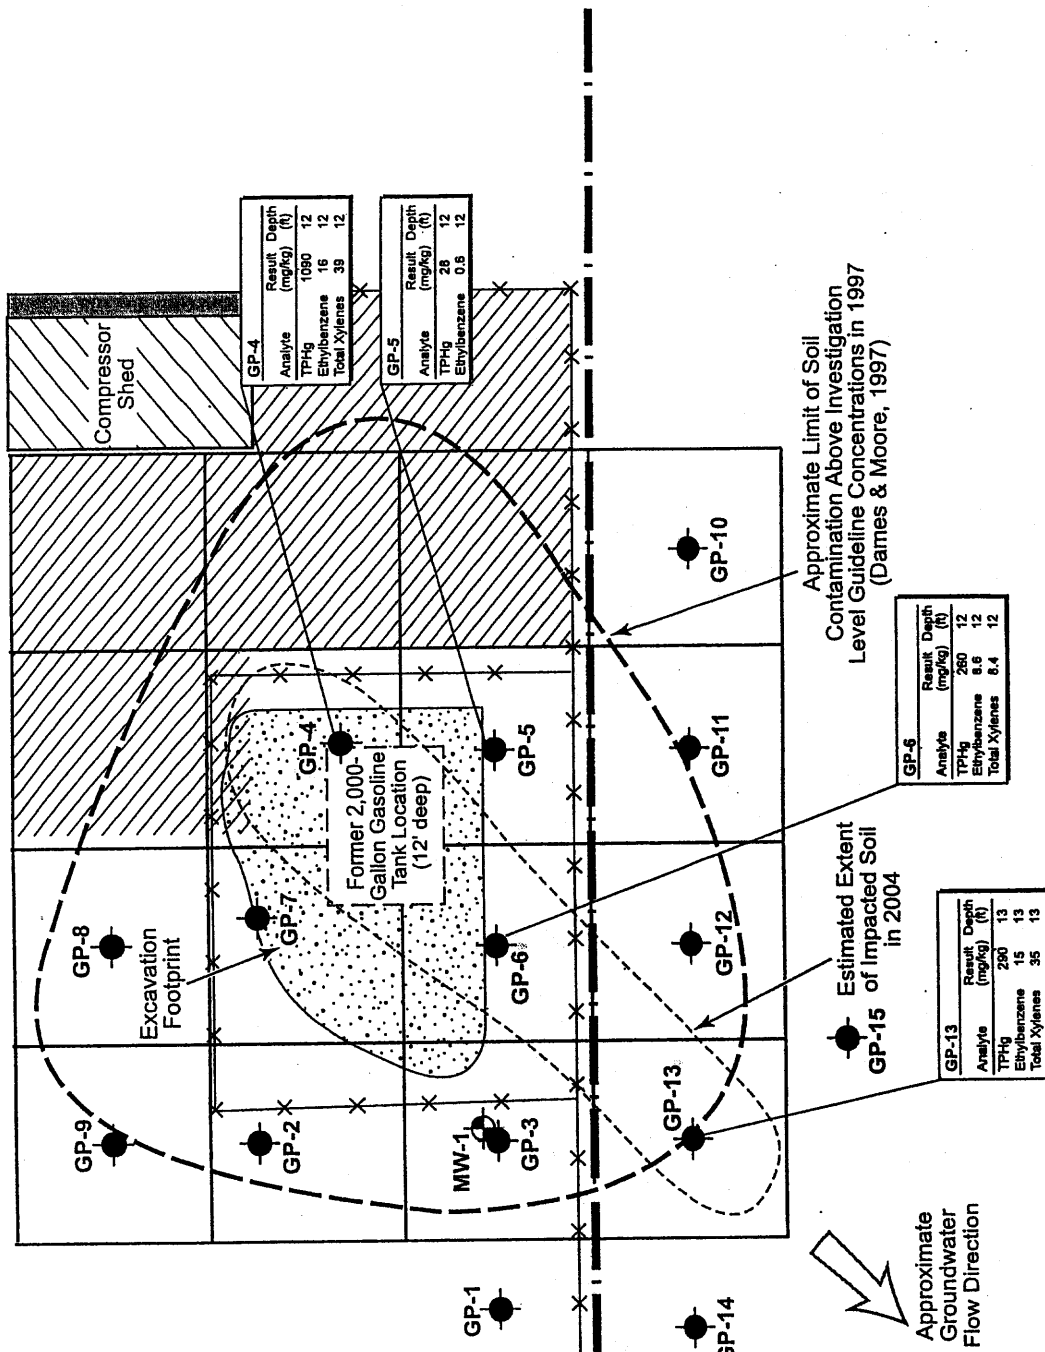
Approximate Limit of Soil Contamination Above Investigation Level Guideline Concentrations in 1997 (Dames & Moore, 1997)

Estimated Extent of Impacted Soil in 2004

Excavation Footprint

Former 2,000-Gallon Gasoline Tank Location (12' deep)
