CALIFORNIA REGIONAL WATER QUALITY CONTROL BOARD  
CENTRAL VALLEY REGION

CLEANUP AND ABATEMENT ORDER NO. R5-2025-0702

FOR  
JOHN ROCHETTE  
ASSESSOR'S PARCEL 704-110-002-000  
SHASTA COUNTY

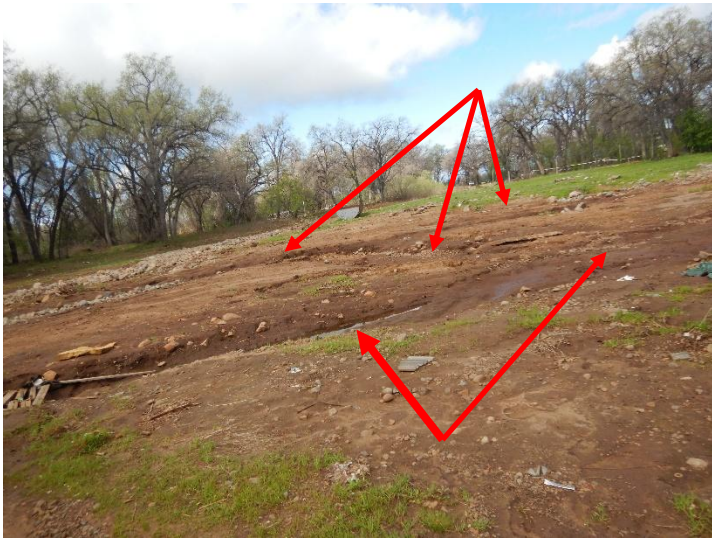
- a. Discharge of sediment (D1) to Lack Creek from the graded and disturbed area on the northern portion of the Site (Graded Area) as evidenced by the erosion and gulying through the bare soil towards Lack Creek (Appendix A, Figure 1 and Appendix B, Photos 1 – 2).

Photo 1. Red arrows show examples of the erosion and gully through the graded and disturbed area (Graded Area).

- iii. Methods to stabilize and prevent sediment discharges from the graded and disturbed area on the northeastern portion of the Site, such as regrading, installation of BMPs, or revegetation with regionally native vegetation or similar native species.

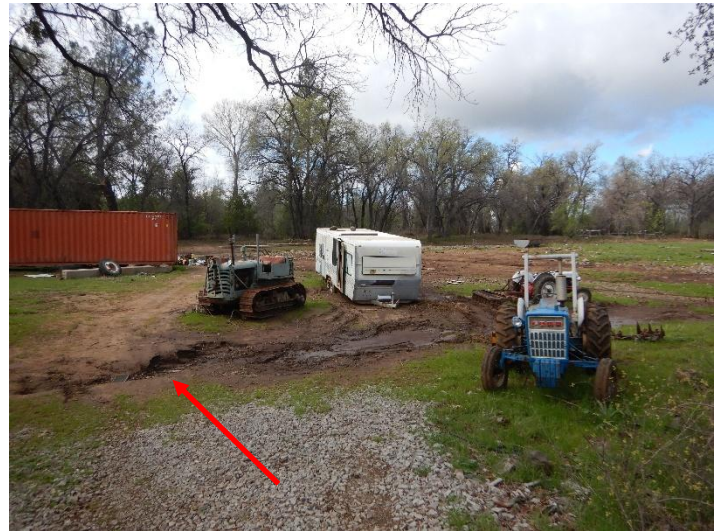
Photo 2. Red arrow shows gully continuing downslope of Photo 1, through the Graded Area, which discharged directly into Lack Creek (D1).

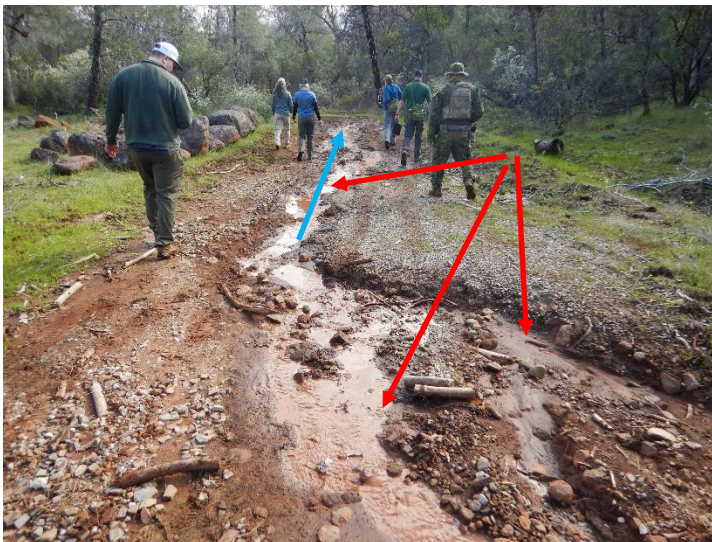
- b. Discharges of sediment (D2) from unmaintained access roads on the southern portion of the Site that were eroding, rilling and gulying, and hydrologically connected to Lack Creek (Appendix A, Figure 1 and Appendix B, Photos 3 – 4).

Photo 3. Red arrows show gully in one of the unmaintained access roads that was hydrologically connected and discharging sediment to Lack Creek. Blue arrow shows the flow direction of runoff towards Lack Creek.

- iv. Plan and details to hydrologically disconnect access roads from watercourses and installation of BMPs to minimize erosion, rilling and gullyng, and prevent sediment discharges to watercourses.

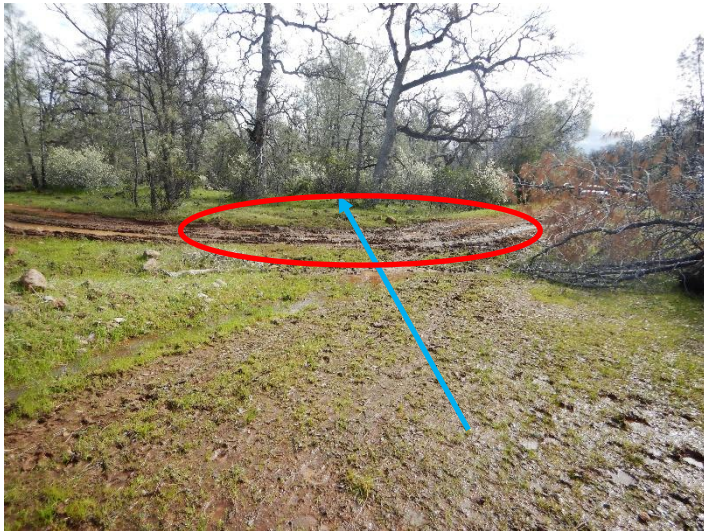
- c. Discharges from ford-type watercourse crossings (X1 and X2) on the southern portion of the Site that lacked best management practices (BMPs) to prevent erosion and sediment discharge from roadway surface (Appendix A, Figure 1 and Appendix B, Photos 5 – 6).

Photo 5. Red oval shows a ford-type watercourse crossing (X1) that lacked best management practices (BMPs) to prevent erosion and sediment discharge from roadway surface. Blue arrow shows...

- v. Identification of all watercourse crossings on Site, and proposed improvements for each crossing to prevent discharges and threats of discharge of sediment to watercourses.

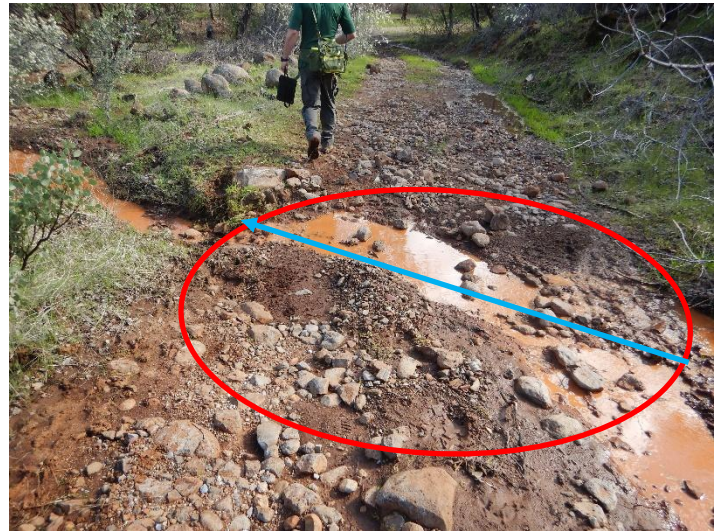
Photo 6. Red oval shows ford-type watercourse crossing (X2) that lacked BMPs to prevent erosion and sediment discharge from roadway surface. Blue arrow shows direction of streamflow.

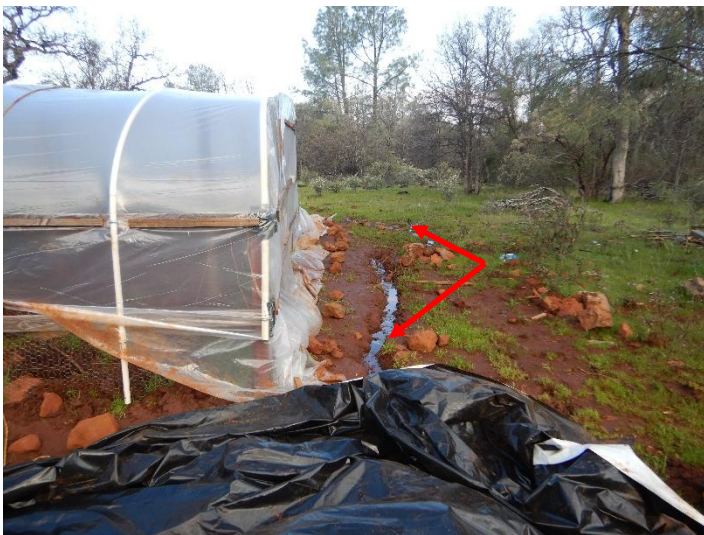
- d. Discharges of sediment from disturbed cultivation area (CA1) and trenches installed around the hoopouses on the southern portion of the Site that were hydrologically connected to Lack Creek (Appendix A, Figure 1 and Appendix B, Photos 7 – 8).

Photo 7. Red arrows show runoff and discharges of sediment from the disturbed cultivation area and trenches installed around the hoopouses.

- vi. Methods to stabilize and prevent sediment discharges from the disturbed cultivation area and trenches around the hoopouses, such as regrading, installation of BMPs, or revegetation with regionally native vegetation or similar native species.

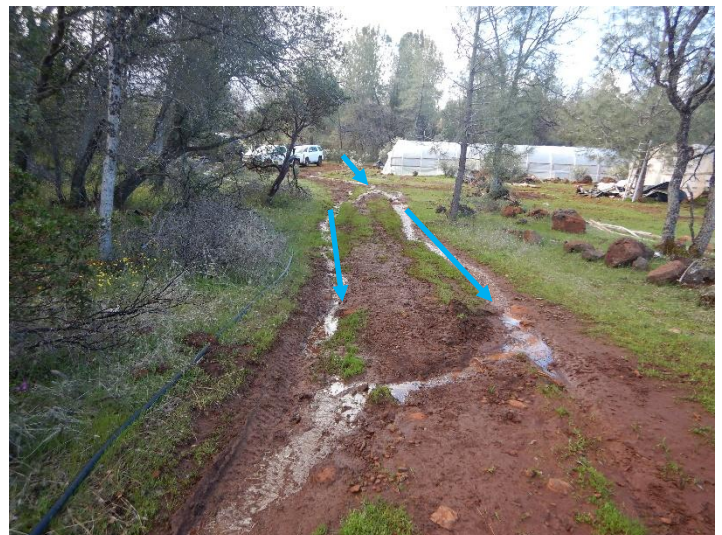
Photo 8. Blue arrows show runoff, erosion and sediment discharge from the disturbed cultivation area, and trenches installed around the hoopouses that were hydrologically connected to Lack Creek.

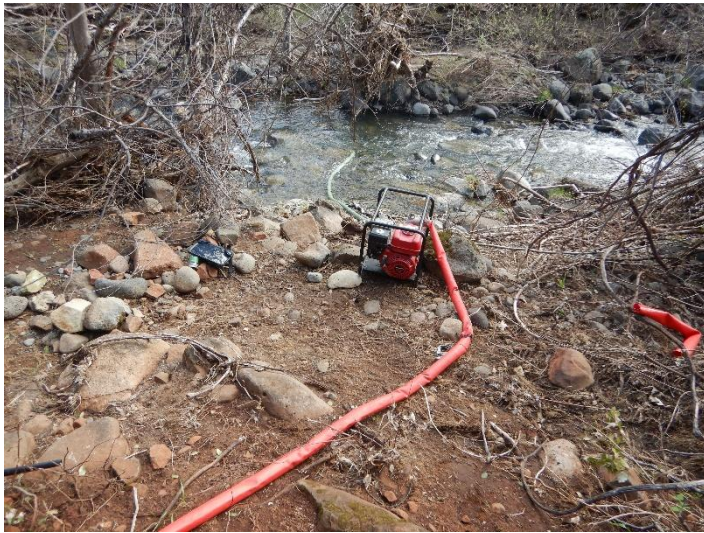
- e. Point of Diversion (POD) on the southern portion of the Site, including gas-powered pump and associated piping, within Lack Creek and riparian zone is a discharge of wastes to waters of the state (Appendix A, Figure 1 and Appendix B, Photo 9).

Photo 9. Point of Diversion (POD), including gas-powered pump and associated piping, within Lack Creek and its riparian zone.

- a. The RMMP shall include, at a minimum, plans for the following items:
    - i. POD, cultivation infrastructure and waste, gas-powered equipment, fuel containers, petroleum products, fertilizers, pesticides, chemicals, and miscellaneous refuse and debris to be removed from watercourses and riparian zones. Materials should be either properly stored on Site or disposed of at an authorized landfill or other disposal site in compliance with state and local laws, ordinances, and regulations.

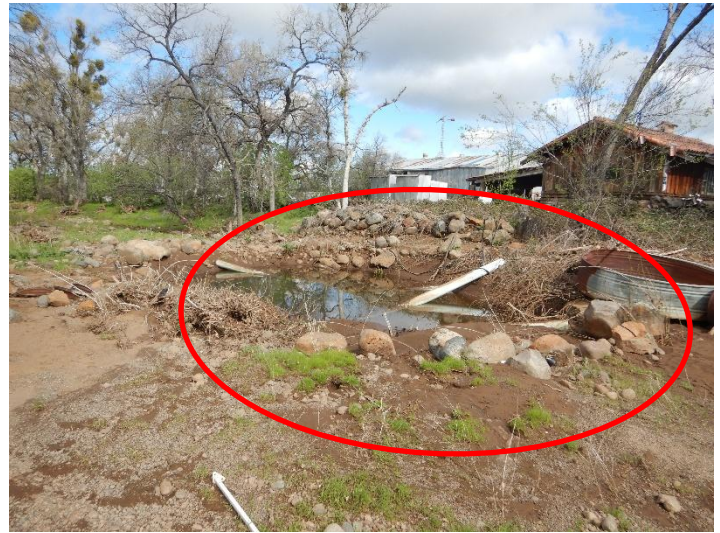
- f. Evidence of discharge of potential septage from a residence (Residence) to an unlined excavated pond (Pond 2) on the northern portion of the Site that threatens groundwater, a water of the state (Appendix A, Figure 1 and Appendix B, Photo 10 – 11).

Photo 10. Red oval shows unlined excavated pond (Pond 2) with evidence of potential septage discharge from the upslope residence (Residence).

- vii. Cleanup and remediation of any discharges of septage, evaluation of septage system and associated pond, and necessary remediation required to prevent future discharges of septage.

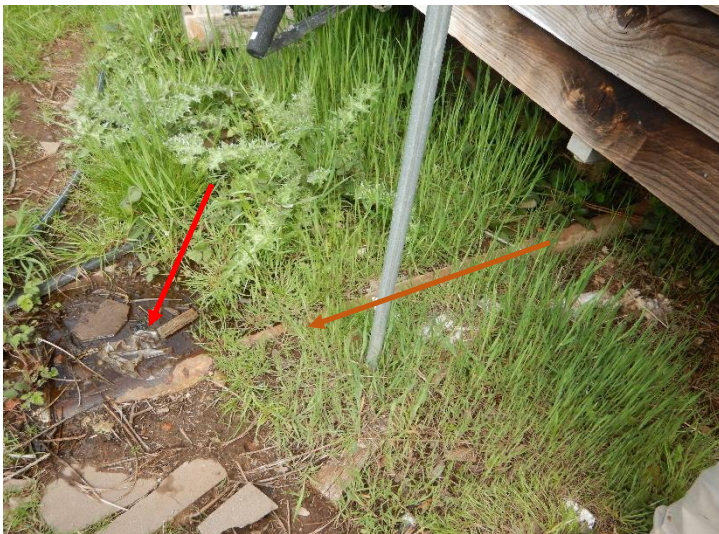
Photo 11. Brown arrow shows septic pipe running from Residence towards Pond 2. Red arrows show potential septage discharge as evidenced by standing water and toilet paper.

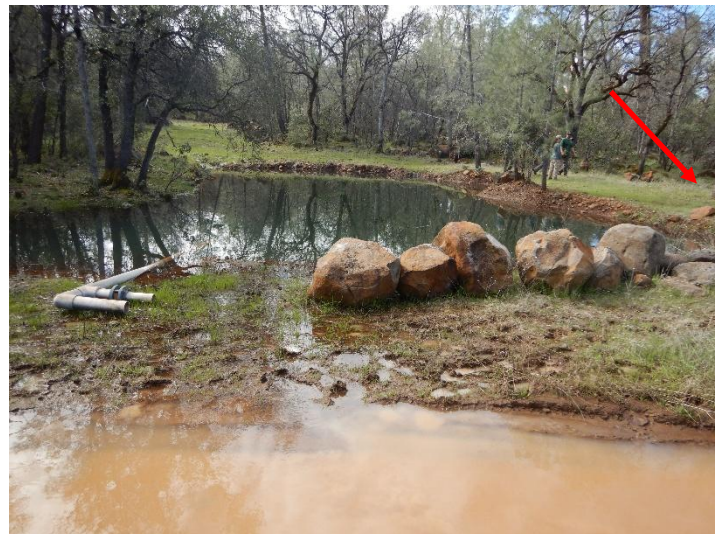
- g. Improperly designed and constructed off-stream reservoir (Pond 1) and excavated discharge ditch (Ditch) on the southern portion of the Site, which presents a threat of discharge if it were to deteriorate, leak, overtop, or otherwise fail (Appendix A, Figure 1 and Appendix B, Photo 12 – 13).

Photo 12. Off-stream reservoir (Pond 1). Red arrow shows the location of the excavated discharge ditch (Ditch).

- viii. Evaluation of off-stream reservoir (Pond 1) and excavated discharge ditch, and proposed remediation including installation of BMPs, to prevent threats of discharge of sediment to watercourses.

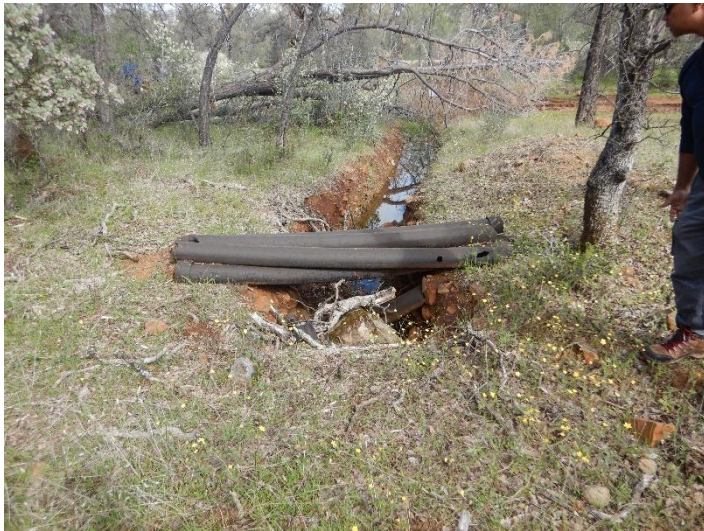
Photo 13. Close-up photo of Ditch, adjacent to Pond 1, shown by red arrow in Photo 12.

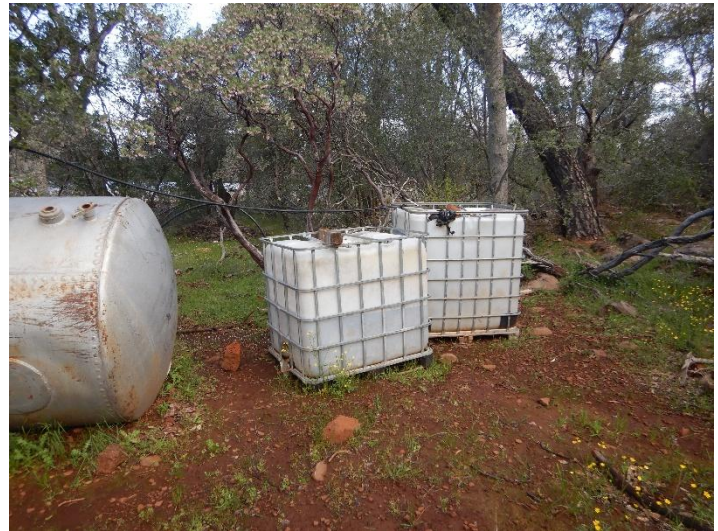
- i. Improperly designed and constructed water storage and nutrient mixing tanks that lacked secondary containment or overflow protection to prevent discharges of wastes if they were to deteriorate, leak, or otherwise fail (Appendix B, Photo 14).

Photo 14. Improperly designed and constructed water storage and nutrient mixing tanks and that lacked secondary containment or overflow protection.

- ix. Removal or proper installation and containment of water storage and nutrient mixing tanks to prevent future threats of discharge.
  - x. Removal or proper storage of all gas-powered equipment, fuel containers, petroleum products, construction debris, cannabis cultivation-related infrastructure and debris, fertilizers, pesticides, chemicals, household garbage, and miscellaneous refuse and debris to prevent discharges. Disposal of these items must be at an authorized landfill or other disposal site in compliance with state and local laws, ordinances, and regulations.

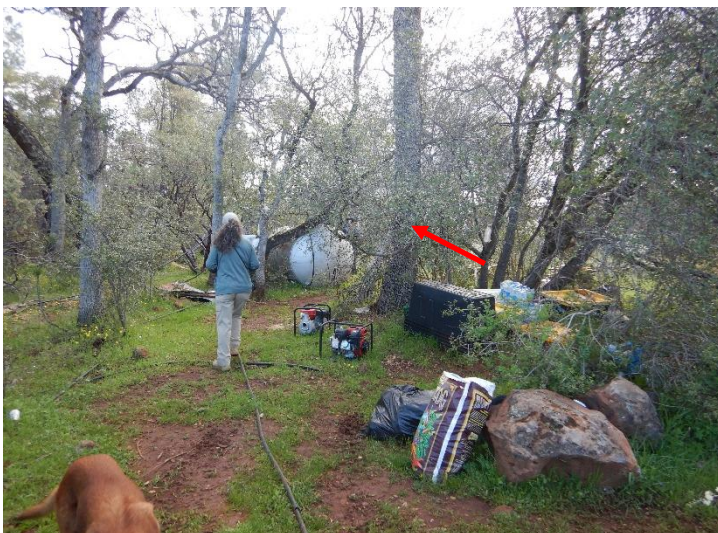
- j. Improperly stored gas-powered pumps and equipment, fuel containers, petroleum products, batteries, fertilizers, pesticides, chemicals, and miscellaneous refuse and debris lacking cover from the elements or secondary containment to prevent discharges of waste to nearby watercourses and groundwater (Appendix B, Photo 15).

Photo 15. Example of improperly stored gas-powered pumps and equipment, petroleum products, fertilizers, cultivation related materials, and miscellaneous refuse and debris.

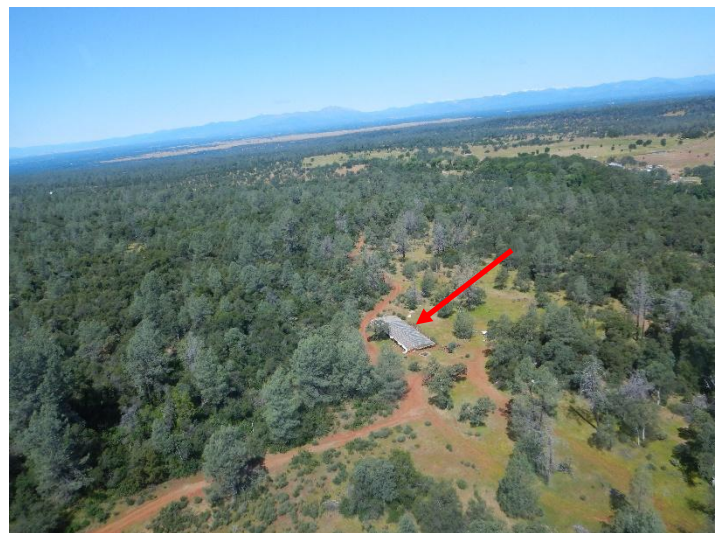
8. On 22 May 2024, Central Valley Water Board staff participated in a overflight of the Discharger's Site. During the overflight staff documented a hoophouse and other activities consistent with active cannabis cultivation within CA1 on the southern portion of the Site where cannabis cultivation activities were documented the previous year (Appendix B, Photo 16).

Photo 16. Overflight photo from 22 May 2024. Red arrow shows a hoophouse and other grading activities consistent with active cannabis cultivation within CA1, where cannabis cultivation activities were documented the previous year.
