California Regional Water Quality Control Board, Lahontan Region

Bishop Creek Vision Plan

A water quality improvement plan to address fecal indicator bacteria affecting Bishop Creek, Inyo County

September 2022

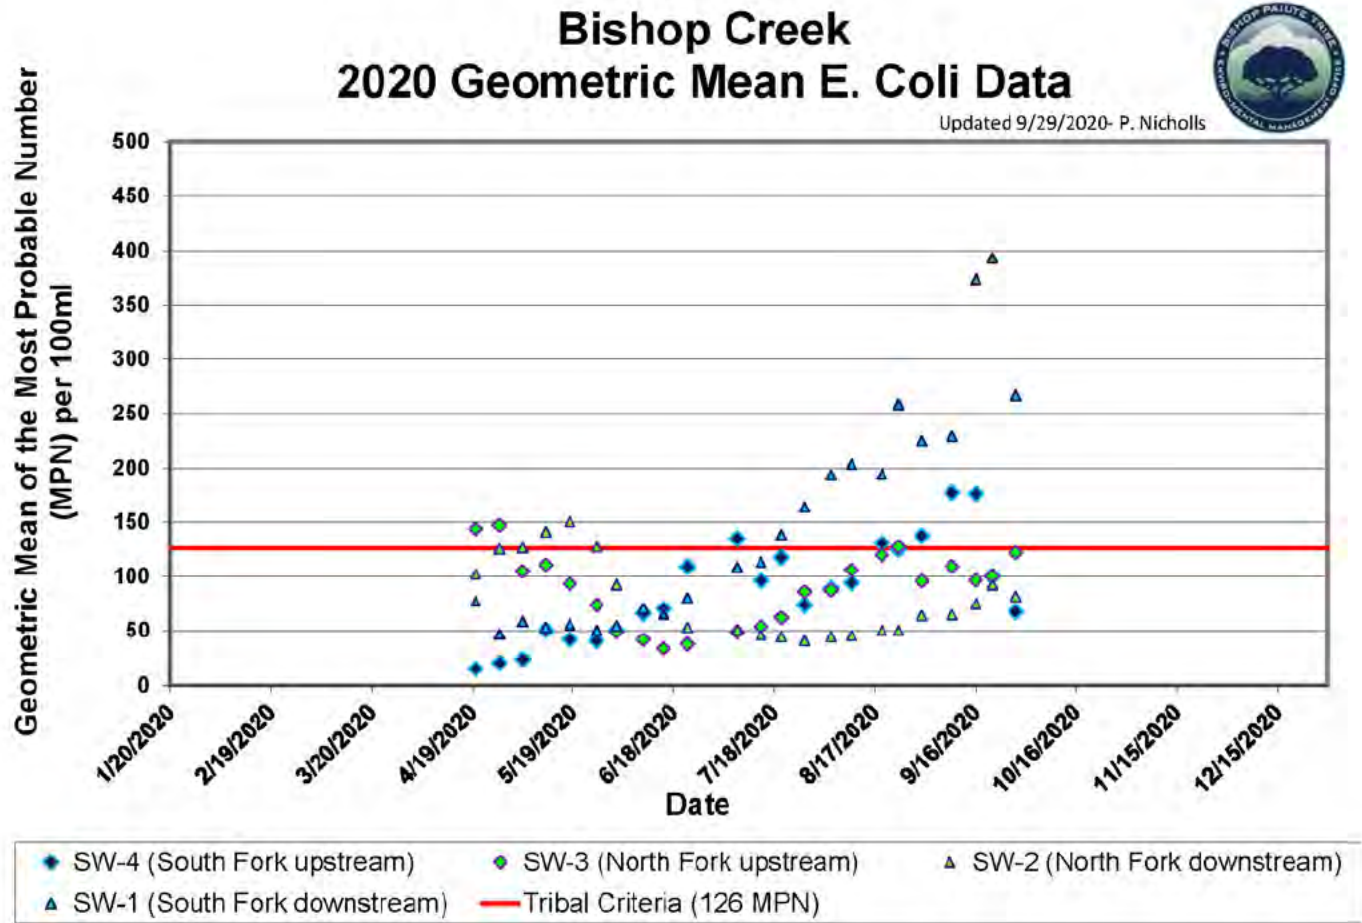
Figure 5-7 2020 *E. coli* geometric means, Bishop Paiute Tribe EMO

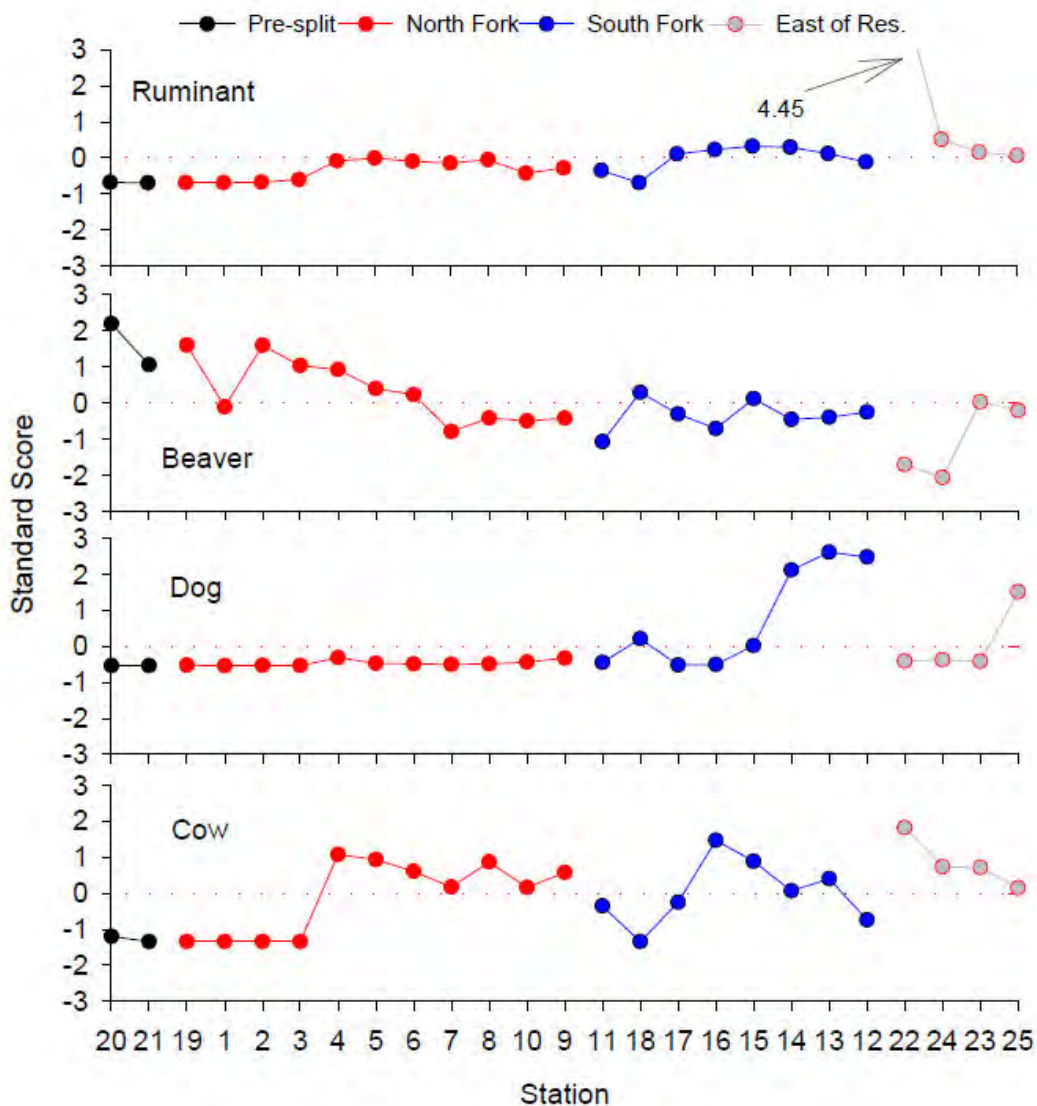
Figure 6-3 Standard score of genetic copies/100mL for each vertebrate non-human assay. Stations are depicted in a west-east progression, with each distinct portion of the creek represented by a different color. Positive values represent above average number of genetic copies and negative values represent below average gene copies. Y-axis values represents the number of standard deviations from the mean (credit: Eastern Sierra Fecal Indicator Bacteria Study (2016), Figure 10)

The LADWP report compared MST data for relative abundance across stations. This method allows an estimate of where each fecal source may be contributing most to FIB bacteria concentrations. Station-specific values were converted to a standardized score representing the number of standard-deviations from the mean each station's score represented. Positive values represent relatively abundant marker density and negative values represent relatively low marker density. It is important to note that, while the data has been converted to a common score, the scores are only comparable to scores originating from the same assay type. Scores are depicted in Figure 6-3.

Cow and beaver markers were the two markers in the LADWP dataset most frequently detected at higher concentrations (Figure 6-3). Ruminant markers were also detected regularly. Cow markers were detected frequently at all stations downstream of station 4 on the North Fork and station 17 on the South Fork. Ruminant markers tended to increase in concentration moving downstream through the study area, increasing appreciably after the first incidence of grazing lands on both the north (station 3) and south (station 17) forks. Maximum ruminant marker concentrations were more than four standard deviations from the mean detected in the downstream portions of the North Fork. Ruminant markers were also detected in moderately high concentrations in the downstream portions of the South Fork. In comparison, beaver markers were relatively rare in the downstream portions of the study area but were detected in the western-most zones with relatively high abundance in upstream portions of the study area above the bifurcation of North and South Forks, and on the North Fork above grazing lands. It is important to note that *E. coli* FIB counts are generally low in the upstream zone, suggesting that beaver waste likely has relatively small impacts on FIB counts. These data support the conclusion that beaver waste is unlikely to drive the FIB contamination which is responsible for violating WQOs and impairing REC-1 uses.

Dog markers were detected with high abundance in the middle (stations 14-16) and downstream areas (station 25) of the South Fork, possibly related to the residential areas occurring in the middle reach downstream of Reata Lane and upstream of the Tribe, and due to recreational activities associated with pet dogs around Bishop City Park. Dog markers were relatively rare in other areas. Additionally, general bird markers were also detected relatively rarely throughout the study area and were concluded to likely not impact the FIB issues affecting Bishop Creek.

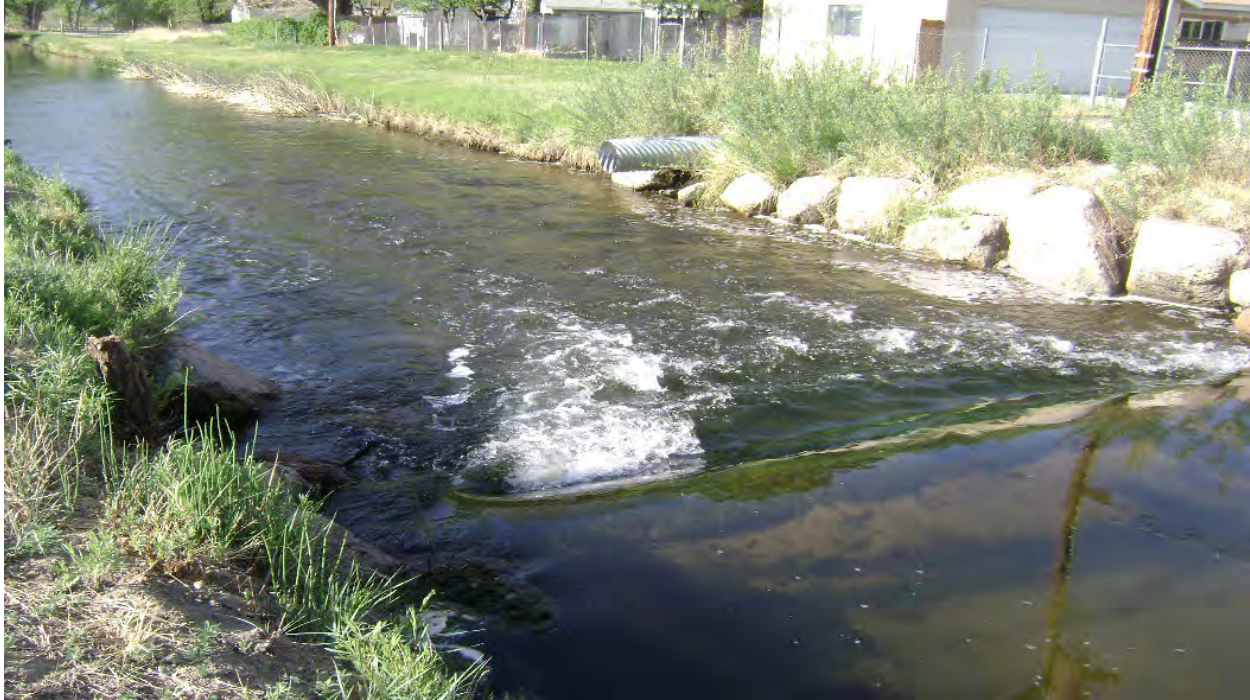
Photo 7-1 Concrete encased clay pipe submerged in water at a canal crossing. City of Bishop planned to replace this 15-inch clay pipe with a new 18-inch plastic pipe (more information contained in Section 7.5.3). *Photo credit: John Morales/Lahontan Water Board*

The City of Bishop sewer system has adequate capacity for current and future flows. One pending capital improvement is the initiation of a pipeline improvement canal crossing project (described in [Section 7.5.3](#)) that will replace the existing clay pipeline with a new and larger plastic pipeline that will connect one manhole to another across the canal.
