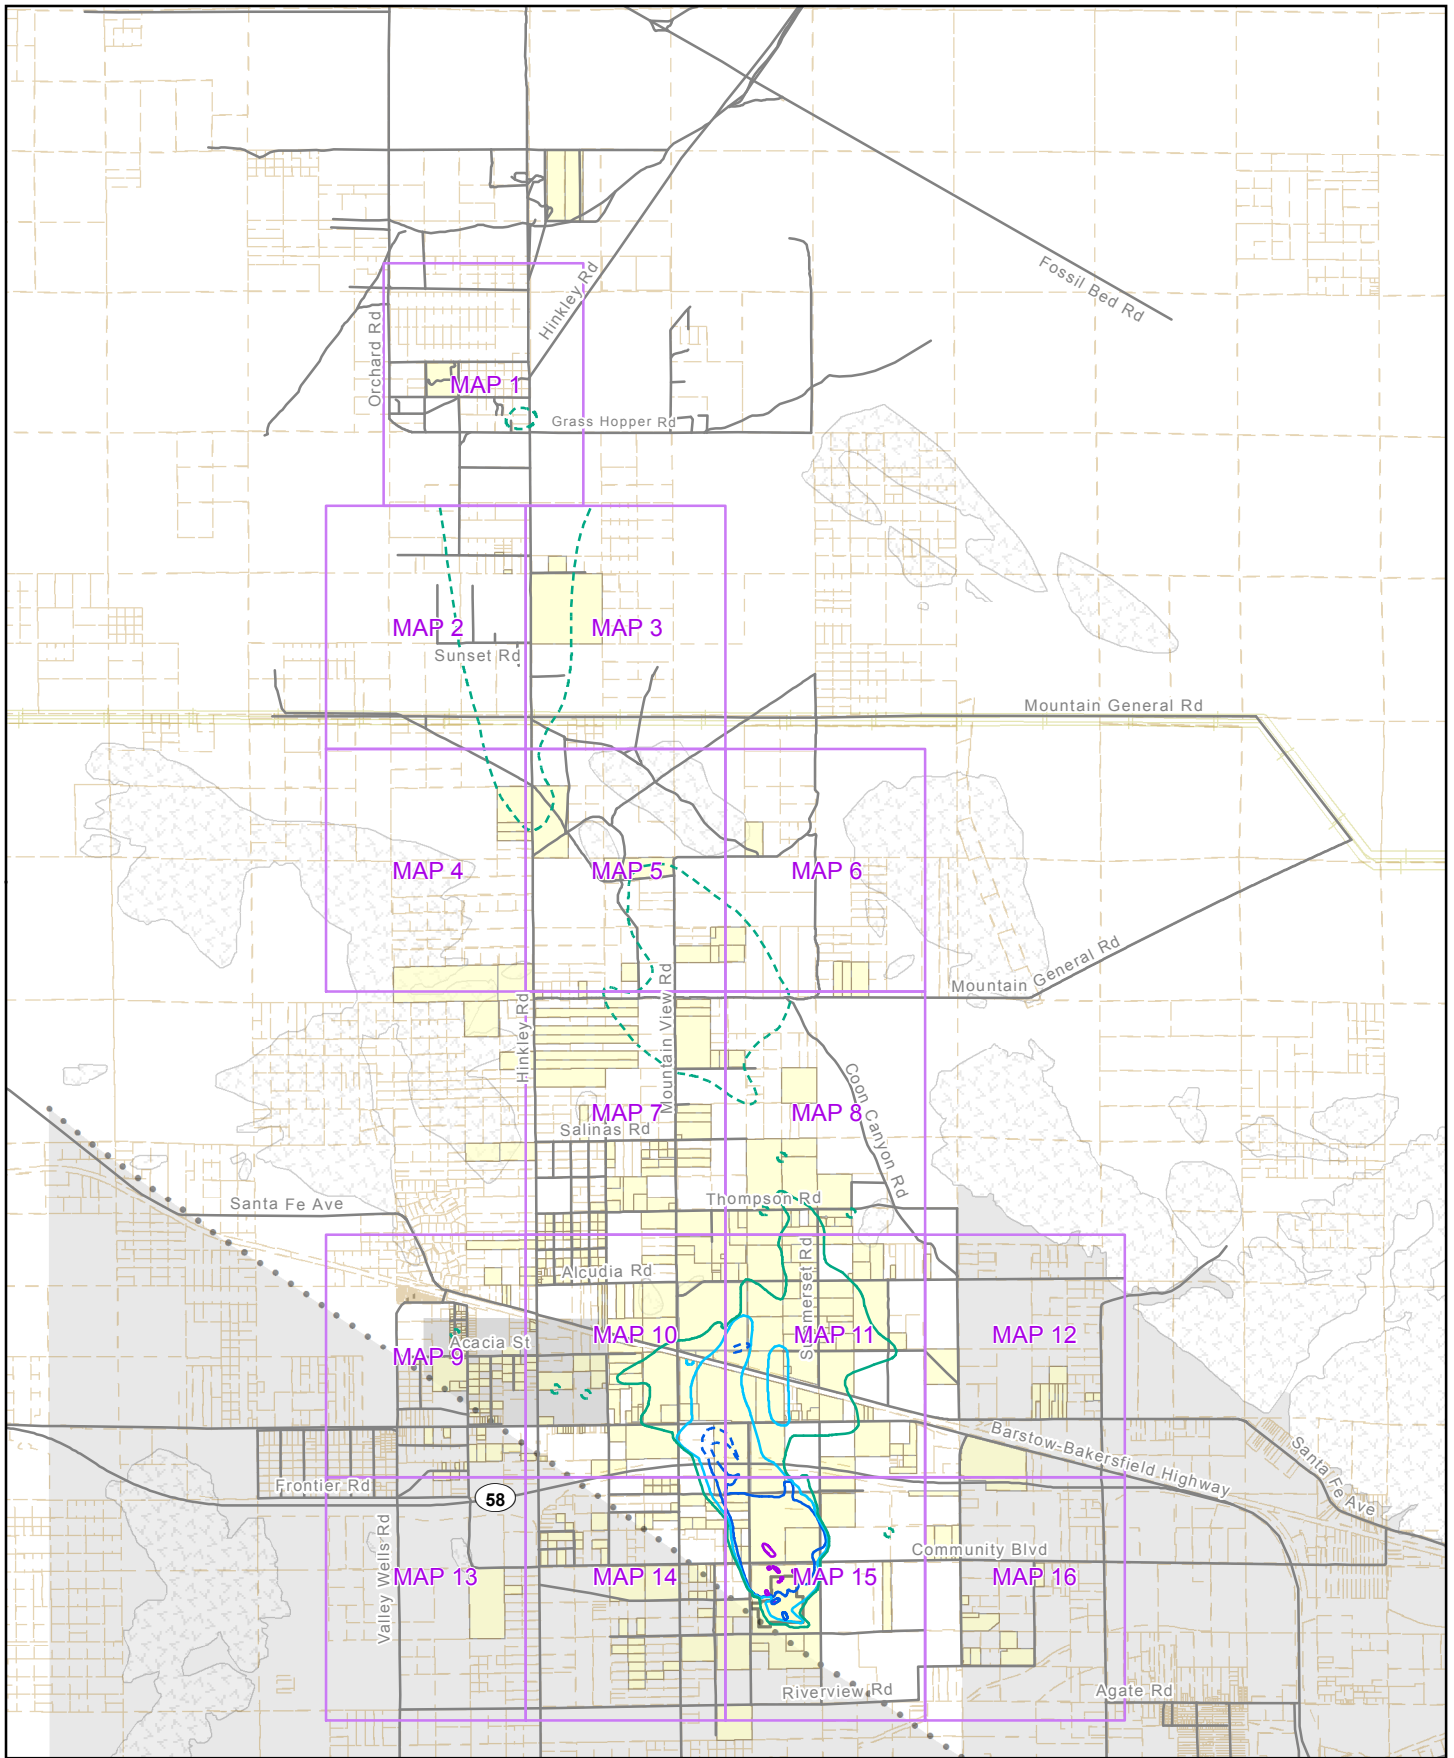
### Map Grid Index

1.6/1.6 Cr(VI)/Cr(T) concentrations in µg/L; maximum of primary and duplicate samples during Fourth Quarter 2017 sampling.  
 (260/260) Data in parentheses are from previous reporting period.  
 See Table E-1 for sample dates.

1. Chromium results are shown for Site-wide Groundwater Monitoring Program and domestic wells sampled in the Fourth Quarter (October through December) 2017 monitoring period. For wells sampled multiple times during the reporting period, the most recent results are shown.

2. The concentration contours are based on Fourth Quarter 2017 chromium results for the groundwater monitoring and extraction wells that are completed in the shallow zone and deep zone of the Upper Aquifer as noted on Figures 5-1 and 5-2. Results for domestic wells (brown-colored labels) were not used for chromium plume contouring, except for those in the northern disputed plume areas, pursuant to the Lahontan Regional Water Quality Control Board's Cleanup and Abatement Order dated November 4, 2015 (Water Board 2015).

3. Pursuant to the Lahontan Regional Water Quality Control Board's Cleanup and Abatement Order dated November 4, 2015 (Water Board 2015), groundwater monitoring wells are not used for chromium contouring if they are located in the areas southwest of the Lockhart Fault and on or east of Dixie Road. Monitoring wells sampled southwest of Lockhart Fault and east of Dixie Road were sampled in support of United States Geological Survey background chromium investigations.

4. Chromium plume contours in the general area south of Highway 58, were developed using a larger set of monitoring data which is presented in the the Fourth Quarter 2017 Monitoring Report for the In Situ Reactive Zone and Northwest Freshwater Injection Projects (Arcadis 2018). Select wells from that program are shown here for reference.

5. Chromium contours were changed on the eastern side of the plume during the Third Quarter of 2016. These changes were made based on discussions with the Water Board, requirements in the Order and professional judgement. These changes to the plume contours on the eastern side of the plume reflect a revised interpretation of monitoring data and do not indicate plume expansion.
