Attachment A to Settlement Agreement and Stipulation for Entry of Administrative Civil Liability Order No. R9-2023-0017: Penalty Calculation Methodology

B. Sanitary Sewer Overflow Background

C. Violation 1: Unauthorized Discharge of 11.23 Million Gallons of Untreated Sewage to Waters of the State and United States.

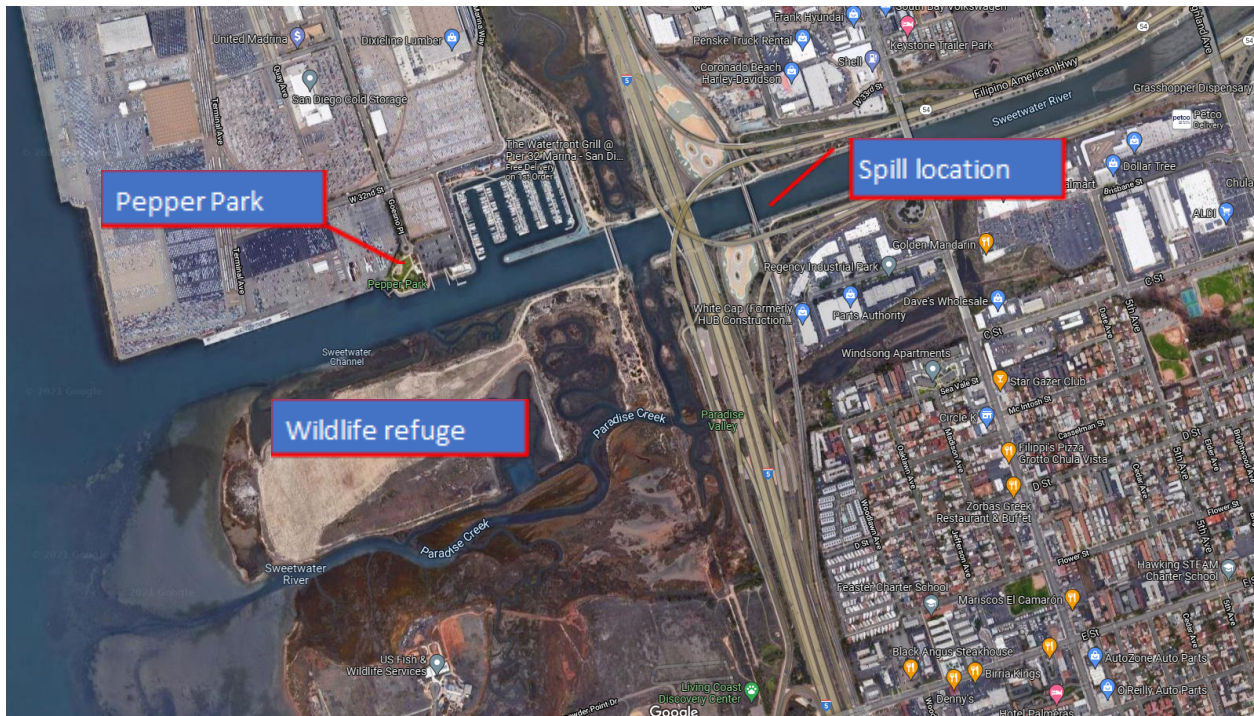
On April 10-11, 2020, after rainfall totaling almost 6 inches over 7 days (as measured by the County of San Diego’s Bonita rain gauge station²), the City’s sanitary sewer system failed, resulting in a sanitary sewer overflow (SSO) of 11.23 million gallons directly into the Sweetwater River. The spill release point is located approximately one-quarter mile upstream of the mouth of the Sweetwater River, where it joins the lower San Diego Bay. The area surrounding the mouth of the Sweetwater River includes recreational areas and wildlife habitat. Pepper Park, which is located on the north side near the mouth of the river, is a community park that has a fishing pier, boat dock, playground, and picnic tables. On the south side of the river mouth is a National Wildlife Refuge that includes high value wetlands with important ecological functions. Figure 1 shows the spill location in relation to these areas and the lower San Diego Bay.

Figure 1. Spill release point near the mouth of the Sweetwater River (Google satellite photo).

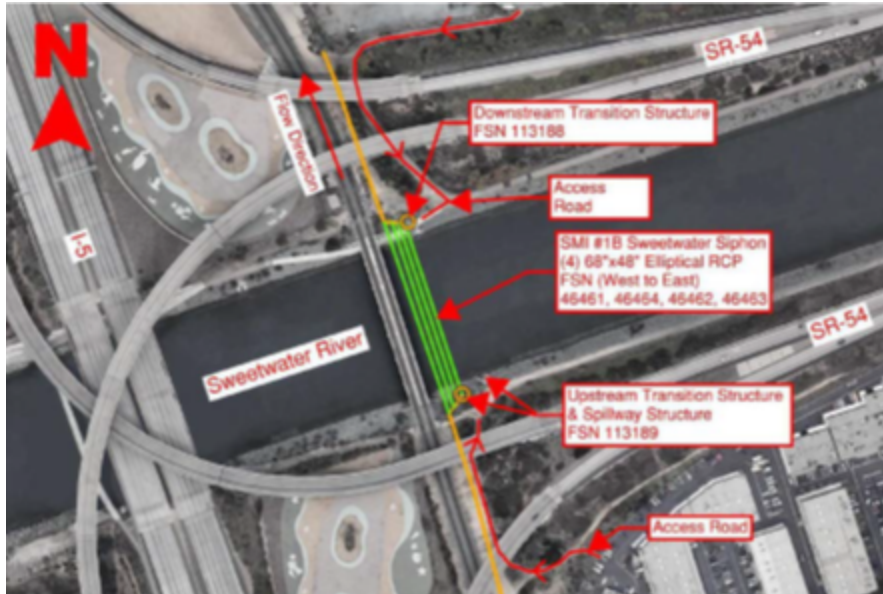
The SSO occurred at the south side of the Sweetwater River at an emergency overflow location, known as the south siphon transition structure. This structure carries wastewater from a trunk sewer northward, and from there the wastewater traverses roughly 400 feet across the River through four elliptical siphon barrels. The wastewater then passes through the north siphon transition structure into a trunk sewer, and onward to Pump Station 1 (PS1). Figure 2 shows the trunk sewers in yellow and the siphon structures in green.

Figure 2. Satellite view of City infrastructure and Sweetwater River³
