Attachment A to Settlement Agreement and Stipulation for Entry of Administrative Civil Liability Order No. R9-2025-0053

Lake Hodges March 2023 Sanitary Sewer Overflow Penalty Calculation Methodology

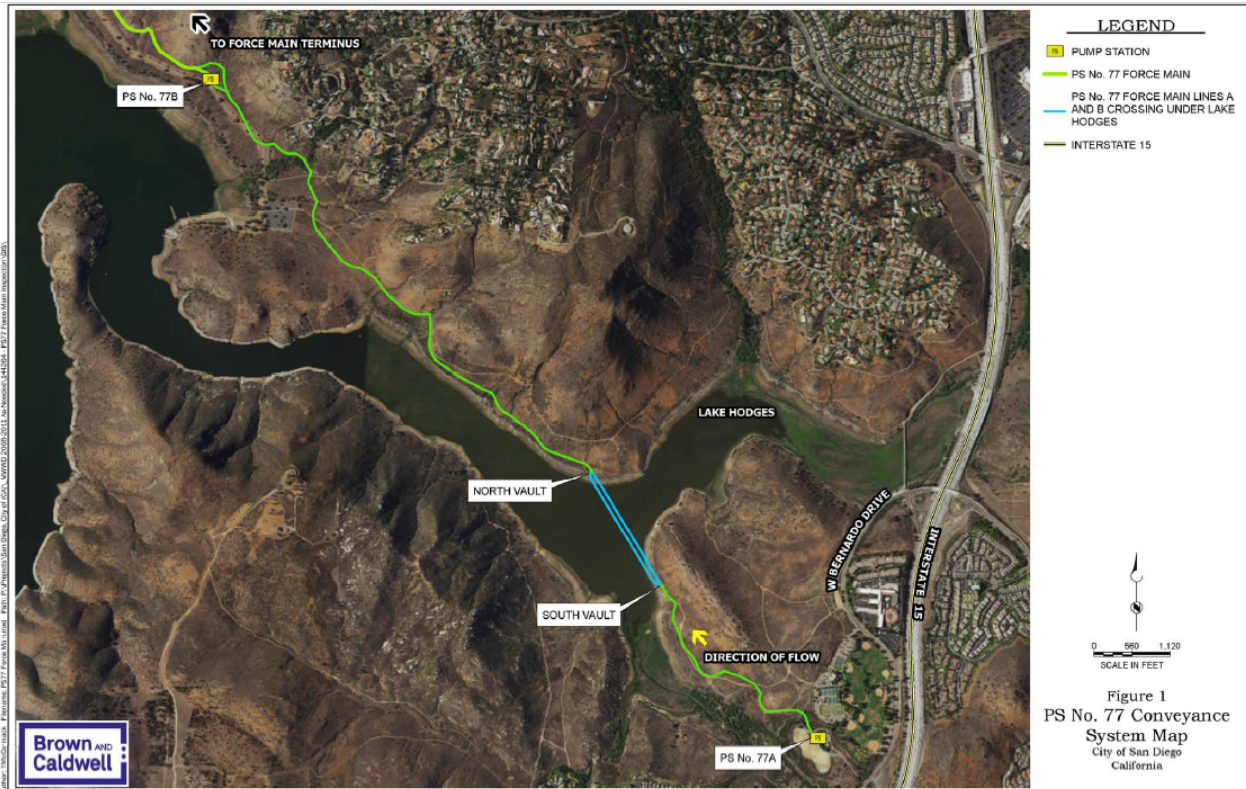
Figure 1. Pump Station 77 Conveyance System Map⁴

Pump Station 77A is located on W. Rancho Bernardo Road, about 0.5 mile southwest of Lake Hodges, a water of the state and United States. Pump Station 77A pumps sewage westward through a 20-inch force main to the South Force Main Vault located on the south side of Lake Hodges, where it splits into two 16-inch force mains about 2,000 feet in length that traverse the lake under water. The two force mains, shown in blue in Figure 1, traverse the lake in parallel then connect at the North Force Main Vault along the north shore of the lake.

⁴ Figure 1 taken from *Pump Station No. 77 Force Main Condition Assessment Report*, March 22, 2017.

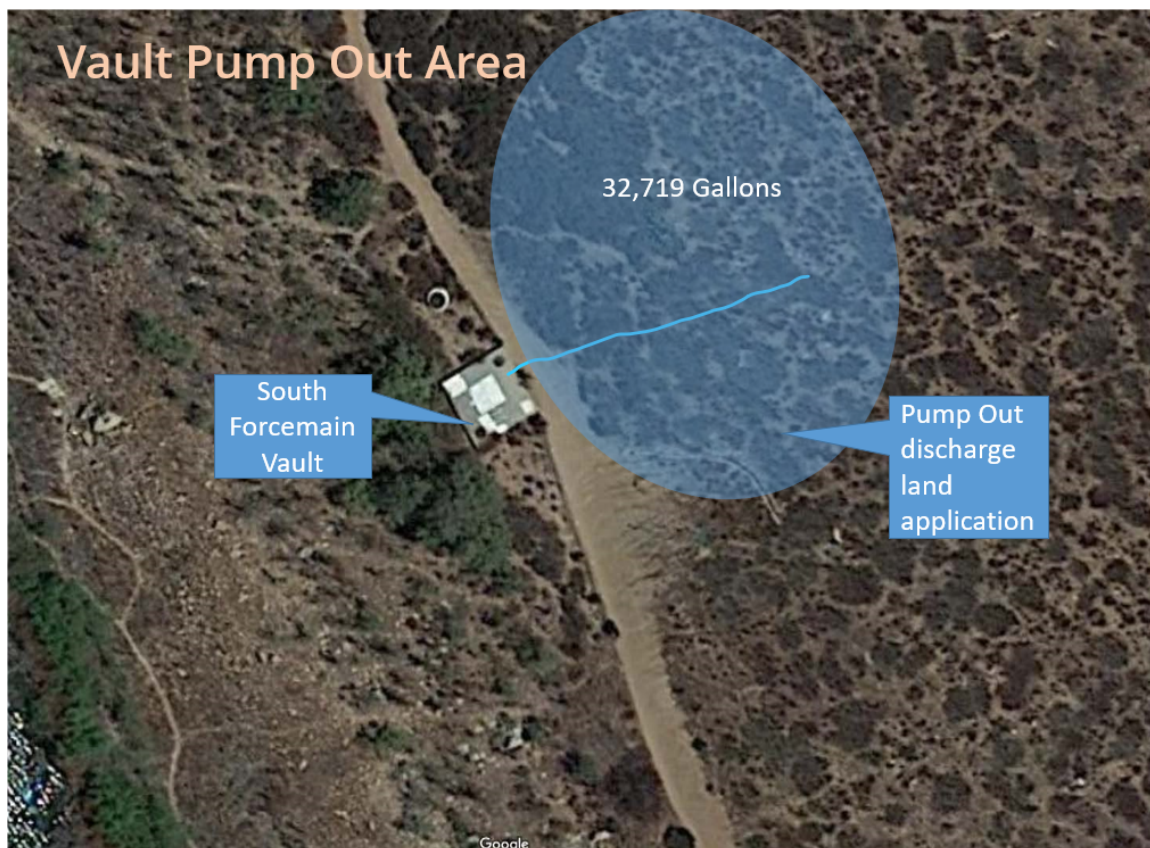
Figure 2. South Force Main Vault Pump-Out Area⁵

The City discovered that the South Force Main Vault was full of sewage and had to use portable pumps to dewater the vault to gain access to the failure area. Heavy trucks and equipment could not access the vault due to muddy roads, so the City pumped the trapped sewage uphill, about 30-50 feet away from the vault, into a bermed containment area on bare soil away from the lakeshore, where it was allowed to infiltrate into the ground (see Figure 2). The City continued pumping sewage uphill to the containment area for two days because the overflow structure at Pump Station 77A had reached capacity. Finally, the City used boats and barges to access this area of Lake Hodges to remove sewage from the vault by transporting it in 250-gallon totes and returning it to the sanitary sewer system.

The City identified the cause of the leak as a fractured cast iron tee connection within the South Force Main Vault. The City experienced technical difficulties with the repair, most notably because the main access roads had been washed out from recent rain events. The City had to construct an emergency access road to reach the vault. The emergency repair, which involved the installation of a temporary spool, was completed on March 31, 2023, seven days after the SSO was identified. In total, the City estimates that 53,169 gallons of untreated sewage were discharged from the South Force Main Vault. Of the total, 32,719 gallons were discharged to land uphill of the lake, 13,000 gallons were recovered by barge and returned to the collection system without ever reaching surface waters, and 7,450 gallons were discharged by gravity on the day the leak was discovered, half of which infiltrated into the ground and half of which (3,725 gallons) discharged into Lake Hodges and was not recovered.

⁵ Figure 2 taken from the City's response to Investigative Order No. R9-2023-0107.
