# Napa County Stream Maintenance Manual

Napa County Flood Control and Water Conservation District  
804 First Street  
Napa, CA 94559  
Contact: Rick Thomasser, P.G. Operations Manager  
707/259- 8600

Horizon Water and Environment  
1330 Broadway, Suite 424  
Oakland, CA 94612  
Contact: Ken Schwarz  
510/986-1851

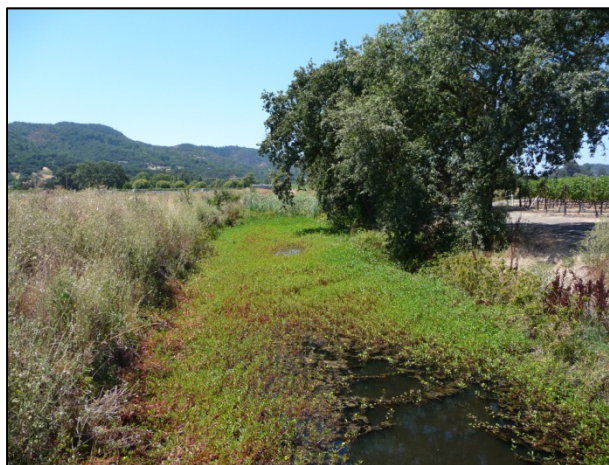
**Photo 2-1: Aquatic vegetation, primarily *Ludwigia*, in the Yountville Outfall.**

Species that may be found in or adjacent to such streams in the program area include torrent sedge (*Carex nudata*), giant chain fern (*Woodwardia fimbriata*), spicebush (*Calycanthus occidentalis*), and small-fruited bulrush (*Scirpus microcarpus*). Certain non-vascular plants, such as aquatic mosses and filamentous algae that are tightly attached to rocks by strong holdfasts, can survive the fast current. Low gradient, slow flowing streams and drainages in the program area support dense growth of aquatic vegetation such as *Ludwigia* (Photo 2-1), water plantain (*Alisma plantago-aquatica*), and smartweeds (*Polygonum* spp.).

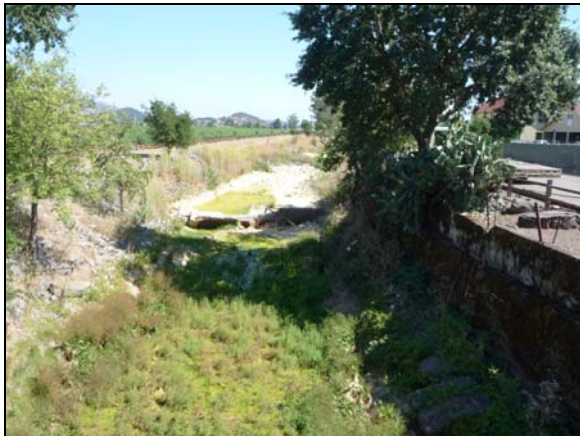
(1) Looking downstream from the upstream end of the reach (Photo taken from the bridge on the Beckstoffer Vineyards property, August 4, 2010).

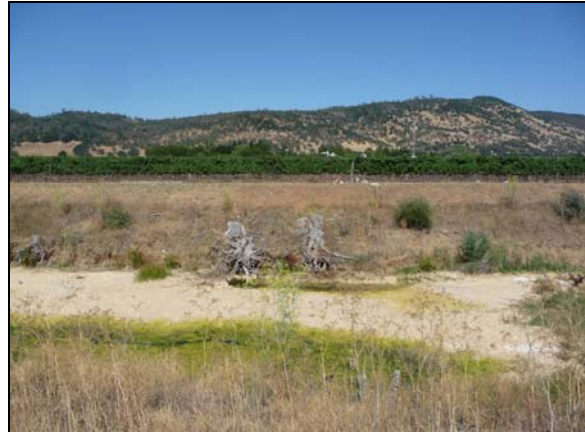
(2) In the upstream portion of the reach, the channel has a trapezoidal cross-section with minimal riparian habitat. A thick layer of algae covers the channel bed. Vegetation along the banks is primarily non-native, invasive herbaceous species and eucalyptus. (Looking east from the west bank, August 4, 2010).

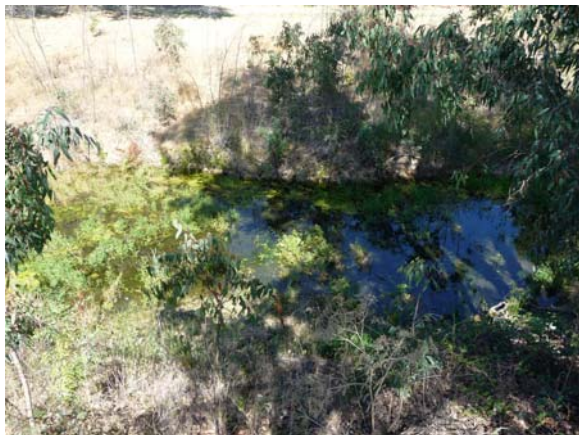
(3) In late summer, much of the reach has relatively stagnant water with considerable algae and aquatic vegetation growth (Looking east near the middle portion of the reach, August 4, 2010).

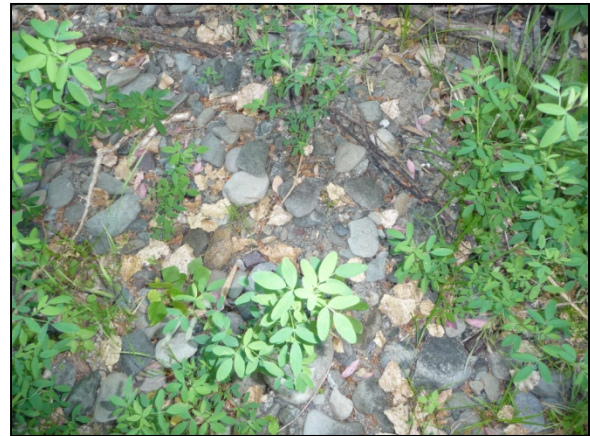
(2) Typical streambed substrate, medium sized pebbles in Reach 2 (August 4, 2010).

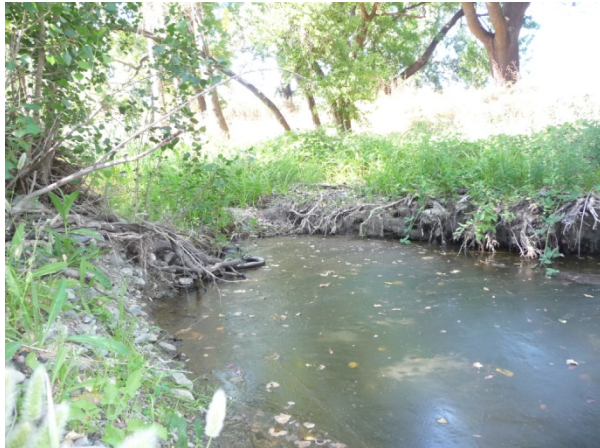
(3) 2-3 ft deep headcut is found midway through Reach 2. Tree roots provide bed stability at this location and the rate of headward migration appears slow (*Looking upstream near the middle portion of the reach, August 4, 2010*).

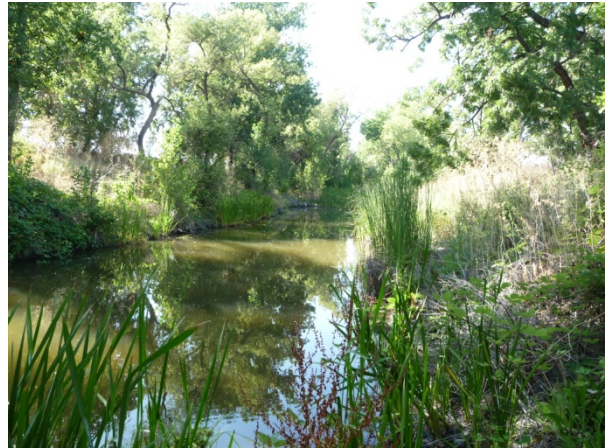
(4) As a result of recent bed incision, the bankfull channel in the downstream portion of the reach is deeper and straighter than in the upstream portion. The riparian corridor remains intact, with mature native riparian trees lining the banks (*Looking upstream near Oakville Road, August 4, 2010*).

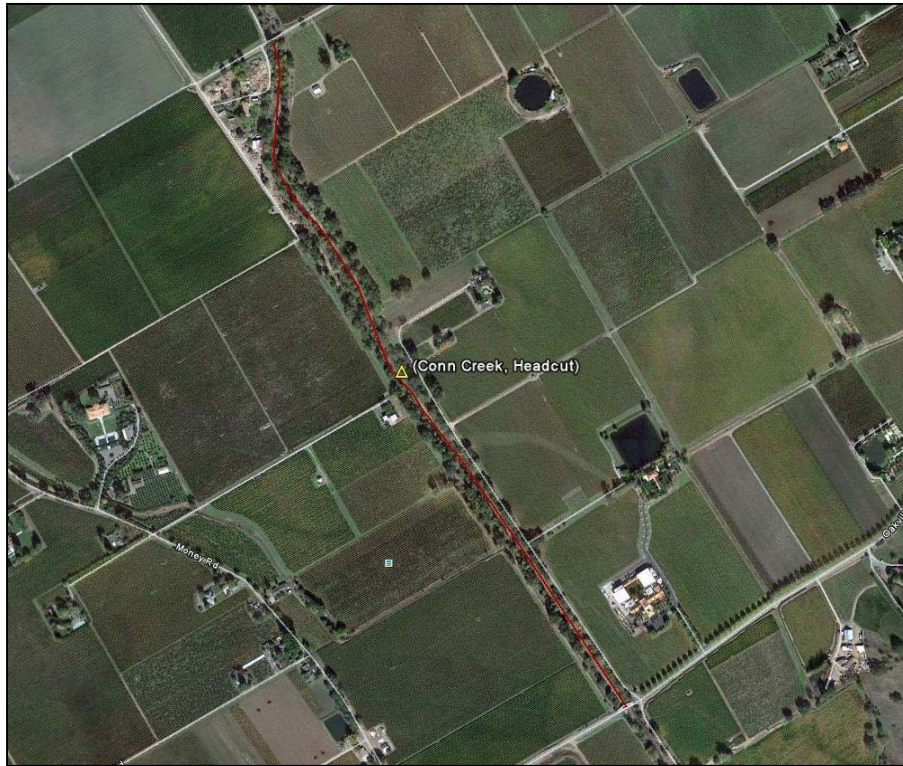
**Map A.** Approximate location of headcut in Reach 2 of Conn Creek.

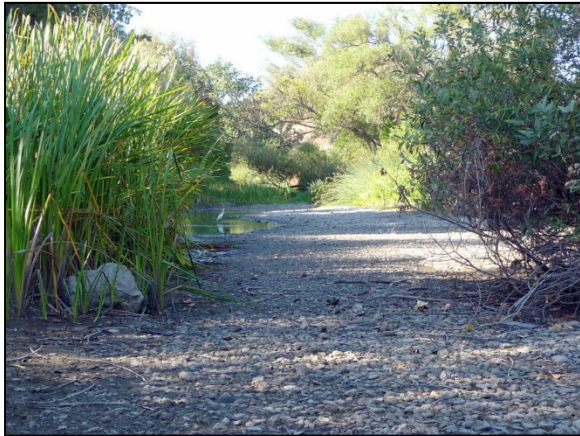
(2) Looking upstream in the lower portion of Reach 3 (August 4, 2010).

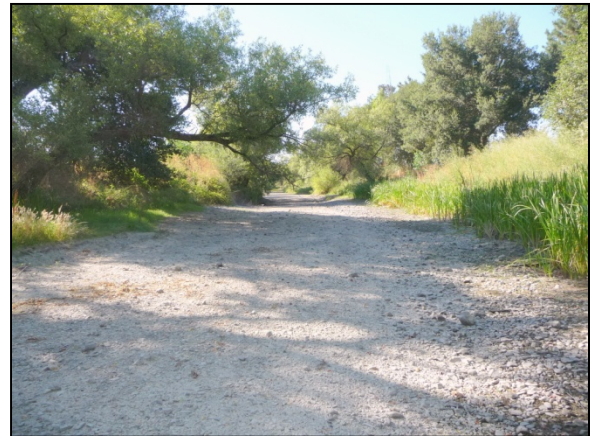
(1) Looking upstream near the upstream end of the reach (August 4, 2010).

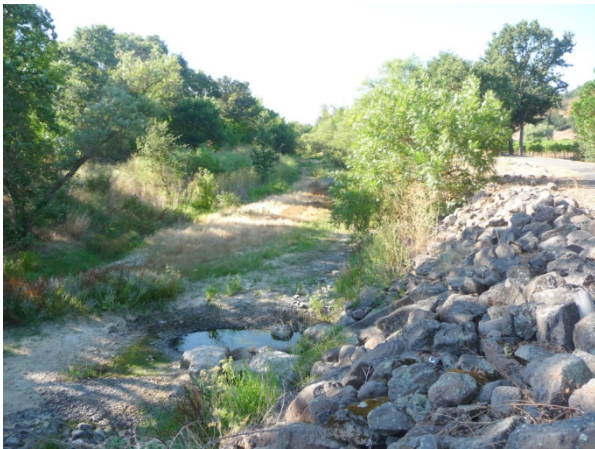
(3) Looking upstream at the riprap section where the channel turns towards the west. Erosion-resistant riprap sloughed into the channel has resulted in some local bed scour and pooling (August 4, 2010).

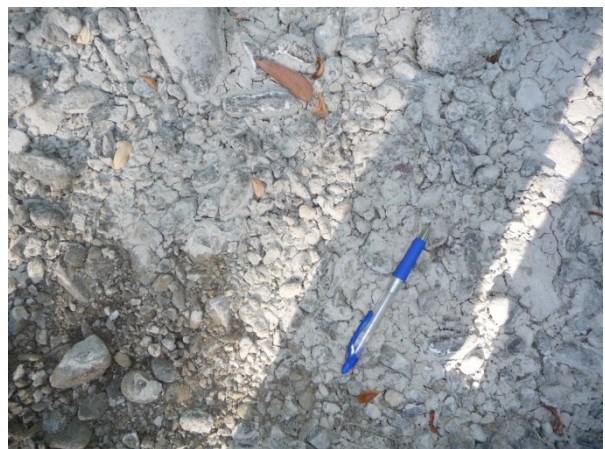
(4) Typical streambed substrate in Reach 3. Note the algae cover on substrate (August 4, 2010).

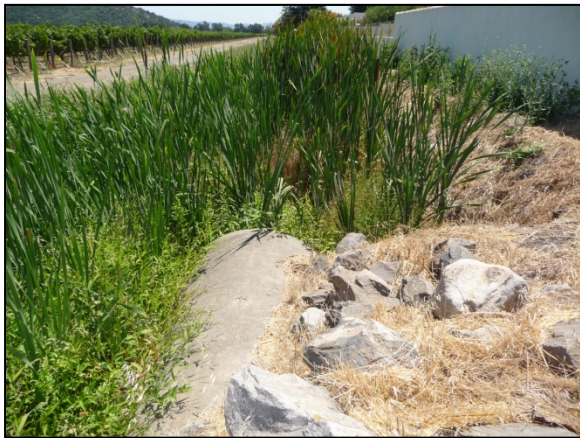
(1) Looking downstream from Finnell Road. Dense emergent vegetation occludes the culvert at this crossing (August 4, 2010).

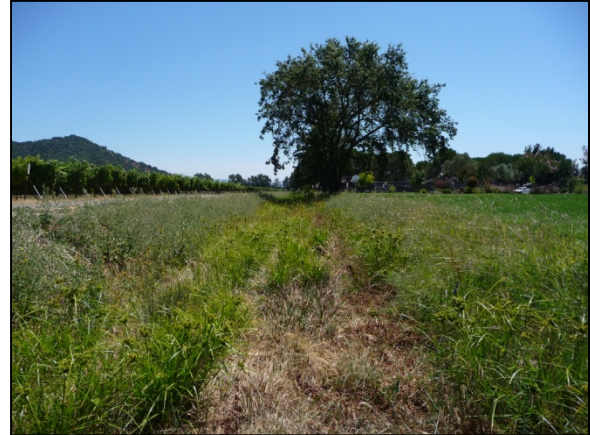
(2) Looking downstream from the mid-point of the Beard Ditch (near Oak Circle). Photo depicts typical conditions in the reach. Adjacent land uses include vineyards along the east (left) bank and residential development along the west (right) bank (August 4, 2010).

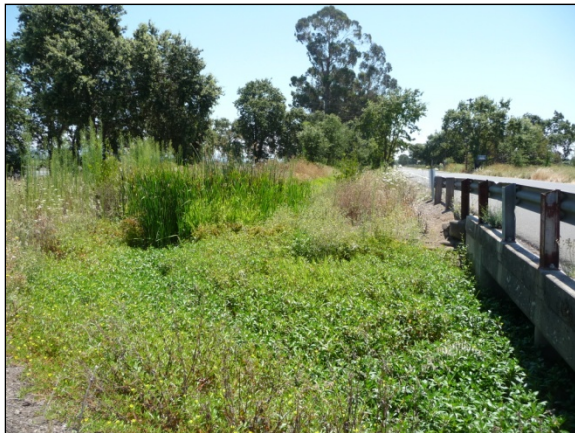
(1) Looking downstream from upstream end of the NYC. Two concrete box culverts pass flows from the main upstream tributary into the NYC. Note the dense aquatic and emergent vegetation in the channel (August 4, 2010).

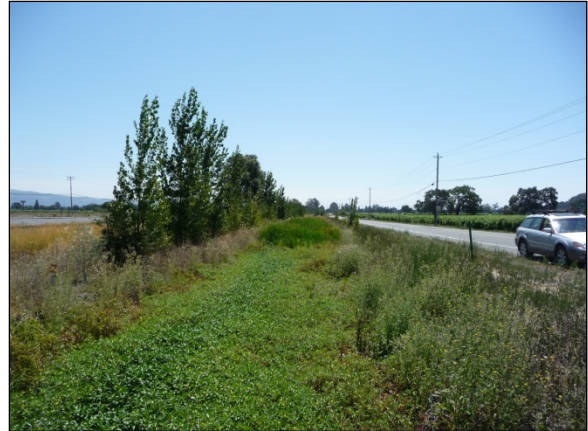
(2) Looking downstream near Vineyard View Drive. The channel supports interspersed patches of aquatic vegetation dominated by *Ludwigia* (foreground) and emergent vegetation dominated by broad-leaved cattail (background). Note cottonwoods planted by District on east (left) bank (August 4, 2010).

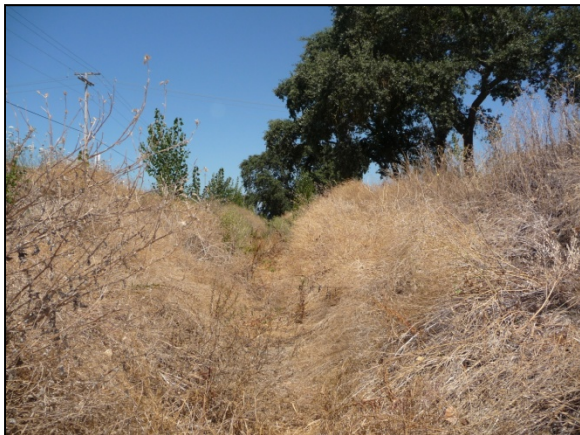
(2) Looking downstream in the upper portion of the SYC. The channel is formed in native soils. The channel bottom and banks are dominated by non-native herbaceous vegetation (August 4, 2010).

**Banks:** Understory: Predominantly herbaceous non-natives. Overstory/Canopy: Extensive planting of native trees, predominantly cottonwood (*Populus fremontii*), along both banks (Photo 3). There are many mature oak trees, and a few eucalyptus trees, along the east bank (Photos 2 and 3).

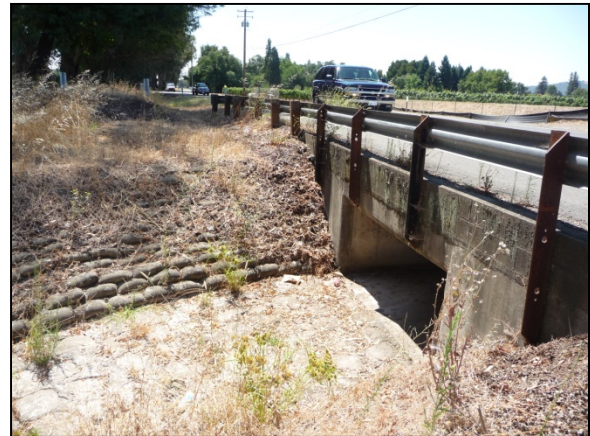
(1) Upstream end of the SYC. A concrete box culvert passes flows (beneath Solano Ave.) from an unnamed tributary to the west into the SYC (August 4, 2010).

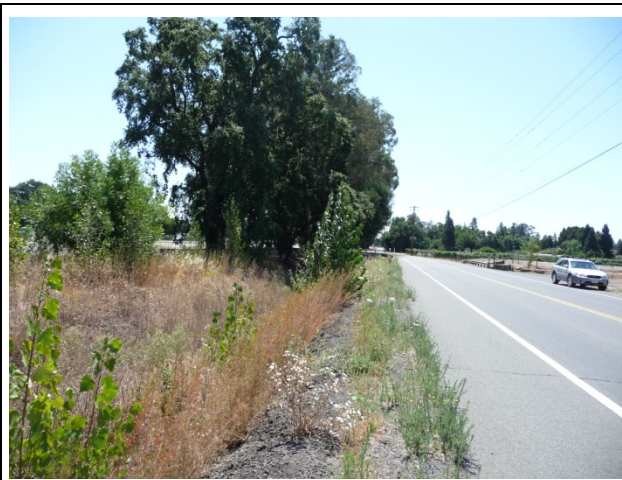
(3) Looking upstream from the mid-point of SYC Reach 1. Note the cottonwoods planted along both banks (August 4, 2010).

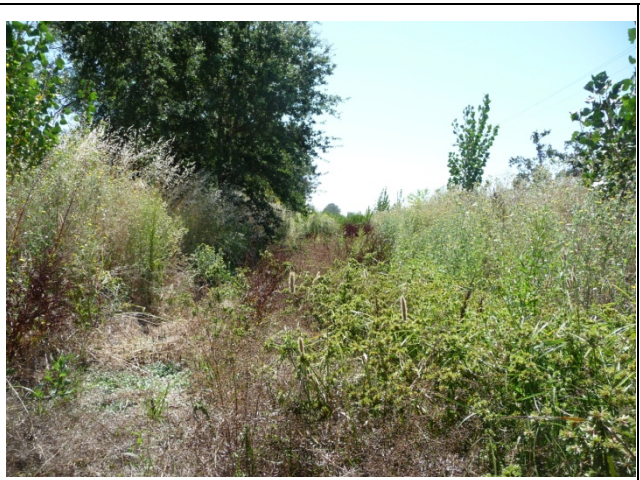
(4) The lower section of the reach has some wetland-associated plant species in the channel bed (August 4, 2010).

**Channel:** Predominantly herbaceous non-native species such as bristly oxtongue (*Picris echioides*), wild radish (*Raphanus sativus*), and wild oats (*Avena fatua*). Some wetland-associated species such as tall flat sedge (*Cyperus eragrostis*) and curly dock (*Rumex crispus*) are present in the lower portion of the reach (Photo 4).

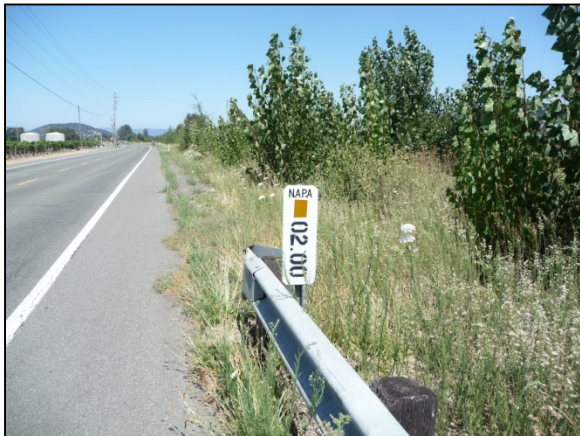
(1) Upstream end of the SYC- Reach 2. The culvert at Mile Marker 2.0 marks the upstream end of the reach. Note the cottonwoods planted along the channel (*Looking downstream, August 4, 2010*).

Banks: Understory: Predominantly herbaceous non-natives. Overstory/Canopy: Extensive planting of native trees along both banks; predominantly cottonwood (*Populus fremontii*). Many trees are well established and thriving (Photo 1).

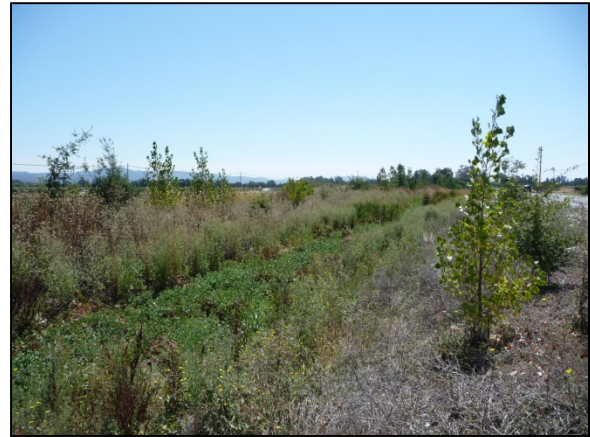
(2) Looking upstream in the mid-portion of SYC Reach 2. The channel is formed in native soils. Dense aquatic vegetation, such as *Ludwigia*, grows in the channel (*August 4, 2010*).

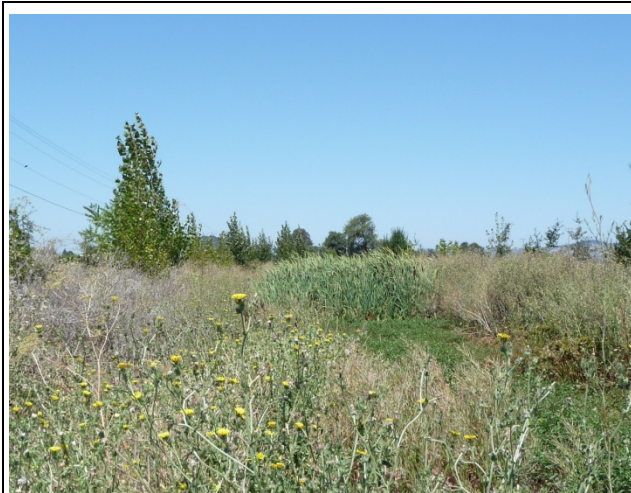
(3) Looking upstream from mid-reach area. Note the cottonwoods planted along banks and cattails in channel (August 4, 2010).

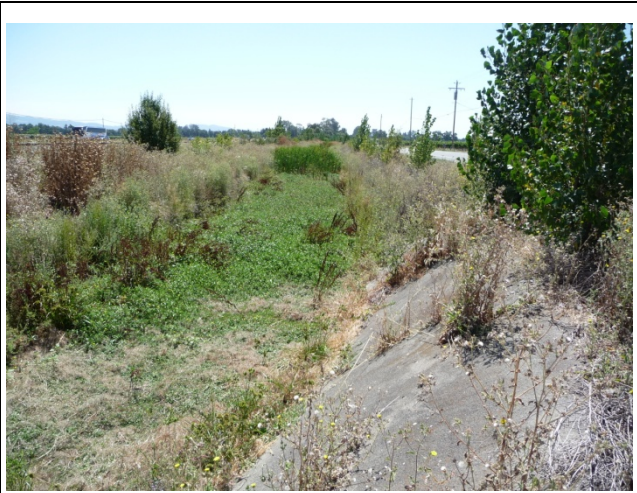
(4) Looking upstream from the confluence with the Yountville Outfall. Note dense *Ludwigia* in the channel (August 4, 2010).

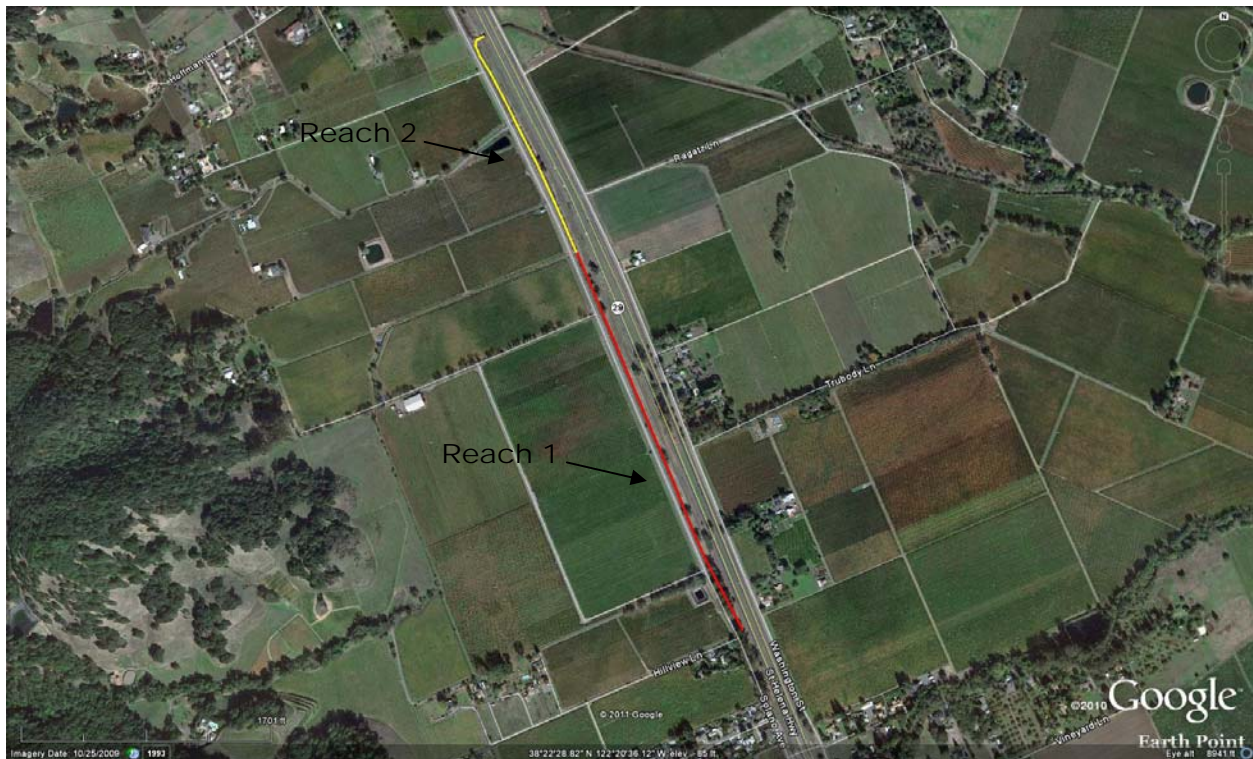
**Map A.** Reach 1 (red line) and Reach 2 (yellow line) of the South Yountville Collector. The tributary that joins at Solano Ave MM 2.0 marks the reach break.

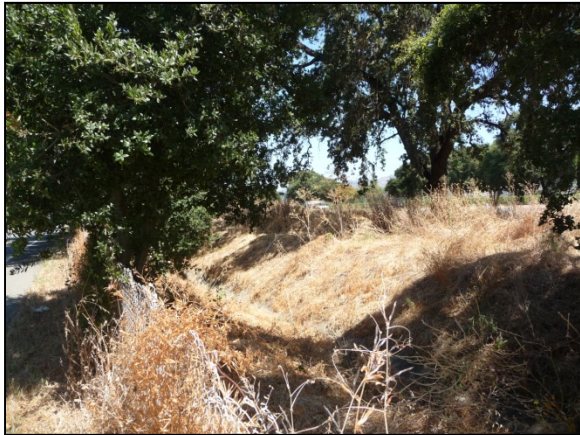
(1) Looking downstream near Oak Knoll Ave [Solano Ave to west (left)]. Mature oaks grow along the upstream portion of the Solano Ditch corridor (August 4, 2010).

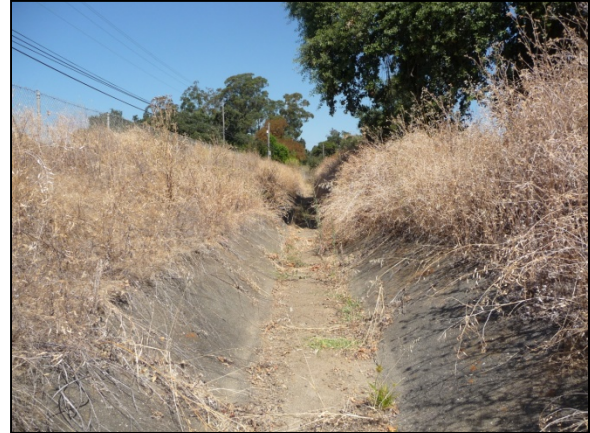
(2) Looking downstream from the mid-point of the Solano Ditch. The channel bottom and low banks are lined with concrete. The upper banks are formed in native soils. Vegetation on the upper banks consists of non-native herbaceous species (August 4, 2010).

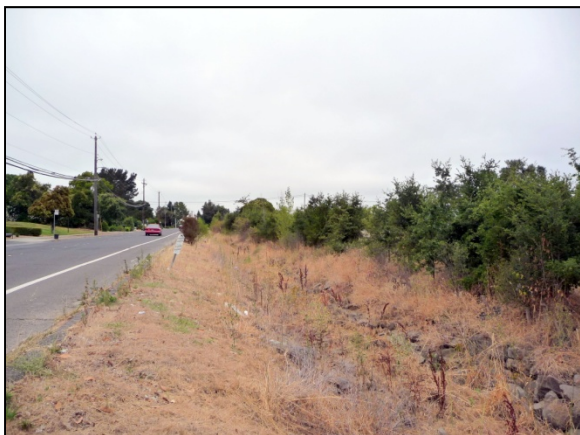
(1). Reach 1 is an intermittent stream that is dry much of the year. In channel vegetation is dominated by mesic species. Riparian trees, predominately oaks, planted by the District line the east side of channel (right side of the photo) (Looking upstream from mid-point in the reach, August 4, 2010).

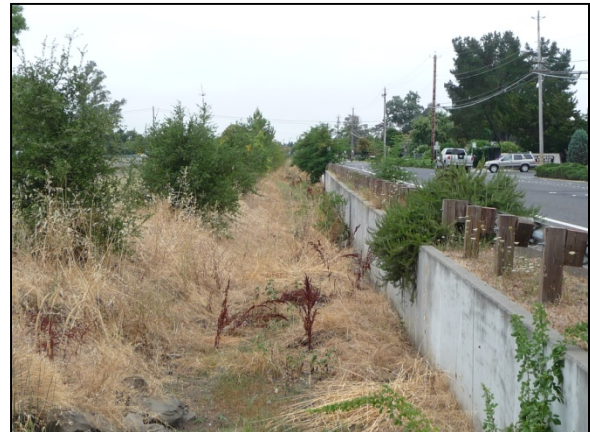
(2) Looking downstream from Luke Road (Solano Ave) to west (left). Note riparian enhancement plantings (primarily oaks) on the left bank and retaining wall on right bank (August 4, 2010).

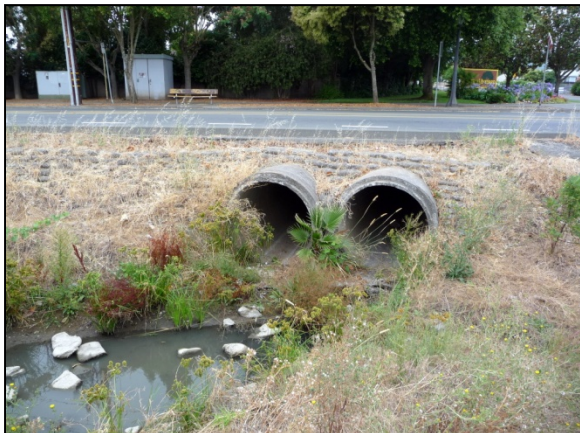
(1) Near the upstream end of Reach 2, two 60-inch concrete culverts deliver flows from upper Salvador Creek, which originates in the Mayacamas Mountains to the west (August 4, 2010).

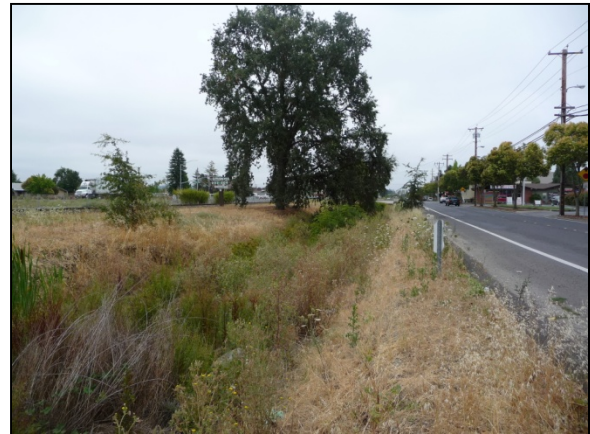
(2) Looking downstream near the mid-point Reach 2. Reach 2 NSC collects more runoff than Reach 1 NSC. Consequently, hydrophytic vegetation is present through most of the channel (August 4, 2010).

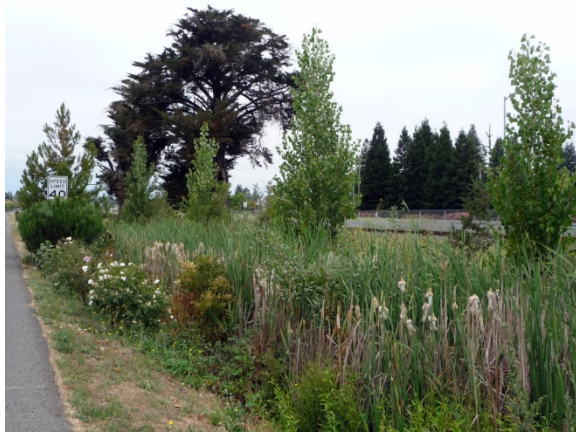
(1). Typical section of the SSC (Looking downstream from upper portion of the reach; August 4, 2010). Note dense emergent vegetation growing in the channel.

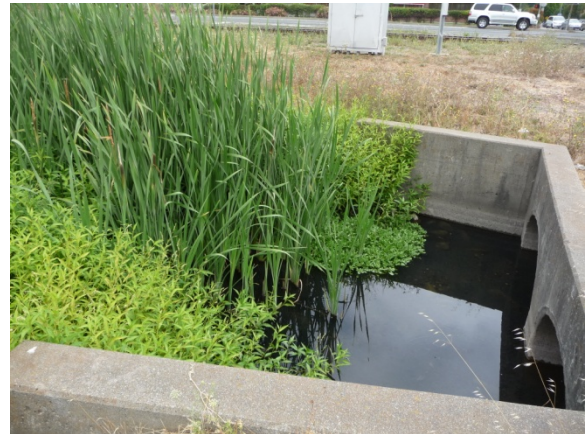
(2) Culvert outlet at upstream end of the SSC. Water clarity at this location was good (August 2010). Note emergent vegetation growing immediately downstream of outfall.

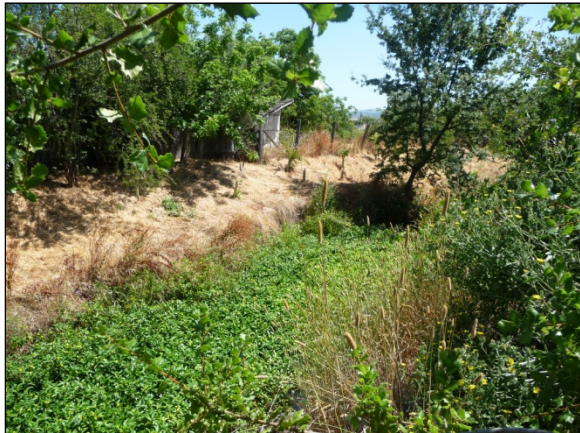
(1) Typical conditions in the upstream portion of the reach (Looking downstream, July 2010).

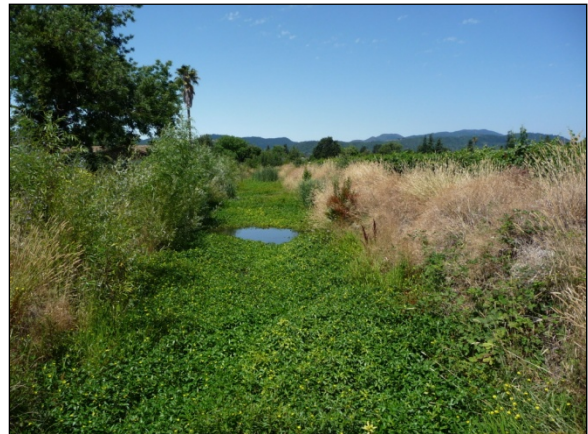
(2) Looking upstream from a bridge approximately 1,600 ft downstream of Hwy 29. Dense growth of *Ludwigia* covers the channel. The District has planted native trees along the south bank (right side of photo) (July 2010).

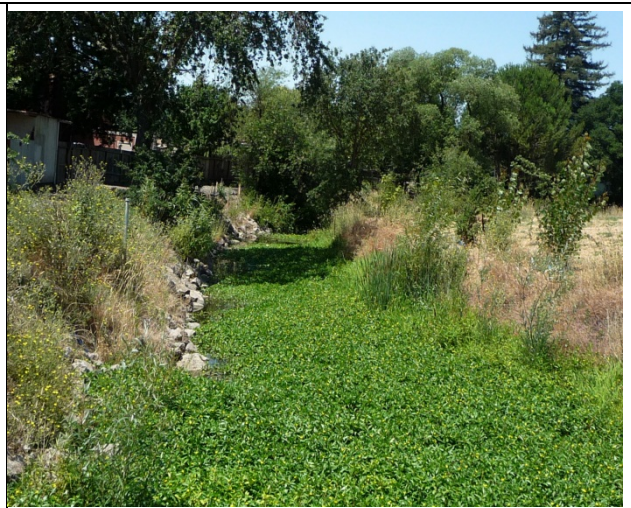
(4) Looking upstream from Jefferson St. Note riprap at the toe of slope on south bank (left side of photo) (July 2010).

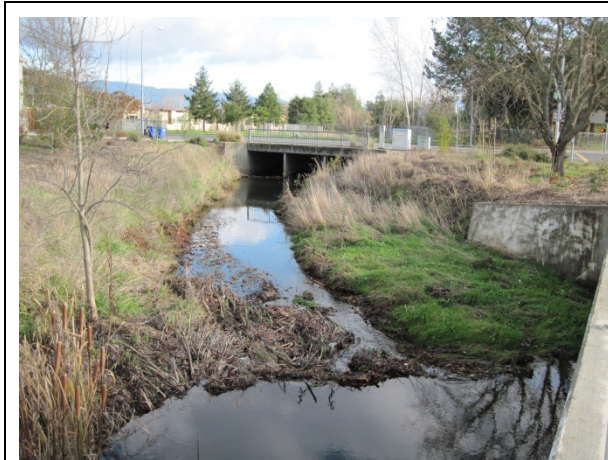
(5) Sediment accumulation along the south bank (right side of photo) between Jefferson St. and Trower Ave. (December 2009).

Trower Ave. and Jefferson St. This channel section is culverted and the combination of the slight gradient, widened channel, and channel bend (creating a point bar on the inner bend between Jefferson St. and Trower Ave. has resulted in the observed deposition.

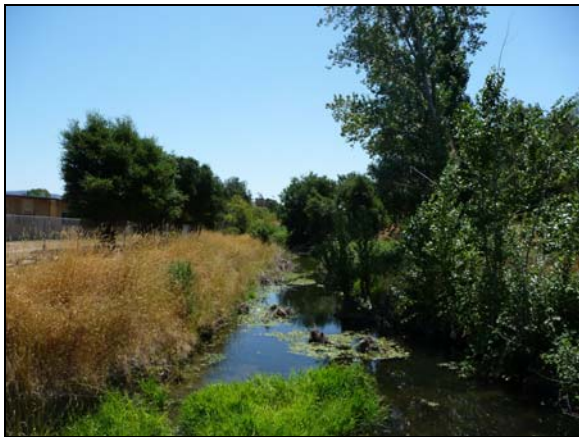
(1) Typical conditions in the upstream portion of the reach. Water is pooled downstream due to beaver dam seen in Photo 2 (Looking downstream from Trower Ave, July 8, 2010).

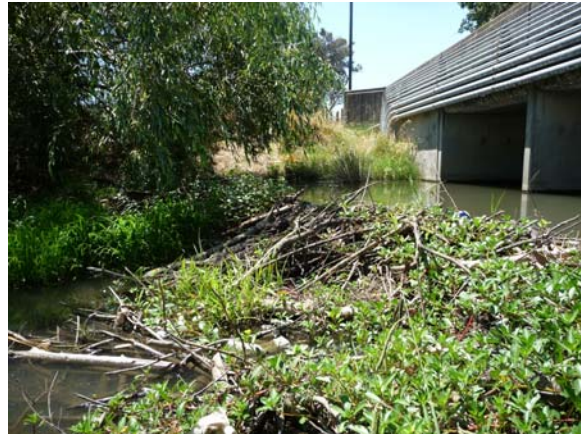
(2) The first beaver dam located approximately 600 ft downstream of Trower Ave. Dam pools water upstream as seen in Photo 1 (July 8, 2010).

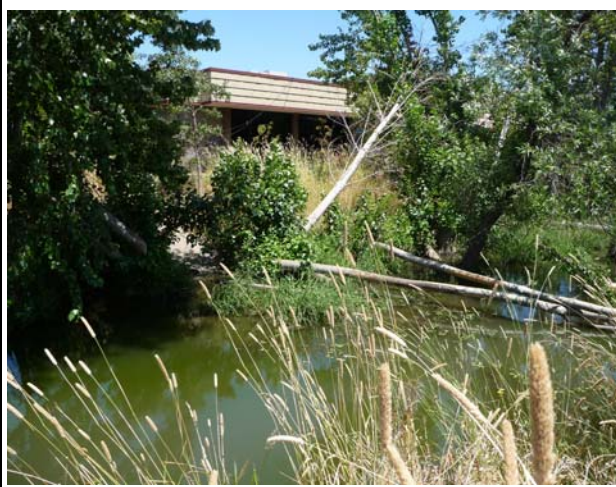
(3) Downed trees crossing the channel from beaver activity (July 8, 2010).

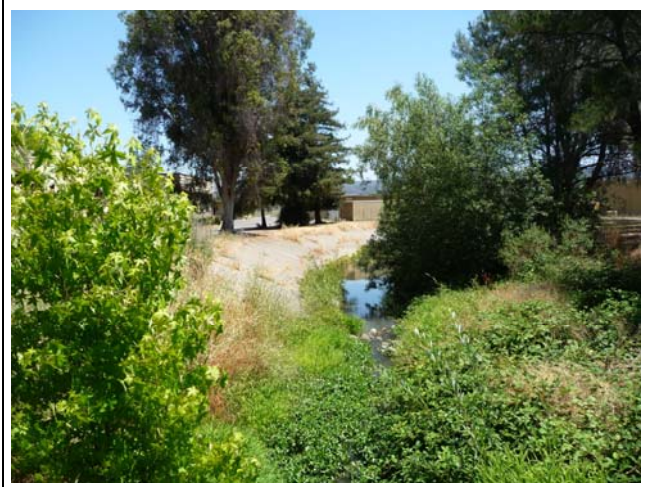
(4) Looking downstream from a bridge in the lower portion of the reach. Note concrete lining on north bank (left side of photo) (July 8, 2010).

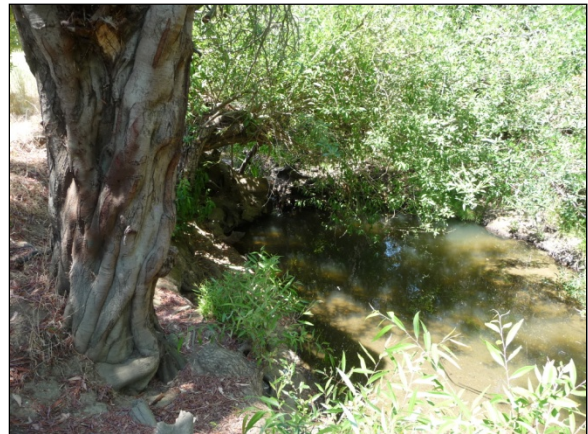
(2) An active headcut marks the upstream extent of the incised portion of the reach (Looking upstream, July 8, 2010).

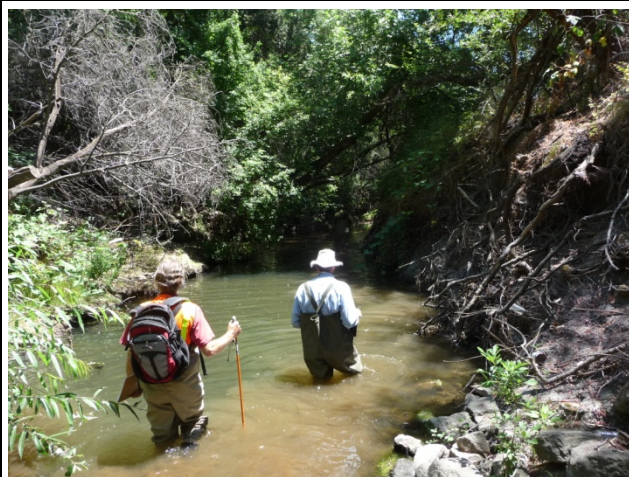
(3) Typical conditions in the lower portion of the reach, with deep pools and undercut streambanks (to right). (Looking downstream, July 8, 2010).

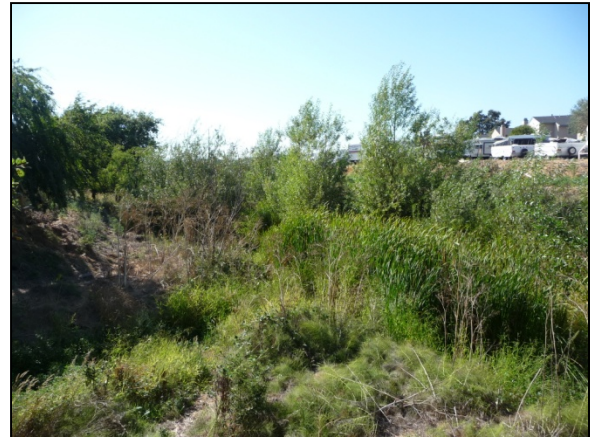
(2) Near confluence of Camille Creek, the more natural Tulocay Creek section transitions to a more modified flood control type channel (Looking downstream from the Tulocay-Camille Creek confluence, September 2010).

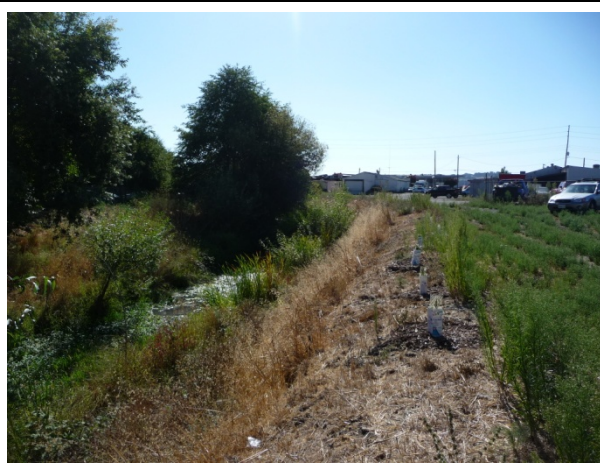
(3) Tulocay Creek - typical channel conditions between Camille Creek and Soscol Ave. (Looking downstream, September 22, 2010).

**Banks:** Understory: Himalayan blackberry (*Rubus discolor*) is dominant in areas with a dense riparian canopy; stinging nettle (*Urtica dioica*) and wild grape (*Vitis californica*) are also common. In areas without a well developed canopy, herbaceous non natives are dominant. The canopy in the upstream portion of the reach is dominated by coast live oak (*Quercus agrifolia*) and black walnut (*Juglans californica*) in the mid-upper bank range, with willow (*Salix* spp.) and white alder (*Alnus rhombifolia*) occupying the inset floodplain. In the lower portion of the reach there are some new riparian plantings on the north (right) bank (Photo 3), and some mid-seral riparian trees on the south (left) bank.

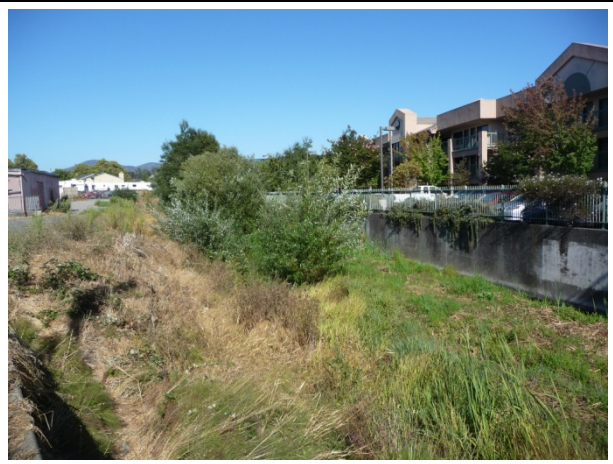
(4) Looking upstream from Soscol Ave crossing. Abundant sediment collects in a large and well developed mid channel bar (sediment wedge). Vegetation grows on deposited sediment, debris is caught on bar too. September 22, 2010).

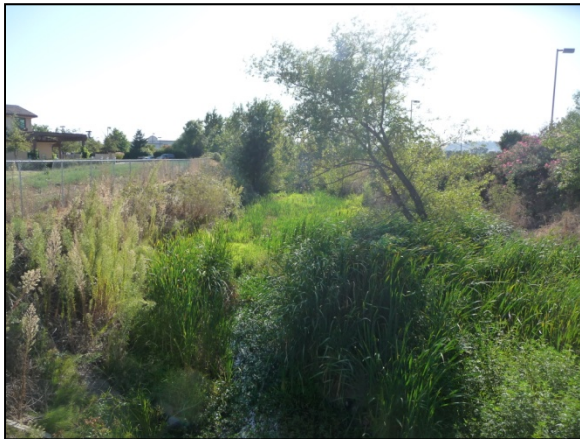
(1) Looking downstream from Soscol Ave. abundant instream vegetation over deposited sediment. (September 22, 2010).

**Channel processes:** Sediment transport in the upstream portion of the reach appears to be impeded by dense vegetation growth in the channel. The low flow channel is either not present or poorly defined. Most low flows occur as shallow diffuse flows across channel bed. During high flows it is likely that suspended sediment is transported through the upper portion of the reach, but much bed load delivered from Tulocay Reach 1 is likely deposited. The modified cross-section (i.e., over-widened) and lack of riparian canopy promotes emergent marsh vegetative conditions that cause fine sediment accumulation.

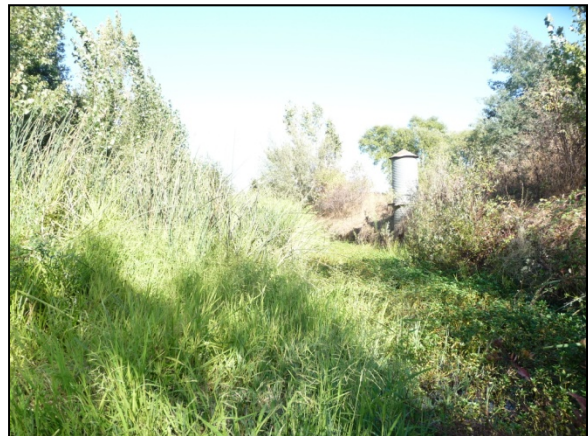
(2) Looking upstream in the upper portion of the reach. Dense aquatic and emergent vegetation in the upstream portion of the reach. Note USGS gauging station on right side of photo (September 22, 2010).

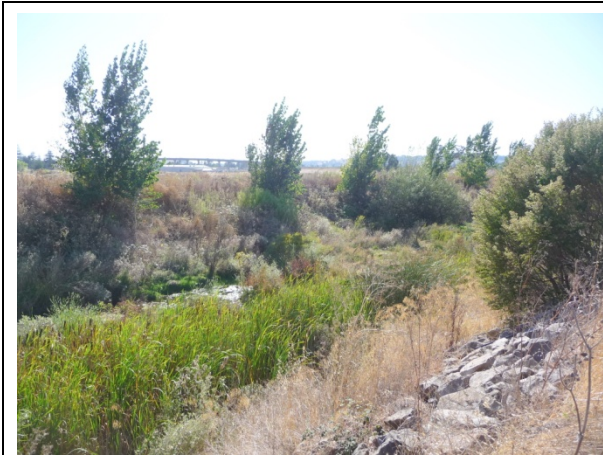
(3) Typical channel conditions near the mid-point of the reach. Note, some isolated sections of riprap are found along the banks (Looking downstream, September 22, 2010).

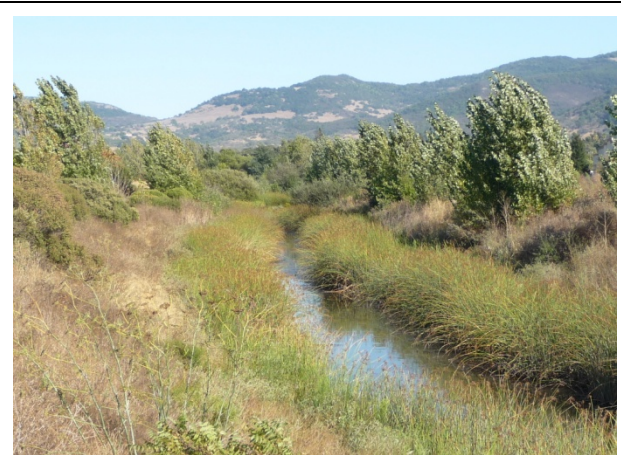
(4) Bulrush line the lower channel banks in the tidal portion of the reach. Cottonwoods have been planted along the upper banks throughout the length of the reach (Looking upstream from the UPRR bridge., September 22, 2010).

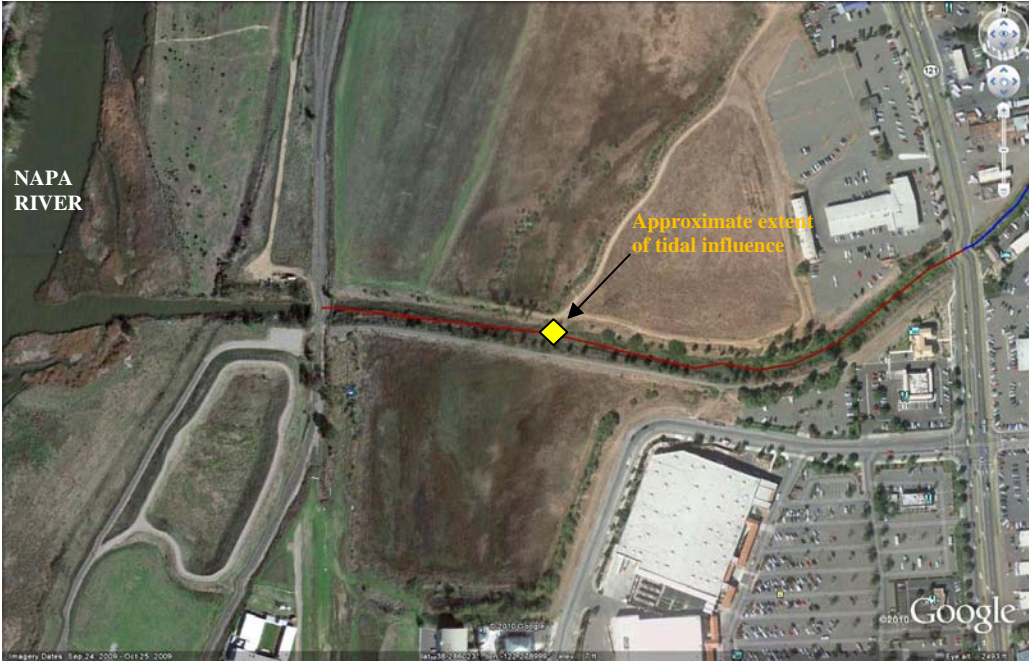
**Map A.** Reach 2 of Tulocay Creek is depicted as the red line above. Reach 2 begins at Soscol Ave. and extends downstream to the UPRR bridge. The approximate extent of tidal influence is denoted above.

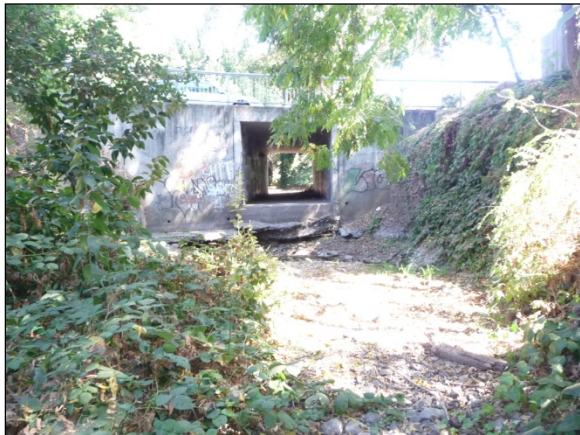
(1) Looking upstream at the South Terrace Road culvert crossing. Note the significant drop in bed elevation at the culvert and steep streambanks bounding the channel (September 2010).

**Channel processes:** The channel has incised over the last several decades as evidenced by the perched culvert and steep banks in the upstream portion of the reach (Photos 1, 5 and 6). The streambed appears to have stabilized more recently with no apparent localized degradation (e.g., headcuts) observed. During large flow events, discharges exiting the culvert at South Terrace Road likely have the potential to cause significant bed and bank erosion.

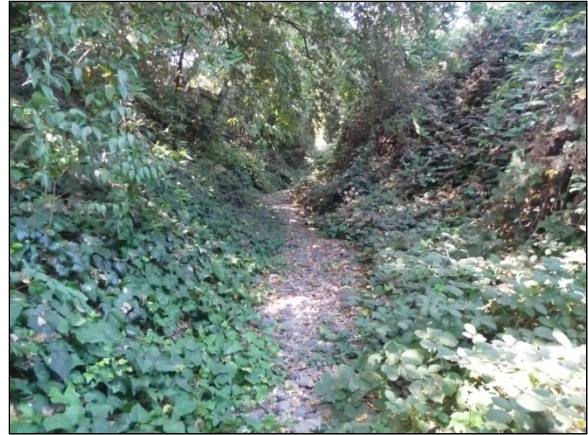
(2) Looking downstream near South Terrace Drive. Note the well defined low flow channel, coarse bed material and steep streambanks (September 2010).

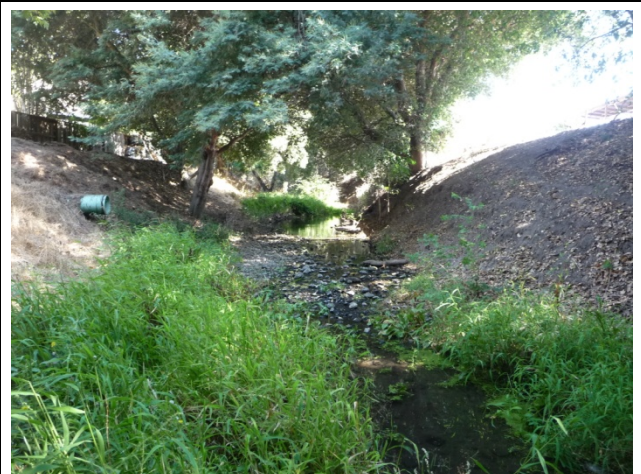
(4) Typical conditions in the lower portion of the reach (Looking upstream, September 22, 2010).

Banks: Understory: English ivy is dominant in the upper section. Himalayan blackberry (*Rubus discolor*) and stinging nettle (*Urtica dioica*) are also common. Streambanks in the lower section are often bare ground (Photo 4). Overstory/Canopy: Mature, diverse canopy including coast live oak (*Quercus agrifolia*), black walnut (*Juglans californica*), big leaf maple (*Acer macrophyllum*), blue elderberry (*Sambucus mexicana*), and a few white alder (*Alnus rhombifolia*) sprouts/saplings; some *Acacia* trees in the lower section.

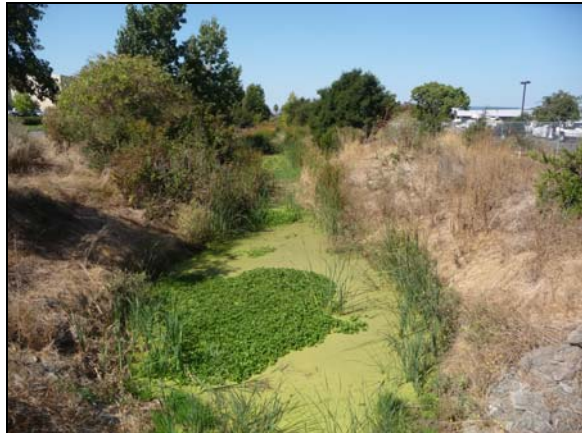
(1) Looking downstream (west) from the bridge at North Kelly Road (September 2010). Stagnant water and poor water quality observed.

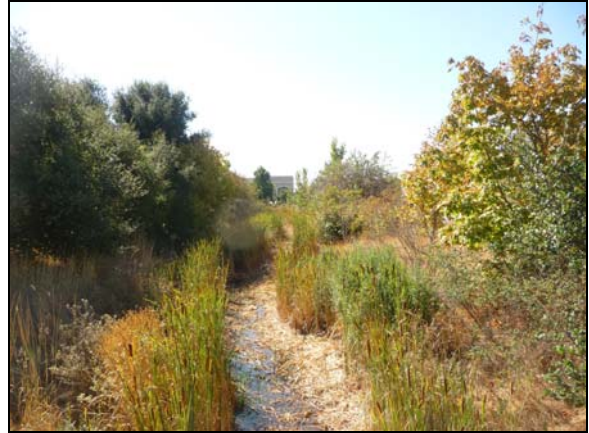
(2) Looking upstream from the pedestrian footbridge in the middle portion of the reach. Note well established riparian plantings on both banks (September 2010).

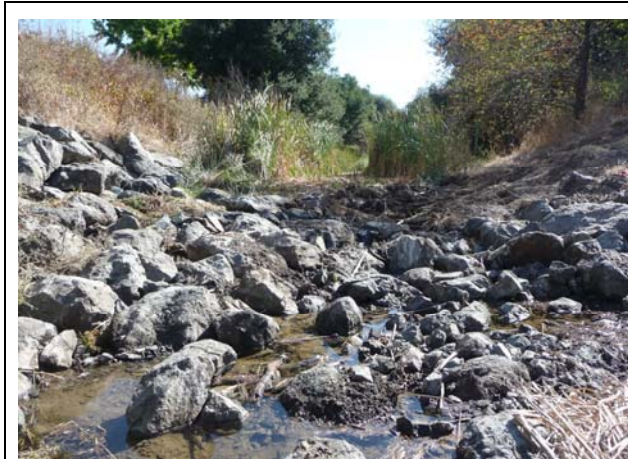
(3) Looking upstream near Highway 29 crossing. Recent riprap was placed along banks and channel bed. Channel bed and riprap crossing create depositional area upstream where sediment accumulates and cattails grow (September 22, 2010).

In 2010, bank stabilization work was performed at the downstream end of the reach (Photos 3 and 4). Cattails in the middle of the main channel are mowed on a routine basis.

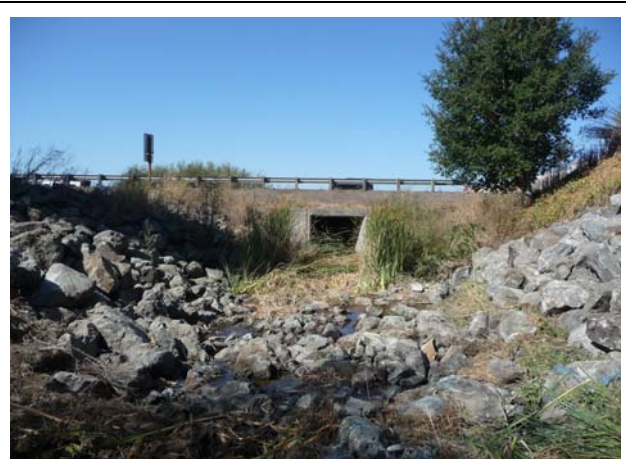
(4) Recent bank stabilization work performed by District included riprap placement upstream of the Highway 29 culvert crossing (view is looking downstream, September 22, 2010).

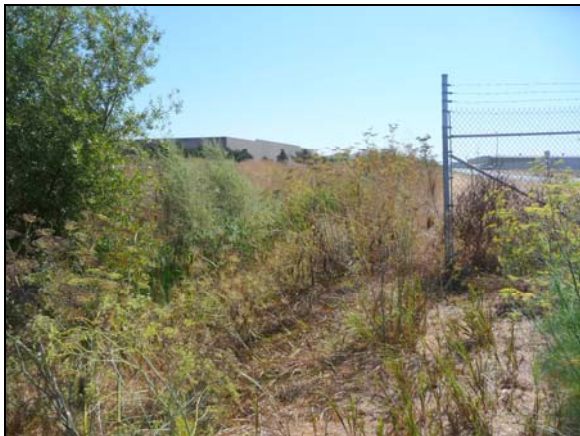
(1) Looking upstream from Airport security fence in the upper portion of the reach. Areas upstream of this point were not surveyed by foot due to access limitations, but from a distance, this section appeared to be of similar character to the channel immediately downstream (September 22, 2010).

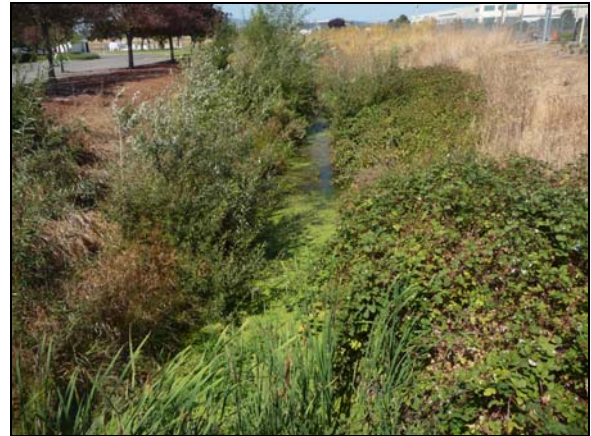
(2) Looking downstream from the bridge at Airport Road. Note willow and blackberry growing on channel banks. (September 22, 2010)

Banks: Herbaceous/Understory: Predominantly herbaceous non-natives including poison hemlock (*Conium maculatum*), sweet fennel (*Foeniculum vulgare*), and mustard (*Brassica* or *Hirschfeldia* sp); there are large patches of Himalayan blackberry (*Rubus discolor*) (Photo 2). Overstory/Canopy: Willow (*Salix* spp.) and black walnut (*Juglans californica*) saplings throughout the channel.

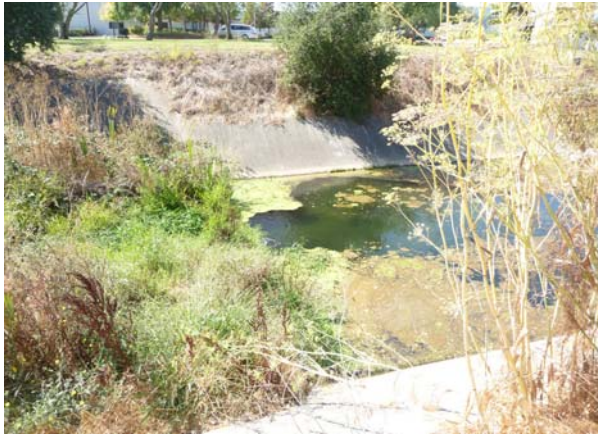
(3) A sediment “plug” has accumulated upstream of a concrete-reinforced cross-section of the channel. (Looking west, September 2010).

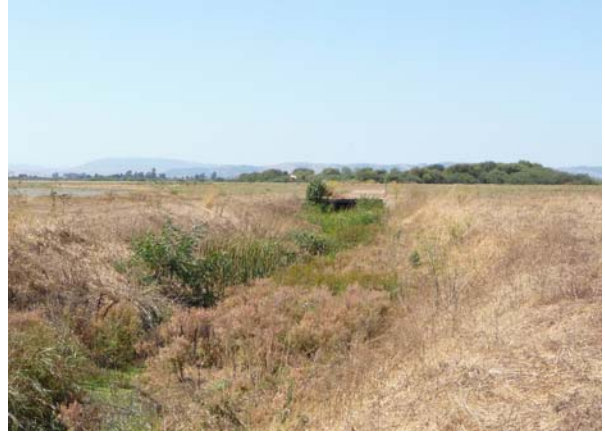
(4) In the lower portion of the reach the open channel transitions to a culverted section (background) that flows beneath the airport runways (Looking west, September 22, 2010).
