# Napa County Stream Maintenance Manual

Napa County Flood Control and Water Conservation District  
804 First Street  
Napa, CA 94559  
Contact: Rick Thomasser, P.G. Operations Manager  
707/259- 8600

Horizon Water and Environment  
1330 Broadway, Suite 424  
Oakland, CA 94612  
Contact: Ken Schwarz  
510/986-1851

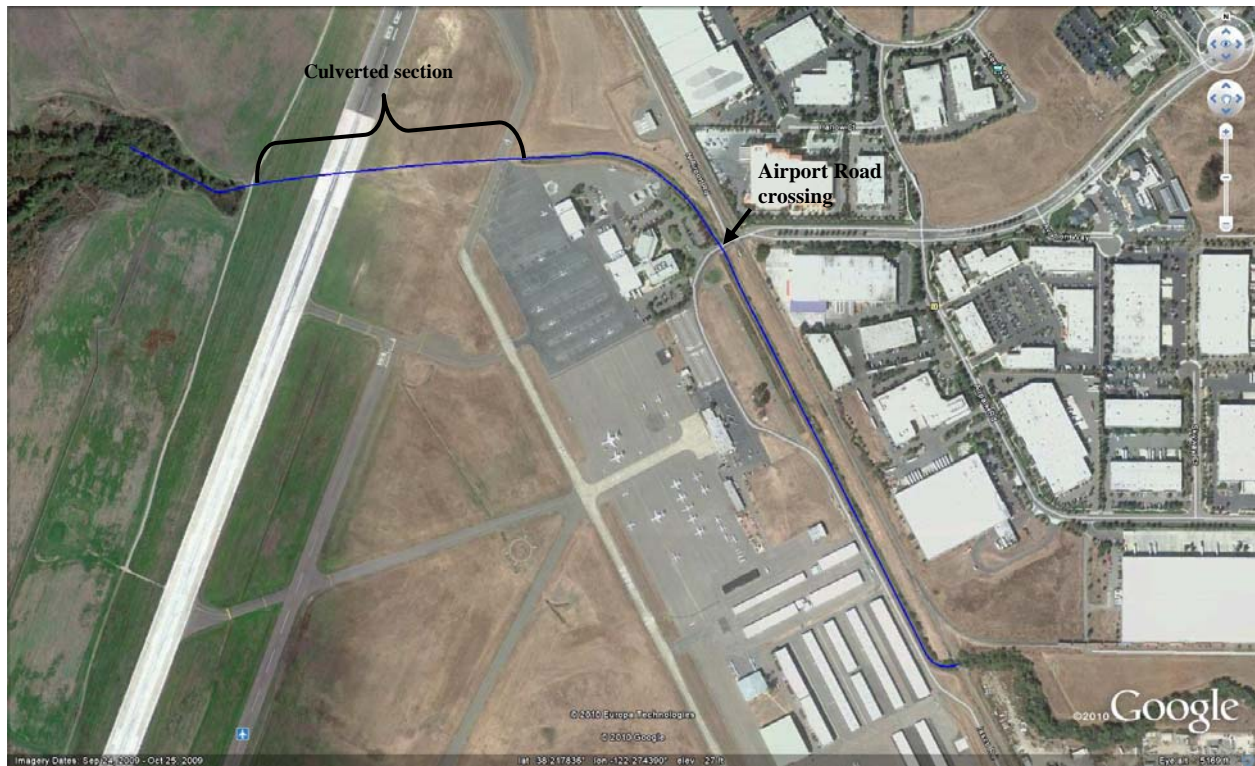
**Map A.** The upper 3,400 ft of the reach is open channel, which transitions to a 1,350 ft culverted section that flows underneath the airport runway, followed by 600 ft of open channel that discharges to Fagan Slough.

The District-maintained portion of Fagan Creek is a trapezoidal engineered channel. The entire reach lies adjacent to or within the boundaries of the Napa County Airport. The upper 3,400 ft is open channel, which transitions to a 1,350 ft culverted section that flows underneath the airport runways, followed by 600 ft of open channel that discharges to Fagan Slough (Map

A). Fagan Slough is a tidal channel that is tributary to the Napa River. The Fagan Creek watershed is approximately 6.8 mi<sup>2</sup> and includes open space, vineyards, a golf course, portions of Highways 12 and 29, as well some commercial and residential development.

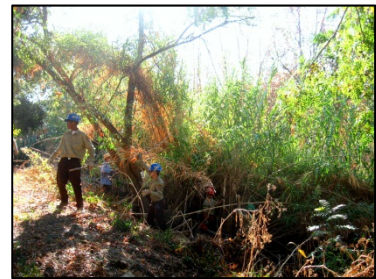
***Arundo donax* removal by  
California Conservation Corps  
team**

The District's approach to managing *Arundo* is to target removal activities by sub-watershed, beginning in upstream areas and eradicating *Arundo* colonies progressively downstream through each sub-watershed. *Arundo* is eradicated by either spraying the entire standing plant with herbicide or mechanically cutting the stalks and painting each stalk-stump by hand with herbicide. The District's standard *Arundo* herbicide mix includes glyphosate, a non-ionic surfactant, and ammonium sulfate. The herbicide mix is applied in the fall from September through early November. Dead canes are removed for fire safety in the fall (September or later) following herbicide application. Any bare soil remaining after cane removal is revegetated with native plants or seeds, such as the native species listed in Table 6-1 in Chapter 6.

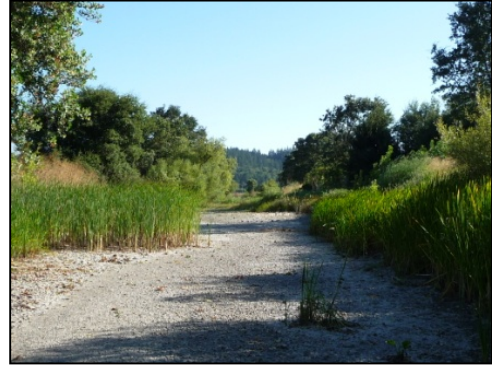
*Cattails*

Cattails are generally removed using bladed weed-eaters. In areas where mature trees do not prohibit access, heavy equipment, such as an excavator with a flail mower extension positioned at top-of-bank, may be used. This approach to cattail management is a shorter-term solution as cattails readily grow back. Cattail removal may also be combined with sediment removal. In such cases, the channel is cleared of both sediment and cattails using methods described in Chapter 7 in order to increase channel capacity. This approach includes removal of cattail roots along with the sediment and can successfully reduce cattail re-growth for several years. Over the long-term, cattail growth is further discouraged by the development of a canopy over the channel and strategic planting of cattail competitors. The District anticipates the need to periodically manage cattails between June 15<sup>th</sup> and October 31<sup>st</sup>.

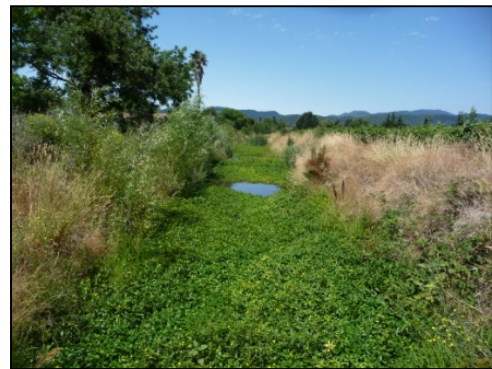
*Ludwigia in Yountville Outfall*

Mechanical removal is the primary method to control Ludwigia and is generally conducted using a long-reach excavator from maintenance roads adjacent to the project site channel. Where the channel is too wide, the excavator may occasionally travel partially down the bank in areas that

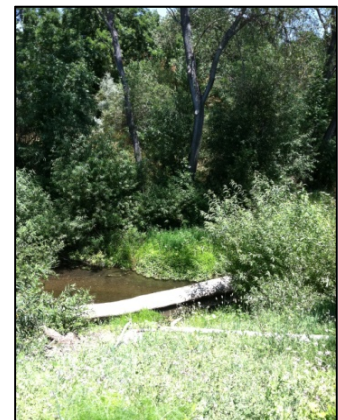
*Downed tree across the Napa River in the Rutherford Reach from 2010 winter storm events.*

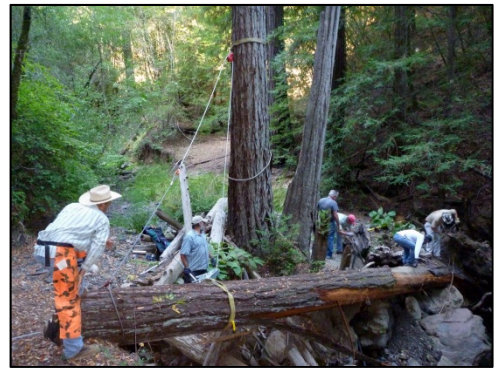
*Field crew repositioning a downed tree in Wing Canyon*

Trees that are repositioned to be more parallel to flow currents in the channel will not be secured in place, unless needed (see Photo 4 in Figure 5-1). In some cases, it may be necessary to secure wood in a specific place to create instream habitat, such as inducing a scour pool for use by salmonids. If necessary, the repositioned wood will be cabled or anchored in place to the banks or some other method with input from regulatory agencies, such as CDFG and NMFS (see Photo 5 in Figure 5-1). The District will retain root masses of the downed trees to the extent feasible. Repositioning of downed trees is conducted using hand-held tools and occasionally heavier mechanical equipment. All repositioned trees are assigned a tracking number and fitted with a metal numbered tag. The GPS location of the tree is entered into the District’s database and the tree location and condition are monitored annually. If needed, the trees are adjusted to improve habitat conditions and prevent flooding. The map below illustrates the locations of the repositioned downed trees currently being monitored by the District.

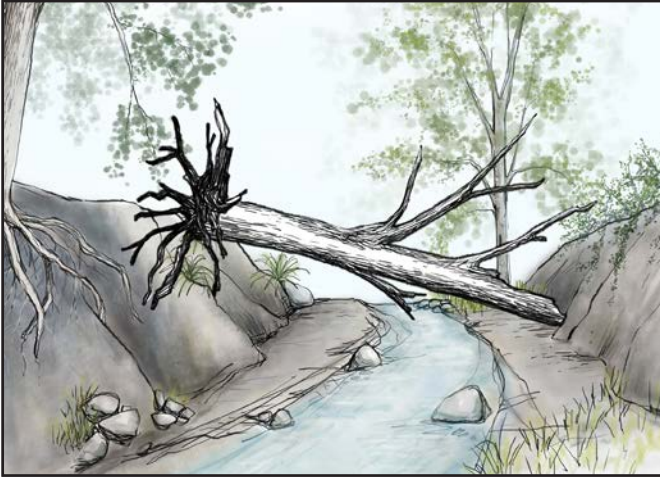
Photo 1. Example of a downed tree across the channel causing flow blockage.

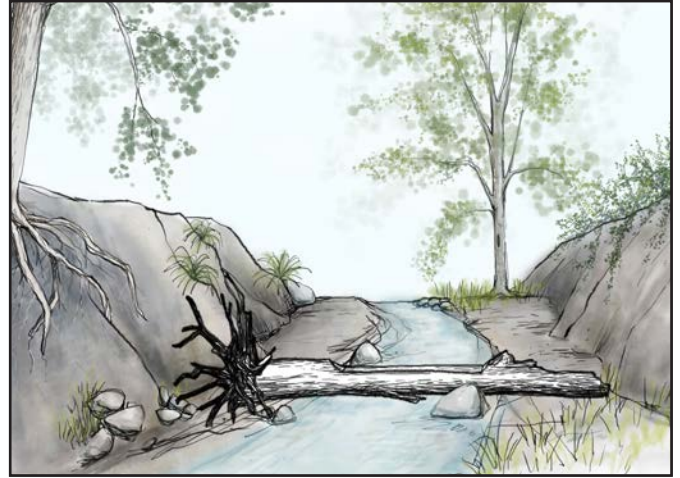
Photo 2. Downed tree limbed, left in place, and modified slightly to function as a weir.

- 2) **Limb branches:** if based on the rationale evaluation, the downed tree provides habitat functions, and does not significantly decrease flood capacity or alter streamflow – then the down tree will be left in place. But, if the downed tree exhibits branches that are perpendicular to flow, extend higher than two feet above the streambed, or has branches that could collect debris, those branches will be trimmed or limbed but the majority of the downed tree will be left in place. See Photo 2 in Figure 5-1.

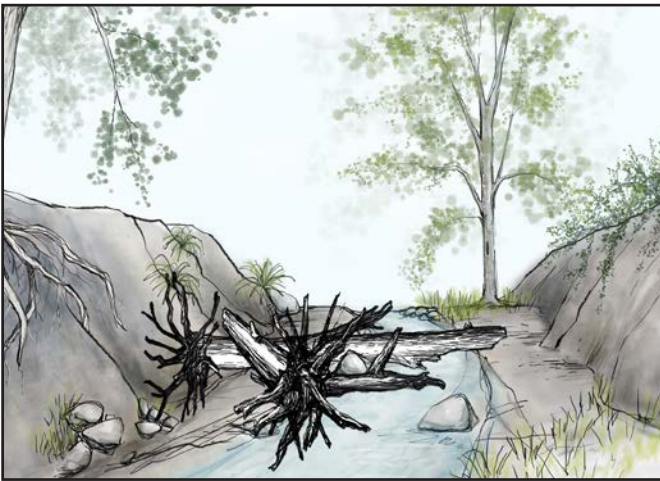
Photo 3. Downed tree, cut into smaller sections and repositioned in the channel to create in-stream complexity.

- 3) **Cut into smaller pieces:** If the downed tree is in a position that does not immediately trigger the need for repositioning or removal, but may pose a threat in the future or a portion of the tree impedes flow or could catch debris, the tree may be cut into shorter lengths (not less than 12 feet long, if possible) or specific sections of the tree may be removed. See Photo 3 in Figure 5-1.

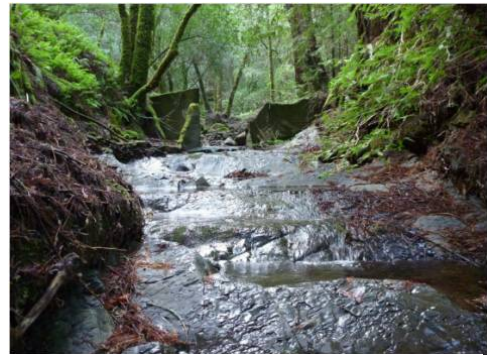
*Abandoned instream dam on Wing Canyon Creek before removal*

There are many abandoned instream dams that remain in County creeks. These abandoned dams (generally small in nature) have typically outlived their purpose and now remain as instream barriers. Other constructed instream facilities considered for potential removal will be evaluated on a case by case basis for consistency with the management objectives and principles of the Stream Maintenance Program. The photos to above illustrate before and after photos of an instream dam on Wing Canyon creek in 2012. This structure was removed by hand-held tools and with approval from CDFG.

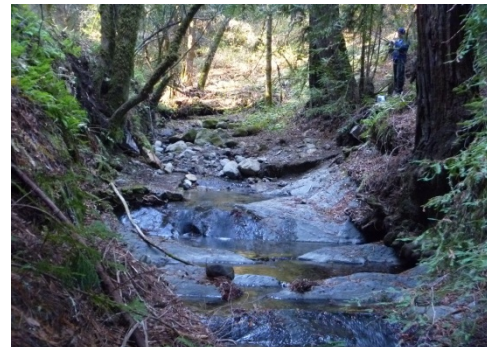
*Wing Canyon Creek after removal of the abandoned instream dam in 2012*

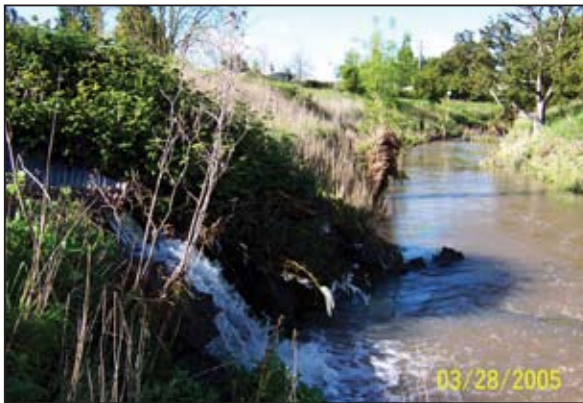
Photo 1. Example of a Culvert Failure.

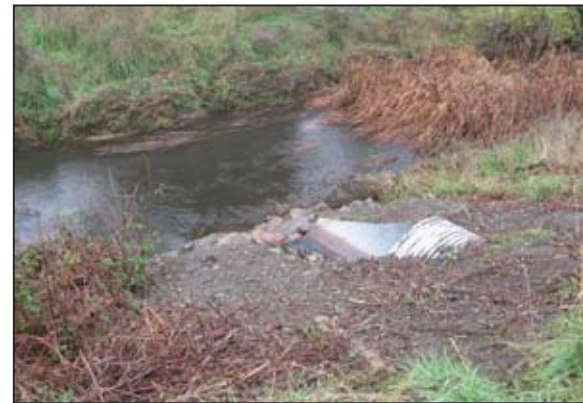
Photo 2. Same site as Photo 1 after bank repair using minimum necessary rock rip-rap.

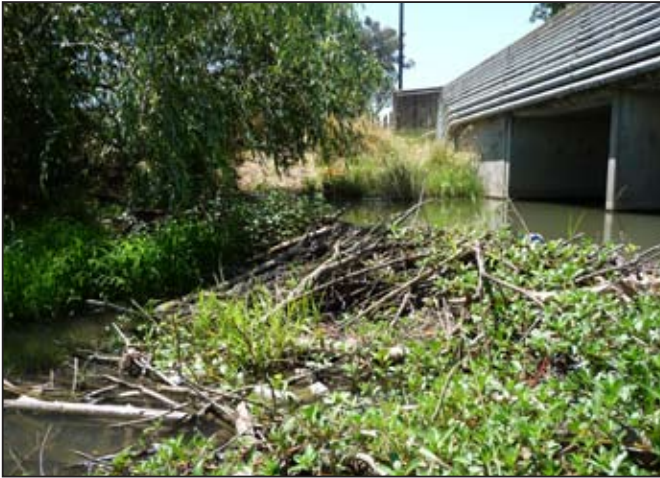
Photo 1. Beaver dam located in Salvador Creek, approximately 600 ft downstream of Trower Avenue (July 8, 2010).
