Executive Officer’s Report January 13, 2020

Asphalt Emulsion Spill Cleanup at Alpine Road Spill in La Honda (David Tanouye)

Spill Response at Kinder Morgan Pipeline Release in Walnut Creek (David Tanouye)

Cleanup Progress at Mission Clay Site, Niles Cone (Ralph Lambert and Kevin Brown)

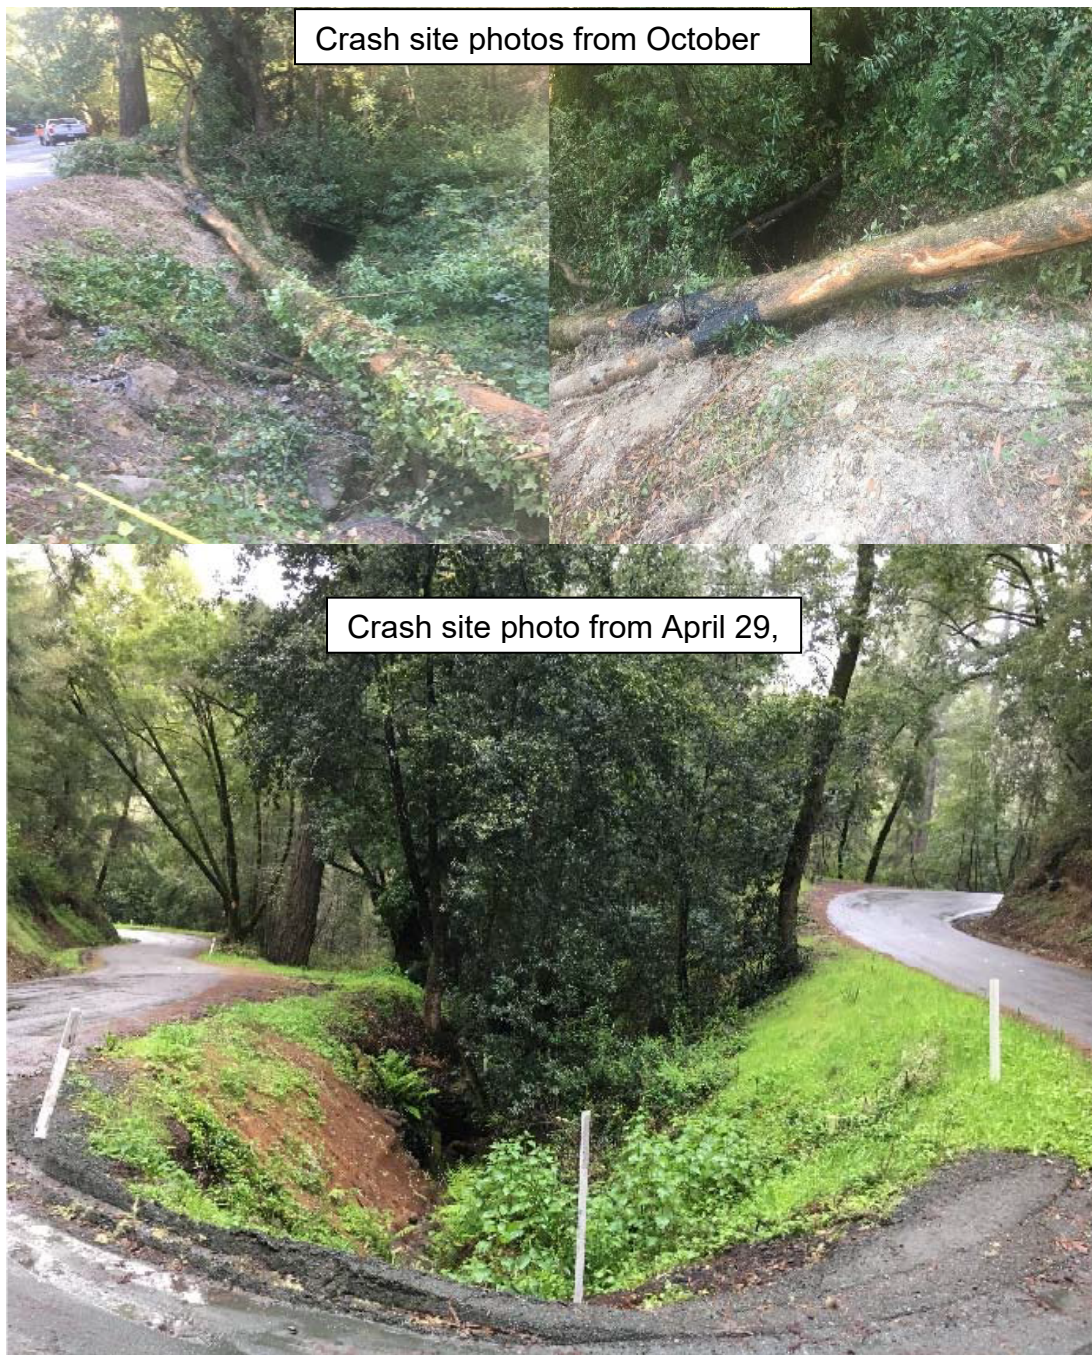
Figure 2. Photos of the crash site from October 2019 and April 2020. Petroleum contamination was excavated to bedrock and stabilization measures were implemented to prevent downstream impacts to the creek.

Immediately after the spill Water Board staff coordinated with USEPA, California Department of Fish & Wildlife, and San Mateo County to direct emergency spill response cleanup activities from the time of the crash through October 2019. During this phase of work, emergency crews were onsite 24 hours a day actively removing spilled material and impacted debris. Cleanup activities included physical excavation and removal of material by hand, physical removal of floating material with skimmer nets, absorbent pads, and containment booms. In-stream controls were implemented to prevent potential mobilization of contamination downstream, and as shown in the Figure

2 photos, the crash site release and tributary drainage was cleaned up and restored with vegetated erosion control mesh to provide bank stabilization.

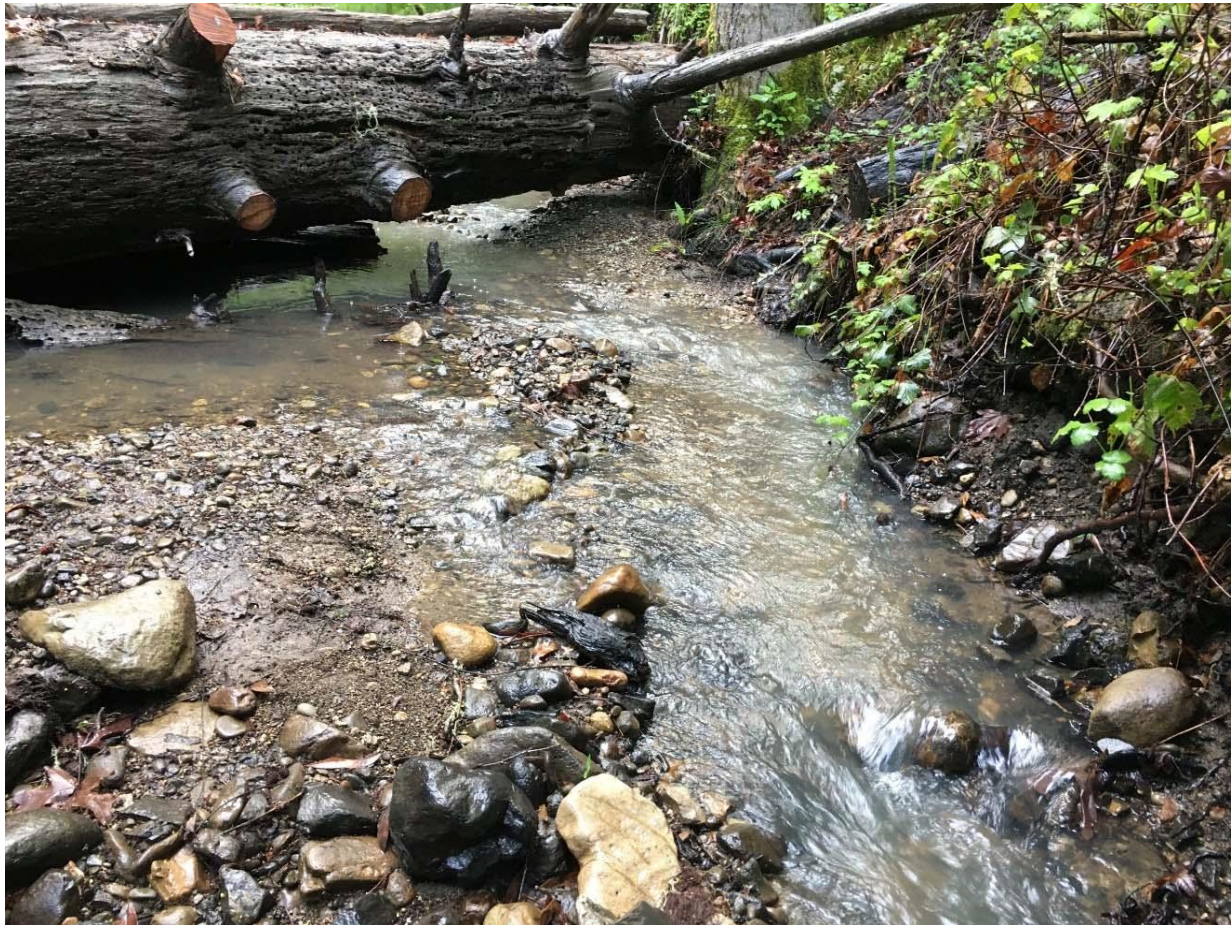
Figure 3. Photo showing Alpine Creek downstream from the confluence of the tributary.

Sampling following the spill cleanup showed a significant reduction of the petroleum asphalt emulsion within the impacted areas. Water quality monitoring was conducted at the Site and in Alpine Creek downstream locations from October 2019 to June 2020 for a total of 11 sampling events. The results indicated that surface water samples showed no petroleum impacts to Alpine Creek.

Further, observations documented from each sampling event to monitor the effectiveness of the erosion control measures indicate that no significant erosion occurred throughout the course of the remediation and restoration project. The in-stream controls remained in place until they were removed in May 2020.

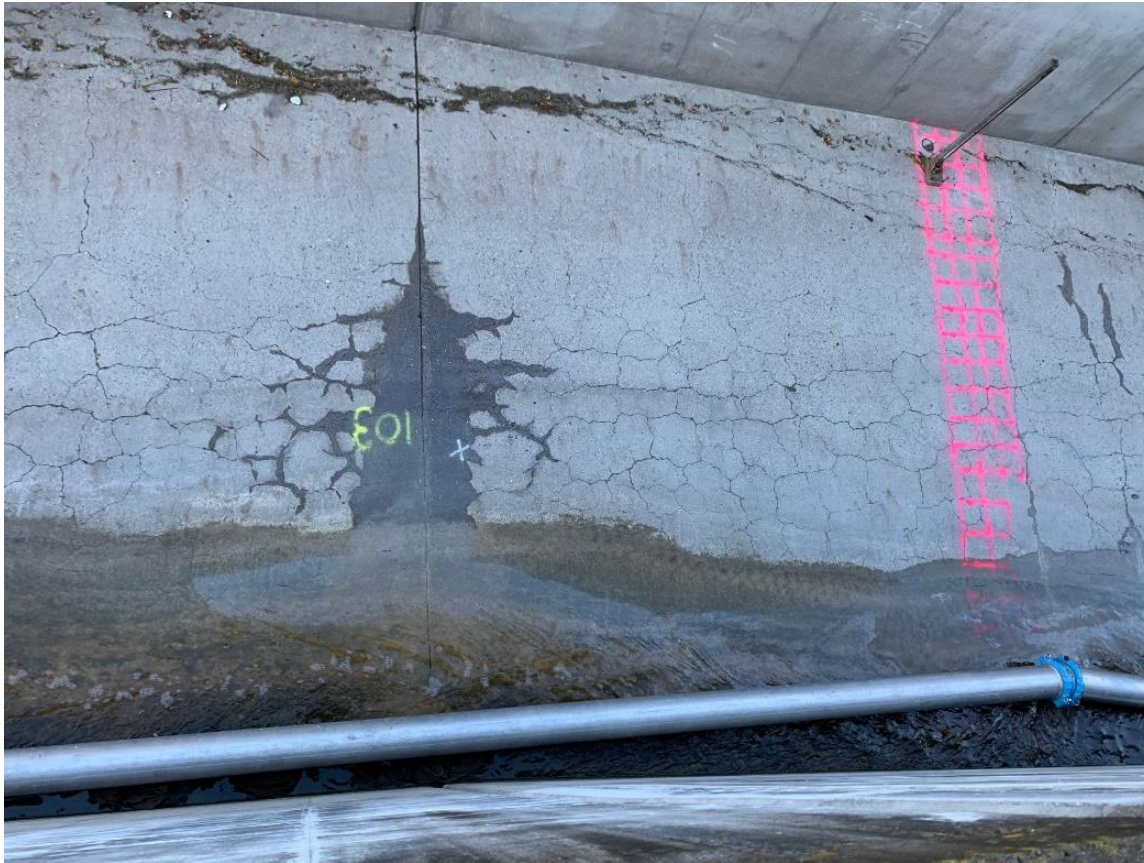
Figure 5. Photo from top view of the concrete channel at Bypass Area where product sheen is observed discharging into the surface water.

The gasoline product has migrated from the Site through the subsurface and has impacted an area that extends about 1.5 miles north of the release Site. About 1.2 miles from the release Site, gasoline has emerged at the surface and has discharged to the concrete-lined Walnut Creek Flood Control/Bypass Area drainage channel and has impacted surface water (see Figure 1 for site vicinity). Cleanup operations have mainly been focused at the intersection of Walnut Creek and San Ramon Bypass Channel near the Iron Horse Trail footbridge where approximately 17,000 gallons of gasoline product to date have been recovered.

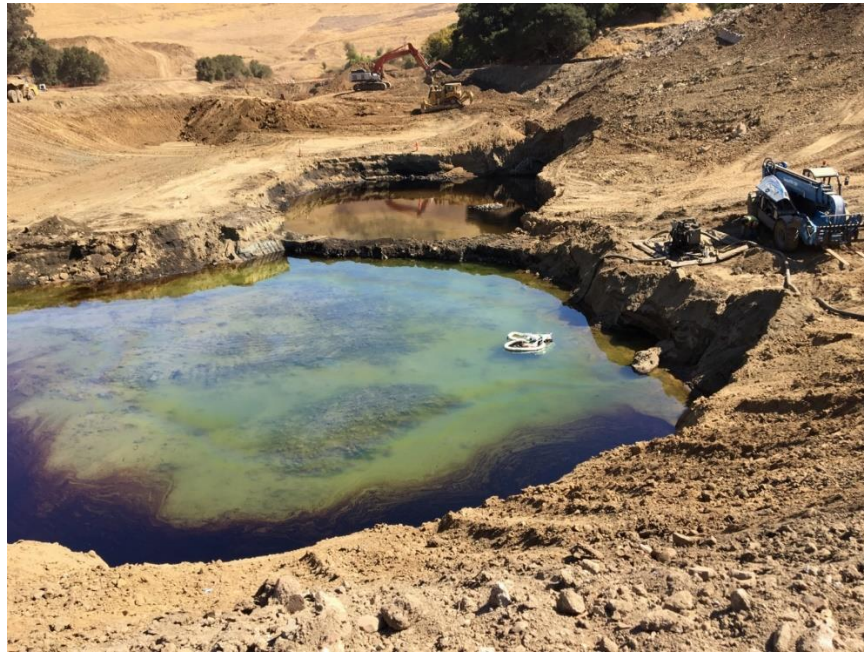
Figure 2. Excavation Area

Source Cleanup: In 2018 and 2019, the Discharger completed two large soil excavations in areas where considerable petroleum contamination was present (Figure 2).

The excavations extended into bedrock about 35 feet deep. A corner of the excavation was treated with an oxidizing agent to clean-up residual petroleum contamination that could not be reached due to the adjacent railroad. Approximately 28,000 cubic yards of contaminated soil were removed and disposed of at the Newby Island landfill. The excavations were backfilled, and interim grading was completed. Over 3.5 million gallons of groundwater from the excavation was pumped and treated to remove contamination, then discharged to land under an approved plan.

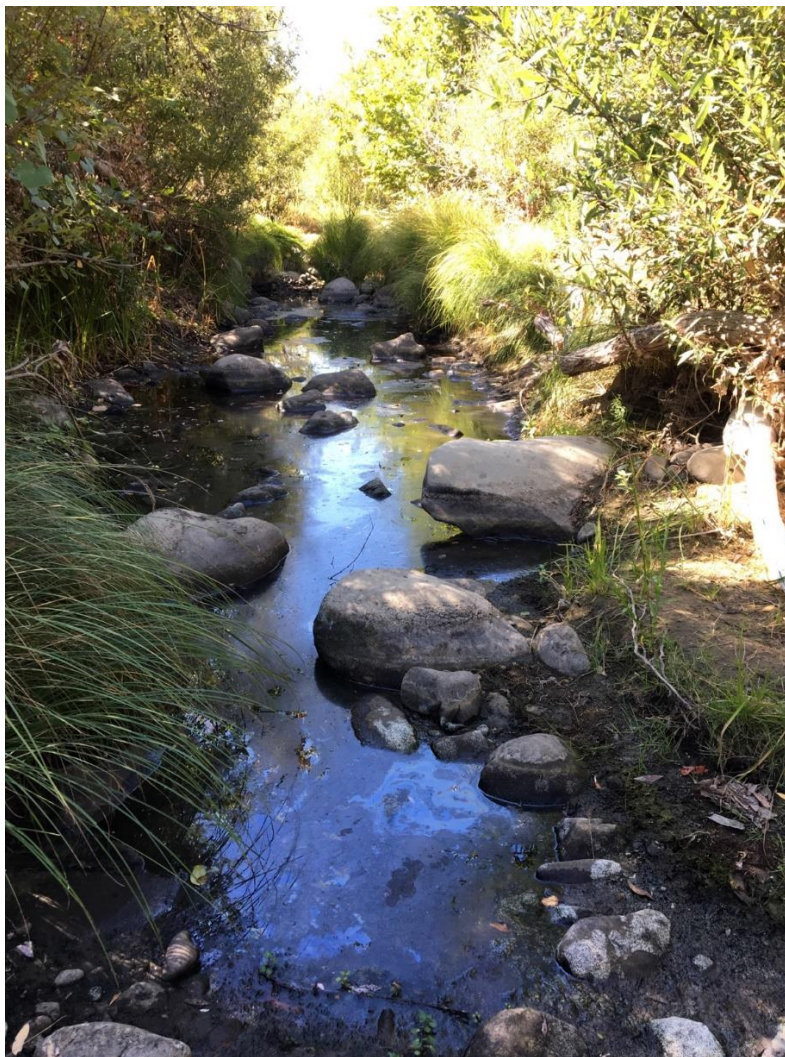
Figure 3: Side Channel to Alameda Creek

Groundwater and Surface Water Impacts: An investigation based on our 2018 Order identified petroleum hydrocarbon impacts to surface water in a nearby channel adjacent to Alameda Creek. Petroleum globules and sheen were observed in the side channel. Interstitial pore water samples were collected by digging shallow pits into sediments adjacent to the creek and sampling the water that flows into the pits. The samples contained petroleum hydrocarbons exceeding screening levels for drinking water and freshwater aquatic toxicity thresholds. Water samples from the main Alameda Creek channel did not exceed screening levels. The side channel, which is groundwater fed, is hydraulically connected to Alameda Creek via groundwater flow, and during flooding events. Additionally, the side channel supports ecological habitat like Alameda Creek. Alameda Creek is used for groundwater recharge, agriculture, commercial, both warm- and cold-water habitat, recreation, spawning habitat, migration, and contains some rare species.

In response to the 2018 discovery of globules and sheen in the side channel, our Order required abatement activities consisting of placing staked straw wattles and absorbent

pads, daily observations, weekly sampling of water within the side channel (Figure 3), and subsequent reporting.
