Re: *Submittal of Pond Characterization Addendum and Response to Conditions –  
Permanente Facility - CIWQS Place ID 273205 (LW); PCA Site ID 2020435*

Re: Workplan Addendum and Response to RWQCB Conditions of Conditional Concurrence  
Dated April 10, 2013, February 22, 2013 Workplan for Pond Characterization (Title 27),  
Permanente Quarry

## **ATTACHMENT 1: DESCRIPTION OF ADDITIONAL PONDS/BASINS**

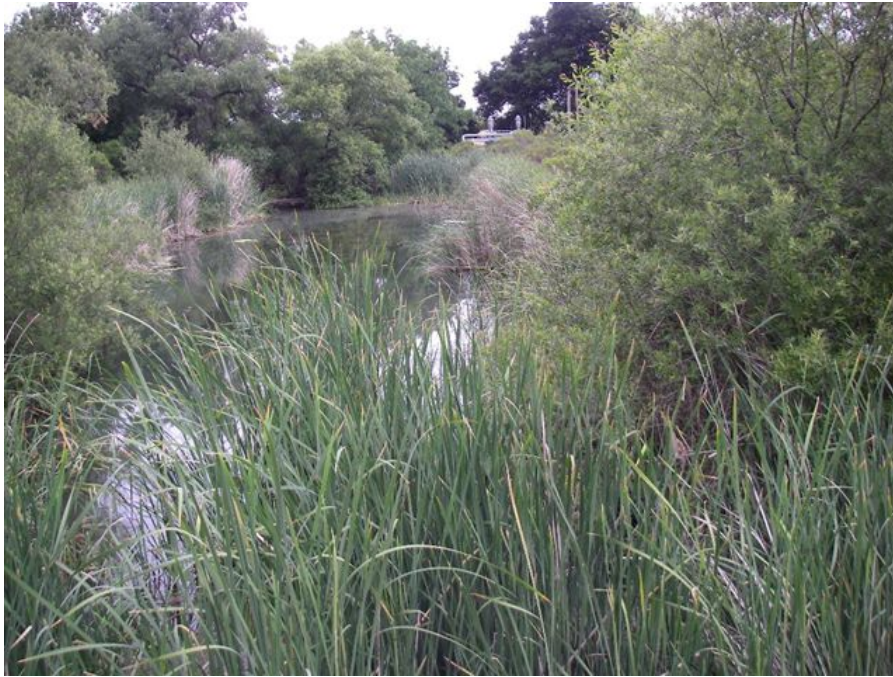
**Photograph 1: Pond 14**

Pond 14 is an unlined pond located within the Permanente Creek watershed just downstream of Pond 22. The pond consists of a concrete wall constructed across Permanente Creek, and was part of the facility's Sediment Control Plan, approved and implemented with significant input from the RWQCB, the California Department of Fish and Game (CDFG), and the Santa Clara Valley Water District (SCVCD). (*Adopted Sediment Control Plan Permanente Cement Plant and Quarry*, Kleinfelder 1992) (Photograph 1). However, a 1999 Cleanup and Abatement Order (CAO) required Hanson to restore the Creek to a natural flowing condition by allowing the Creek to bypass Pond 14, while maintaining CRLF and wetland habitat in Pond 14. This work was documented in the *Bypass Work Plan and Implementation Schedule*, and was performed by Hanson in the early 2000s.

The 2010-2011 Annual Storm Water report for the site explicitly states the following: “*Ponds 22 and 14 have not been maintained due to the presence of federally-listed Threatened California red-legged frog. Pond 14 is utilized as a diversion retention pond to capture sediment in case any upstream infrastructure is damaged or overwhelmed in a storm event... these ponds are no longer maintained and therefore they are not expected to remove sediment.*”

- CRLF is present in 14, 21, and 22, and are successfully breeding in Ponds 14 and 21.
- Ponds 14, 21 and 22 have been delineated as Waters of the U.S., and are effectively within Permanente Creek.

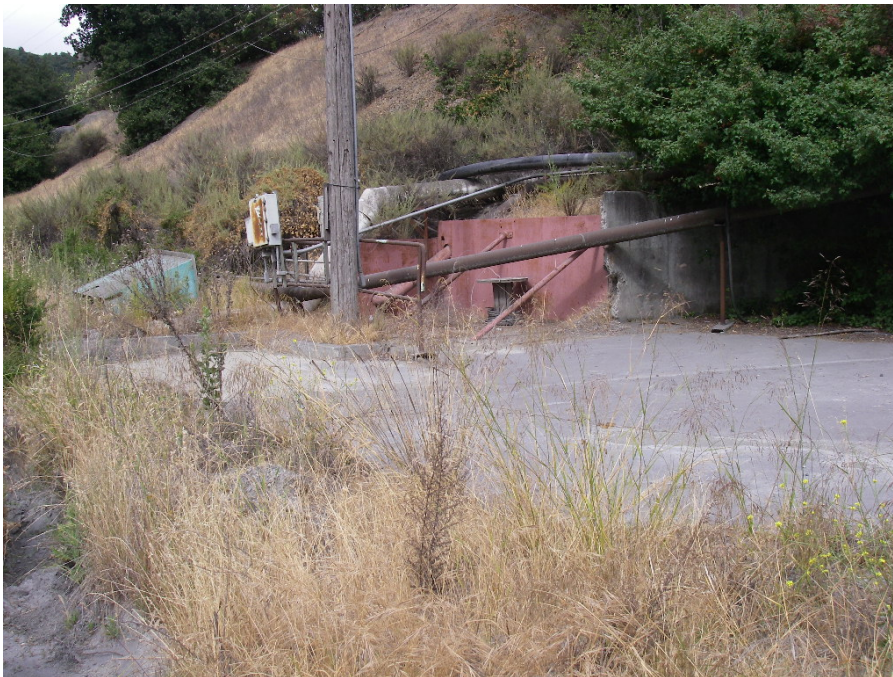
**Photograph 2: Pond 18**

Pond 18 consists simply of a concrete pad structure that is located adjacent to a sump that historically pumped the truck wash water from the Cement Plant and Rock Plant areas to the Reclaim Water System (Photographs 2 and 3). This area was not designed to function as a “pond,” and no long-term storage of water or accumulation of sediments occurred there.

This area is not currently used, and simply consists of a lined area that was designed to capture and convey the wash water toward the sump to which Pond 18 is connected.

- These basins were not designed or act as ponds. These are actually catch basins or sumps that are already steel and/or concrete lined, and do not merit further analysis as a surface impoundment that may pose a threat to groundwater.
- In the case of Basin B, characterization is not feasible because this basin has been destroyed.

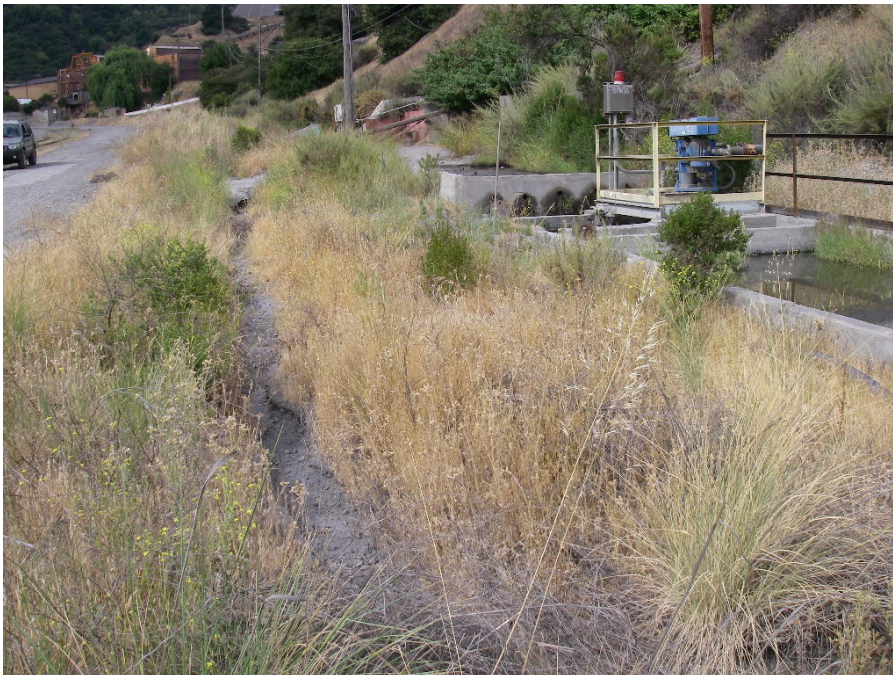
Currently, because the pond is shallow and small, and has not been maintained over the years due to CRLF, the exact location of Pond 19 cannot be identified, so a photo of Pond 19 does not accompany this document. However, a photo upstream of Pond 20 is included (Photograph 4), which shows the drainage channel between Ponds 19 and 20 (left hand side of the photograph, flows through the single small culvert on the left-hand side of the photo), the now defunct Pond 18 infrastructure (top right, reddish color) adjacent to what is believed to be Pond 19, and the currently used truck wash reclaimed water system that captures and conveys truck wash water back into the Reclaim Water System of the Permanente Facility.

**Photograph 4: Upstream of Pond 20. Pond 18 is also visible in the upper right (near the rust-brown steel structure). Also visible is drainage channel between Ponds 19 and 20, although the exact location of Pond 19 cannot be located.**

- The areas of Ponds 19 and 20 are currently poorly defined and not discernible from the surrounding terrain.
- The areas of these ponds are inhabited by CRLF. Soil sampling could potentially be conducted after agency authorizations are obtained and work windows to minimize disturbance to CRLF are established. However, even if sampling is conducted and analytical results suggest that typically prescribed activities under Title 27 (i.e. soil removal or capping) are warranted, such activities could not be implemented without destroying the habitat. Therefore, there is no reasonable basis to conduct further characterization<sup>1</sup>.

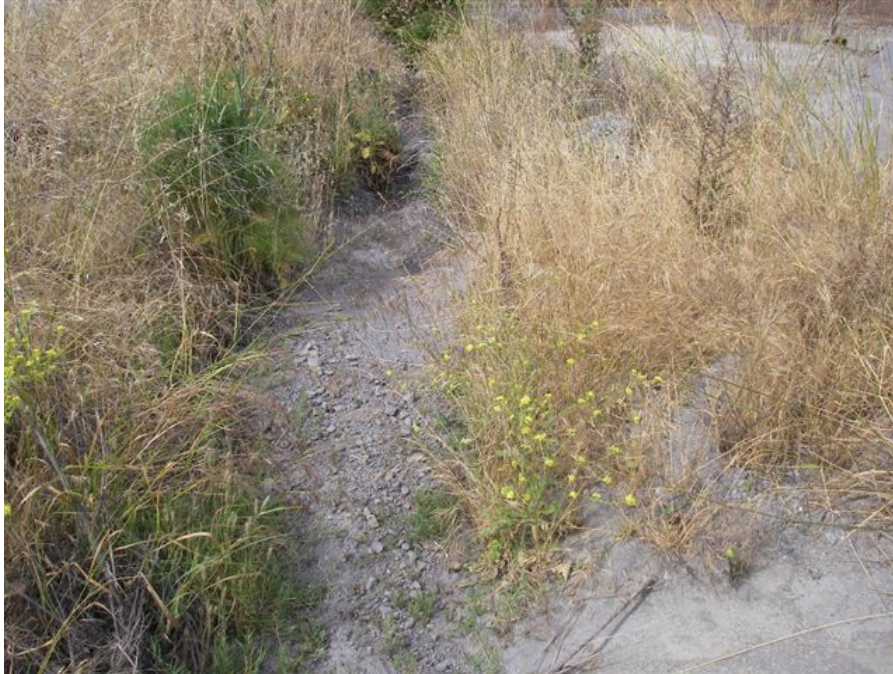
**Photograph 5: Pond 20 (presumed)**

Pond 20 is a shallow unlined pond that receives storm water runoff from Pond 19, and subsequently discharges to Pond 21. Pond 20 also receives runoff from the south slope hillside, the entry road, guard gate, and EMSA access road areas (Photographs 4 and 5). Pond 20 may

also receive remnants of non-potable water from the facility used for dust suppression, and can periodically receive water from the truck wash system in emergency scenarios (severe storms or pump failures). Water in Pond 20 subsequently flows to Pond 21 through a drainage channel. Lehigh samples the discharge from Pond 20 to Pond 21 and that discharge is regulated by the NPDES Permit for Sand & Gravel operations.

Currently, because the pond is shallow and small, and has not been maintained over the years due to CRLF, the exact location of Pond 20 cannot be identified, but is generally located adjacent to the sump that is associated with the currently used truck wash and reclaimed water system.

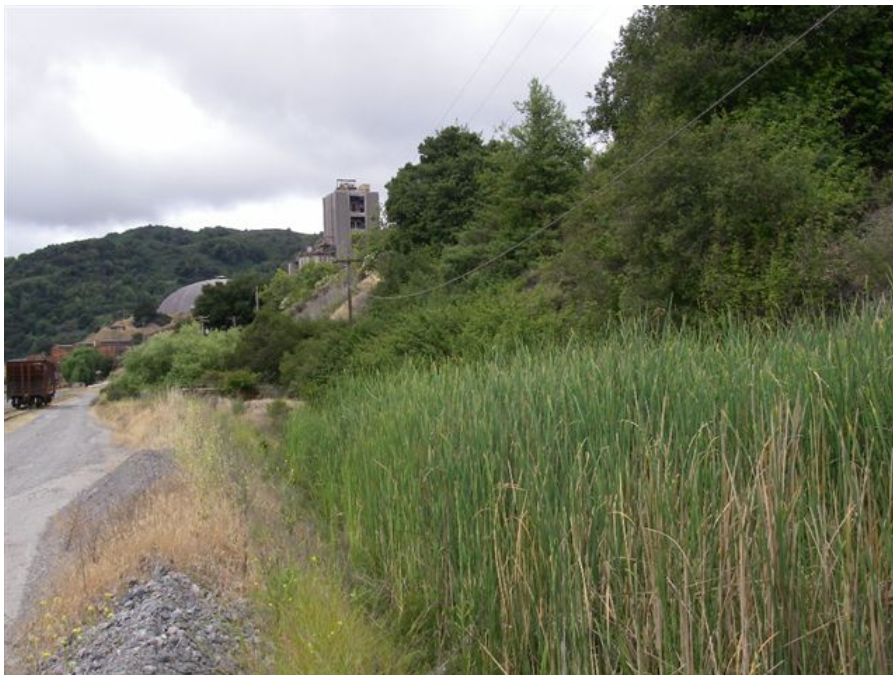
**Photograph 6: Pond 21.**

Pond 21 is a shallow, unlined pond that conveys flows from Ponds 19 and 20, as well as localized storm water runoff and/or remnants of non-potable water from the facility used for dust suppression, to Permanente Creek (Photograph 6). Pond 21 has been determined to be a jurisdictional "Waters of the United States," and is treated as such by Lehigh.

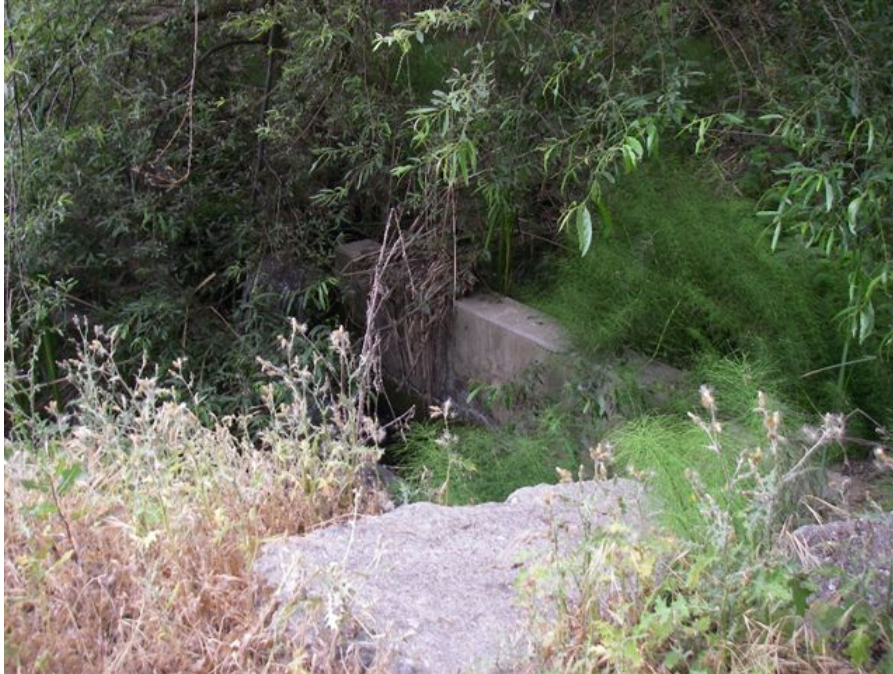
Pond 22 is an unlined pond that is actually located within Permanente Creek (Photographs 7 and 8). Historic aerial photographs indicate that Pond 22 existed in some form by 1987, either as a constructed basin or a natural creek feature. The current configuration of Pond 22, however, was constructed in the 1990s and includes a concrete dam structure as well as a steel diversion structure, culverts, and an ancillary concrete structure at the pond outlet. These structures were installed to slow the Creek's flow and create a pond-like water feature.

**Photograph 7: Downstream terminus of Pond 22 at concrete weir**

Pursuant to the proposed Consent Decree between Lehigh and the Sierra Club, the steel diversion structure, culverts, and ancillary concrete structure at the pond outlet will be removed, leaving the concrete dam structure in place. Immediately down-gradient of the concrete dam structure, Lehigh will create an appropriate transition channel profile to ensure sustainable fish passage up and over the concrete dam structure.

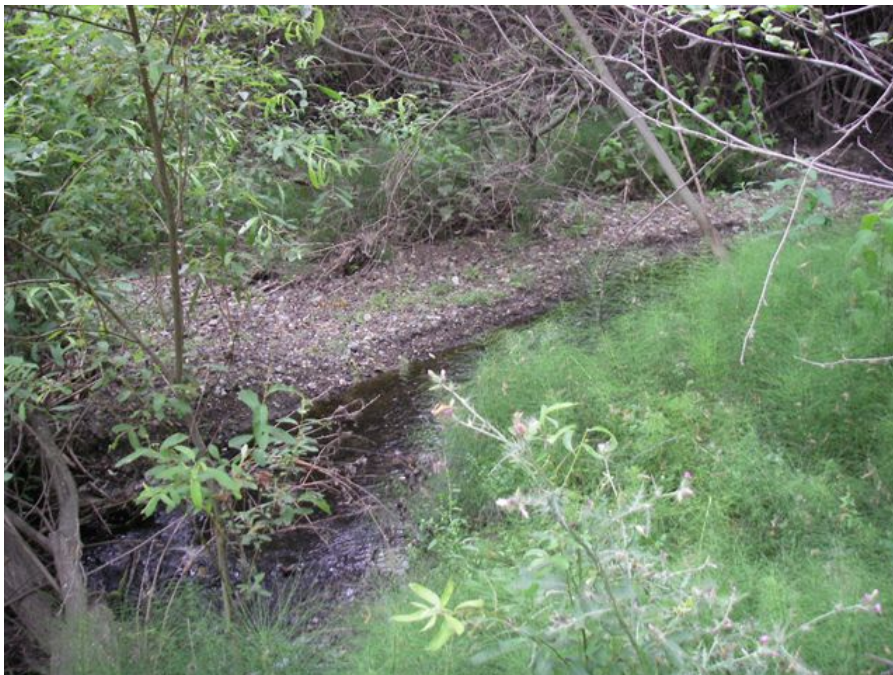
**Photograph 8: Pond 22 just upstream of the weir**

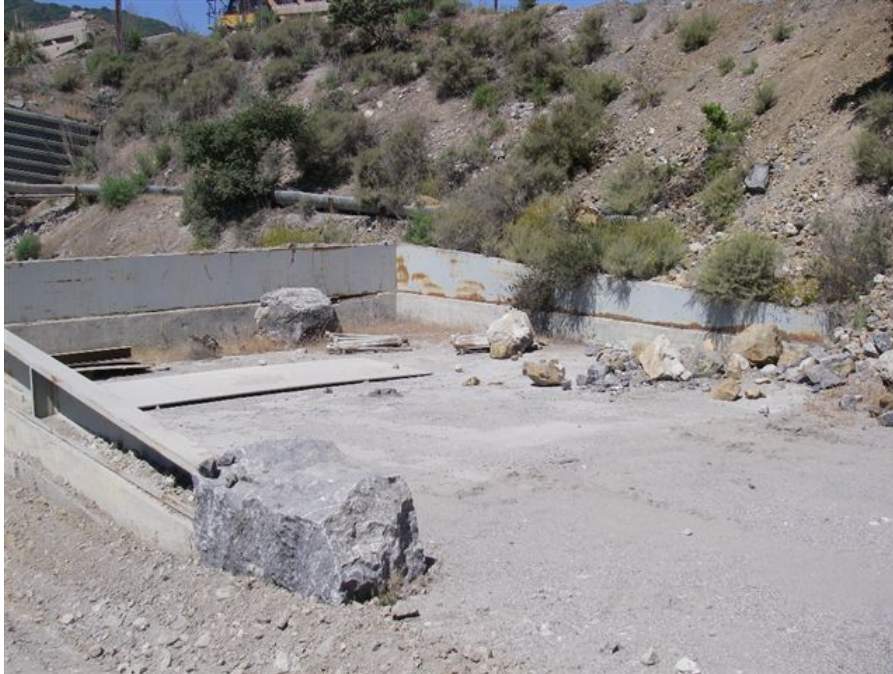
**Photograph 9: Basin A**

Basins A and B were originally constructed as concrete catch basins east of the Primary Crusher with drainage culverts to collect storm water runoff from the nearby road and related areas that was subsequently diverted to Pond 13A.

- Basin A still exists physically, but it is no longer hydrologically connected to Pond 13A and does not act as a catch basin.
- Basin B has been destroyed, and no longer exists.
- Basin E was re-plumbed in 2012 so that there is no longer a connection to Pond 13A. Water from Basin E is either reused in Primary Crusher operations or is pumped to Pond 4A.

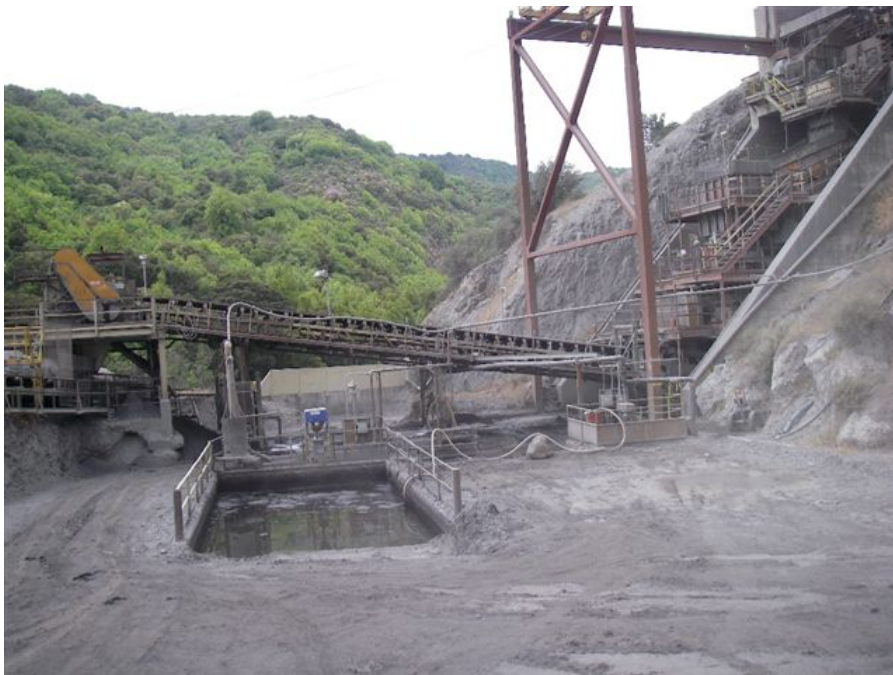
**Photograph 10: Basin E**

Basin E was constructed as a steel and concrete sump installed underground and adjacent to the wash-water basin at the Primary Crusher to capture and reuse that water and overland runoff from the Primary crusher area; this Basin was previously connected and could discharge to Pond 13A. These areas were not designed to function or appear as "ponds."

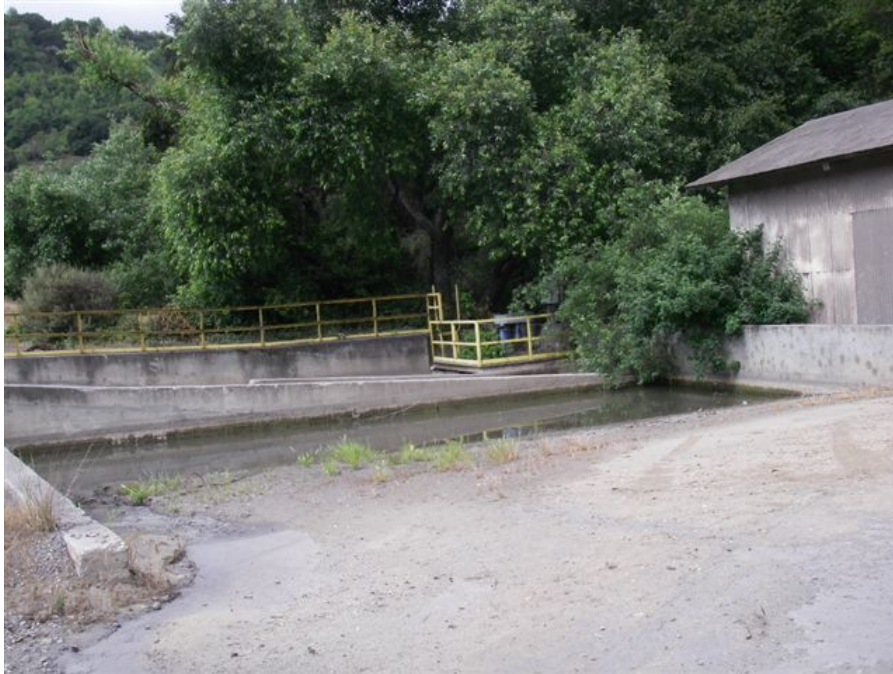
The Dinky Shed Basin was built in 2000 and is located at a topographic low-point in the vicinity of Pond 9 and the entrance into the Rock Plant. The Dinky Shed Basin is essentially a concrete-lined collection basin and sump that has also been referred to as the Dinky Shed Pond (Photographs 11 and 12). This sump collects storm water and dust suppression water from the Lower Quarry Road below the Pond 9 interceptor grates, and from the Rock Plant road below the Pond 17 interceptor grates. Water collected in the Dinky Shed Basin is pumped into the Reclaim Water System.

**Photograph 11: Dinky Shed Basin. Note pump located just beyond the sump near the yellow railing**

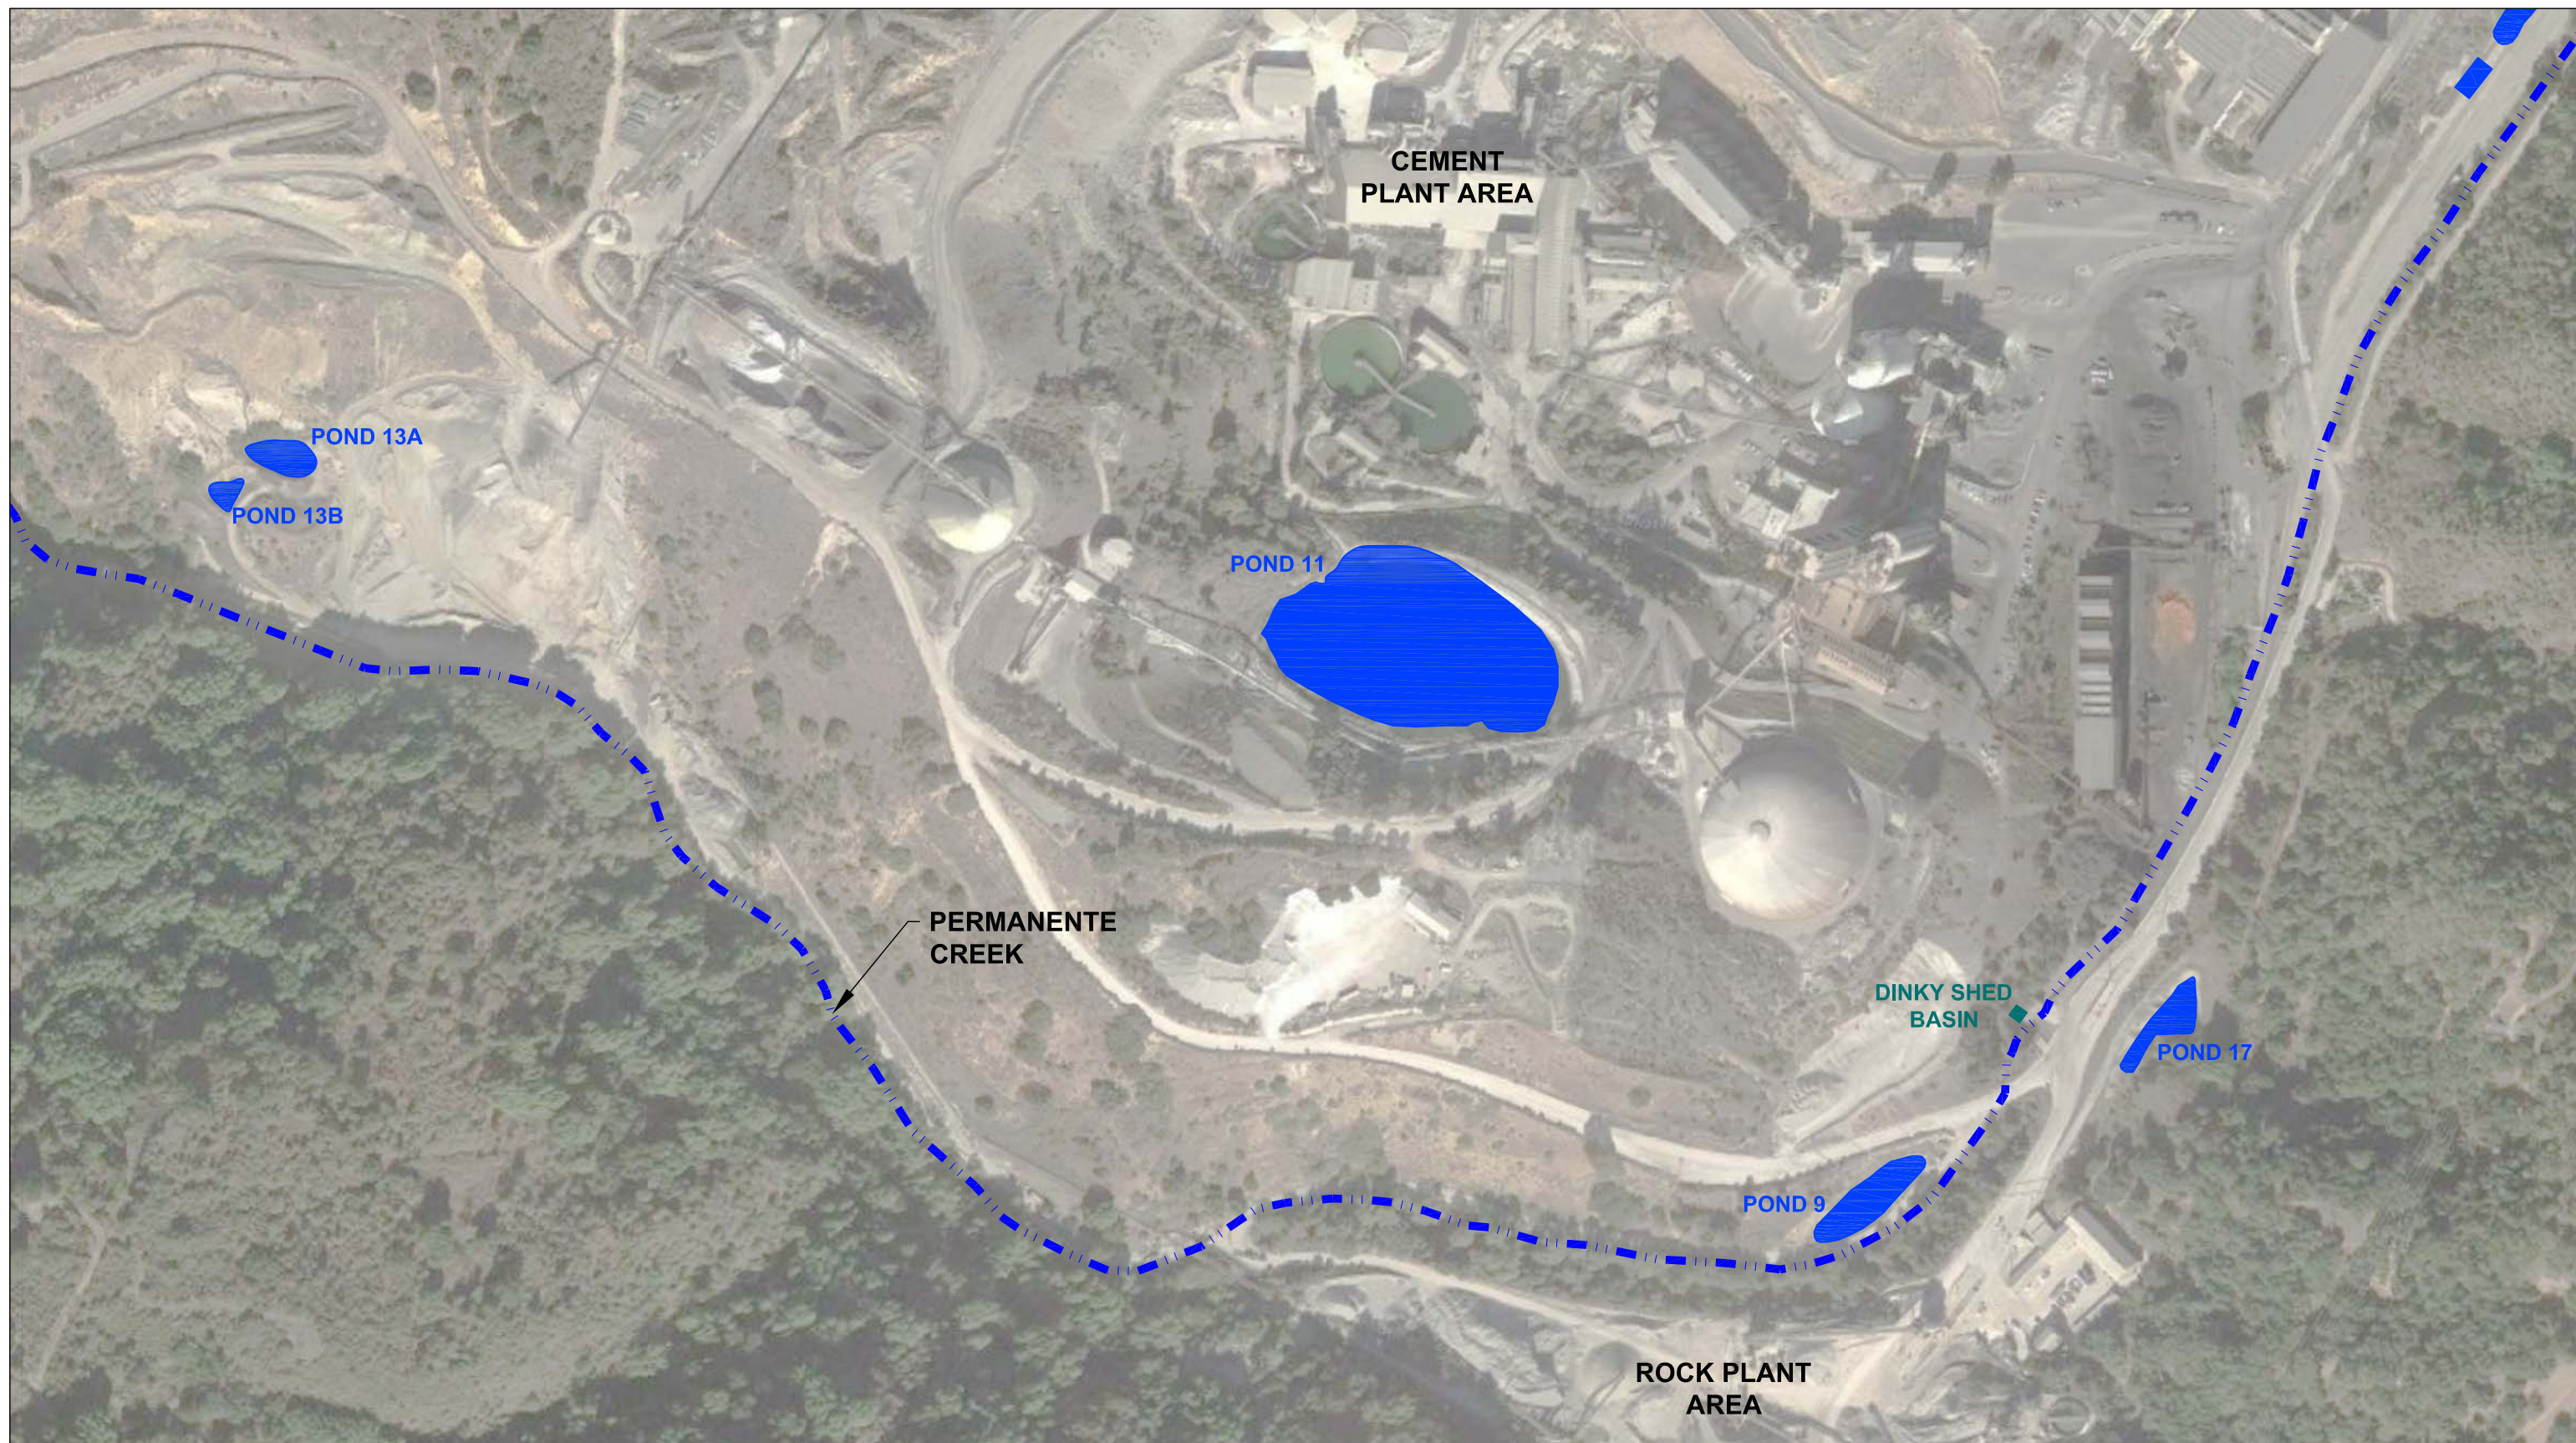
Figure 3

**Pond Locations**

Condition 1 of the April 10, 2013 Conditional Concurrence to the February 22, 2013 *Workplan for Pond Characterization* (Workplan) requests additional information on the following “ponds” or basins to determine whether these areas are surface impoundments that should be characterized for regulation under Title 27: Ponds 14, 18, 19, 20, 21, 22 the Dinky Shed Basin, and Basins A, B, and E. Figures 1-5 show the location of these ponds, and photographs are provided in Attachment 2.
