Figure 16  
 Sub-basin Geomorphic/Hydrologic Features  
 Chiquita and Narrow Canyon Sub-Basins  
 Infiltration and Runoff

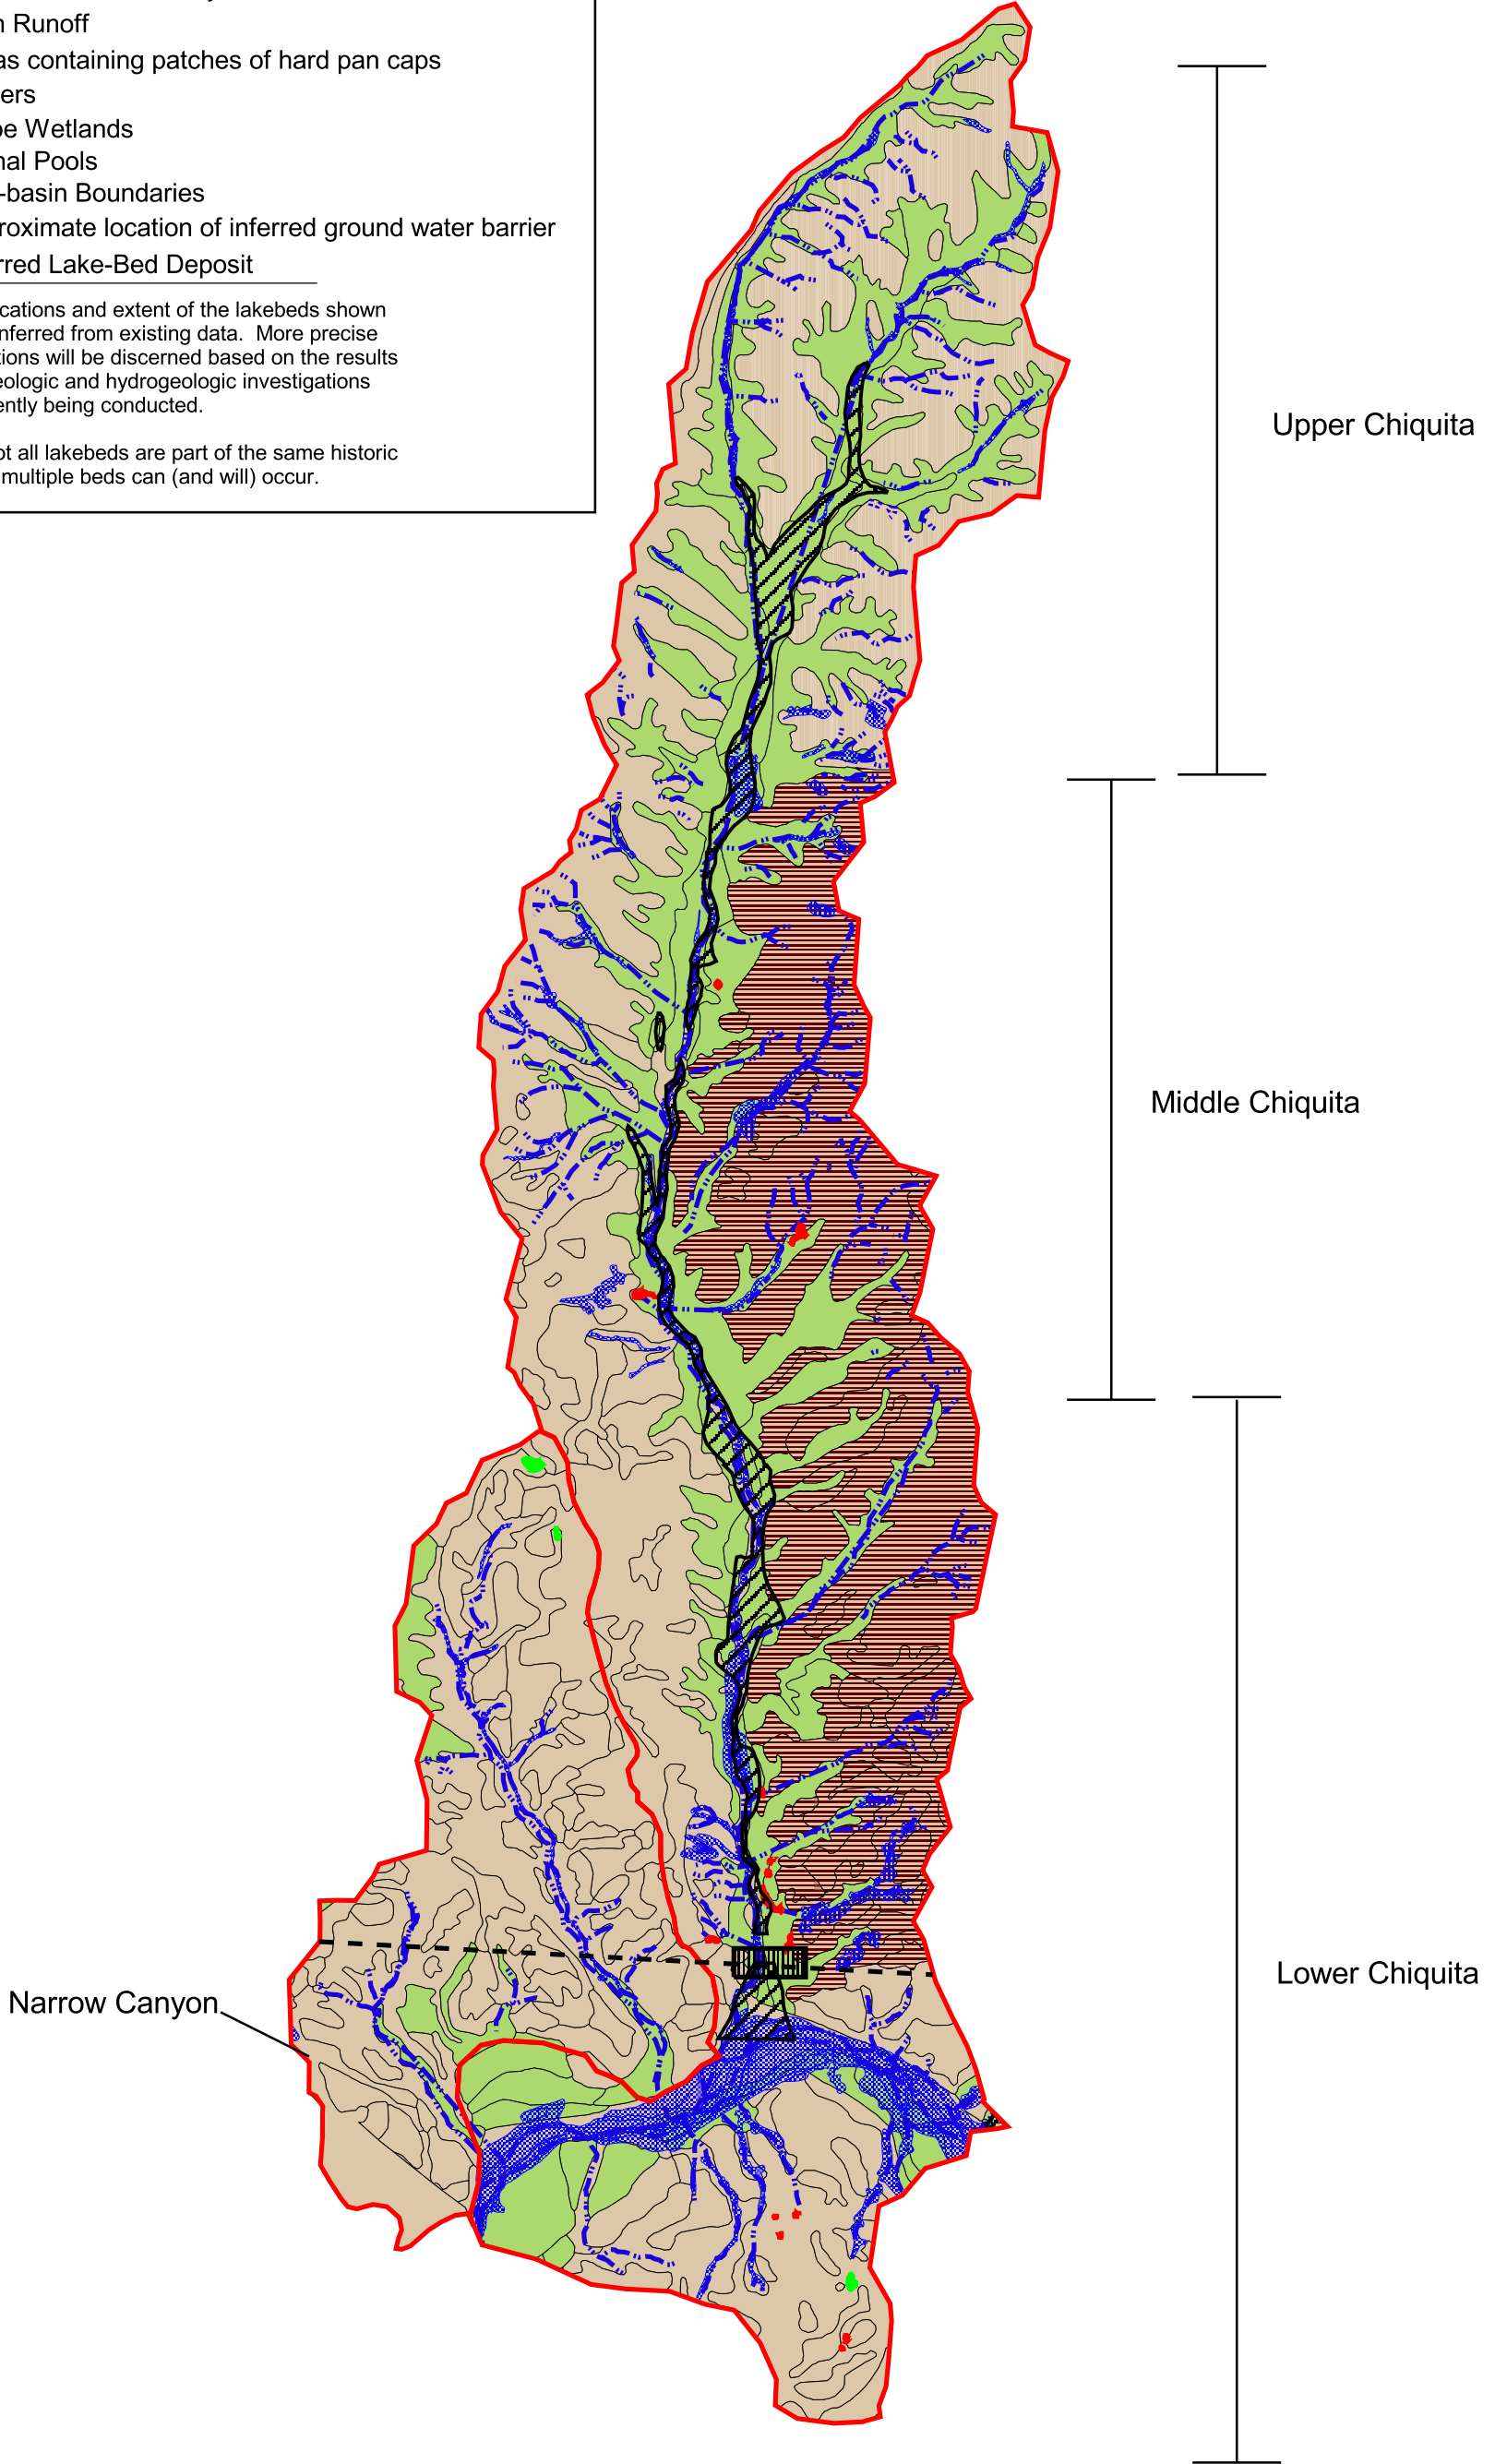
- Infiltration Areas/Sandy Swales
- High Runoff
- Areas containing patches of hard pan caps
- Waters
- Slope Wetlands
- Vernal Pools
- Sub-basin Boundaries
- Approximate location of inferred ground water barrier
- Inferred Lake-Bed Deposit

(a) locations and extent of the lakebeds shown are inferred from existing data. More precise locations will be discerned based on the results of geologic and hydrogeologic investigations currently being conducted.

(b) not all lakebeds are part of the same historic lake; multiple beds can (and will) occur.
