State of California The Resources Agency Department of Water Resources

SUMMARY OF THE COLLECTION, HANDLING, TRANSPORT, AND RELEASE (CHTR) PROCESS AND DATA AVAILABLE ON STATE WATER PROJECT (SWP) AND CENTRAL VALLEY PROJECT (CVP) FISH SALVAGE

DECEMBER, 2005

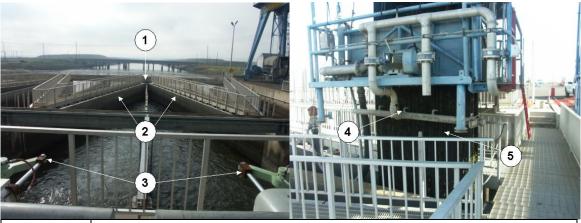
Figure 2-7 Louvers

<u>Louvers</u> – The louvers are designed to divert fish into the bypass system while passing flow to the pump station. The channel downstream of the flow control gates is divided into 5 bays containing the louvers. The louver assemblies are comprised of two panels, stacked and bolted together. Each panel is approximately 13.75 feet high. The louvers are arranged in a "Vee" shape and are composed of one-inch-clear vertical slots oriented perpendicular to the direction of flow. The louvers turn the water 90-degrees to flow between the slots. This creates turbulence along the face of the louvers. Theoretically, the fish seek to avoid the turbulence and are thus guided to the bypass at the apex of the "Vee". The louvers are seated on vertical pipe guides. Cleaning is accomplished by lifting a louver panel with the gantry crane and washing it with high-pressure washer hoses mounted to the gantry crane structure. See Figure 2-7.

1	Fish Bypass Entrance
2	Louvers (looking downstream)
3	Flow Control Vane Actuators
4	High-pressure nozzle for louver cleaning.
5	Louver is in raised position for cleaning.

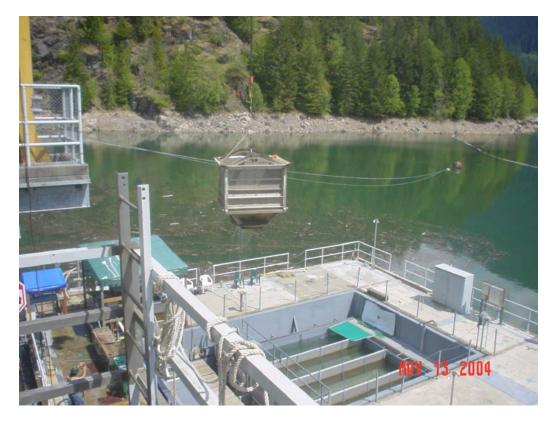
Figure 1 Hopper and Fish Trap

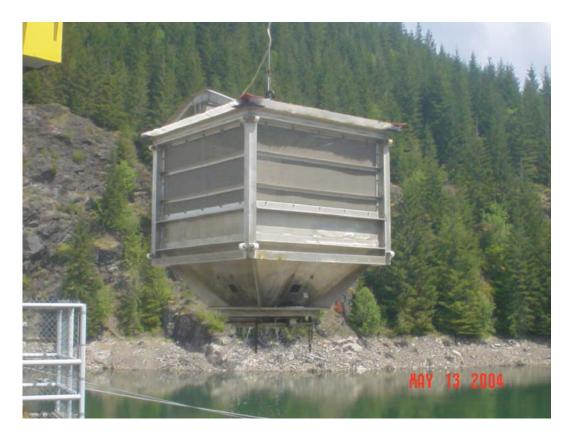
Figure 2 Fish Hopper

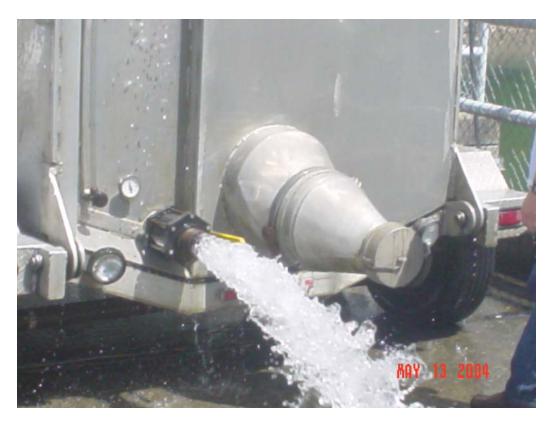
Figure 4 Drain Valve and Release Pipe

The trailer is towed about 10 miles to the confluence of the Baker and Skagit Rivers. The truck backs the trailer down a boat ramp into the water so that the release pipe is partially submerged. No extension pipe is required. The release gate is then opened, and the fish are released directly into the river. The gate is located inside the trailer and is operated after the hatch in the top of the tank is opened. The advantage of the trailer is that it can be backed into the water. A tanker truck's wheels would be in the water and loose traction.

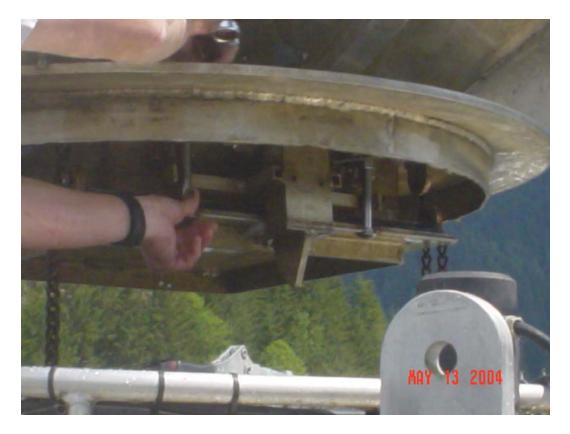
Figure 5 Release Latch and Retaining Bolts

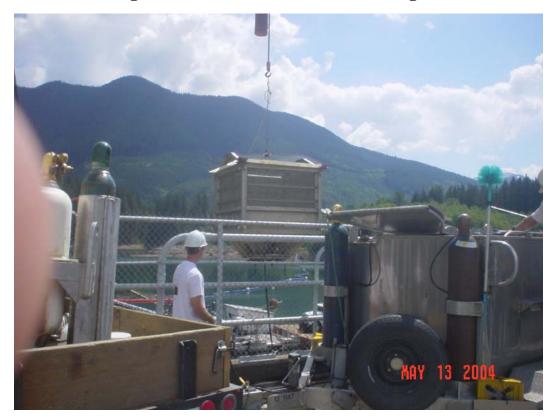
Figure 6 Transport Trailer
