NOTICE OF VIOLATION FOR UNAUTHORIZED DIVERSION AND FAILURE TO FILE
A STATEMENT OF WATER DIVERSION AND USE FOR DEL NORTE COUNTY
ASSESSOR PARCEL NUMBER (APN) 127-200-020.

Subject: Notice of Violation, Transmittal of Inspection Report for October 12, 2022, Inspection of Del Norte County Assessor's Parcel No. 127-200-020, and Requirement to Respond within 30 days

FACILITIES INSPECTION REPORT

Crowley Inspection Photo Log -Attachment C
Photos taken October 12, 2022, by Katherine Hawken

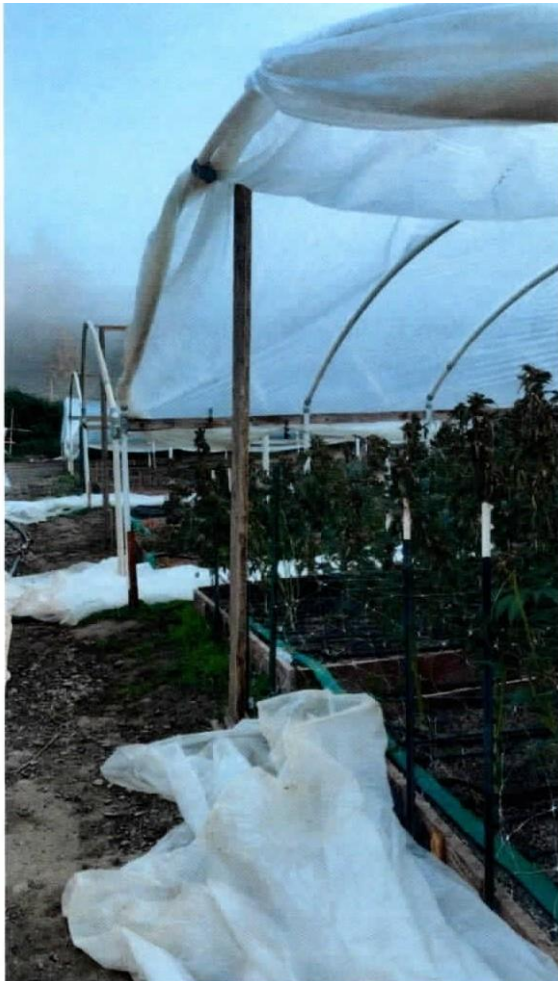
Cultivation Area: I observed three active hoop houses with cannabis plants in raised beds (Photo 1). I observed plastic netting around the plants. I observed potting soil and plant waste piled around the hoop houses (Photo 2).

Photo 1, Cultivation Area: Hoop houses with cannabis plants in raised beds

2. If the owner and/or tenant plan to continue cultivating cannabis, enroll for coverage under the state Water Board's Order WQ 2019-0023-DWQ, General Waste Discharge Requirements and Waiver of Waste Discharge Requirements for Discharges of Waste Associated with Cannabis Cultivation Activities and take steps to comply with all local and state regulations governing cannabis cultivation.

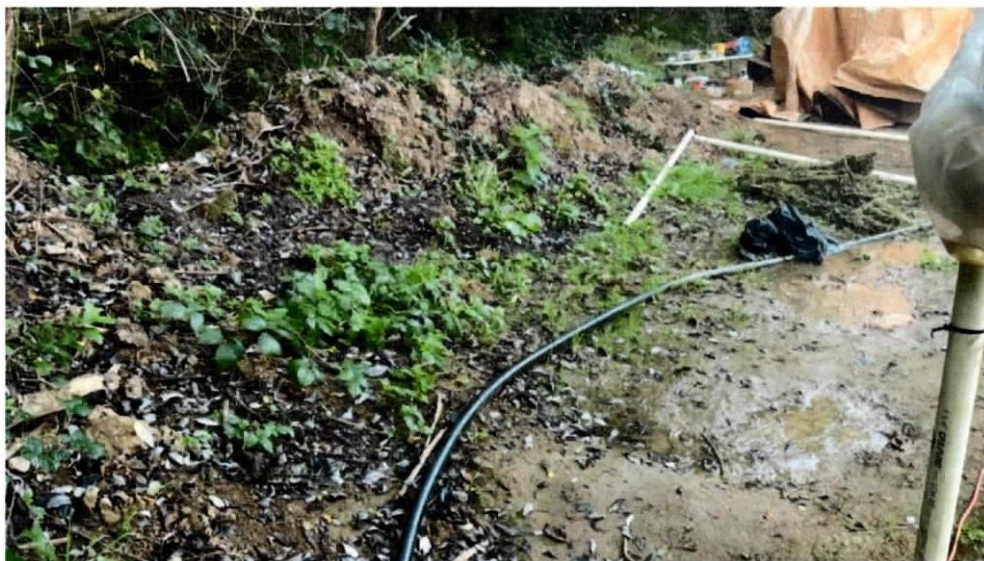
Photo 2, Cultivation Area: Potting soil, plant waste, and trash piled around hoop houses

3. Contain and properly dispose of potting soil, fertilizers, plant waste, petroleum products, and human waste to prevent spillage and transport into receiving waters, and to maintain public health. Relocate materials at least 50 feet away from ephemeral watercourses, and 100 feet away from wetland habitat.

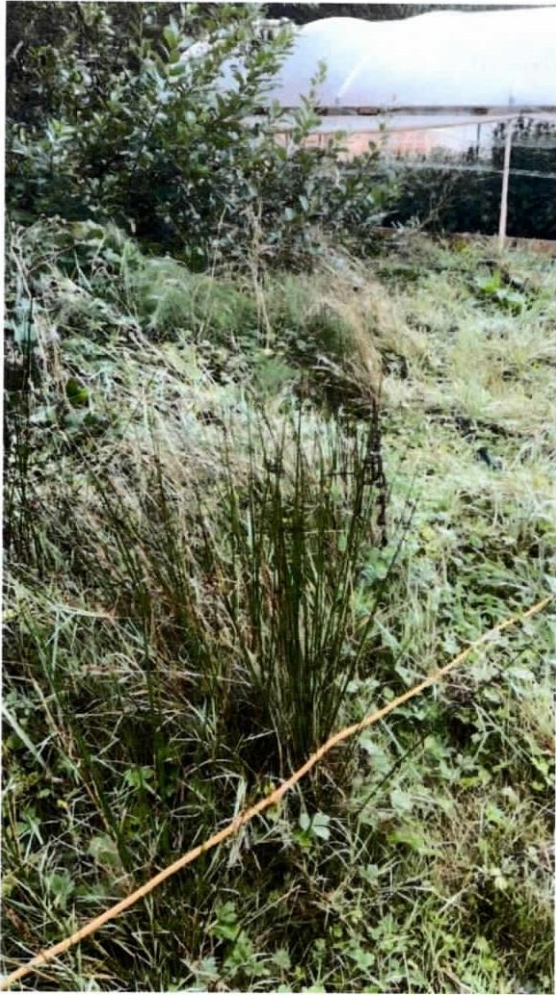
Wetland: Emergent freshwater wetlands are mapped on this Property. I observed hydrophytic plants including willows, alders, skunk cabbage, rushes, and sedges. I observed isolated areas with standing water. I observed grasses growing around the hoop houses, and willows on the edges of the cultivation area (Photo 3).

Photo 3, Wetland: View of hydrophytic plants near the cultivation area

1. Prior to further development of the Property, retain a qualified professional to delineate the extent of the wetlands. Do not operate machinery in, stockpile materials next to, or otherwise threaten discharges of waste to wetlands.

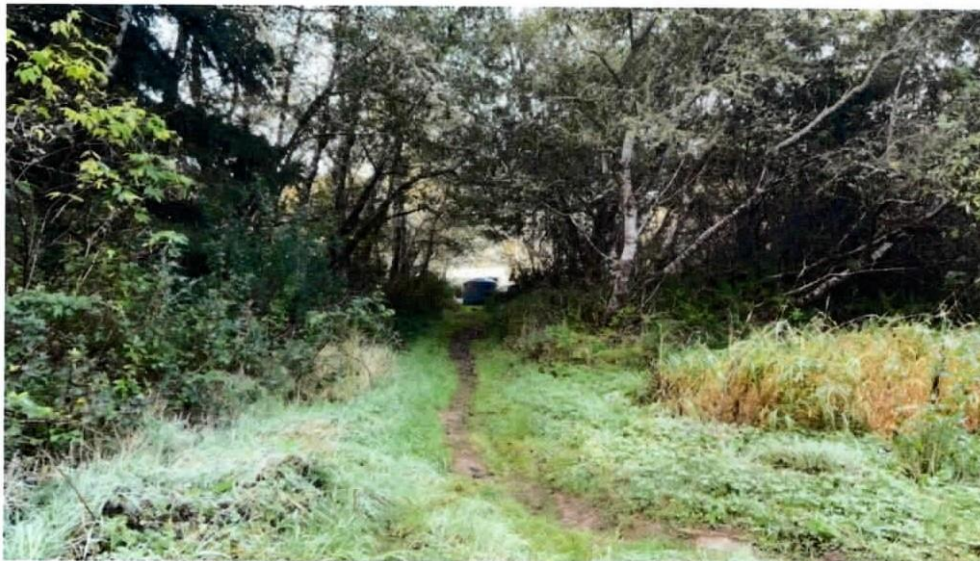
Storage Area: I observed a dirt road from the cultivation area, through wetland habitat, to a materials storage area (Photo 4). I observed water storage tanks, fertilizer containers, petroleum products, and a pump situated atop an ephemeral culvert stream crossing on the dirt road (Photo 5-6). The fertilizers and petroleum products were stored inadequately to protect the adjacent watercourse and wetland complex.

Photo 4,
Storage Area:
View of road
through
wetland
habitat
leading to
water storage
tanks

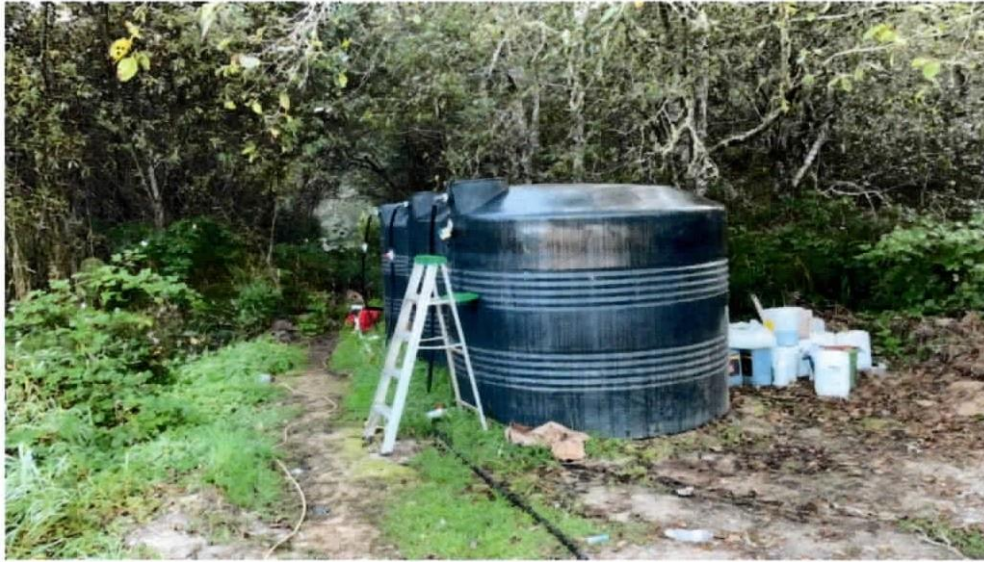
Photo 5,
Storage Area:
Water storage
tanks,
fertilizers, red
pump, on dirt
road surface
atop culvert
stream
crossing

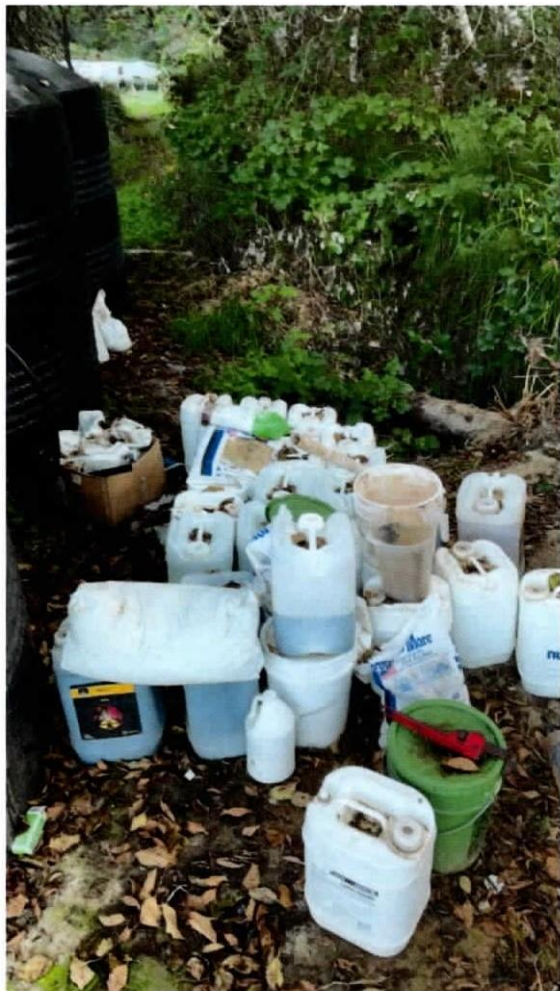
Photo 6, Storage Area: Fertilizer containers
near ephemeral watercourse culvert inlet.
View of cultivation area in background

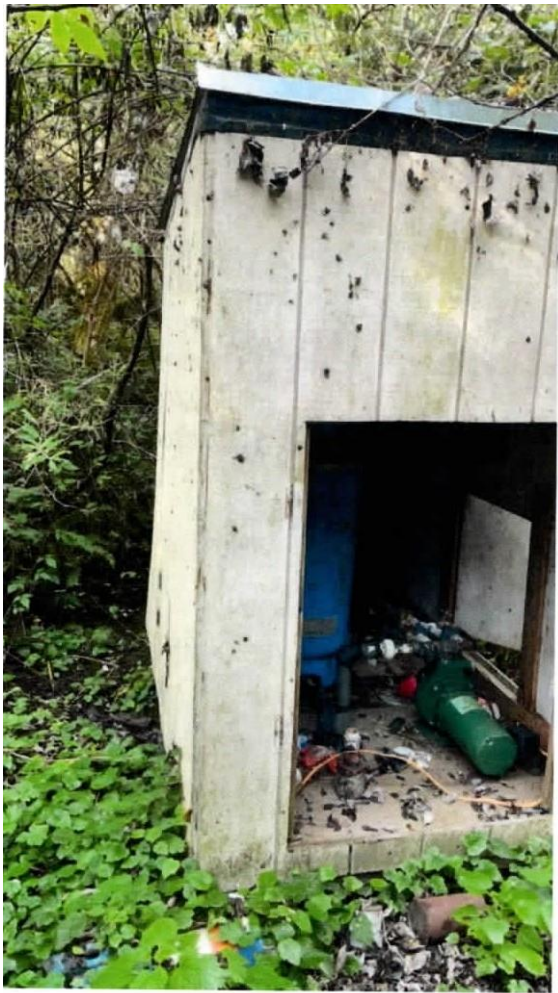
Water Source: I observed a well shed near a pool of standing water in the wetland complex (Photo 7). The water lines connecting to the well shed were buried.

Photo 7, Water Source: Well shed in wetland complex. Pool of standing water visible behind well shed

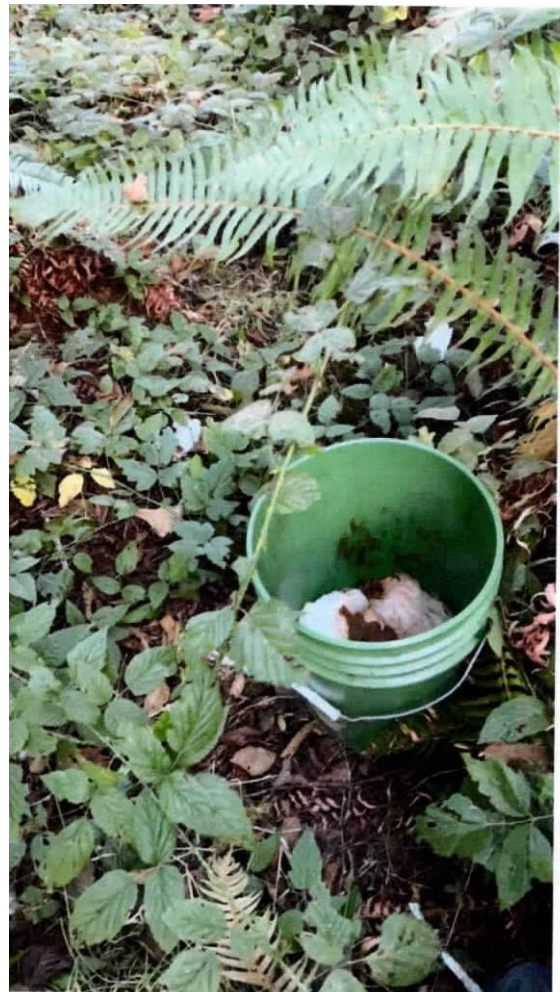
Human Waste: I observed human waste and toilet paper in a bucket and on the ground in the wetland complex (Photo 8).

Photo 8, Human Waste: Bucket with human waste and toilet paper. Waste also visible on ground
